Beam End Repair for Prestressed Concrete Beams

Final Report
September 2020

Sponsored by
Iowa Highway Research Board
(IHRB Project TR-715)
Iowa Department of Transportation
(InTrans Project 17-598)

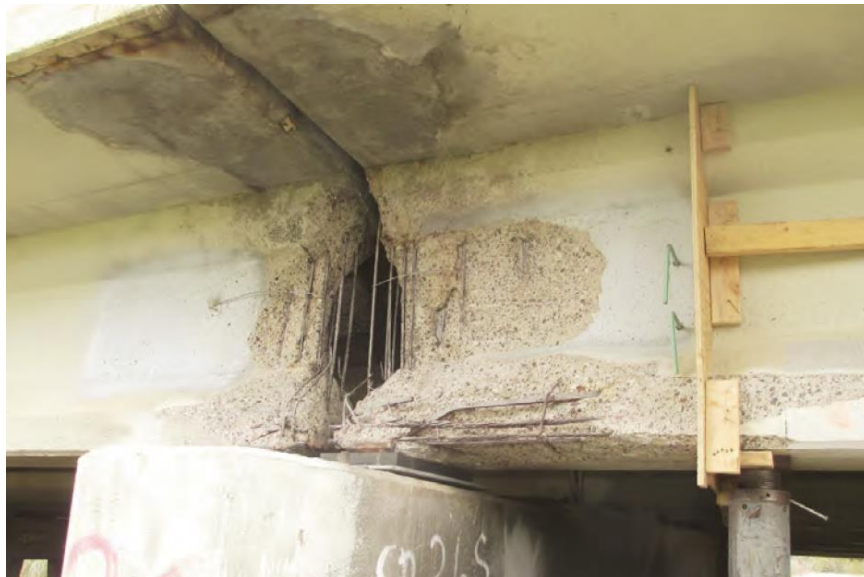
When possible, expansion joints are eliminated by utilizing integral abutments. However, in cases where integral abutments are not feasible, a common problem noted by departments of transportation (DOTs) across the nation is the considerable deterioration of the beam-end regions compared to the otherwise satisfactory condition of the remainder of the beam. This deterioration has a few contributing factors. Due to failure at the expansion joints, water containing deicing agents begins to flow directly onto the beam ends. Subsequently, freezing and thawing cycles of these saturated beam ends cause scaling and spalling of the concrete cover, resulting in direct exposure of the reinforcing steel. Once the steel is exposed, the girders experience accelerated corrosion and further damage in the region of the water infiltration (Figure 1.1).

Figure 1.1. Severely corroded prestressed concrete girder (Minnesota)

Additional corrosion of the bottom flanges of beam ends results from the chloride-laden runoff near the deck drainage pipes. This type of damage is localized near the bearings and therefore the

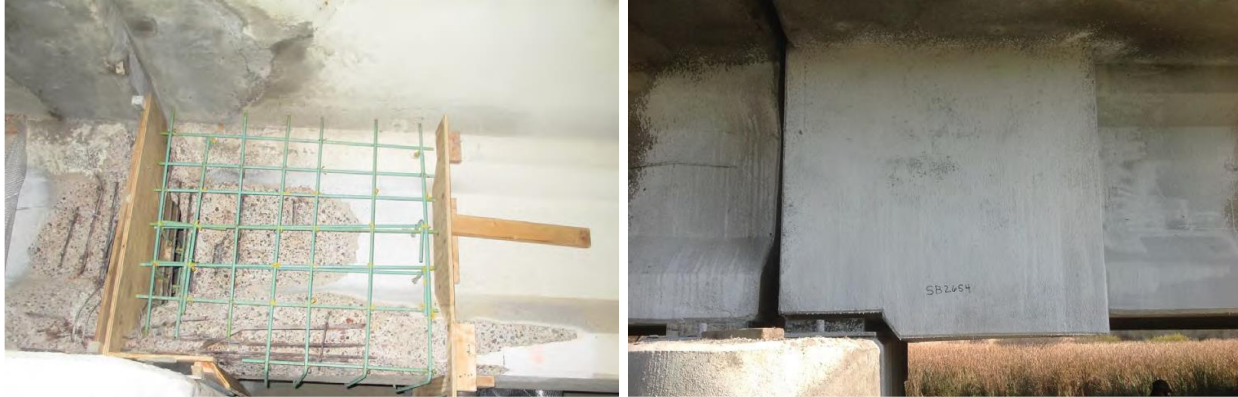
A variety of materials can be used in concrete beam patch repairs. Mortar repairs are common for mild to moderately damaged beam ends. Patching with mortar succeeds in replacing lost concrete cover; however, this material fails to restore the original strength and stiffness of the girder (Shaw and Andrawes 2017). Normal concrete (NC) has also been used in repair methods (Figure 2.1) (Shield and Bergson 2018).

Figure 2.1. Reinforced shotcrete repair of a damaged beam end in Minnesota

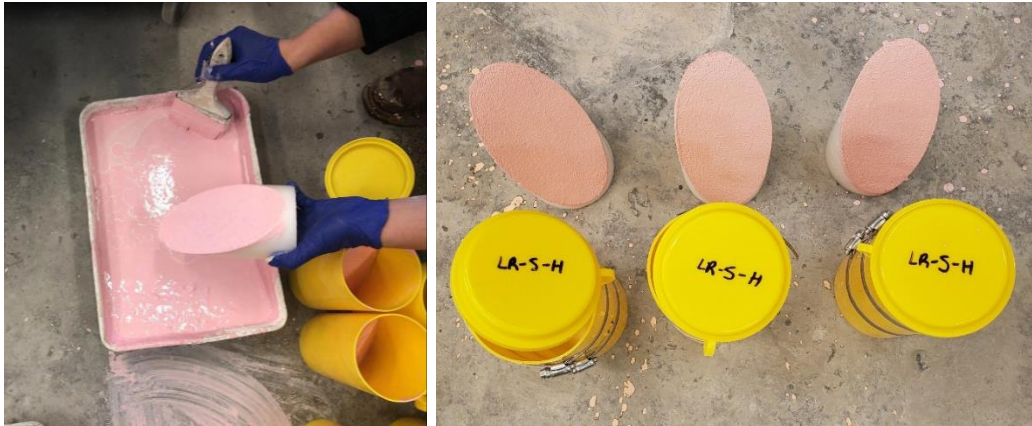
To compare the effects of the surface roughness of the interface between conventional concrete and the patching materials, three levels of roughness were studied for this research. Unroughened (UR) samples had a relatively smooth interface surface because they were cast against foam forms. Roughened samples were achieved by applying a chemical retarder to the mold before pouring the concrete (Figure 3.2).

Figure 3.2. Formwork retarder application

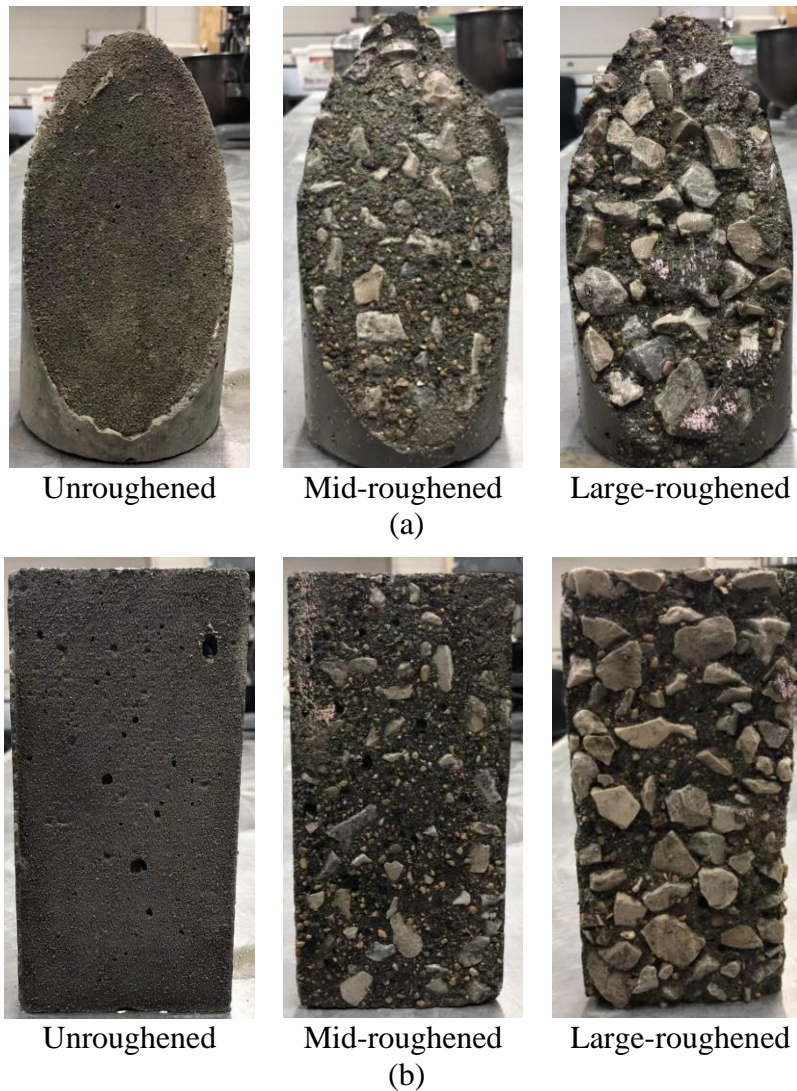
After 24 hours, each roughened specimen was washed to remove the unset material and expose the aggregate. Mid-roughened (MR) samples had a theoretical peak-to-valley depth of $3/8$ in. Large-roughened (LR) samples had a theoretical peak-to-valley depth of $5/8$ in. Sample specimens showing each surface type are presented in Figure 3.3.

Figure 3.3. Various levels of surface roughness for the substrate specimens: (a) slant shear specimens and (b) splitting tensile specimens

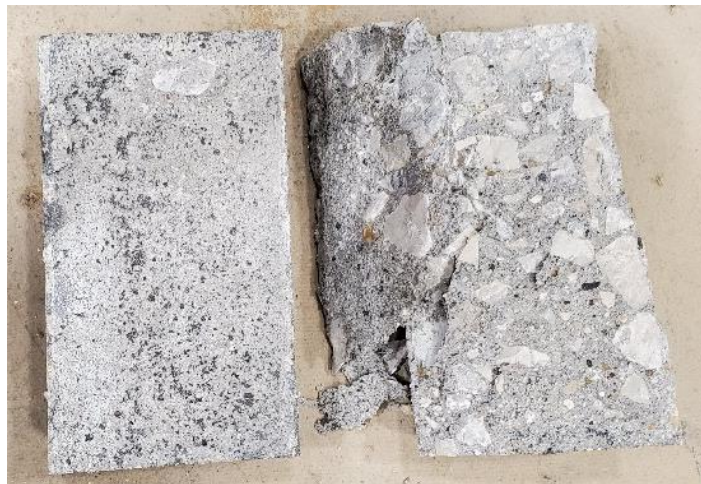
Figure 3.9 shows a broken UHPC-NP specimen after failure, with fragments on the right showing the substrate and the portion of substrate material that had remained bonded to the UHPC-NP. The condition of this sample indicates that failure of the substrate likely occurred before the higher strength UHPC-NP failed, resulting in much higher peak loads recorded by the testing machine.

Figure 3.9. Example of UHPC-NP specimen after failure

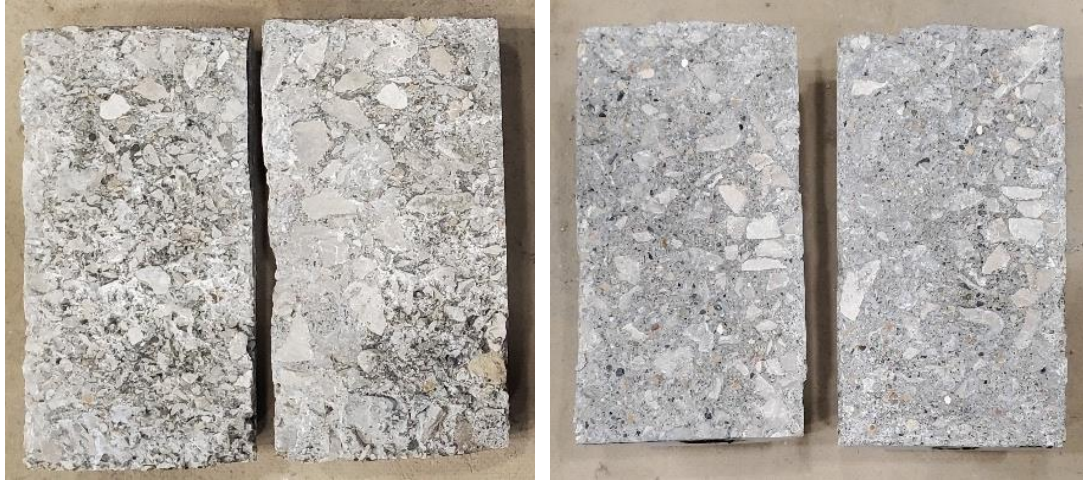
Figure 3.10 shows examples of partial substrate failures for the HESC and SCC-C specimens.

Figure 3.10. Examples of partial substrate failure: HESC (left), SCC-C (right)

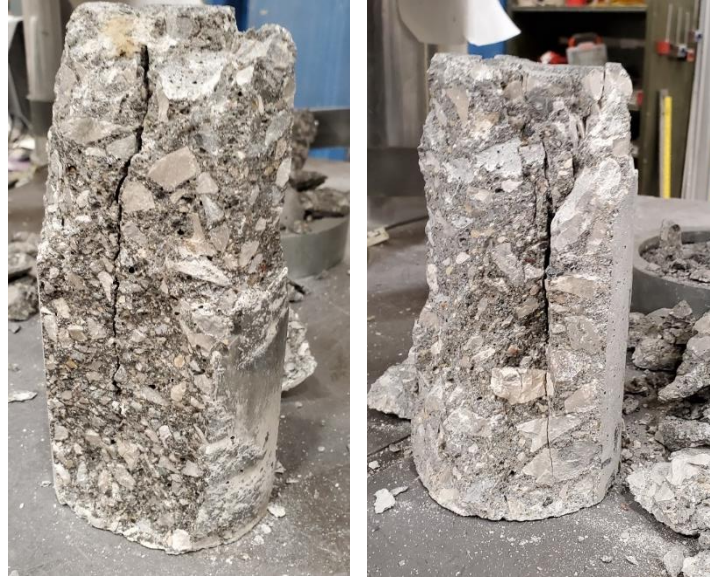
All slant shear specimens failed in compression, with none failing at the bond interface. The compressive failures for the HESC and SCC-C specimens always initiated in the substrate. These substrate cracks propagated through the full cylinder most commonly in form of nearly vertical splitting cracks before the interfacial shear stresses reached the maximum bond strength (Figure 3.11).

Figure 3.11. Examples of failed slant shear specimens: HESC (left) and SCC-C (right)

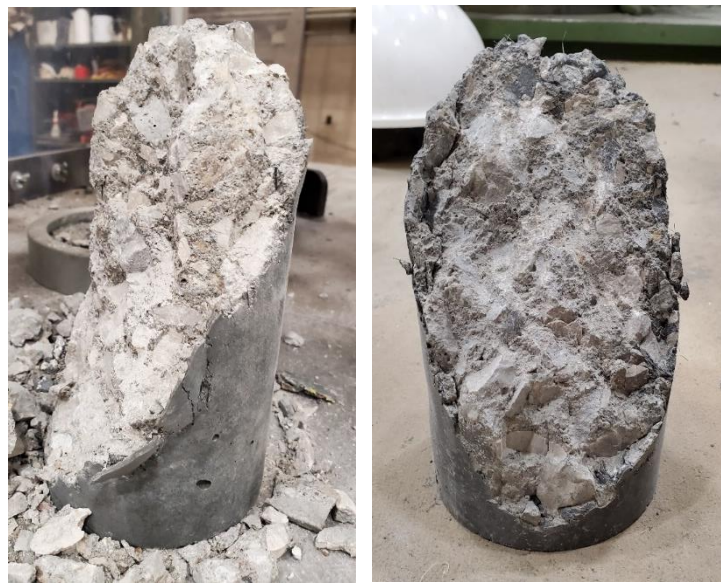
In contrast, in both types of UHPC samples, failure was localized in the substrate. Some cracking was visible into the UHPC material, but these cracks were arrested by the steel fibers in the UHPC mixes (Figure 3.12).

Figure 3.12. Examples of failed UHPC slant shear specimens

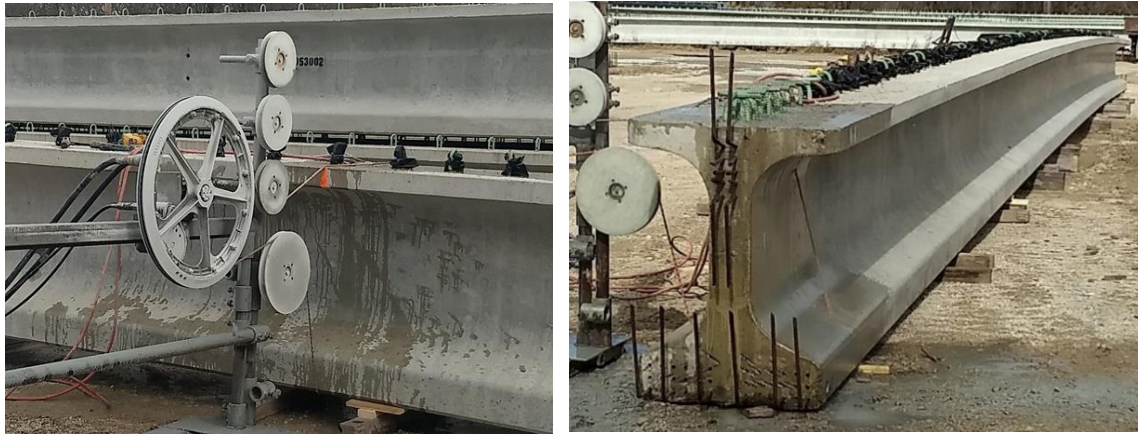
To cut the BTC115 beam, a wire saw method was chosen. The cutting mechanism for this type of saw involves a spinning diamond-studded wire being pulled through the concrete beam (Figure 4.2).

Figure 4.2. Wire saw cutting in progress

It was more desirable to use a wire saw than a hand-held circular saw because the wire saw reduces cutting time and labor costs while resulting in a cleaner edge. Two end pieces 2 ft 5 in. in length were cut from the BTC115 beam and discarded as scrap to avoid the large amount of shear reinforcement in that zone. The remaining beam was then cut symmetrically in order to reduce variation due to changes in tendon profile. The result was eight mirrored beam segments that could be used in direct comparison to each other. Each segment was cut to 11 ft to ensure the beams would fail in shear as opposed to bending (Figure 4.3).

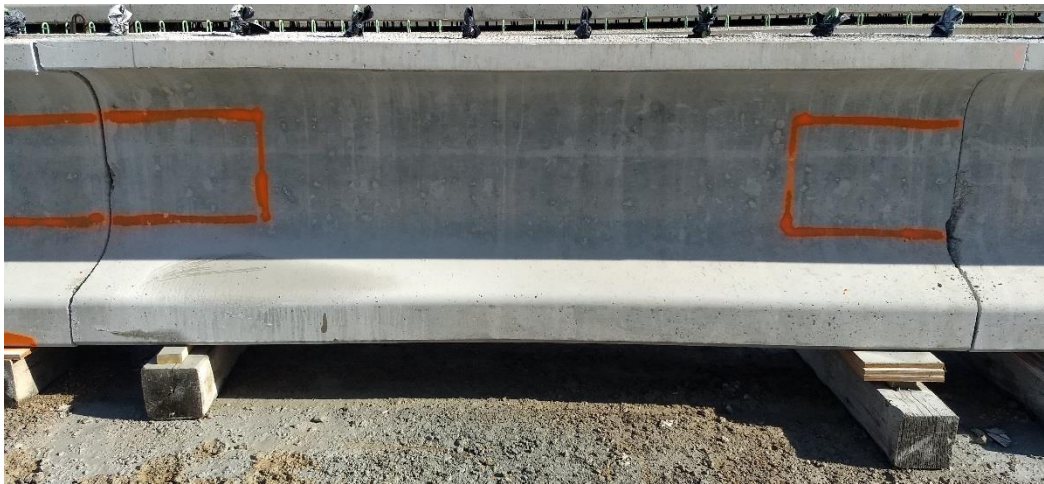
Figure 4.3. Cut beam segment marked for artificial damage

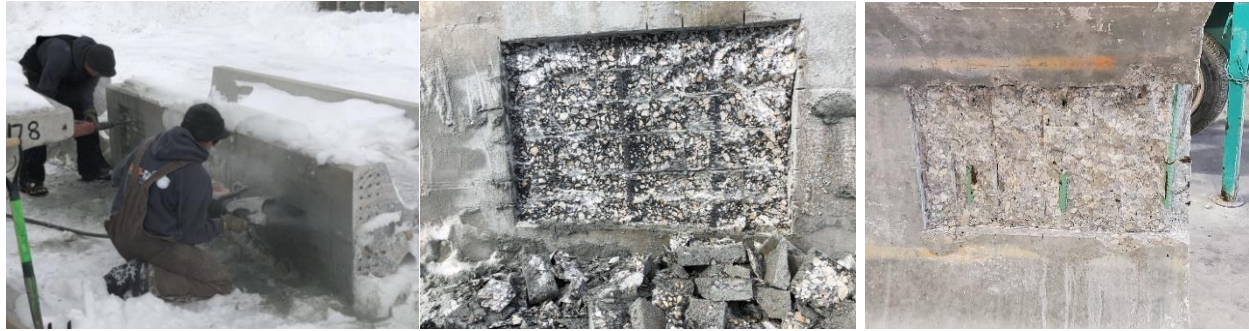
The region of concrete removed from the beam web resulted in an approximately 30% reduction of the width and cross-sectional area of the beam web. Each beam web had a damaged region with a height of approximately 1 ft, while the length of the area varied between approximately 1 ft and 2 ft, as shown in **Error! Reference source not found.**. The region of concrete was removed from the beam web by first cutting a grid with a depth of 1 in. Next, a hammer drill with a chisel attachment was used to remove the concrete within the grid, with care taken not to damage the stirrups. This process was repeated on both sides of the web and on each end of the specimen, and a similar process was used to remove concrete from the bottom flanges (Figure 4.5).

Figure 4.5. Cutting and chiseling (left), damaged bottom flange (center), and damaged web (right)

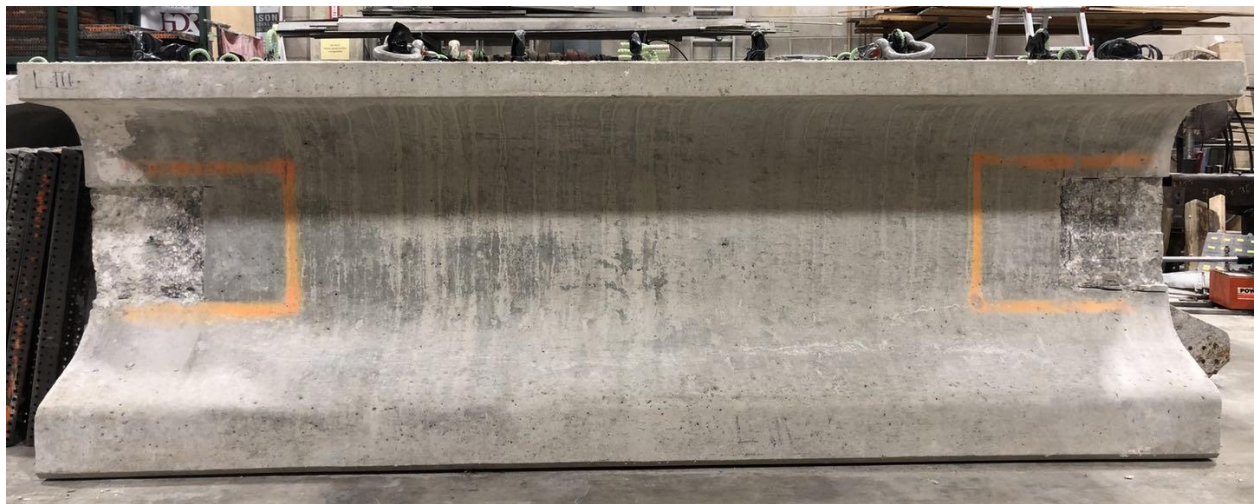
An example of a final damaged specimen is shown in Figure 4.6.

Figure 4.6. Artificially damaged beam specimen (1 ft damage)

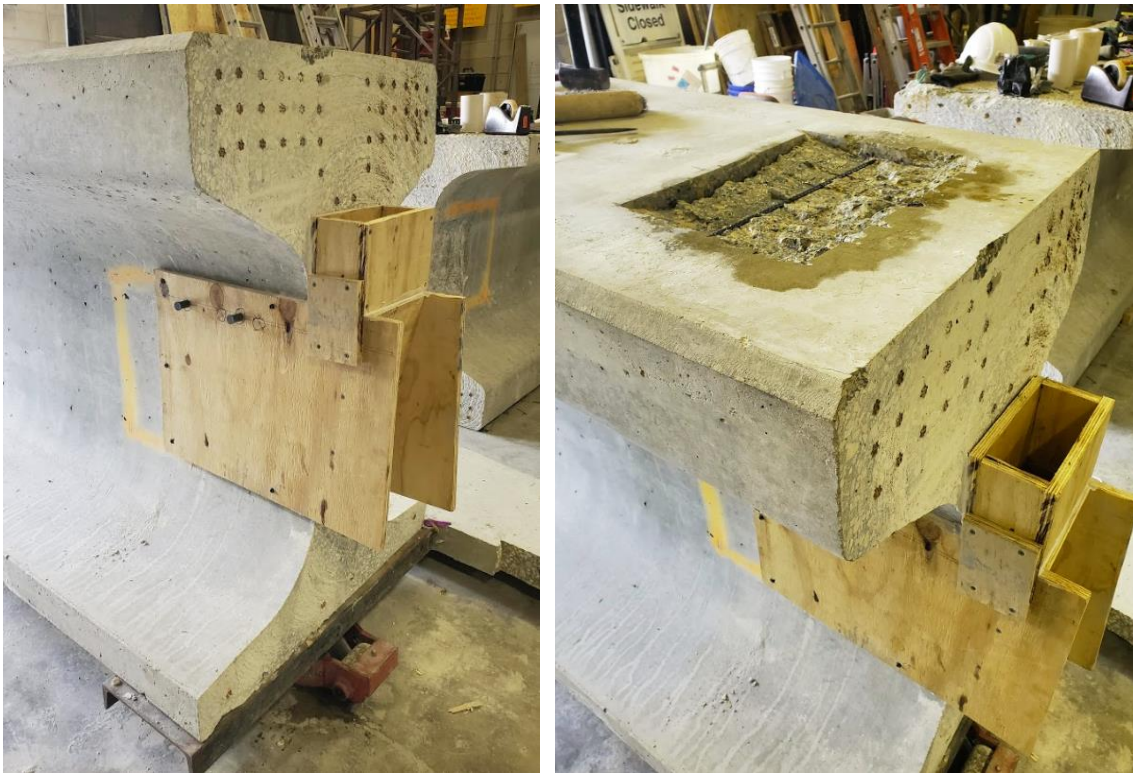
end area. Prior to pouring the patch mix, the concrete area to be patched and the formwork was wetted to limit water loss from the mix (Figure 4.7).

Figure 4.7. Beam patching formwork (left) and wetted area to be patched (right)

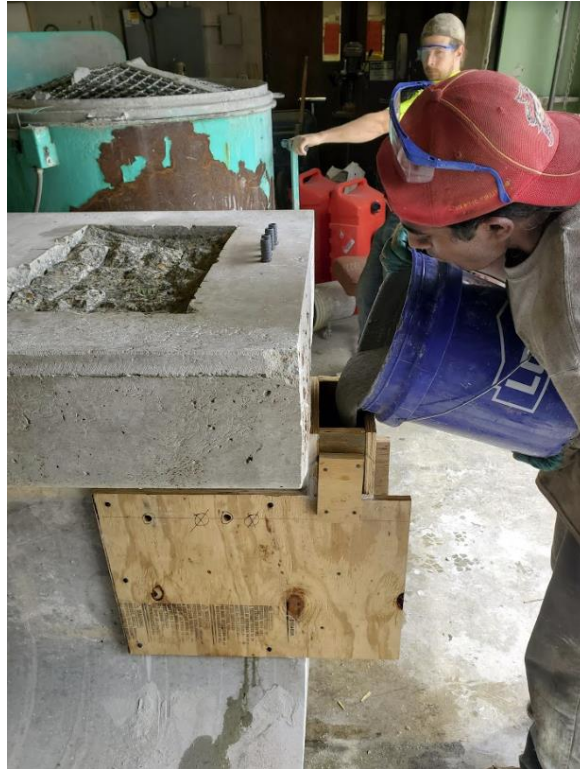
Workers transported the patch mix using buckets and poured the mixture into the forms until full. As the damaged areas filled with patching, more mix was added to fill the forms completely (Figure 4.8).

Figure 4.8. Patch mix being poured into formwork

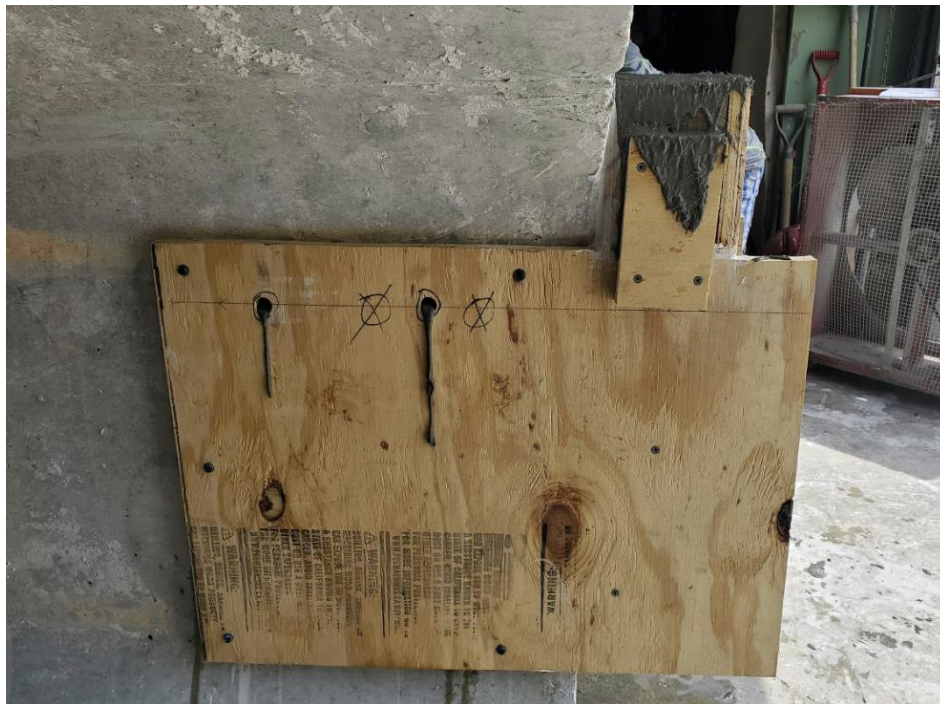
Weep holes in the formwork were plugged when the mixture began draining (Figure 4.9).

Figure 4.9. Patch mix flowing from weep holes

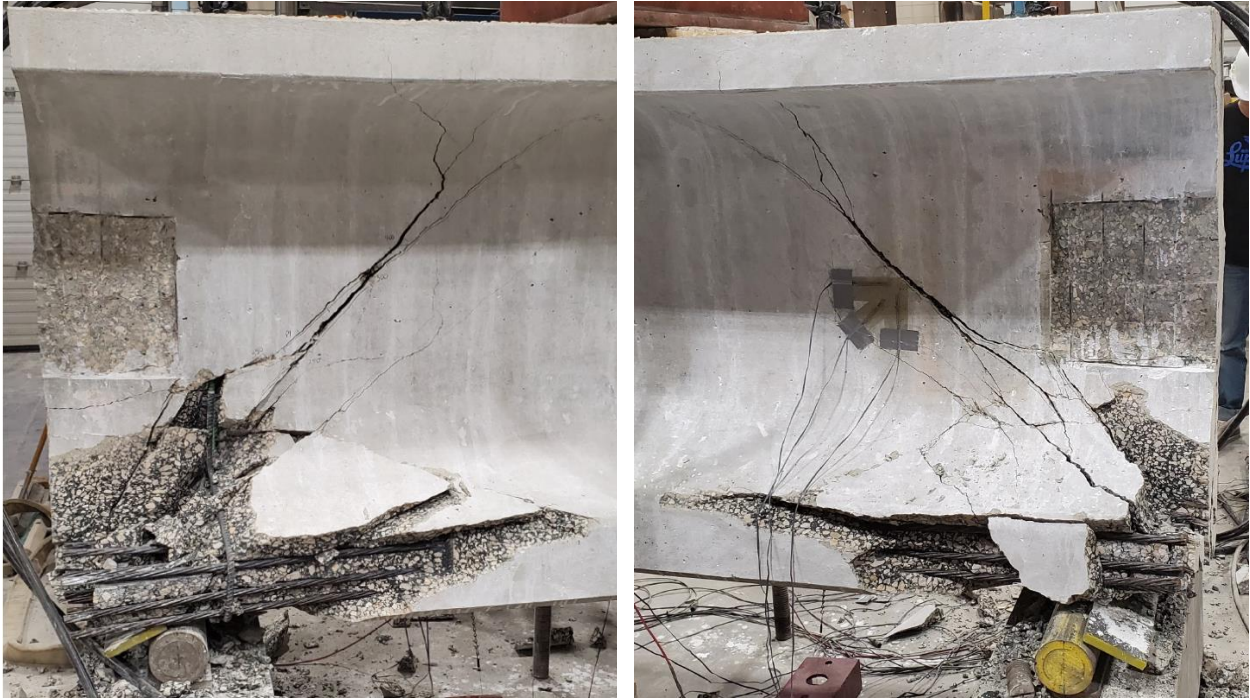
The Control-2 specimen was the only beam specimen to reach total failure. Significant shear cracking occurred in the web above the theoretical shear cracking path. The results of the initial loading had otherwise been comparable to those of other beam specimens. Cracking first occurred between 250 kips and 300 kips. During the second loading cycle, brittle failure occurred at a peak load of 400.6 kips (Figure 4.13).

Figure 4.13. Control-2 failure

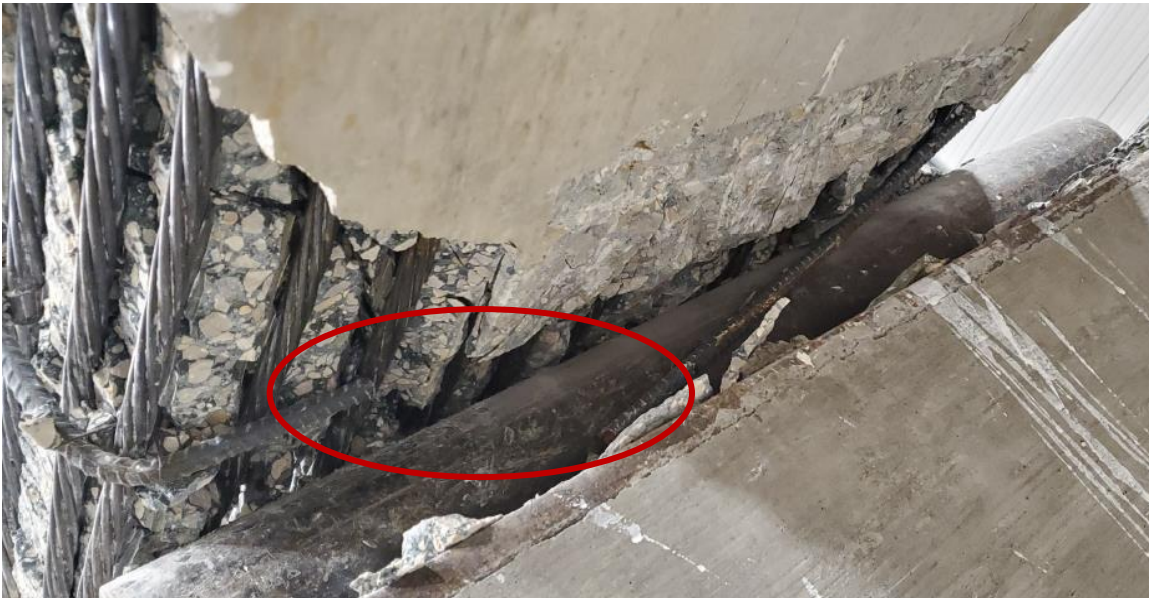
The first stirrup from the south bearing fractured in one location: the bottom flange (Figure 4.14). Because of this, the mode of failure is assumed to be confinement failure, which caused the bottom flange to burst.

Figure 4.14. Fractured stirrup on bottom flange of Control-2

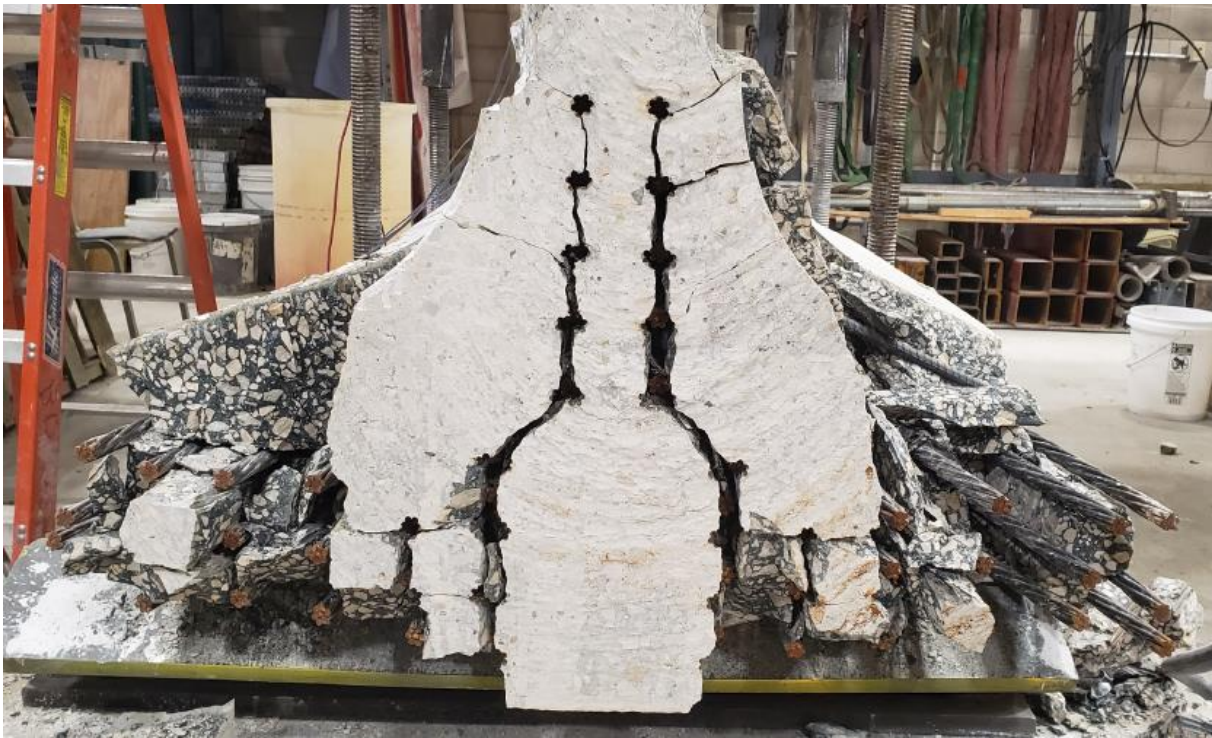
force remaining in the strands after the full-length beam was cut into the shorter test specimens (Figure 4.15).

Figure 4.15. South beam end of Control-2 after failure

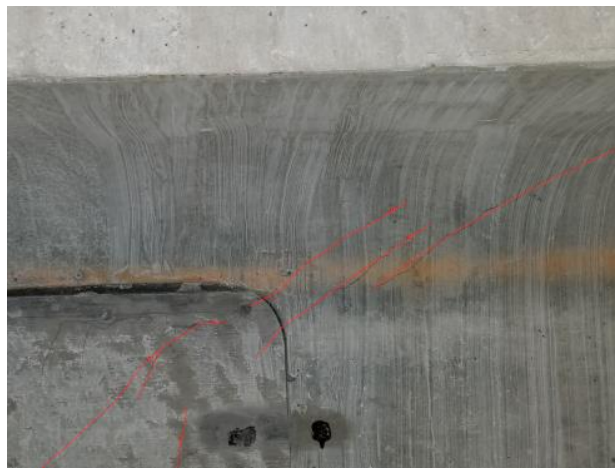
The first sign of visible cracking in the UHPC-1 and UHPC-2 specimens occurred between 300 and 350 kips. Cracking started in the existing concrete outside of the repair region. Cracking propagated in the upper web at 40° from horizontal. Cracking occurred both above the theoretical shear path and along the expected path. Some existing cracks that had formed due to cutting of the pretensioned steel cables expanded horizontally at loadings greater than 300 kips. Cracking propagated approximately 1 to 2 in. in each of the second and third load cycles, with little to no propagation in the final loading. Visible cracking can be seen within the UHPC patching surface for both specimens, demonstrating an adequate bond between the patching material and the substrate (Figure 4.16, Figure 4.17).

Figure 4.16. UHPC-1 crack pattern

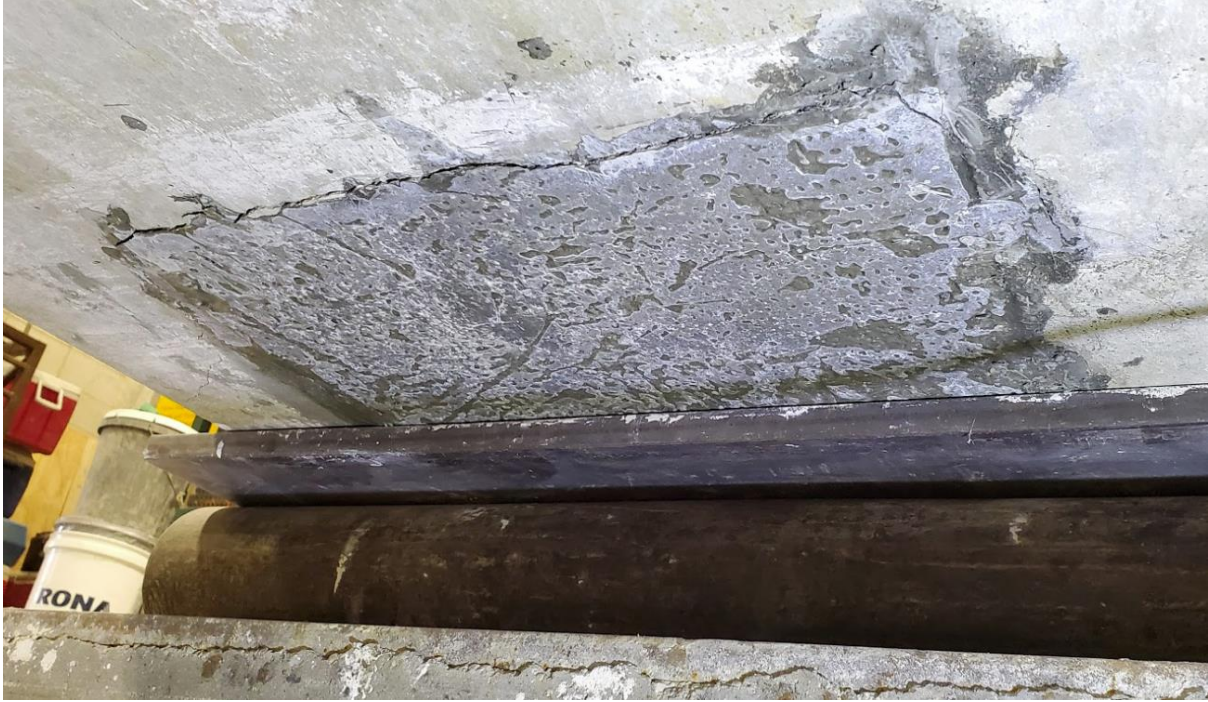
Visible cracks appeared on the bottom flange of UHPC-2 at the interface of the NC and UHPC patch at loadings greater than 300 kips (Figure 4.18).

Figure 4.18. UHPC-2 south flange patch cracking along interface

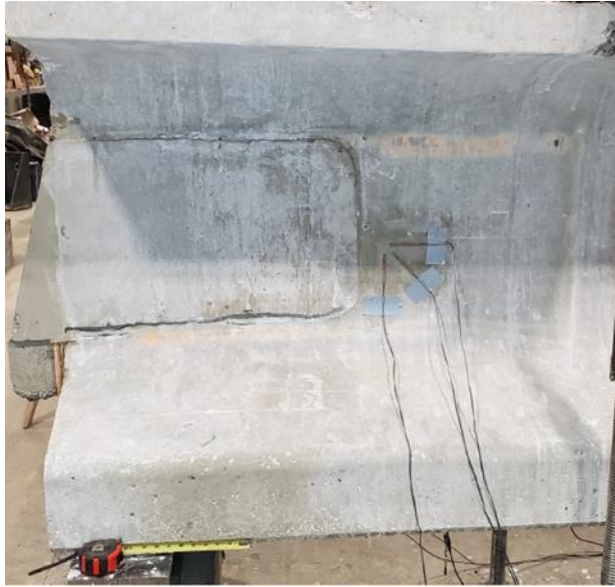
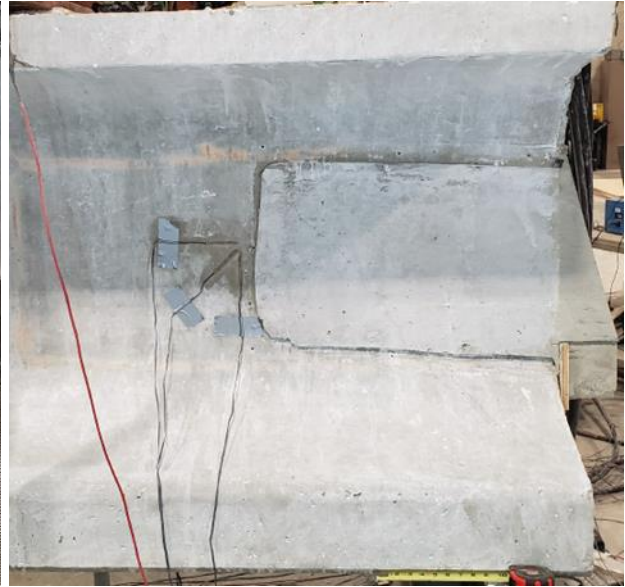
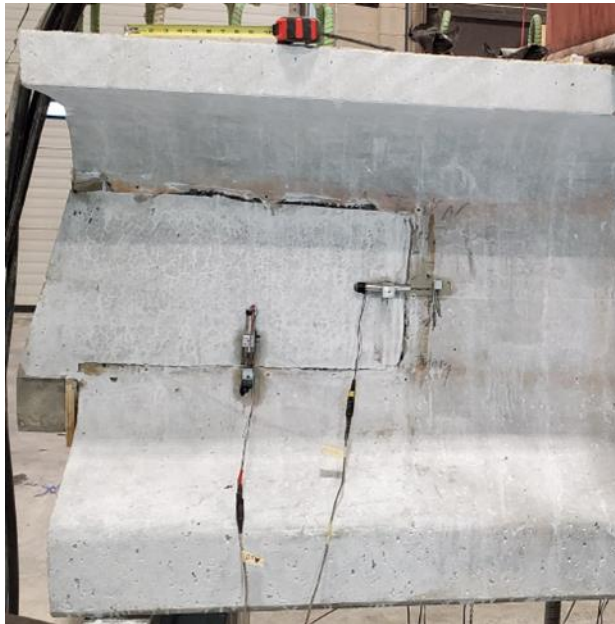
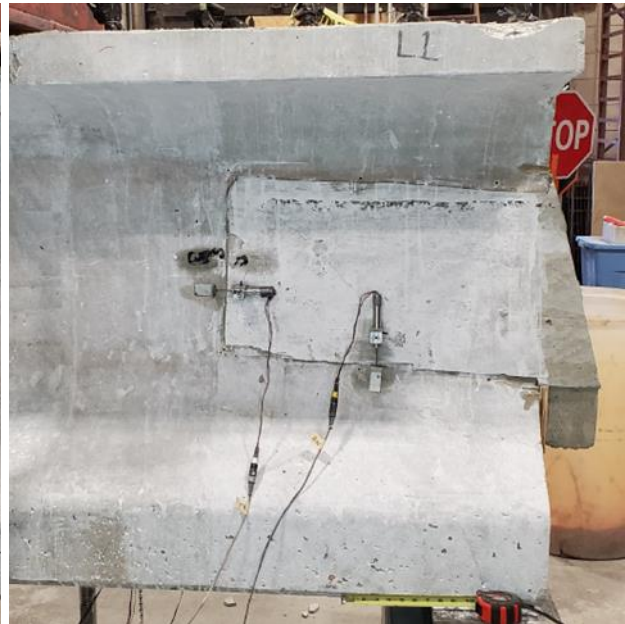
The first sign of visible cracking in the HESC-1 and HESC-2 specimens occurred between 300 and 350 kips. Cracking started in the existing concrete outside of the repair region. Cracking propagated in the upper web at 45° from horizontal. Cracking occurred both above the theoretical shear path and along the expected path. Some existing cracks that had formed due to cutting of the pretensioned steel cables expanded horizontally at loadings greater than 300 kips. Cracking propagated approximately 1 to 2 in. in each of the second and third load cycles, with little to no propagation in the final loading. Visible cracking can be seen within the HESC patching surface for both specimens, demonstrating an adequate bond between the patching material and the substrate (Figure 4.19, Figure 4.20). No visible cracks appeared on the bottom flange at the interface of the NC and HESC patch.

Figure 4.19. HESC-1 crack pattern
