Beam End Repair for Prestressed Concrete Beams

tech transfer summary

September 2020

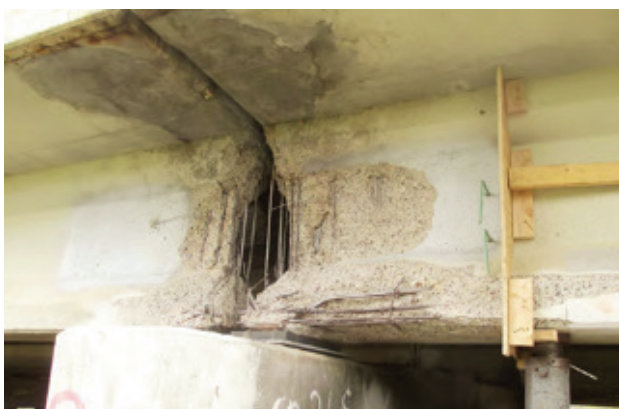
Severely deteriorated prestressed concrete beam ends in Minnesota

A primary concern with the use of precast prestressed concrete beam (PPCB) bridges is the frequent occurrence of cracking and spalling of the concrete towards the ends of the prestressed concrete beams.

This deterioration allows water and chlorides to penetrate into the beam ends, causing exposure and corrosion of the beams' steel reinforcement and prestressing strands. Chloride ingress is particularly problematic in areas with colder climates, such as Iowa, where deicing salts are used on roadways.

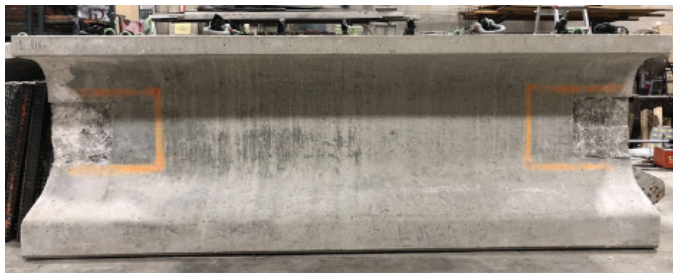
Beam specimen with artificial damage on both ends

Full-scale laboratory testing was conducted to determine the properties and performance of UHPC and HESC as beam patching materials. Six prestressed concrete beams 11 ft in length were cut from a full-size bulb-tee C-shaped beam and artificially damaged at the ends. Two segments were left unrepaired, two were repaired with UHPC, and two were repaired with HESC.

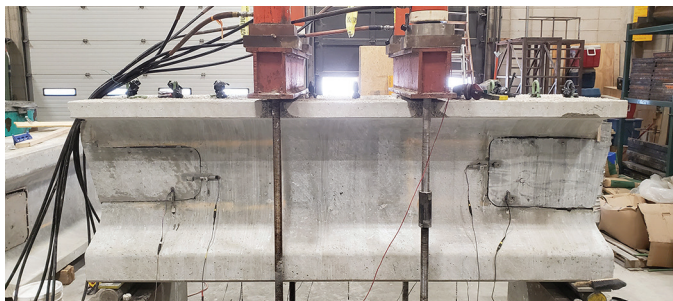
Patched beam specimen instrumented for the four-point bending test

The beams segments were instrumented with various strain and displacement gauges, and structural response was measured using four-point bending tests.
