FINAL REPORT FOR IHRB TR-719

# DEVELOPMENT OF SELF-CLEANING BOX CULVERTS

Phase III

**M. Muste, H. Xu**  
IIHR-Hydroscience & Engineering, The University of Iowa  
Iowa City, IA 52242-1585

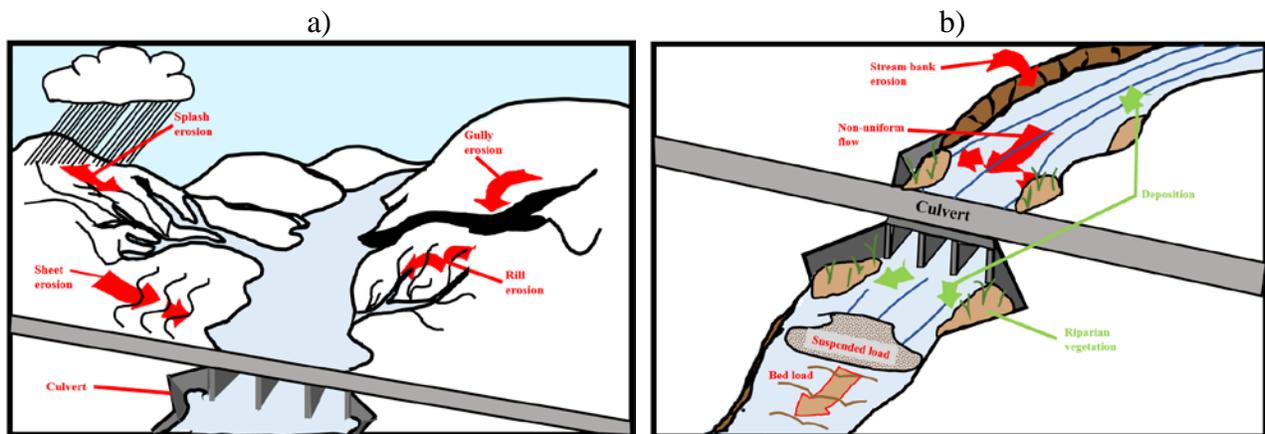
Figure 1. End-to-end culvert sedimentation processes: a) soil detachment (sediment production and overland transport) in the culvert drainage area; b) in-stream sediment transport to culvert vicinity and deposition processes in the vicinity of the culvert (Muste and Xu, 2017).

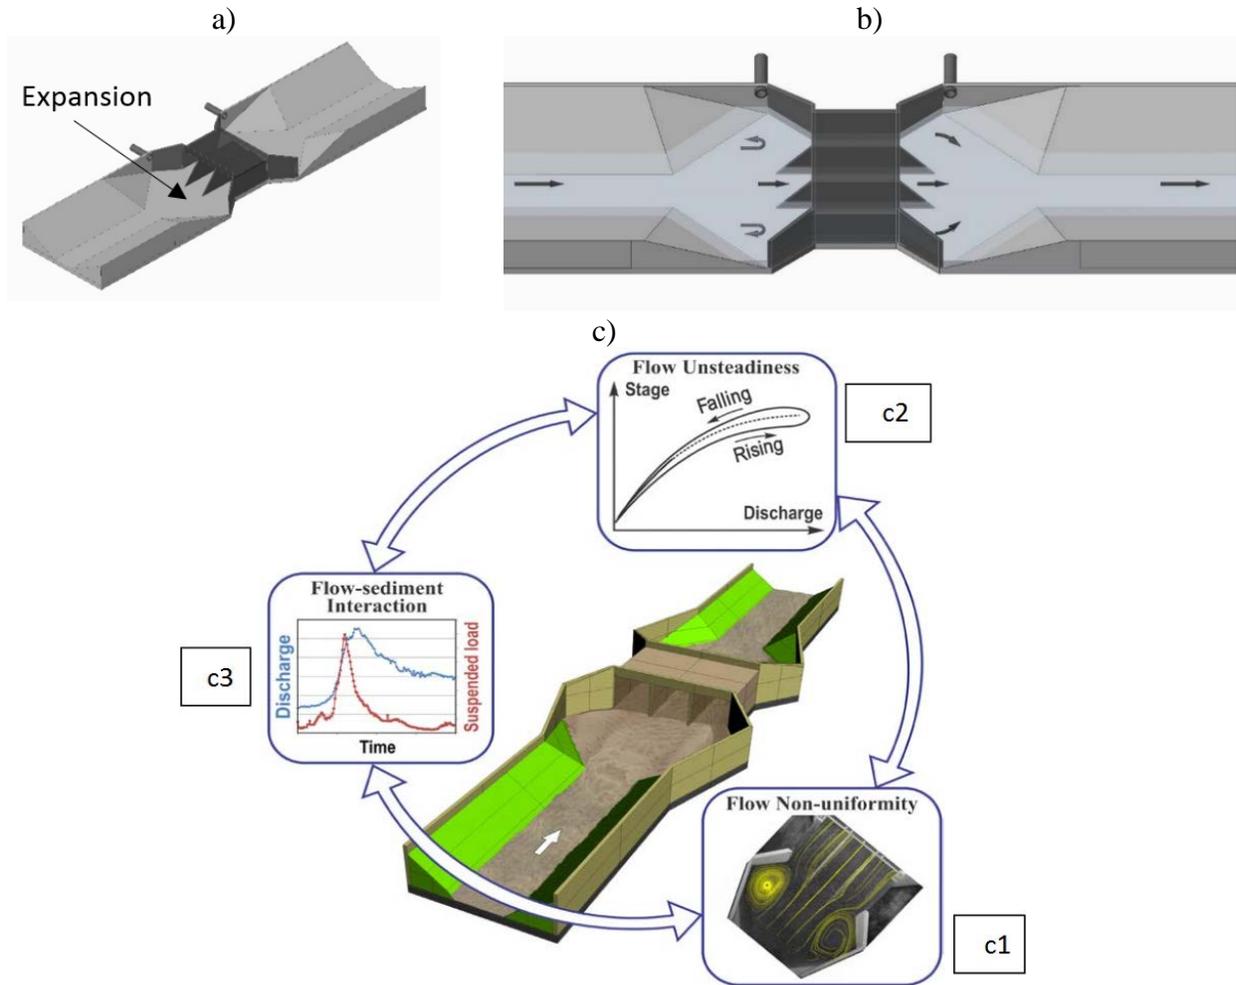
Figure 3. Flow configuration at culvert sites: a) stream-to-culvert transition; b) flow patterns in the vicinity of culvert (patterns vary with the streamflow magnitude); c) flow complexities due to flow unsteadiness (Muste and Ho, 2013)

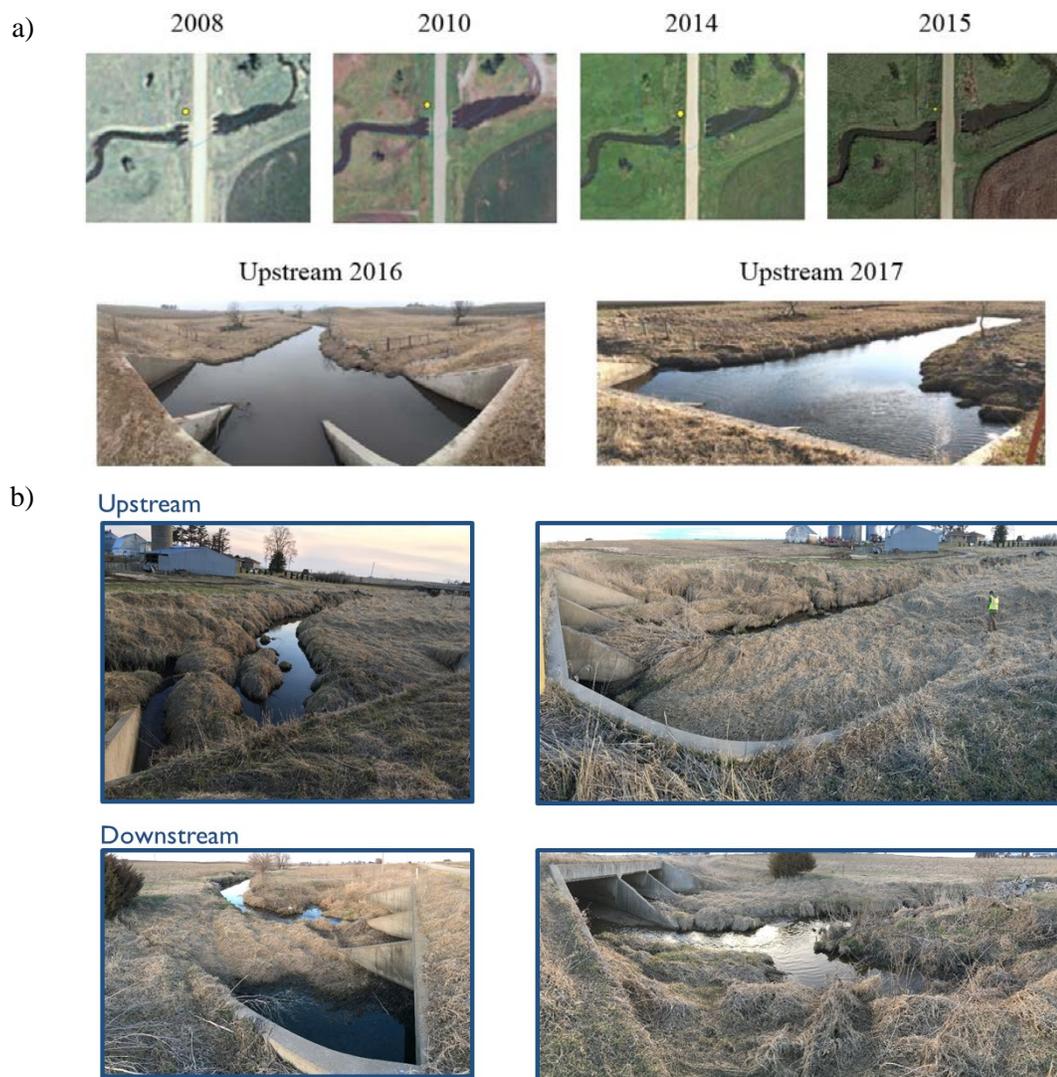
Figure 4. Sample of culverts in Iowa: a) ideal operation (less than 5%); b) silted culvert (about 90%)

The view of an ideal culvert operation is indicated by its stable stream geometry in the culvert vicinity as illustrated in Figure 4a. Situations such as those shown in Figure 4a are, however, rare across Iowa's landscape. The surveys conducted by our research team in 2009 and 2013 indicate that about 95% of Iowa culverts are silted (Ho, 2010; Muste & Xu, 2017b). Sedimentation (a.k.a., silting) of culverts will considerably reduce their capability to handle larger flow events, as the partial blockage of their structures may severely impair their hydraulic capacity to convey designed flows. For such conditions, obstruction at the culvert inlet may cause both damage to the transportation structure (due to culvert and road overtopping) and upstream flooding. Culvert sedimentation concerns are widespread in the nation, from California to Pennsylvania and from Wisconsin to Florida (Rowley, 2014), with direct bearing on their ability to maintain normal operation during extreme flows when culverts are essential for the communities they serve.

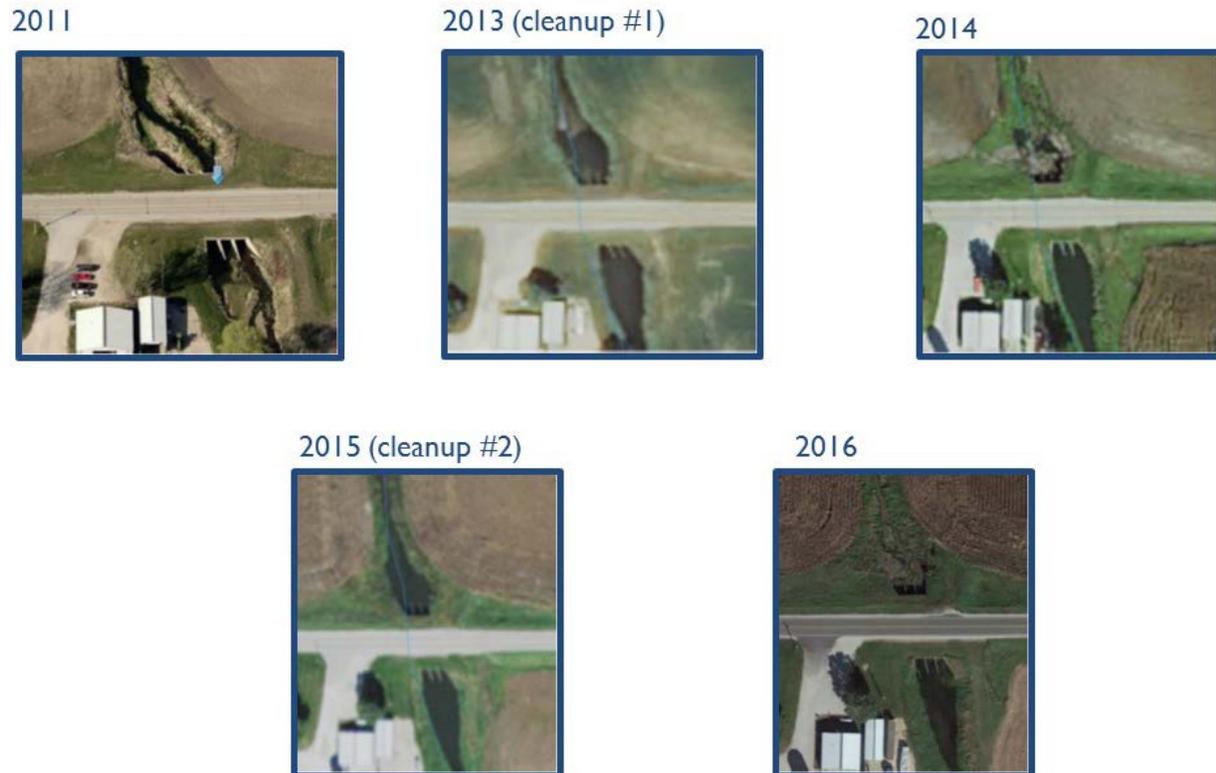
Figure 5. Sedimentation is fast and can quickly reduce a culvert's conveyance capacity.

Multi-box culverts located within flat, erodible watersheds are especially prone to sediment blockage. This is precisely the case for the highly erosive Iowa landscape where sediment accumulation may quickly fill the culvert cross section. Information assembled during field visits and by inspecting aerial photographs collected over successive years has revealed that the process of sedimentation at culverts can attain a stable form of sediment deposits in no more than four to five years (Muste & Xu, 2017a), as shown in Figure 5.

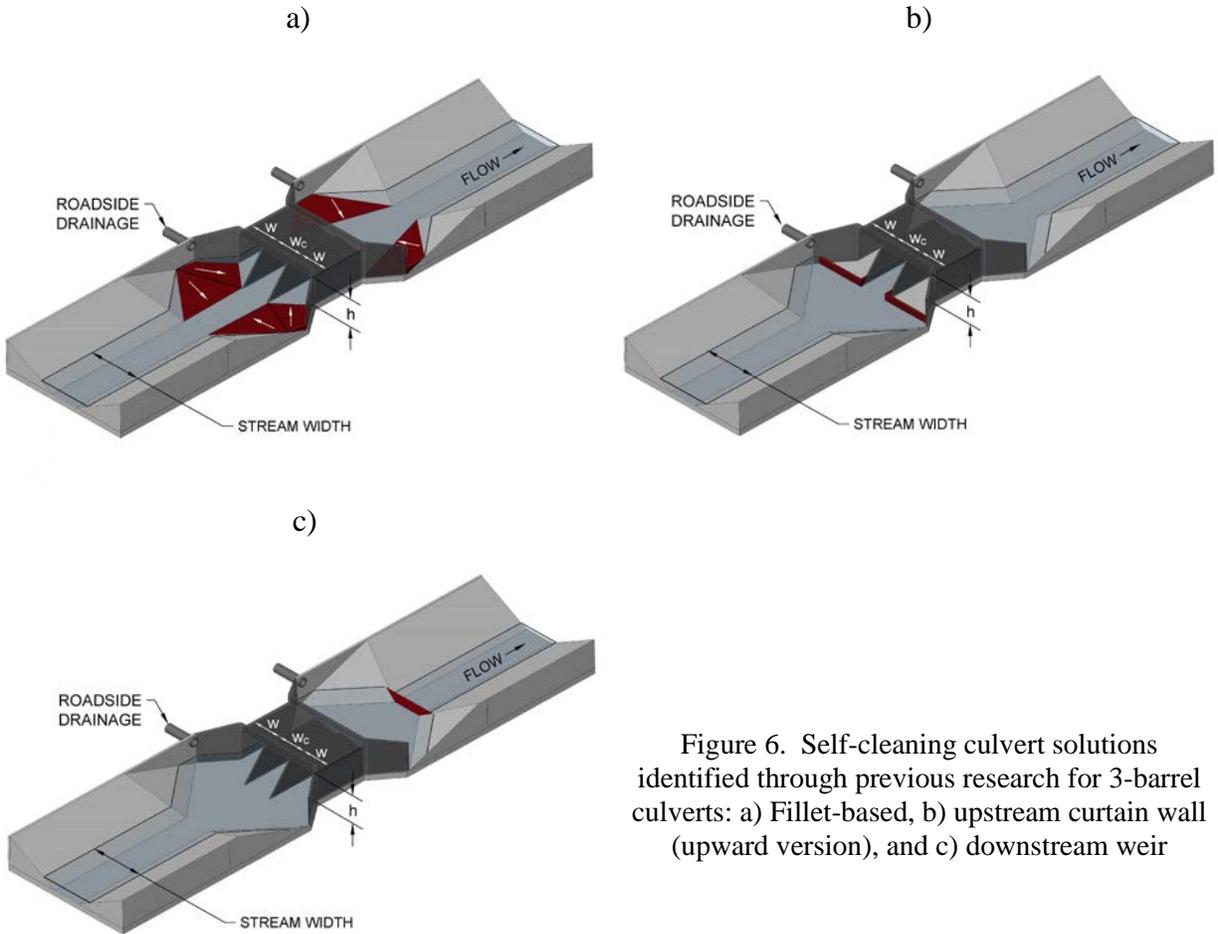
Figure 6. Self-cleaning culvert solutions identified through previous research for 3-barrel culverts: a) Fillet-based, b) upstream curtain wall (upward version), and c) downstream weir

The ideal candidates for permanently solving the sedimentation at culverts are grounded in the self-cleaning concept. This concept relies entirely on the use of the stream's hydraulic power for passing downstream the culvert the suspended and bed loads carried by the stream. During more than 10 years of researching various aspects of sedimentation mitigation at multi-barrel culverts, our team identified three possible candidates for reducing or completely eliminating the formation of sediment deposits at culverts (see Figure 6): a) filled-based (Design A); upstream curtain wall (Design B; upward or downward curtain), and downstream weir (Design C).

It should be noted that Site #1 (FHWA #031711) was partially retrofitted through the project TR 619 Phase II by using the Design A concept based on self-cleaning principles (Muste and Xu, 2017a). The retrofitting ensured its successful operation for 5 years following the cleanup and it continues to operate as such to this day. In contrast, the downstream area of a culvert which has not been previously retrofitted, has built up sediment over the same period of time. During the conduct of the FHWA's State Transportation Innovation Councils (STIC) project (Muste and Xu, 2017b), the project's TAC suggested to complete the retrofitting of the downstream part of the culvert in order to observe its performance. A second culvert was suggested for retrofitting, following the site surveys conducted by our research team in the spring of 2016 as part of the TR 619 project. Specifically, we encountered 3 culvert sites in various Iowa regions that were relatively sediment-free in an area where all the neighboring culverts were silted. The common element of the clean culverts was the presence of a pool in the culvert's vicinity. The shallow pools were created by low-head weirs constructed ad-hoc by beavers or by land owners in order to facilitate stream crossing. These observations led to the realization that this type of culvert "retrofitting" might also serve as self-cleaning design and warrants further investigation. The new self-cleaning solution was labeled as Design C (as illustrated in Figure 6c).

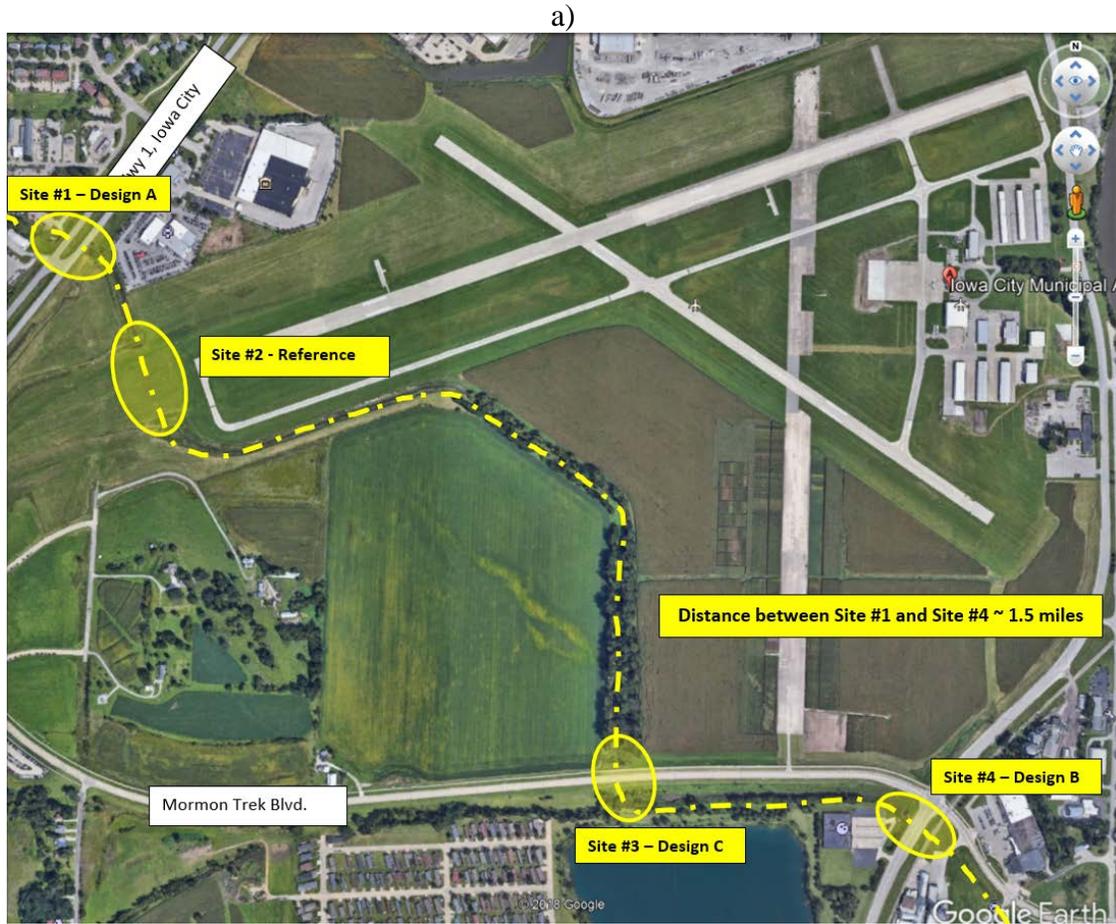
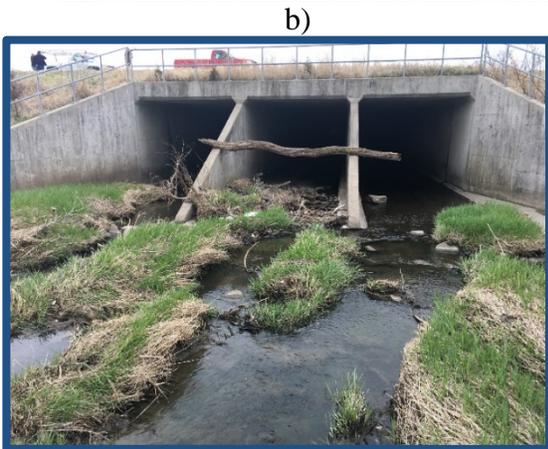
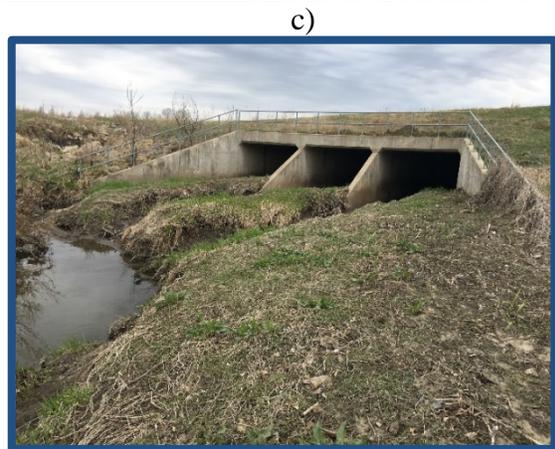
Figure 7. Culvert study location: a) the layout of the four observed culverts, b) view of the reference culvert entrance; c) view of the location of the reference culvert exit

This study assembles observations and experiments acquired since 2010 on three of the four 3-barrel culverts located within 1.5 miles on the Willow Creek in Iowa City (Iowa). The location of the four culverts is shown in Figure 7. Through this study, Designs A and C located at culvert Site #1 (FHWA #031711) and Site #3 (FHWA # 364790) respectively, were implemented and monitored for their performance between 2017 and 2019. Design B is not part of this study. In between Site #1 and Site #3, there is a 3-box culvert that was not modified since its construction in 2006. This culvert is heavily silted and will be used as a reference for the present study.

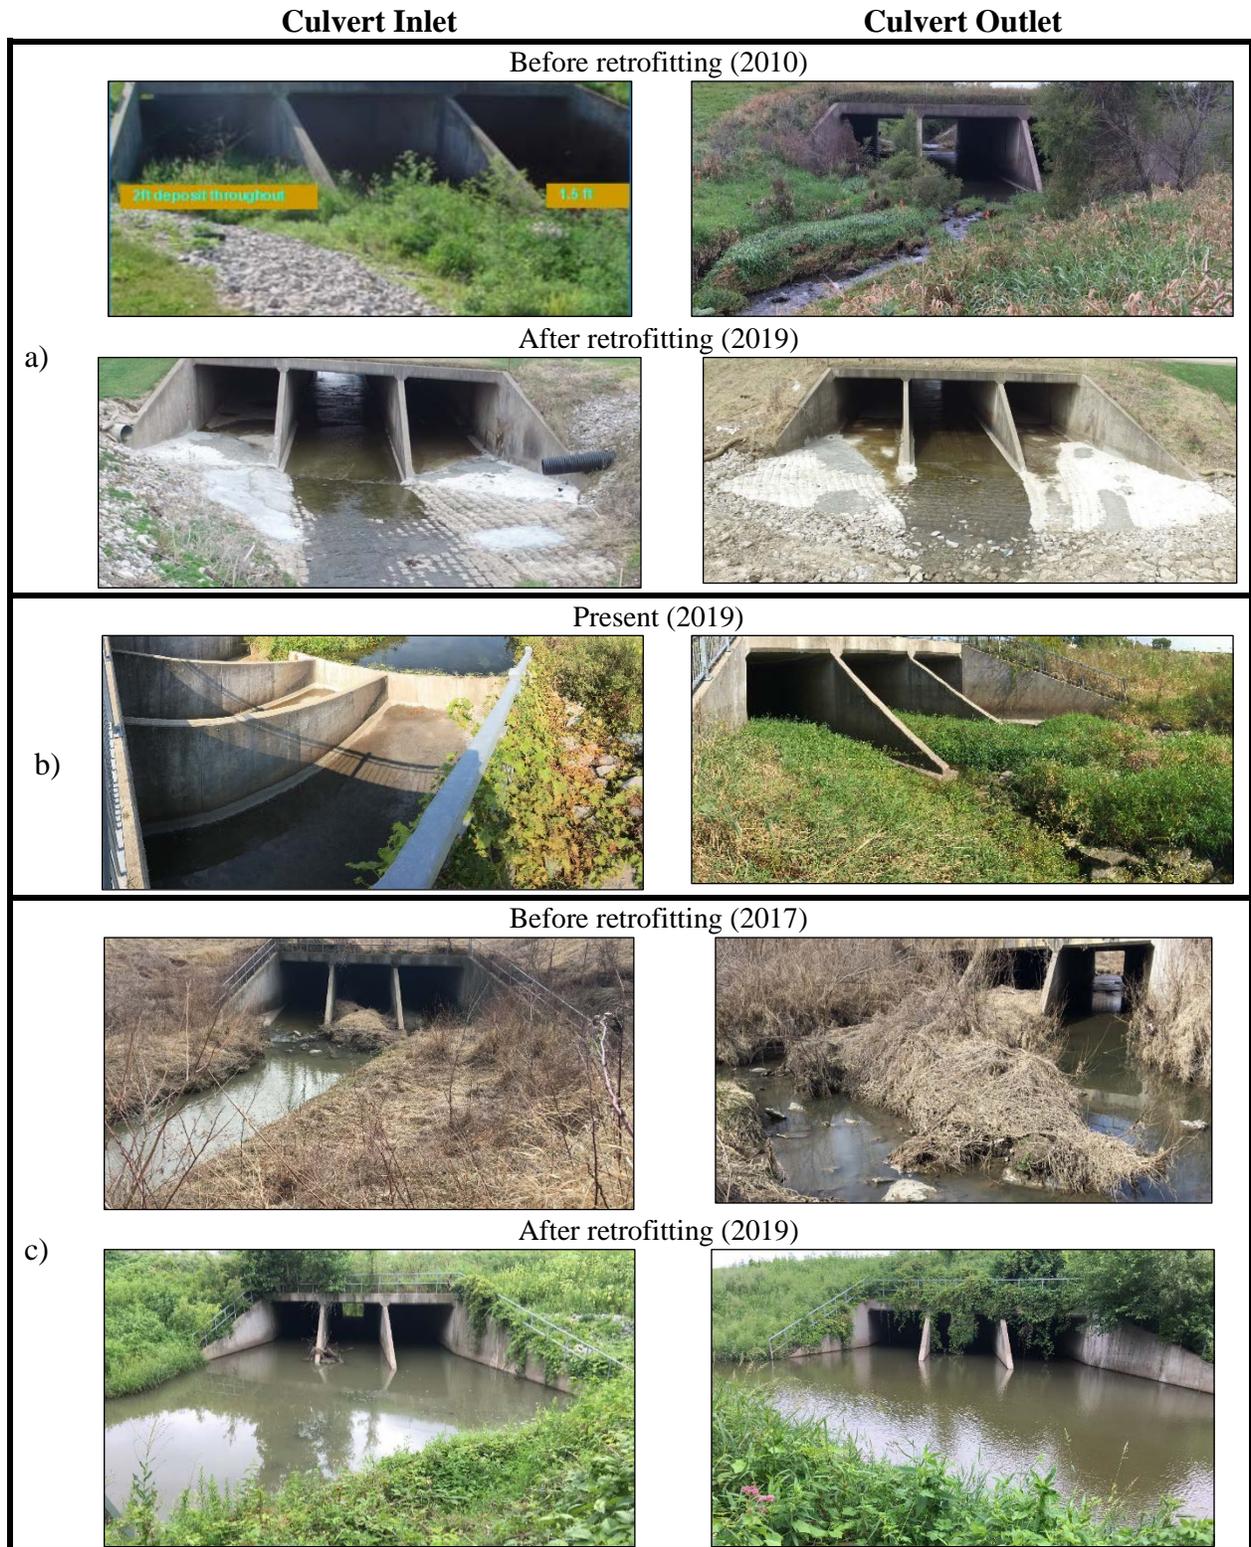
Figure 8. Self-cleaning solutions: a) Design A (fillet-based) applied to a triple 15'-18'-15x12' ~ 170-ft long culvert; b) Design B (upstream downward curtain) applied to a triple 15'-18'-15x12' ~ 800-ft long culvert ; c) Design C (downstream weir) used for a Triple 15'-18'-15x12', ~ 200-ft long culvert

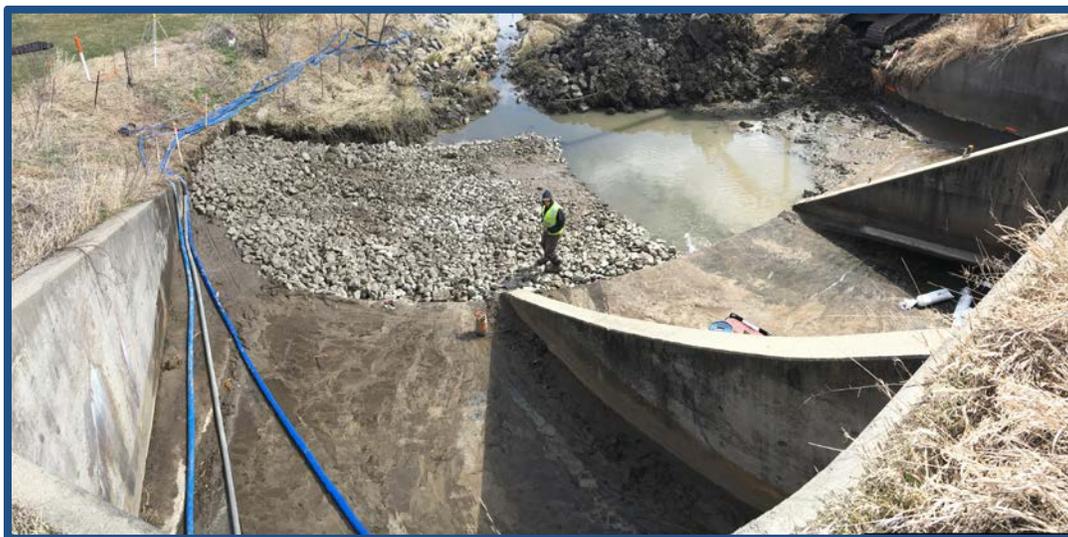
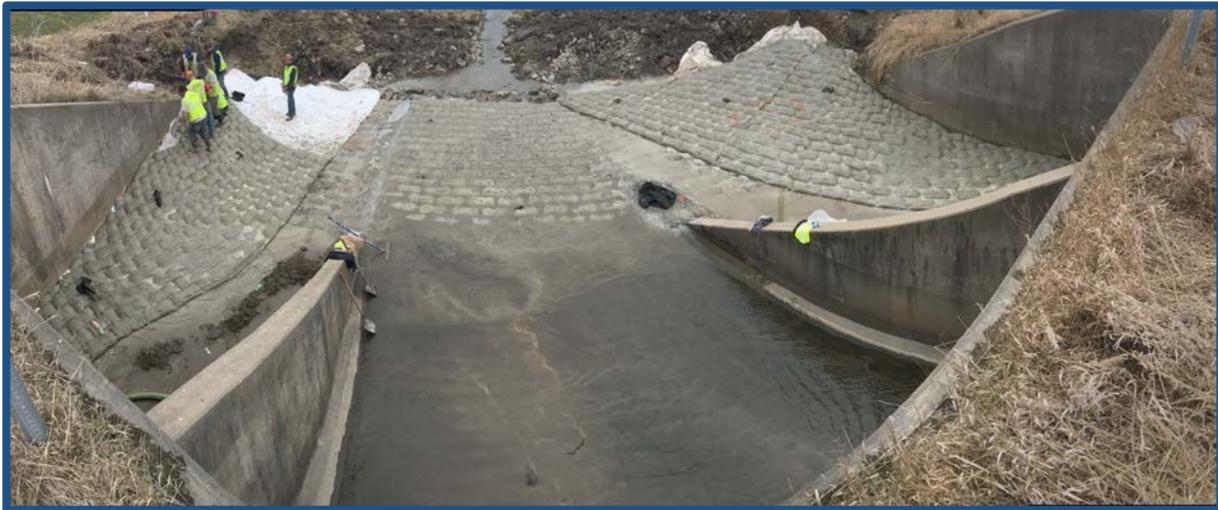
Figure 9. Aspects of the preparation and installation of the articulated block mat at FHWA #031711 site

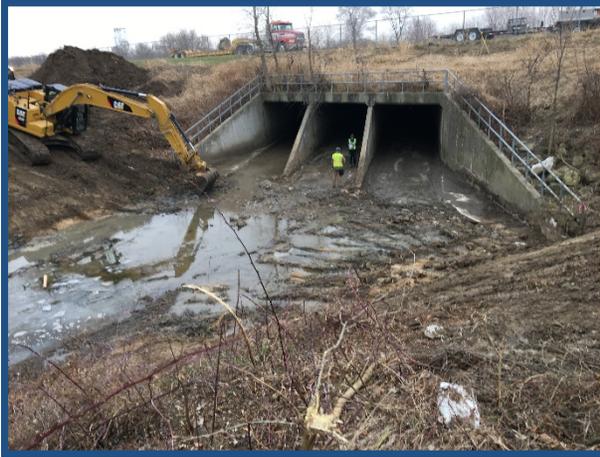
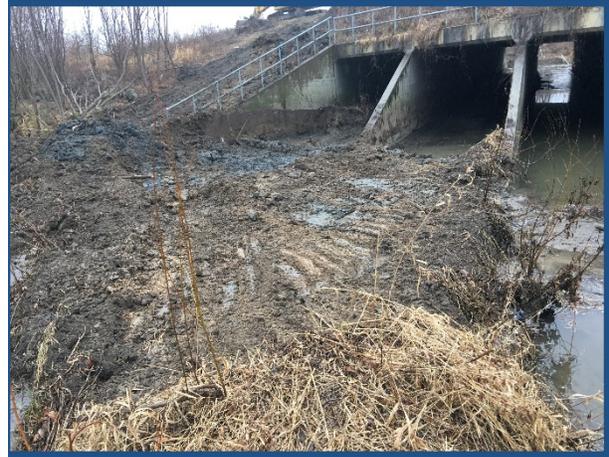
Culvert inlet

Culvert outlet

In contrast with the situation at FHWA #031711 site, the retrofitting conducted at the culvert FHWA #364790 site posed multiple construction and maintenance problems. They are mostly related to the downstream weir associated with the self-cleaning Design C. The original plans for retrofitting this site were based on in-kind contributions from the City of Iowa City. Typically, such funds are relatively limited, as they depend on an unpredictable timeline. Despite these constraints, the City of Iowa City accomplished all tasks associated with the project. The cleanup of the culvert area was made through a hired contractor in two phases: December 18-22, 2017 and February 1, 2018 (see Figure 11). Following the cleanup, the site was also provided with vegetation mats as shown in Figure 12.

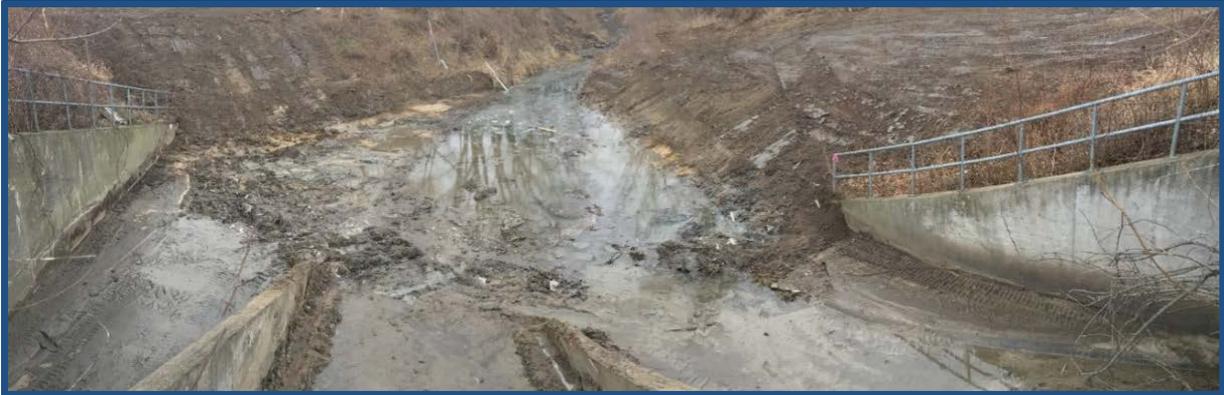
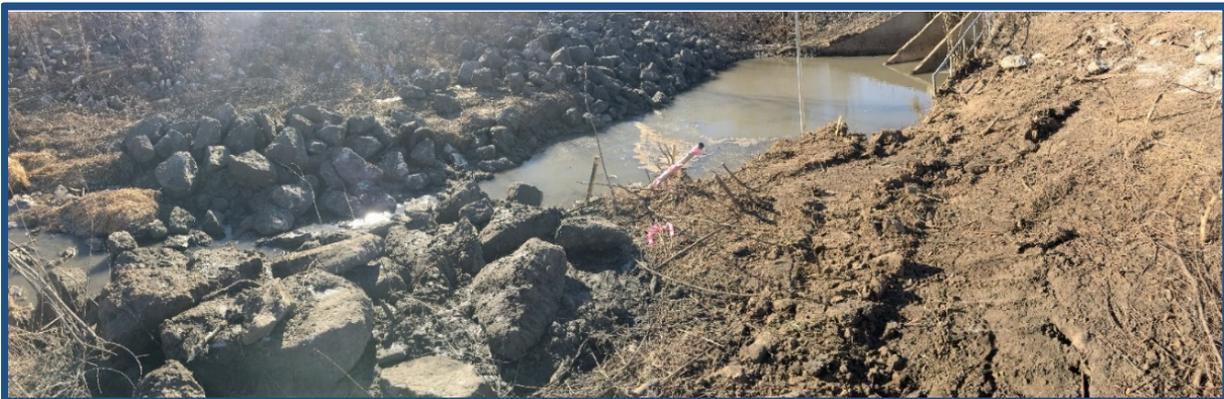
Culvert inlet at the end of cleanup

Culvert outlet at the end of cleanup

Figure 11. Views of the culvert site during the site cleanup (compare with Figure 8c)

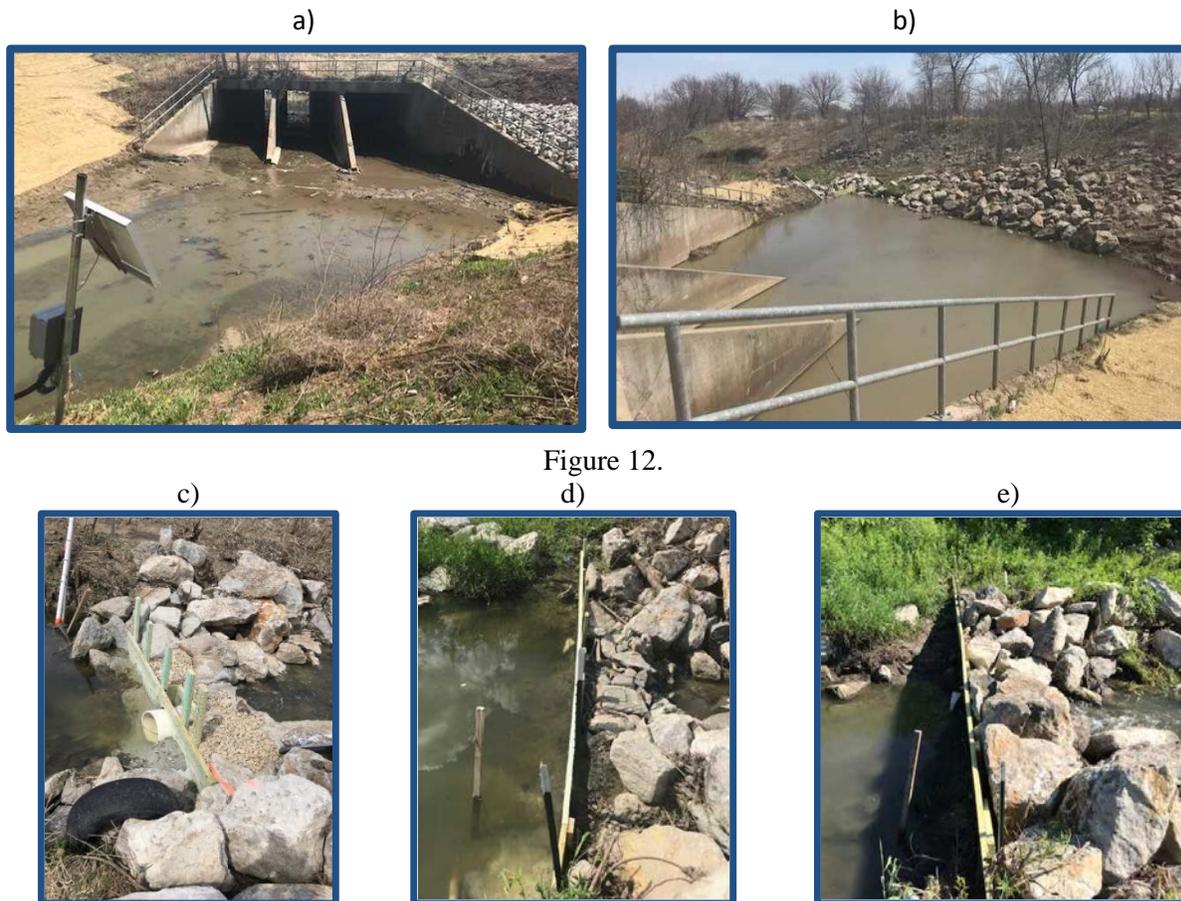
The weir's construction has been completed in three phases by gradually raising its level and observing the hydraulics of the ponded area with dedicated instrumentation. The phases of the temporary weir construction are shown in Figure 12. Given that the foundation of the weir was

formed by large boulders (already existent at the site since the culvert’s construction 10 years before), setting the wood-made upper structure for tight holding of the flow had met with difficulties at the interface between the boulder base and the wood structure. As the weir level was elevated with each phase, the water pressure increased which led to the formation of under-weir leaks. While the construction and setting of the wooden part of the weir was a straightforward job, the stoppage of the leaks under the weir required substantial efforts of the IIHR staff. Since the costs for the weir setting were not included in the original TR 719 phase III proposal, IDOT provided extra funds to cover the time associated with the weir construction by the IIHR shop.

The fragility of the weir was an issue, since its monitoring was tenuous and required extra effort in order to check for the stability and water-proofing of the structure. The efforts carried out with the modest resources available at the IIHR shop were barely enough to keep the project fairly close to, yet short of reaching the optimum stage required by the Design C specifications. Similarly, the evaluation of the performance of the proposed mitigating solution for FHWA # 364790 required a constant consultation with the project TAC and subsequent interventions over the course of its completion. In spite of these difficulties, the project was finalized and delivered as planned.

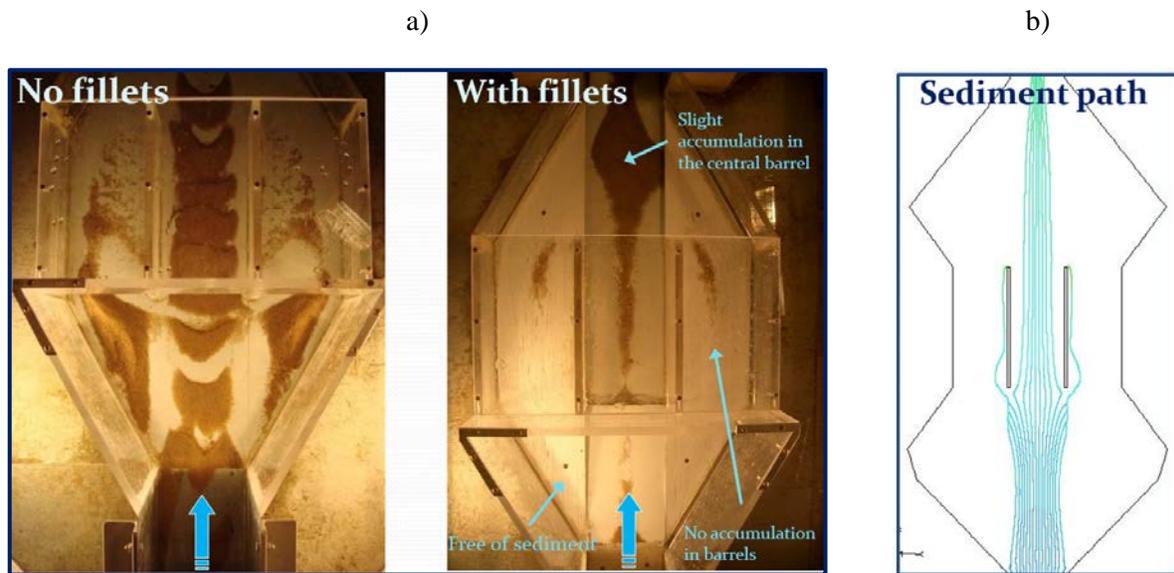
Figure 13. Results from laboratory and numerical modeling: a) experiments with sediment on culvert Design A; b) numerical simulations with FLUENT for culvert Design A (Muste et al., 2009)

A complete series of baseline and screening tests were conducted through an IHRB project on a small scale model (1:20) followed by performance tests on a larger scale model (1:5). This sequence of tests led uncompromisingly to the filled-based solution (Design A) that showed good capabilities for totally eliminating the formation of sediment deposits at 3-barrel culverts, as illustrated in Figure 13a. The numerical simulations conducted with FLUENT confirmed the experimental findings, as illustrated in Figure 13b.

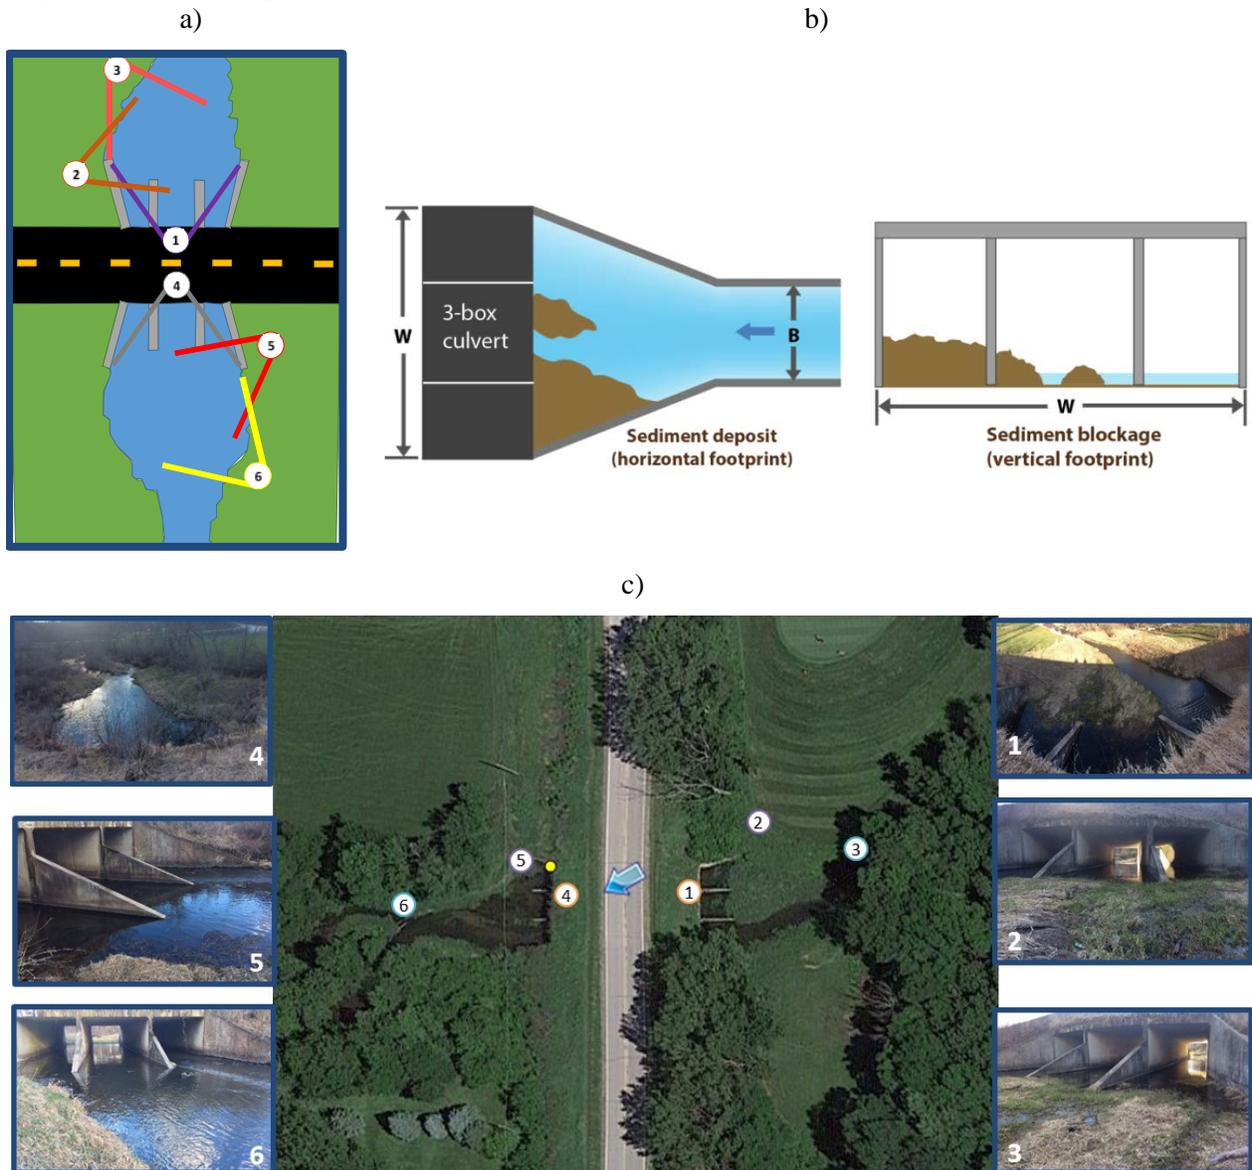
Figure 14. Field measurement protocols: a) positioning of the photo camera during the photo survey; b) illustration of the measurement acquired for the degree of sedimentation blockage; and c) illustration of the photo-documentation acquired at the culvert site.

*In-situ terrestrial synoptic surveys.* The most comprehensive visual evidence of the sedimentation processes has been obtained with photo-documentation (see Figure 14). These surveys are most effective if they are conducted in early March and April (before the spring vegetation begins to grow) using a uniform experimental protocol illustrated in Figure 14a. The close-up images recorded at the sites provide detailed information about the sediment deposit layout, structure, and -- if continuously acquired over time -- they will give substantial information to understand the underlying mechanism for sedimentation patterns and their evolution. This is the only type of survey that provides critical information about the status and the effects of vegetation on the deposit formation.

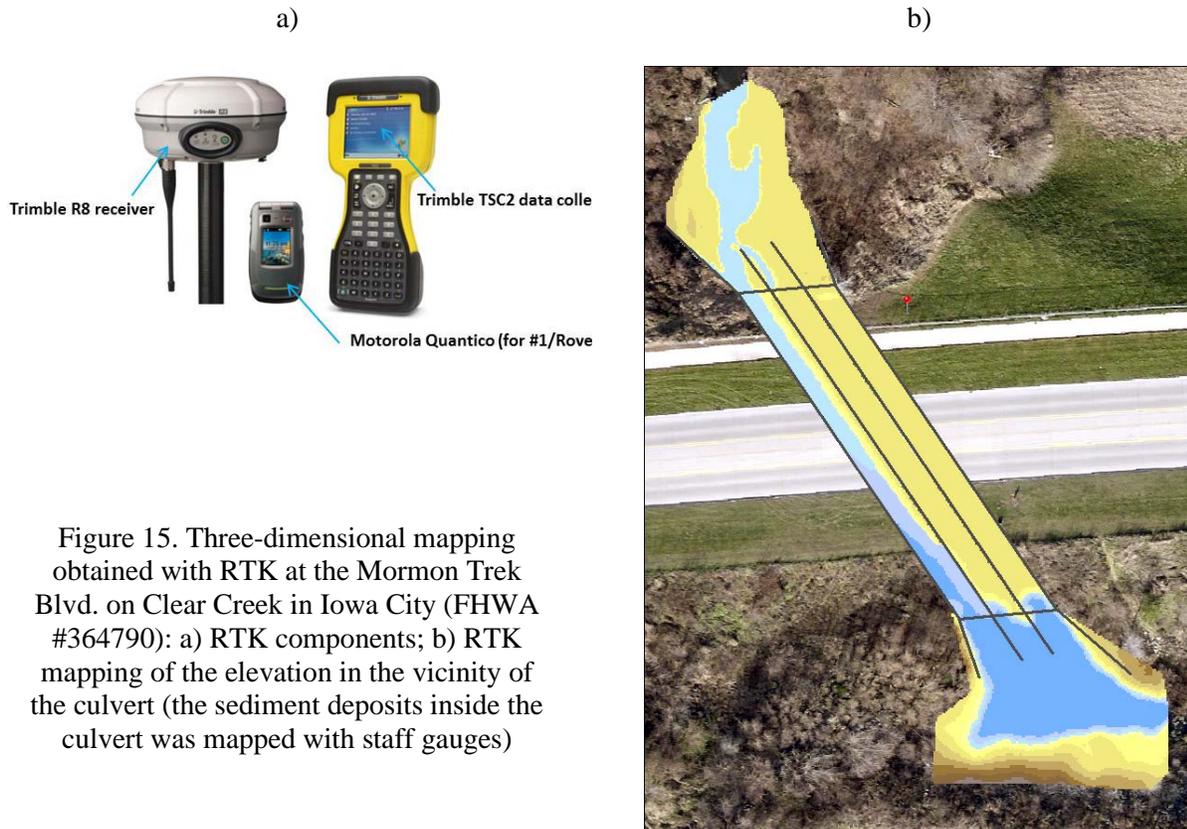
Figure 15. Three-dimensional mapping obtained with RTK at the Mormon Trek Blvd. on Clear Creek in Iowa City (FHWA #364790): a) RTK components; b) RTK mapping of the elevation in the vicinity of the culvert (the sediment deposits inside the culvert was mapped with staff gauges)

For sites where the quantitative estimation of the sedimentation was essential, an in-situ survey with Real Time Kinetic (RTK) GPS instrumentation was used (see Figure 15). The resultant survey of the sediment deposits allows to quantify efficiently both the degree of culvert sedimentation and the blockage at the culvert inlet and outlet. These indicators define the most important parameters of the functional relationship outlining the outcomes of the sedimentation process, hence their estimation and accuracy are critical. However, the in-situ deployment of the equipment and personnel for acquiring the needed RTK data is time and cost consuming, so only relatively few such surveys have been conducted. The role of the detailed RTK in-situ surveys was to compare or supplement the aerial photographs obtained, as described next.

- 1) the stream stage is measured with the IFC stream gage sensor shown in Figure 15a.
- 2) the comparison is extracted from a prior study as during the current one the stage sensor was removed due to construction work in the culvert area.

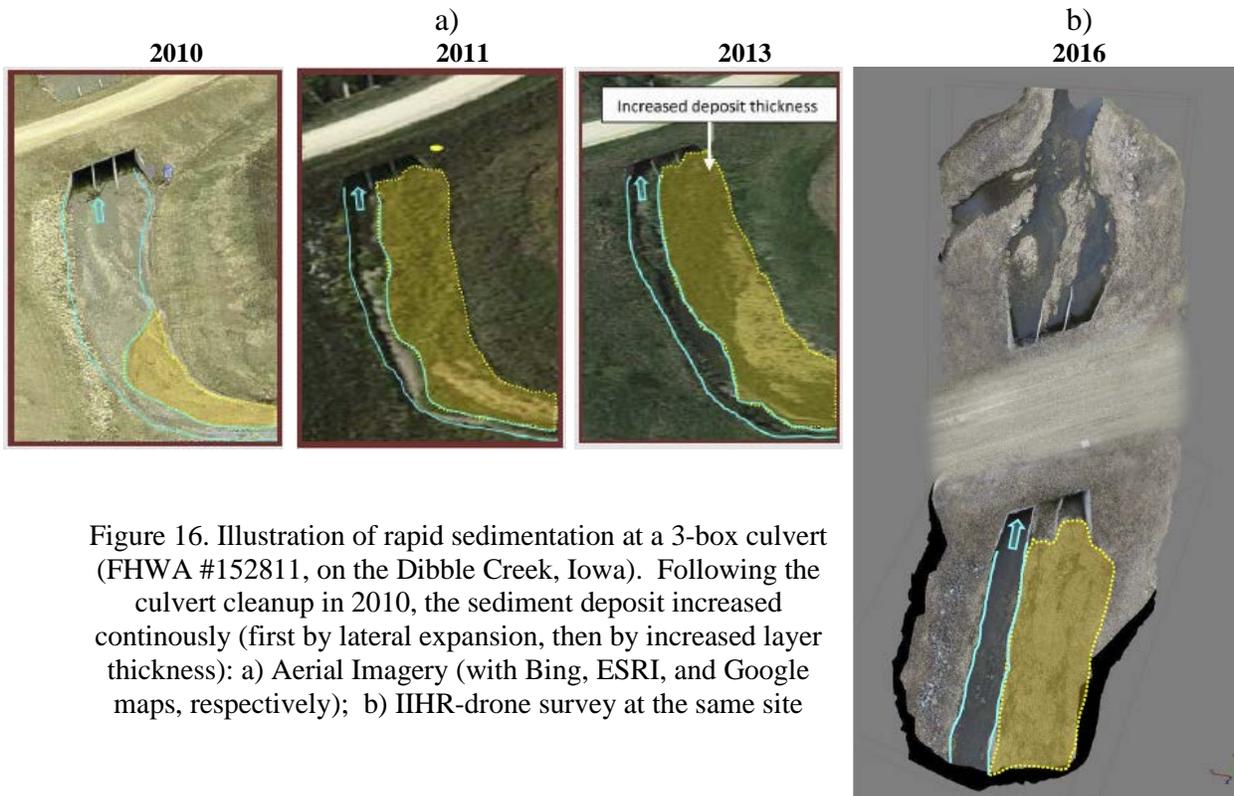
Figure 16. Illustration of rapid sedimentation at a 3-box culvert (FHWA #152811, on the Dibble Creek, Iowa). Following the culvert cleanup in 2010, the sediment deposit increased continuously (first by lateral expansion, then by increased layer thickness): a) Aerial Imagery (with Bing, ESRI, and Google maps, respectively); b) IIHR-drone survey at the same site

Drone-based surveys entail low-altitude flights with continuous image recordings followed by post-processing of the images using Structure from Motion (SFM) processing in conjunction with specialized photogrammetry software (Agisoft Photoscan Software). The software applies photogrammetric principles to the drone-acquired images to reconstruct the landscape as 3D digital photos or elevation maps. This modern type of survey has become increasingly popular due to its low cost and simple deployment. As most civil drones are equipped with digital cameras with continuously increased resolution and positioning accuracy, they have become reliable substitutes for aerial photo surveys. A sample drone-based survey obtained through a previous research project is illustrated in Figure 16b (Muste & Xu, 2017a) to fully demonstrate capabilities of the technique. Similar results for the FHWA # 364790 culvert investigated in this study will be presented in a subsequent section. Given the absence of sediment formation at the other culvert studies through the project (FHWA #031711), this type of survey was not engaged.

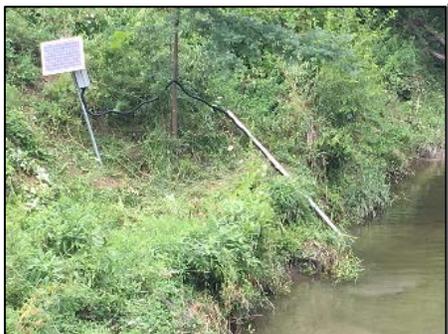
Upstream the culvert (stage & turbidity sensors)

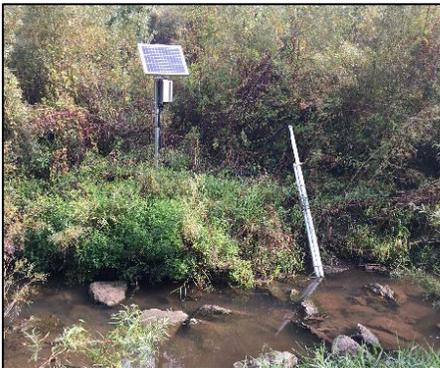
Downstream the culvert (stage sensor)

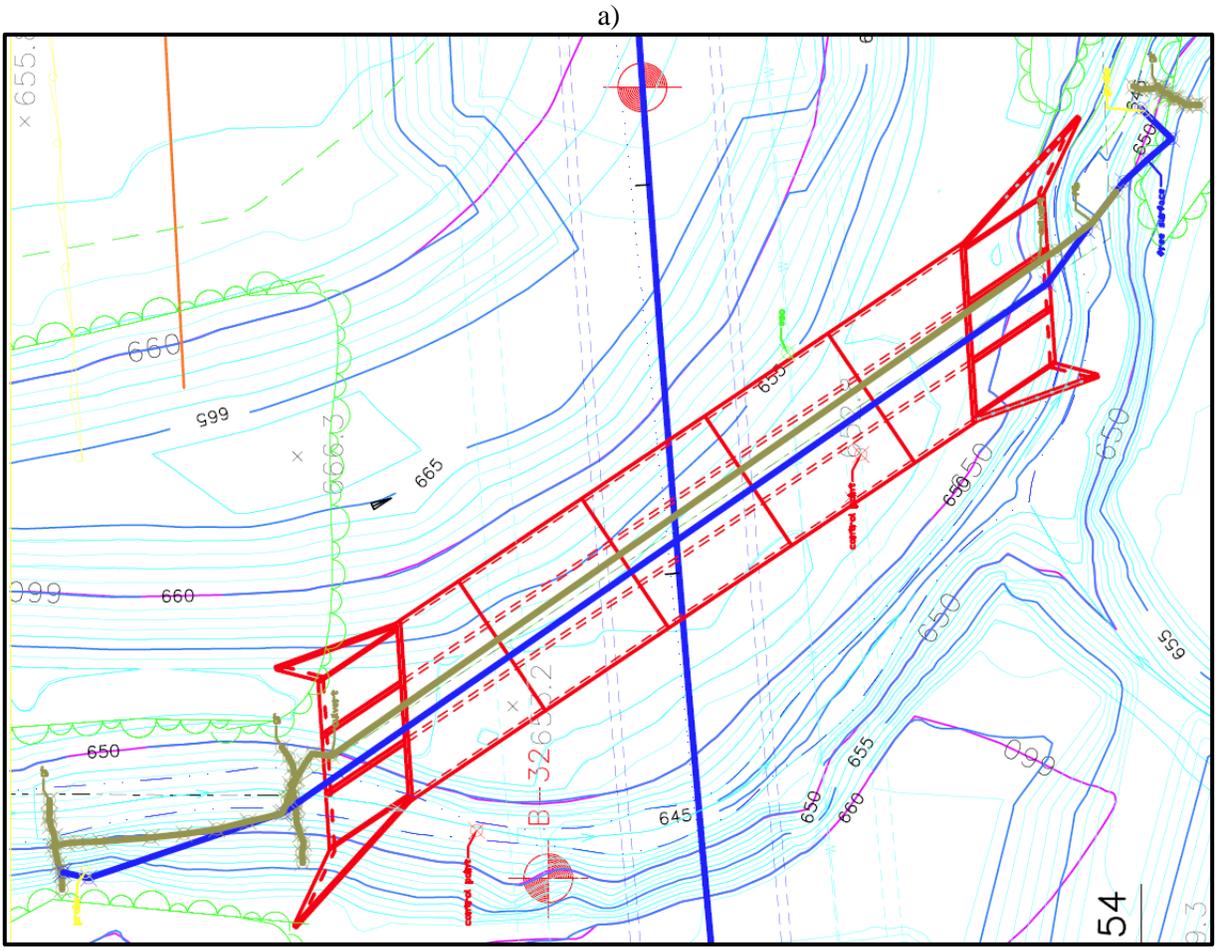
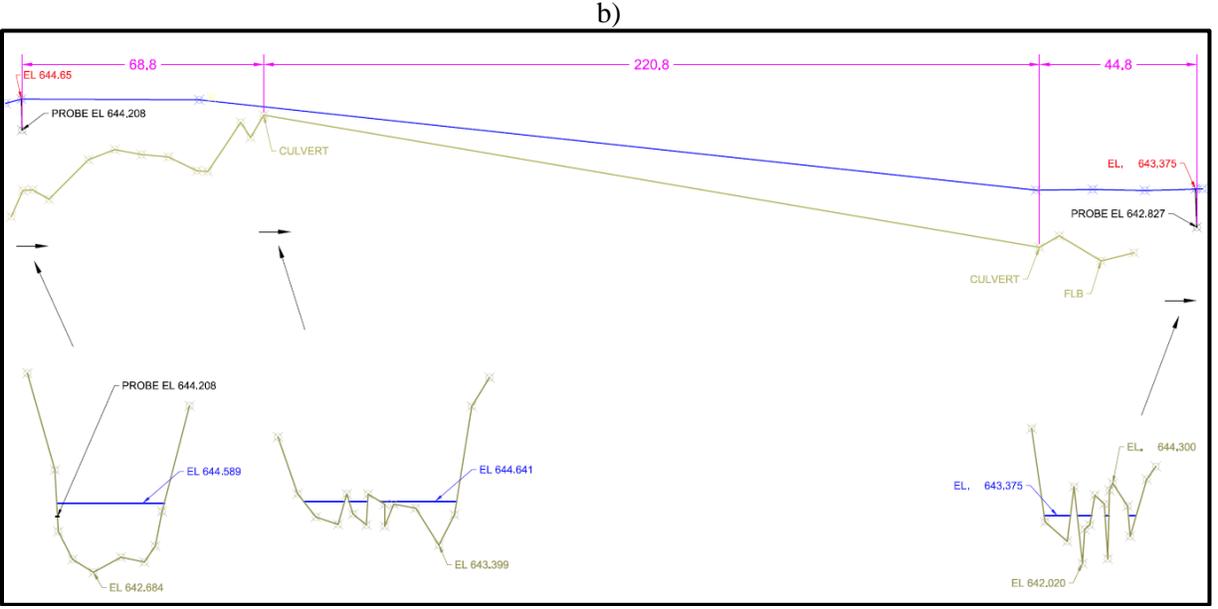
Figure 18. Topographic survey for the FHWA #364790 culvert site: a) plan view, b) cross section

The morphological characterization for the FHWA #364790 culvert site was accomplished by a total station survey conducted by the City of Iowa City personnel prior to the downstream retrofitting which followed the deployment of the hydraulic observation system. Results of the topographic survey are shown in Figure 18. The survey of stage sensors deployed at the FHWA #364790 allowed for the estimation of the free-surface slope through the culvert area needed to quantify the degree of disturbance produced by the downstream weir in comparison with the stream geometry with just the culvert in place. A good configuration for any of the self-cleaning designs should not considerably change the energy losses through the retrofitted culvert in comparison to an as-constructed culvert. The change in the water level drop after the weir installation was less than one foot (specifically, between 1.3 ft to 0.45 ft), as illustrated in Figure 19a. The aforementioned local variables were complemented with precipitation records from a neighboring weather station located within the airport, along with local turbidity measurements (see Figure 19b). The quantitative and qualitative observations made on the development of the sediment deposits may be subsequently corroborated with measurements of water stages and slopes, along with those of precipitations during each storm. Rates of suspended sediments could be obtained from hydrologic variables coupled with sediment concentration measurements. This comprehensive characterization is helpful for assessing the relationship between sediment deposition rates and the factors driving flow and sedimentation processes at the culvert site.
