FINAL REPORT FOR IHRB TR-719

# DEVELOPMENT OF SELF-CLEANING BOX CULVERTS

Phase III

**M. Muste, H. Xu**  
IIHR-Hydroscience & Engineering, The University of Iowa  
Iowa City, IA 52242-1585

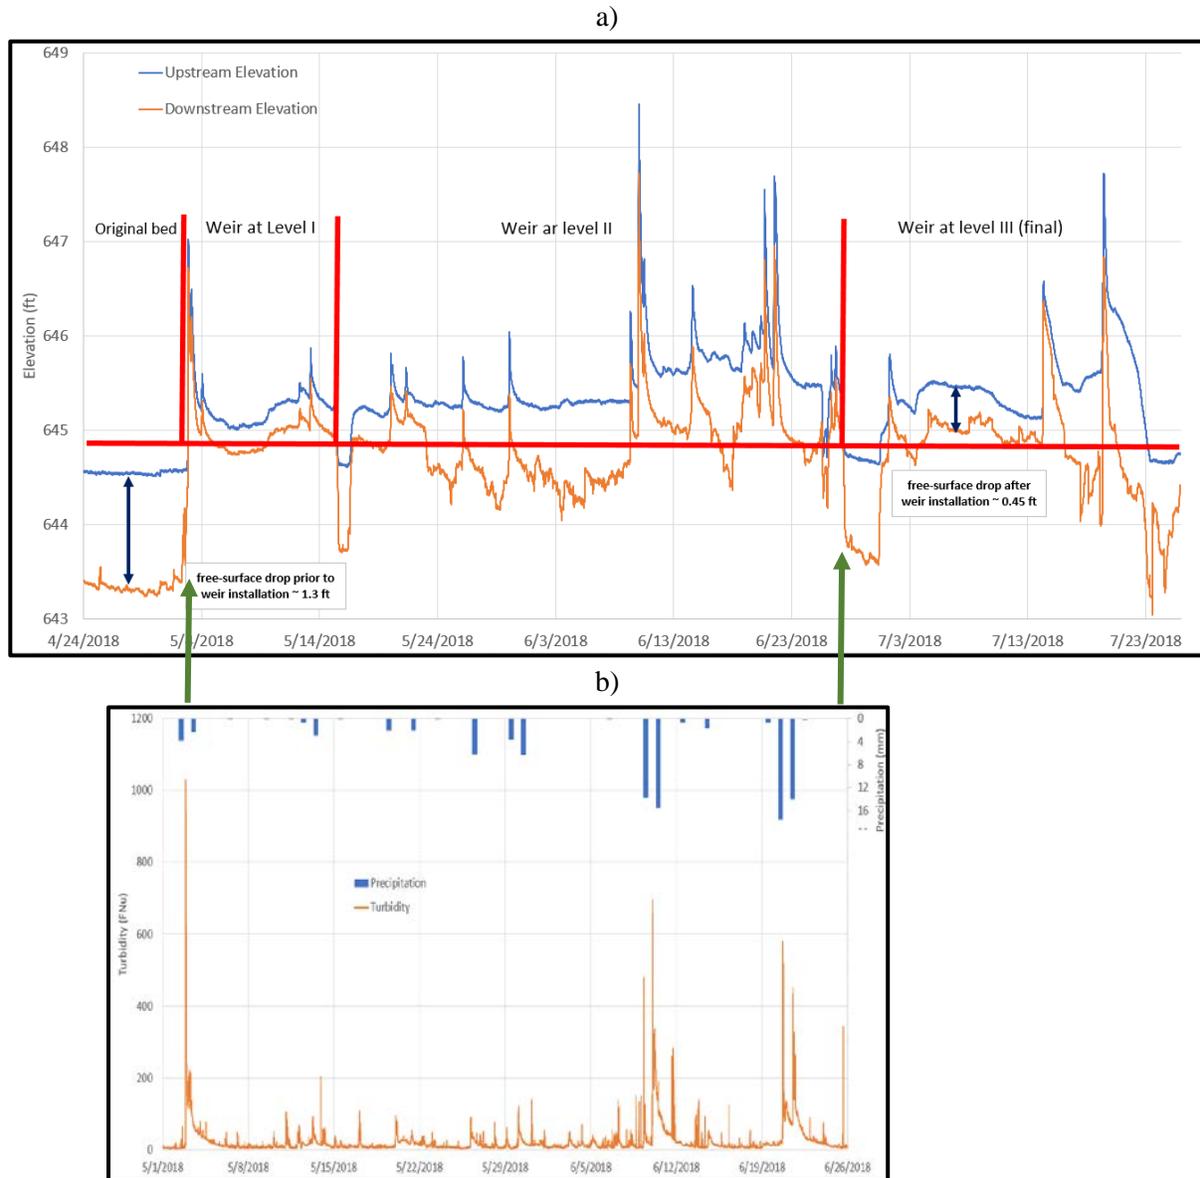
Figure 19. Hydrologic/hydraulic variables along with turbidity measurements acquired at the FHWA #364790 culvert site: a) water surface stage variation during downstream weir construction; b) precipitation measurements and turbidity sampled upstream the culvert. Note: the two plots were scaled to cover the same time interval for allowing inferences.

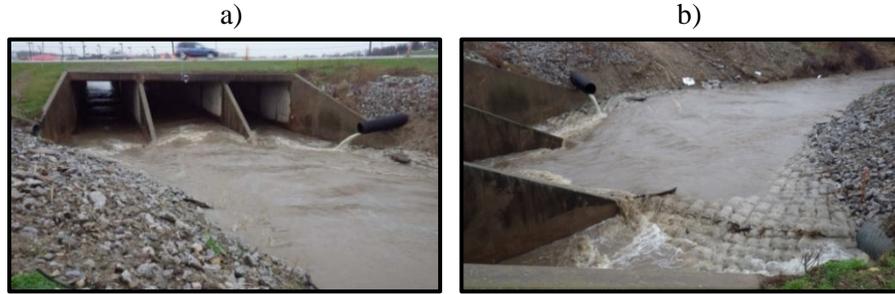
Figure 20. Documentation of the culvert performance during a storm event at FHWA #031711: a) and b) views of the flow through culvert during a storm; c) precipitation and stage hydrograph at the culvert location for the same storm.

- 1) the stream stage is measured with the IFC stream gage sensor shown in Figure 15a.
- 2) the comparison is extracted from a prior study as during the current one the stage sensor was removed due to construction work in the culvert area.

The aforementioned hydraulic measurements made possible associating the qualitative visual information of the flow through the culvert with direct stage measurements, as illustrated in Figure 20 for the FHWA #031711 site. The description of the dynamics of the suspended and bed load movement through the culvert exceeds the scope of the present study. However, in order to highlight the potential value of the complementary measurements of water hydrodynamics to sediment transport for evaluating the performance of culvert operations (with or without retrofitting installations), we illustrate the measurements of local variables recorded for the FHWA #364790 culvert site in Figure 21.

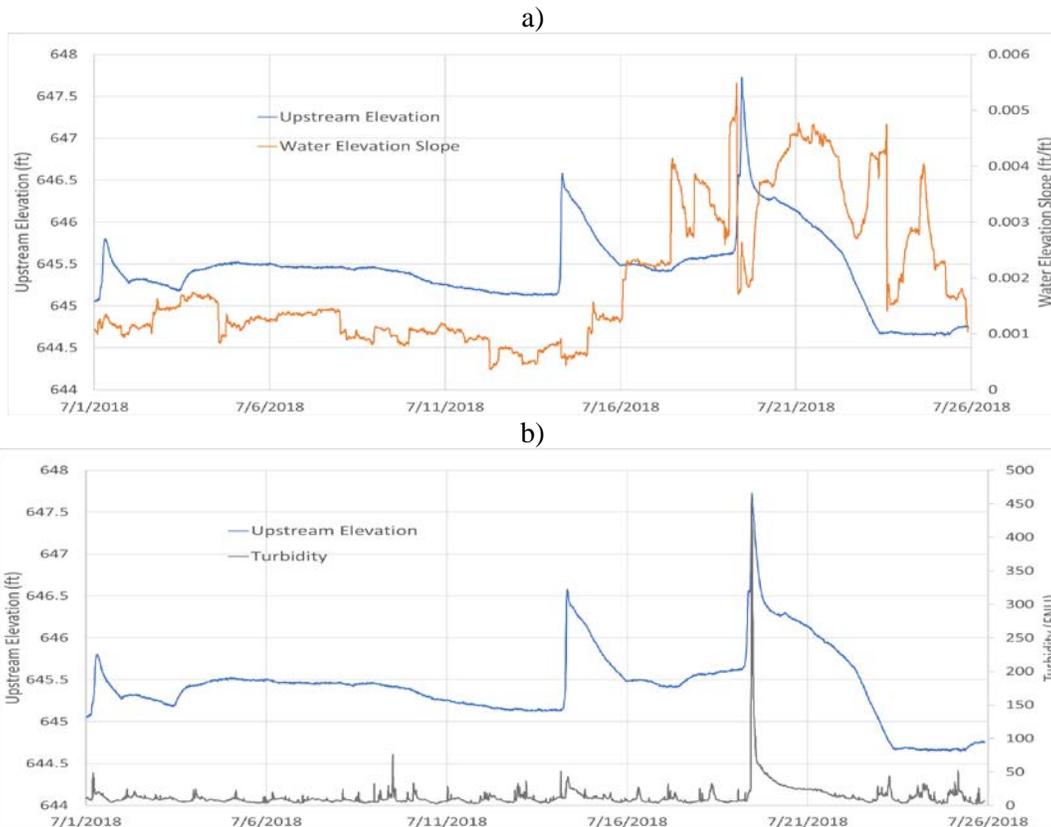
Figure 21. Recordings of water stages and turbidity at the retrofitted culvert for FHWA #364790 site: a) upstream stage and free-surface slope, b) stage and turbidity recording at the inlet of the culvert

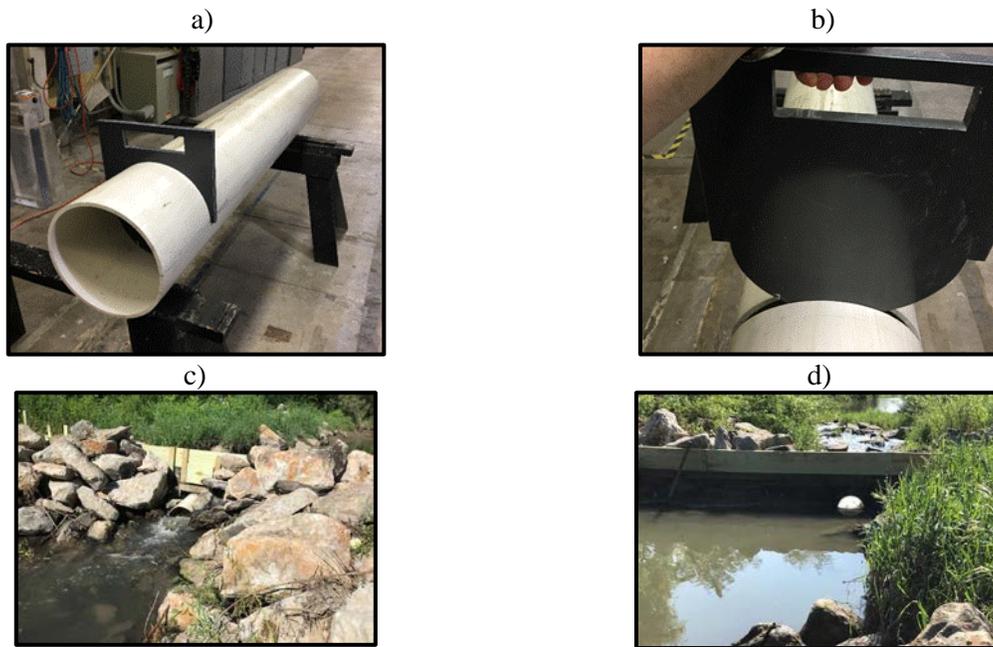
Figure 23. Draining pipe set in the downstream weir at the FHWA #364790: a, b) views of the pipe segment and vane, c, d) downstream and upstream views of the pipe segment during draining.

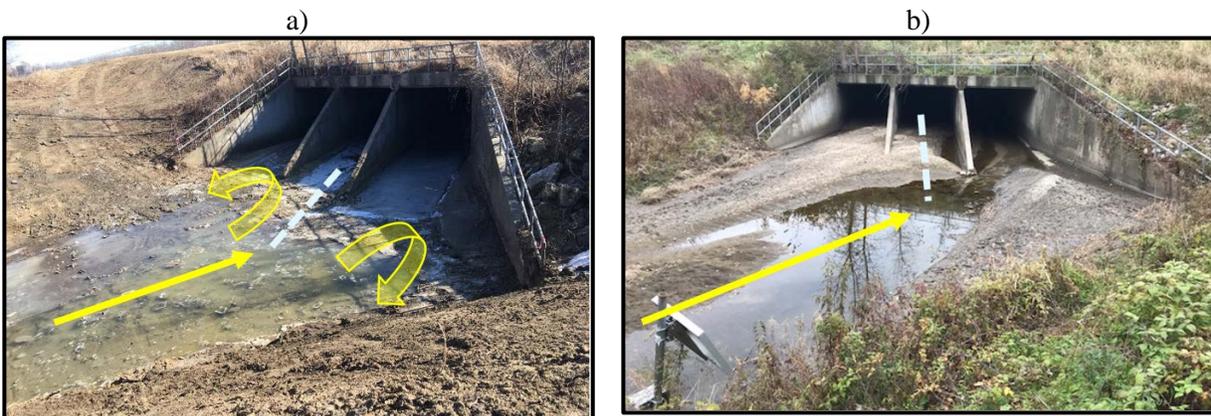
Figure 24. Preferential sedimentation of the sediment transport in the upstream area of the FHWA #364790 culvert during the first 12 months of culvert operation from the total cleanup: a) culvert after cleanup in February, 2018; b) sediment deposits in October, 2018. Yellow arrow: streamflow dominant direction; dotted white line: culvert orientation.

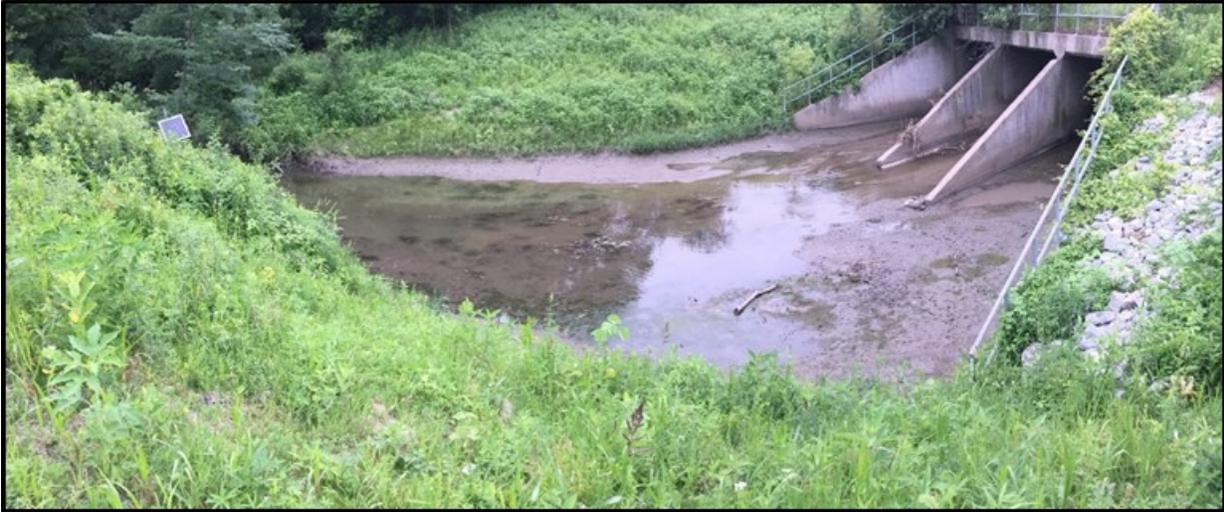
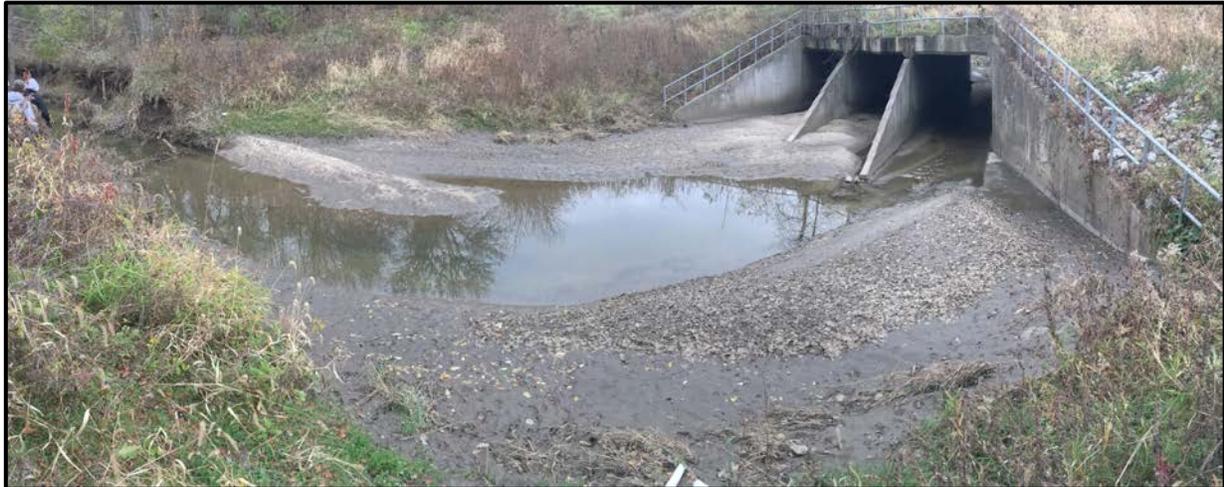
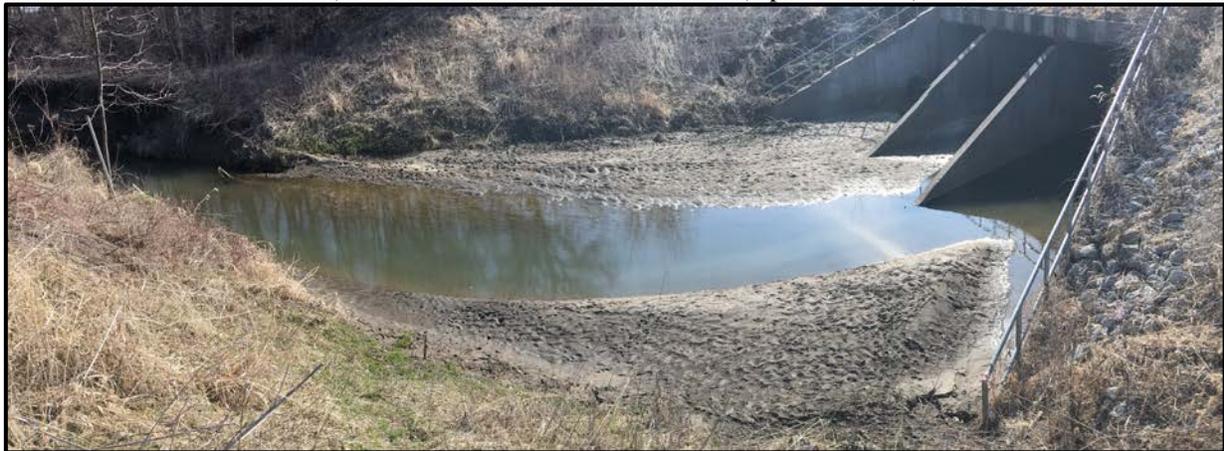
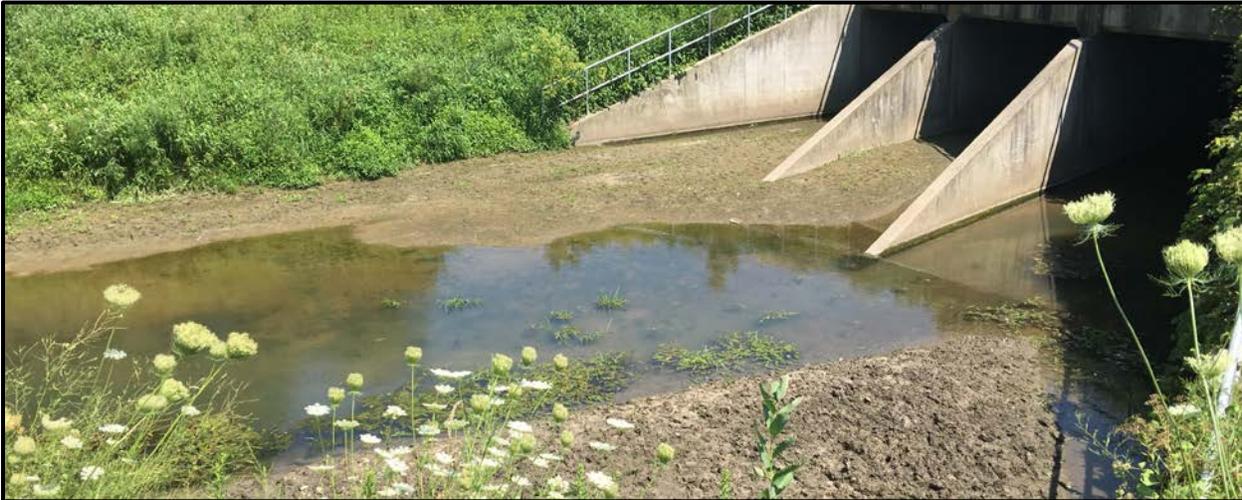
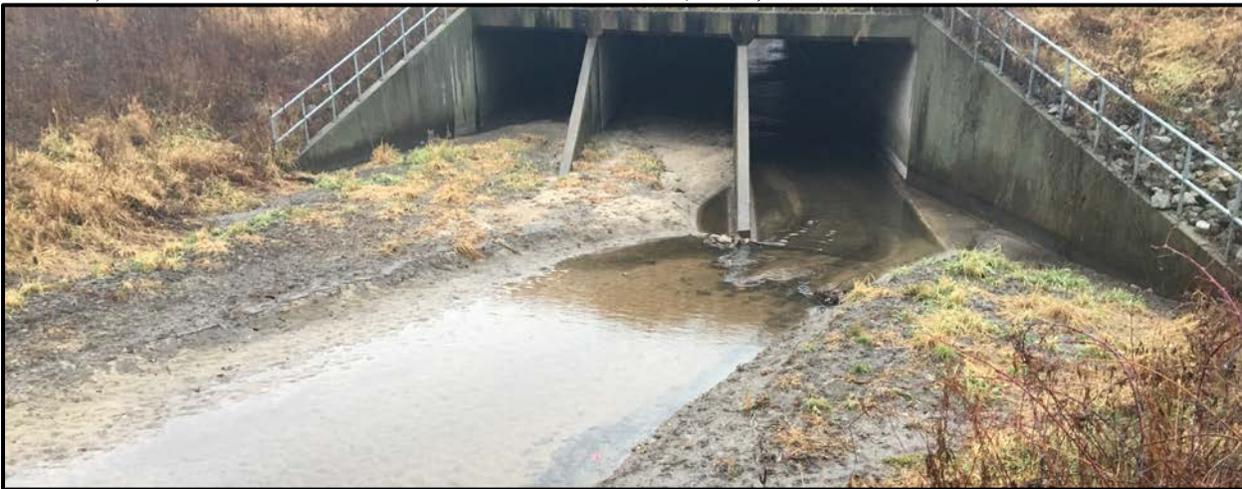
a) 2 months after weir installation (June 15, 2018)

b) 7 months after weir installation (November 8, 2018)

c) 12 months after weir installation (April 1, 2019)

d) 18 months after the weir installation (July 26, 2019)

e) 24 months after the weir installation (December 1, 2019) and 4 months after weir removal.

Figure 25. Development of the underwater sediment deposits in the upstream area of FHWA #364790 culvert site over the period of study. Note: the draining pipe shown in Figures 23 was used to empty the pooled area. The culvert downstream area is not shown as it remained submersed after pipe opening.

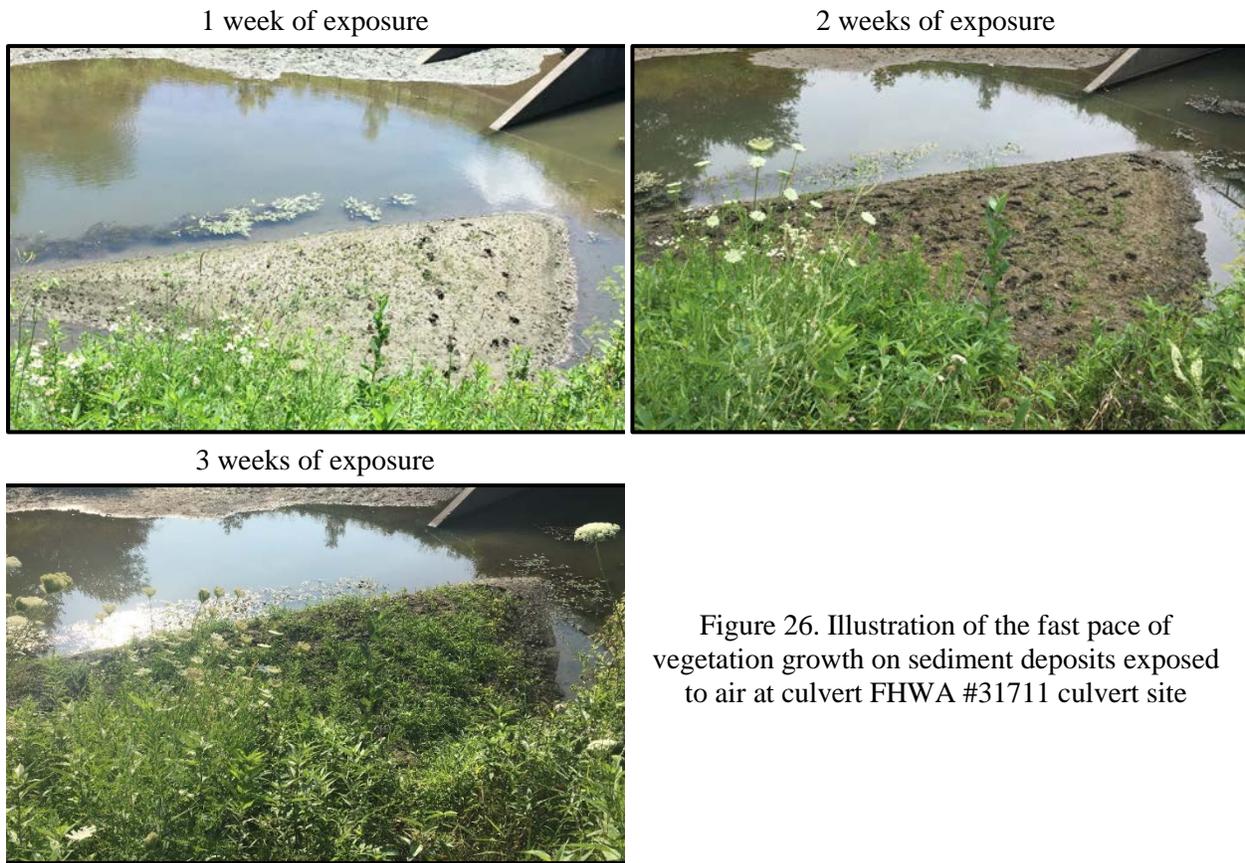
Figure 26. Illustration of the fast pace of vegetation growth on sediment deposits exposed to air at culvert FHWA #31711 culvert site

The fast pace of vegetation growth could be observed during the monitoring of the FHWA #364790 culvert site after the weir removal in August 2019. Figure 26 contains images recorded on the upstream deposits at this culvert illustrating well the vegetation growth despite that it was late summer when the images were taken. The grown vegetation act as a sediment attractor leading in short time the deposits that are reinforced by the vegetation roots. The increase of the island is however limited, as after a certain growth of their high they become less frequently covered by the storm flows. Prior observations on Iowa culverts led to the conclusion that the sediment deposits “stabilizes” in no more than five years.

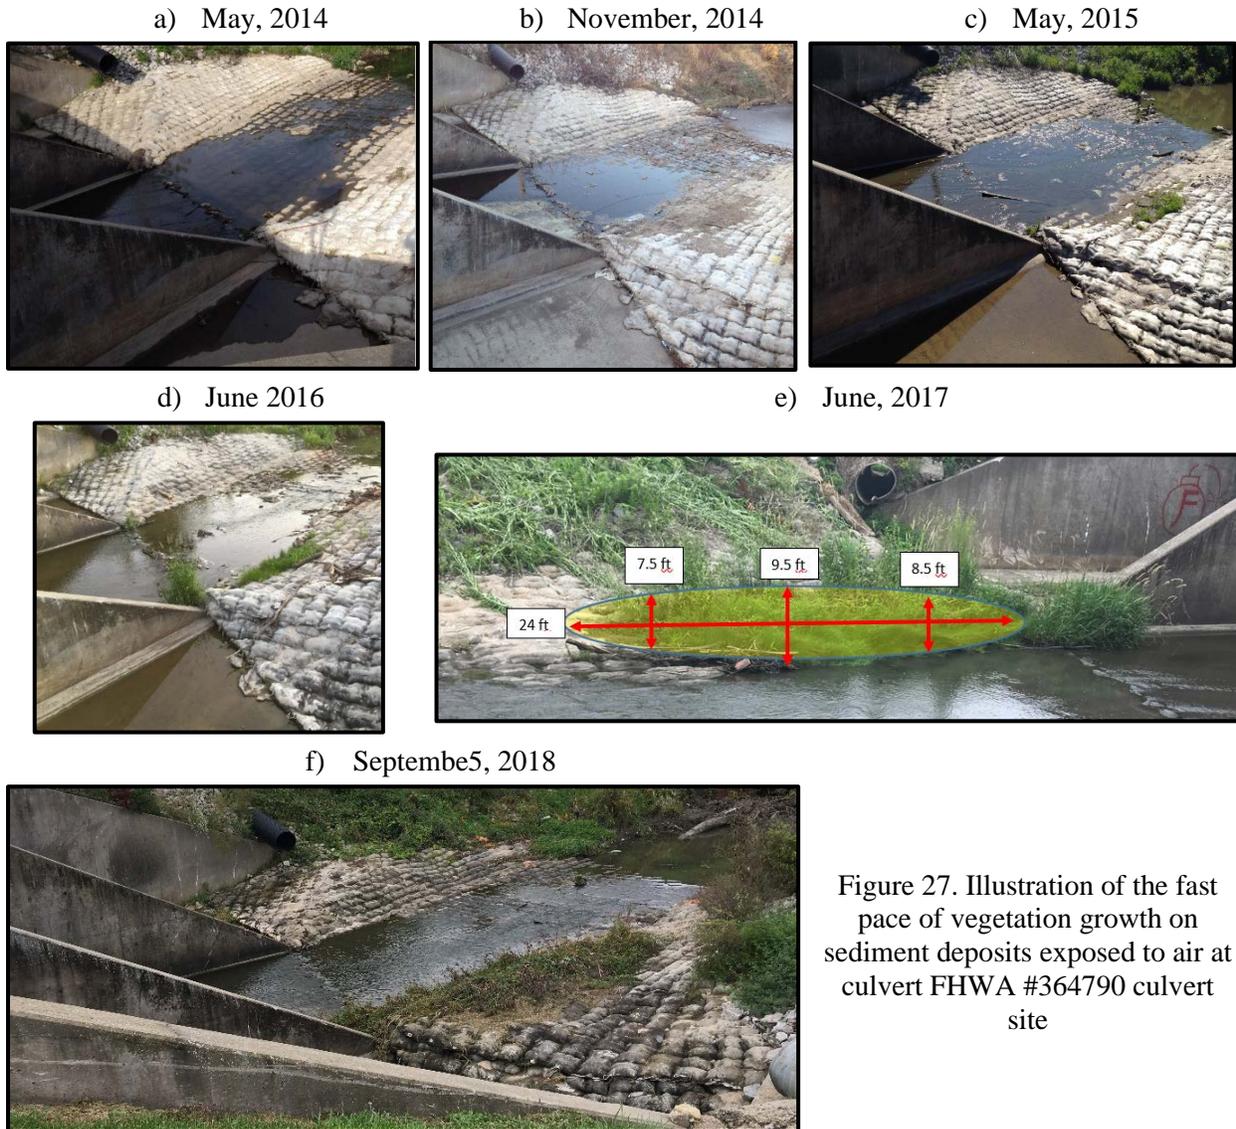
Figure 27. Illustration of the fast pace of vegetation growth on sediment deposits exposed to air at culvert FHWA #364790 culvert site

Another illustrative example of the pace of vegetation growth is provided by an opportunistic situation occurred at FHWA #031711 culvert site during the previous retrofitting of the upstream area. Specifically, during the installation of the ABM in the upstream area of the culvert (December, 2013), the contractor miss positioned one of the ABM mats on the left side of the culvert entrance, as illustrated in Figure 27a. This barely perceivable depression led in subsequent seasons to a sedimentation problem that could compromise the performance of the entire retrofitting structure. Specifically, this depression developed in time a “patch” of vegetation that continue to growth even if the layer of the soil had no communication with the stream bed as the sediment island was sitting on the top of the mat. The abundant water and sediment supply provided by the stream during normal and higher flows led to a continuous development of the island as shown in Figures 27 b, c, d, e, and f. The area was retrofitted to this project and, similarly to the right fillet area, did not show favorable conditions for vegetation development during the current monitoring phase.

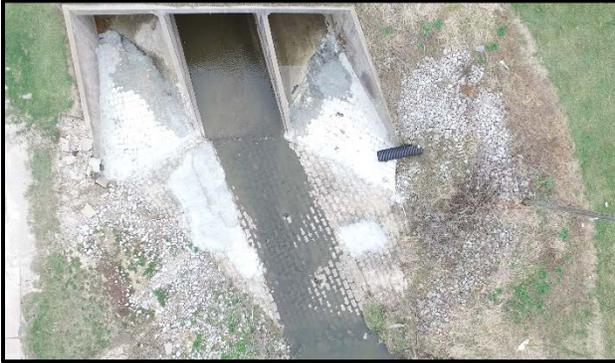
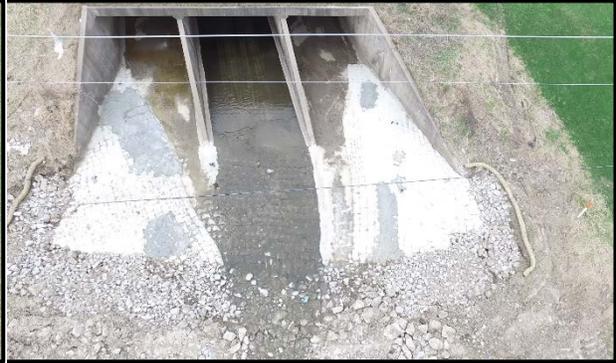
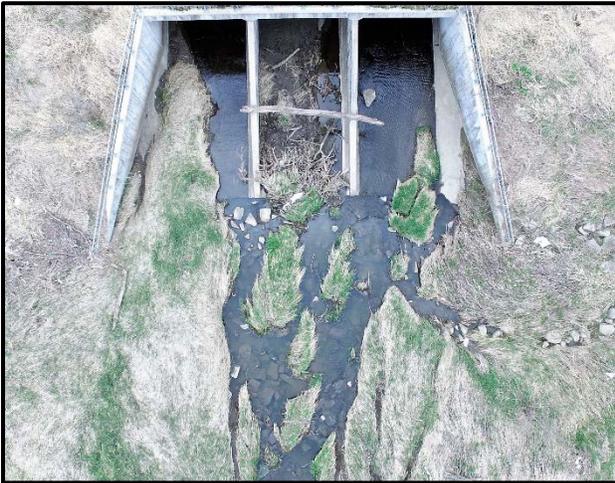
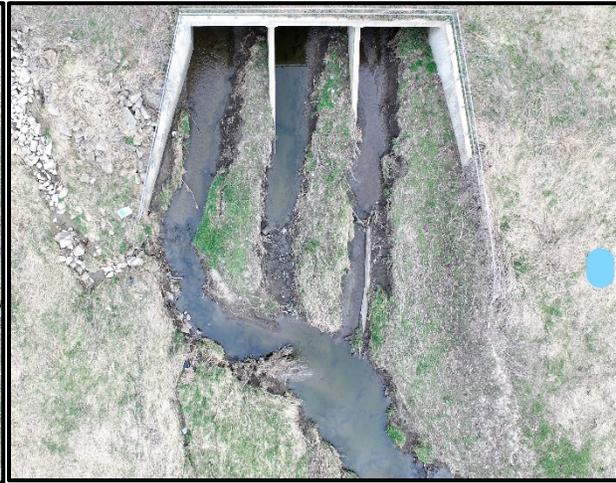
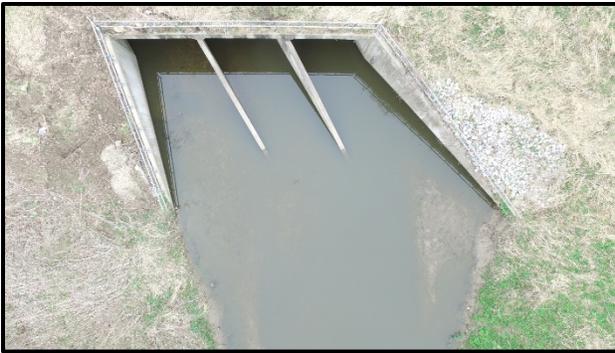
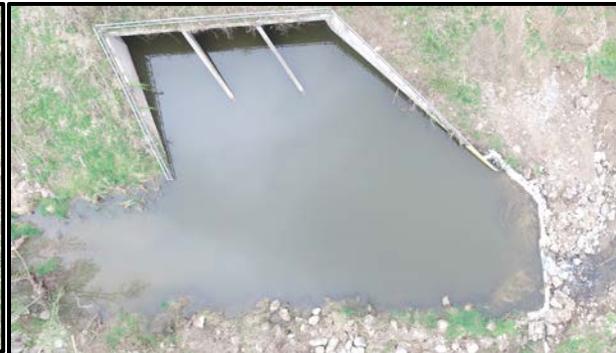
Figure 28. Drone surveys of the culverts monitored through the present study (see Figure 7a for locating the culverts on the map): a) and b) upstream and downstream areas of FHWA #31711 culvert Site #1 (Design A), respectively; c) and d) upstream and downstream areas of the 3-box culvert Site #2 (reference), respectively; e) and f) upstream and downstream areas of FHWA #364790 culvert Site #3 (Design C); and g) and h) upstream and downstream areas of the 3-box culvert Site #4 (Design B).

***Quantitative sediment deposit mapping and structure analysis.*** Complementary to the short-time qualitative monitoring associated with passing of individual storms, quantitative analyses applied to the periodic in-situ surveys offered by aerial photographs or drone surveys can offer useful information on the sedimentation evolution over seasonal or annual scales. The power of this analysis is self-evident in the series of photos taken in successive years for the culverts in the study area, as illustrated in Appendix A. These images can be explored quantitatively to inform on the patterns of sediment development, rates of evolution over time, and formulation of the correlations between stream geometry, culvert geometry and the nature of the drainage area upstream from the culvert site using, for example, the IDOT Culverts web-platform developed by the authors through a previous study (Demir et al., 2019). A more precise quantification of the extent of sediment deposits can be obtained from local drone surveys. The drone surveys carried out after culvert retrofitting are illustrated in Figures 28a and 28c along with the other culverts in the study area.

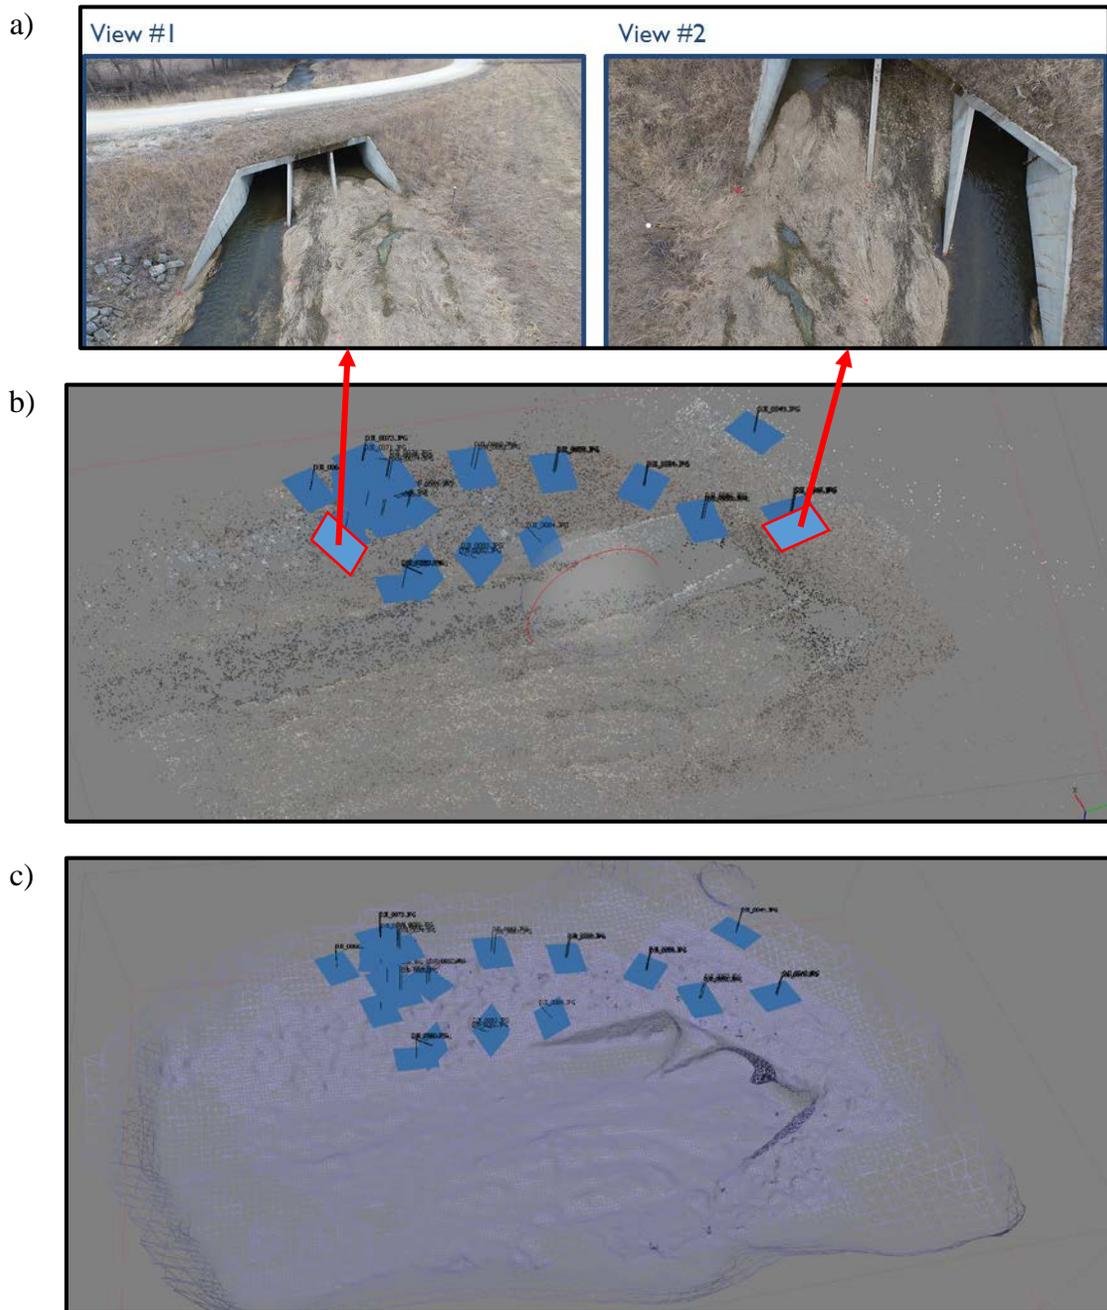
Figure 29. Image reconstruction using Structure From Motion software (Muste & Xu, 2017a): a) drone images; b) image stitching using tie points; and c) addition of the terrain texture.

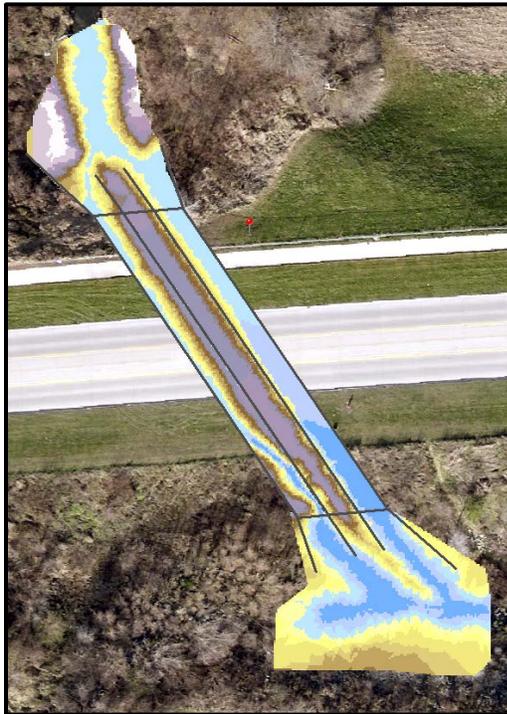
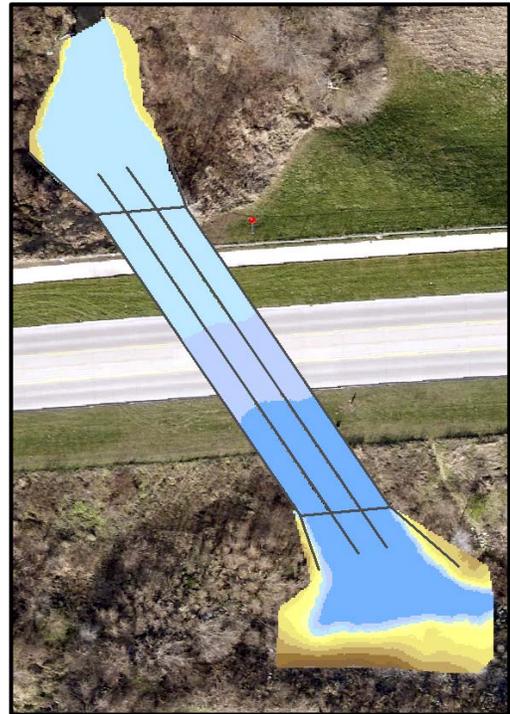
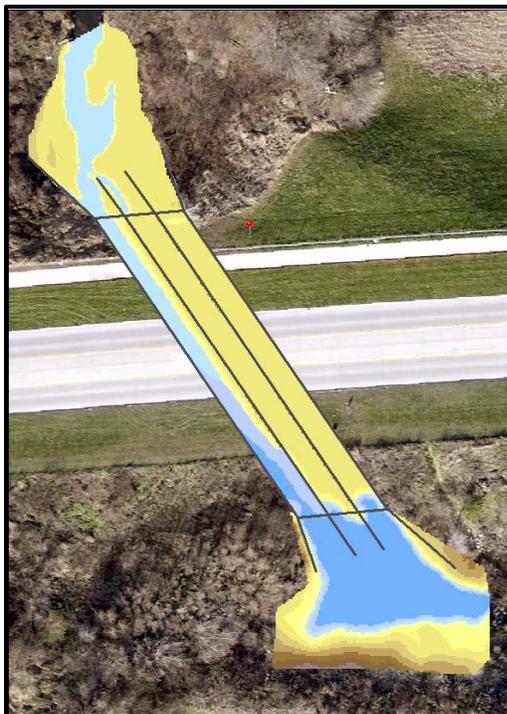
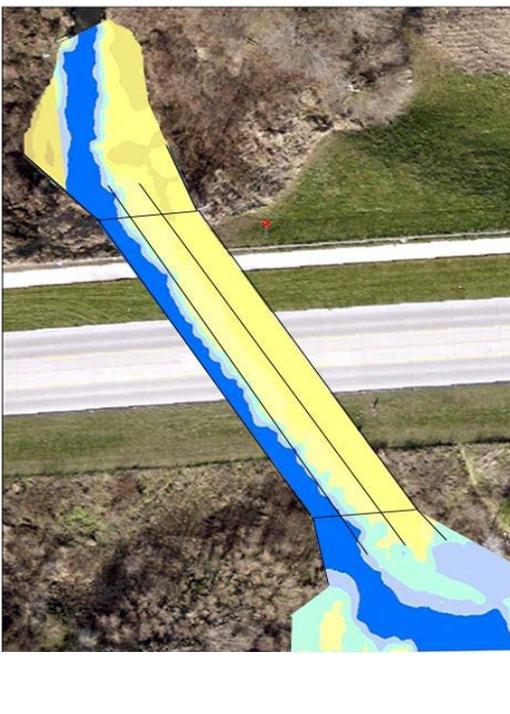
Figure 30.  
3-D digital  
elevation maps  
for the FHWA  
#364790  
culvert site  
during the  
study period

A notable feature of the sedimentation pattern during this study is the fact that the sediment deposition does occur in the left and central barrels, as illustrated in Figure 30d. This pattern is consistent with the “natural” course of the flow through a bend, as flow velocities in the outer bend area are typically higher, preventing the deposition of sediments. An identical flow pattern was also observed in the historical photographs of this site in the first years after the culvert construction (see Appendix A). However, 3 years after the culvert construction, a massive accumulation of debris blocked the flow passage through the right barrel and the flow was diverted toward the left barrel. From this moment onwards, the flow through the right and central barrels was slowed down, leading to sedimentation on the right side of the culvert behind the debris curtain. In time, the sediment deposited in these barrels became “fossilized,” forcing the stream to choose the left barrel as a free way. The culvert was found in this status prior to its 2017 retrofitting (as illustrated in Figure 30a).

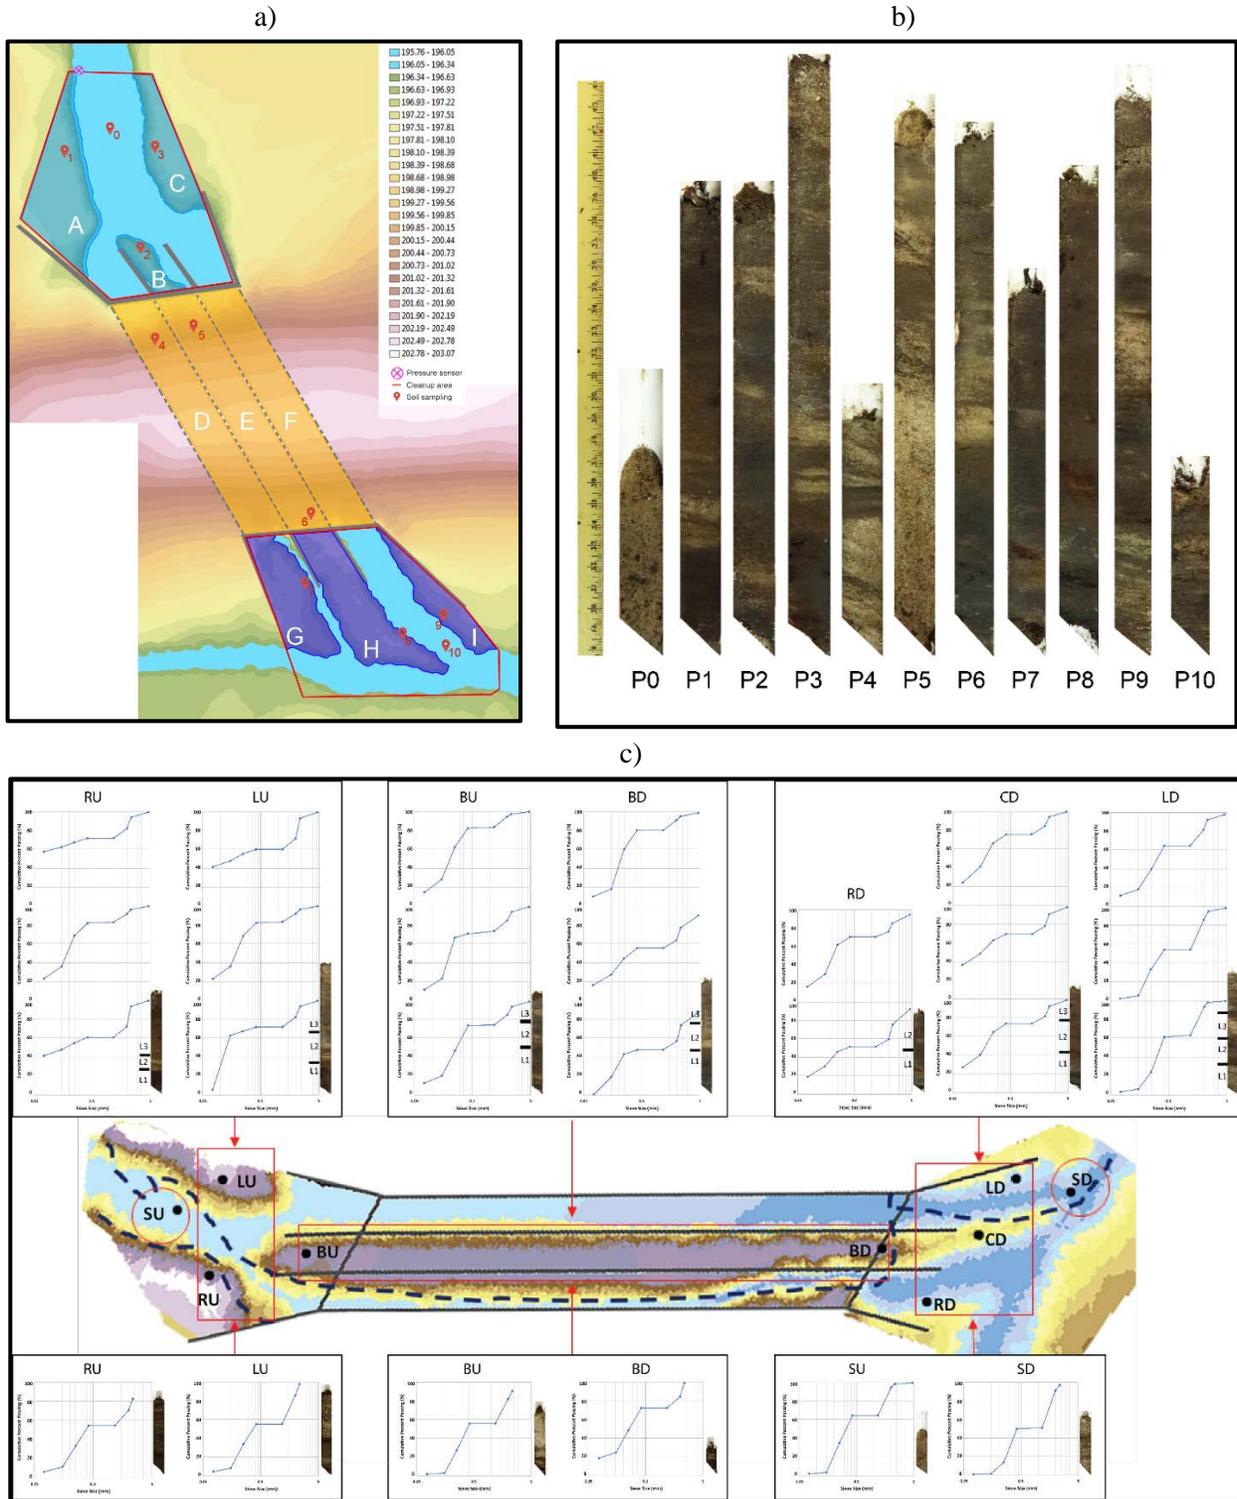
Figure 31. Analysis of the soil cores collected at the FHWA #364790 culvert site prior to retrofitting (original sediment deposits): a) coring locations, b) view of the of the cores, c) synthetic view of the coring analysis including sediment granulometry analysis

Finally, another important analysis for understanding of the sedimentation process or evaluating the effectiveness of a mitigation solutions is the investigation of the sediment deposits formed at the culvert. Of interest in this analysis is both content and stratification in the deposits. For this purpose we sampled cores from representative areas of the deposits (i.e., upstream, downstream, inside and outside the channel, and within the covered area by culvert). The cores were analyzed for capturing the layering in the deposits and to estimate the particle size distribution in the samples. The analysis of the coring data for the FHWA #364790 culvert site prior to cleanup (November, 2017) is provided in Figure 31. As expected, the cores visualized in Figure 31b reveal that most of the sediment in the deposit is of the silty-loam nature and that there is alternating layers through the culvert length that requires more detailed analysis to lead to robust conclusions. This layering was observed in the coring analysis conducted after one year of retrofitting and was related to the passage of coarse materials carried in the culvert during extreme storm events.

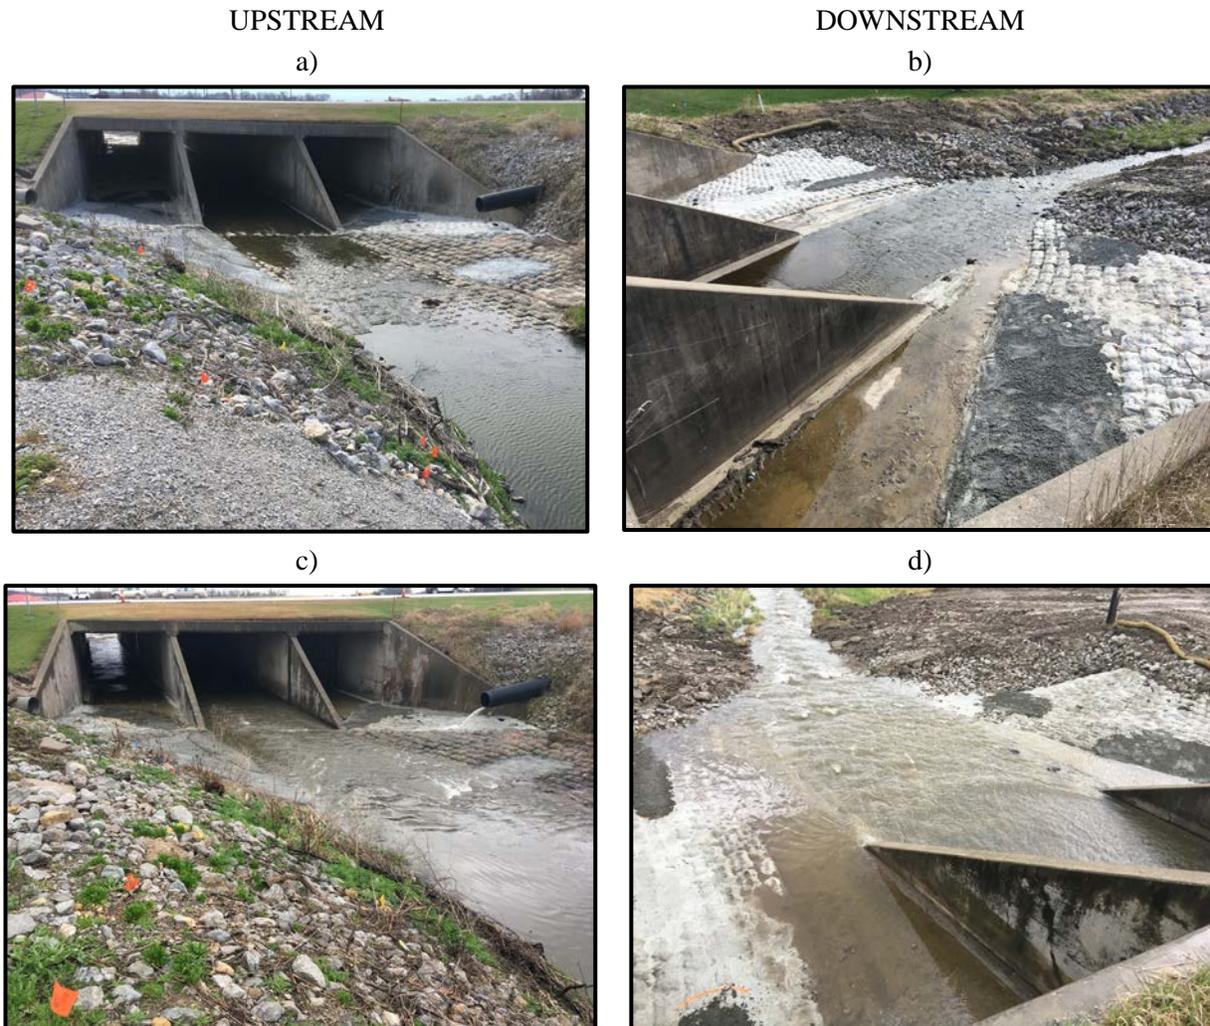
Figure 32. Design A at FHWA #31711 culvert site: a), b) during normal flow; c), d) during storm

Another important finding observed through this study is related to the design of long culverts. It was observed that given the low slope of the culvert invert at FHWA #31711 site, the deposition of the sediment occurs at the lower end of the culvert barrels due to the friction losses developing along the culvert length. For long culverts it is recommended that the fillets placed at the culvert outlet to be set lower than elevation of the culvert invert in that area. This arrangement will avoid creation of backflow that will further increase sedimentation in the culvert barrels.

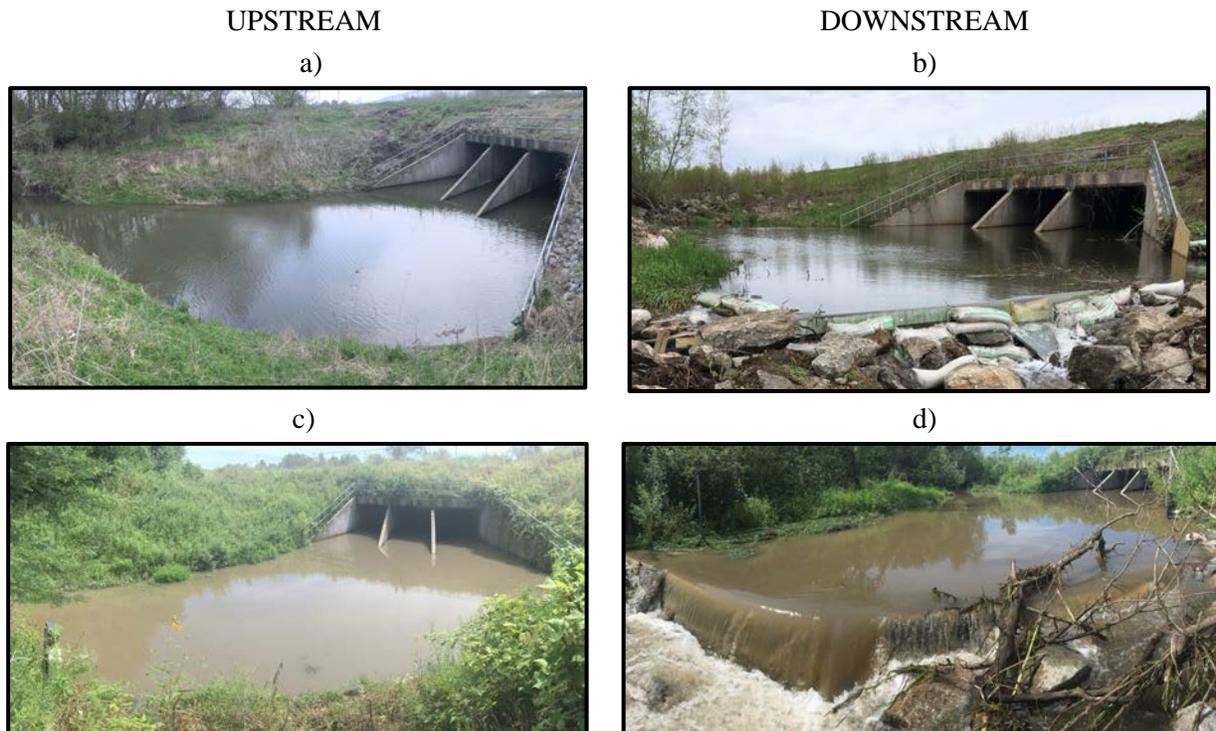
Figure 33. Design C at FHWA #364790 culvert site: a) , b) during normal flow; c), d) during storm

**Design C: downstream weir.** This design was implemented by the construction of a low-head weir downstream of the FHWA #364790 culvert site. It should be noted that this solution was inspired by the clean appearance of a few 3-barrel culverts visited throughout Iowa, as shown in Figure 4a. The views of the retrofitted culvert shown in Figures 28e and 28f provide a striking resemblance with the view of the clean culverts observed in the previous study. While the latter culvert sites have not been investigated for the status of the submersed sediment deposits, it is assumed herein that the sedimentation layers are similar to those reported in Figure 25. The plots in this figure show that the path of the flow and sediment are following a natural (i.e., streamlined) course whereby the sediment deposits are initiated in the side areas of the expansion and contraction toward the culvert where the water velocities are lower. The deposits continue to grow in elevation on the initial footprint.

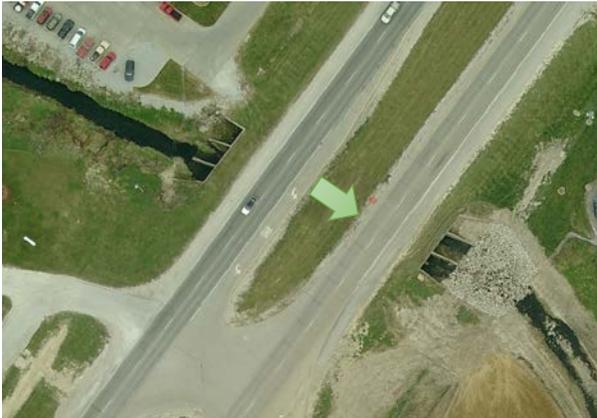
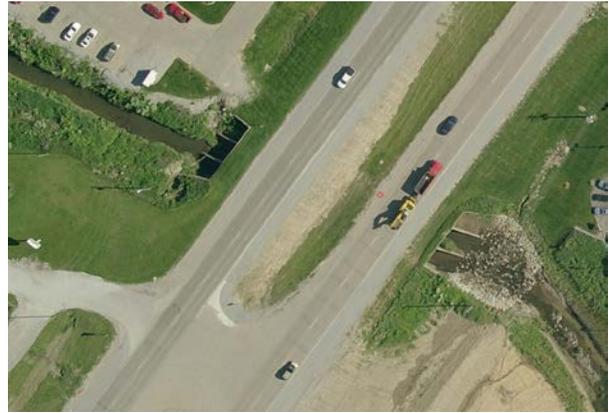
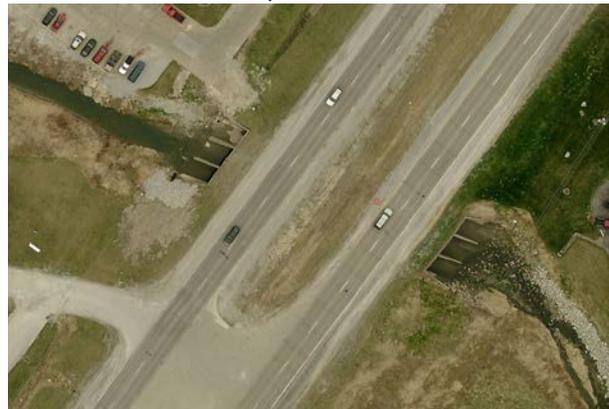
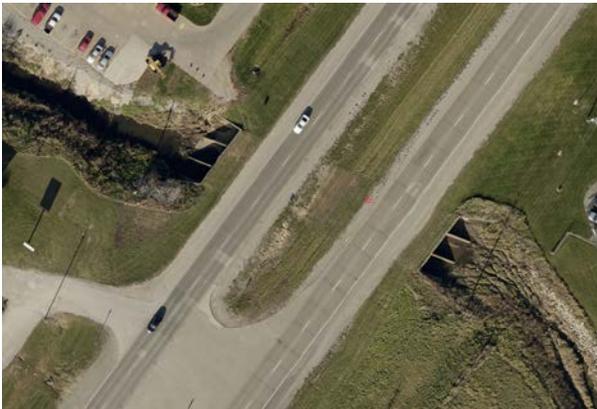
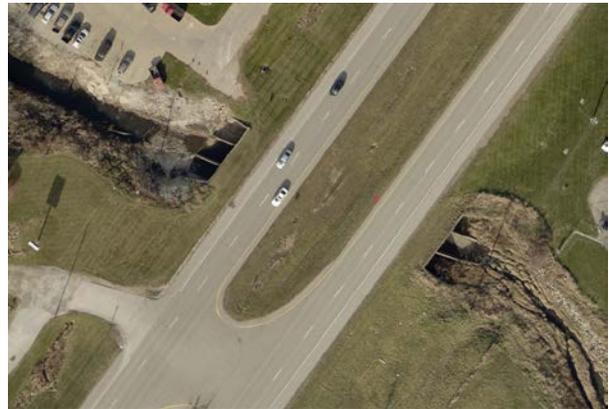
Chronological evolution of the investigated culvert sites (see also Figure 7a).
