Holding Strategies for Low-Volume State Routes – Phase II

Final Report
November 2020

Sponsored by
Iowa Highway Research Board
(IHRB Project TR-735)
Iowa Department of Transportation
(InTrans Project 17-634)

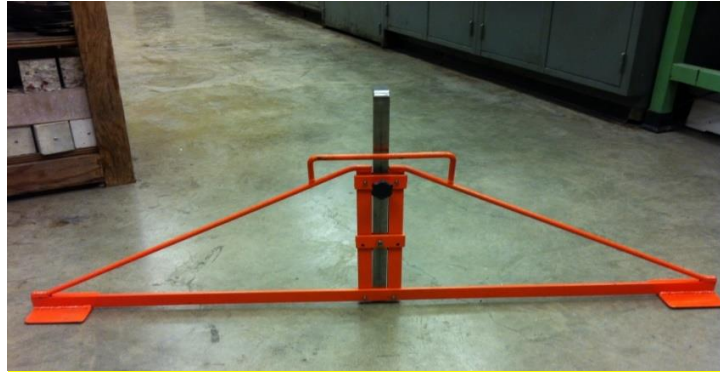
Figure 1. Deflectometer for measuring rutting

Pavement condition surveys were performed according to the Federal Highway Administration (FHWA) pavement distress identification manual (Miller and Bellinger 2014). The severity level of the cracks was determined using a caliper. Figure 1 shows a deflectometer equipped with a 4 ft straight edge and a vertical ruler used to measure the rutting in the wheel paths.

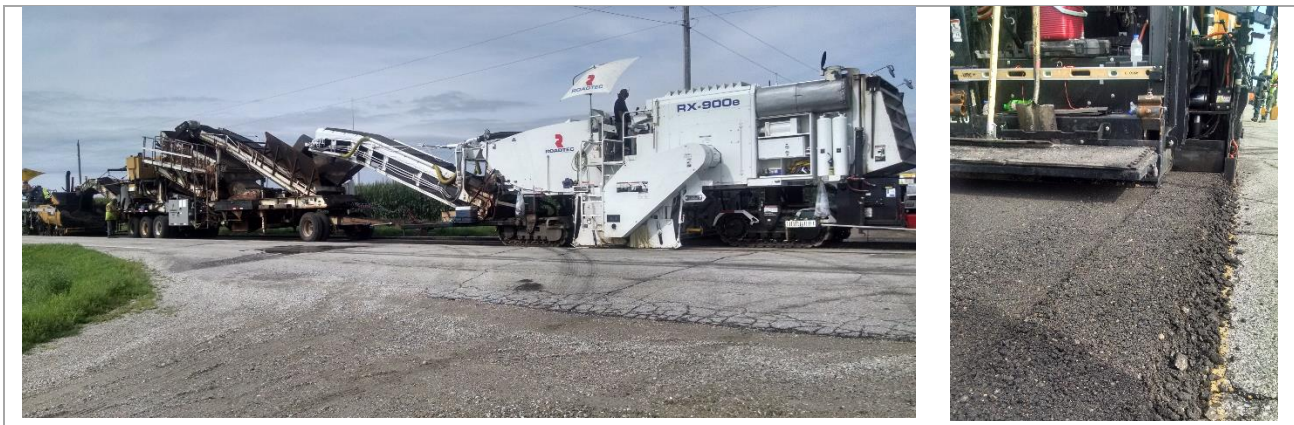
Figure 9. CIR operations: train, left, and pavement placement, right

Cold in-place recycling operations were conducted by a CIR train including a milling machine, a crushing and screening unit, a pug mill, and an oil tank trailer (Figure 9).

The milling machine milled the existing pavement to 4 in. depth and the RAP was conveyed to the crushing and screening unit. This unit further crushed large chunks of RAP into smaller particles that met the specification requirements for RAP gradation. The processed RAP was then conveyed to the pug mill, where it was blended with foamed asphalt. The asphalt binder was supplied by the oil tank trailer that was attached behind the pug mill. The blended mixture was placed in a windrow for the paver. Iowa specifications require the density of the CIR layer to be 94% or above the laboratory density.

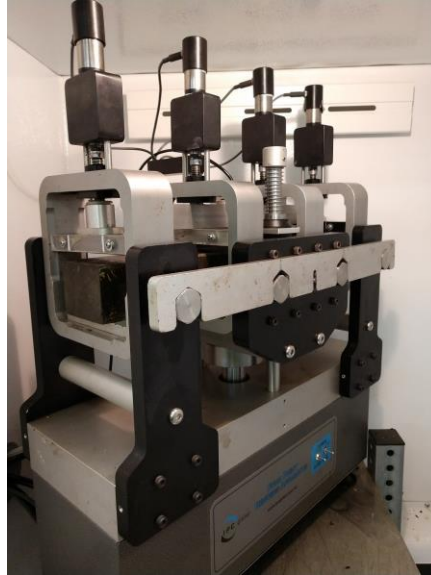
Figure 15. Four-point bending test apparatus

Sections 3, 4, 5, and 6 contained highly elastic modified binders and were tested using the AASHTO T 321 four-point bending test to evaluate their fatigue performance (Figure 15).
