# Implementation of Recommendations for Eliminating Longitudinal Median Joints in Wide Bridges

**Final Report**  
**June 2022**

**Sponsored by**  
Iowa Highway Research Board  
(IHRB Project TR-752)  
Iowa Department of Transportation  
(InTrans Project 18-660)

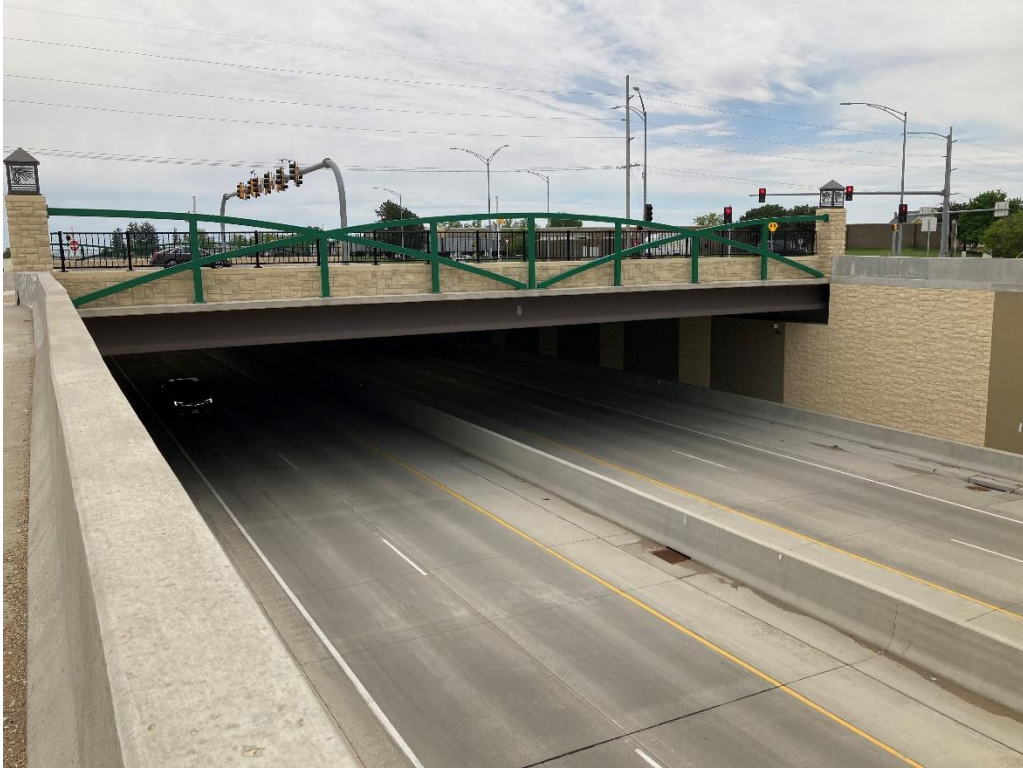
**Figure 1. Viking Road Bridge over IA 58**

This bridge was a single span bridge measuring 115 ft long by 228 ft wide on a 0-degree skew. Figure 1 shows the completed bridge looking south along IA 58.

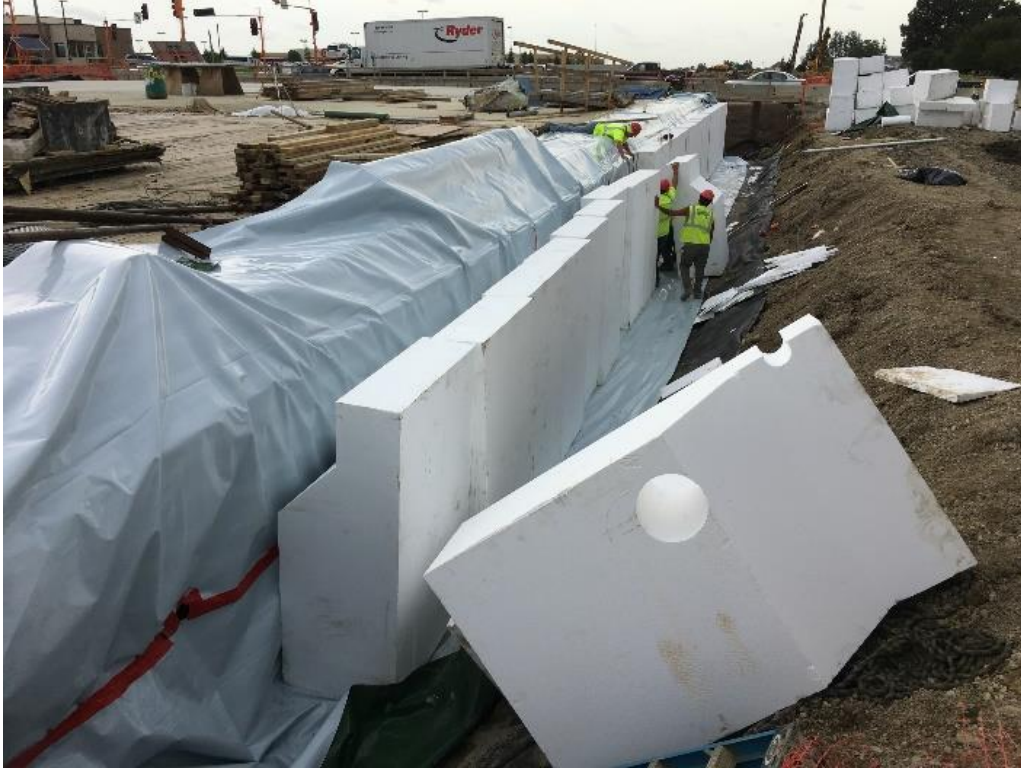
**Figure 7. Preparing for placement of EPS isolation barrier**

Since the bridge was designed with an integral abutment, the abutment diaphragm concrete was placed together with the deck concrete. After the placement of the bridge deck and abutment diaphragm concrete, the thermal isolation barrier was placed along the back side of both abutments, as shown in Figure 7 and Figure 8.

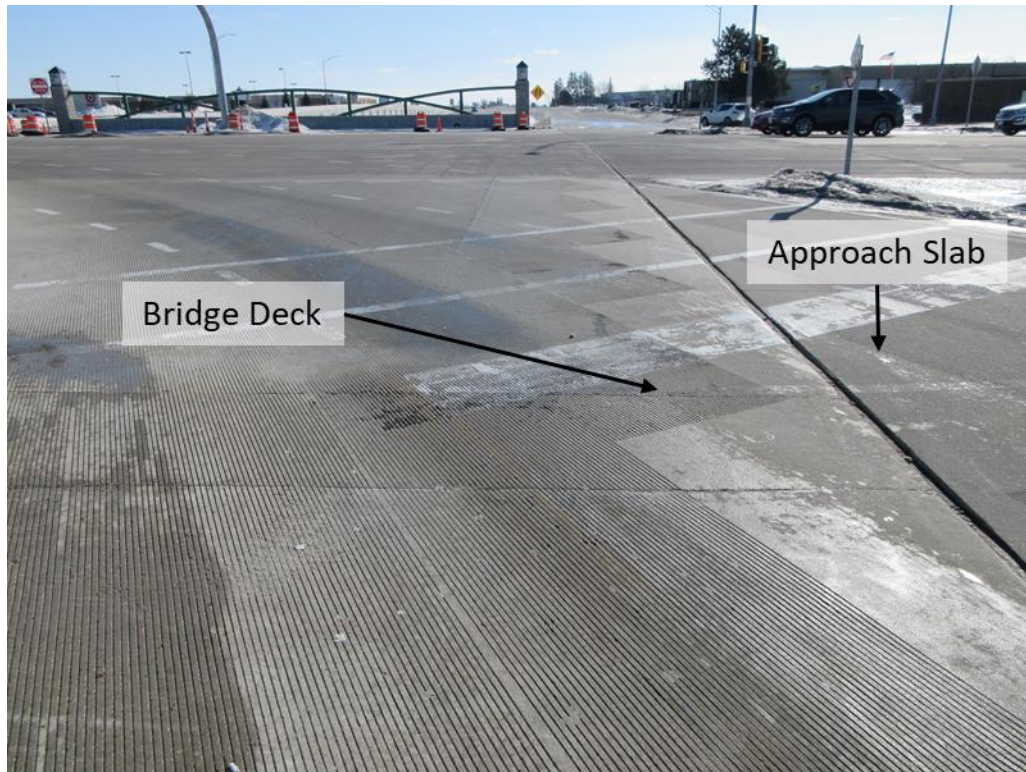
**Figure 9. Deck end at West abutment**

Figure 9 shows the bridge deck top surface (near the abutment) after the bridge opened to traffic.

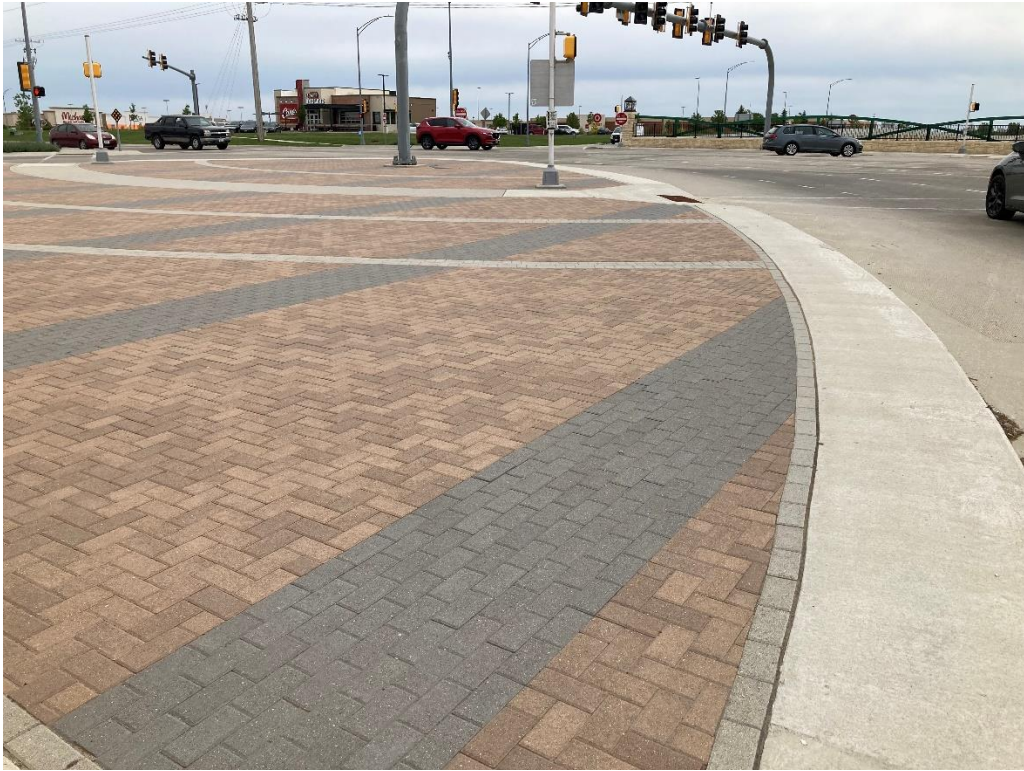
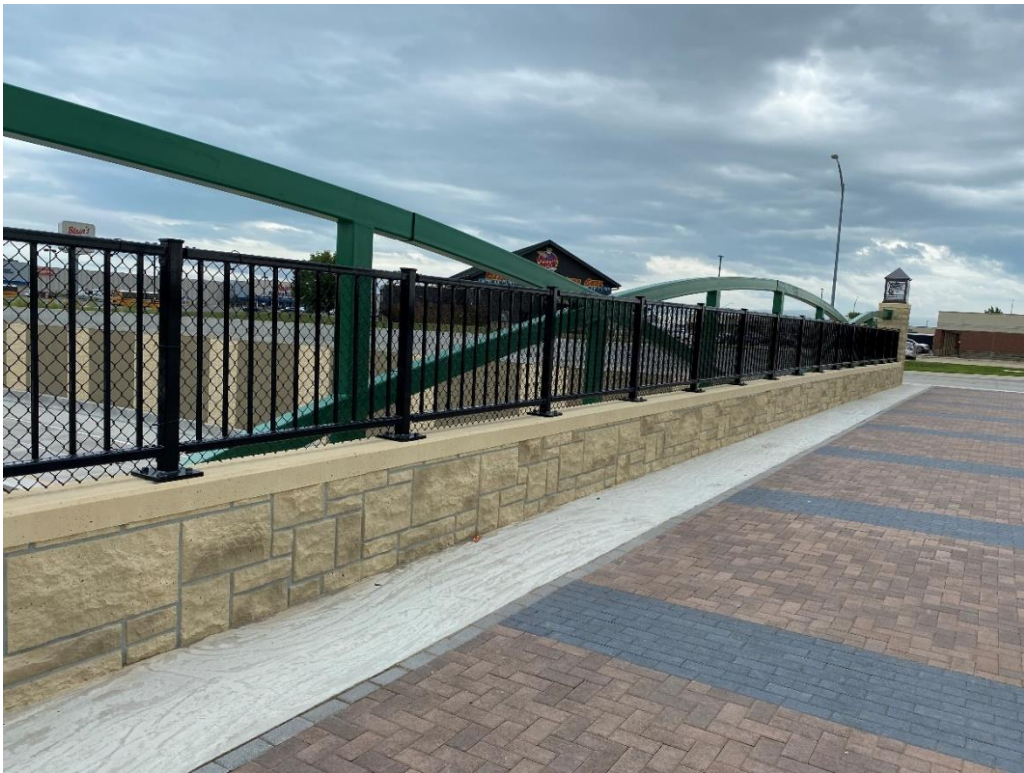
**Figure 11. Raised island and decorative rails**

Figure 11 shows the raised island and the rail on the bridge deck after construction completion.

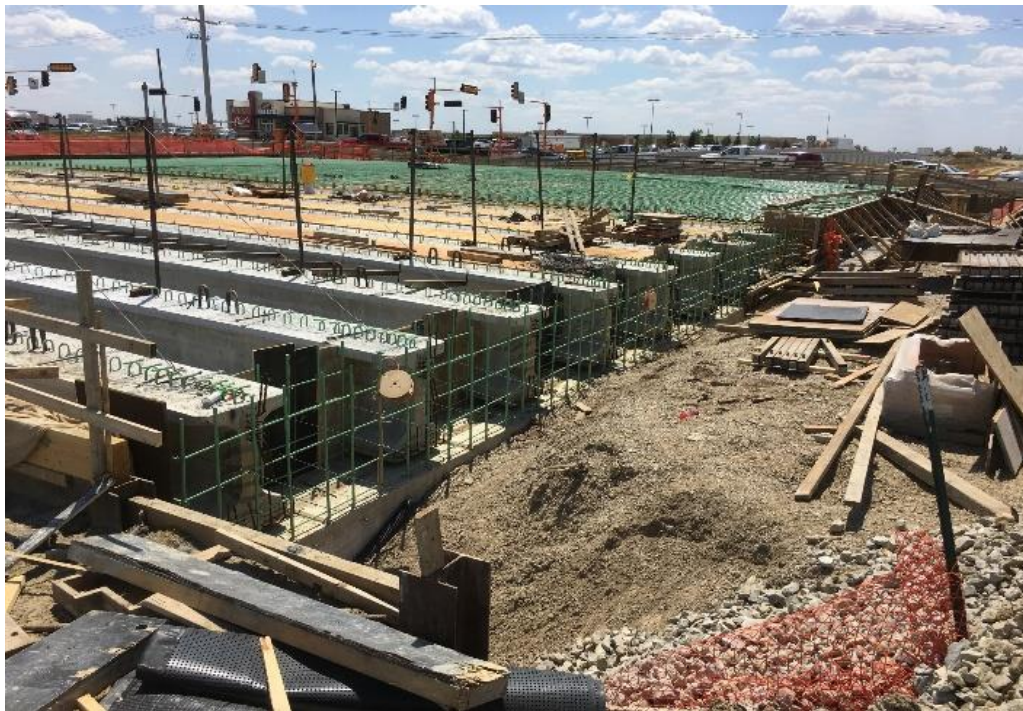
**Figure 13. Prestressed girder placement**

Digital images were captured during the installation of instrumentation. The research team followed the bridge construction schedule and completed the physical instrumentation along with bridge deck construction. Figure 13 shows the prestressed, precast girders placed in the field.

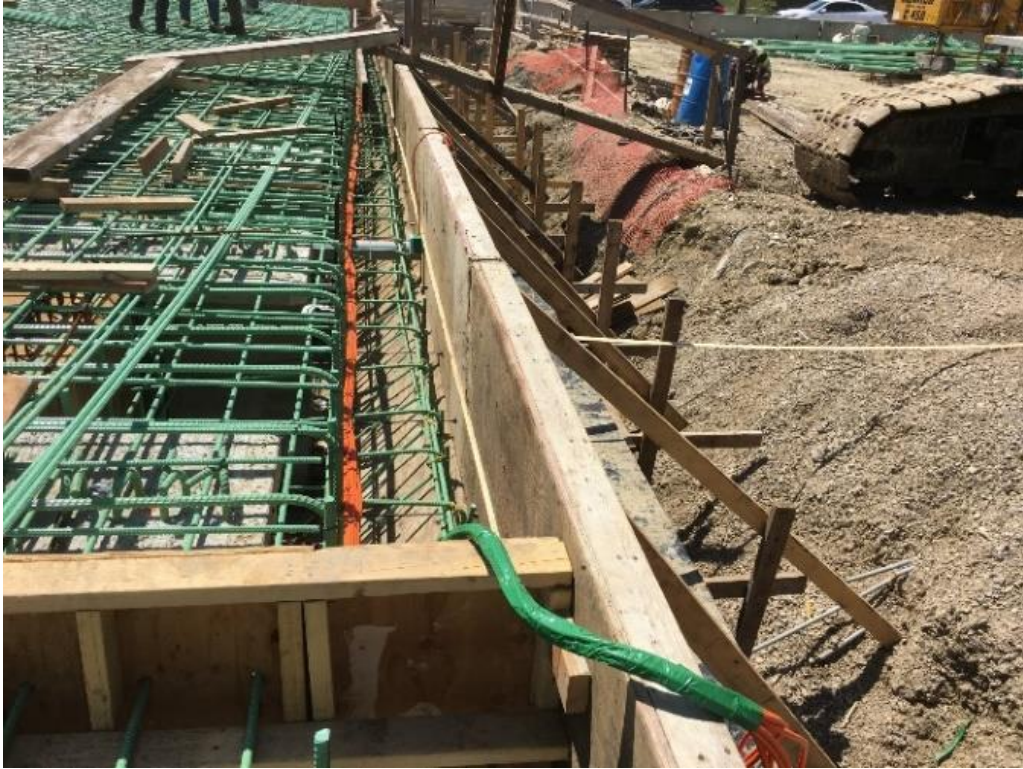
**Figure 14. Thermistor wires placed in abutment formwork**

Figure 14 shows the wire arrangement along the end of the bridge deck.

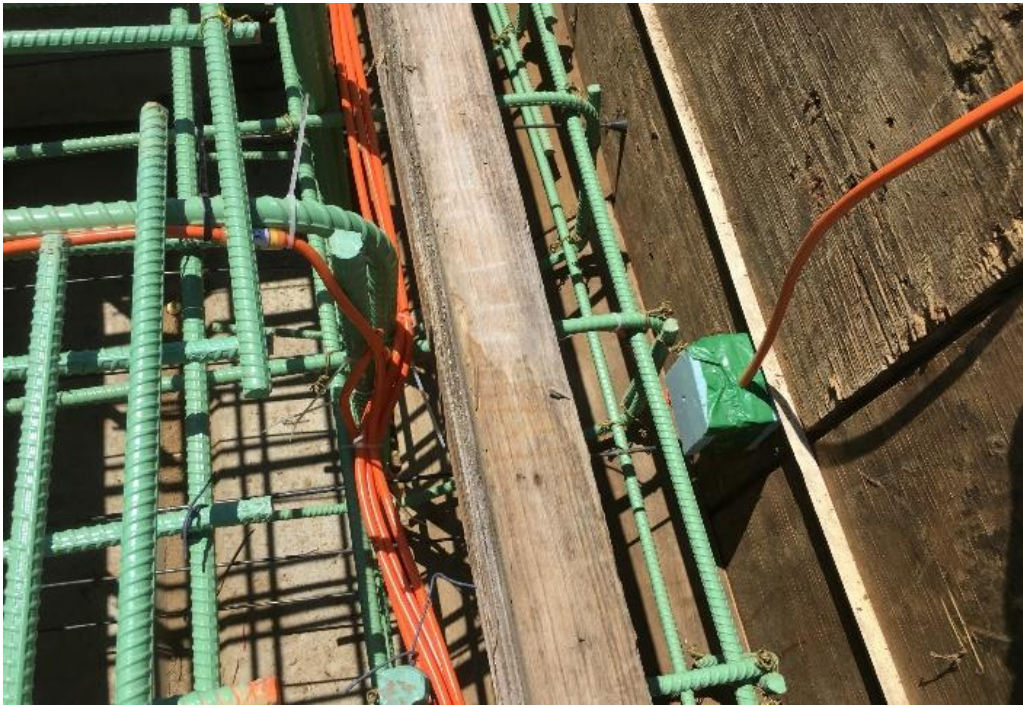
**Figure 15. Thermistor placement in deck and at back face of abutment**

Figure 15 shows one embedded thermistor in the abutment.

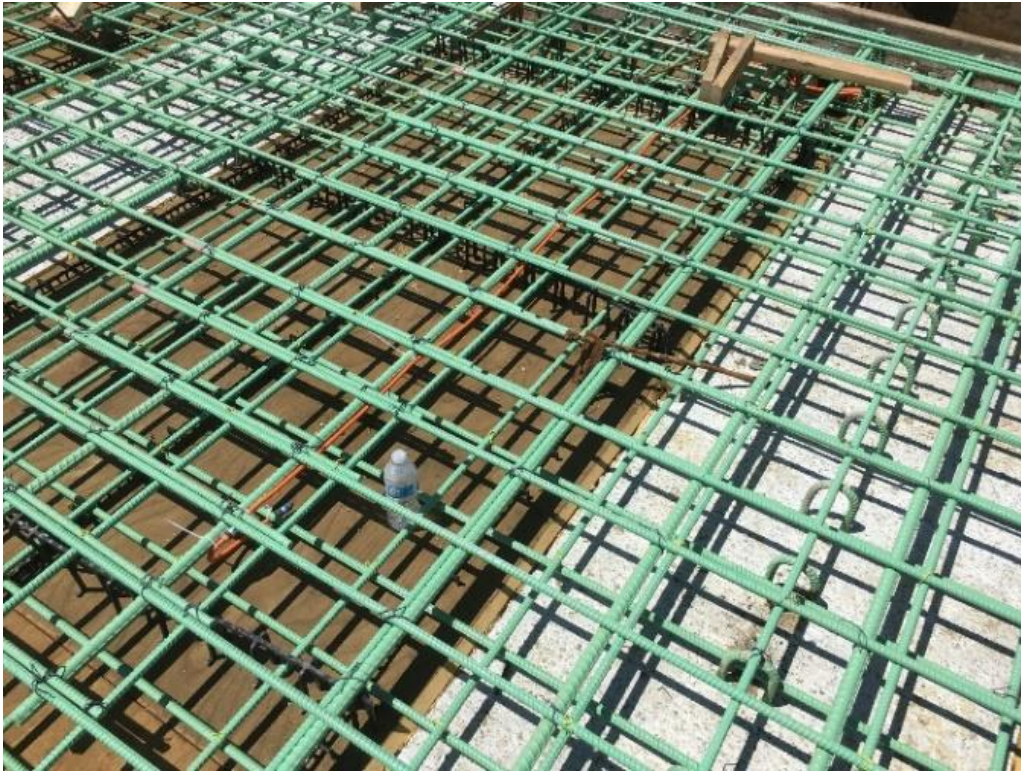
**Figure 16. Thermistor placement along deck reinforcement**

Figure 16 shows one embedded thermistor in the deck.

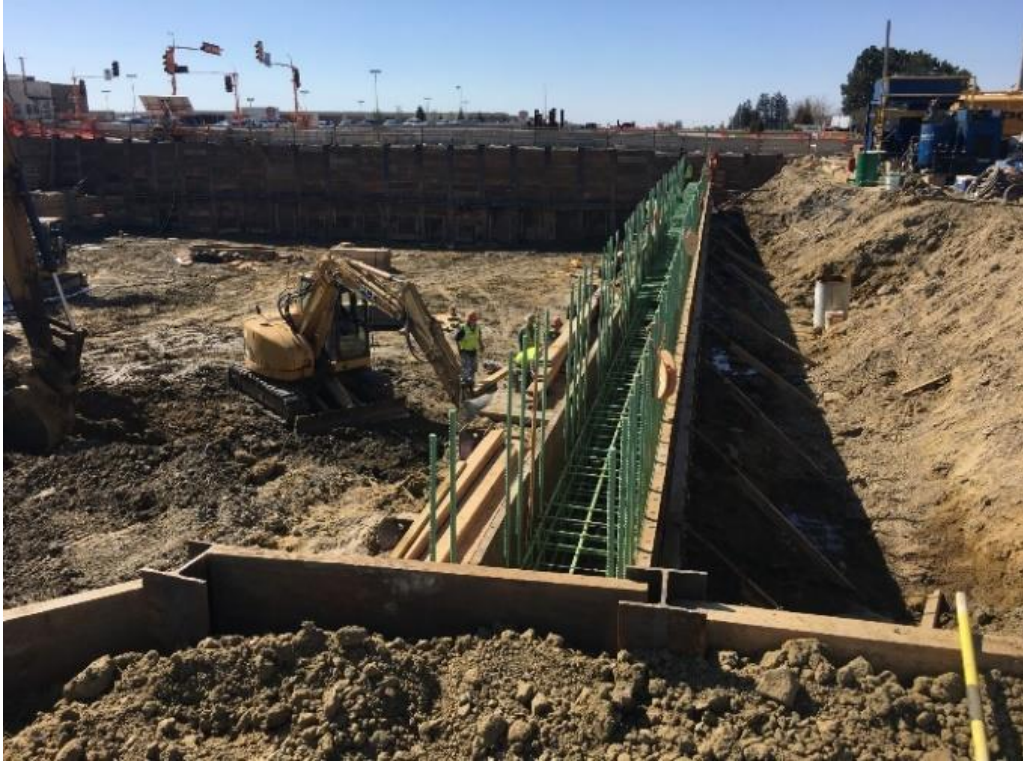
**Figure 17. Abutment formwork**

Figure 17 and Figure 18 show the abutment formwork and the wire alignment for the thermistor in the abutment.

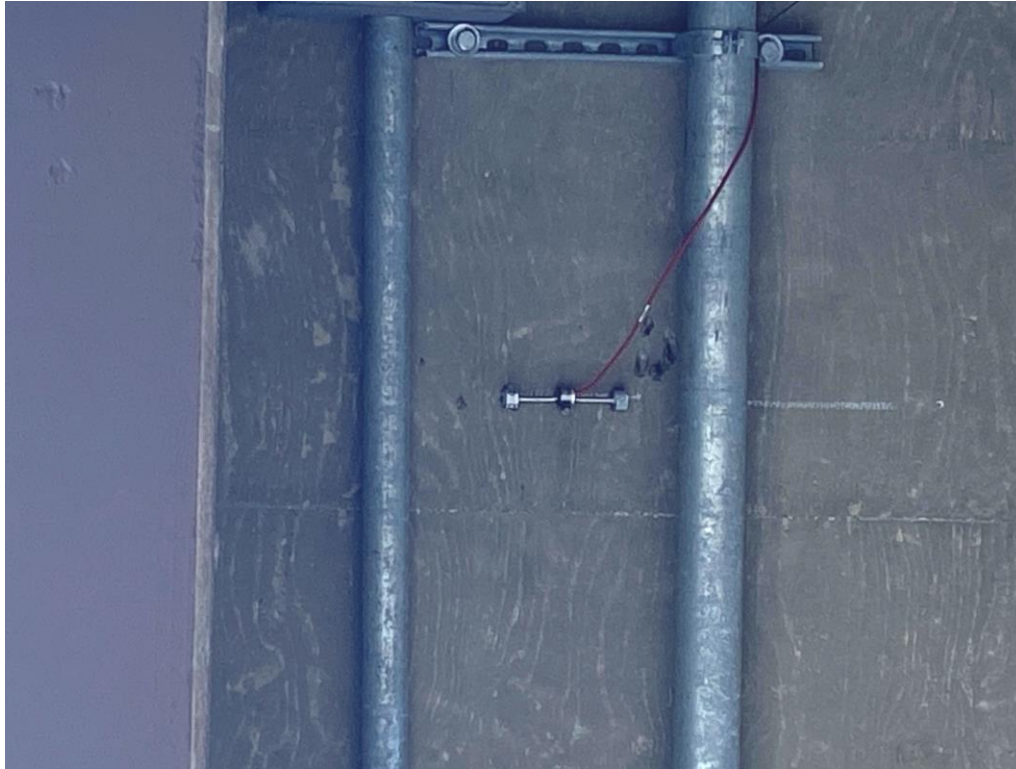
**Figure 19. Vibrating wire strain gauge on the deck bottom**

Similar to the instrumentation plan used in the Phase I research work, one VWSG was attached to the deck (D) at the bottom surface of the deck to measure the strain development in the bridge transverse direction as shown in the previous Figure 12. Figure 19 shows the attached VWSG at the bottom of the bridge deck.

Based on the results from the Phase I research work, VWSGs at this location will provide sufficient data for the evaluation of the bridge deck end behavior subject to thermal loading.

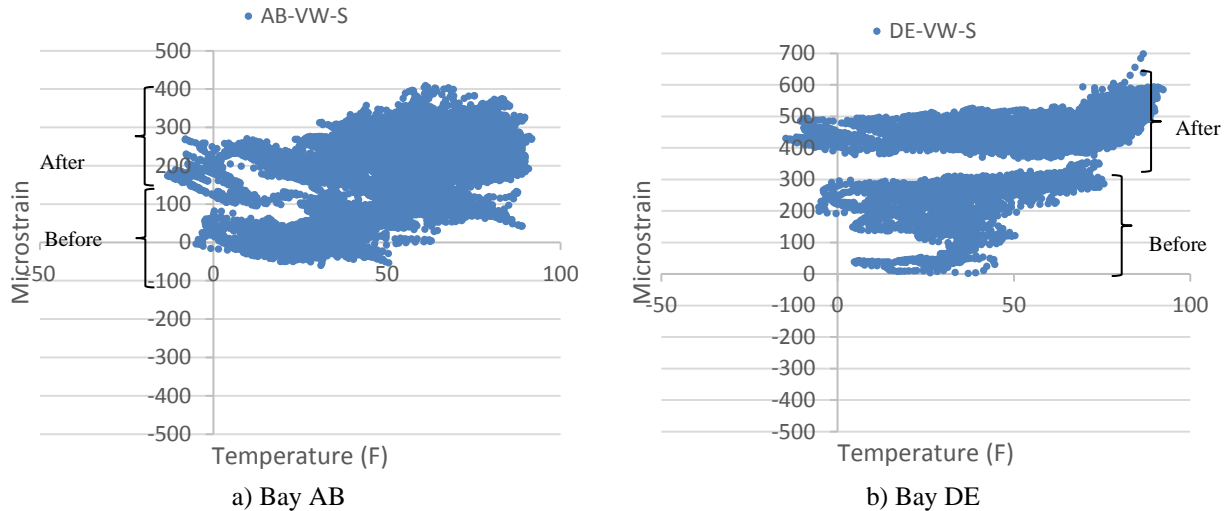
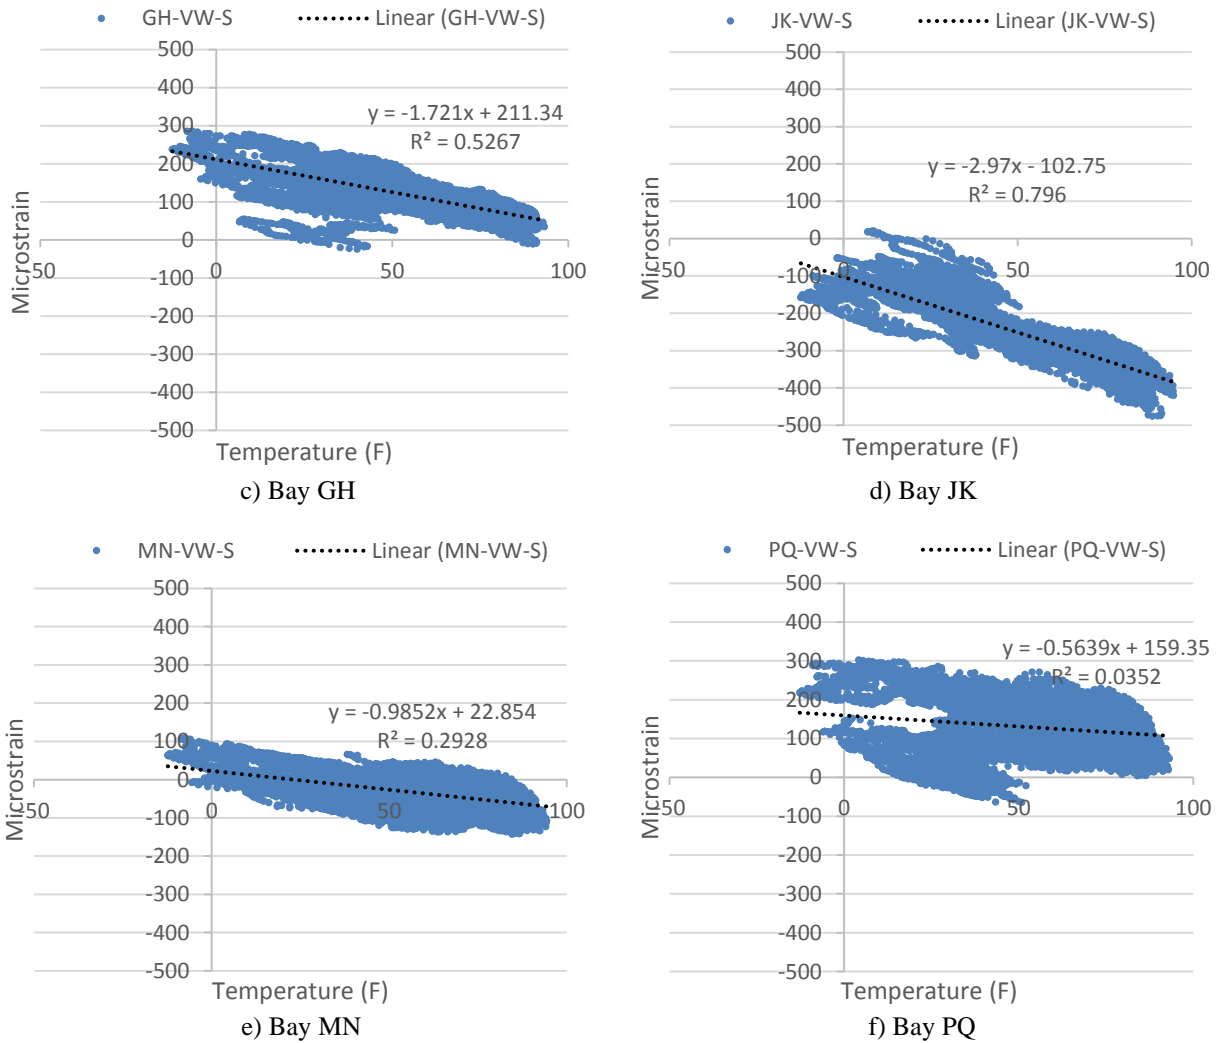
**Figure 32. Strain data vs. temperature**

Figure 32-a to-f plot the strain data versus the temperature data collected from each VWSG.

The data collected from gauges AB-VW-S and DE-VW-S distributes into two groups as shown in Figure 32-a and -b. This separation is caused by the construction of the raised island. As shown in the previous Figure 30, the raised island was directly over the gauges AB-VW-S and DE-VW-S, and the weight of the raised island induced an increase in the strain reading. Such phenomenon was not observed in the data collected from other strain gauges (Figure 32-c to -f).

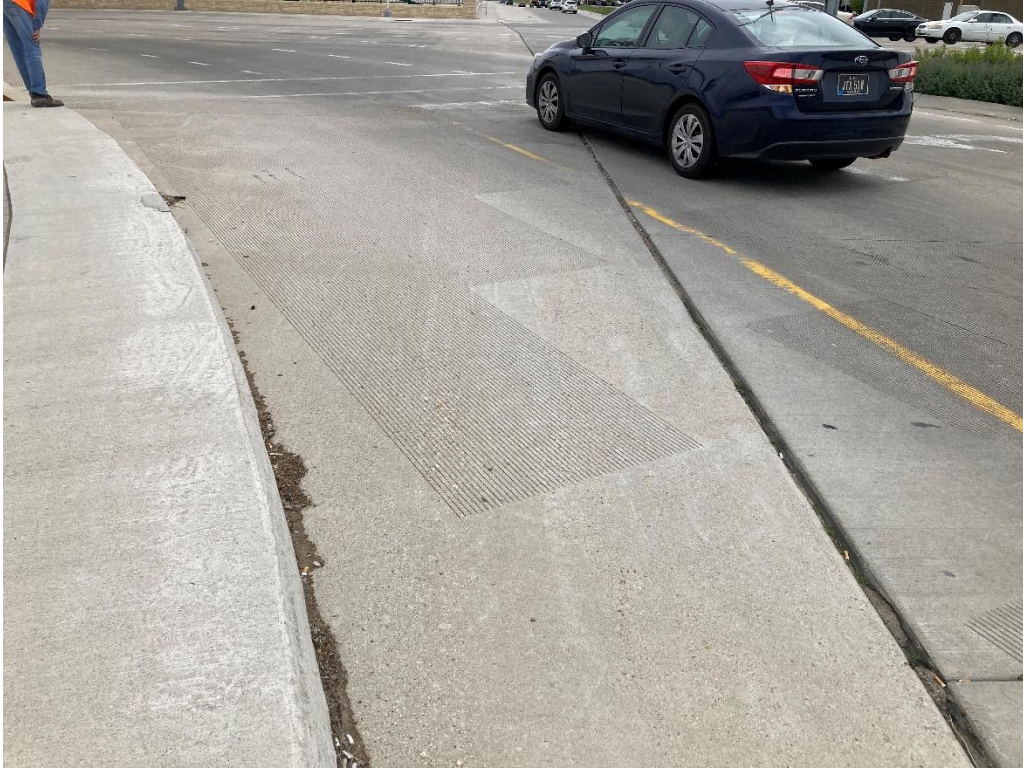
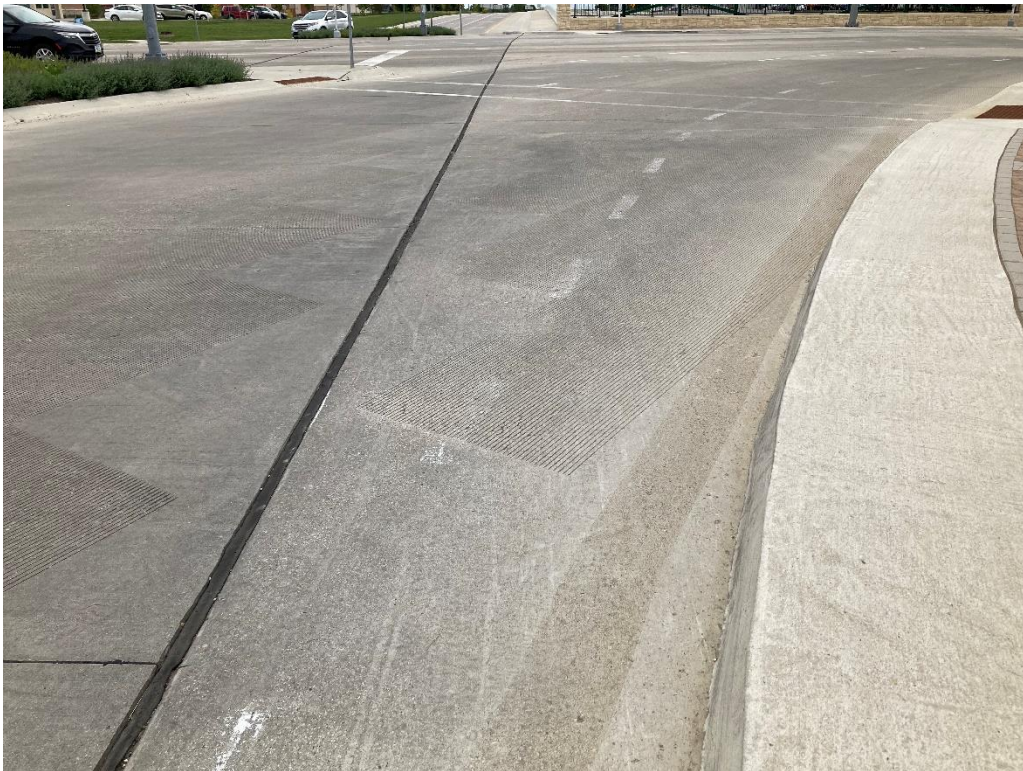
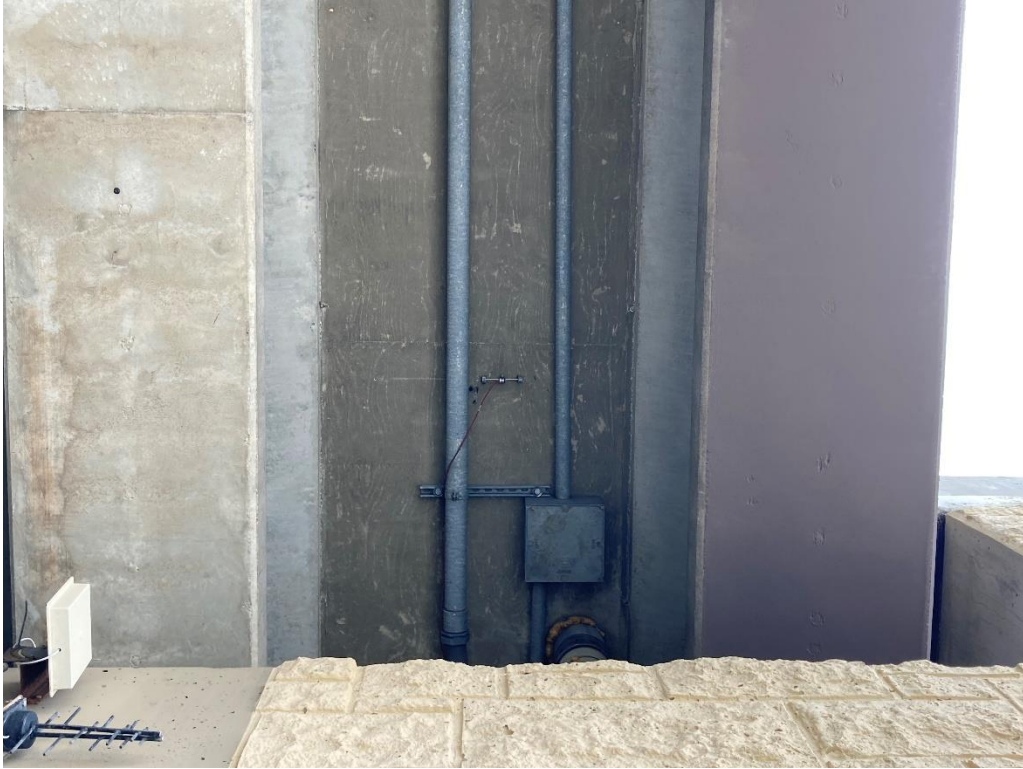
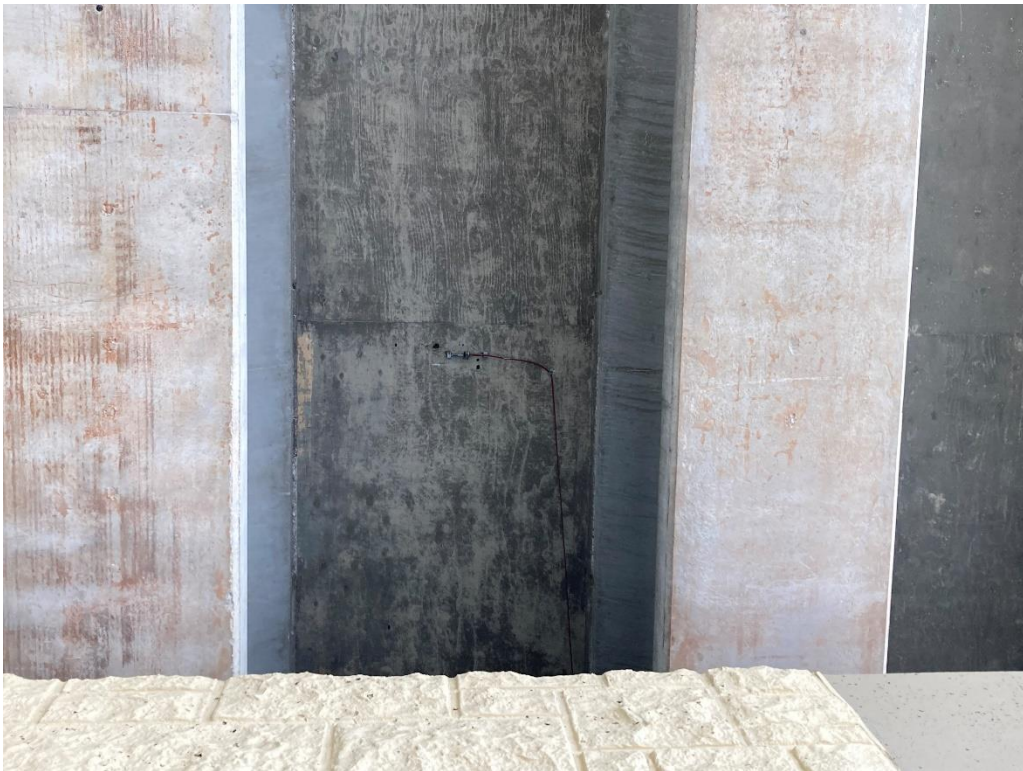
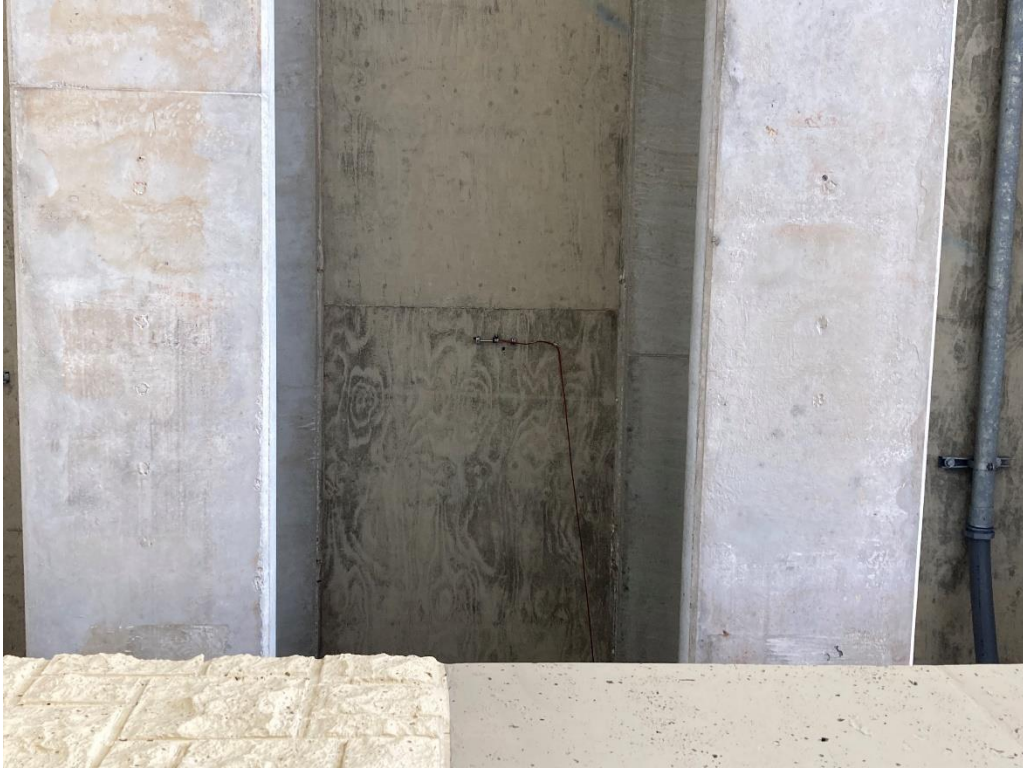
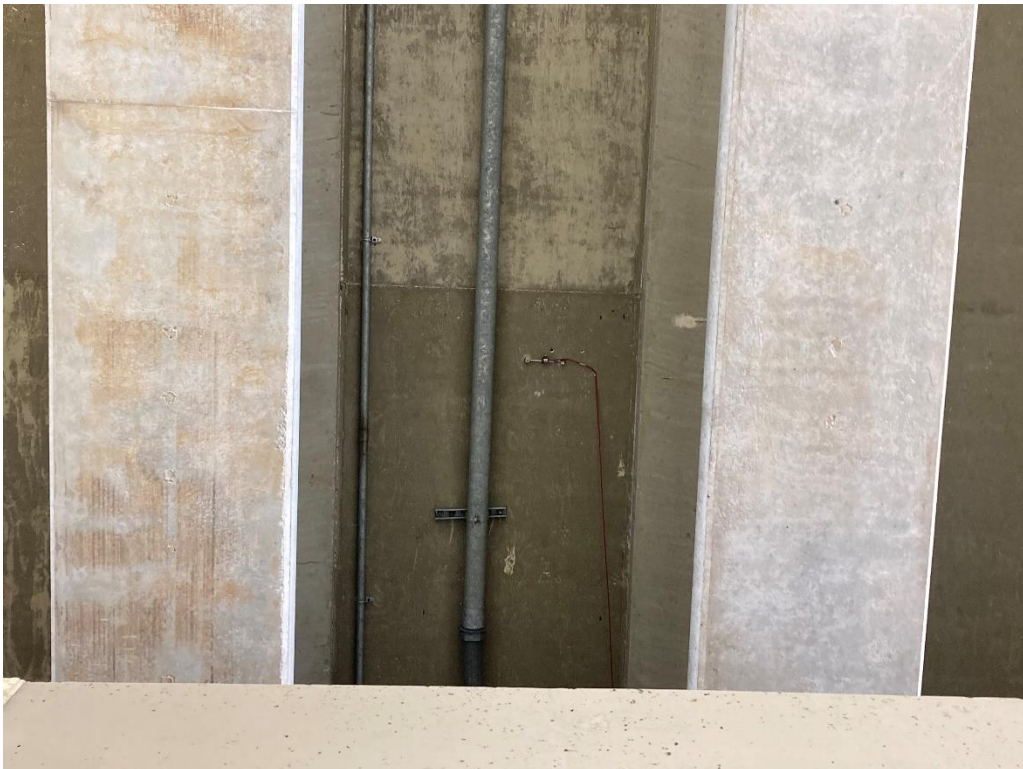
The inspection results speak well to the positive effects of the isolation barrier behind the abutments. These results support the findings from the Phase I research that development of cracking in bridge decks seems less dependent on the total width of the deck. Images are provided in Figure 33 through Figure 41 showing the visual results from the onsite inspections.

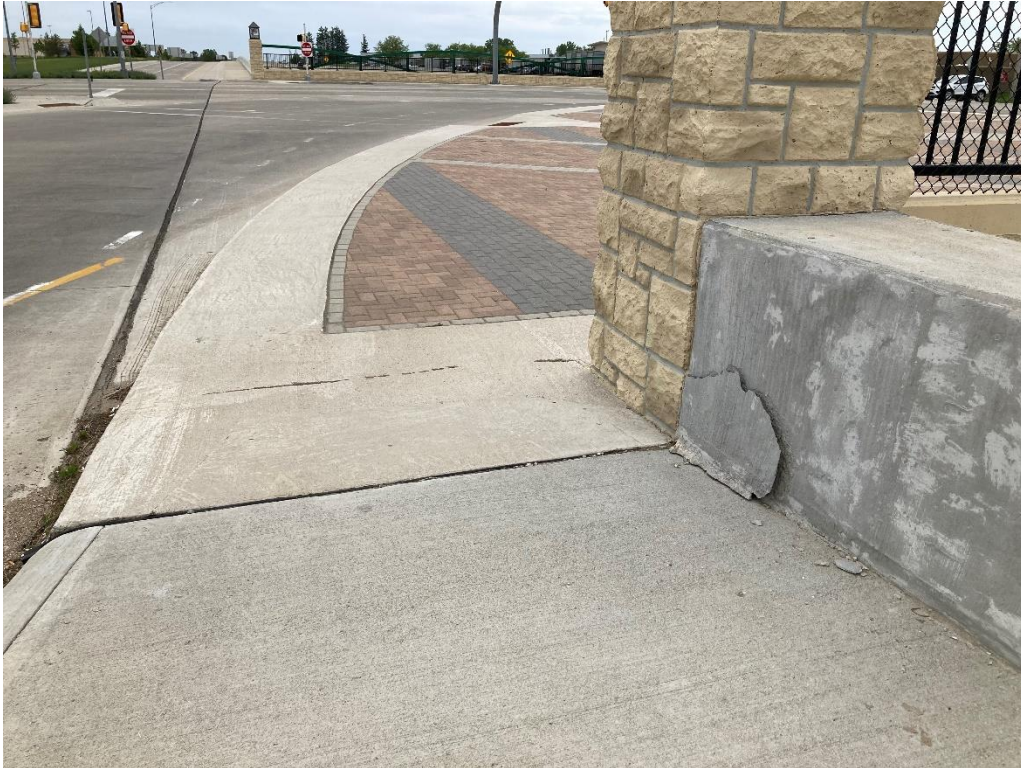
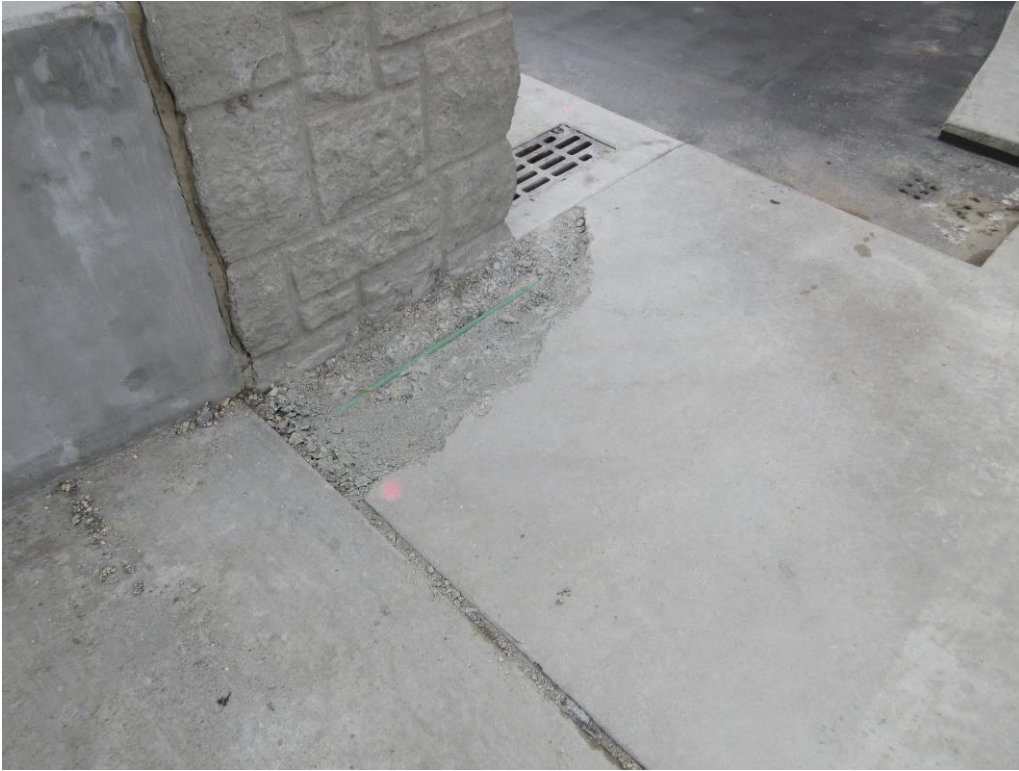
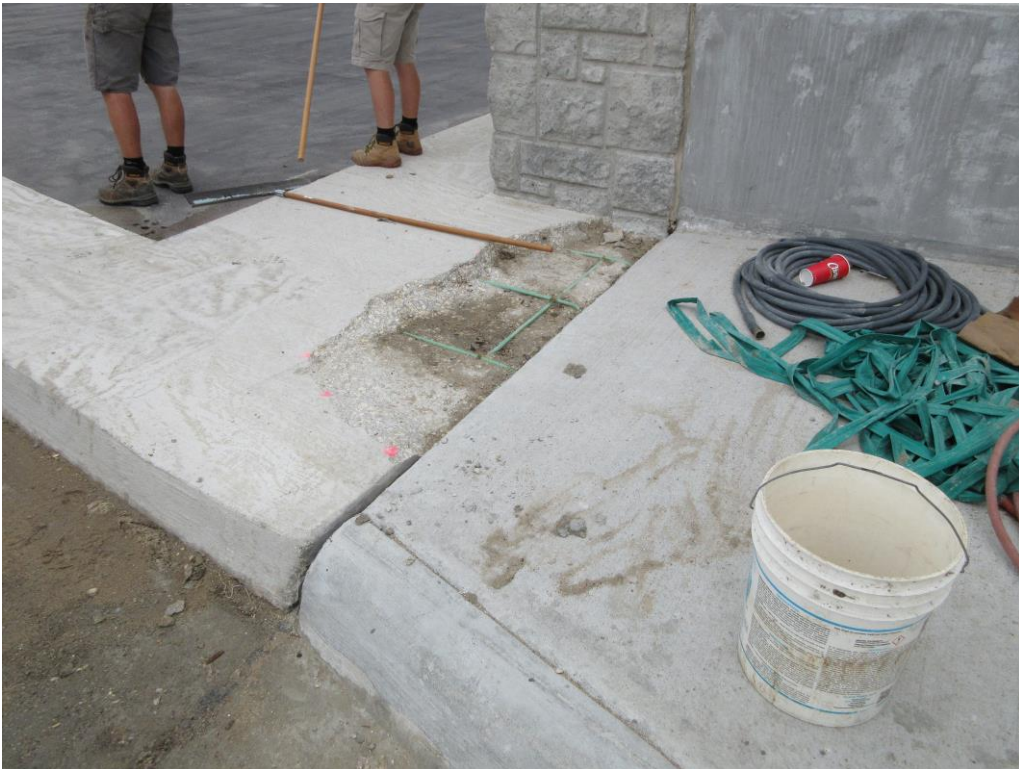
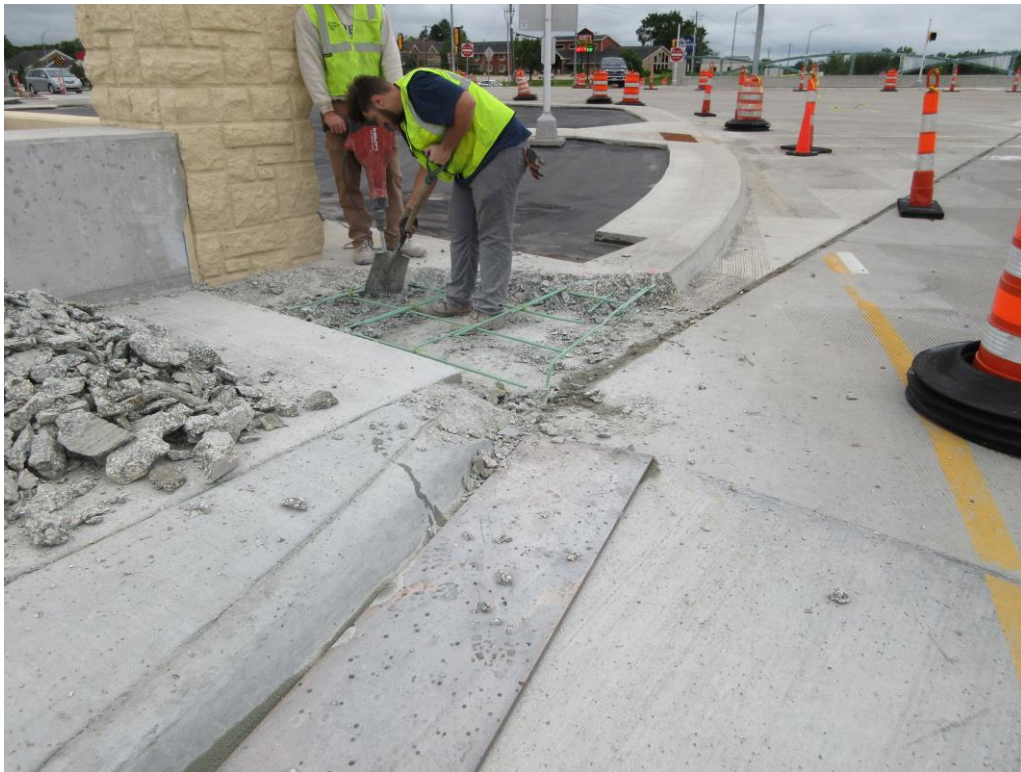
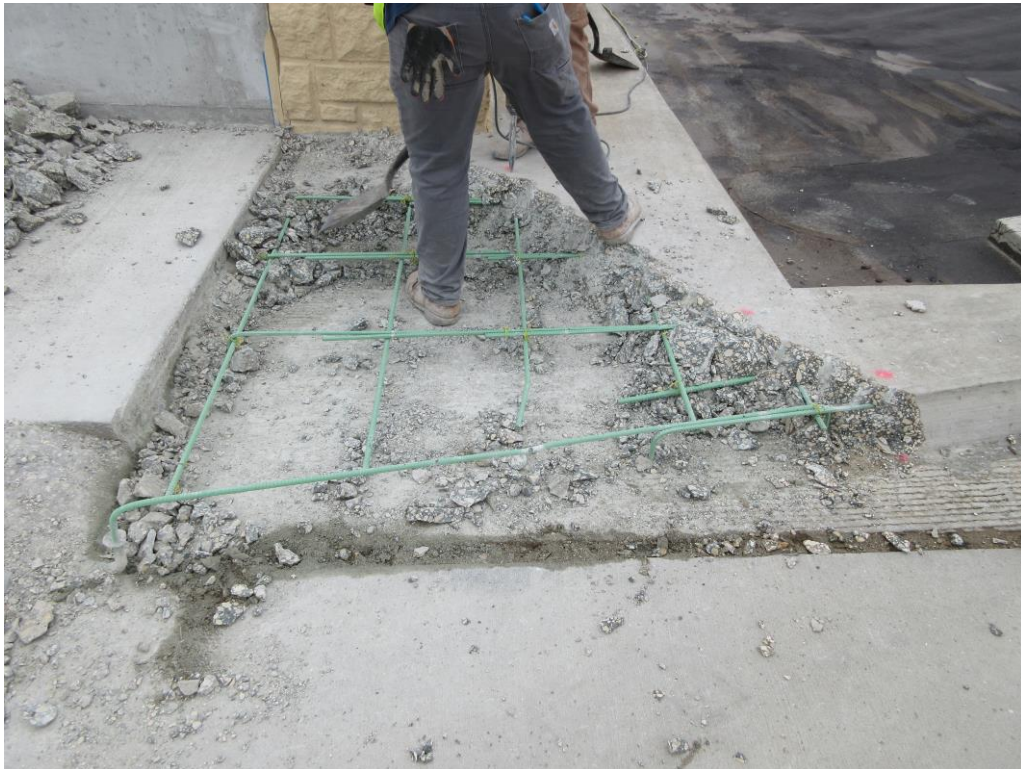
While on site, it was noted that the condition of the flanking sidewalks, barrier rail, and raised island at the north and south of the bridge experienced varying levels of cracking, which required repair. It is presumed that the barrier rail and sidewalk lengths leading up to the bridge were such that their expansion pushed them directly against the bridge, and the compressive forces created were large enough to result in cracking. Images are provided in Figure 42 through Figure 46 showing some of the damaged areas.

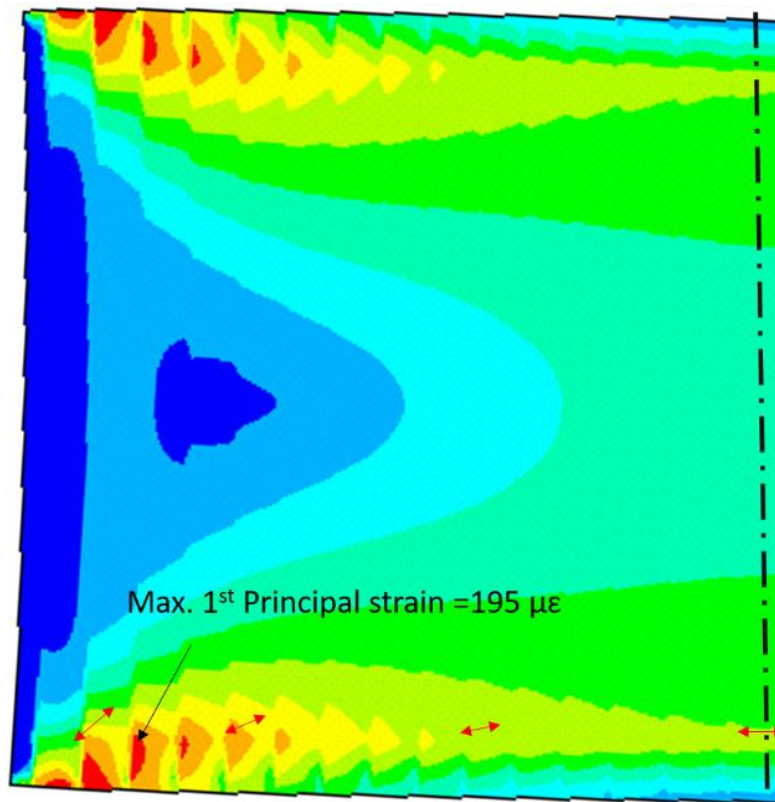
**Figure 51. First principal strain on the bottom of the deck for FE Model 2 without isolation barrier**

The first principal strain contour plot at the bottom surface of the bridge deck is presented in Figure 51, and the maximum strain is approximately 195 microstrain.

The FE model results indicated that significantly higher deck strains exist when a thermal isolation barrier is not in place to limit the temperature differential through the thickness of the abutment. In fact, the maximum deck strain was found to be 46% greater when the thermal isolation barrier was not included in the models.

The validated FE model analysis indicated that, without the barrier, the strain values at the deck ends of the Viking Road Bridge could exceed the calculated cracking strain of the concrete.
