Implementation of Recommendations for Eliminating Longitudinal Median Joints in Wide Bridges

tech transfer summary

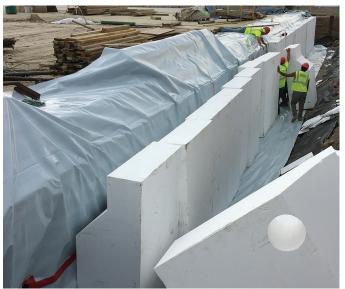
Preparing for placement of expanded polystyrene (EPS) block behind the integral abutments to create thermal isolation from the adjacent backfill soils

Based on the finite element (FE) results from that study, it was proposed that an effective solution to reduce cracking in the deck might be to place a thermal isolation barrier between the backfill soils and the back side of the abutment, thus maintaining closer temperatures within the abutment and bridge deck.

Using the recommendations from the previous research, a thermal isolation barrier was used between the backfill soils and the abutment.

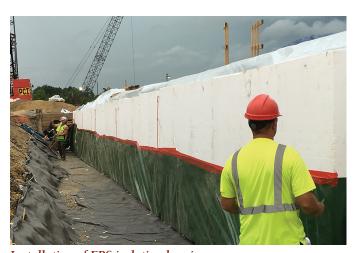
Installation of EPS isolation barrier

With a thermal isolation barrier, the temperature difference between the back face and front face at each level of the abutment remained relatively close throughout the year with differences being less than 10°F in most cases. The value of the thermal isolation barrier was especially apparent when ambient temperatures changed very quickly and a greater temperature differential was more likely.
