## ST-008 Appendix IX. PROJECT TEST RESULTS

### Introduction

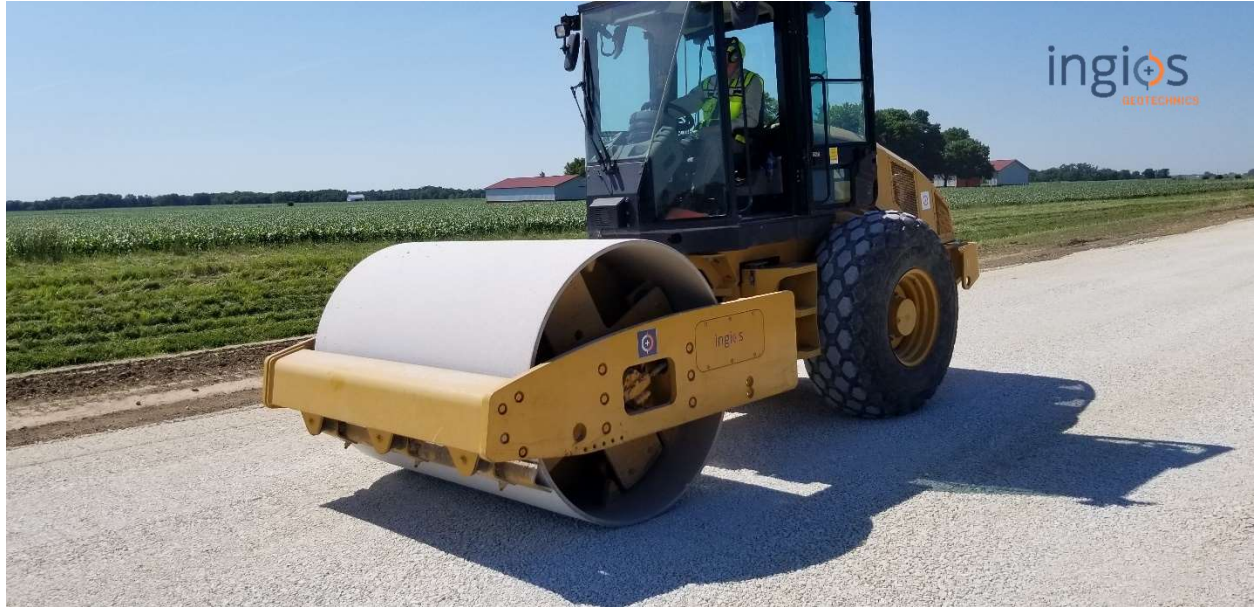
**Figure 1 .Caterpillar CS56 vibratory smooth drum roller outfitted with Ingios COMP-Score RT system and GPS.**

For this project, a CS56 smooth drum vibratory roller weighing approximately 27,450 lbs outfitted with Ingios RT retrofit system was used (Figure 1). Calibration was developed from APLT results to output stress-dependent  $k$  and  $M_r$  values (Figure 2).

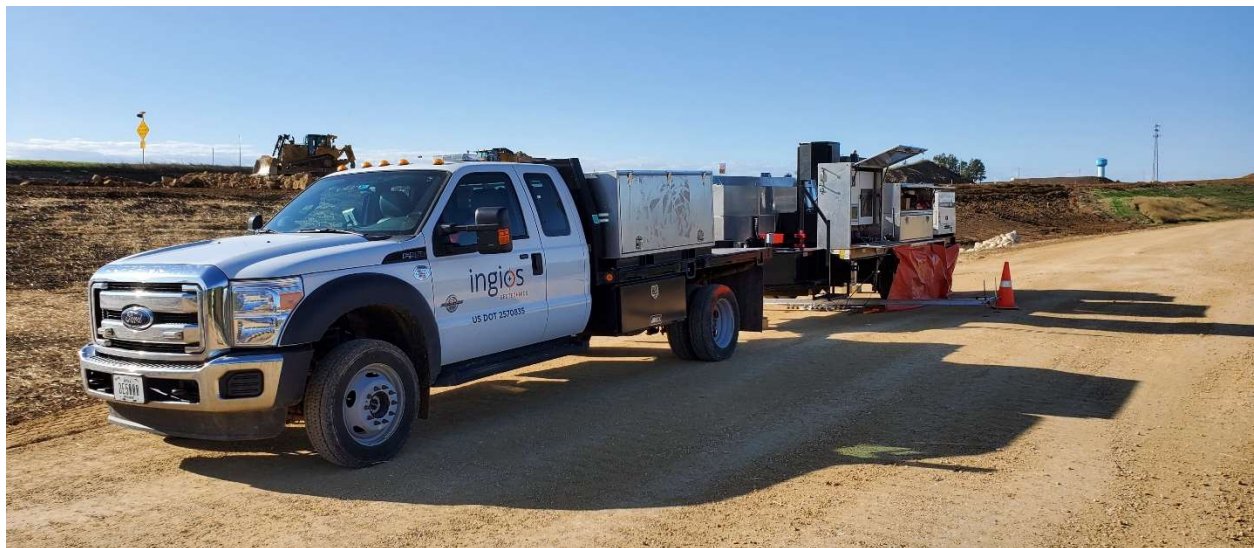
**Figure 2. Automated Plate Load Testing trailer.**

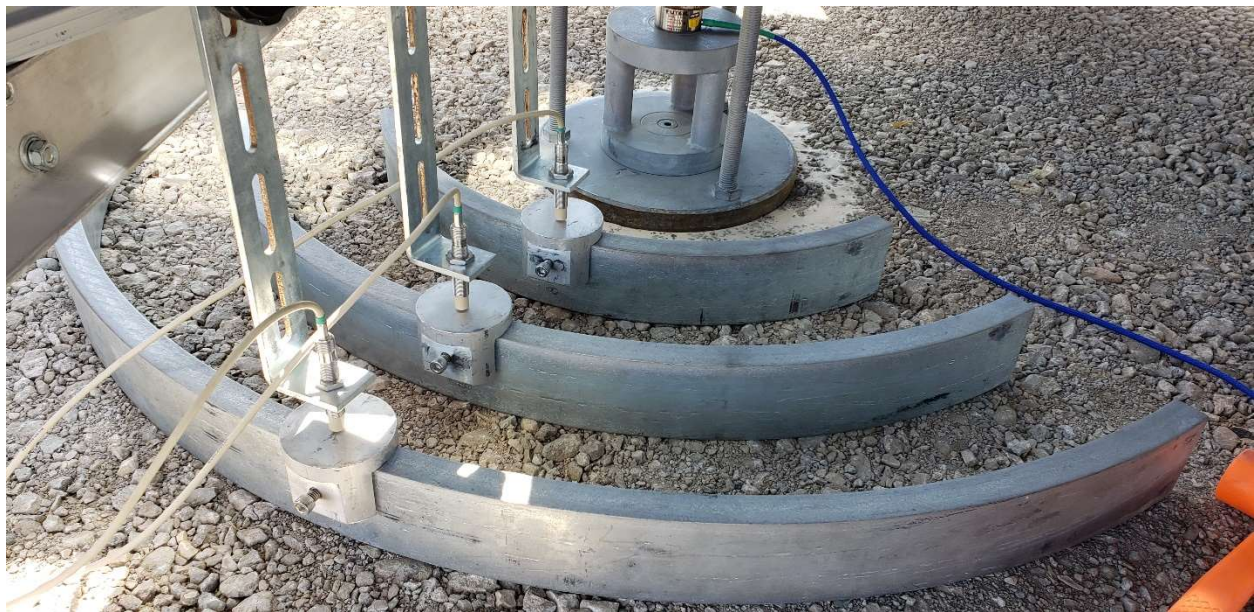
**Figure 4. 12 in. diameter loading plate setup for cyclic APLT [picture taken on 08/28/2019 on Blackhawk US20 NHSX-020-6(71)--3H-07 project site over compacted special backfill material]**

The APLT testing plan summarizing the loading sequences for cyclic and static testing provided in Table 4. Cyclic APLTs involved performing a total of 1,500 loading cycles, which involved a 500 cycle conditioning sequence at 15 psi maximum stress followed by 100 to 250 cycles at 5 to 40 psi maximum stresses. Plate deformations and deflection basin measurements at 2x, 3x, and 4x, the plate radius were obtained for back-calculation of the two-layered  $M_r$  properties for each stress sequence. The average of the last 5 cycles was used for representation of  $M_r$  for each loading sequence. A 0.2 sec load time and a 0.8 sec dwell time was used. Static APLTs were performed following AASHTO T222 (2012), using two loading cycles.

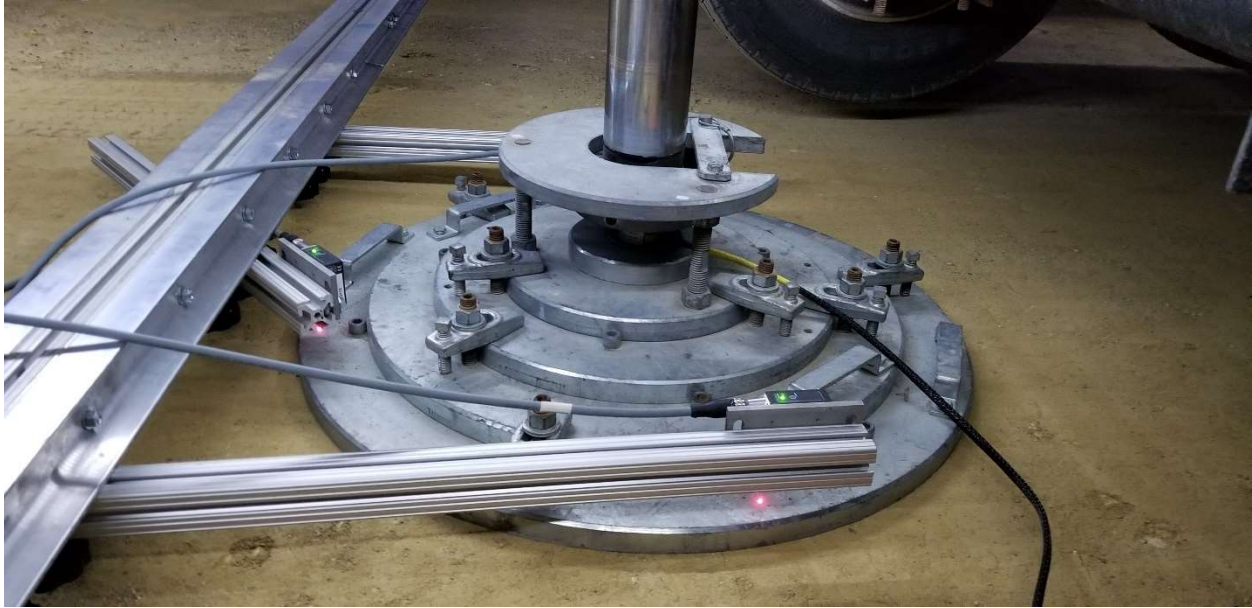
Figure 5. 30 in. diameter loading plate setup for static APLT [picture taken on 10/23/2019 on Des Moines US61 NHSX-061-2(62)--3H-29 project over compacted select subgrade]

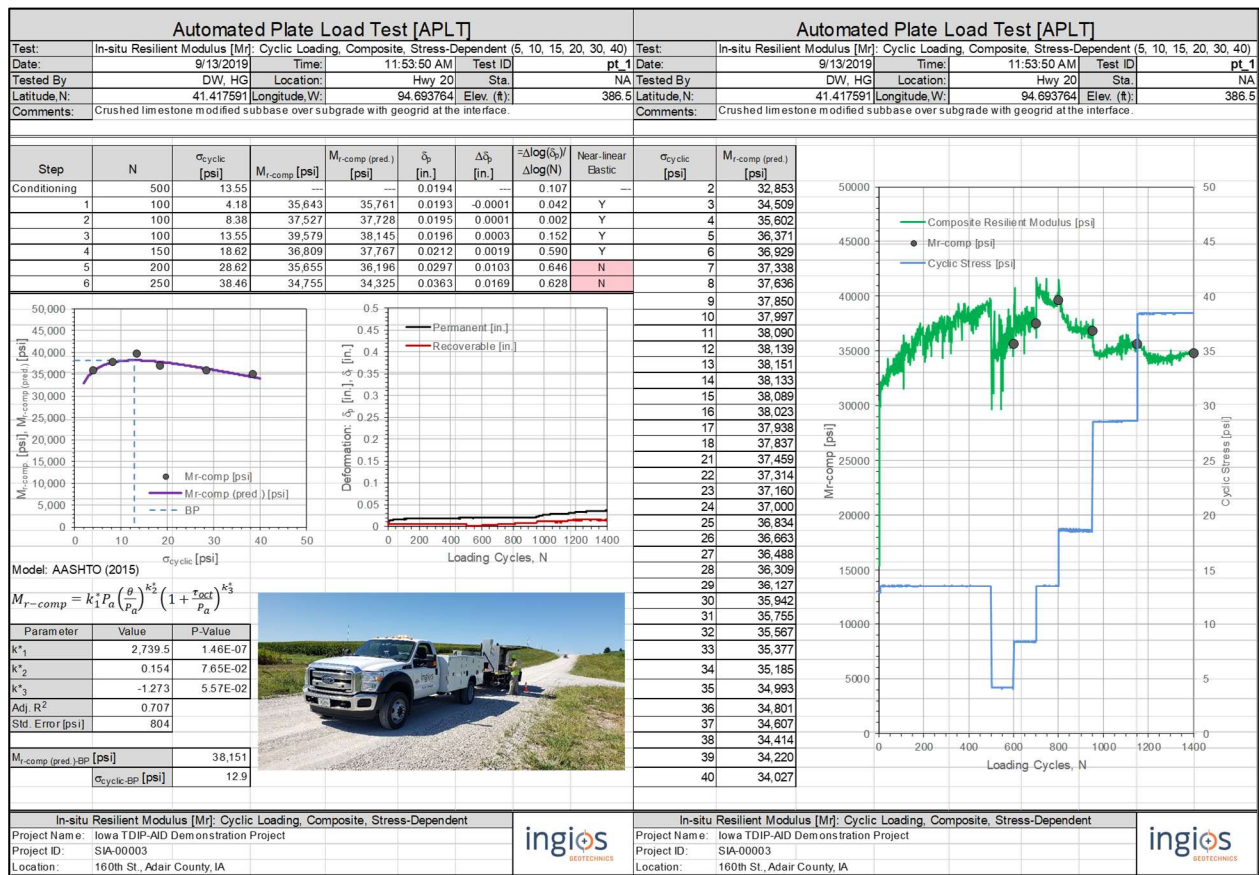
Figure 6. Example APLT data record showing 12 in. static plate load test results (Test A)

Example records of APLT results from Test A and Test B are provided in Figure 6 and Figure 7, respectively. All individual test reports are included in Appendix B. No moisture adjustments were made in this study for future changes in saturation levels and those corrections can be applied (AASHTO T222, NCHRP 2000).

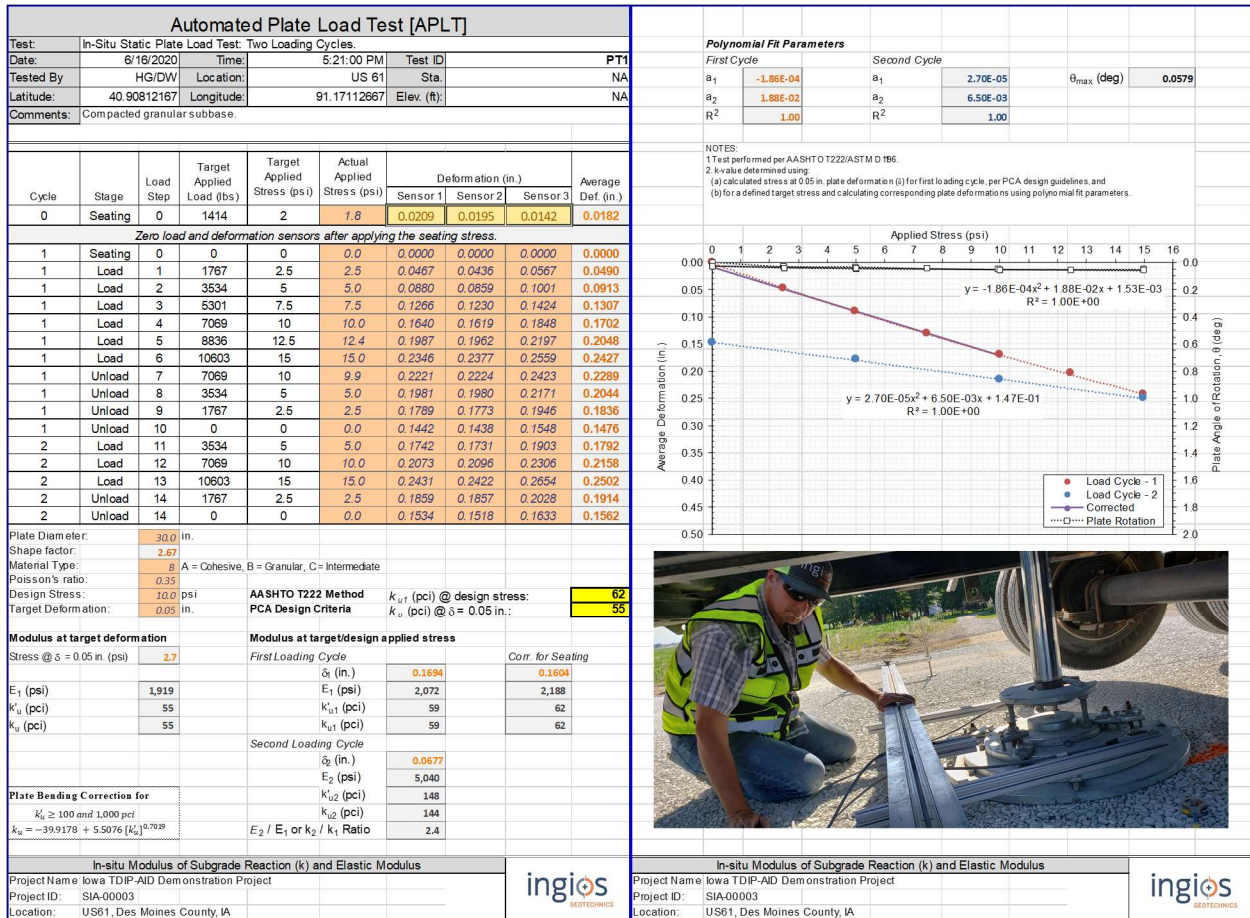
Figure 7. Example APLT data record showing 30 in. static plate load test results (Test A)

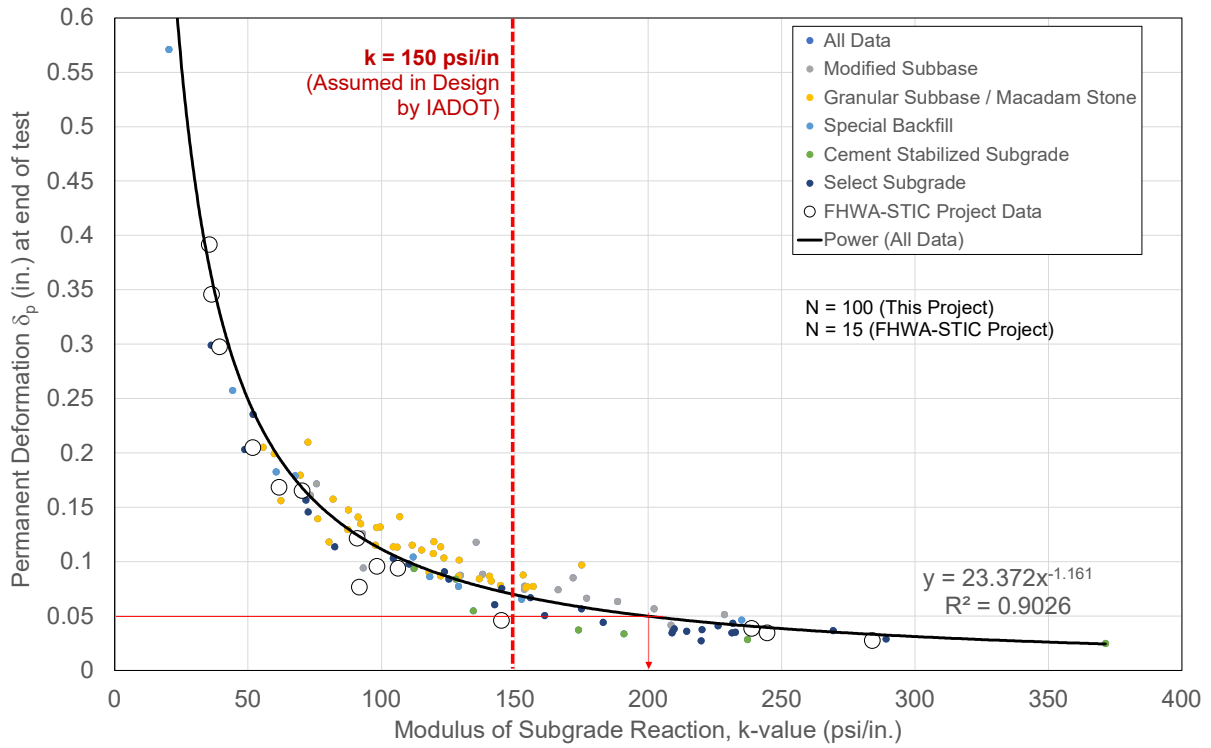
**Figure 8. k-value versus permanent deformation ( $\delta_p$ ) at the end of test from field test measurements at all project sites**

Permanent deformations ( $\delta_p$ ) were monitored during cyclic and static APLTs conducted for this project. A summary of  $\delta_p$  values from static PLTs is provided in Table 8. Figure 8 provides a graph of  $k_{u(1)}$  versus  $\delta_p$  from static APLT results at all project sites, which shows a strong power relationship between the two parameters. Based on this relationship, to limit  $\delta_p$  to a critical 0.05 in., a minimum  $k_{u(1)} = 200$  pci must be achieved. Further, the results indicated that 63 out of the 100 measurements obtained from this project showed k-values less than the assumed value of 150 pci.

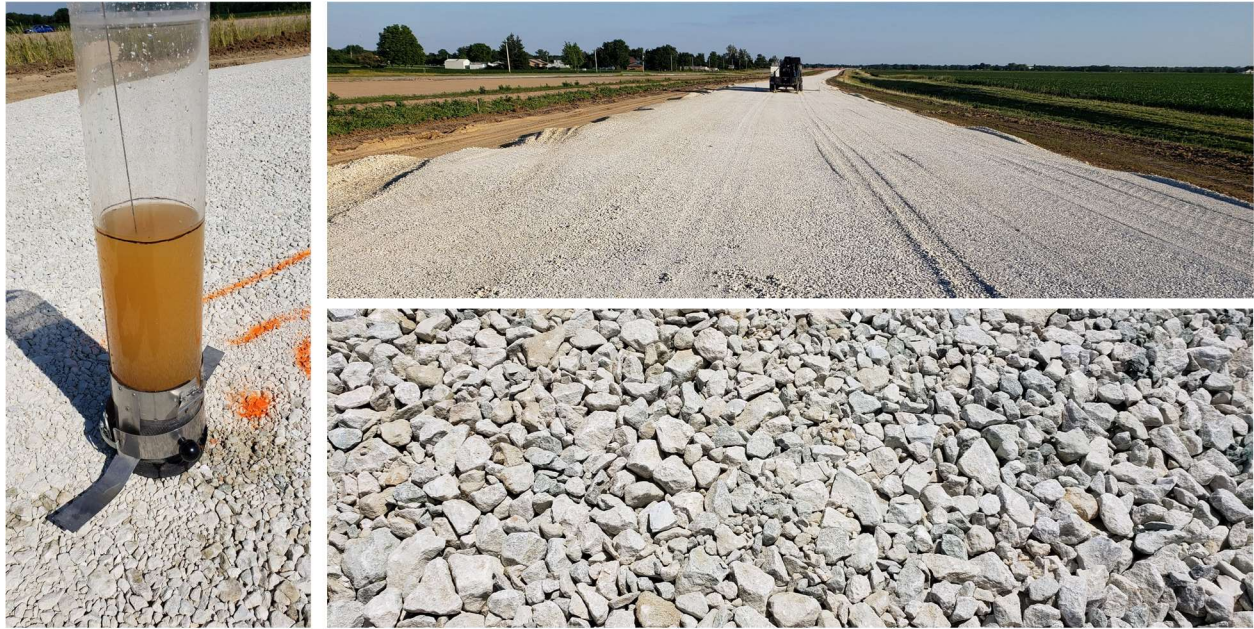
**Figure 16. Vu meter testing on crushed limestone granular subbase on Des Moines County US61 project (06/16/2020).**

Pictures from testing are included in Figure 16 to Figure 18. Results from the testing are summarized in Table 11 and Figure 19.

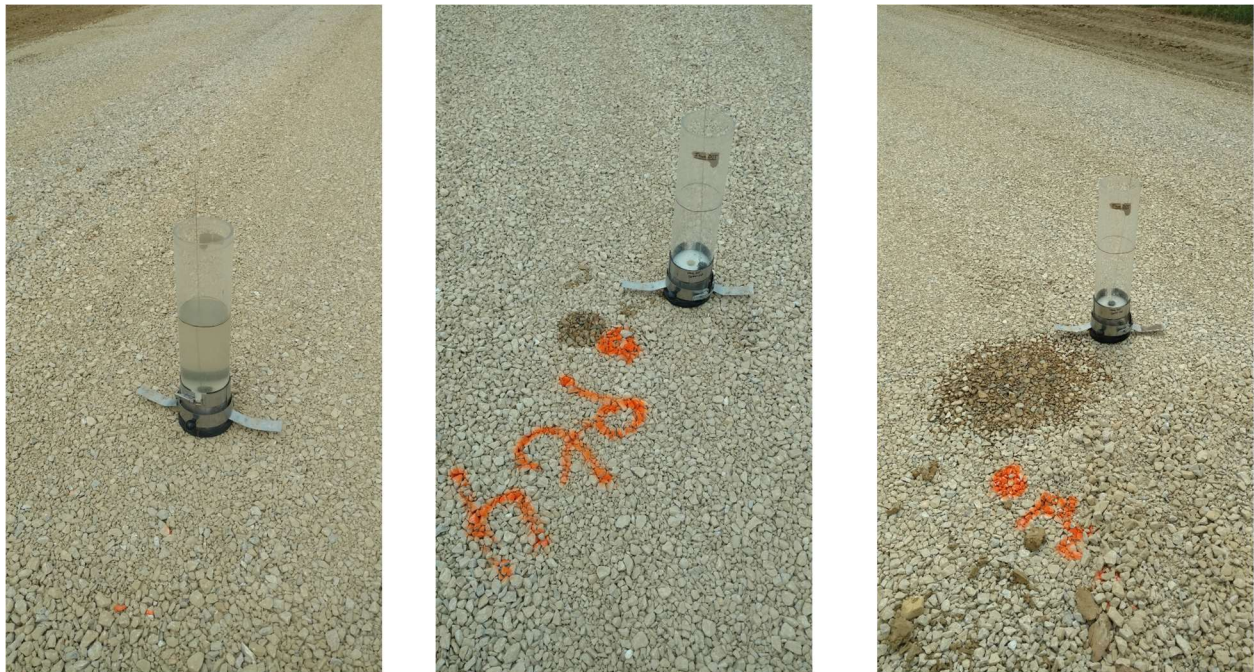
**Figure 17. Vu meter testing on crushed limestone granular subbase on Tama County US30 (07/09/2020).**

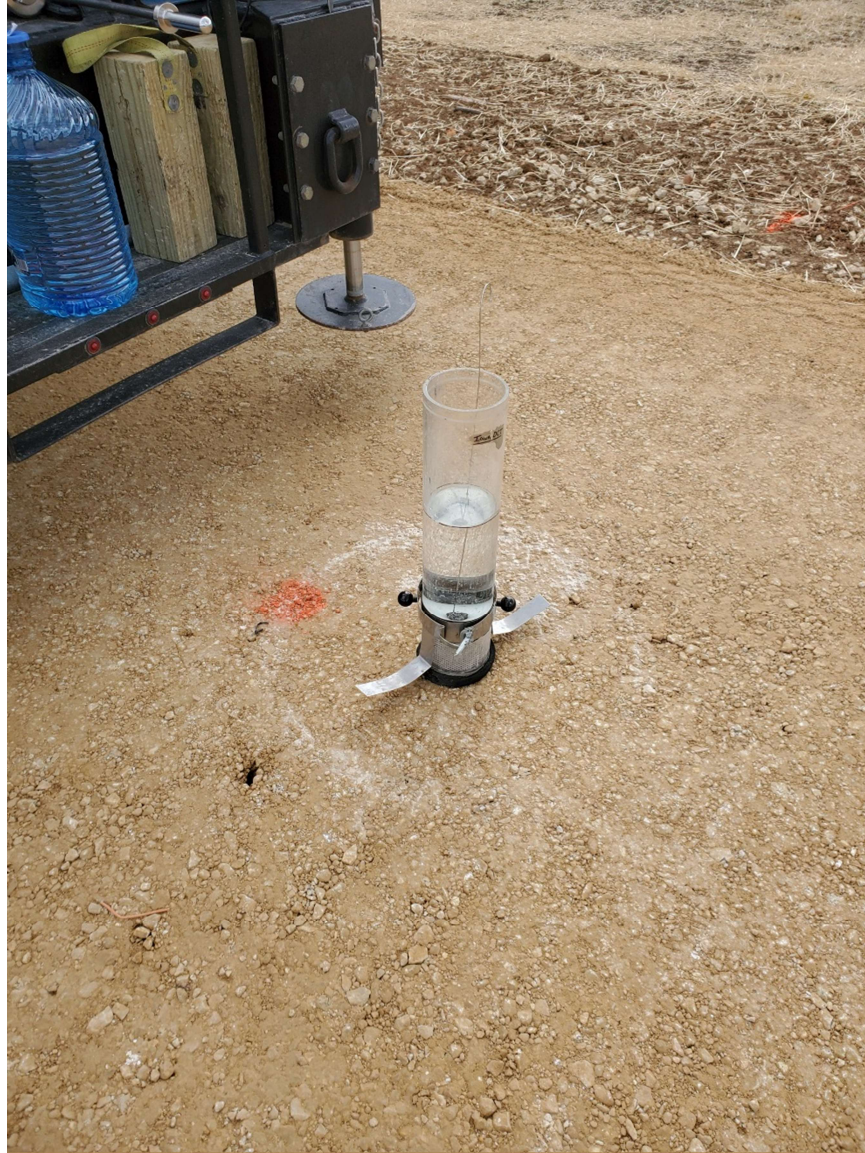
**Figure 18. Vu meter testing on crushed limestone modified subbase on Dubuque County US20 project (09/30/2020).**

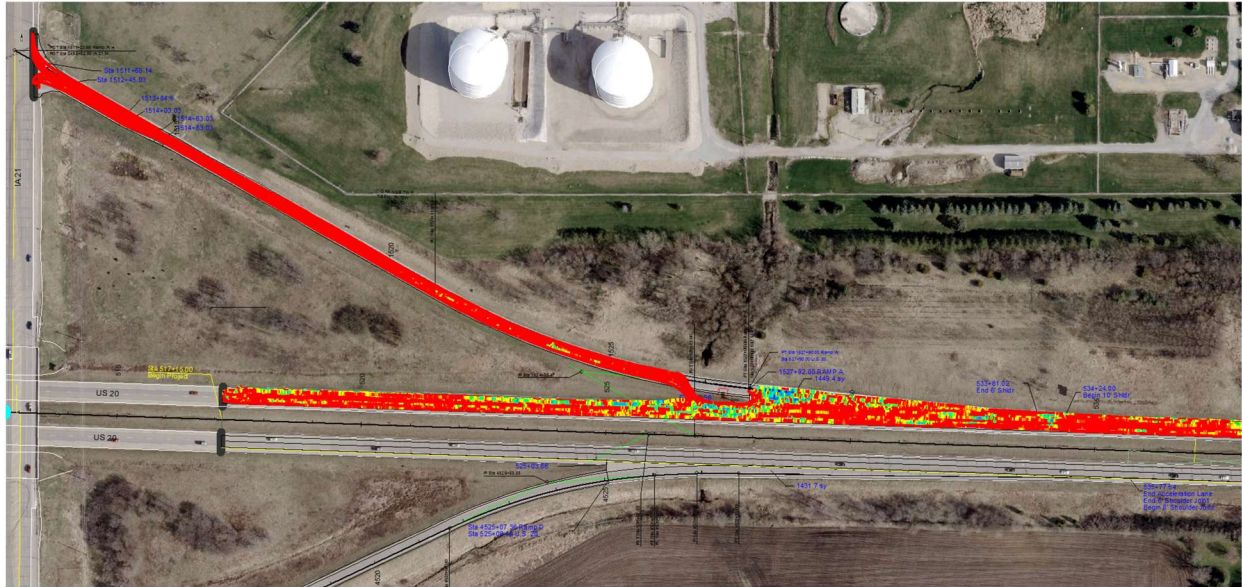
**Figure 20. Delta k-value map (assuming a target k-value of 150 pci) of granular subbase layer on Blackhawk US20 project (08/27/2020).**

The RT mapping results showing geospatial record of k-values allows for design life prediction analysis. To illustrate this possibility, k-value mapping results form the Blackhawk County US20 project are shown in Figure 20 and the predicted design life values are shown in Figure 21. Both these maps are shown as delta maps with a reference target value as noted in the figures.

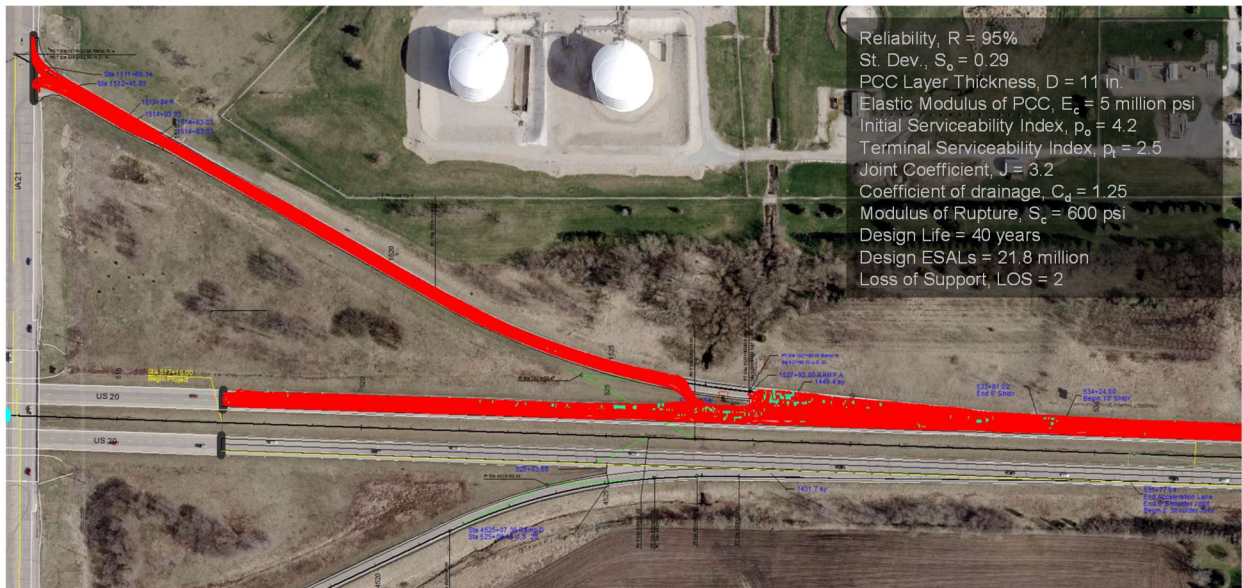
**Figure 21. Predicted delta design life map (assumed target design life = 40 years) per AASHTO (1993) pavement design assuming LOS = 2.**

The design life was calculated using the AASHTO (1993) rigid pavement design model using the design loading conditions (ESALs) assumed for the project by the Iowa DOT and other input parameters are noted in Figure 21, and applying a reduction in the k-value for a LOS condition. An LOS = 2 was assumed (per AASHTO 1993), because of the potential void gap at locations with > 0.05 inch permanent deformation. This was determined using the empirical relationship between k-value and  $\delta_p$  from static APLTs (Figure 8), and all grid point locations on the map with k-value < 200 pci was corrected for the LOS condition.

Results indicated a 20% to 25% decrease in assumed pavement design life as an impact of the foundation support conditions. This has significant cost implications in terms of potential maintenance work and safety impacts to public and construction works due to road closures.
