# Concrete Box Culvert Earth Pressure Monitoring

**Final Report**  
**March 2022**

**Sponsored by**  
Iowa Highway Research Board  
(IHRB Project TR-776)  
Iowa Department of Transportation  
(InTrans Project 19-694)

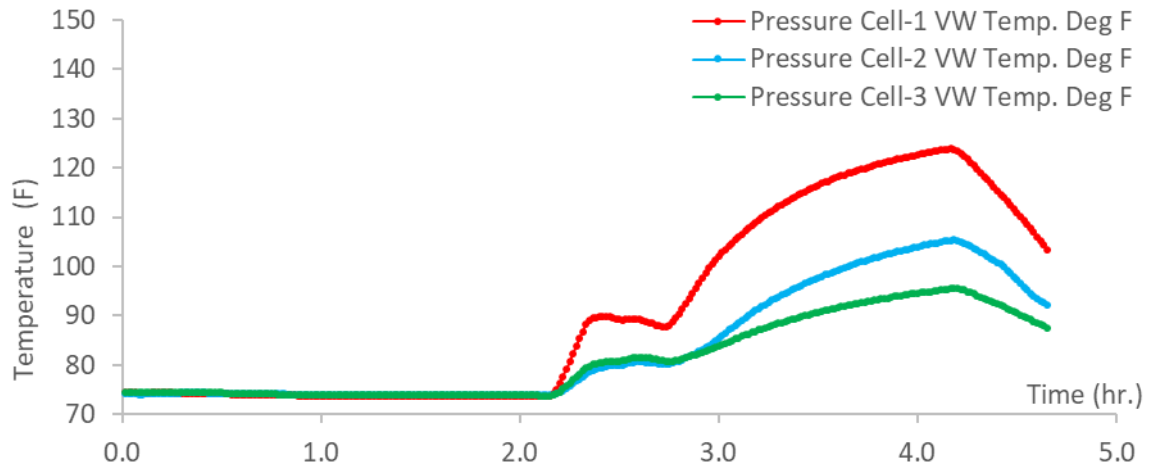
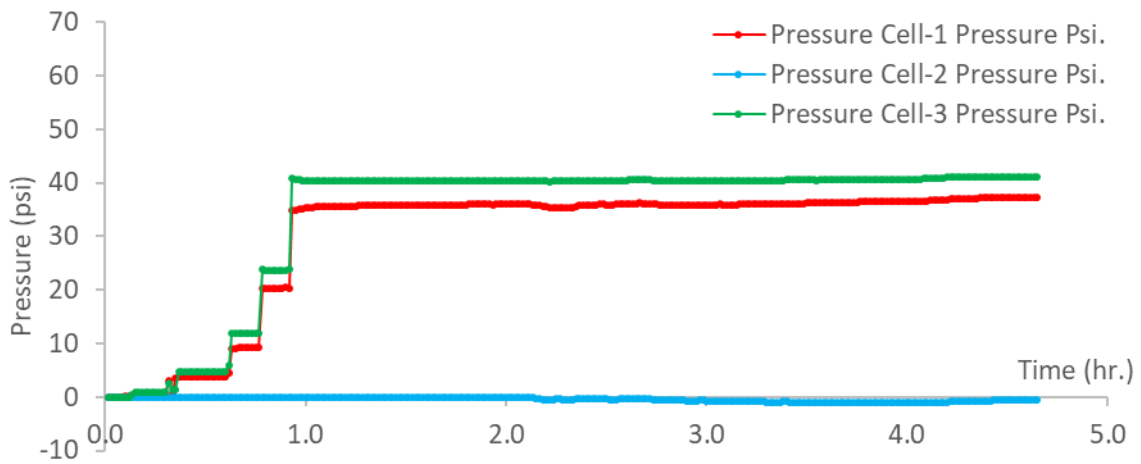
**Figure 11. First test data**

Figure 11-a and 11-b plot the temperature and pressure data versus time for the first test.

a) Temperature vs. time in the first test

b) Pressure vs. time in the first test

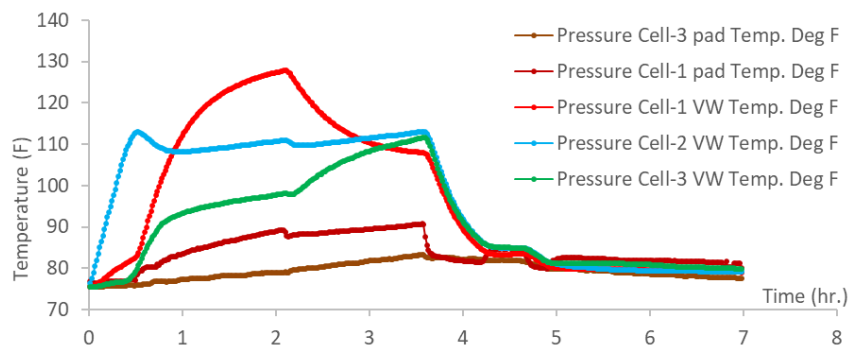
Figure 13-a and 13-b show the temperature and pressure data versus time for the second test.

**a) Temperature vs. time in the second test**

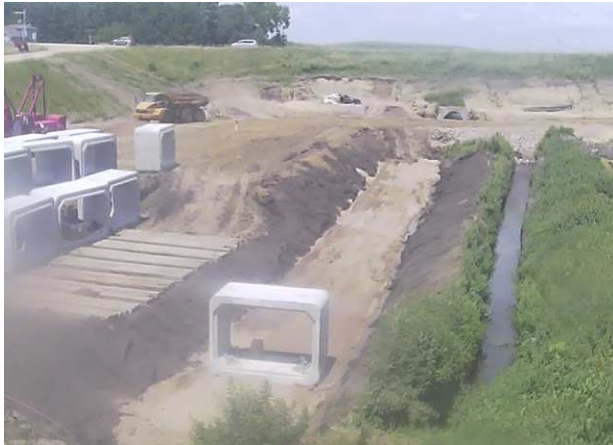
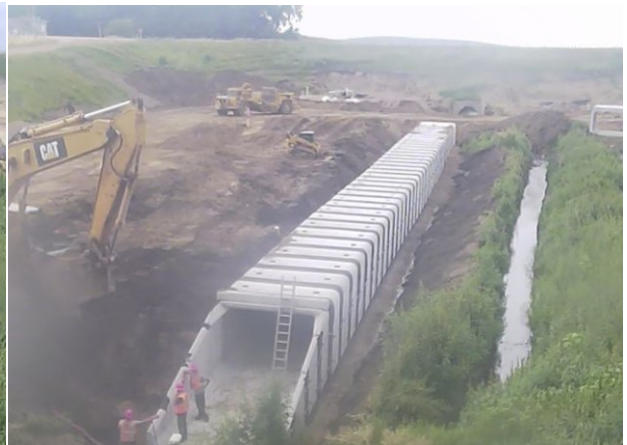
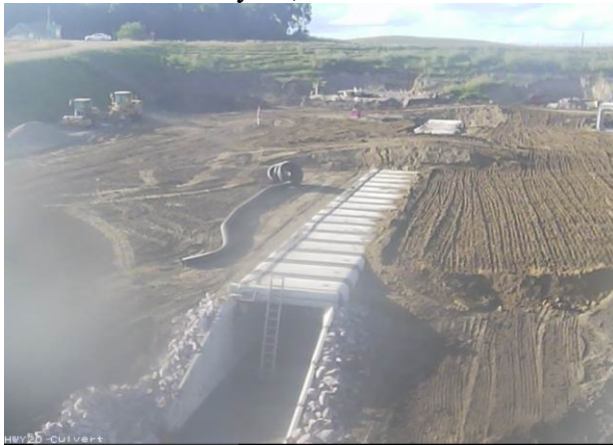
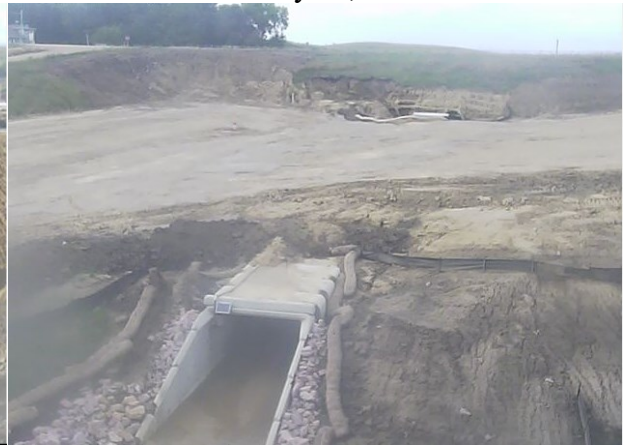
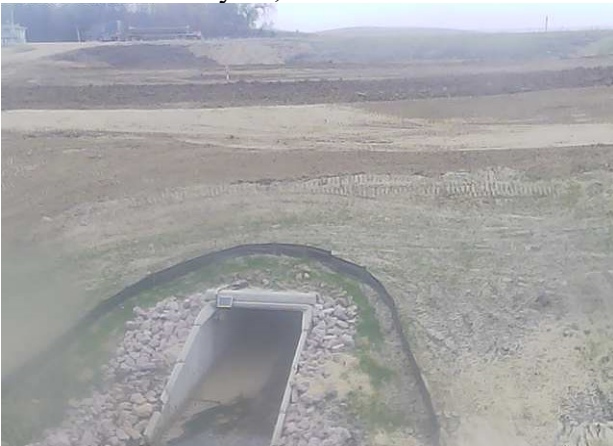
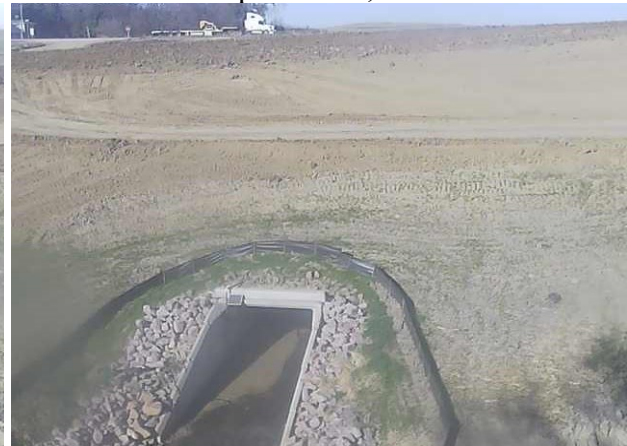
**Figure 19. Ida County earthwork progress**

A web camera was installed in early April 2016 to collect general site information during construction. Figure 19 shows several video screenshots of the earthwork progress.

Along the side of the box, the contractor used flooded backfill up to the top of the box. Sand was put in using 2 ft lifts. Class 10 fill above the box was placed in 8 in. lifts using a tractor and pans and a wedge foot roller for compaction. The first lift above the box was about 3 ft deep to protect the box from the weight of the construction equipment. Figure 18 shows the soil profile over the culvert.

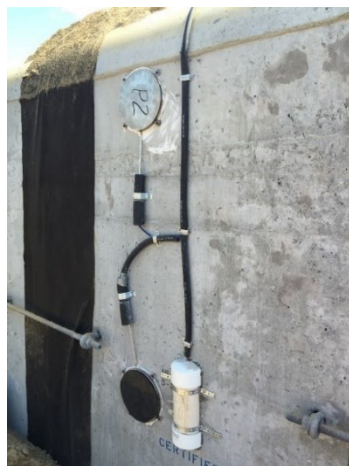
a) Strain and earth pressure gauges

**Figure 20. Sensors and data logger**

The previous Figure 20-a presents the sensors and covers. The other strain gauges (S4, S5, and S6) inside the culvert were left uncovered. The Campbell CR-1000 data logger worked with the sensors to collect earth pressure and strain data at a user-selected frequency of one reading per hour.

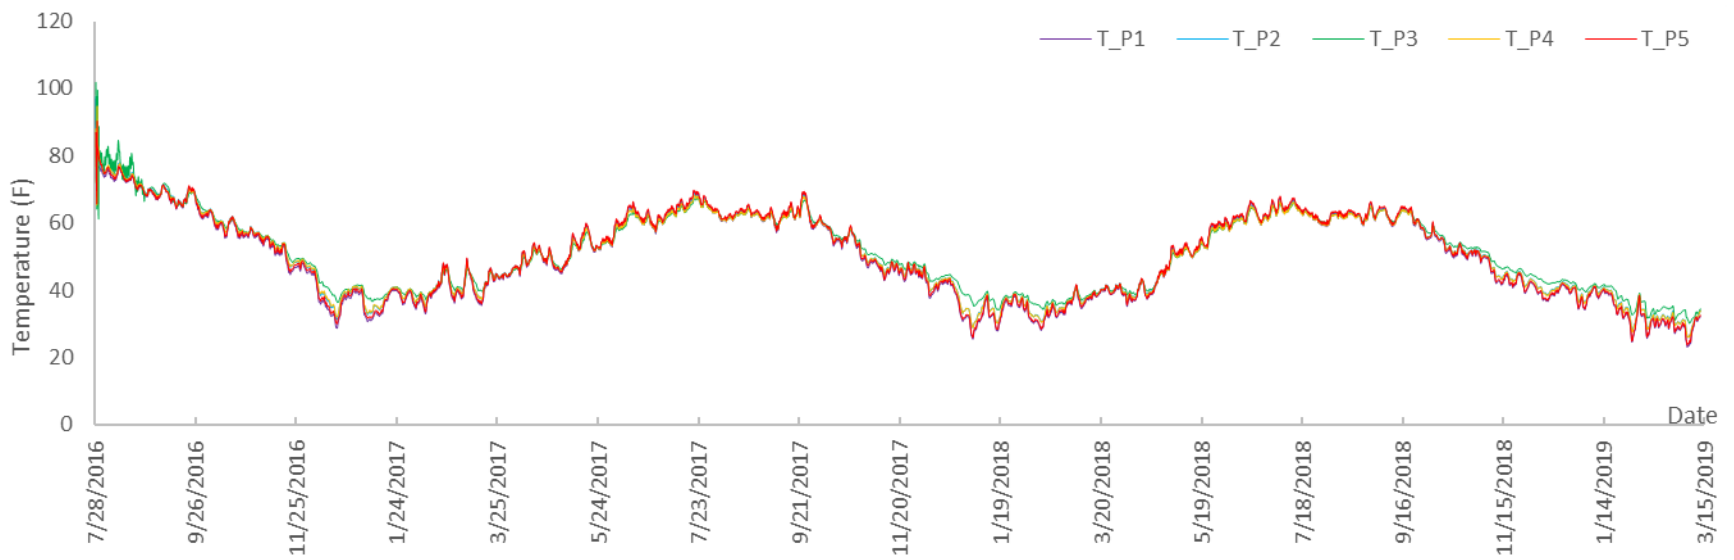
**Figure 22. Ida County pressure and temperature data from pressure cells**

The pressure data from all pressure cells were thermally corrected utilizing the previous Equation 1 and the thermal factor provided on the gauge data sheet. Figure 22-a and -b present the field-collected pressure and temperature data from July 28, 2016 through March 15, 2019.

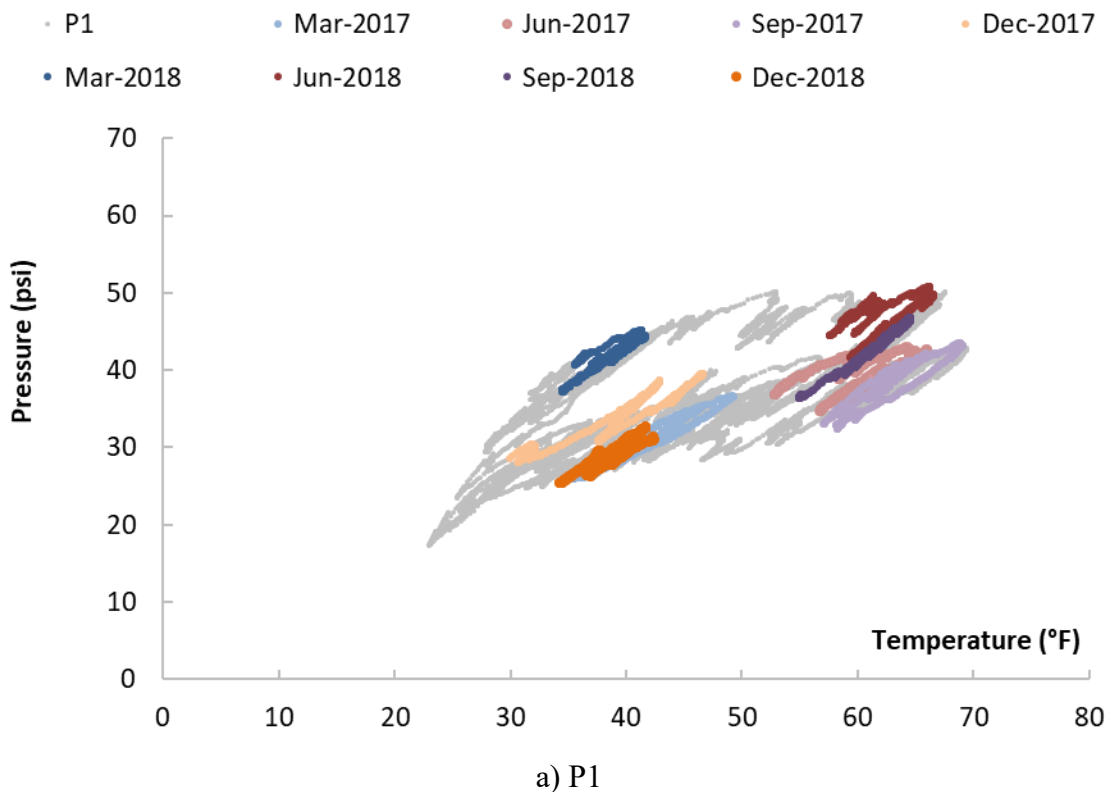
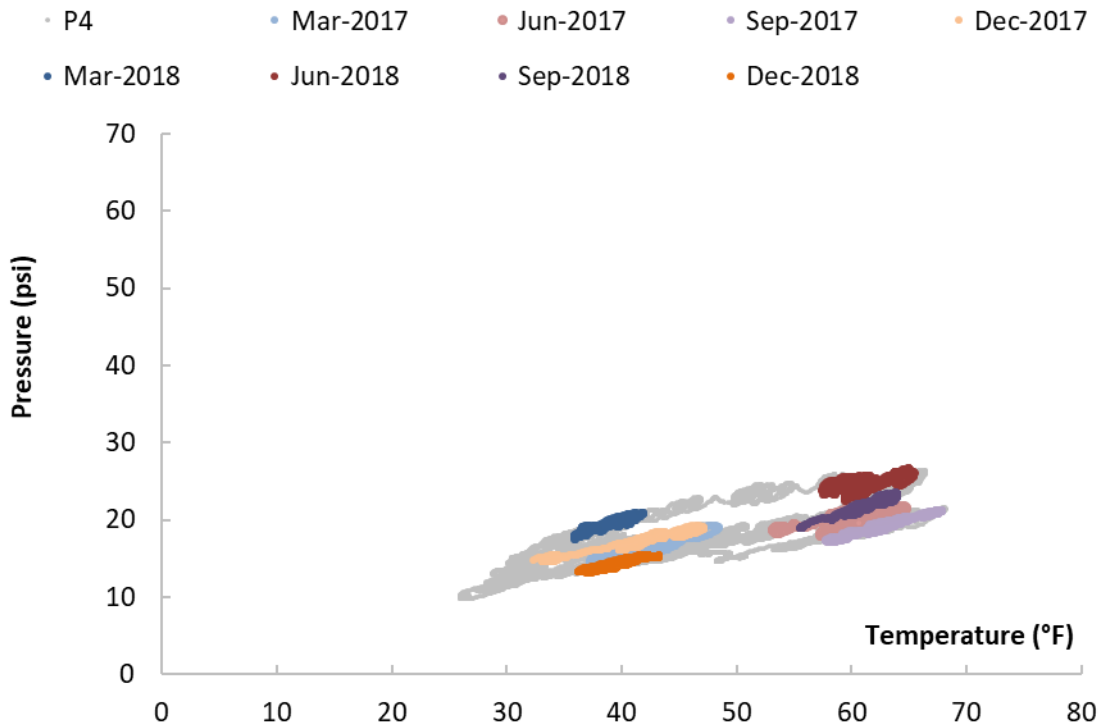
**Figure 23. Ida County pressure vs. temperature data (pressure data zeroed on July 28, 2016)**

To better illustrate the relation between the pressure and temperature data, Figure 23 plots the pressure versus temperature for each pressure cell.

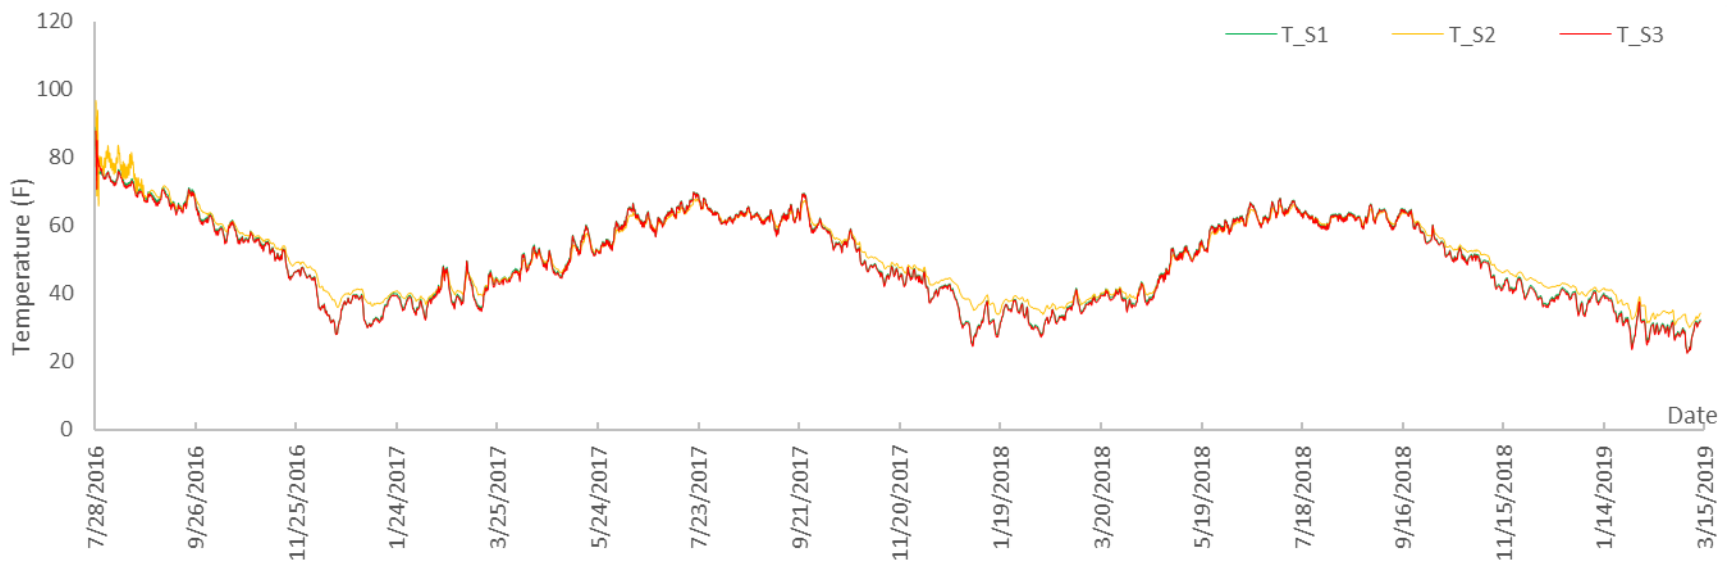
**Figure 25. Ida County temperature data from VWSGs**

The temperature and strain data captured by the six VWGSGs are shown in Figure 25 and Figure 26.

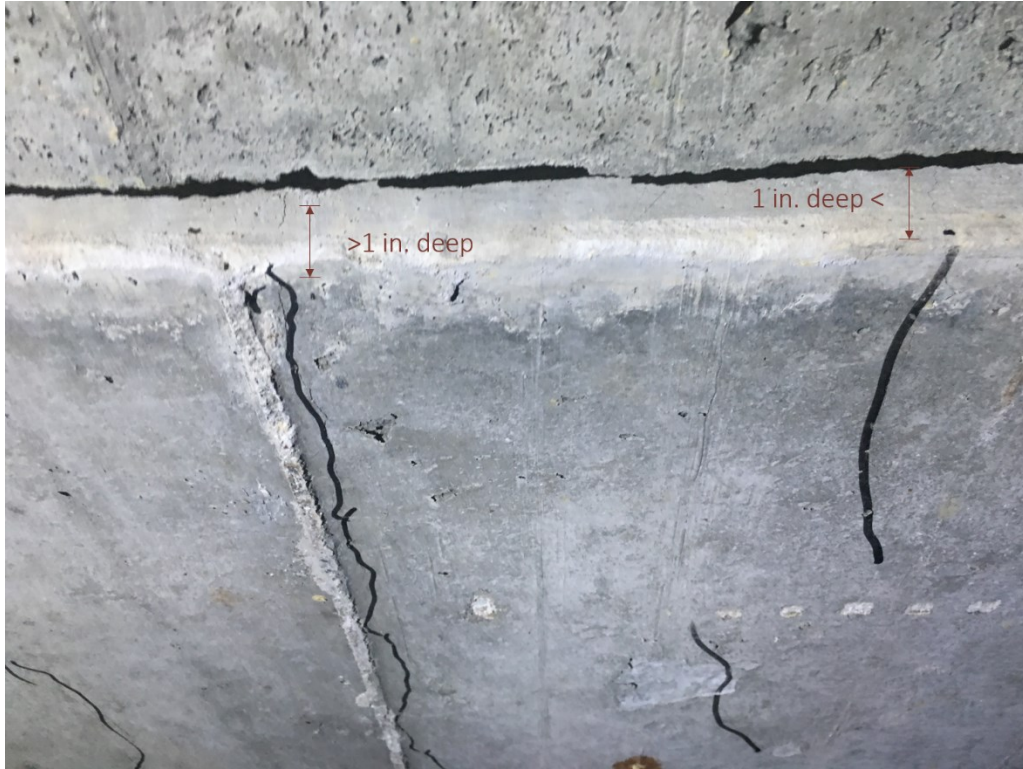
**Figure 27. Ida County culvert crack situation**

A field inspection was conducted on the instrumented box culvert to record any cracking. A significant number of cracks were found near the middle span of the top slab within the one-quarter span length on each side. The cracks were highlighted using black marker and are shown in Figure 27-a.

a) Longitudinal cracks on the bottom of the top slab

b) Crack depth at the end of instrumented culvert unit

At the end of the culvert unit, it can be seen that some of the cracks propagated to more than 1 in. deep (see Figure 27-b). Since the cracking on the top slab increased the downward deflection at the mid-span of the top slab, part of the soil above the culvert tended to be carried by the surrounding soil due to the soil arching effect. This eventually reduced the pressure recorded by P3.

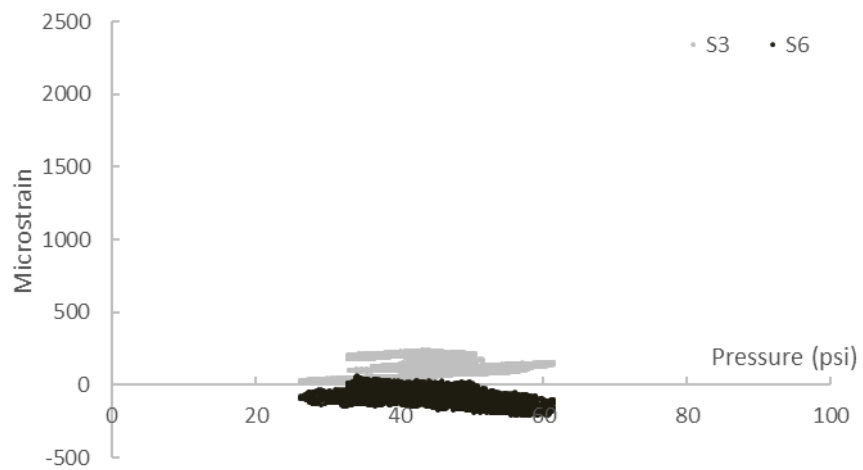
Figure 28 plots the strain data versus pressure data collected from the pressure cell.

As the pressure increased and the strain at the outside surface of the exterior wall increased, the strain at the interior surface decreased. This was because the bending caused by earth pressures led to tensile strain at the outside surface and compression at the inside surface.

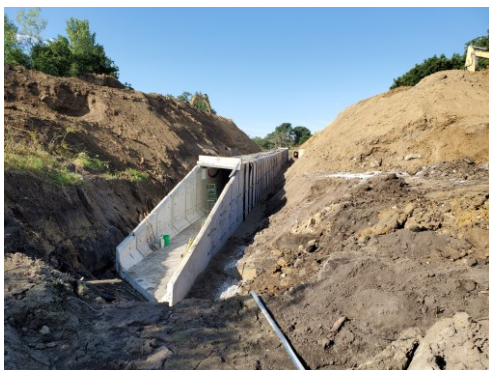
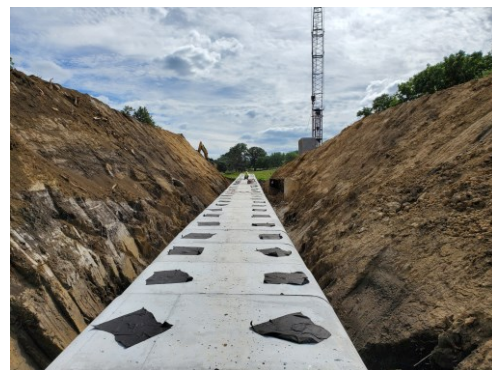
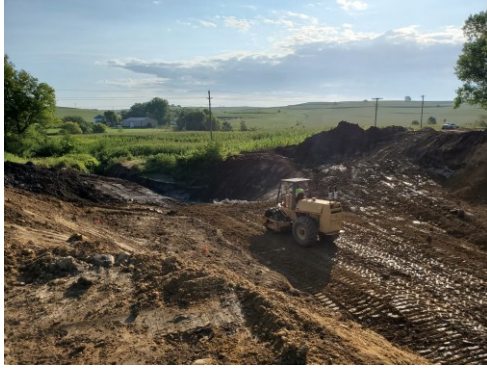
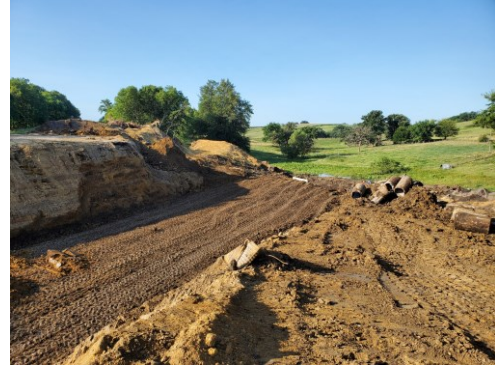
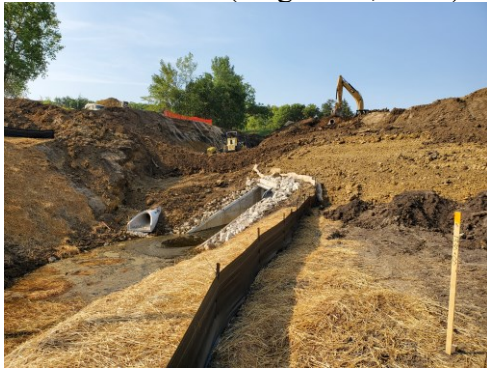
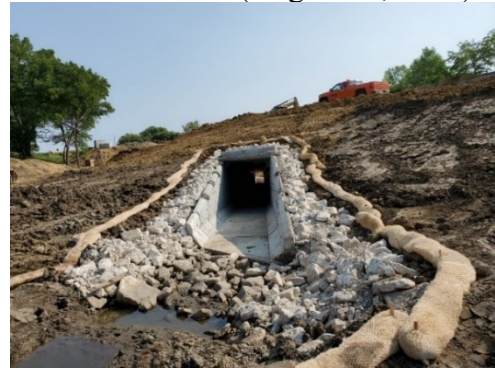
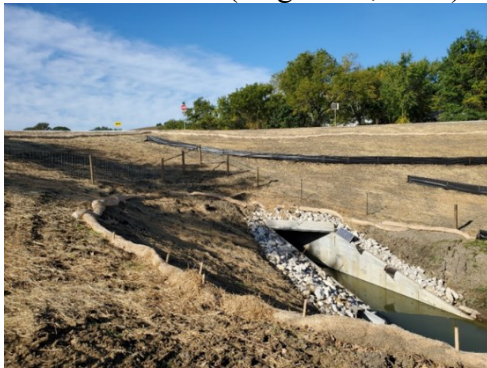
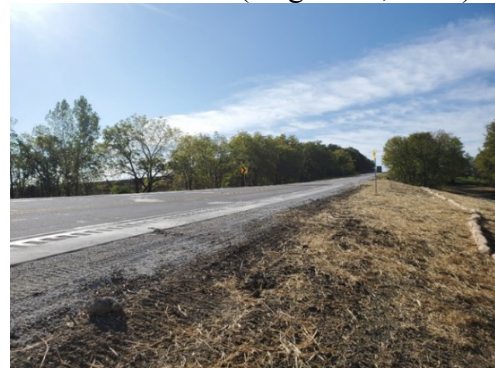
**Figure 36. Crawford County earthwork progress**

During construction observation, several images were captured to demonstrate the earthwork progress. Figure 36 shows the backfill progress and the completed project.

Then, the contractor installed the culvert segments, and the instruments were installed. Following the placement of the culvert, the sides were compacted and filled every 8 to 12 in.

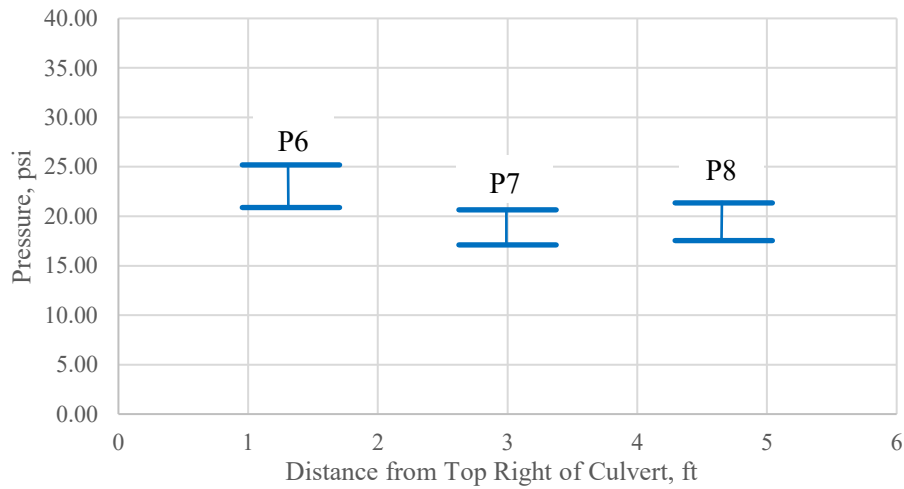
**Figure 40. Crawford County pressure distribution on top of culvert**

Figure 40, Figure 41, and Figure 42 show the pressure distribution on the top and both sides of the culvert.

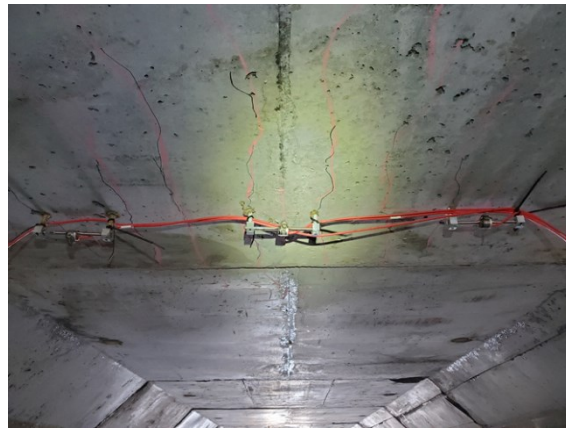
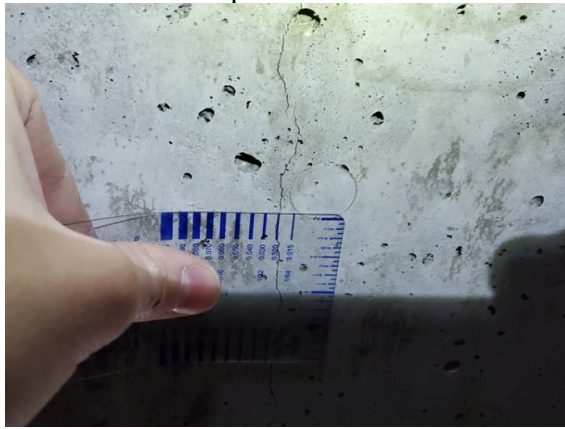
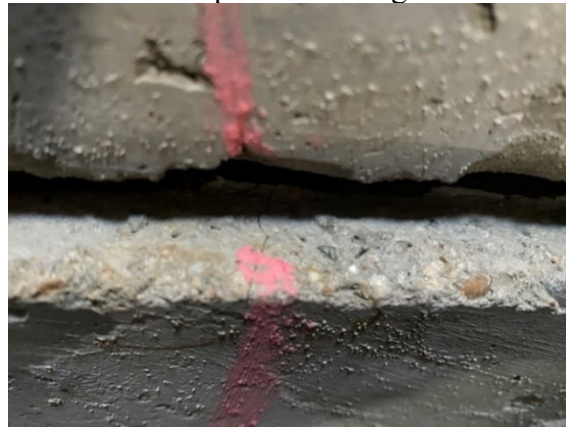
**Figure 47. Crawford County cracking inspection in NE section**

The culvert was inspected on March 10, 2021 to assess cracking and the condition of the culvert. Figure 47-a and -b show the cracking, marked using chalk on the bottom of the top slab in the NE section.
