BULLETIN NUMBER 10

# AN EPIDEMIOLOGICAL STUDY OF POWER TAKE-OFF ACCIDENTS

THE UNIVERSITY OF IOWA · 1966

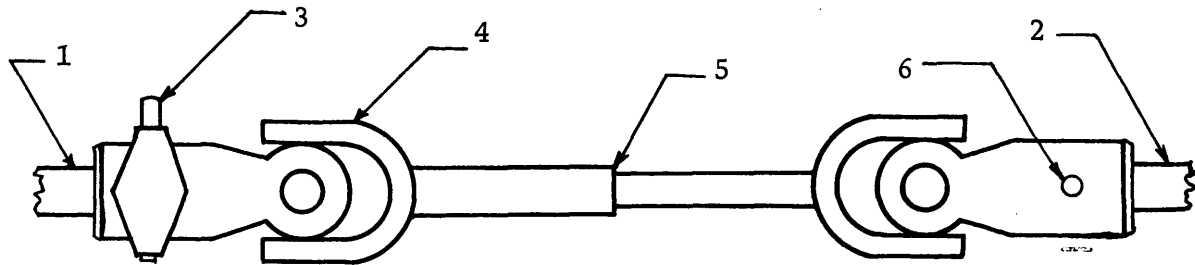
FIGURE 1

| (1) tractor PTO shaft | (4) universal joint |

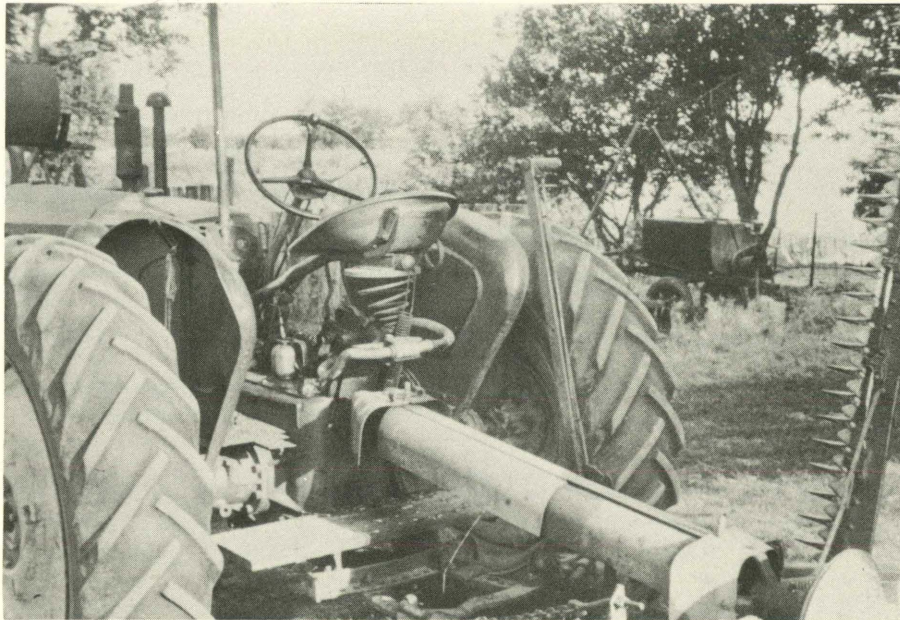
Figure 2: Inverted trough or U-shaped shield connected to tractor master shield and implement stub shield.

1. Inverted Trough, or U-Shaped Shielding Device: The PTO shaft assembly revolves underneath the shield, which is supported at either end, with protection afforded the worker from side or top contact with the rotating shaft.

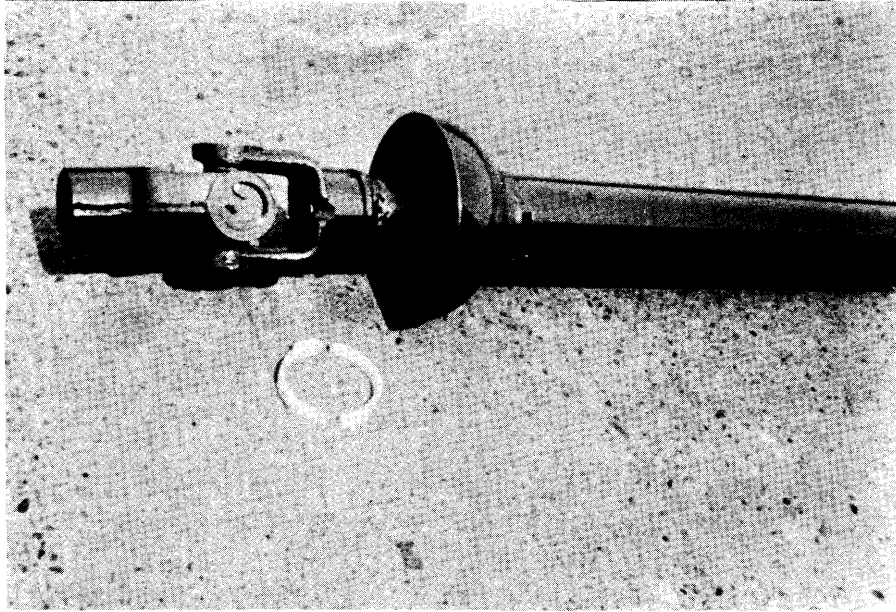
Figure 3: Integral mounted shield disassembled to show nylon bearing.

2. Integral Mounted Shield : The PTO shaft itself supports a tubular shield covering the shaft and universal joints which, when in contact with an object (man) becomes stationary, while the shaft rotates inside of the shield. Bearings separate the shield from the shaft, permitting it to become stationary. The shield also has conical ends which partially cover the universal joints, affording some protection from accidental contact in this area.

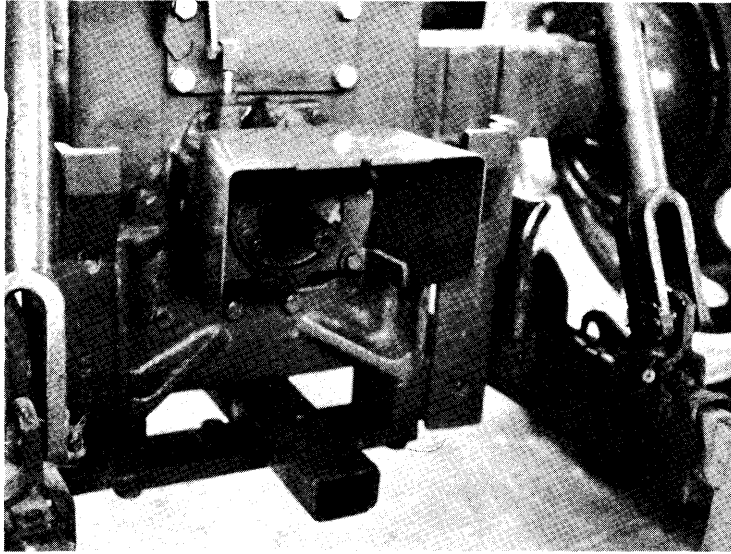
Figure 4: Tractor Master Shield

3. Master Shields and Stub Shields: Master shields on the tractor (Fig. 4) and permanent stub shields (Fig. 5) on the machine are mounted in

such a manner as to protect the exposed splined ends of the PTO shaft when using the integral mounted shield, and serve as mounting points for the inverted trough shield. The stub shield covering the equipment attaching area is usually not as complete as that of the tractor's master shield. The tractor master shield often has to be removed for certain farm operations. It can be damaged accidentally and is often not replaced after removal. The use of the newer integral mounted shield, which needs no outside support as does the inverted trough, also reduces the incentive to replace the shield, once removed.

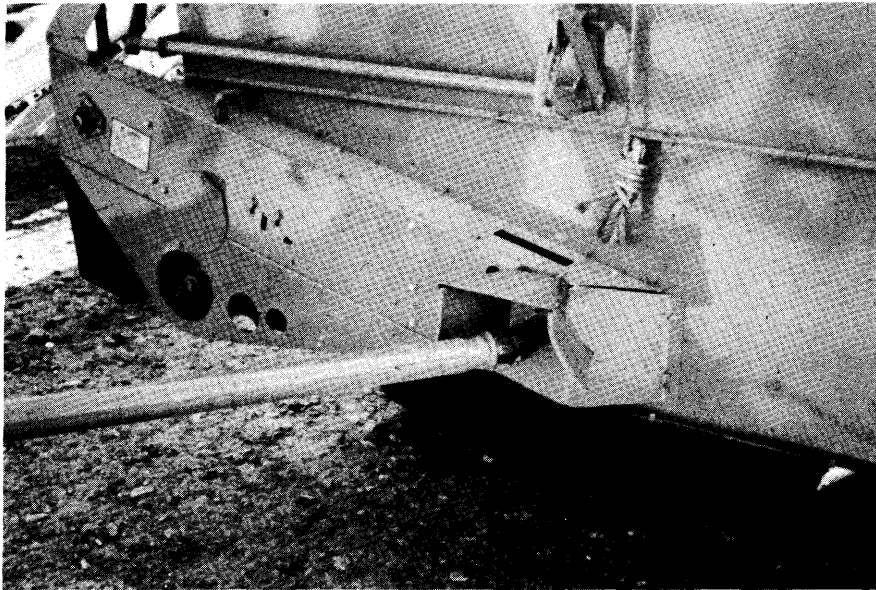
Figure 5: Implement Stub Shield

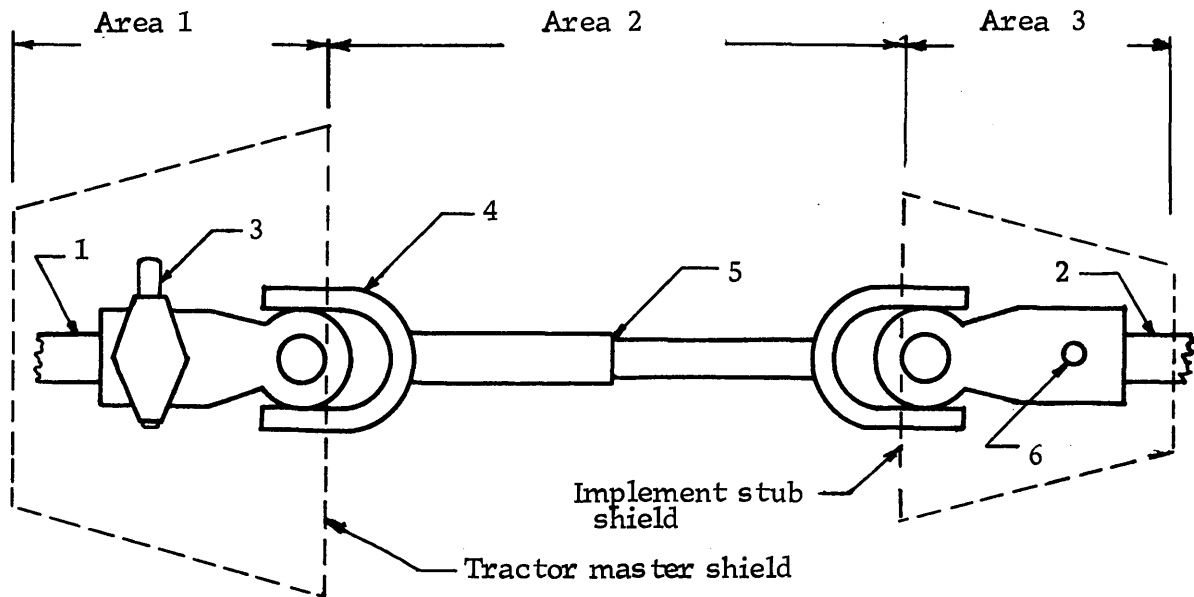
FIGURE 6  
DIAGRAM OF PTO

- (1) tractor PTO shaft
- (2) driven implement shaft
- (3) spring-loaded pin connecting PTO to tractor
- (4) universal joint
- (5) telescoping portion of PTO shaft
- (6) pin and keyway for connecting PTO to implement.

Area (1) is the portion of the PTO which attaches to the tractor's PTO shaft. The most common type of coupling device is the spring-loaded pin. Bolts and cotter pins are also used occasionally. This portion of the PTO is intended to be shielded by the tractor master shield.

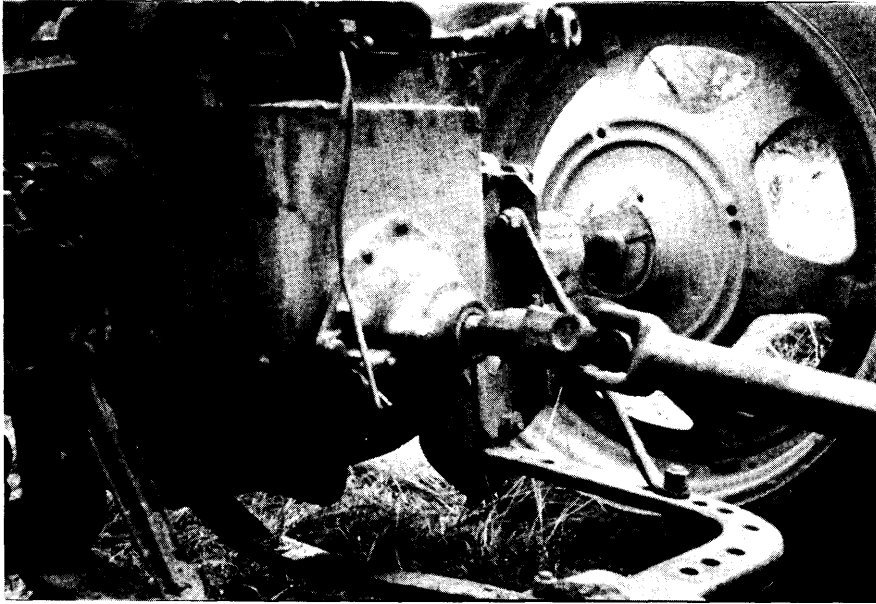
Figure 11: A 17 year old boy was injured as he stepped across the PTO of the above equipment from the right side of the drawbar to disengage the PTO by depressing the lever with the heel of his shoe. The spring-loaded pin caught the cuff of his overalls, hospitalizing him for two days with extensive skin abrasions.

It was noted in the investigations that in half of the accidents where the inverted trough shield was missing, the victim continued to use the equipment without shielding. an example is illustrated by Figure 11 on the following page, where the father of the

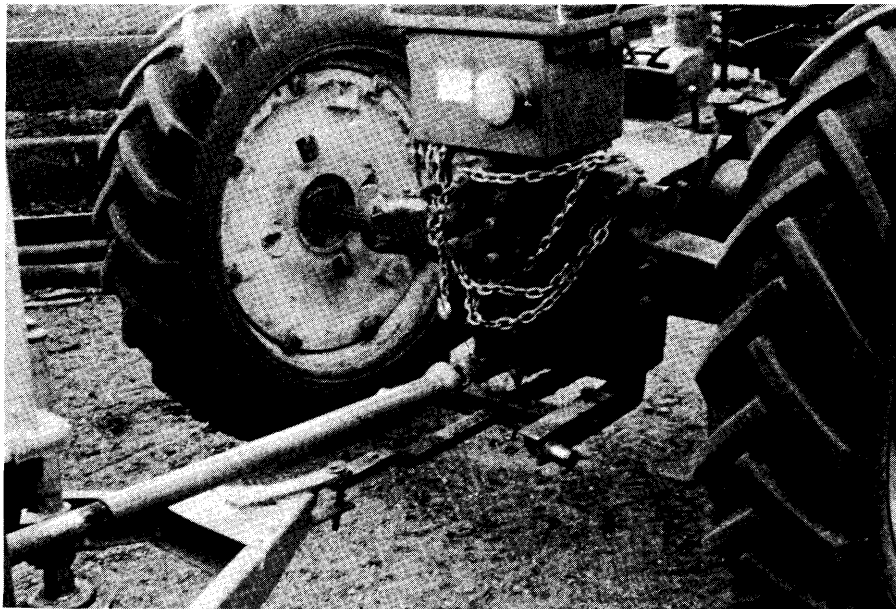
Figure 10: Example of chore equipment with integral mounted shield, but the tractor master shield is missing.

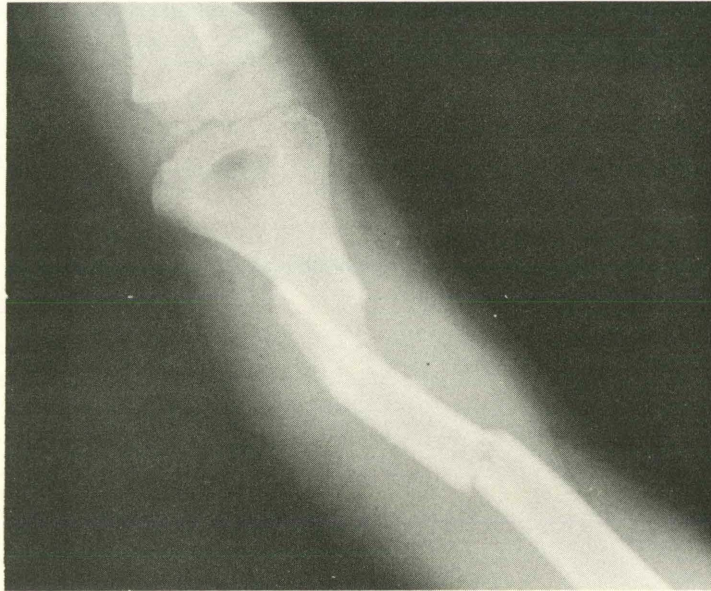
Figure 9: X-rays of fractures of the humerus of the same 7 year old boy.

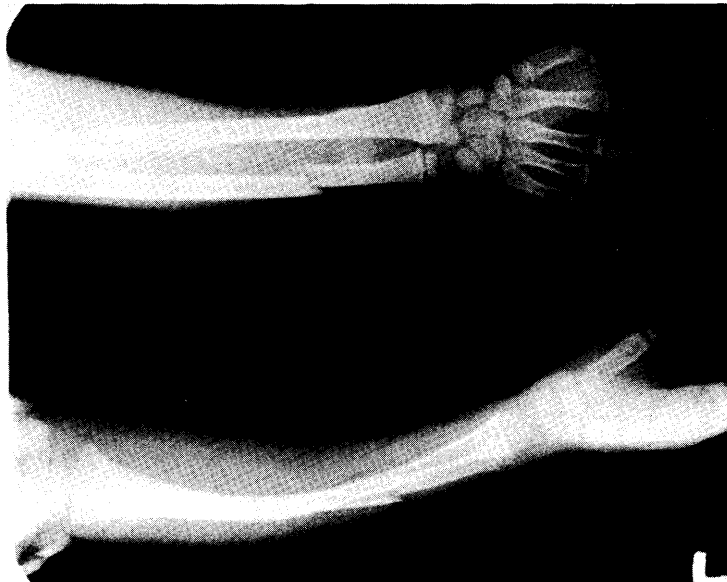
Figure 8: X-rays of fractures of the radius and ulna and an unseen "green limb" fracture.

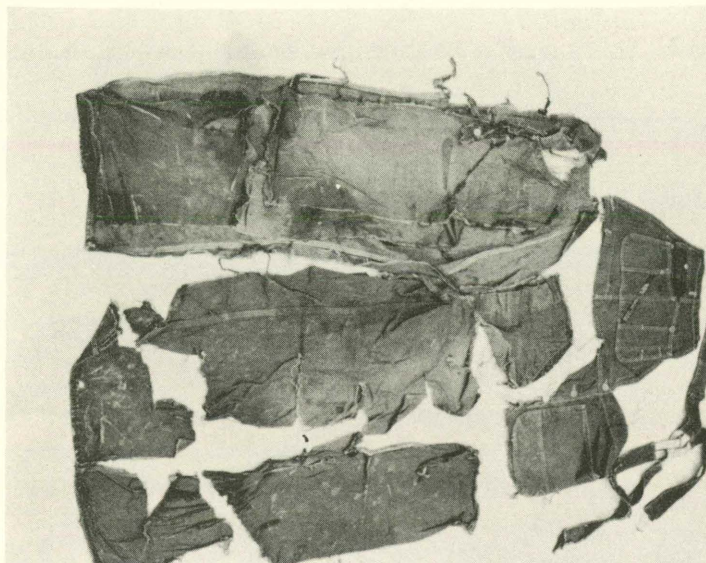
Figure 7: Torn clothing.

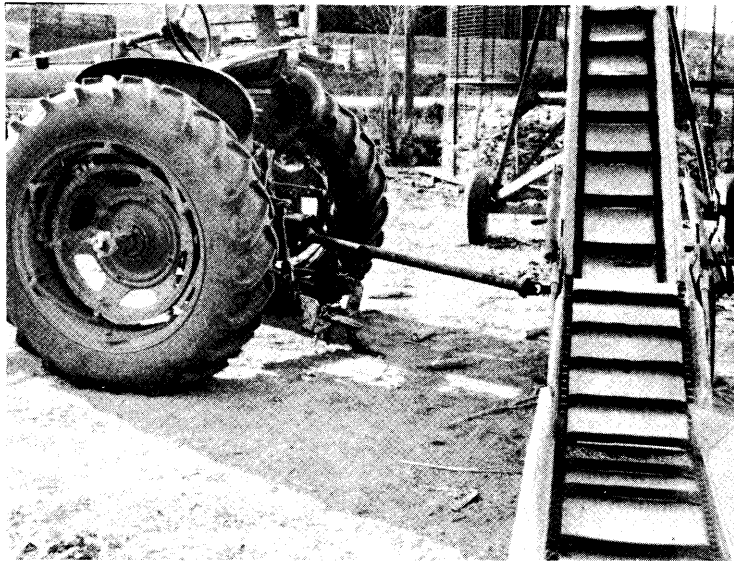
Figure 12: The tractor and PTO driven elevator in the above picture were being used during the harvesting of eared corn. While using this equipment, the operator would mount the tractor platform from the left rear to start the tractor and engage the PTO. However, he dismounted from the right rear and stepped across the PTO to return to the elevator hopper. Such a pattern was particularly dangerous because of two conditions: (a) there was eared corn strewn on the ground around the tractor, and (b) the portion of the PTO which connects to the elevator was unshielded and the end of the bolt protruded from the shaft.

The following discussion of work patterns contains examples of those found in this study. The first, illustrated in Figure 12, documents an unusual work pattern which increased the operator's hazard without any additional benefit to him.

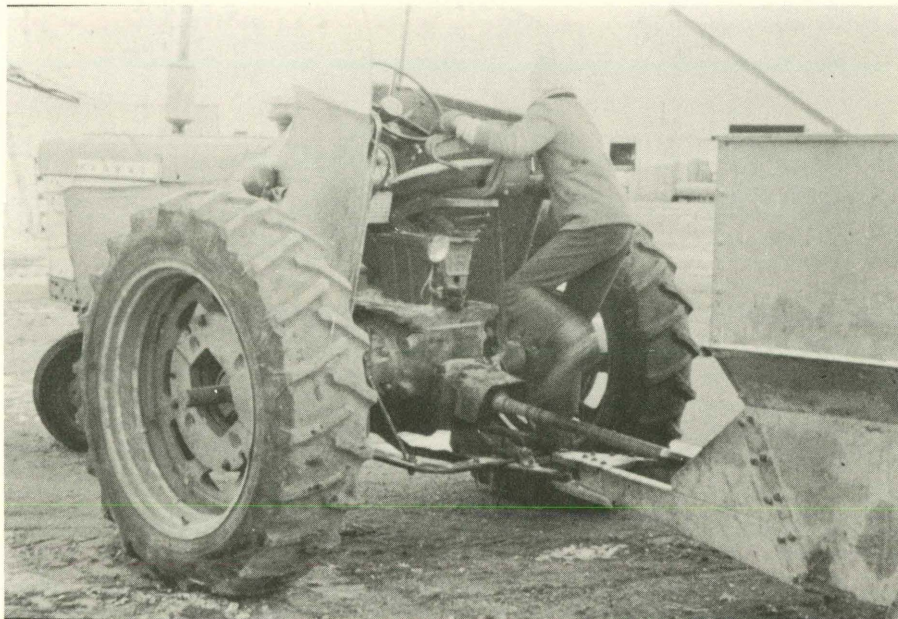
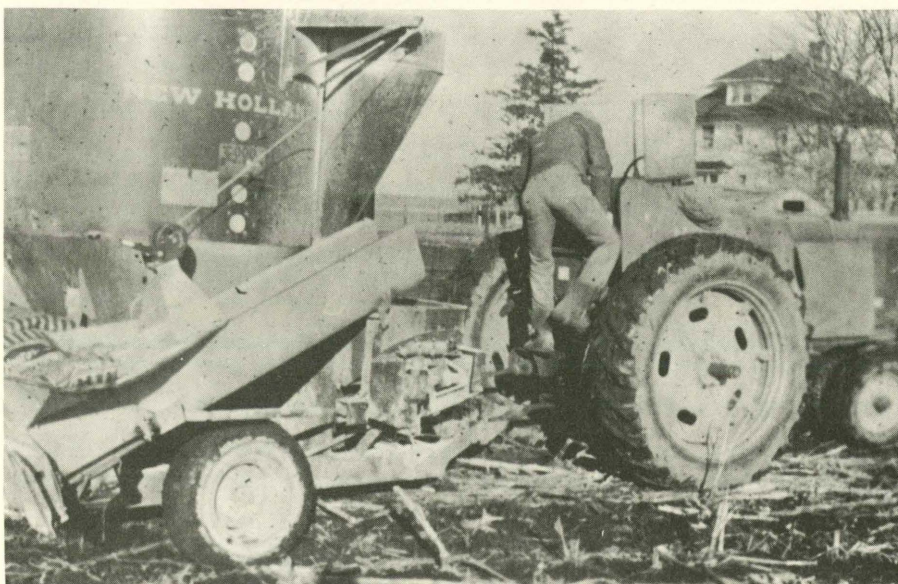
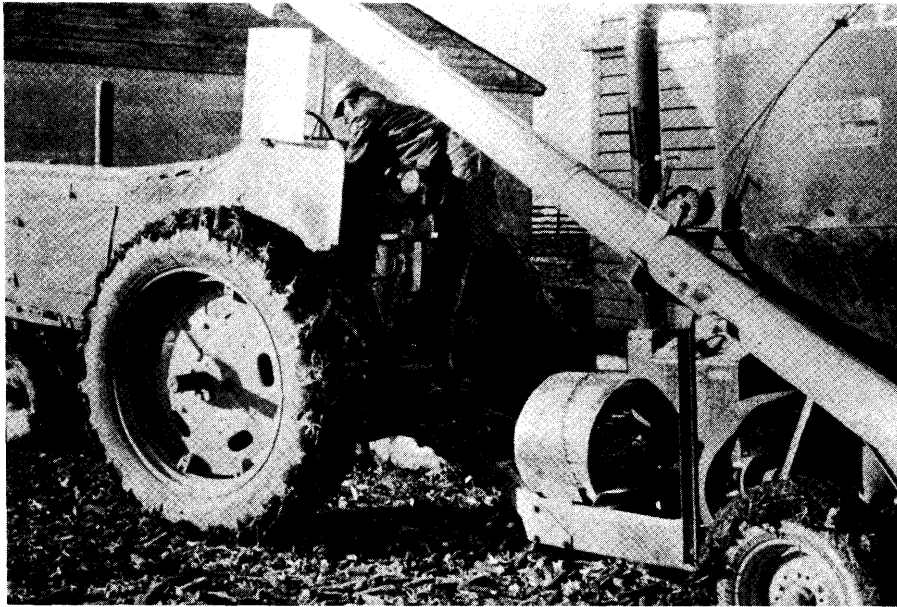
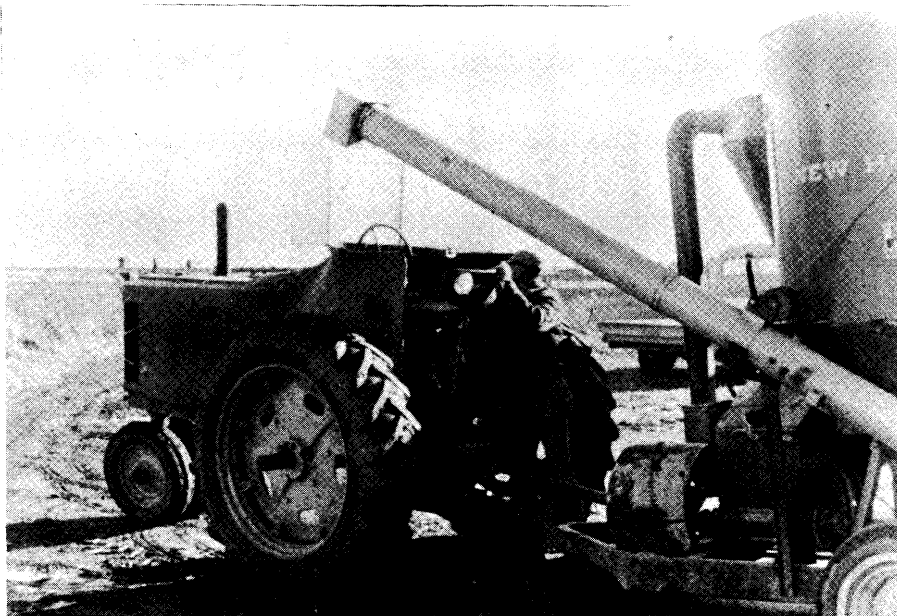
Figure 13: Operator jumping across PTO shaft to disengage power before the feeder ran over.

Figure 14: Operator mounting tractor to disengage PTO and move the equipment.

Figure 15: Operator adjusting throttle setting.

Figure 16: Operator disengaging PTO.

Figures 13, 14, 15, and 16 will illustrate the simple work patterns of adjusting tractor controls while using chore equipment. These pictures were taken during actual operation and while the PTO was running. In Figure 13, the operator is jumping across the PTO to disengage it before the feeder overflowed. In Figures 14, 15 and 16,

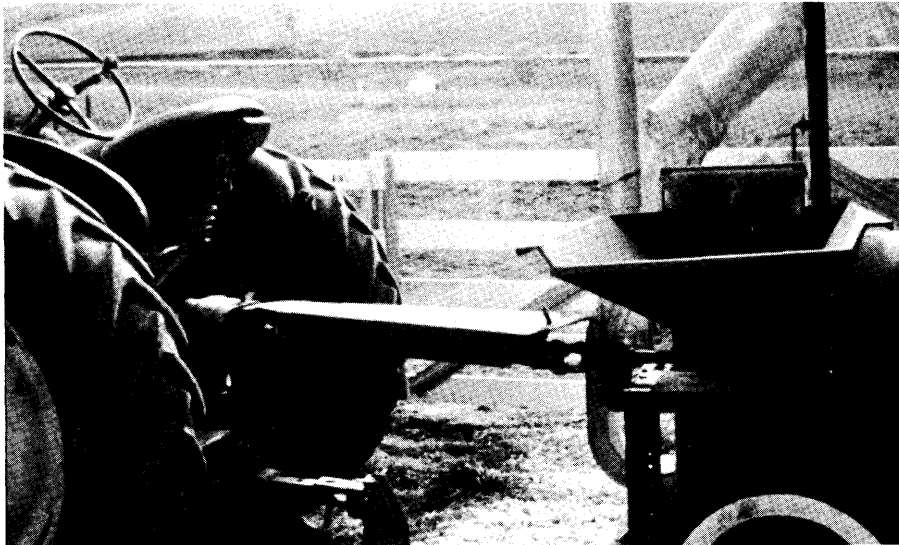
Figure 17: This heavily constructed inverted trough shield offers protection to the operator from the middle of the PTO, but no side protection where the PTO couples to the hammer mill or to the tractor. A cotter pin protrudes from the PTO shaft where it connects to the hammer mill and the first universal joint and there is a spring-loaded pin where it attaches to the tractor.

The inverted trough shield as best designed only offers protection to the operator from the top and sides of the PTO drive, and many shields offer only minimal side protection. Stationary drive lines covered with this type of shield are serious offenders regarding side protection. The problem of protection for the operator using the inverted trough shield is well illustrated in Figure 17.

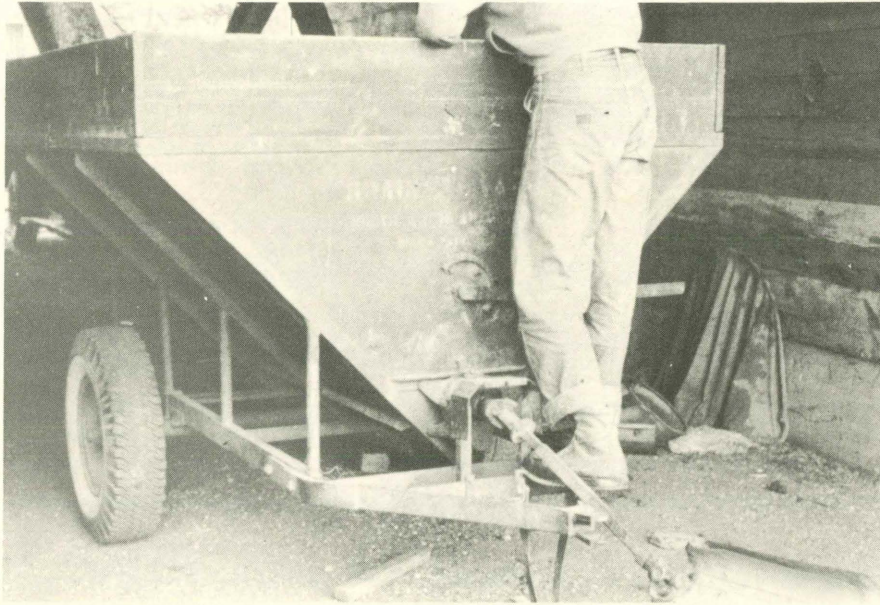
Figure 18: Victim standing on drawbar as at the time of the accident.

Figure 18 shows an auger wagon which was purchased second-hand by an accident victim and illustrates the economic philosophy which produced an accident. Approximately one month after the purchase of this wagon the operator became entangled in the PTO as he was standing on the drawbar to observe the contents of the wagon. He had asked about the cost of purchasing an integral mounted shield for the PTO and was informed that such a shield necessitated the purchase of a new PTO shaft, and this would represent a considerable portion of the total investment. However,

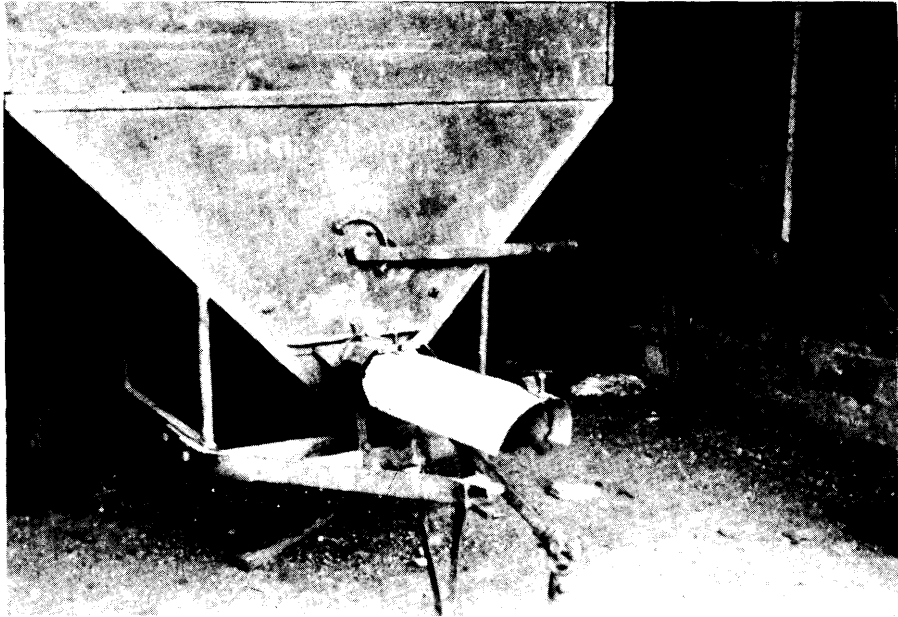
Figure 19: Inverted trough shield constructed by the victim after the accident.

after the accident he made the inverted trough shield shown in Figure 19, and has since made a similar shield for a recently purchased used mower.

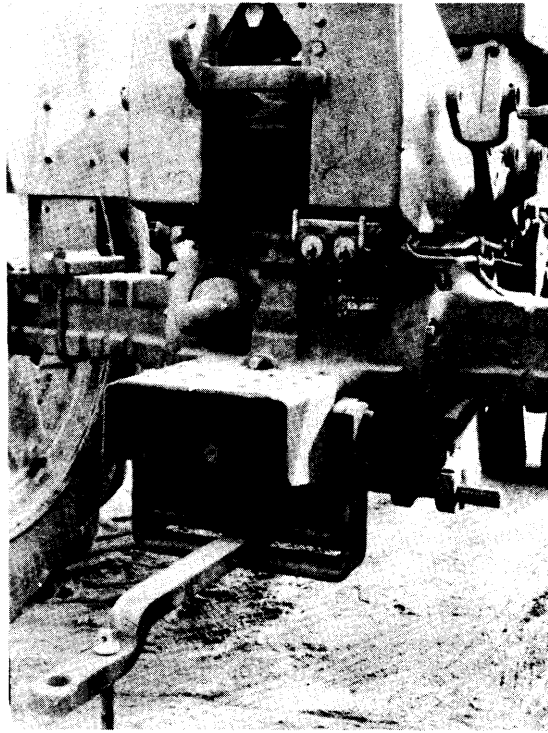
Figure 20: Rear view of front-mounted tractor. The only plausible place for mounting from the rear or riding as a passenger is the drawbar or master shield.

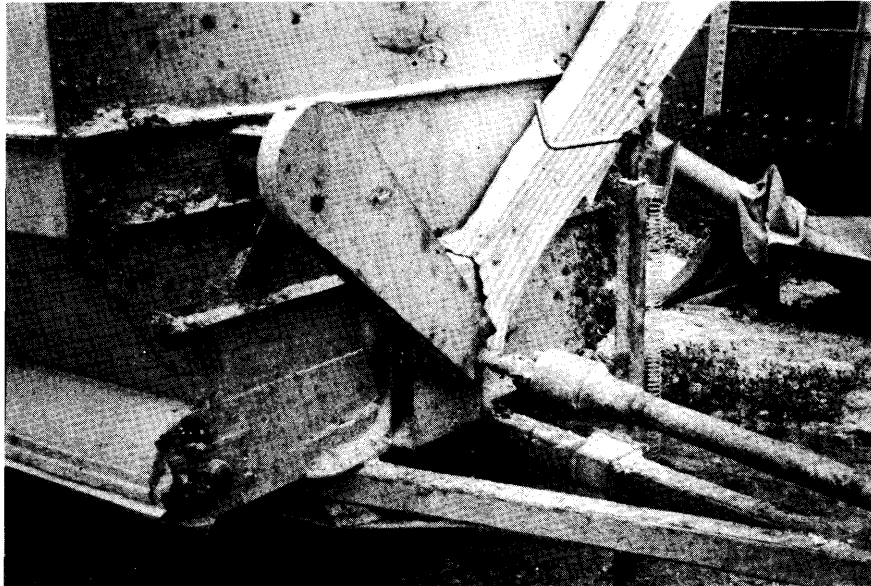
Figure 21: Auger wagon with integral mounted shield but no stub shield.

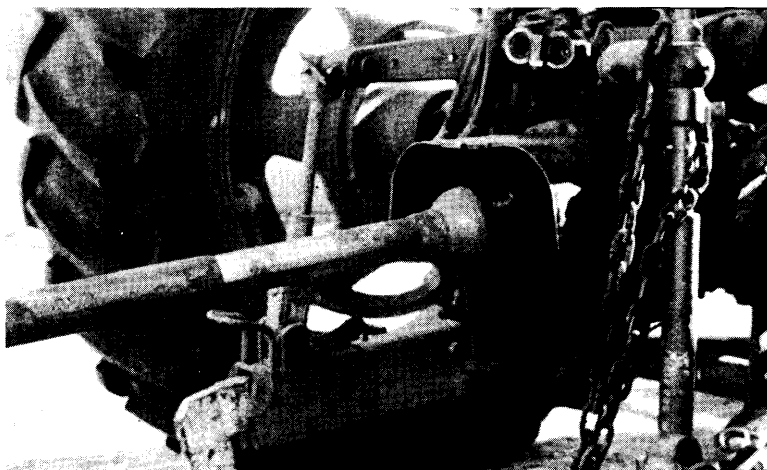
Figure 22: View of open area between integral mounted shield and tractor master shield.

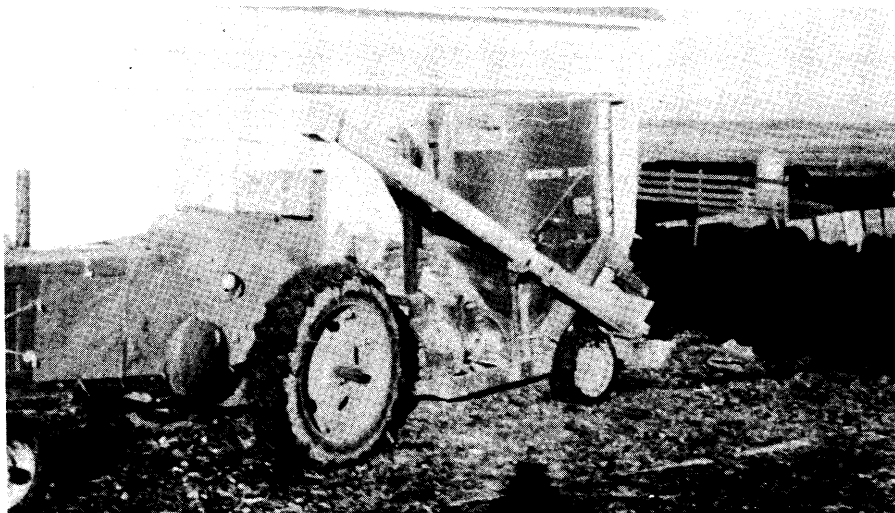
Figure 23: A grinder-mixer being used in the feed lot under muddy conditions with loose corn cobs underfoot.

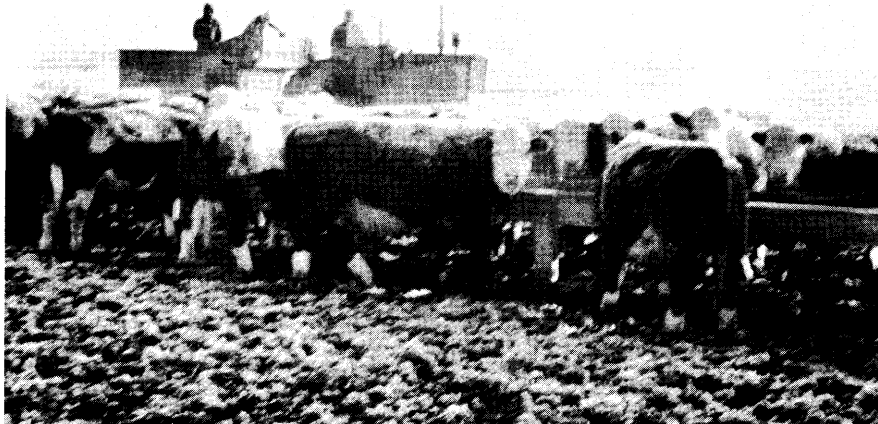
Figure 24: A feed wagon being used on a cold winter morning with heavy frost about, making mounting and dismounting of equipment hazardous.

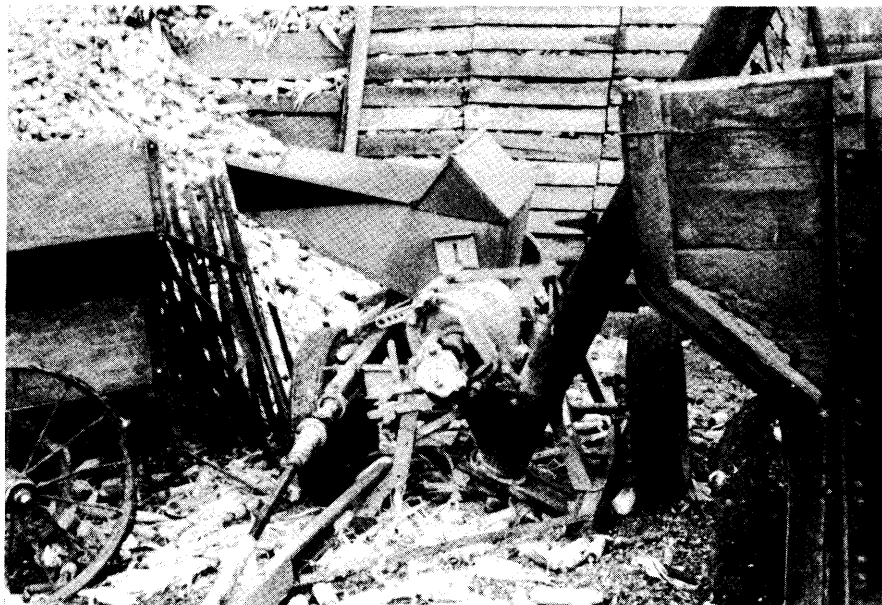
Figure 25: A grinder being used on hard ground with eared corn underfoot.

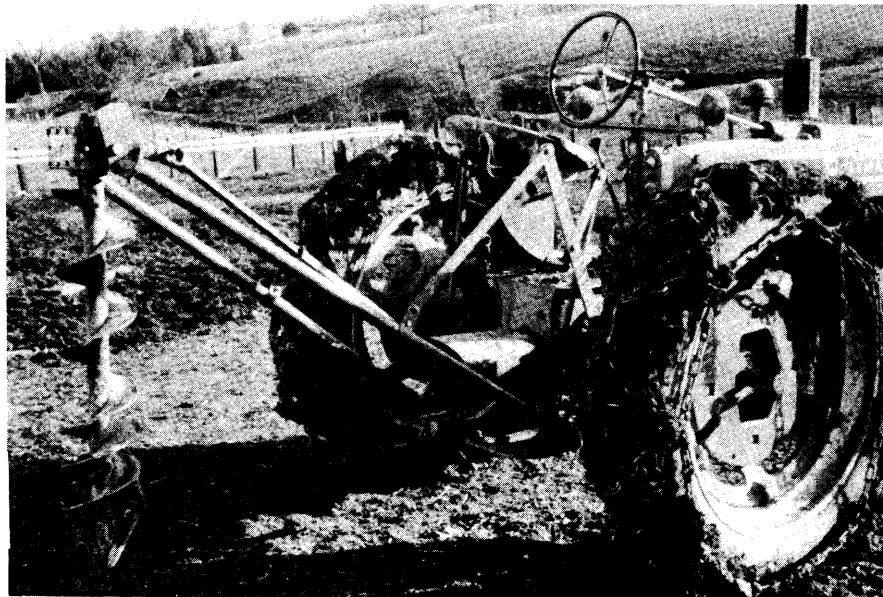
Figure 26 shows the equipment following alterations made following the accident.

Figure 26: Edward T. tractor and post hole digger.

The protruding pin has been cut flush with the drive yoke and an angle-iron welded to the top of the auger to provide a safer means of forcing the auger into the ground, as well as providing mechanical support for the operator when working near it on slippery ground.

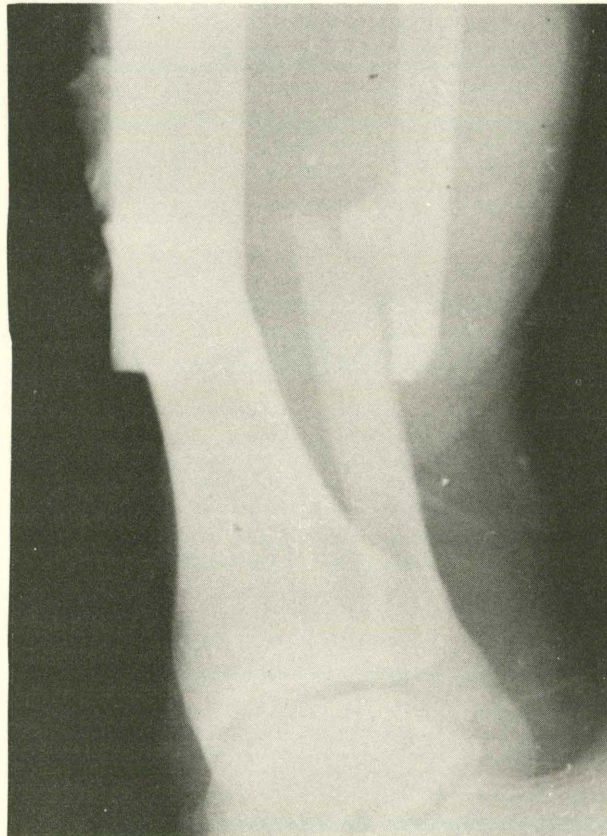
X-ray #1: Fracture when admitted to hospital

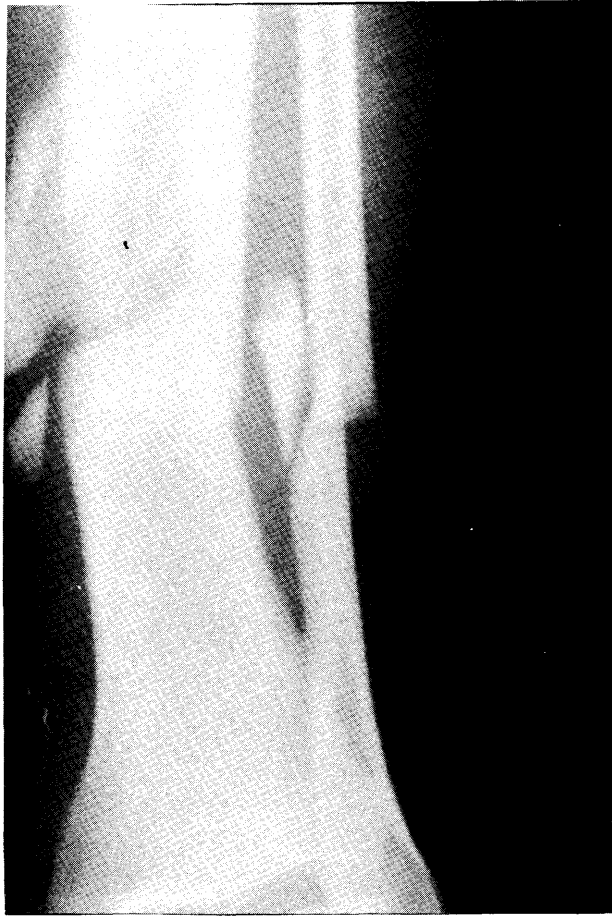
X-ray #2: Fracture after initial  
reduction
