**"1000 MILE CORRIDOR"  
IOWA SCENIC BYWAY EVALUATION**

Prepared For:  
IOWA DEPARTMENT OF TRANSPORTATION

By:  
Decision Data Inc.  
2730 S.W. 57th Street  
Topeka, Kansas 66609

November 1995

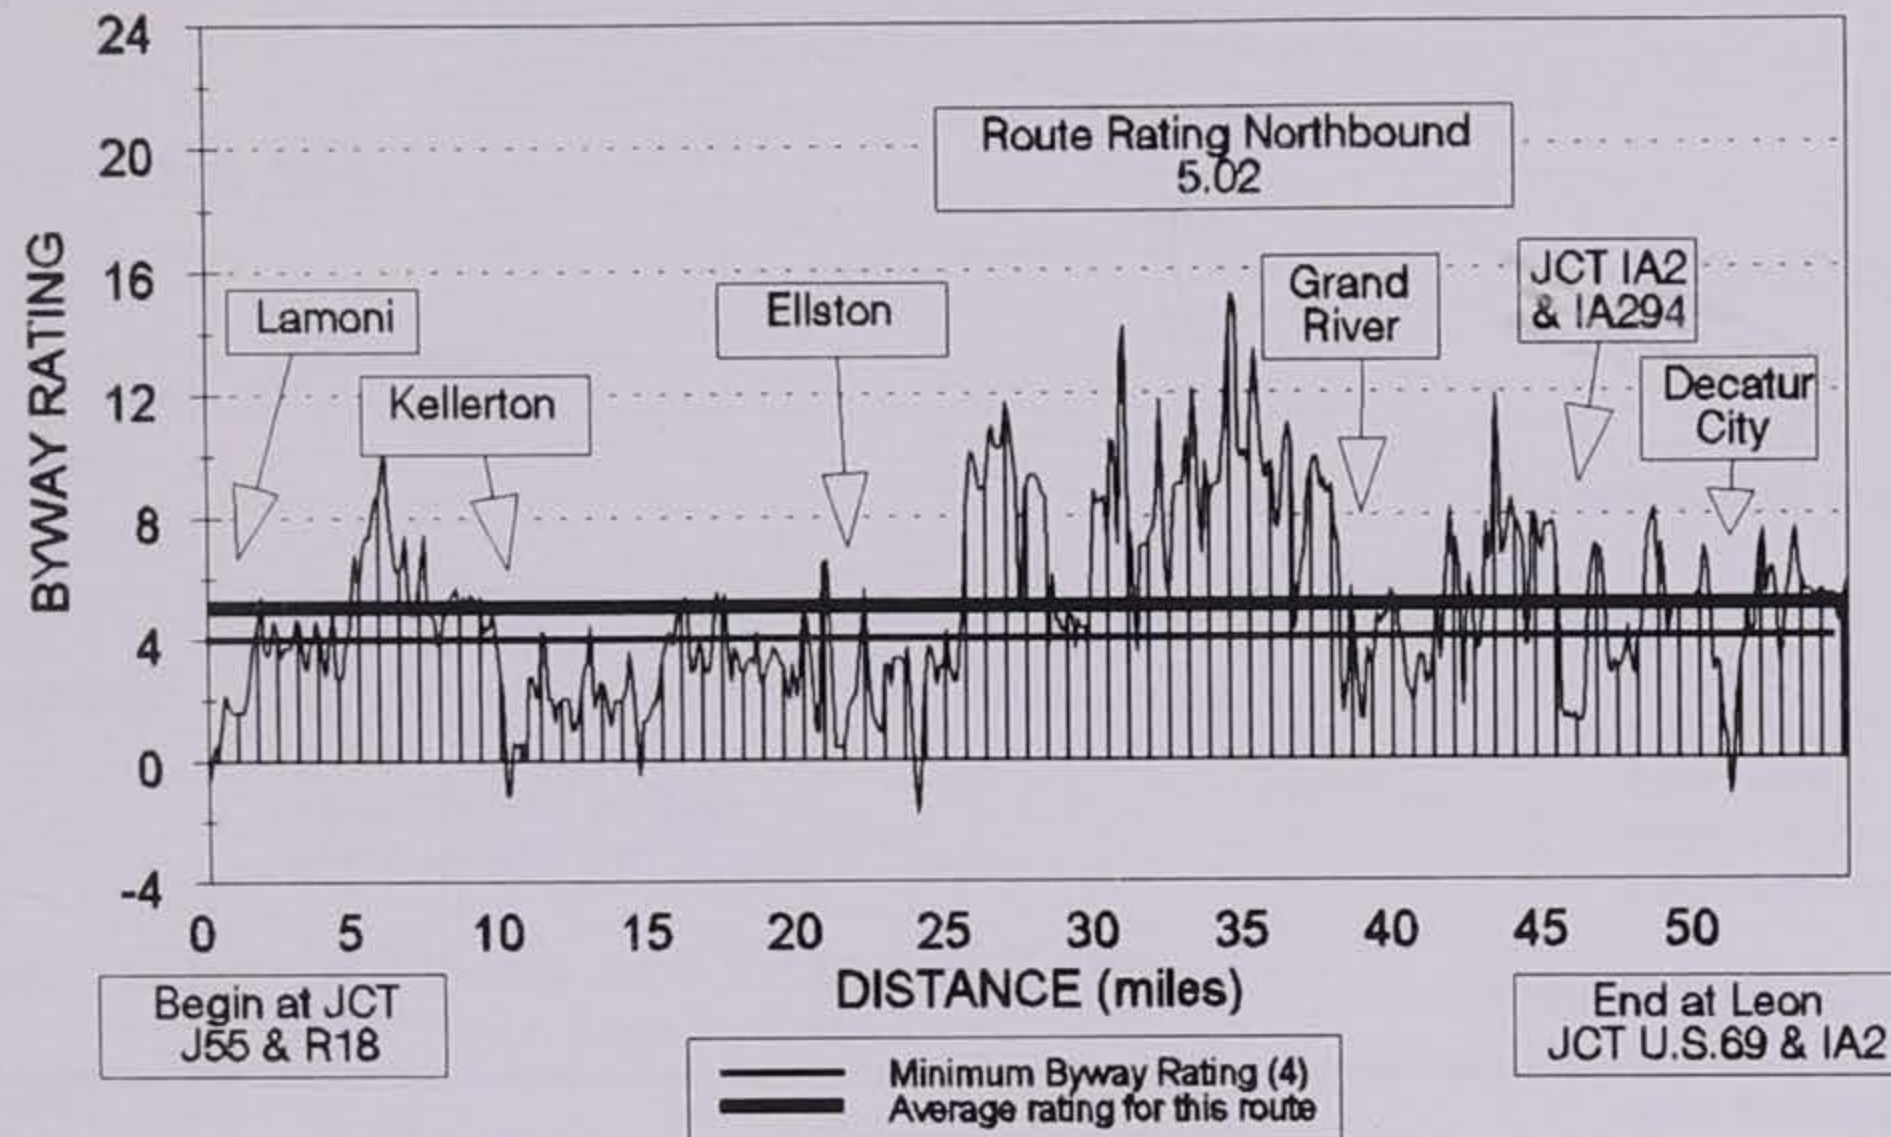
**ROUTE 50 - Northbound**  
Projected Spring & Fall Rating

**NORTH RATING SUMMARY**

Avg. Agriculture	0.28
Avg. F. Agriculture Act/Op	-0.02
Avg. F. Agriculture Structures	0.12
Avg. F. Man Made Color/Pattern	-0.47
Avg. F. Man Made Unique	0.02
Avg. F. Structures	0.02
Avg. F. Vegetation	1.01
Avg. F. Vegetation Unique	0.00
Avg. F. Water Edge	0.00
Avg. Mixed Agriculture	0.67
Avg. P. Landform	0.02
Avg. P. Vegetation	0.05
Avg. Road Ribbon	0.17
Avg. Road Terrain	0.91
Avg. S. Agriculture Act/Op	0.00
Avg. S. Agriculture Color/Pattern	0.00
Avg. S. Agriculture Unique	0.00
Avg. S. Landform	0.11
Avg. S. Man Made Color/Pattern	-0.01
Avg. S. Moving Water	0.00
Avg. S. Structures	0.00
Avg. S. Structures Color/Pattern	-0.01
Avg. S. Vegetation	0.84
Avg. S. Vegetation Color/Pattern	0.73
Avg. S. Vegetation Edge	0.45
Avg. S. Water	0.08
Avg. Suburban/Urban	0.00
Avg. Woodlands	0.01
<b>Avg. Total Route Summary</b>	<b>5.02</b>

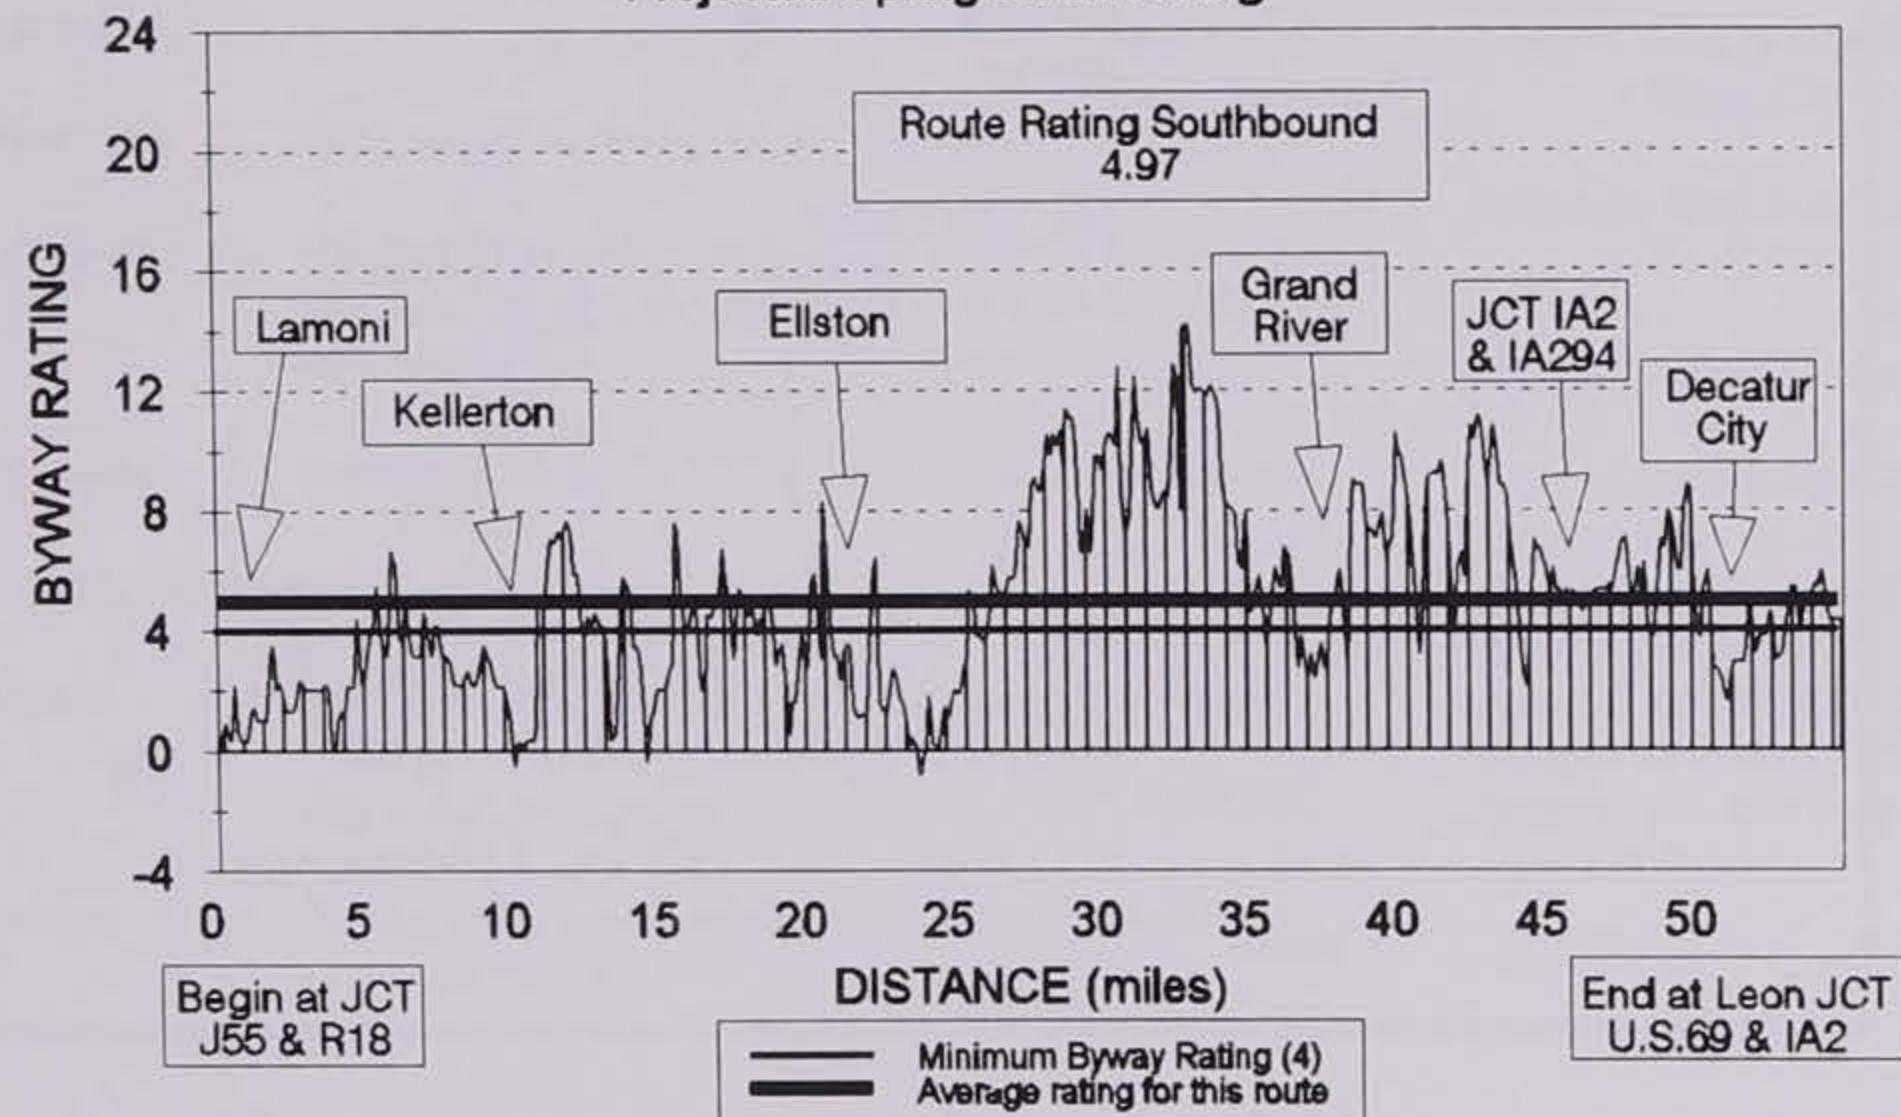
**ROUTE 50 - SOUTHBOUND**  
Projected Spring & Fall Rating

**SOUTH RATING SUMMARY**

Avg. Agriculture	0.34
Avg. F. Agriculture Act/Op	-0.04
Avg. F. Agriculture Structures	0.14
Avg. F. Man Made Color/Pattern	-0.46
Avg. F. Man Made Unique	0.00
Avg. F. Structures	0.00
Avg. F. Vegetation	1.00
Avg. F. Vegetation Color/Pattern	0.04
Avg. F. Vegetation Unique	0.02
Avg. F. Water Edge	0.00
Avg. Mixed Agriculture	0.51
Avg. Mixed Native	0.14
Avg. P. Landform	0.01
Avg. P. Vegetation	0.02
Avg. Road Ribbon	0.16
Avg. Road Terrain	0.80
Avg. S. Agriculture Act/Op	0.00
Avg. S. Landform	0.32
Avg. S. Man Made Color/Pattern	-0.01
Avg. S. Moving Water	0.00
Avg. S. Structures	0.00
Avg. S. Structures Color/Pattern	0.00
Avg. S. Vegetation	0.56
Avg. S. Vegetation Color/Pattern	0.91
Avg. S. Vegetation Edge	0.37
Avg. S. Water	0.08
Avg. Suburban/Urban	0.04
Avg. Woodlands	0.01
<b>Avg. Total Route Summary</b>	<b>4.97</b>

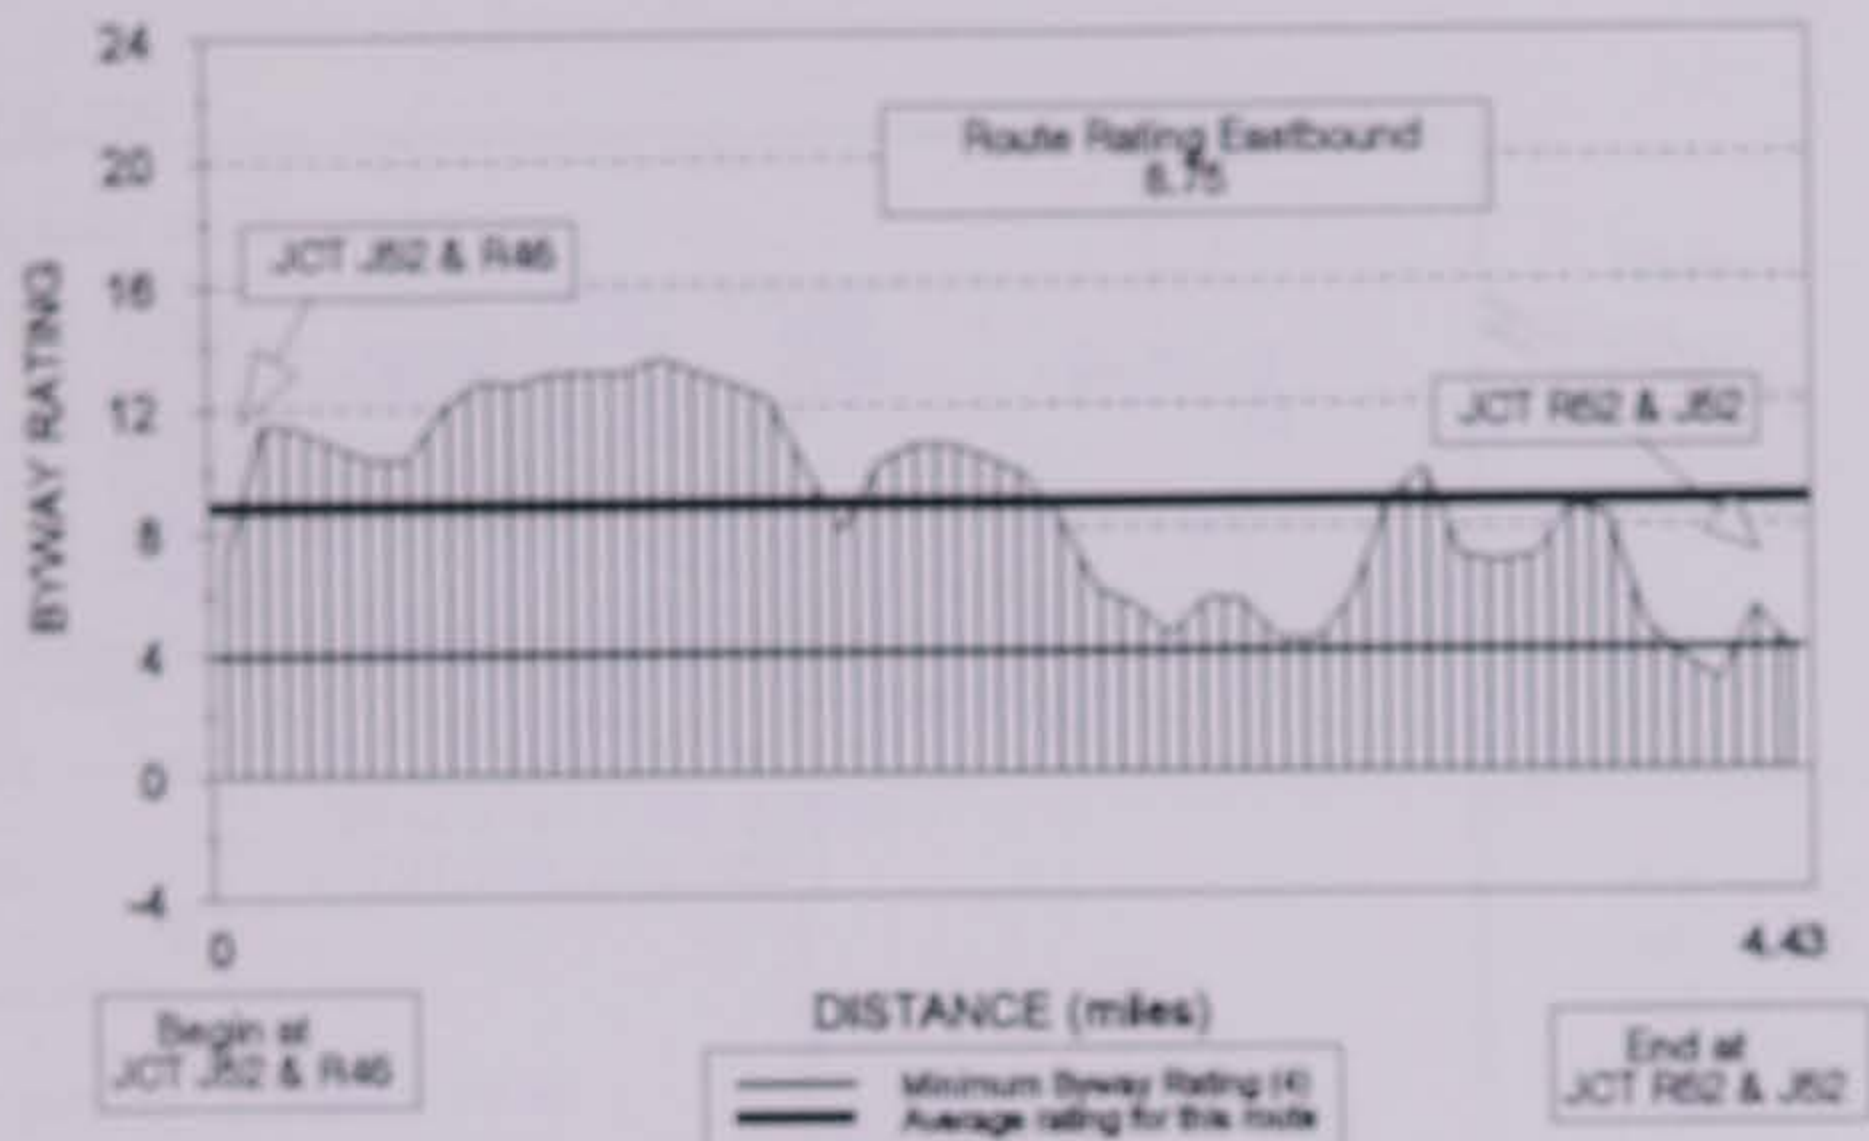
**ROUTE 51 SPUR - Eastbound**  
Projected Spring & Fall Rating

**EAST RATING SUMMARY**

Avg. Agriculture	0.76
Avg. F Agriculture Act/Op	0.03
Avg. F Agriculture Structures	0.08
Avg. F Vegetation	1.55
Avg. Mixed Agriculture	0.00
Avg. Mixed Native	0.48
Avg. F Vegetation	0.04
Avg. Road Ribbon	0.48
Avg. Road Terrain	0.88
Avg. S Landform	0.27
Avg. S Landform Material	0.01
Avg. S Moving Water	0.00
Avg. S Vegetation	1.74
Avg. S Vegetation Color/Pattern	1.20
Avg. S Vegetation Edge	1.08
Avg. S Water	0.08
<b>Avg. Total Route Summary</b>	<b>8.75</b>

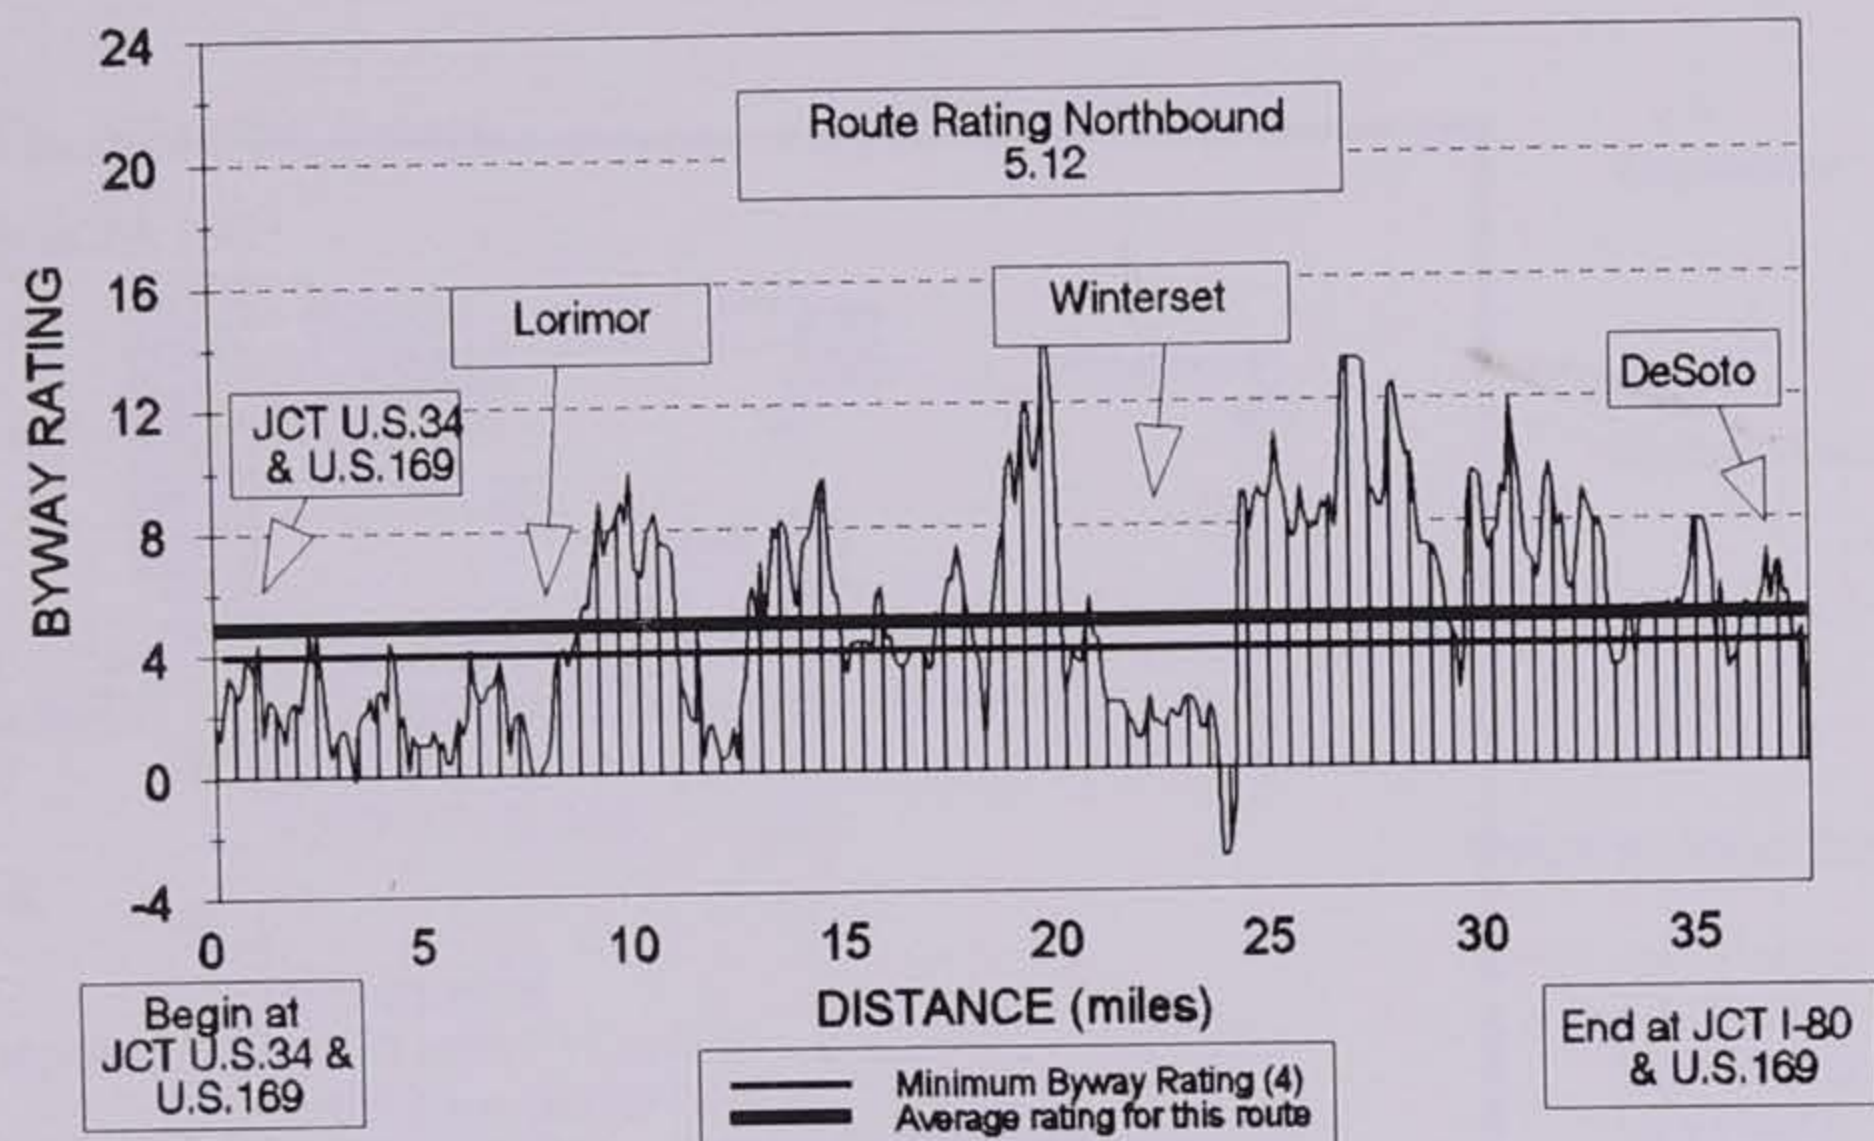
**ROUTE 55 - Northbound**  
Projected Spring & Fall Rating

**NORTH RATING SUMMARY**

Avg. Agriculture	0.34
Avg. F: Agriculture Act/Op	0.01
Avg. F: Agriculture Structures	0.18
Avg. F: Agriculture Unique	0.02
Avg. F: Landform Material	0.01
Avg. F: Man Made Color/Pattern	-0.45
Avg. F: Man Made Unique	0.01
Avg. F: Structures	0.01
Avg. F: Vegetation	1.21
Avg. F: Water Edge	0.00
Avg. Mixed Agriculture	0.24
Avg. Mixed Native	0.24
Avg. P: Landform	0.04
Avg. P: Vegetation	0.04
Avg. Road Ribbon	0.21
Avg. Road Terrain	0.50
Avg. S: Agriculture Act/Op	-0.01
Avg. S: Landform	0.46
Avg. S: Landform Material	0.04
Avg. S: Man Made Color/Pattern	-0.05
Avg. S: Moving Water	0.01
Avg. S: Structures	0.01
Avg. S: Vegetation	0.90
Avg. S: Vegetation Color/Pattern	0.27
Avg. S: Vegetation Edge	0.78
Avg. S: Water	0.08
Avg. Suburban/Urban	0.02

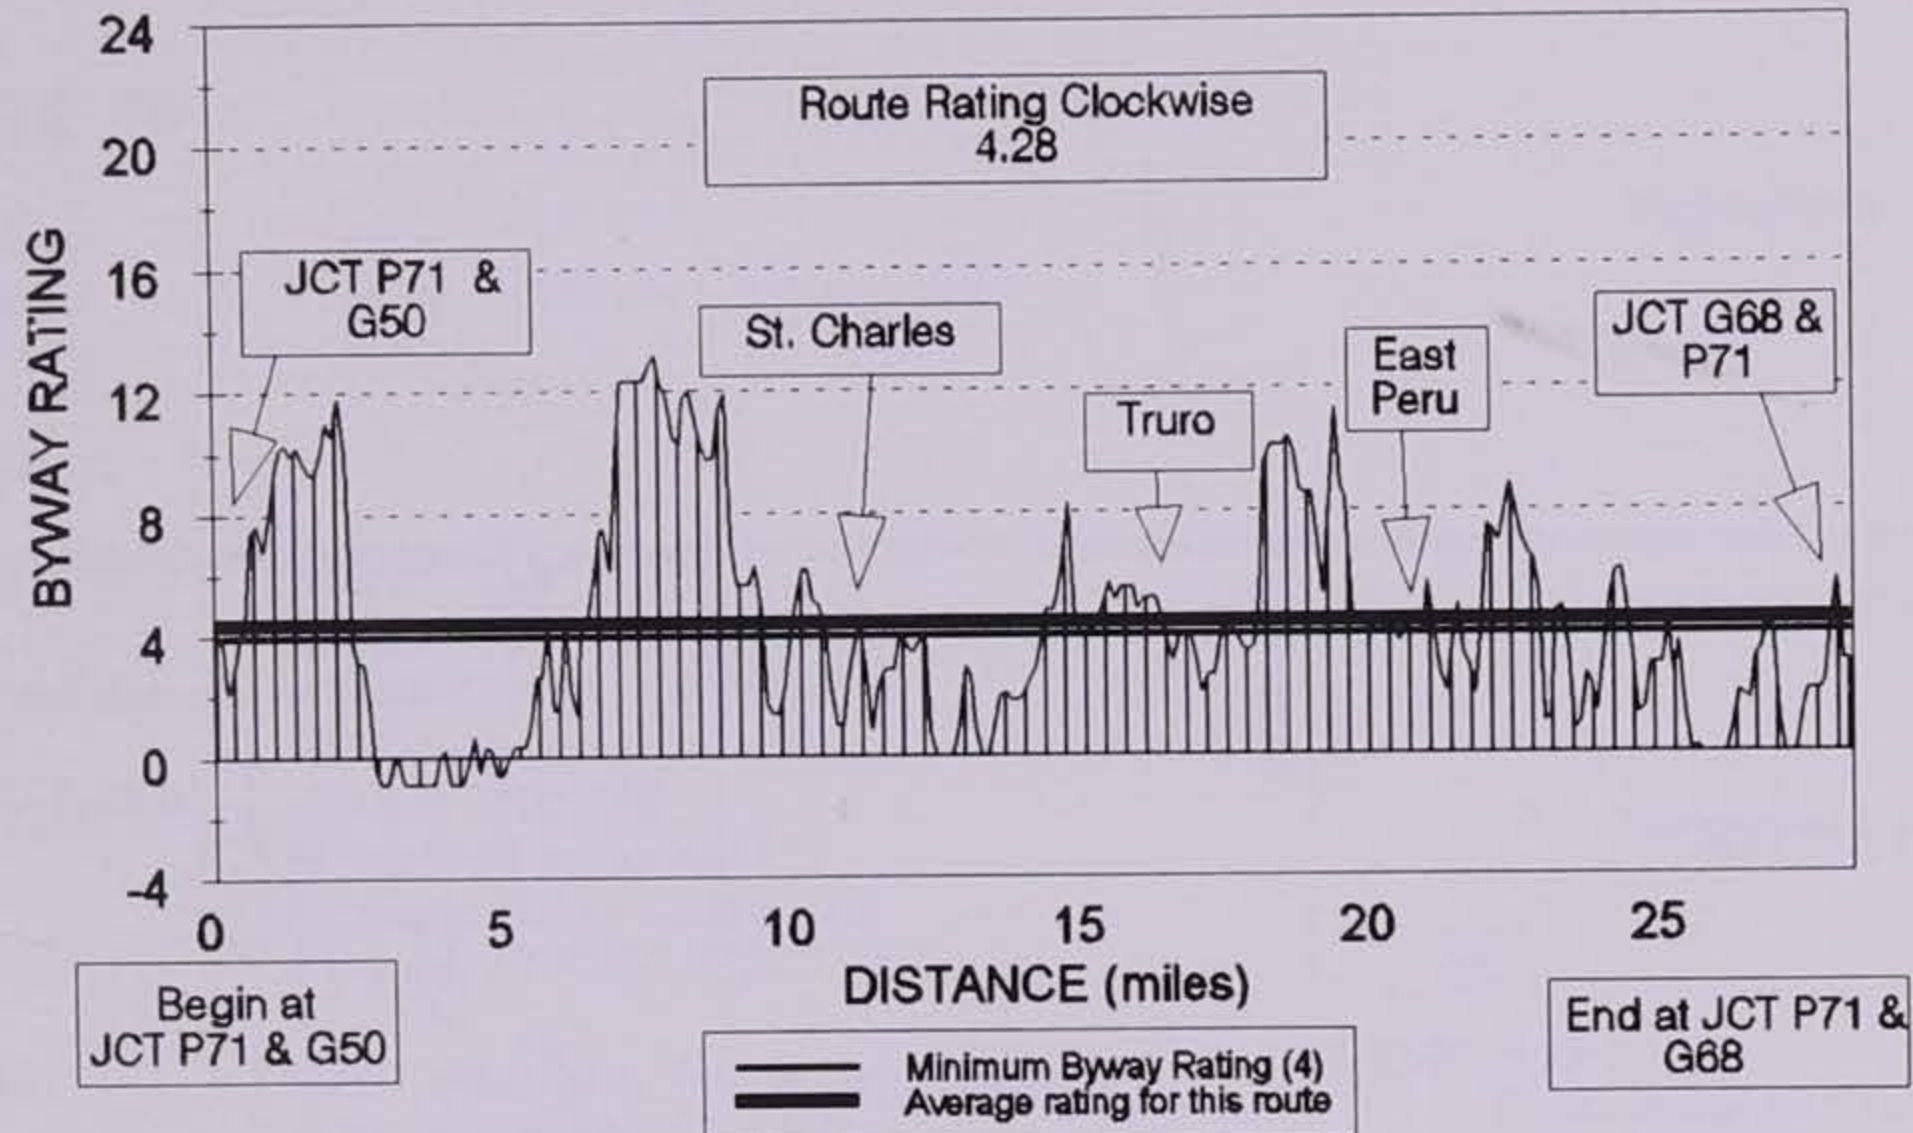
**ROUTE 56 Loop - Clockwise**  
Projected Spring & Fall Rating

**CLOCKWISE RATING SUMMARY**

Avg. Agriculture	0.33
Avg. F. Agriculture Act/Op	-0.01
Avg. F. Agriculture Structures	0.24
Avg. F. Agriculture Unique	0.01
Avg. F. Landform Material	0.01
Avg. F. Man Made Color/Pattern	-0.24
Avg. F. Man Made Unique	0.00
Avg. F. Structures	0.03
Avg. F. Vegetation	1.14
Avg. Historic Site	0.01
Avg. Mixed Agriculture	0.08
Avg. Mixed Native	0.02
Avg. P. Landform	0.04
Avg. P. Vegetation	0.05
Avg. Road Ribbon	0.36
Avg. Road Terrain	0.31
Avg. S. Agriculture Act/Op	0.00
Avg. S. Landform	0.38
Avg. S. Man Made Color/Pattern	-0.04
Avg. S. Moving Water	0.00
Avg. S. Structures	0.00
Avg. S. Vegetation	0.80
Avg. S. Vegetation Color/Pattern	0.29
Avg. S. Vegetation Edge	0.42
Avg. S. Water	0.03
Avg. Suburban/Urban	0.03

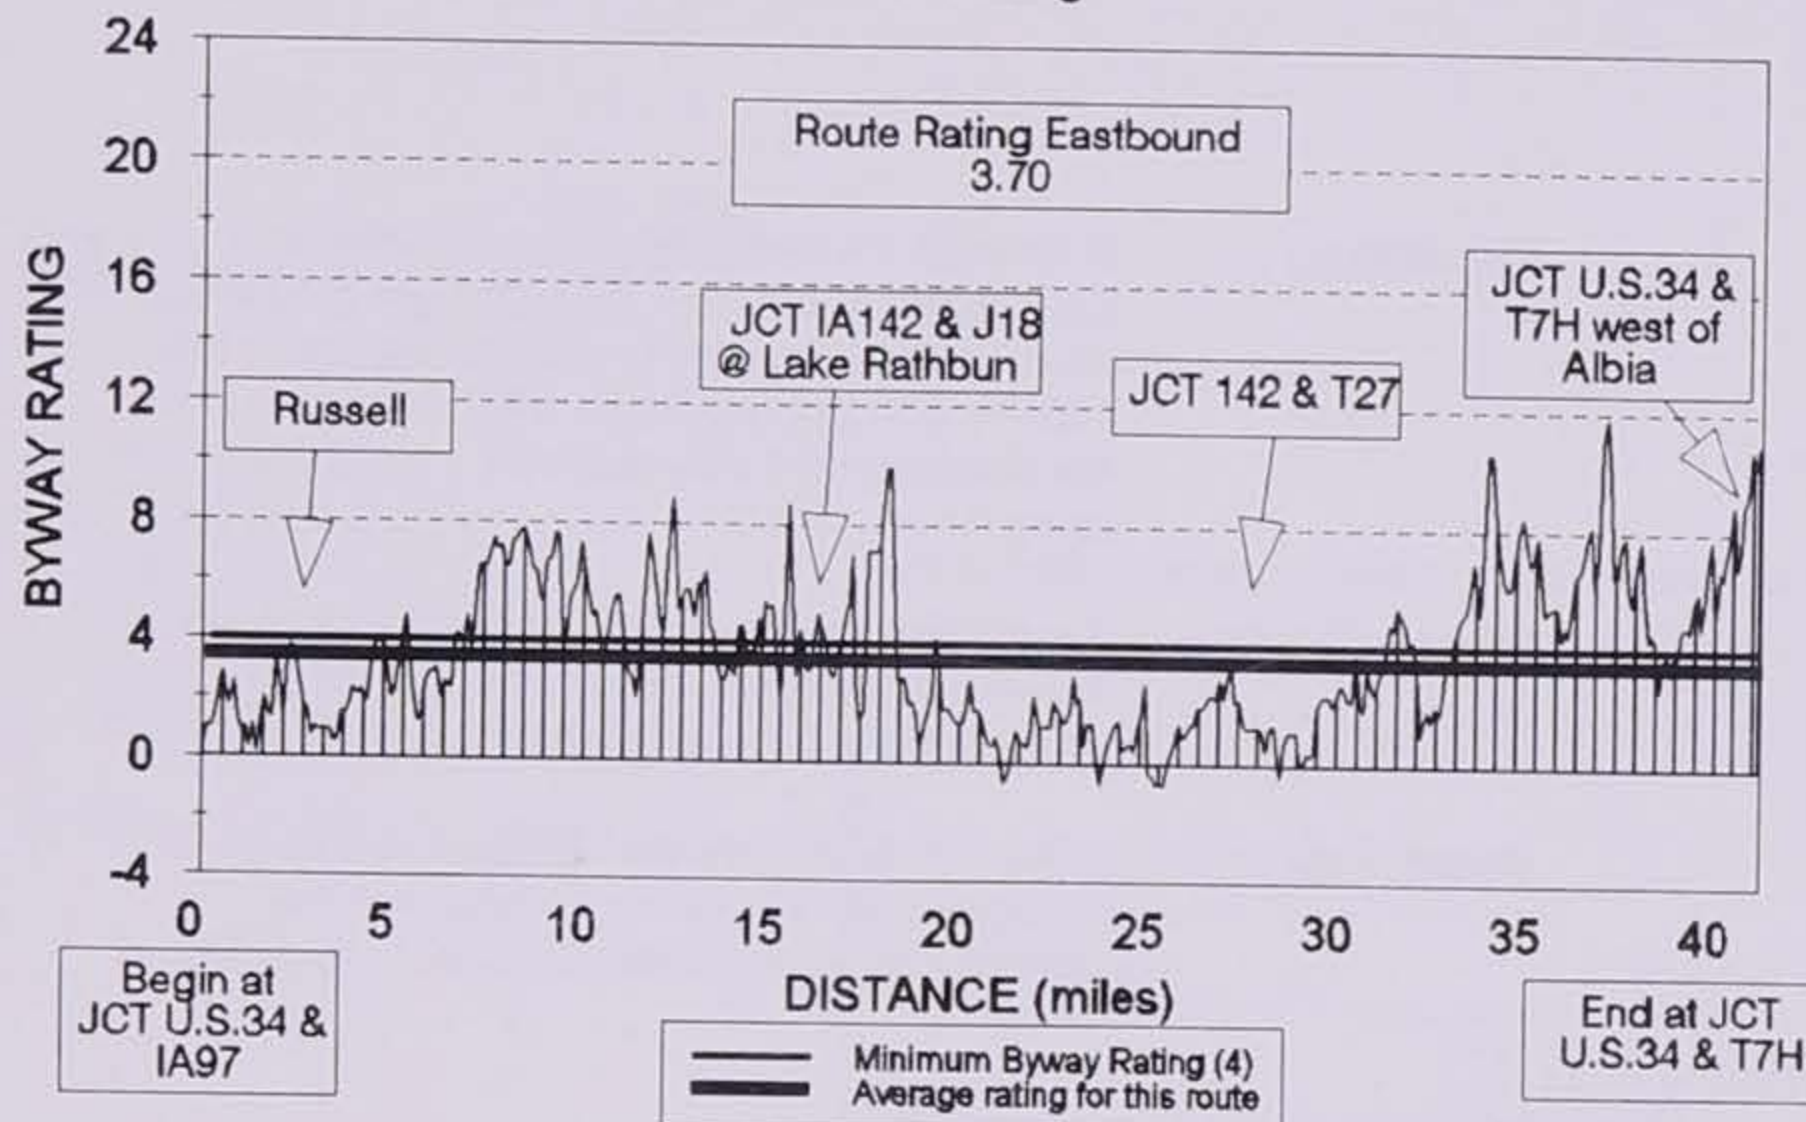
**ROUTE 58 - Eastbound**  
Summer Rating

**EAST RATING SUMMARY**

Avg. Agriculture	0.23
Avg. F: Agriculture Act/Op	0.01
Avg. F: Agriculture Structures	0.16
Avg. F: Agriculture Unique	0.00
Avg. F: Man Made Color/Pattern	-0.33
Avg. F: Man Made Unique	0.01
Avg. F: Structures	0.02
Avg. F: Vegetation	0.48
Avg. F: Water Edge	0.04
Avg. Mixed Agriculture	0.24
Avg. Mixed Native	0.30
Avg. P: Landform	0.02
Avg. P: Vegetation Color/Pattern	0.02
Avg. P: Vegetation	0.03
Avg. P: Water	0.01
Avg. Road Ribbon	0.25
Avg. Road Terrain	0.60
Avg. S: Agriculture Act/Op	0.00
Avg. S: Agriculture Color/Pattern	0.02
Avg. S: Landform	0.34
Avg. S: Man Made Color/Pattern	-0.02
Avg. S: Moving Water	0.00
Avg. S: Structures	0.03
Avg. S: Vegetation	0.52
Avg. S: Vegetation Color/Pattern	0.09
Avg. S: Vegetation Edge	0.42
Avg. S: Water	0.16
Avg. Suburban/Urban	0.04
<b>Avg. Total Route Summary</b>	<b>3.70</b>

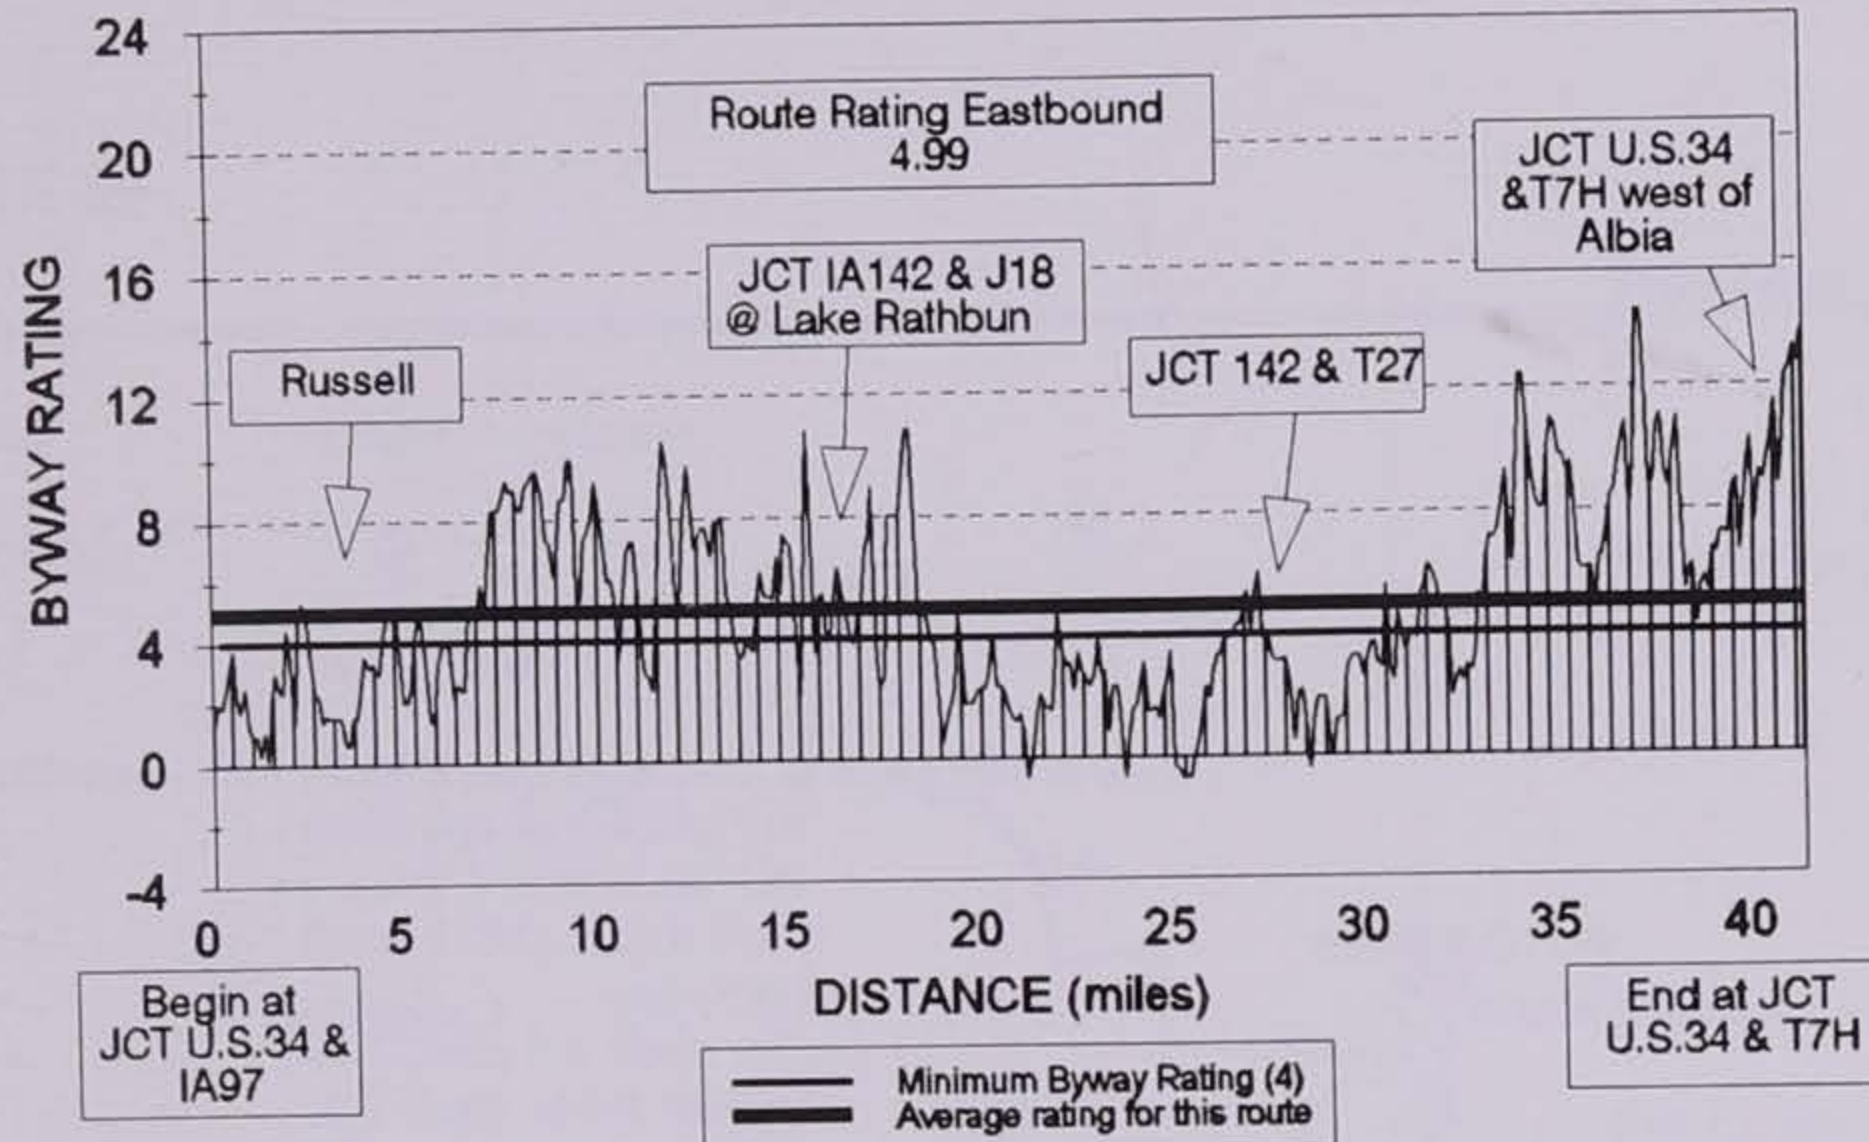
**ROUTE 58 - Eastbound**  
Projected Spring & Fall Rating

**EAST RATING SUMMARY**

Avg. Agriculture	0.23
Avg. F: Agriculture Act/Op	0.01
Avg. F: Agriculture Structures	0.16
Avg. F: Agriculture Unique	0.00
Avg. F: Man Made Color/Pattern	-0.33
Avg. F: Man Made Unique	0.01
Avg. F: Structures	0.02
Avg. F: Vegetation	0.94
Avg. F: Water Edge	0.04
Avg. Mixed Agriculture	0.24
Avg. Mixed Native	0.30
Avg. P: Landform	0.02
Avg. P: Vegetation Color/Pattern	0.02
Avg. P: Vegetation	0.03
Avg. P: Water	0.01
Avg. Road Ribbon	0.25
Avg. Road Terrain	0.60
Avg. S: Agriculture Act/Op	0.00
Avg. S: Agriculture Color/Pattern	0.01
Avg. S: Landform	0.34
Avg. S: Man Made Color/Pattern	-0.02
Avg. S: Moving Water	0.00
Avg. S: Structures	0.03
Avg. S: Vegetation	0.89
Avg. S: Vegetation Color/Pattern	0.16
Avg. S: Vegetation Edge	0.82
Avg. S: Water	0.16
Avg. Suburban/Urban	0.04
<b>Avg. Total Route Summary</b>	<b>4.99</b>

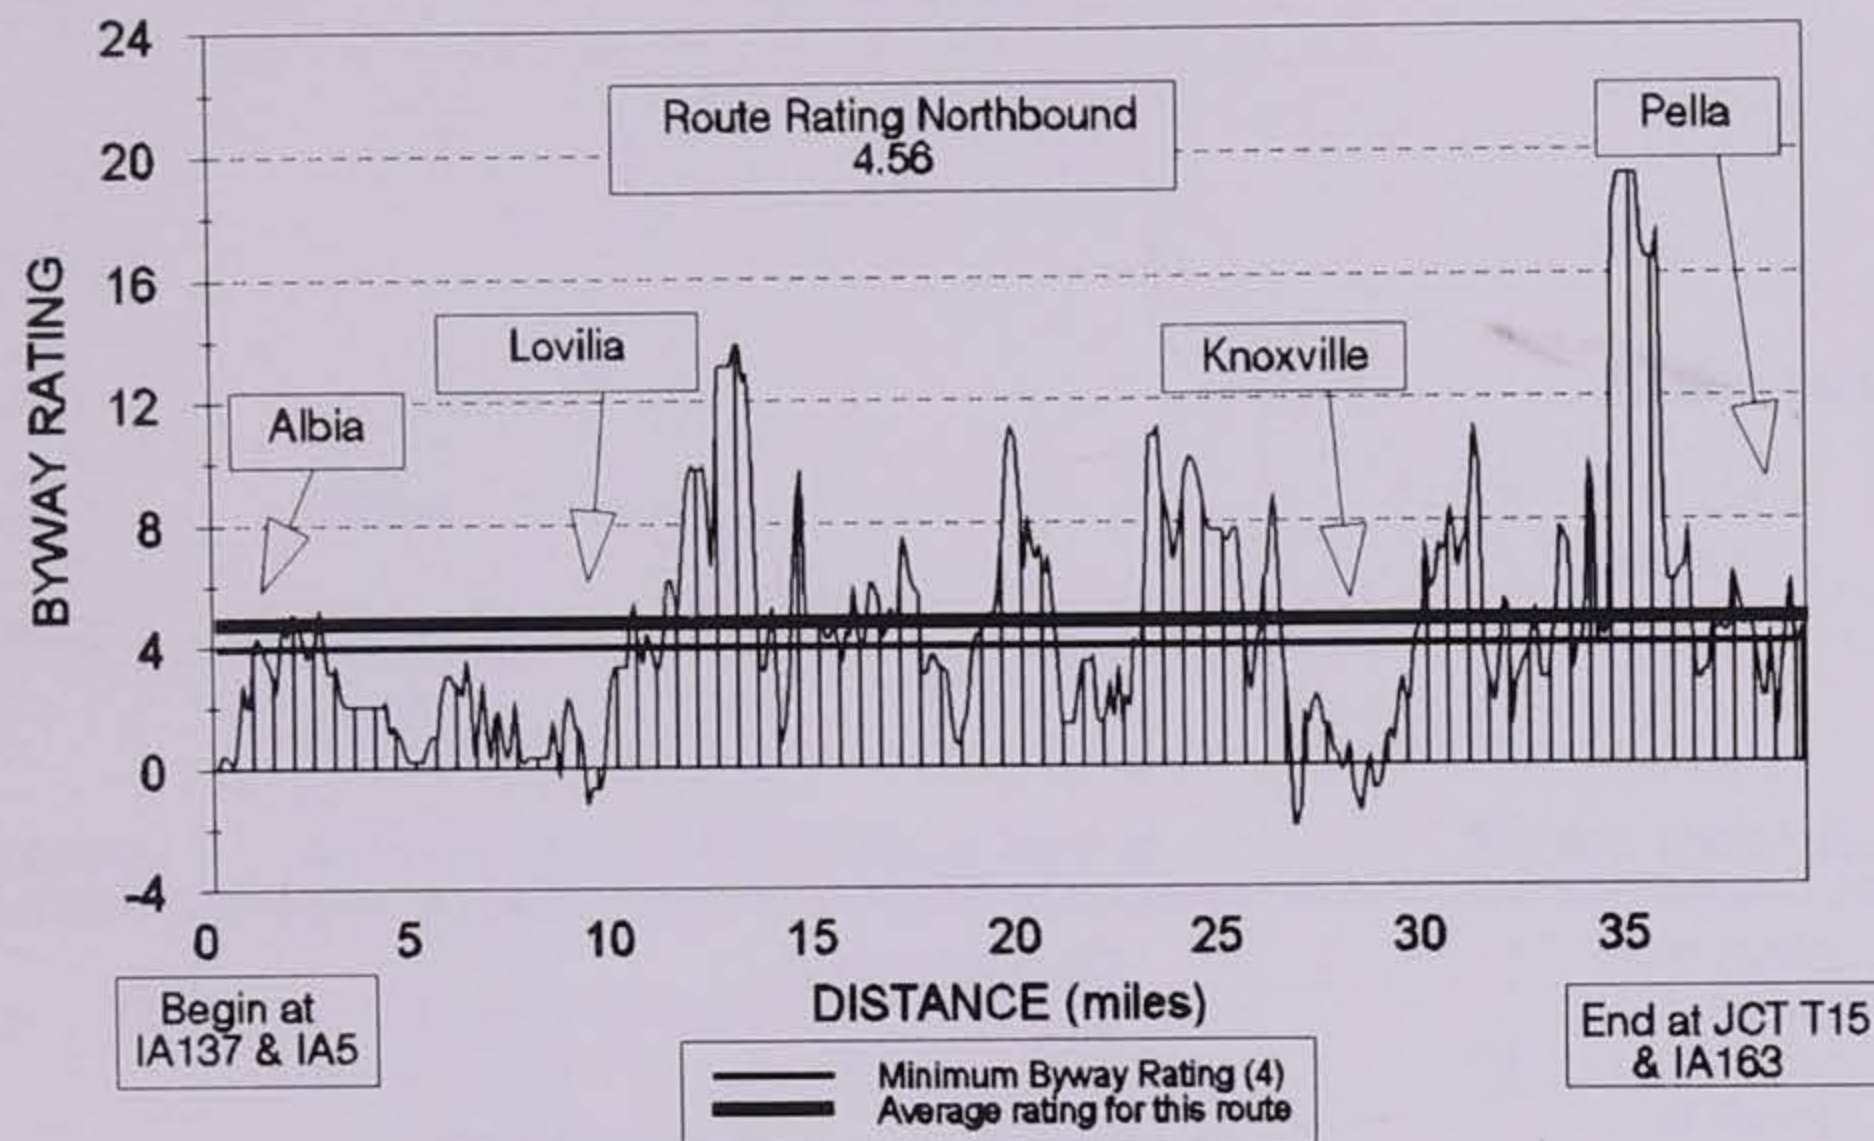
**ROUTE 59 - Northbound**  
Projected Spring & Fall Rating

**NORTH RATING SUMMARY**

Avg. Agriculture	0.44
Avg. F. Agriculture Act/Op	0.04
Avg. F. Agriculture Structures	0.17
Avg. F. Landform Material	0.00
Avg. F. Man Made Color/Pattern	-0.45
Avg. F. Man Made Unique	0.04
Avg. F. Structures	0.07
Avg. F. Vegetation	1.25
Avg. F. Water Edge	0.08
Avg. Historic Site	0.00
Avg. Mixed Agriculture	0.06
Avg. Mixed Native	0.19
Avg. P. Landform	0.06
Avg. P. Water	0.04
Avg. Road Ribbon	0.17
Avg. Road Terrain	0.28
Avg. S. Landform	0.18
Avg. S. Man Made Color/Pattern	-0.09
Avg. S. Moving Water	0.06
Avg. S. Structures	0.05
Avg. S. Vegetation	0.77
Avg. S. Vegetation Color/Pattern	0.28
Avg. S. Vegetation Edge	0.58
Avg. S. Water	0.13
Avg. Suburban/Urban	0.16

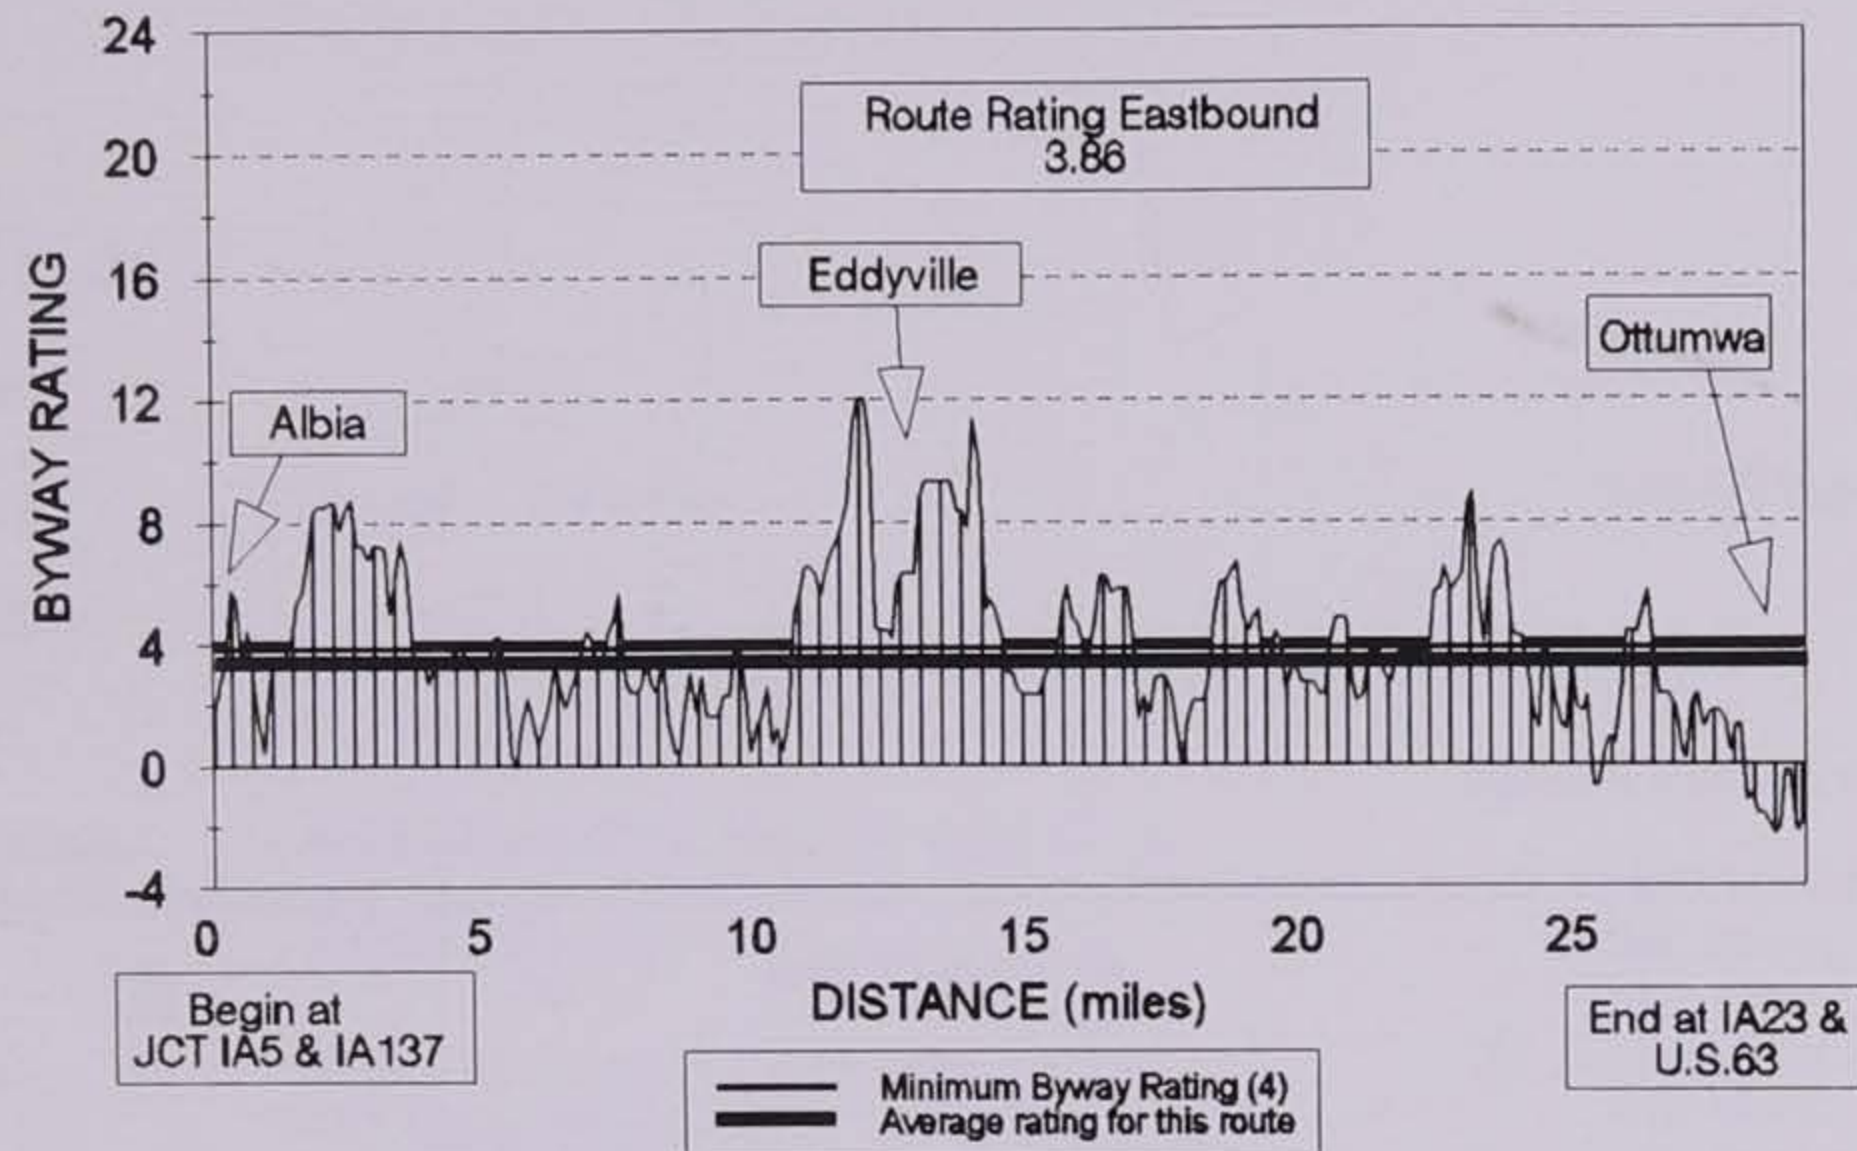
**ROUTE 60 - Eastbound**  
Projected Spring & Fall Rating

**EAST RATING SUMMARY**

Avg. Agriculture	0.24
Avg. F: Agriculture Act/Op	-0.01
Avg. F: Agriculture Structures	0.16
Avg. F: Landform Material	0.00
Avg. F: Man Made Color/Pattern	-0.61
Avg. F: Man Made Unique	0.02
Avg. F: Structures	0.00
Avg. F: Vegetation	1.25
Avg. F: Water Edge	0.00
Avg. Mixed Agriculture	0.29
Avg. Mixed Native	0.17
Avg. P: Landform	0.01
Avg. Road Ribbon	0.12
Avg. Road Terrain	0.27
Avg. S: Landform	0.34
Avg. S: Man Made Color/Pattern	-0.08
Avg. S: Moving Water	0.01
Avg. S: Structures	0.08
Avg. S: Vegetation	0.69
Avg. S: Vegetation Color/Pattern	0.22
Avg. S: Vegetation Edge	0.58
Avg. S: Water	0.06
Avg. Suburban/Urban	0.04
<b>Avg. Total Route Summary</b>	<b>3.86</b>
