**"1000 MILE CORRIDOR"  
IOWA SCENIC BYWAY EVALUATION**

Prepared For:  
IOWA DEPARTMENT OF TRANSPORTATION

By:  
Decision Data Inc.  
2730 S.W. 57th Street  
Topeka, Kansas 66609

November 1995

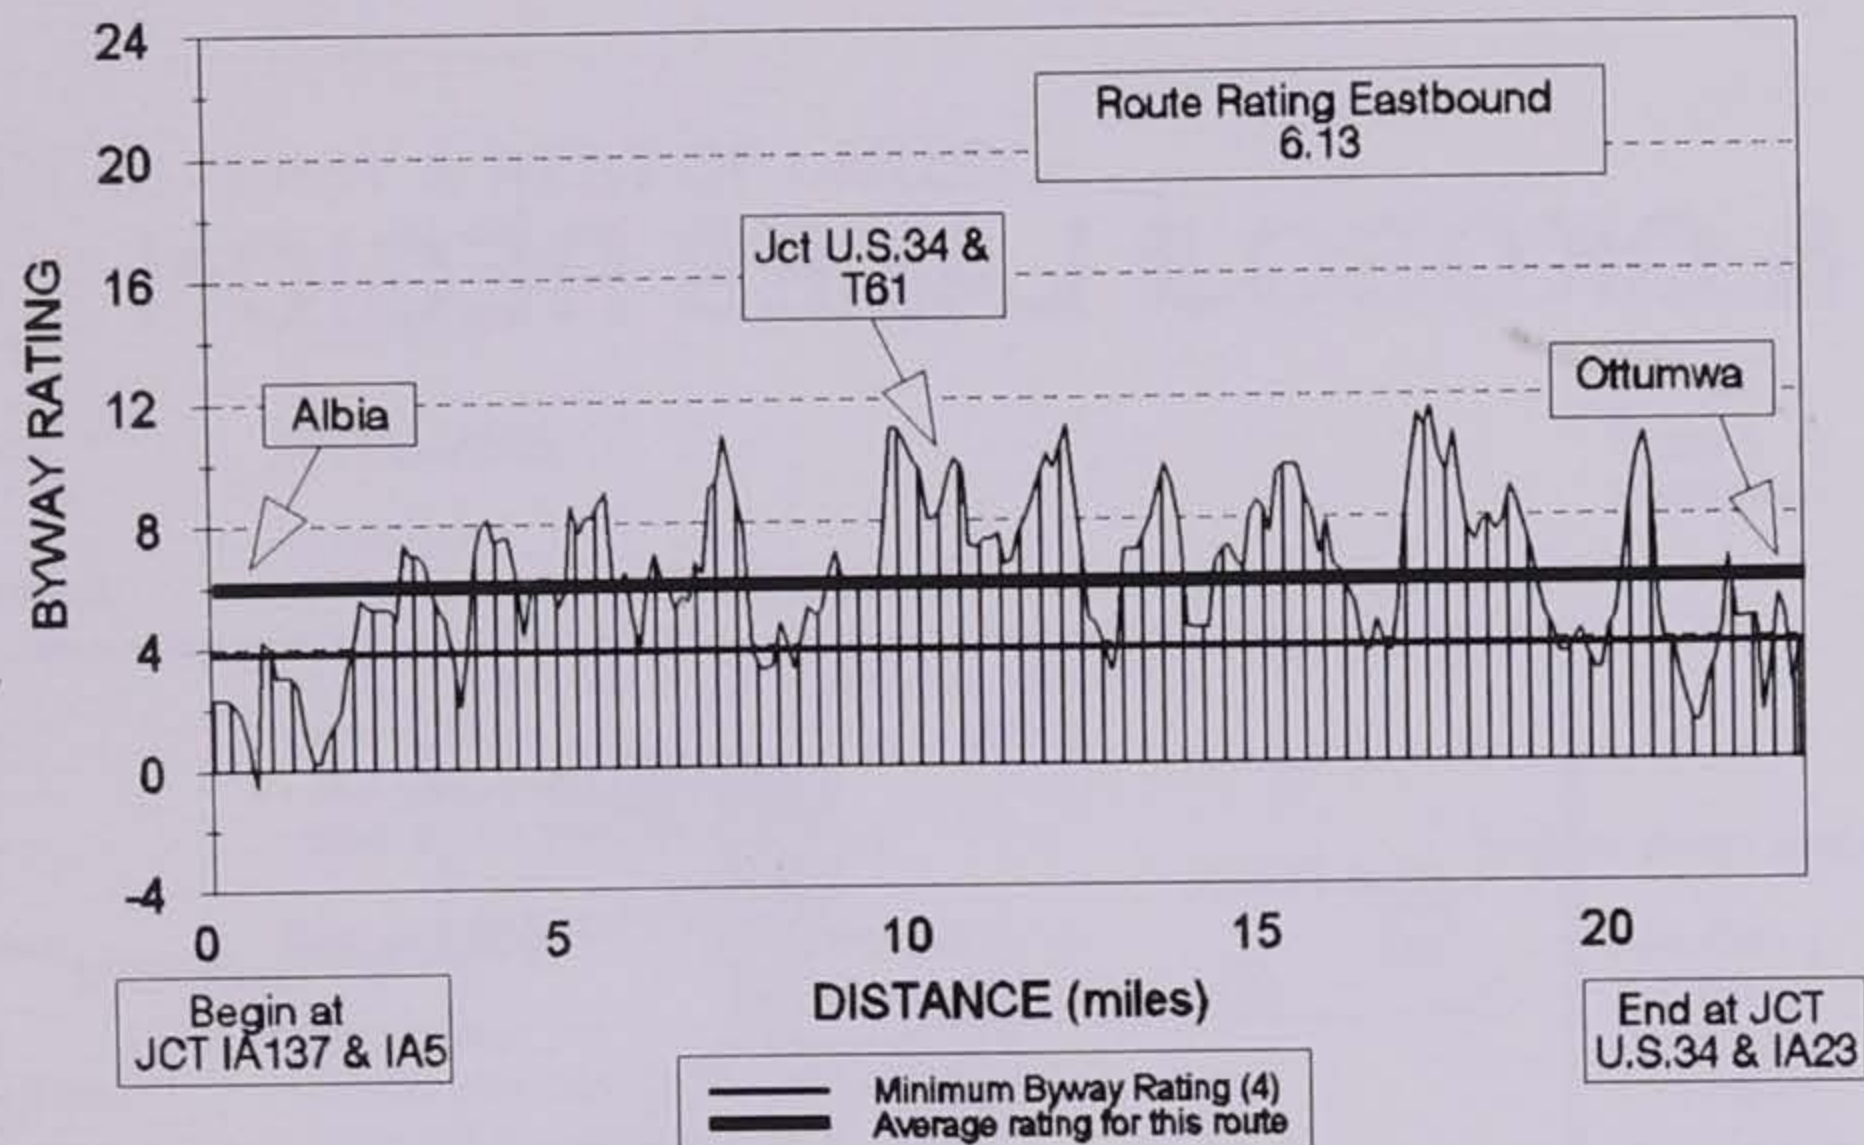
**ROUTE 34 - Eastbound**  
Projected Spring & Fall Rating

**EAST RATING SUMMARY**

Avg. Agriculture	0.00
Avg. F: Man Made Color/Pattern	-0.10
Avg. F: Man Made Unique	0.02
Avg. F: Structures	0.01
Avg. F: Vegetation	1.66
Avg. F: Vegetation Color/Pattern	0.18
Avg. F: Water Edge	0.00
Avg. Mixed Agriculture	0.03
Avg. Mixed Native	0.78
Avg. P: Landform	0.02
Avg. P: Vegetation	0.06
Avg. Park Recreation	0.00
Avg. Road Ribbon	0.25
Avg. Road Terrain	0.66
Avg. S: Agriculture Act/Op	0.02
Avg. S: Landform	0.18
Avg. S: Man Made Color/Pattern	-0.01
Avg. S: Moving Water	0.02
Avg. S: Structures	-0.02
Avg. S: Vegetation	0.85
Avg. S: Vegetation Color/Pattern	0.75
Avg. S: Vegetation Edge	0.67
Avg. S: Water	0.01
Avg. Suburban/Urban	0.10
<b>Avg. Total Route Summary</b>	<b>6.13</b>

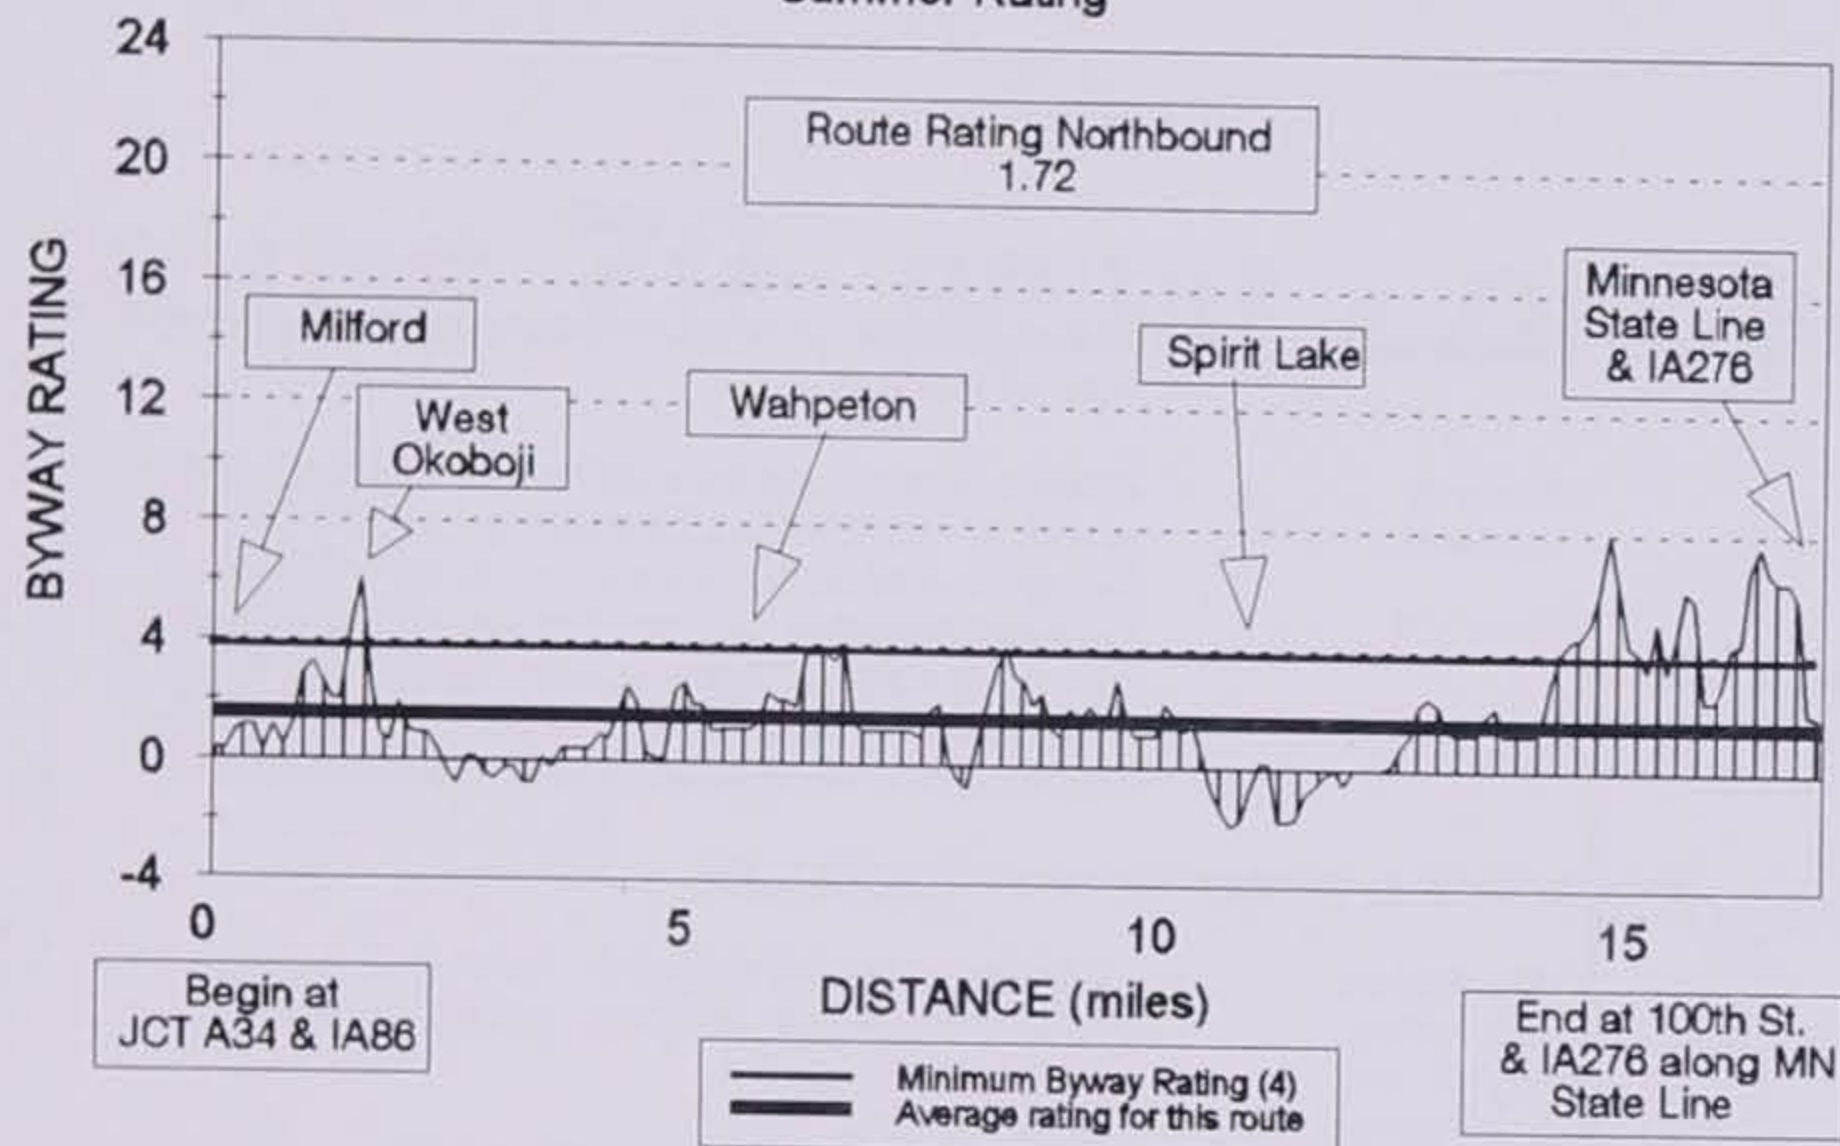
**ROUTE 70 West of Lakes - Northbound**  
Summer Rating

**NORTH RATING SUMMARY**

Avg. Agriculture	0.12
Avg. F. Agriculture Act/Op	0.00
Avg. F. Agriculture Structures	0.02
Avg. F. Man Made Color/Pattern	-0.65
Avg. F. Man Made Unique	0.03
Avg. F. Structures	0.00
Avg. F. Vegetation	0.46
Avg. F. Vegetation Color/Pattern	0.03
Avg. F. Vegetation Unique	0.01
Avg. F. Water Edge	0.11
Avg. Mixed Agriculture	0.21
Avg. Mixed Native	0.14
Avg. P. Vegetation	0.01
Avg. P. Water	0.00
Avg. Park Recreation	0.00
Avg. Road Ribbon	0.06
Avg. Road Terrain	0.08
Avg. S. Landform	0.10
Avg. S. Man Made Color/Pattern	-0.05
Avg. S. Structures	-0.04
Avg. S. Vegetation	0.41
Avg. S. Vegetation Color/Pattern	0.08
Avg. S. Vegetation Edge	0.13
Avg. S. Water	0.22
Avg. Suburban/Urban	0.21
Avg. Wetlands	0.02

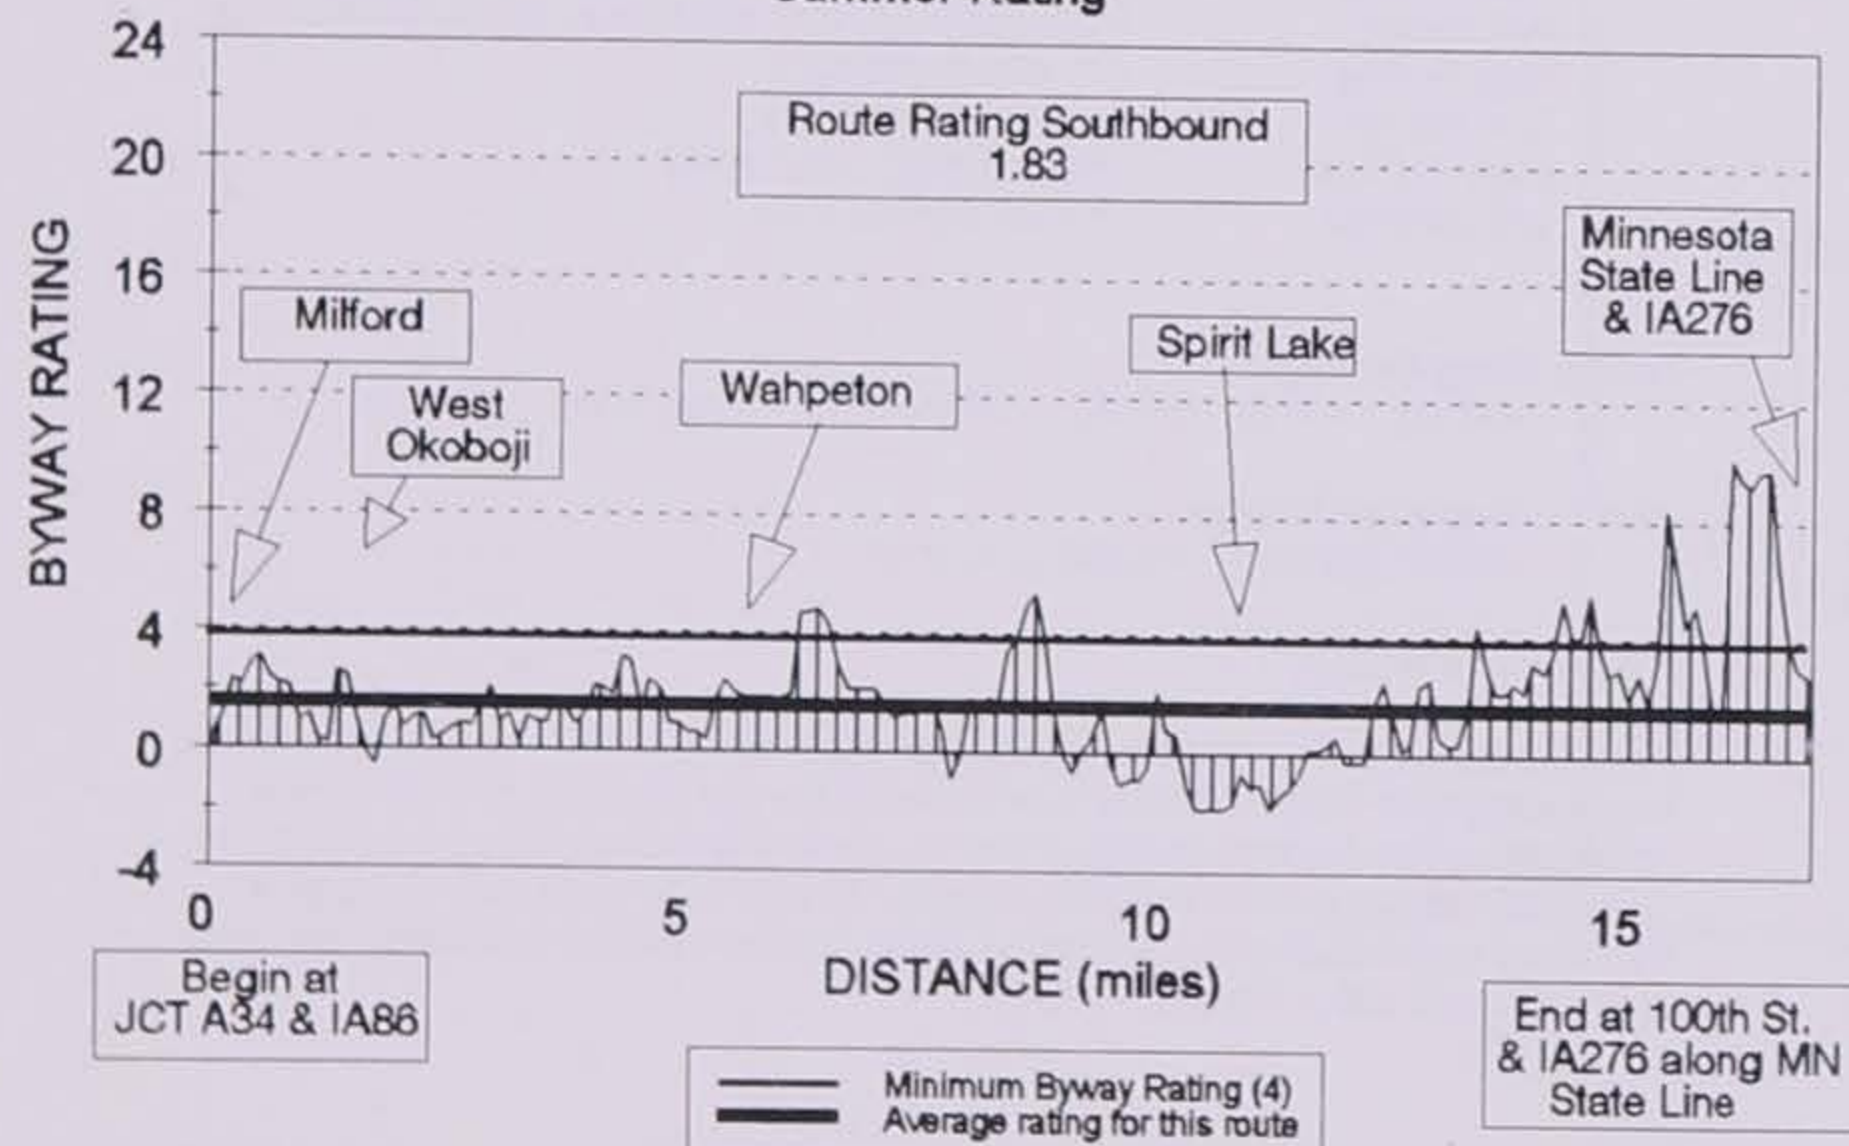
**ROUTE 70 West of Lakes - Southbound**  
Summer Rating

**SOUTH RATING SUMMARY**

Avg. Agriculture	0.00
Avg. F. Agriculture Act/Op	0.00
Avg. F. Agriculture Structures	0.08
Avg. F. Man Made Color/Pattern	-0.60
Avg. F. Man Made Unique	0.01
Avg. F. Structures	0.00
Avg. F. Vegetation	0.70
Avg. F. Vegetation Color/Pattern	0.01
Avg. F. Vegetation Unique	0.00
Avg. F. Water Edge	0.12
Avg. Mixed Agriculture	0.04
Avg. Mixed Native	0.16
Avg. P. Water	0.03
Avg. Park Recreation	0.00
Avg. Pull Off/ Rest Area	0.00
Avg. Road Ribbon	0.05
Avg. Road Terrain	0.08
Avg. S. Man Made Color/Pattern	-0.06
Avg. S. Structures	-0.05
Avg. S. Vegetation	0.38
Avg. S. Vegetation Edge	0.34
Avg. S. Water	0.28
Avg. Suburban/Urban	0.25

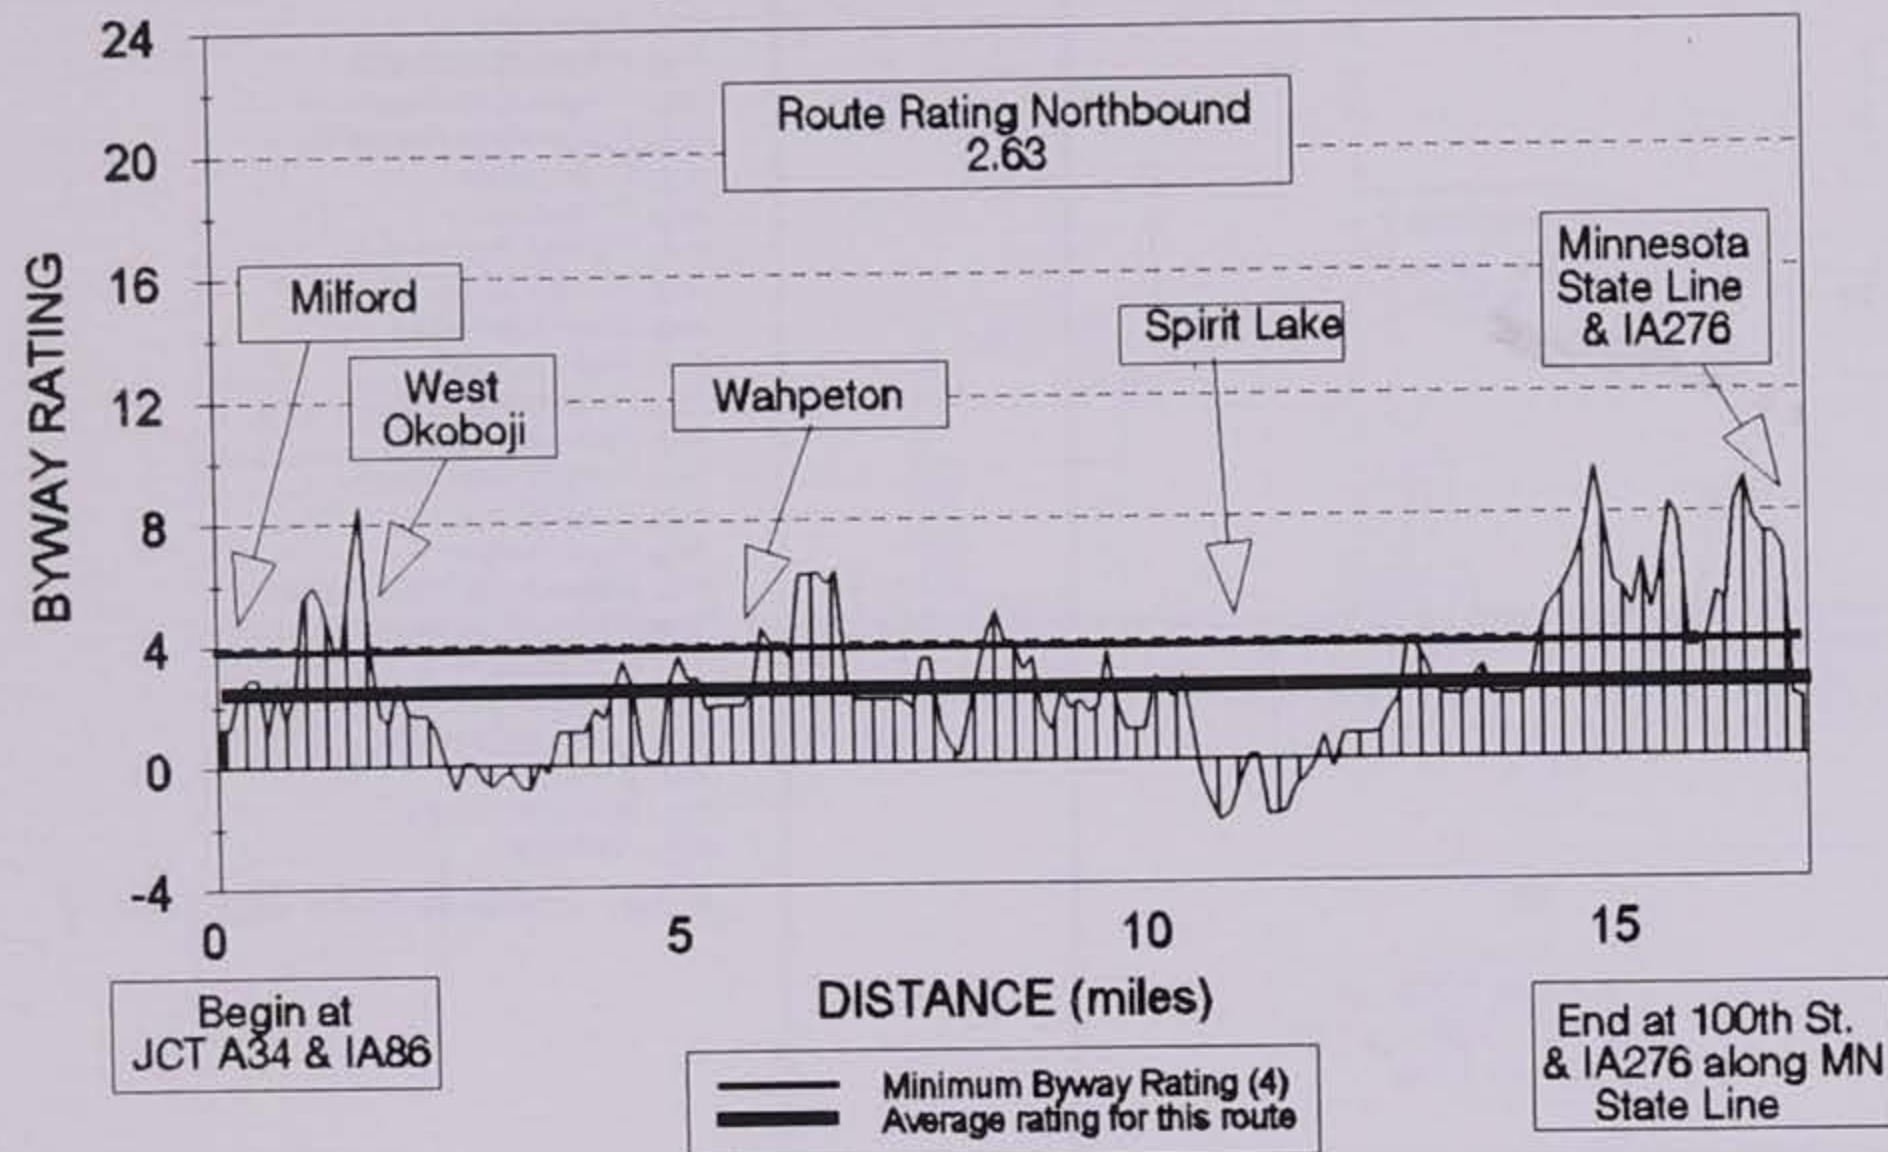
**ROUTE 70 West of Lakes - Northbound**  
Projected Spring & Fall Rating

**NORTH RATING SUMMARY**

Avg. Agriculture	0.12
Avg. F: Agriculture Act/Op	0.00
Avg. F: Agriculture Structures	0.02
Avg. F: Man Made Color/Pattern	-0.65
Avg. F: Man Made Unique	0.03
Avg. F: Structures	0.00
Avg. F: Vegetation	0.89
Avg. F: Vegetation Color/Pattern	0.05
Avg. F: Vegetation Unique	0.01
Avg. F: Water Edge	0.11
Avg. Mixed Agriculture	0.21
Avg. Mixed Native	0.14
Avg. P: Vegetation	0.01
Avg. P: Water	0.00
Avg. Park Recreation	0.00
Avg. Road Ribbon	0.06
Avg. Road Terrain	0.08
Avg. S: Landform	0.10
Avg. S: Man Made Color/Pattern	-0.05
Avg. S: Structures	-0.04
Avg. S: Vegetation	0.71
Avg. S: Vegetation Color/Pattern	0.15
Avg. S: Vegetation Edge	0.21
Avg. S: Water	0.22
Avg. Suburban/Urban	0.21
Avg. Wetlands	0.02

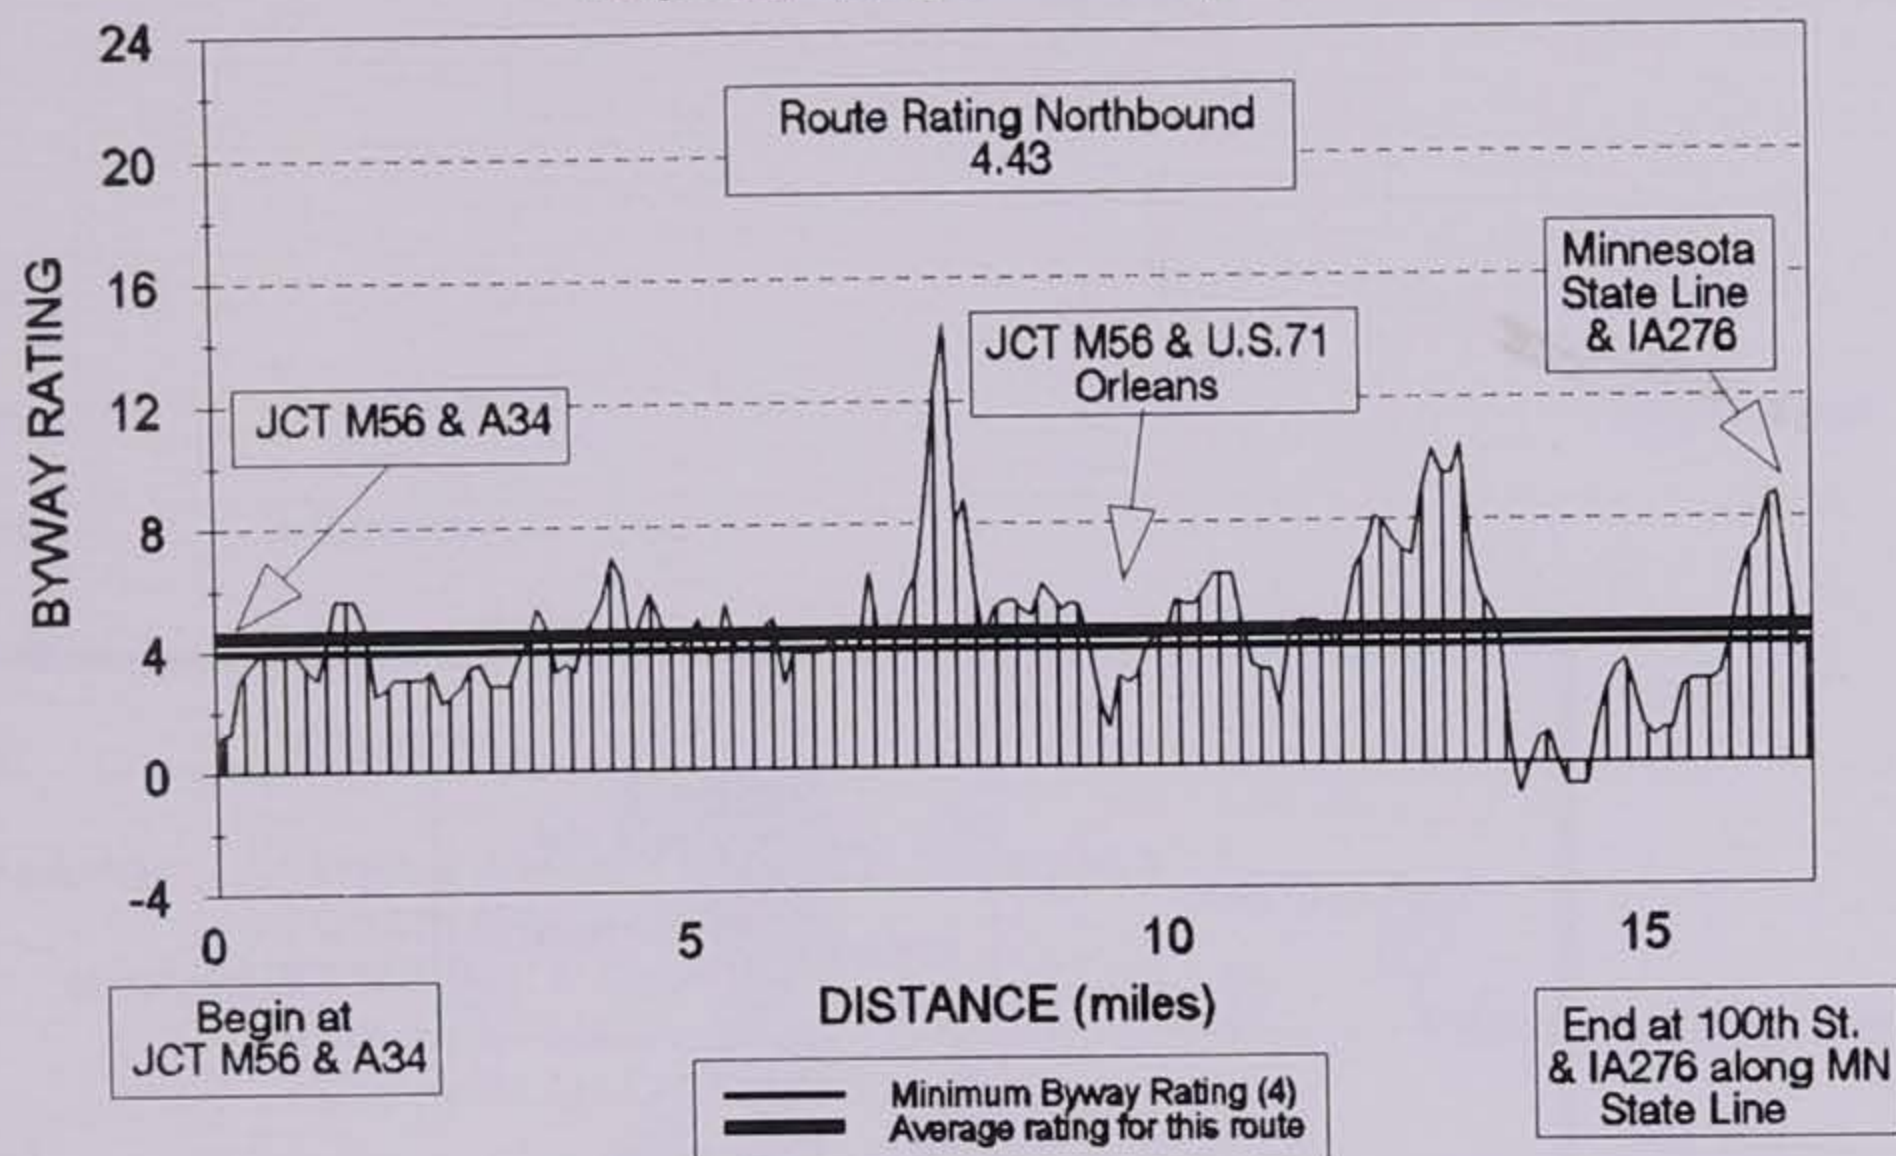
**ROUTE 70 East of Lakes -Northbound**  
Projected Spring & Fall Rating

**NORTH RATING SUMMARY**

Avg. Agriculture	0.13
Avg. F:Agriculture Act/Op	-0.01
Avg. F:Agriculture Structures	0.19
Avg. F:Man Made Color/Pattern	-0.32
Avg. F:Structures	0.00
Avg. F:Vegetation	1.55
Avg. F:Vegetation Unique	0.01
Avg. F:Water Edge	0.11
Avg. Mixed Agriculture	0.17
Avg. Mixed Native	0.15
Avg. P:Water	0.01
Avg. Park Recreation	0.00
Avg. Pull Off/ Rest Area	0.00
Avg. Road Ribbon	0.45
Avg. Road Terrain	0.07
Avg. S:Man Made Color/Pattern	-0.01
Avg. S:Structures	-0.02
Avg. S:Vegetation	0.64
Avg. S:Vegetation Color/Pattern	0.38
Avg. S:Vegetation Edge	0.51
Avg. S:Water	0.25
Avg. Suburban/Urban	0.16
Avg. Wetlands	0.01
<b>Avg. Total Route Summary</b>	<b>4.43</b>

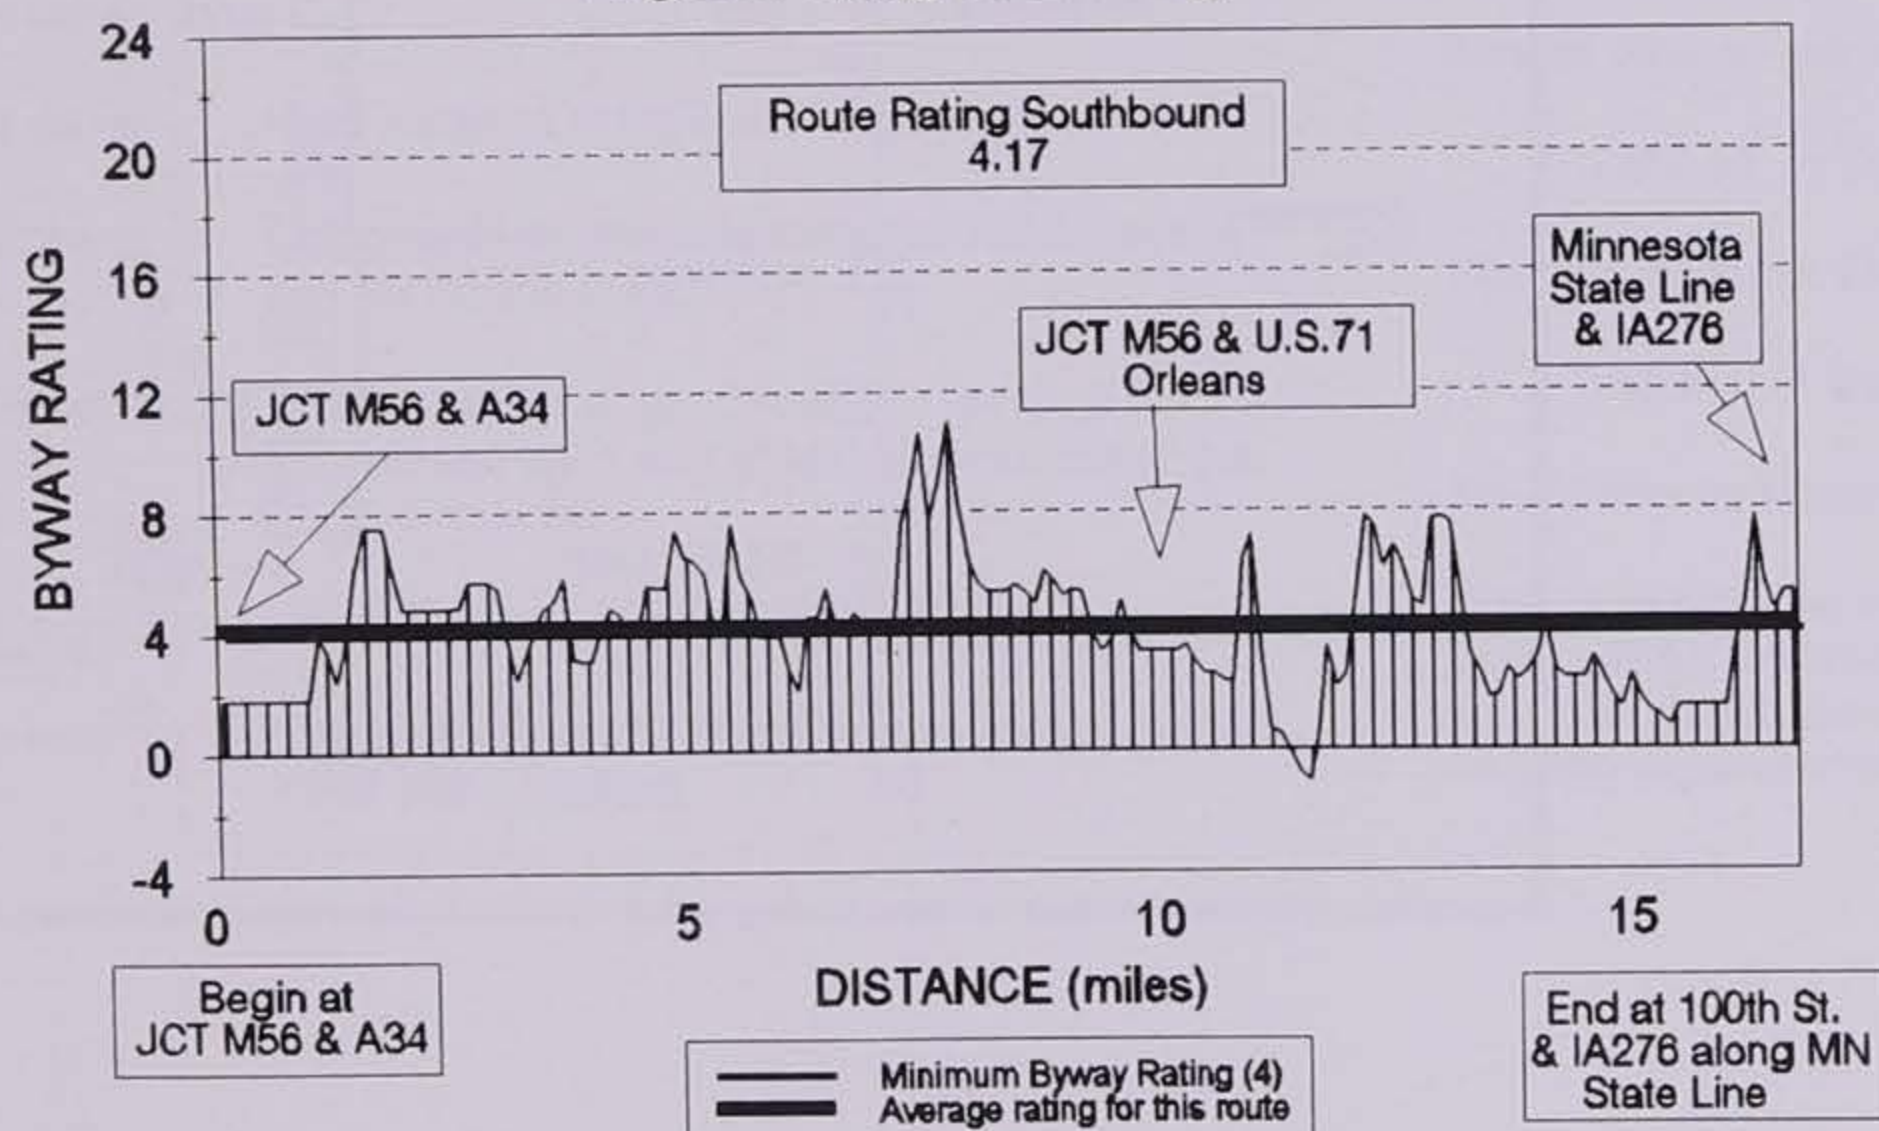
**ROUTE 70 East of Lakes -Southbound**  
Projected Spring & Fall Rating

**SOUTH RATING SUMMARY**

Avg. Agriculture	0.21
Avg. F:Agriculture Act/Op	-0.01
Avg. F:Agriculture Structures	0.05
Avg. F:Man Made Color/Pattern	-0.21
Avg. F:Vegetation	1.26
Avg. F:Vegetation Unique	0.01
Avg. F:Water Edge	0.10
Avg. Mixed Agriculture	0.18
Avg. Park Recreation	0.00
Avg. Pull Off/ Rest Area	0.00
Avg. Road Ribbon	0.51
Avg. Road Terrain	0.07
Avg. S:Agriculture Act/Op	-0.02
Avg. S:Man Made Color/Pattern	0.00
Avg. S:Structures	-0.01
Avg. S:Vegetation	0.81
Avg. S:Vegetation Color/Pattern	0.42
Avg. S:Vegetation Edge	0.30
Avg. S:Water	0.25
Avg. Suburban/Urban	0.25
Avg. Wetlands	0.01
Avg. Woodlands	0.00
<b>Avg. Total Route Summary</b>	<b>4.17</b>

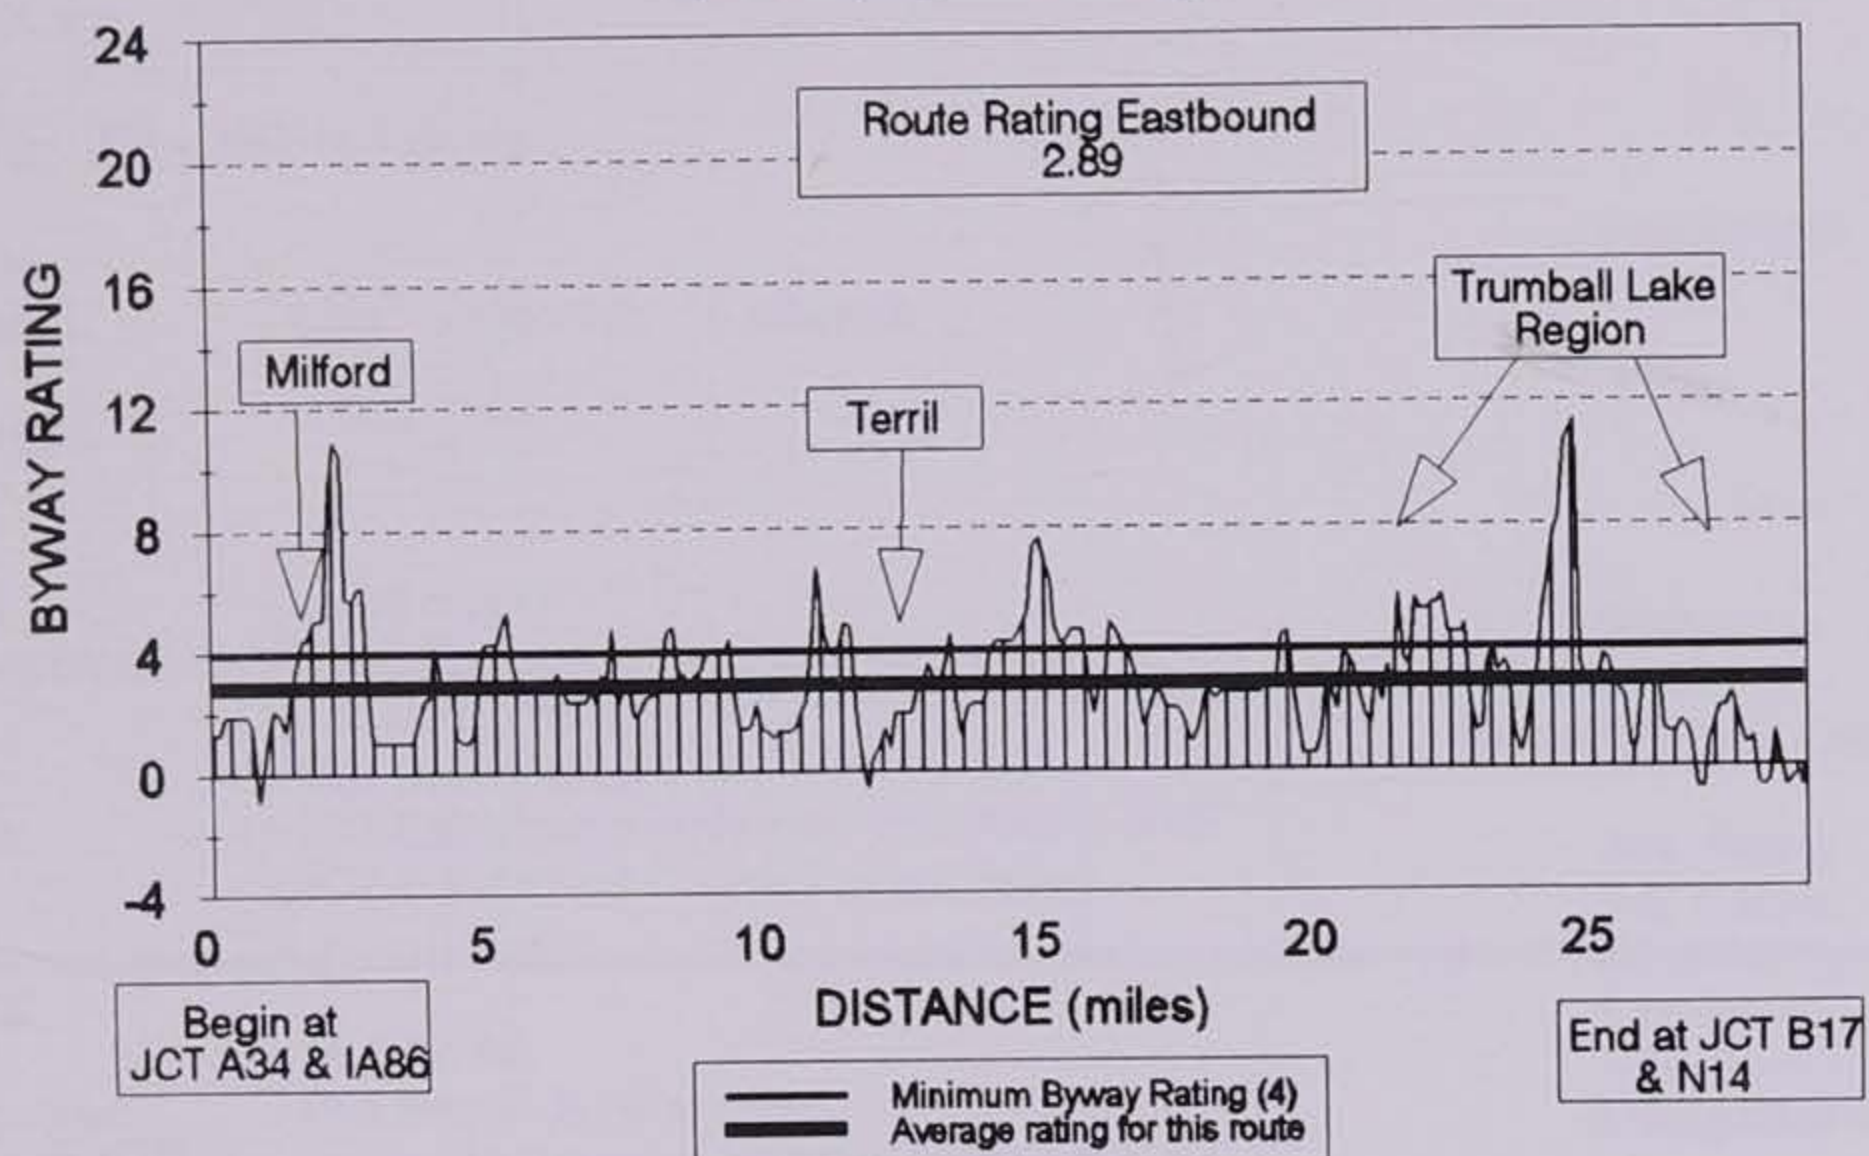
**ROUTE 71 - Eastbound**  
Projected Spring & Fall Rating

**EAST RATING SUMMARY**

Avg. Agriculture	0.05
Avg. F: Agriculture Act/Op	0.00
Avg. F: Agriculture Structures	0.21
Avg. F: Agriculture Unique	0.03
Avg. F: Man Made Color/Pattern	-0.33
Avg. F: Vegetation	0.95
Avg. F: Vegetation Unique	0.02
Avg. F: Water Edge	0.02
Avg. Mixed Agriculture	0.26
Avg. Park Recreation	0.00
Avg. Road Ribbon	0.02
Avg. Road Terrain	0.03
Avg. S: Agriculture Act/Op	0.03
Avg. S: Landform	0.05
Avg. S: Man Made Color/Pattern	-0.05
Avg. S: Moving Water	0.00
Avg. S: Structures	0.04
Avg. S: Vegetation	0.43
Avg. S: Vegetation Color/Pattern	0.79
Avg. S: Vegetation Edge	0.14
Avg. S: Water	0.11
Avg. Suburban/Urban	0.01
Avg. Wetlands	0.07

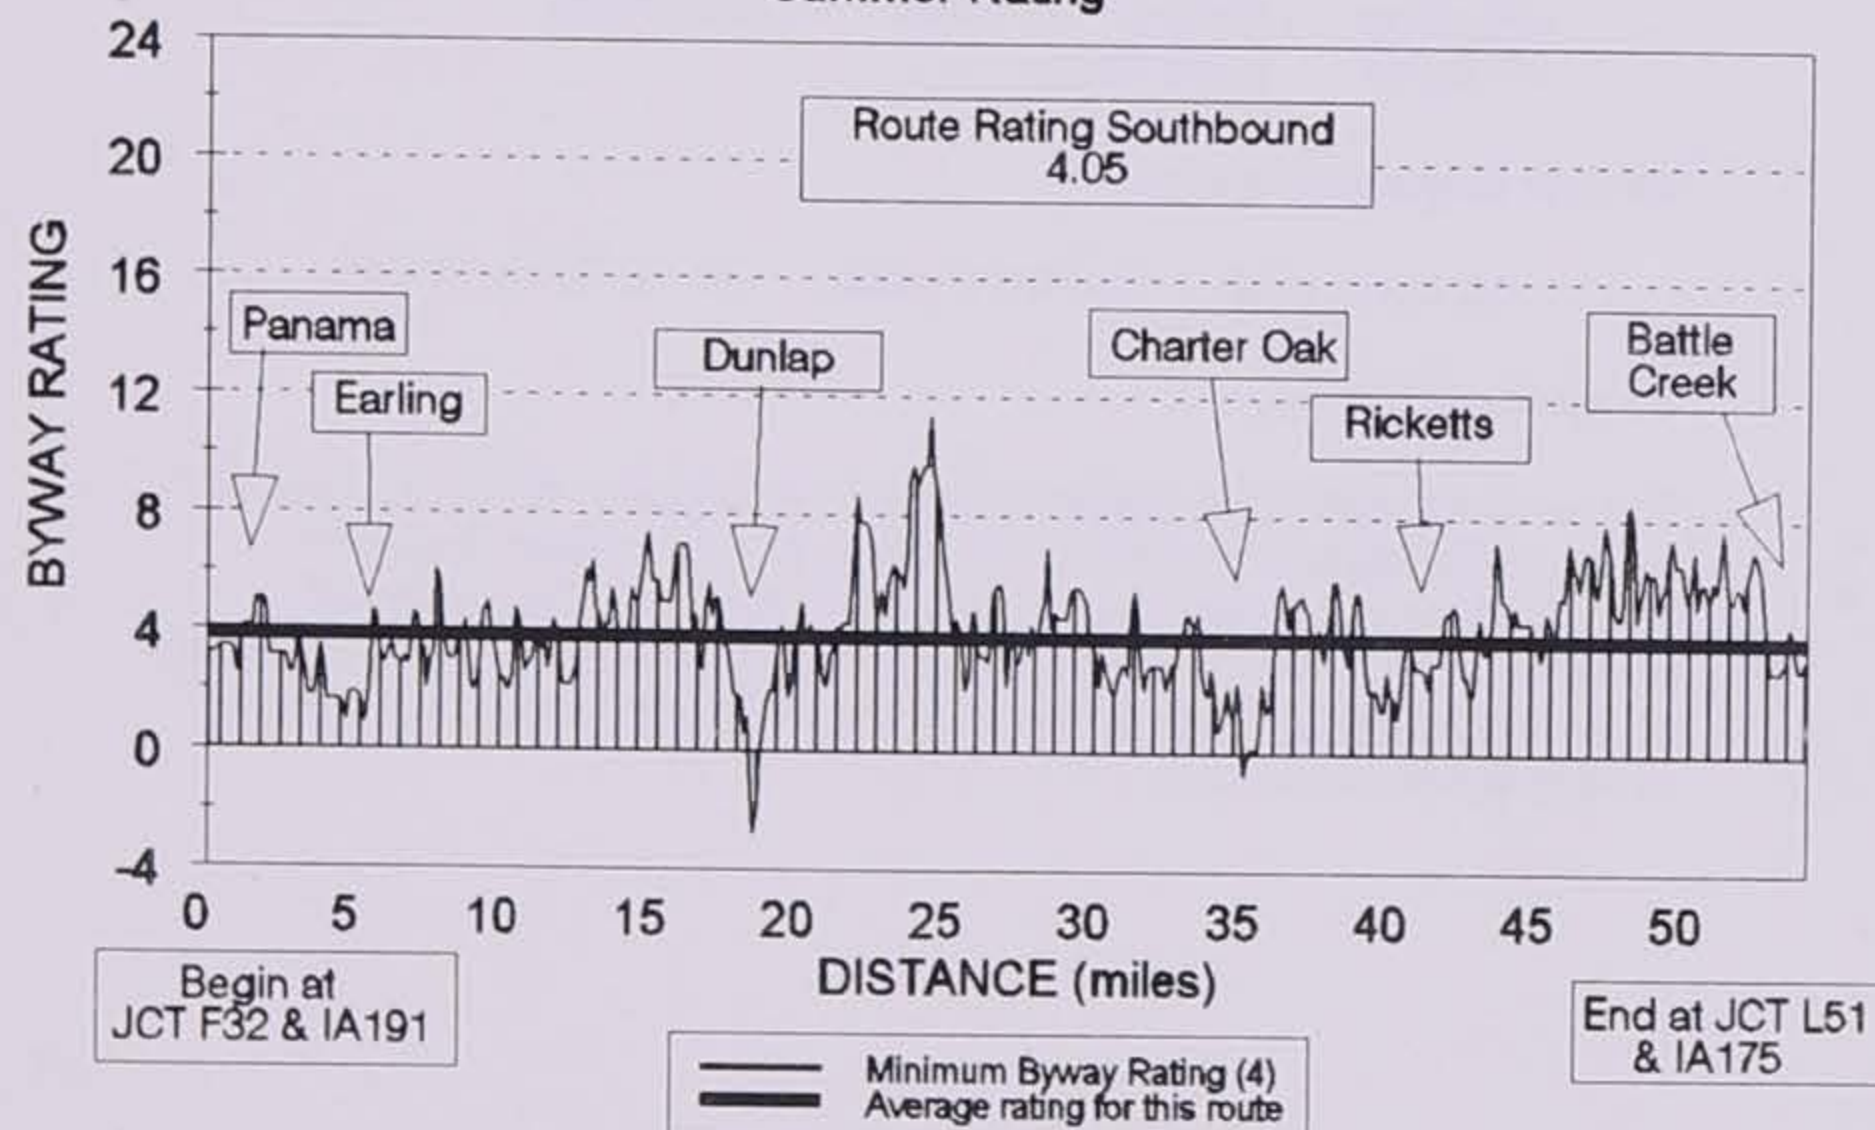
**ROUTE 75 - Southbound**  
Summer Rating

**SOUTH RATING SUMMARY**

Avg. Agriculture	0.38
Avg. F: Agriculture Act/Op	0.06
Avg. F: Agriculture Structures	0.11
Avg. F: Man Made Color/Pattern	-0.34
Avg. F: Man Made Unique	0.00
Avg. F: Structures	0.02
Avg. F: Vegetation	0.52
Avg. Landform Background	0.11
Avg. Mixed Agriculture	0.44
Avg. Mixed Native	0.05
Avg. P: Agriculture	0.08
Avg. P: Landform	0.05
Avg. P: Vegetation	0.00
Avg. Road Ribbon	0.06
Avg. Road Terrain	0.73
Avg. S: Agriculture Act/Op	0.05
Avg. S: Agriculture Color/Pattern	0.40
Avg. S: Agriculture Structures	0.01
Avg. S: Landform	0.38
Avg. S: Man Made Color/Pattern	-0.05
Avg. S: Moving Water	0.00
Avg. S: Structures	0.04
Avg. S: Vegetation	0.44
Avg. S: Vegetation Color/Pattern	0.24
Avg. S: Vegetation Edge	0.20
Avg. S: Water	0.03
Avg. Suburban/Urban	0.04
<b>Avg. Total Route Summary</b>	<b>4.05</b>

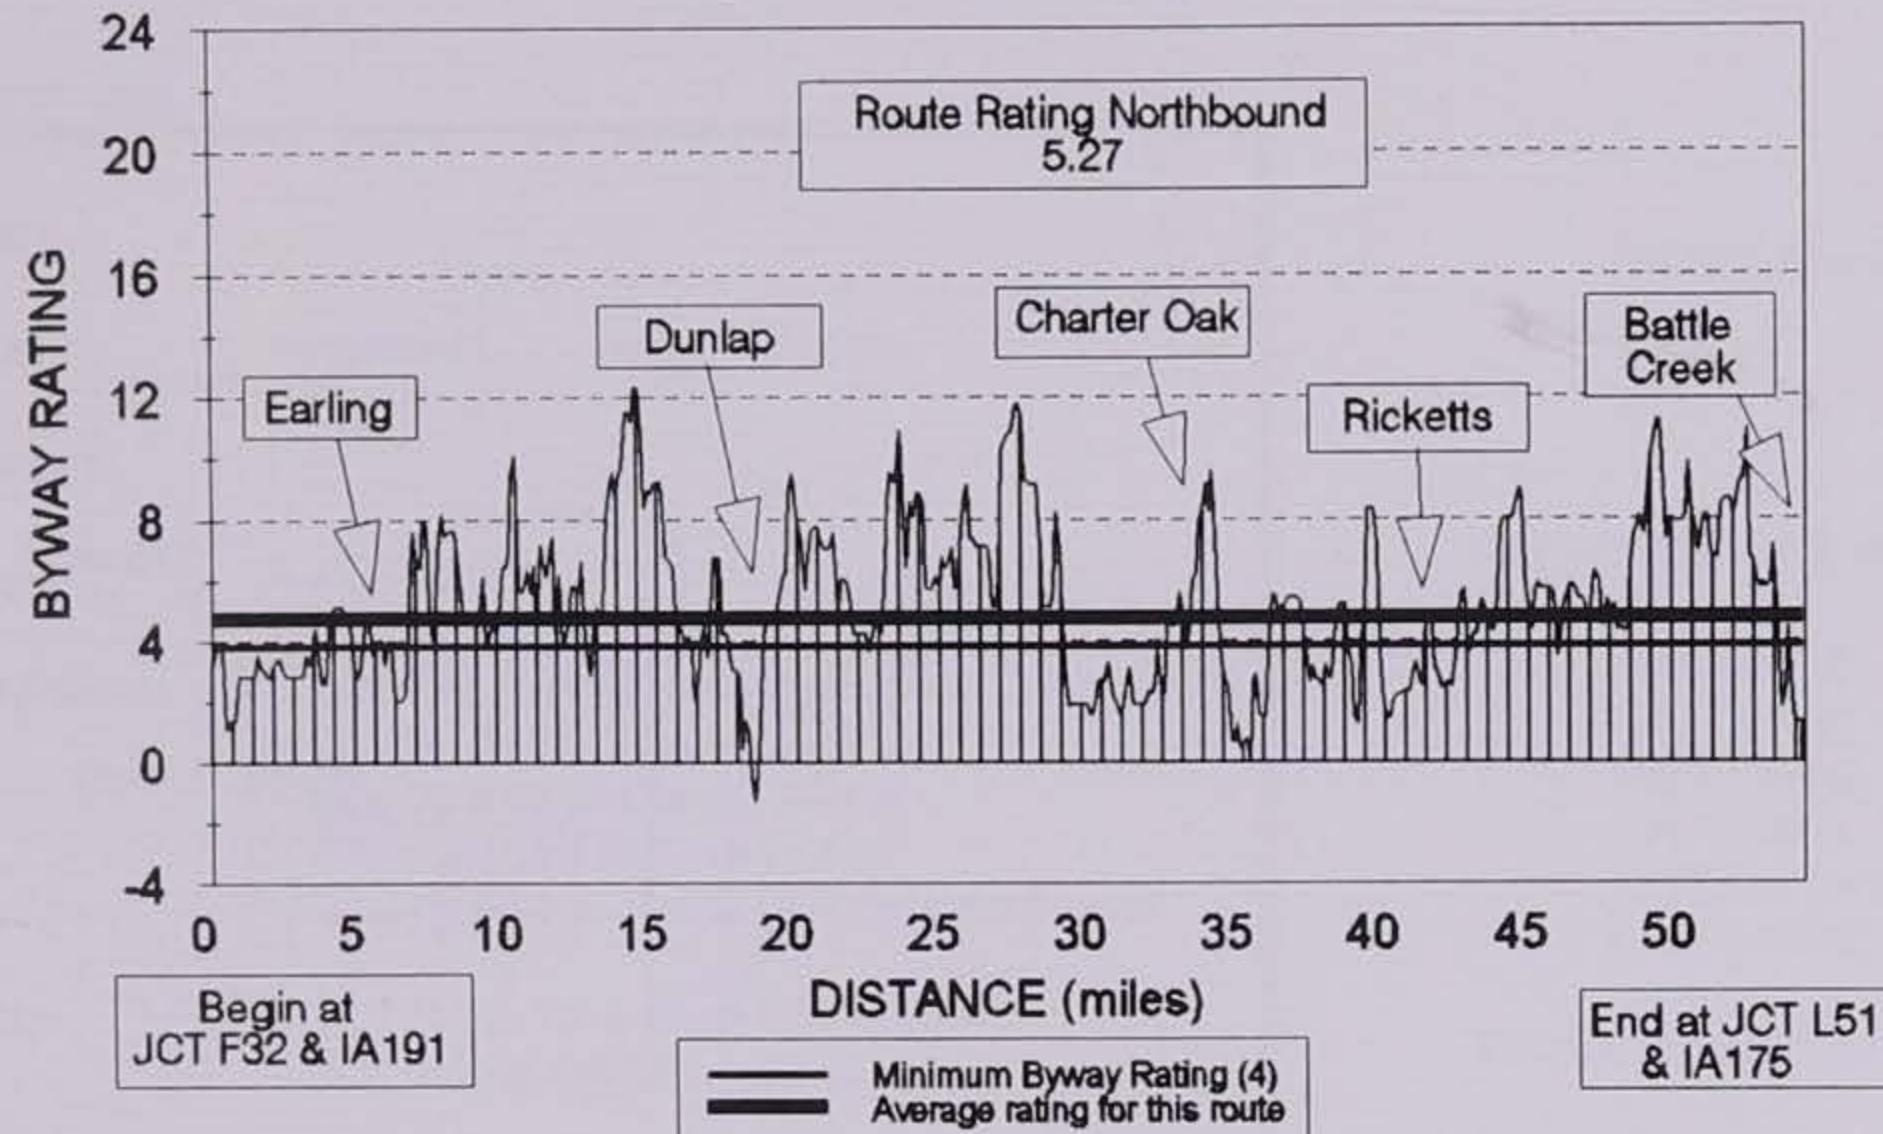
**ROUTE 75 - Northbound**  
Projected Spring & Rating

**NORTH RATING SUMMARY**

Avg. Agriculture	0.64
Avg. F:Agriculture Act/Op	0.01
Avg. F:Agriculture Structures	0.15
Avg. F:Man Made Color/Pattern	-0.34
Avg. F:Man Made Unique	0.00
Avg. F:Structures	0.04
Avg. F:Vegetation	0.72
Avg. F:Vegetation Color/Pattern	0.00
Avg. Landform Background	0.23
Avg. Mixed Agriculture	0.17
Avg. Mixed Native	0.11
Avg. P:Agriculture	0.13
Avg. P:Agriculture Color/Pattern	0.01
Avg. P:Landform	0.00
Avg. P:Vegetation	0.03
Avg. Road Ribbon	0.11
Avg. Road Terrain	0.73
Avg. S:Agriculture Act/Op	0.06
Avg. S:Agriculture Color/Pattern	0.04
Avg. S:Agriculture Structures	0.01
Avg. S:Landform	0.44
Avg. S:Man Made Color/Pattern	-0.05
Avg. S:Moving Water	0.00
Avg. S:Structures	0.07
Avg. S:Vegetation	0.61
Avg. S:Vegetation Color/Pattern	1.06
Avg. S:Vegetation Edge	0.21
Avg. S:Water	0.05
Avg. Suburban/Urban	0.04
<b>Avg. Total Route Summary</b>	<b>5.27</b>
