**"1000 MILE CORRIDOR"  
IOWA SCENIC BYWAY EVALUATION**

Prepared For:  
IOWA DEPARTMENT OF TRANSPORTATION

By:  
Decision Data Inc.  
2730 S.W. 57th Street  
Topeka, Kansas 66609

November 1995

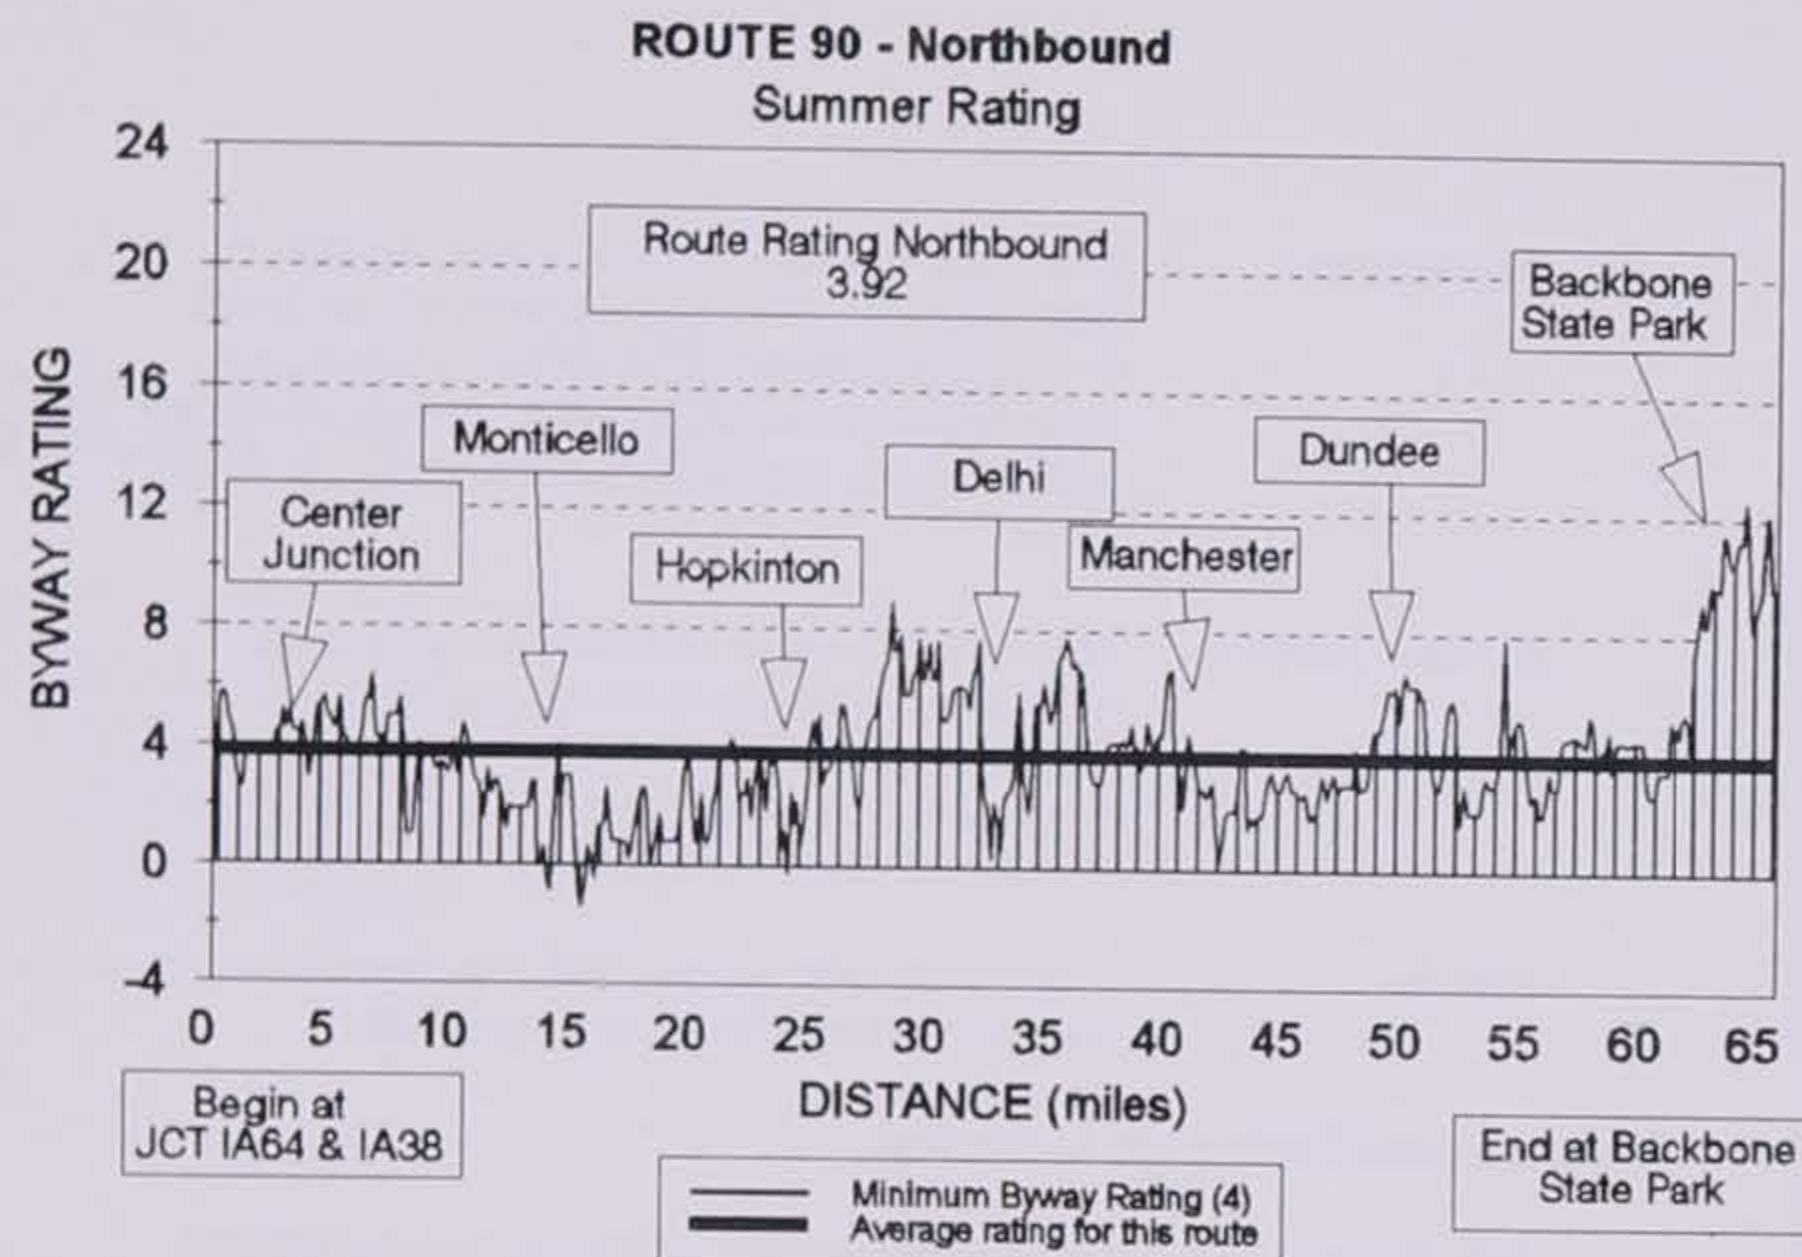
### NORTH RATING SUMMARY

Avg. Agriculture	0.77
Avg. F. Agriculture Act/Op	-0.01
Avg. F. Agriculture Structures	0.22
Avg. F. Landform Material	0.03
Avg. F. Man Made Color/Pattern	-0.16
Avg. F. Man Made Unique	0.02
Avg. F. Structures	0.01
Avg. F. Vegetation	0.80
Avg. F. Vegetation Color/Pattern	0.20
Avg. F. Water Edge	0.00
Avg. Historic Site	0.00
Avg. Mixed Native	0.01
Avg. P. Landform	0.05
Avg. P. Vegetation Color/Pattern	0.00
Avg. P. Vegetation Color/Pattern	0.00
Avg. Park Recreation	0.00
Avg. Road Ribbon	0.37
Avg. Road Terrain	0.18
Avg. S. Agriculture Act/Op	0.02
Avg. S. Agriculture Color/Pattern	0.07
Avg. S. Agriculture Structures	0.07
Avg. S. Landform	0.21
Avg. S. Man Made Color/Pattern	-0.04
Avg. S. Moving Water	0.00
Avg. S. Structures	0.01
Avg. S. Vegetation	0.22
Avg. S. Vegetation Color/Pattern	0.40
Avg. S. Vegetation Edge	0.23
Avg. S. Water	0.02
Avg. Suburban/Urban	0.11
Avg. Woodlands	0.10
<b>Avg. Total Route Summary</b>	<b>3.92</b>
