# Field Demonstration of an Innovative Box Beam Connection

**Final Report**  
**February 2023**

**Sponsored by**  
Iowa Highway Research Board  
(IHRB Project TR-743)  
Iowa Department of Transportation  
(InTrans Project 18-647)

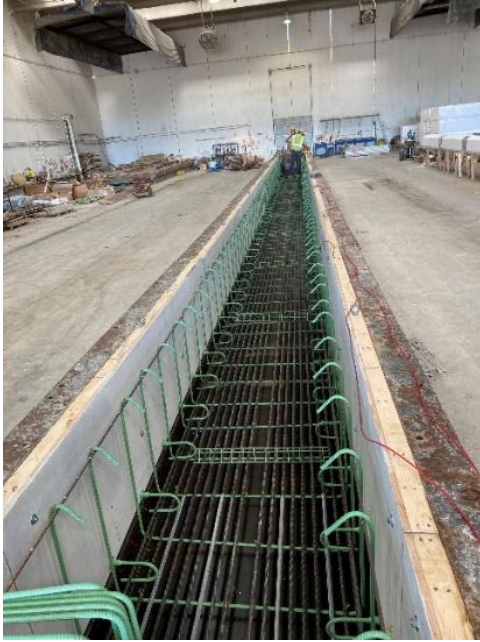
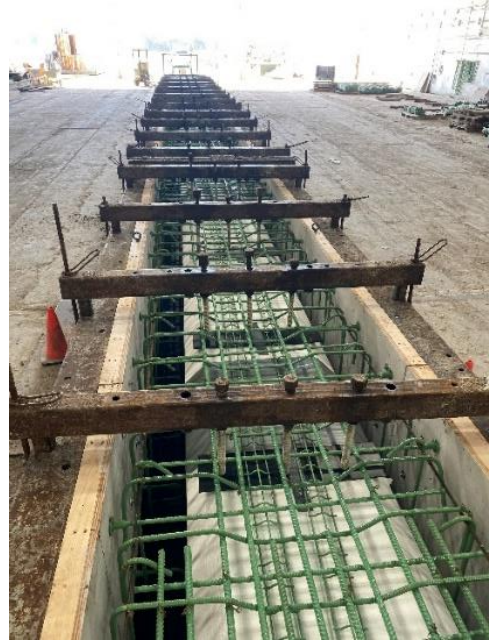
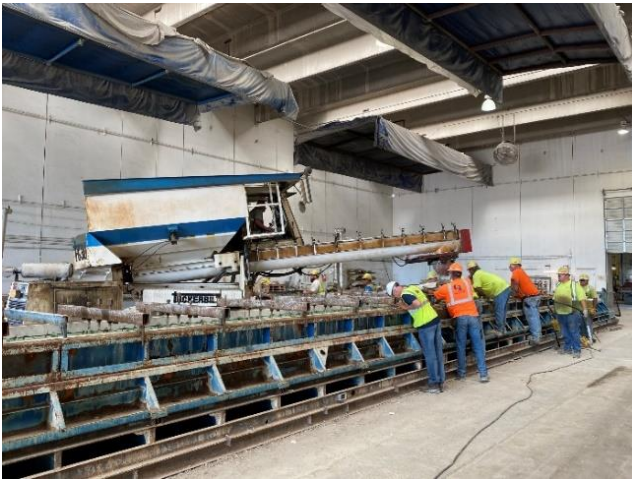
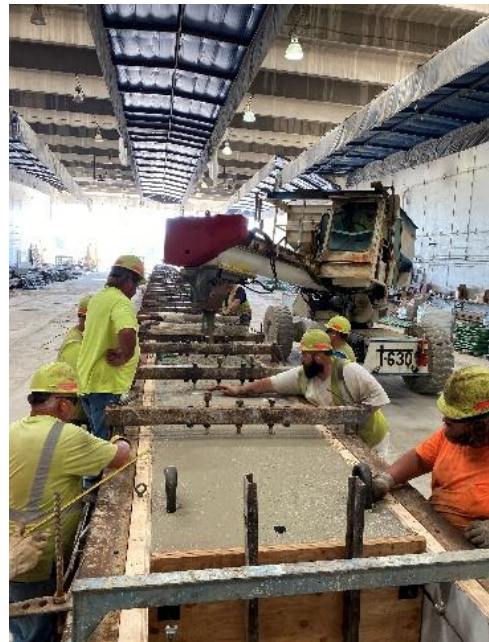
Figure 5 shows photographs of the girder fabrication. For each girder, the box girder concrete was placed into a steel form, as shown in Figure 5a. Boards were attached to the side of the steel form to form the shape of the wide joint. A large polyethylene form was used in the middle to create the void of the box girder. The formwork was completed by using cross-steel frames to resist the fluid concrete pressure, as shown in Figure 5b. Figure 5c shows the concrete placement. The process was completed when the surface was hand-troweled, as shown in Figure 5d.

(a) Box girder reinforcement placement

(b) Internal box

(c) Box girder concrete placement

(d) Surface completion

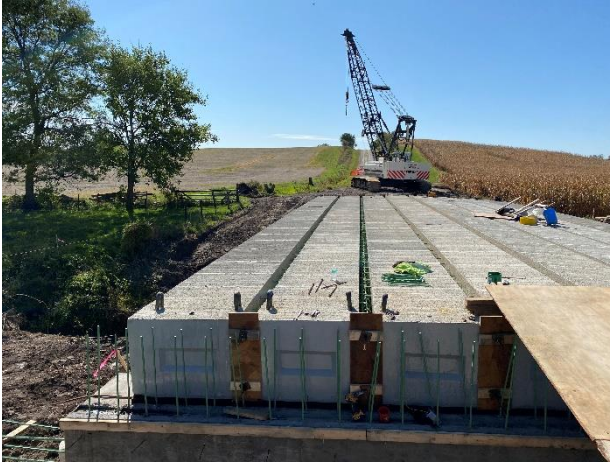
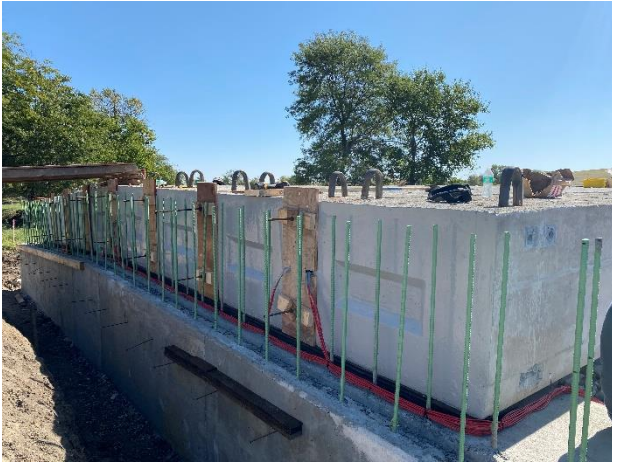
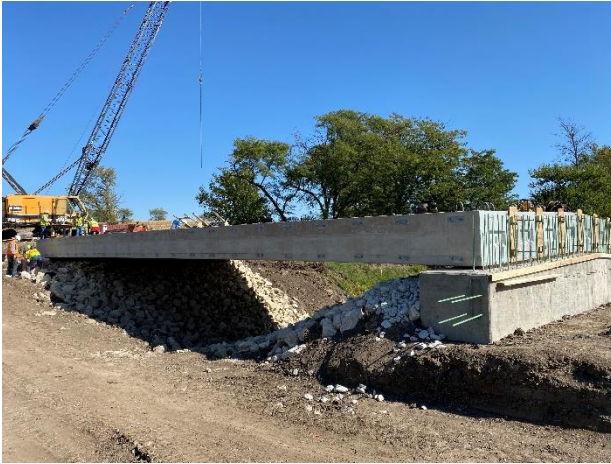
In order to hold the fresh concrete in the joints, timber boards were attached to the ends of the box girders. These boards were anchored into the ends of the girders, as shown in Figure 6c. Figure 6d shows an overview of the bridge superstructure before the placement of the joint material and abutment concrete.

(a) Box girders placed

(b) Joint reinforcement

(c) Plywood forms at the ends of the joints

(d) Bridge before placement of joint concrete

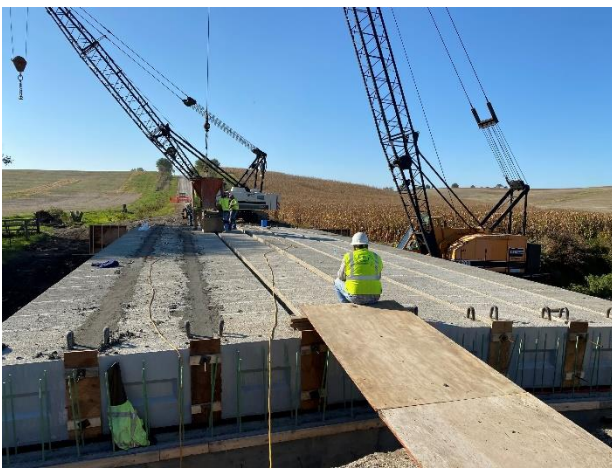
(a) Placement of joint concrete

Figure 8a shows an overview of the bridge during placement of the joint concrete. The concrete was delivered by truck and then dumped into a large bucket, as shown in Figure 8b. A crane then lifted the bucket over the joint, and the concrete was dispensed (see Figure 8c).

Figure 8 shows the labor workforce placing the joint concrete.

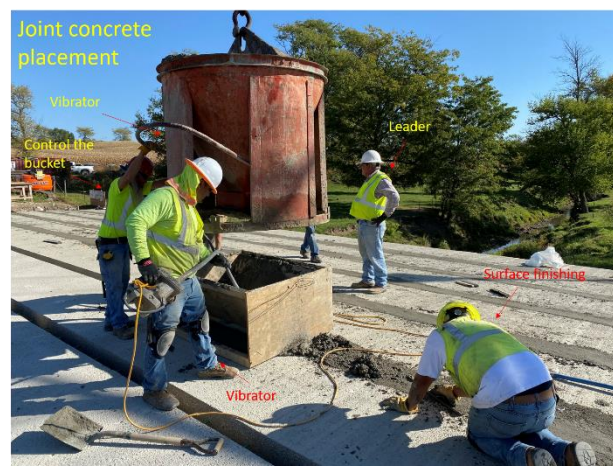
(d) Work crew during concrete placement

Figure 8d shows the total workforce used for the joint completion. Only four people were used to pour concrete during the 3 hour and 40 minute period. As shown in Figure 8d, one person controlled the bucket, two workers utilized the vibrator, and another person completed the surface finishing. One senior construction engineer provided continuous oversight of the work. In general, it was demonstrated that special skills and equipment beyond what is typical for constructing other bridge types were not required to complete the new longitudinal joint design.

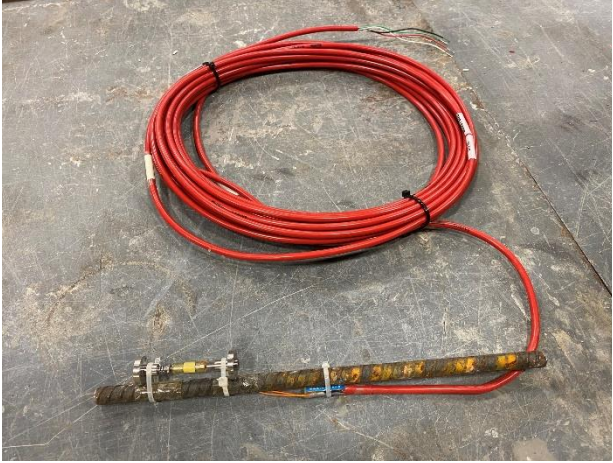
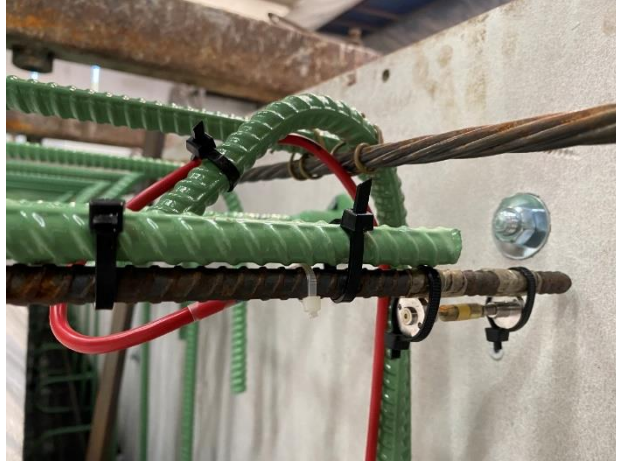
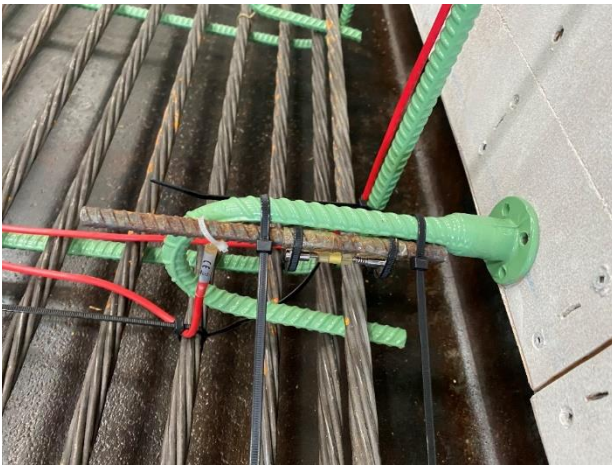
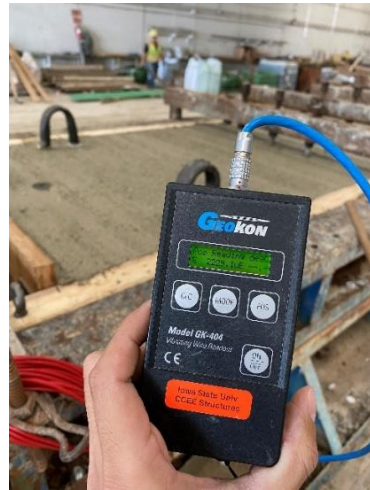
Considering the limited timeframe and access during box girder fabrication at the precast plant and completion of the joint in the field, each of the strain gauges (red rectangles in Figure 10a) was attached to a piece of steel rebar (blue lines in Figure 10a, photograph in Figure 11a) and then installed in its position within the girder. Figure 11b and Figure 11c show the strain gauges embedded in a box girder at the top and bottom, respectively. After placement of the box girder concrete, all of the strain gauges in the girders were tested to ensure that they were operational (Figure 11d). The results indicated that they were working properly.

(a) Strain gauge attached to a piece of rebar

(b) Strain gauge at the top of a box girder

(c) Strain gauge at the bottom of a box girder

(d) Testing of the strain gauges

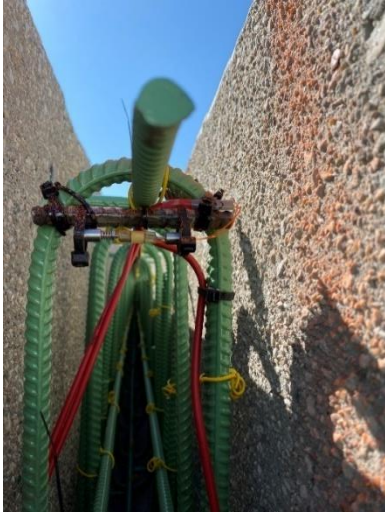
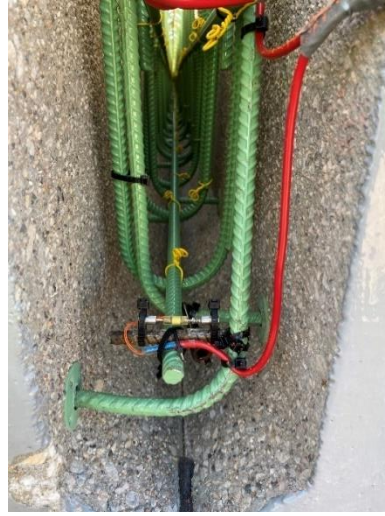
The strain gauges in the joints were placed using a similar approach. Figure 12a and Figure 12b show the gauges embedded in a joint near the top and bottom, respectively.

(a) Strain gauge placed at the top of a joint (b) Strain gauge placed at the bottom of a joint

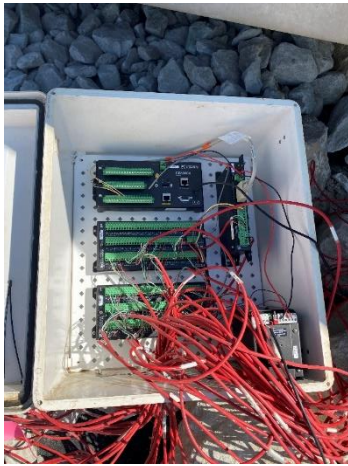
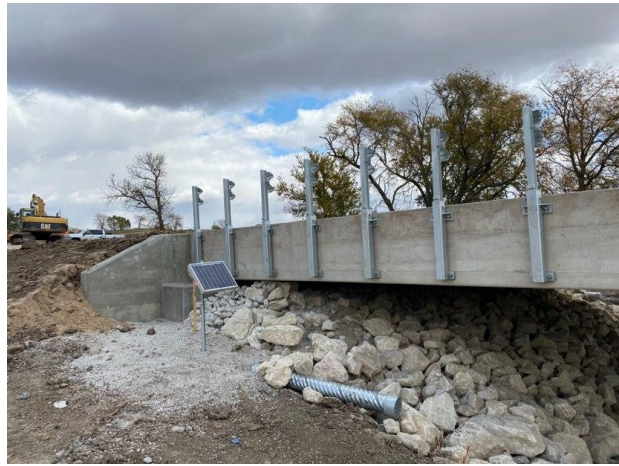
All of the strain gauges were connected to the Campbell Scientific CR1000 data logger, as shown in Figure 13a, and the whole data acquisition system was powered by a solar panel, as shown in Figure 13b.

(a) Data logger

(b) Solar panel

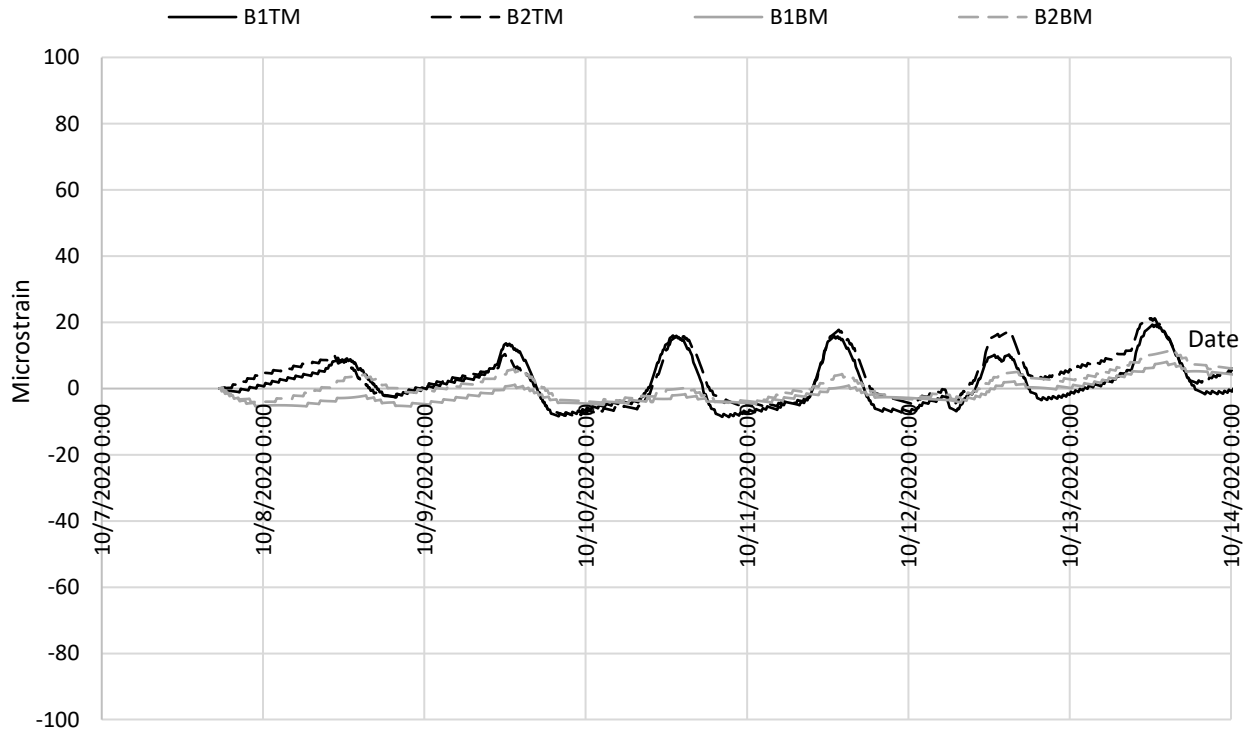
Figure 17 shows the strain development in the box girders during the first seven days after placement of the joint concrete. In general, all of the strain measured in the girders indicates a small tensile force (less than 20 microstrain). This indicates that the daily temperature change did not induce a significant effect on the box girders.

(a) Strain data from gauges B1TM, B2TM, B1BM, and B2BM

(b) Strain data from gauges B1TE, B2TE, B1BE, and B2BE

(c) Strain data from gauges B4TM, B5TM, B4BM, and B5BM

(d) Strain data from gauges B4TE, B5TE, B4BE, and B5BE

The strain data results from the end-span are presented in Figure 17b and Figure 17d. It was found that the construction of the abutment had a positive effect on the beam end behavior and reduced the transverse strains. This is likely a result of the shrinkage of the integral abutment during the first few days after placement of the abutment concrete, which provided transverse restraint to the beam ends.

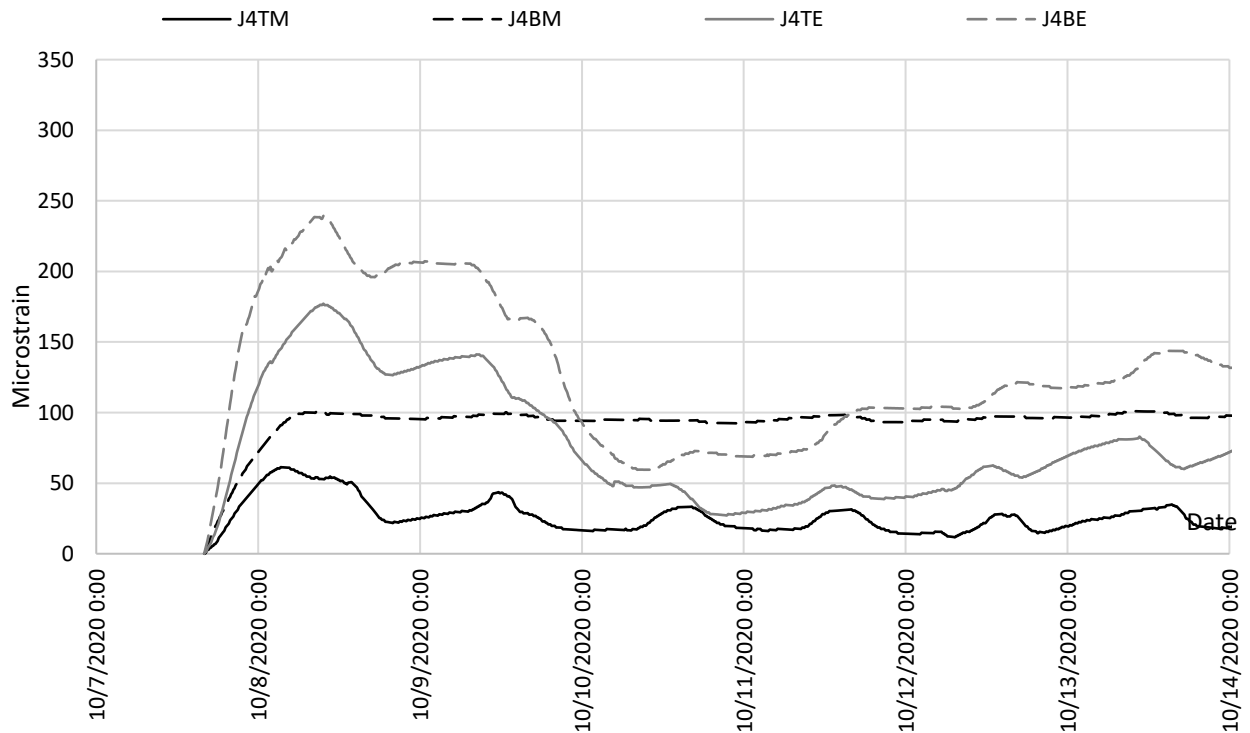
Figure 18 shows the strain data results from the longitudinal joints. Similar to the findings from the Phase I work (Phares 2017), an initial increase of 50 to 300 microstrain was captured during the first 24 hours after joint placement. This tensile force was induced by the Type K cement in the joint material and is desired to create compression at the joint-to-girder interface (Liu and Phares 2019, Liu and Phares 2020, Liu et al. 2020). A comparison of the results from Joints 1 and 4 shows that greater expansion of the joint material occurred in Joint 1.

(a) Strain data from gauges J1TM, J1BM, J1TE, and J1BE

(b) Strain data from gauges J4TM, J4BM, J4TE, and J4BE

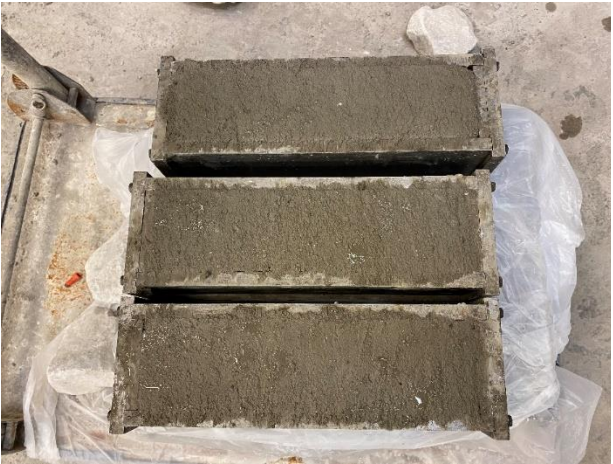
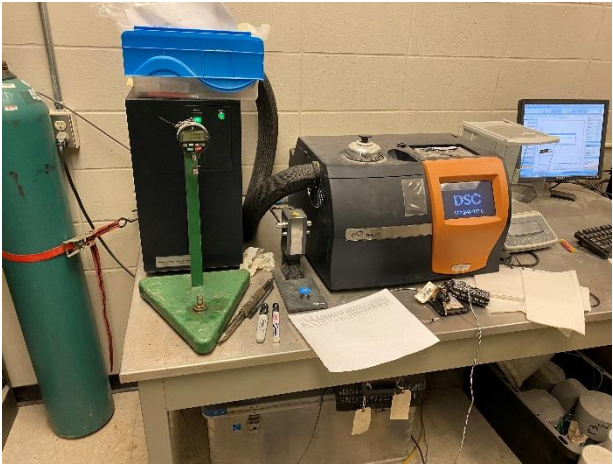
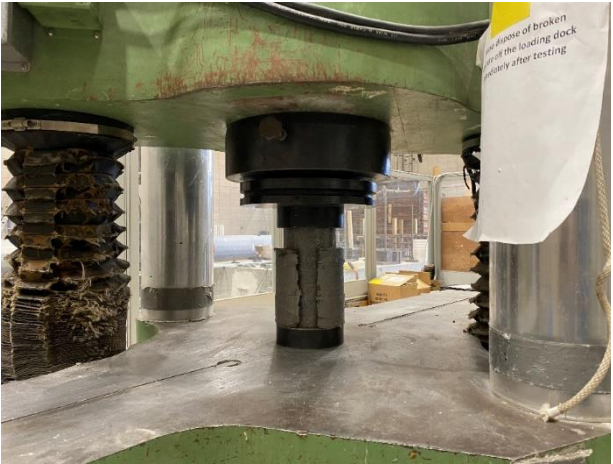
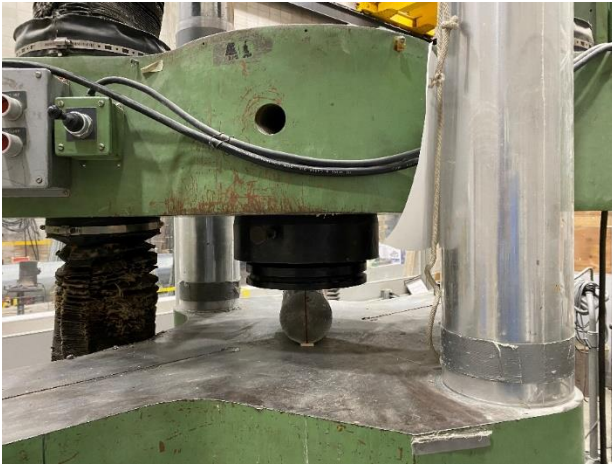
**Figure 19. Material property tests**

Shrinkage testing was conducted following the methods prescribed in ASTM C157, Standard Test Method for Length Change of Hardened Hydraulic-Cement Mortar and Concrete. This test method determines changes in length in hardened hydraulic cement mortar and concrete that are produced by causes other than externally applied forces and temperature changes. For each truck material (Truck 1 and Truck 2), three specimens (shown in Figure 19a) were cast and then cured at room temperature, or about 24°C (75°F), with 100% humidity. For each test, the mold was removed 6 hours after pouring, and the first data were measured immediately after removal of the mold. Shrinkage data were collected at 12 hours, 1 day, 2 days, 3 days, 7 days, 14 days, and 28 days.

(a) Concrete samples for shrinkage testing

(b) Shrinkage test machine

(c) Compressive strength test

(d) Splitting tensile strength test

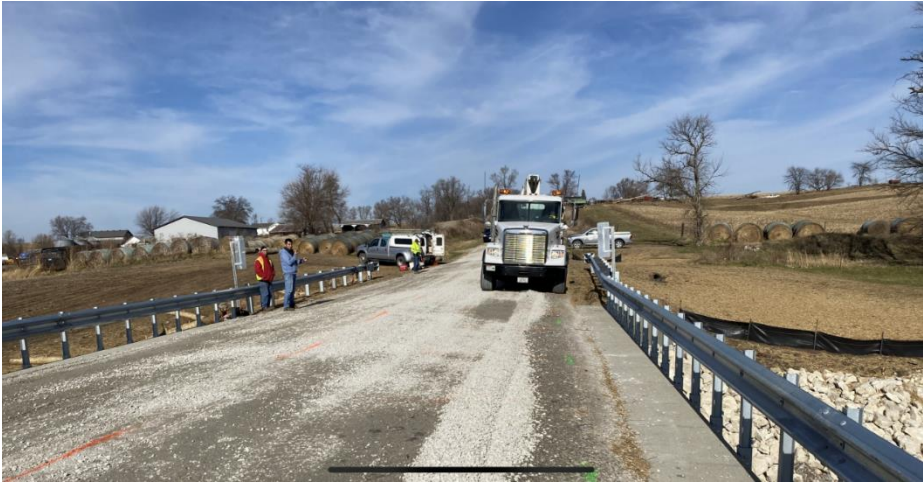
**Figure 23. Live load test**

During testing, the strain data were marked at 10 ft intervals as the truck traveled longitudinally down the bridge. Marking the data allowed the timestamp to be converted to truck position and ensured that the collected time-domain data matched the physical truck position. Figure 23 shows one of the live load tests being completed.

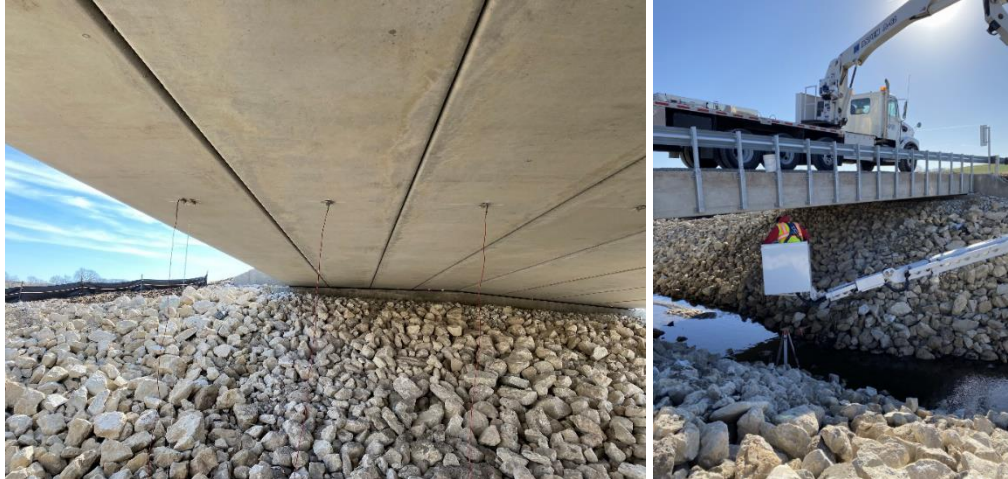
**Figure 25. Live load test instrumentation placement**

Figure 25 shows photographs of the on-site instrumentation placement.

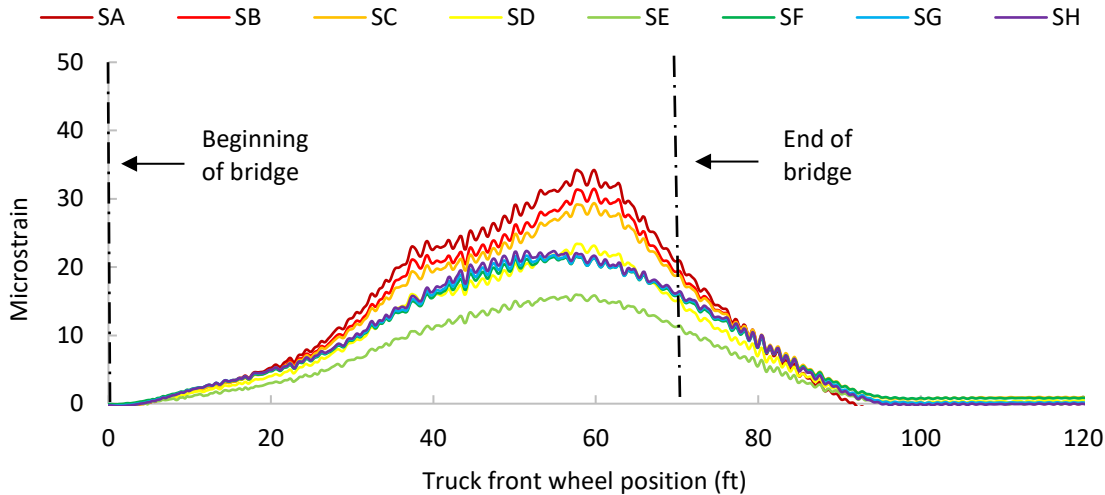
**Figure 27. Strain results from LC3 (2020)**

Figure 27 shows the strain data collected during LC3. The maximum strain ranges from 15 to 34 microstrain. In general, this strain is small compared to the concrete cracking strain of 132 microstrain as calculated by  $7.5 \sqrt{f'_c} / 57,000 \sqrt{f'_c}$  (ACI Committee 318 2011).

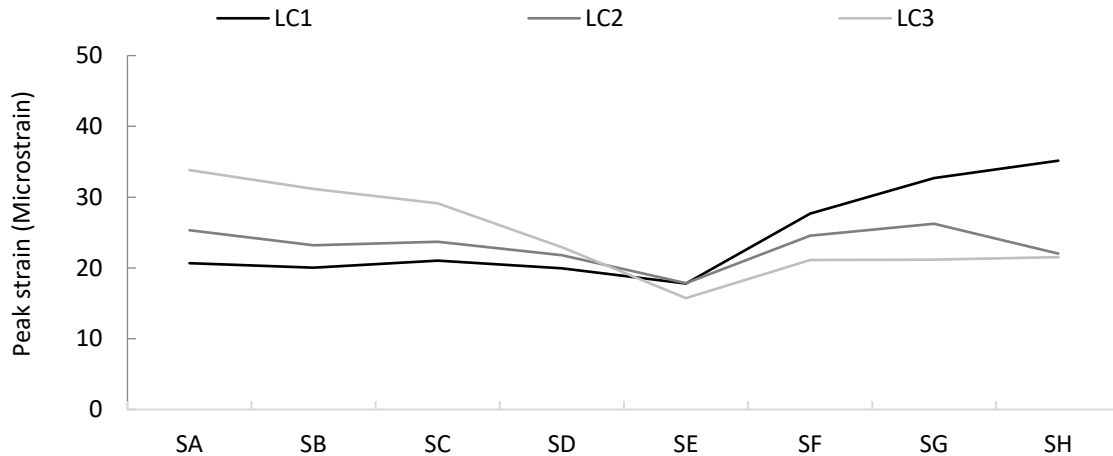
**Figure 28. Peak strain distribution in the transverse direction (2020)**

Figure 28 shows the peak strain distribution in the transverse direction for all three load cases, which provides a better illustration of the load distribution. The results indicate that all girders are engaged and resisting load regardless of the truck’s transverse position. The maximum strain from all three LCs is about 38 microstrain, which is not significant for prestressed concrete girders.

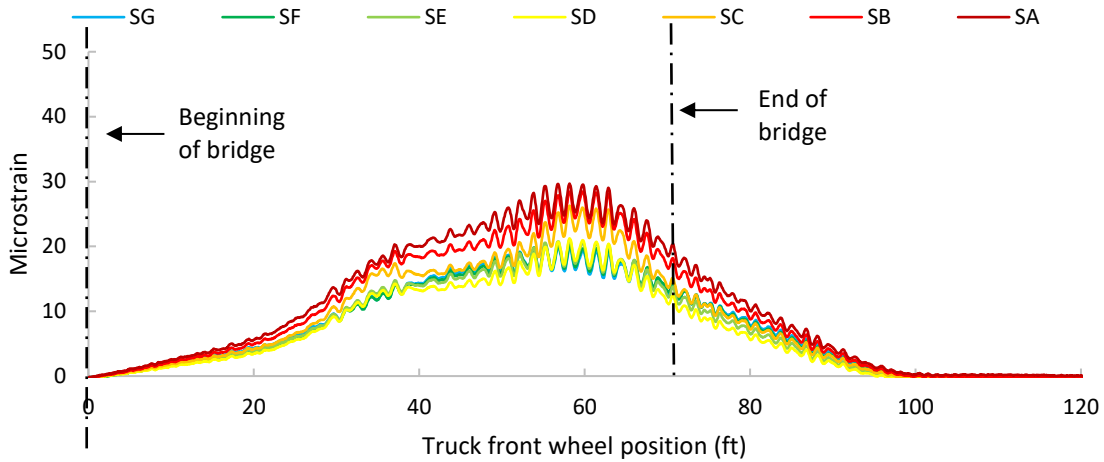
**Figure 33. Strain results from LC3 (2022)**

Figure 33 shows the strain data collected from gauges SA to SG during LC3. During the 2022 load test, the strain gauge below Girder H (SH) malfunctioned, and no data were collected from this gauge. The maximum strain ranges from 15 to 29 microstrain, which is consistent with the strain range observed during the 2021 load test (15 to 31 microstrain). As previously noted, these strain values are small compared to the concrete cracking strain of 132 microstrain as calculated by  $7.5 \sqrt{f'_c} / 57,000 \sqrt{f'_c}$  (ACI Committee 318 2011).

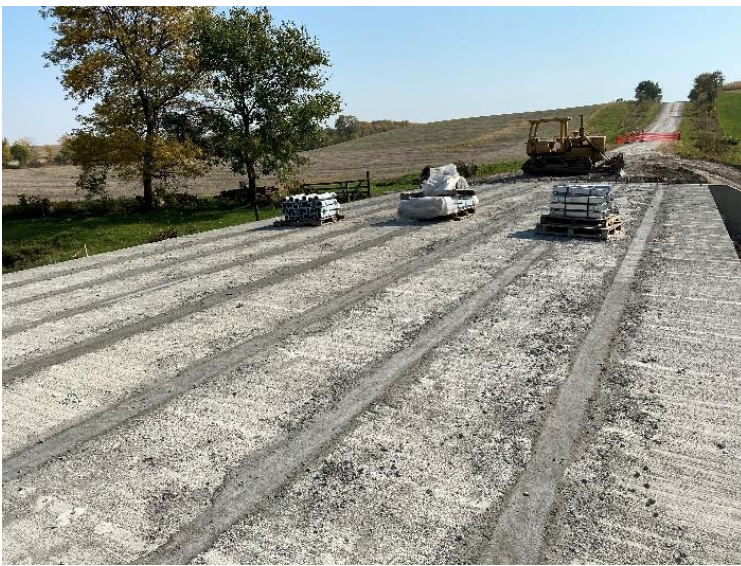
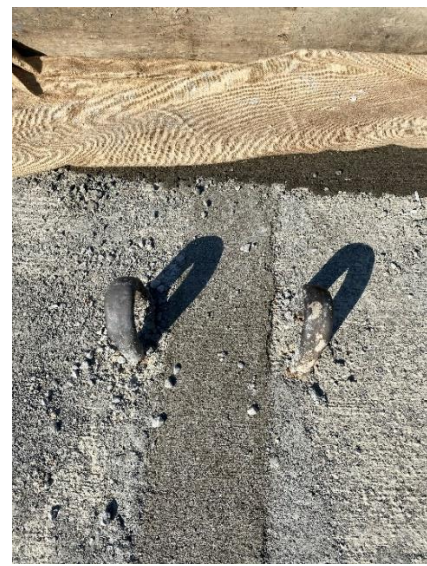
**Figure 35. Crack inspection – October 2020**

The first inspection was conducted in October 2020. The road had not been covered by gravel at this time, and the bridge had not been opened to traffic. A detailed inspection was completed on all joints, and no cracks were observed. Figure 35 shows the top surface during this inspection.

(a) Bridge top surface

(b) Top surface near joint end

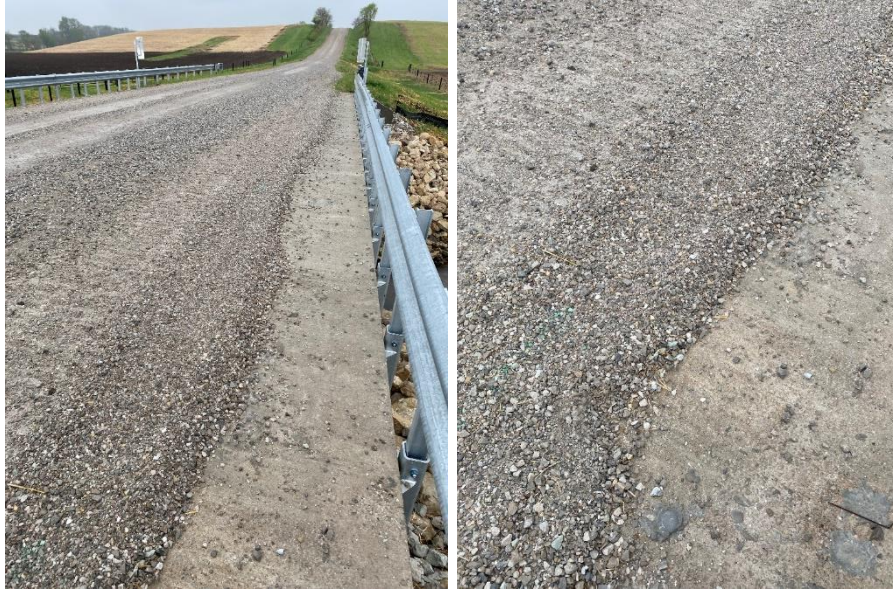
**Figure 36. Top surface of the bridge deck – May 2021**

The second inspection occurred on May 3, 2021, approximately half a year after the previous inspection. By this time, the deck had been covered with gravel, as shown in Figure 36.

The gravel did not allow for a comprehensive inspection of the top surface. However, the research team intentionally chose to complete the inspection on a rainy day to observe any potential water permeation through the joints. The research team observed the bottom side of the bridge during the rain. During this period, the underside of the bridge remained dry and clean, with no evidence of water permeation. The only evidence of leakage through the joints appeared to be that of concrete paste, which is most likely a byproduct of joint construction (see Figure 37).
