Utility Cut Repair Research Continues

IOWA DEPARTMENT OF TRANSPORTATION **RESEARCH**news

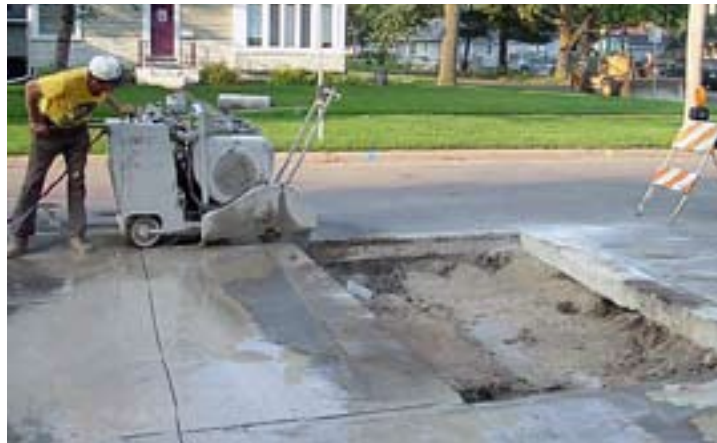
Concrete pavement cut being made

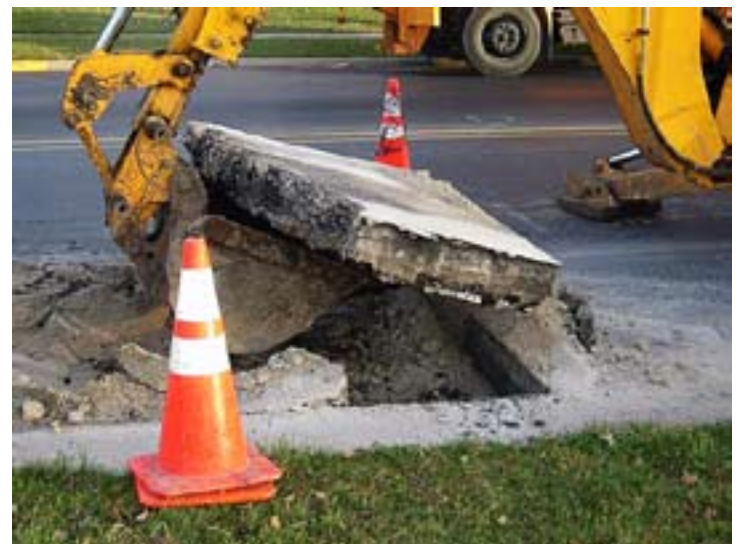
Pavement removal

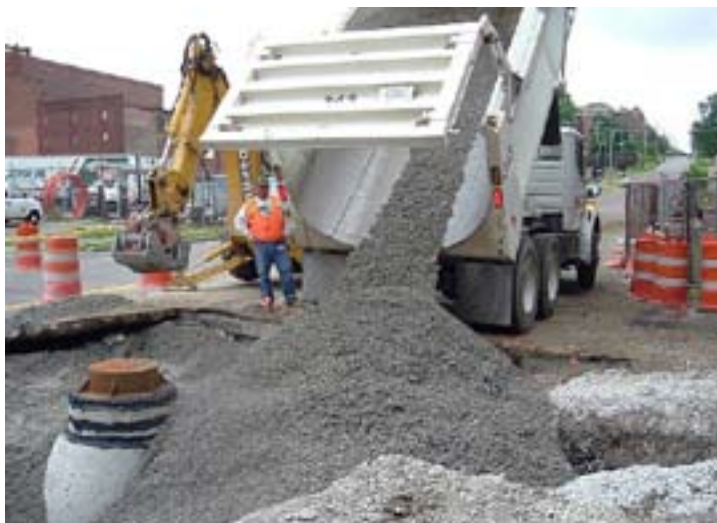
Large backfill lift being placed

Phase I of utility cut repair research, funded through the Iowa Highway Research Board (IHRB), consisted of both a survey of municipal authorities and field and laboratory investigations to identify factors contributing to the settlement of utility cut restorations in pavement sections. Responses received from seven cities across Iowa indicated that utility cut restorations often last less than two years. Observations made during site inspections showed that backfill material varies from one city to another, backfill-lift thickness often exceeds 12 inches and backfill material is often placed at
