Report On A

HWS HOSKINS-WESTERN-SONDEREGGER, INC.
ENGINEERS ARCHITECTS PLANNERS
LINCOLN, NEBRASKA

December 8, 1978

Traffic *Safety* *Study* **ANKENY, IOWA**

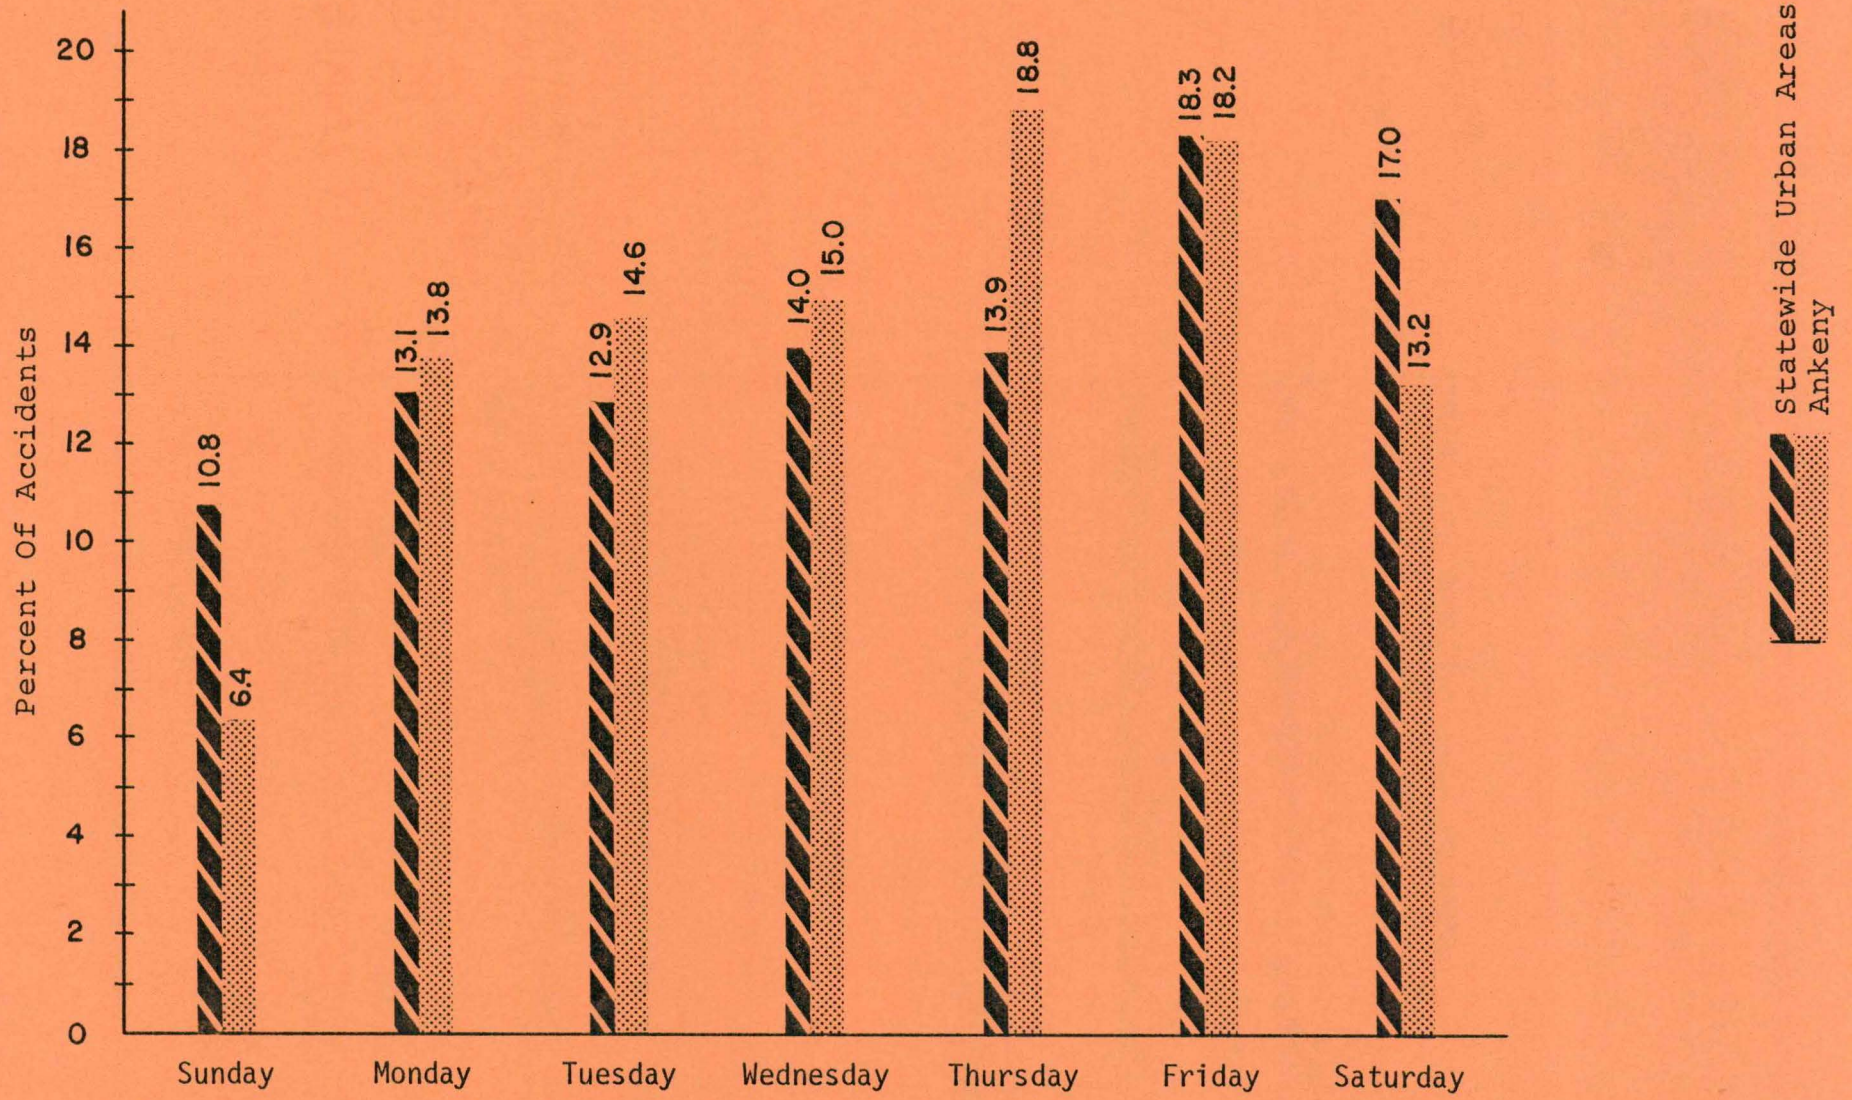
FIGURE C-2

CITYWIDE ACCIDENT STUDY
 DAY OF WEEK

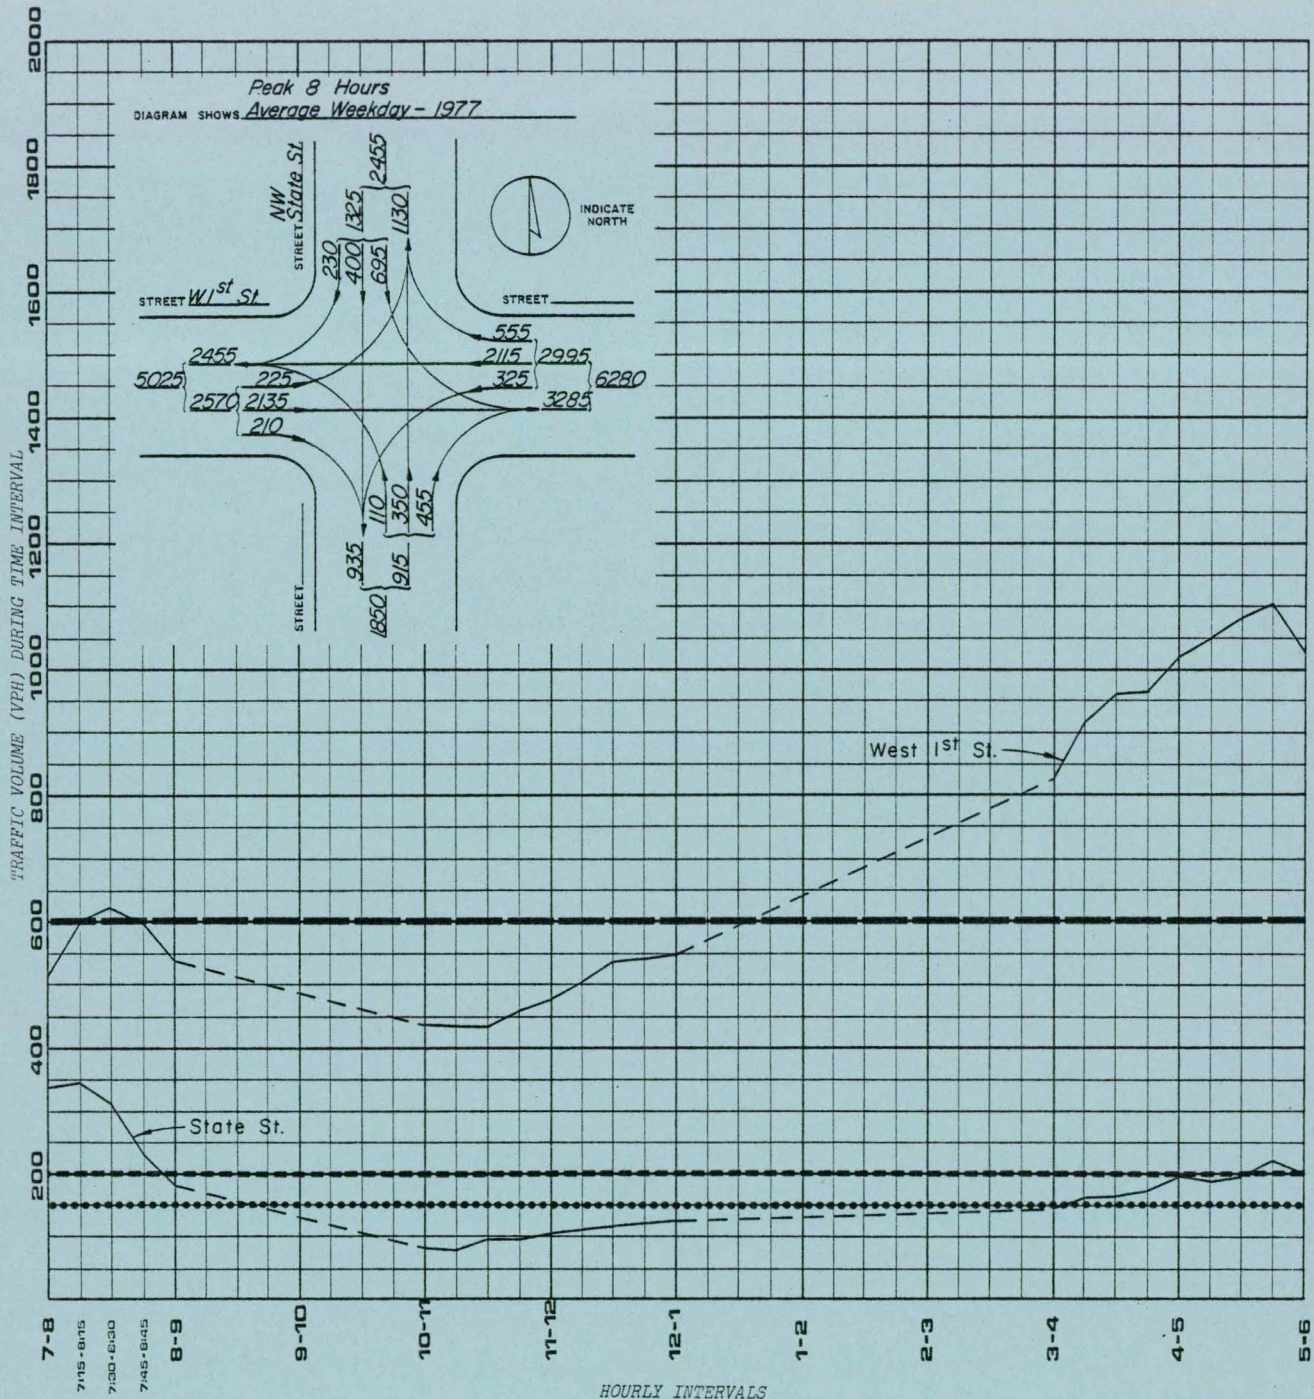
CITY OF ANKENY, IOWA TRAFFIC SAFETY STUDY	
TRAFFIC VOLUME TYPICAL HOURLY RATE W 1st ST. & STATE ST.	
Hoskins - Western - Sonderegger Lincoln, Nebraska	FIGURE D-2

TRAFFIC VOLUME - SIGNAL WARRANT

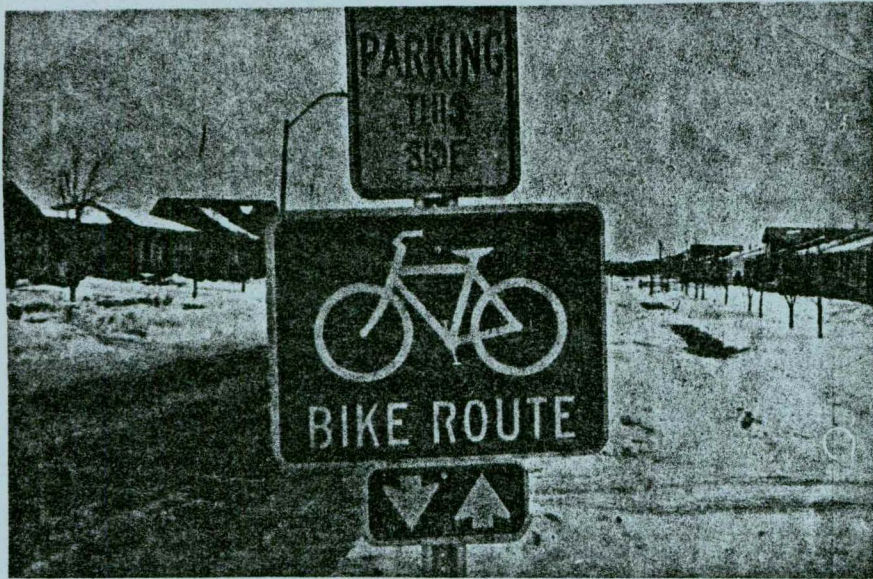
72 Bike Route signs in place throughout the City.

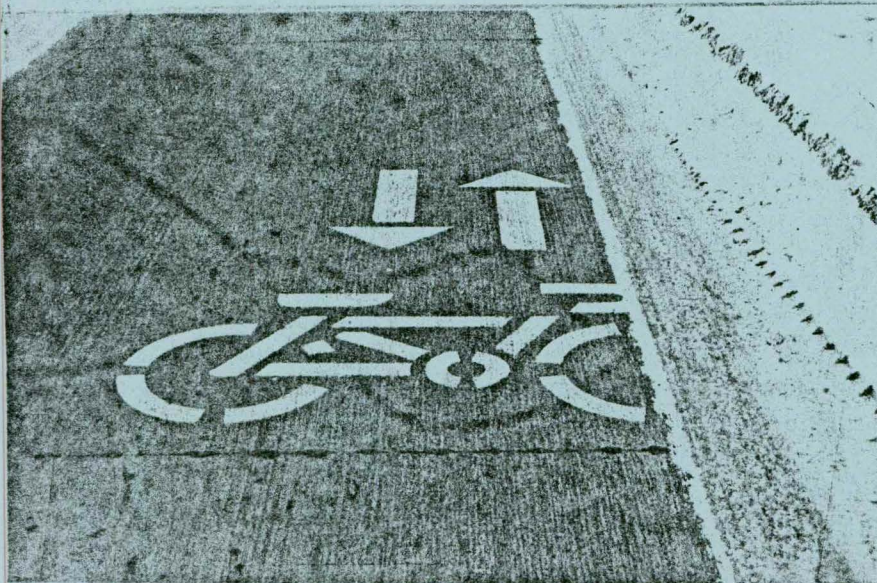
Nonstandard symbol marking, approximately 125 in place along designated routes.

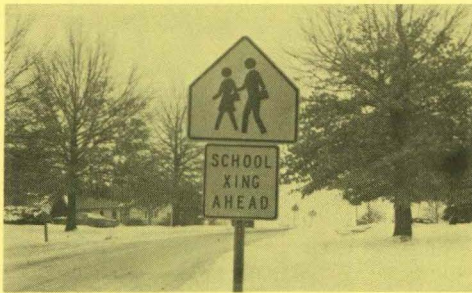
A Assembly recommended for approaches to designated school crossings--36" S1-1 sign and 24" panel.

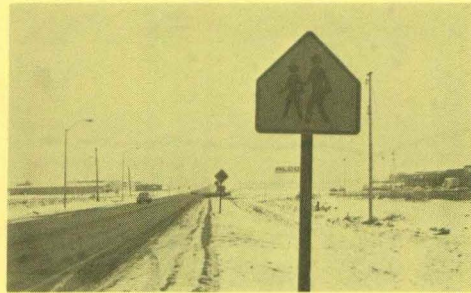
B 36" Type S1-1 Advance School sign for use on approaches to school areas.

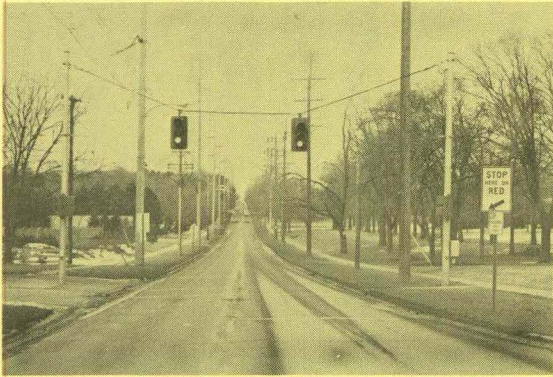
A Typical span-wire supported school crossing signal on a two-lane arterial, approximately 75 feet from intersection.

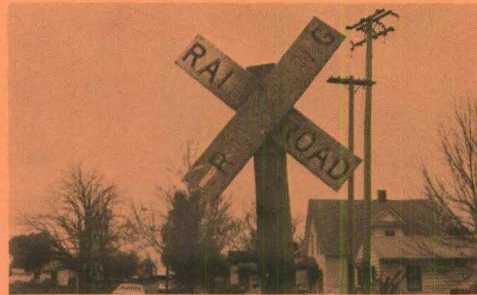
E-2 SW WALNUT STREET--Deteriorated Crossbuck

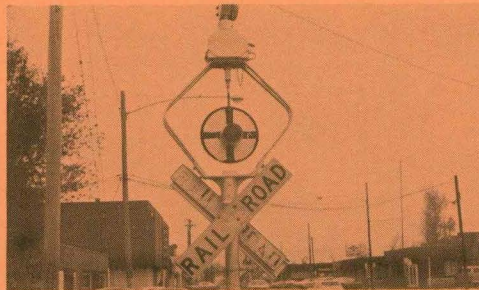
G-2 SW 3rd STREET--Deficient Maintenance
Of Substandard Equipment
