Creston, Iowa

# TRAFFIC SAFETY STUDY

Henningson, Durham & Richardson

January 1977

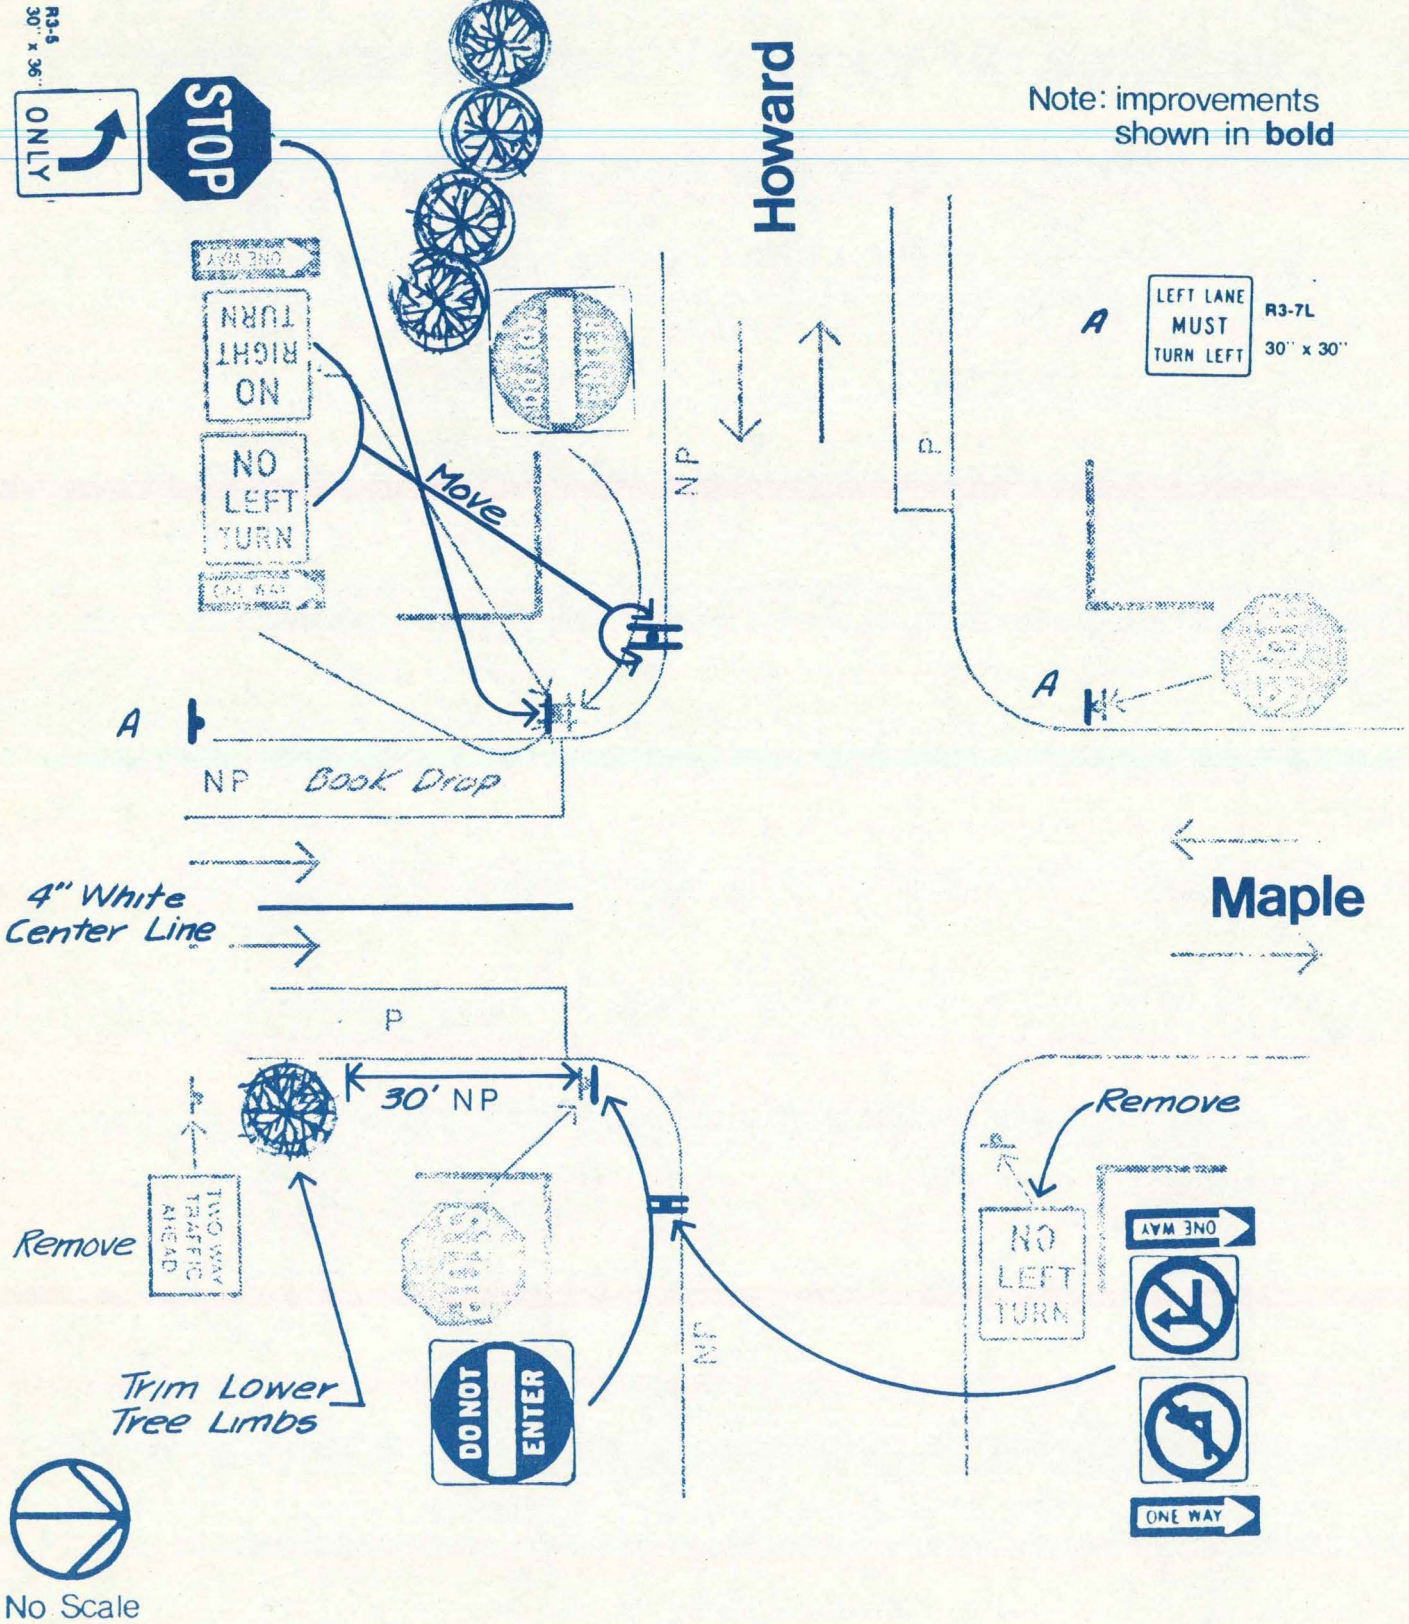
Creston, Iowa	P parking NP no parking	curb extensions & traffic islands	figure <b>5-23</b>
	<b>HOWARD at MAPLE</b>

Howard at Maple. The Appendix collision diagram shows a pattern number of right angle accidents at this intersection. A field inspection of the location shows that the sight distance for vehicles stopped on Maple (south leg of the intersection) is restricted by a line of trees extending along the south side of Howard and to the west of Maple. The trimming of the lower limbs of these trees should be completed to improve the sight distance and lower the accidents at this location. A sketch drawing of this improvement as well as additional signing improvements at this intersection may be found in Chapter 5.
