# **Cold In-Place Recycling Project Selection and Guidance for Iowa Roadways**

**Final Report  
July 2023**

**Sponsored by**  
Iowa Highway Research Board  
(IHRB Project TR-774)  
Iowa Department of Transportation  
(InTrans Project 19-695)

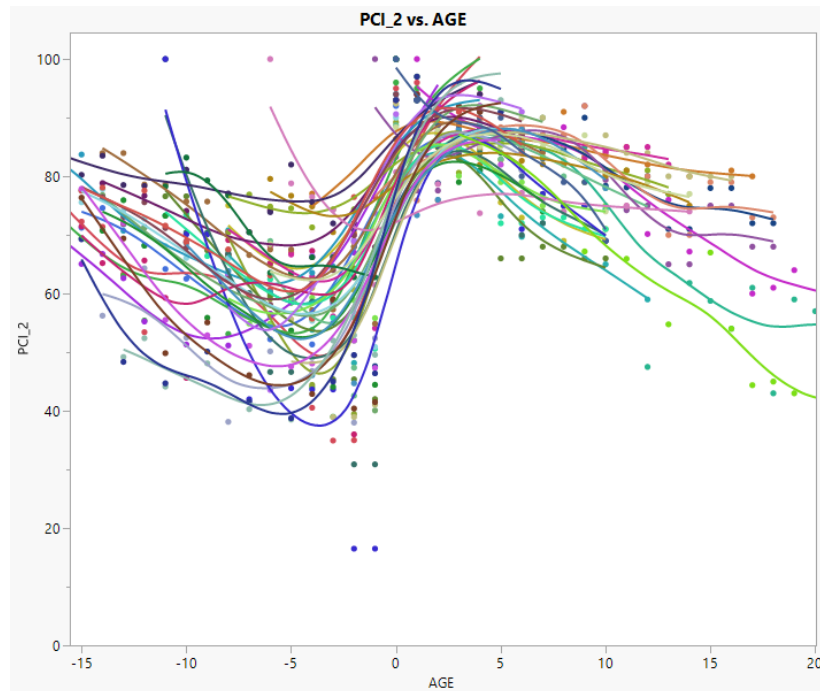
Figure 2-1 shows the PCI<sub>2</sub> values of the 44 pavement sections over the years from 1998 to 2019. For each pavement, the negative age indicates the period before the pavement had undergone CIR treatment.

**Figure 2-1. PCI<sub>2</sub> versus pavement age after CIR construction for 44 pavement sections**

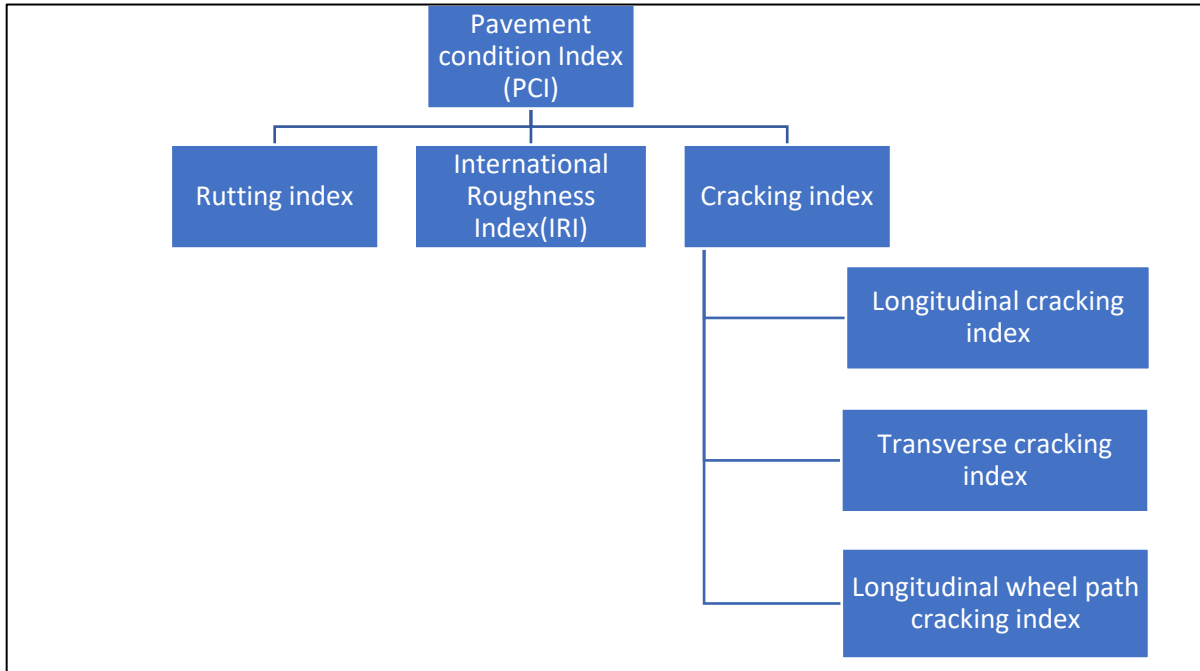
Figure 2-33 shows graphically which indices contribute to the pavement condition index (PCI<sub>2</sub>) and the cracking index (CRACK\_INDEX).

**Figure 2-33. Relationship among distress indices**

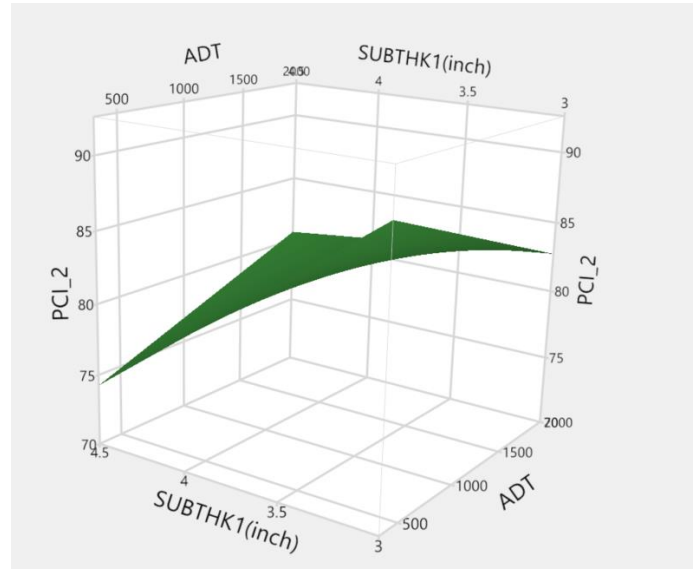
Figure 2-38 graphically depicts the relationship between ADT and CIR thickness. At high traffic levels, an increase in CIR thickness lends itself to higher PCI\_2 values, indicating that thicker CIR sections perform better than thinner CIR sections. However, this trend is reversed at low ADT levels, where an increase in CIR thickness tends to correspond with reduced PCI\_2 ratings. This trend appears to be the opposite at an ADT of 2,000, as seen in Figure 2-38(c). One explanation for this trend is that sections with lower ADT volumes had insufficient subgrade support to begin with, and it is possible that the load of a CIR train on these sections reduced the structural integrity of the base layers, leading to poorer performance. While this might not necessarily explain the variation in PCI\_2 values across CIR thickness levels, the PCI\_2 values for sections with lower ADT volumes are lower than those at higher ADT volumes, which strengthens the claim that adequate base support is required for good CIR performance. Another point of note is that no data exist for CIR thicknesses other than 3, 4, and 4.5 in., making it challenging to predict a surface connecting these points. In this regard, the surface plot should only be used for understanding the relationship between variables of interest and PCI\_2 and not for predicting intermediate values or any values that are not in the project dataset.

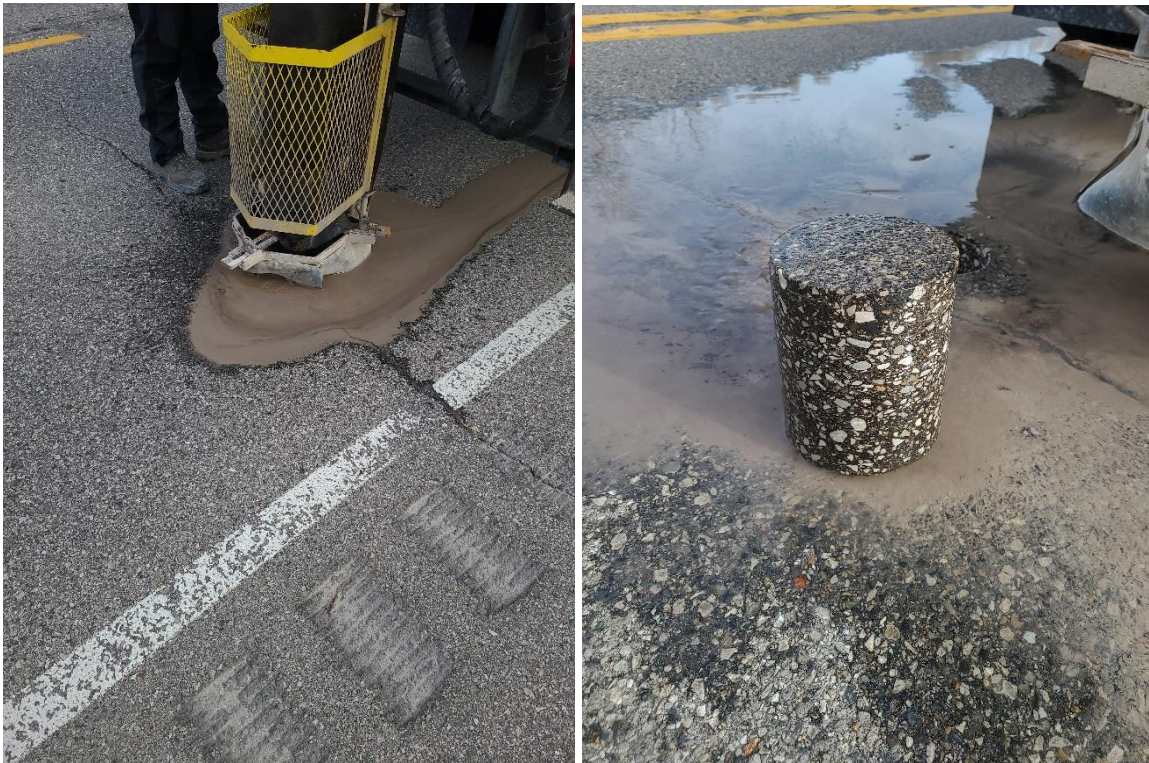
To investigate the underlying characteristics of CIR, field cores were collected from CIR/HMA overlay sections on US 34 in Mills and Wapello Counties, Iowa, on November 16, 2021. The cores were evaluated to determine the cracking resistance, binder contents, and gradations of both the CIR and HMA layers. A total of 16 cores with 6 in. diameters were collected from 8 locations at one-mile intervals along US 34. Two cores were collected at each location, one in the wheel path and one between wheel paths. The process used to obtain the CIR cores is shown in Figure 3-1.

**Figure 3-1. Process of collecting cores from US 34**

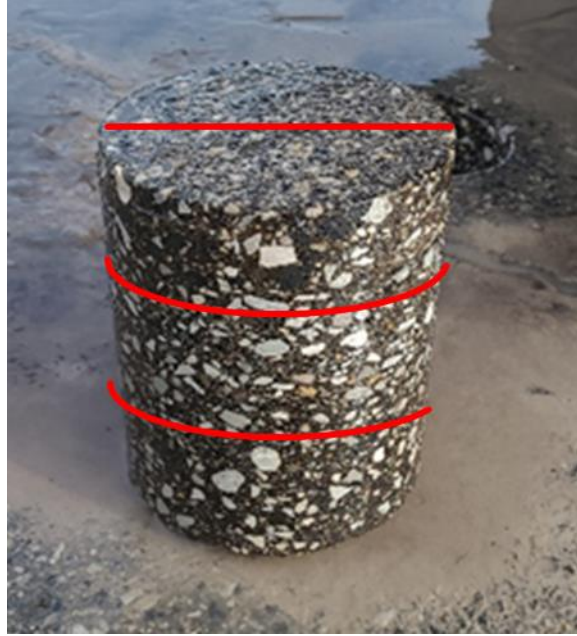
SCB tests were performed according to AASHTO TP 124 on the cores taken from US 34. As shown in Figure 3-2, samples for SCB testing were prepared by cutting the cores into semicircular specimens, each with a diameter of 150 mm and a maximum thickness of 50 mm (with some samples thinner because field core samples have various thicknesses). A notch 15 mm long and 1.5 mm wide was made on the flat side of each semicircular specimen to induce cracking. All specimens were conditioned at 25°C for 2 hours before performing SCB testing.

**Figure 3-2. Cuts made to prepare a semicircular specimen with a thickness of 50 mm**

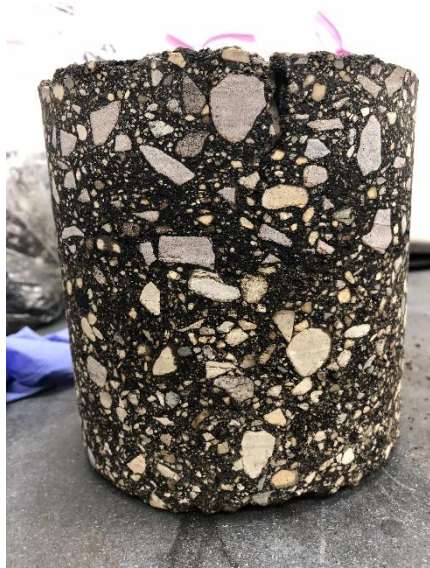
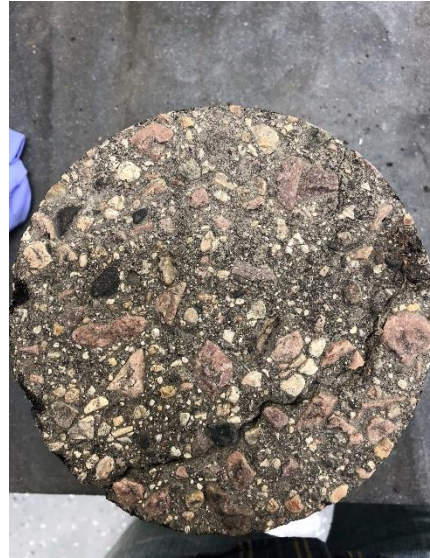
**Figure 4-2. Side view (a) and top view (b) of cracked O'Brien County core O3, which had a relatively thinner HMA lift thickness compared to cores with no distresses**

Figures 4-2 to 4-4 show broken or cracked cores.

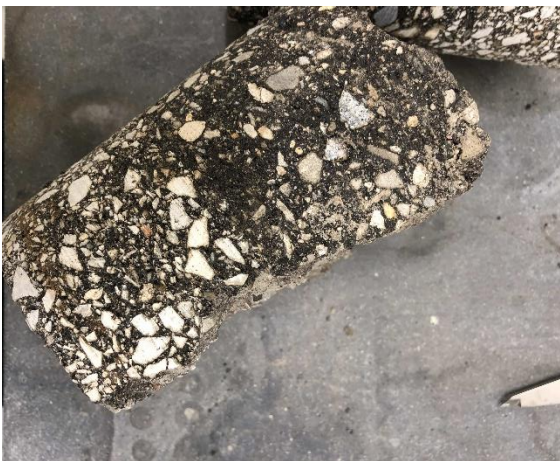
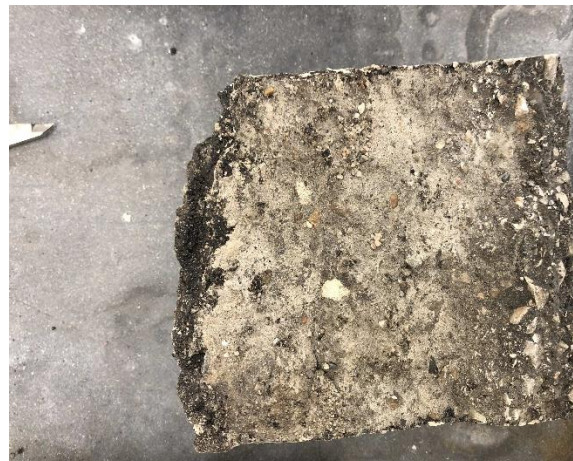
**Figure 4-3. Story County core S2 broken along its length due to cracking**

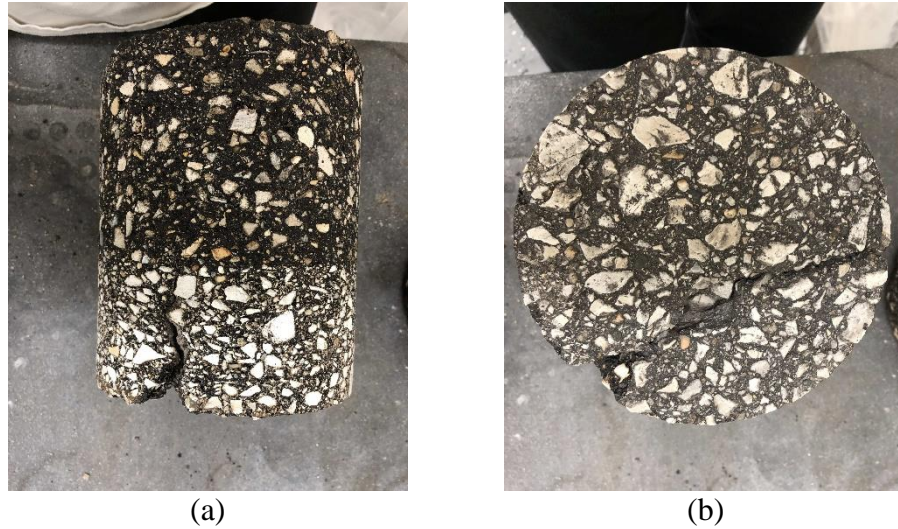
**Figure 4-4. Side view (a) and top view (b) of cracked Story County core S7, which had an insufficient HMA lift thickness**
