# Increase Service Life at Bridge Ends through Improved Abutment and Approach Slab Details and Water Management Practices

**Final Report  
October 2023**

**Sponsored by**  
Iowa Highway Research Board  
(IHRB Projects TR-722 and TR-739)  
Iowa Department of Transportation  
(InTrans Projects 17-605 and 17-637)

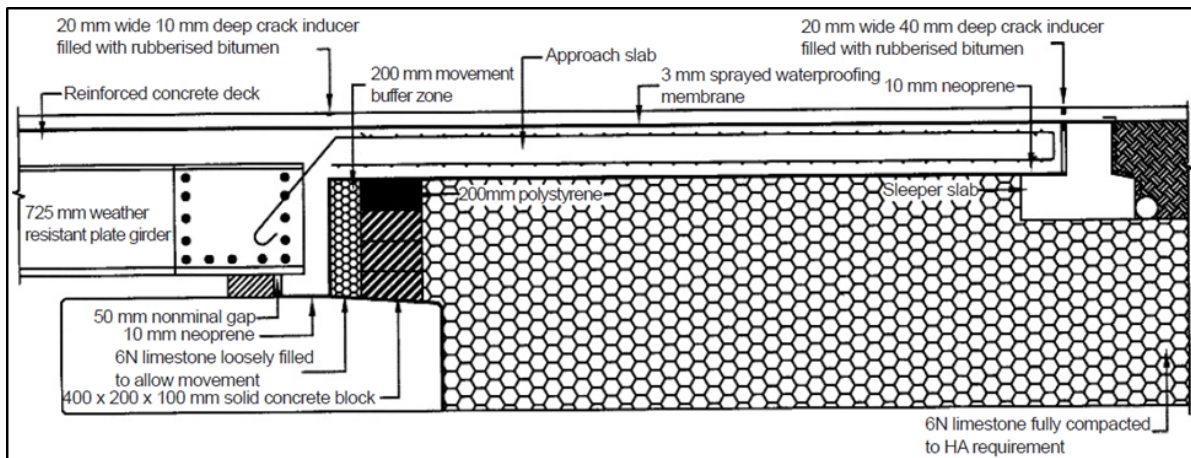
High skew angles can complicate bridge behavior and have a negative effect on performance if a bridge is not properly detailed. Biana (2010) presented a unique design completed in the United Kingdom to overcome some difficult design restraints (Figure 2.16).

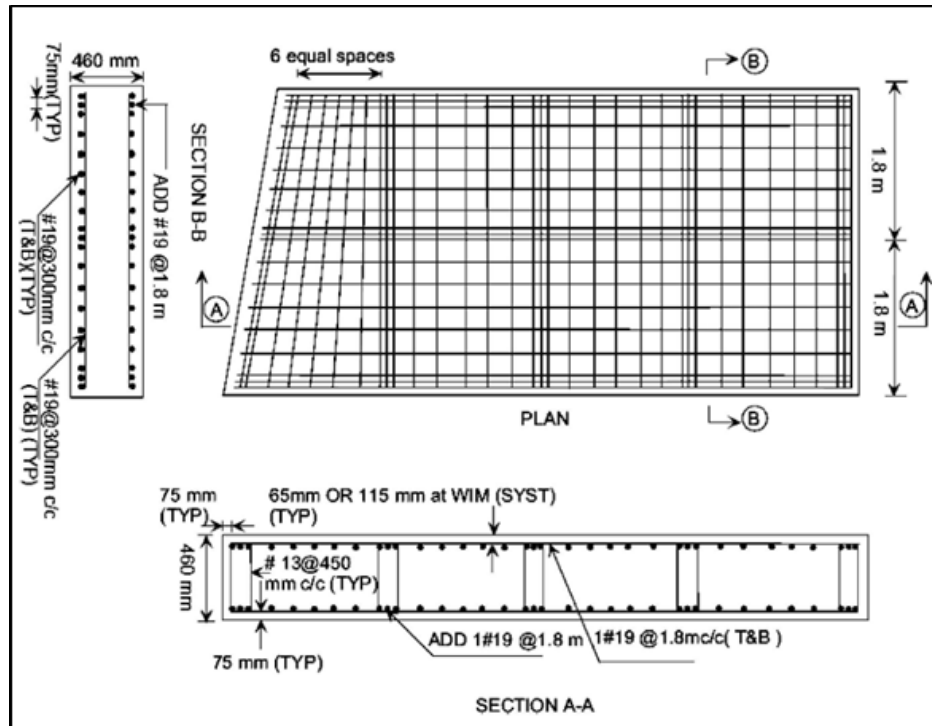
Nassif et al. (2009) compared the performance of the existing New Jersey standard approach details with two different prototype standards through field monitoring and finite element modeling. The two designs considered were embedded beam, shown in Figure 2.18, and continuous thickness. The continuous thickness design offers an increased thickness over the traditional design, and the embedded beam design places effective beams inside the slab every 1.8 meters in both directions to create plates that support only one wheel load of an HS-20 truck at a time. ABAQUS was used to create a 2D FE model using shell and spring elements along with a full 3D model of solid elements to model soil behavior. Both designs provided a minimum 2.8 times the cracking capacity of the existing New Jersey design, and the embedded beam design entrapped cracks within plates surrounded by effective beams. The embedded beam design was recommended for adoption by the NJDOT for future approach slabs.

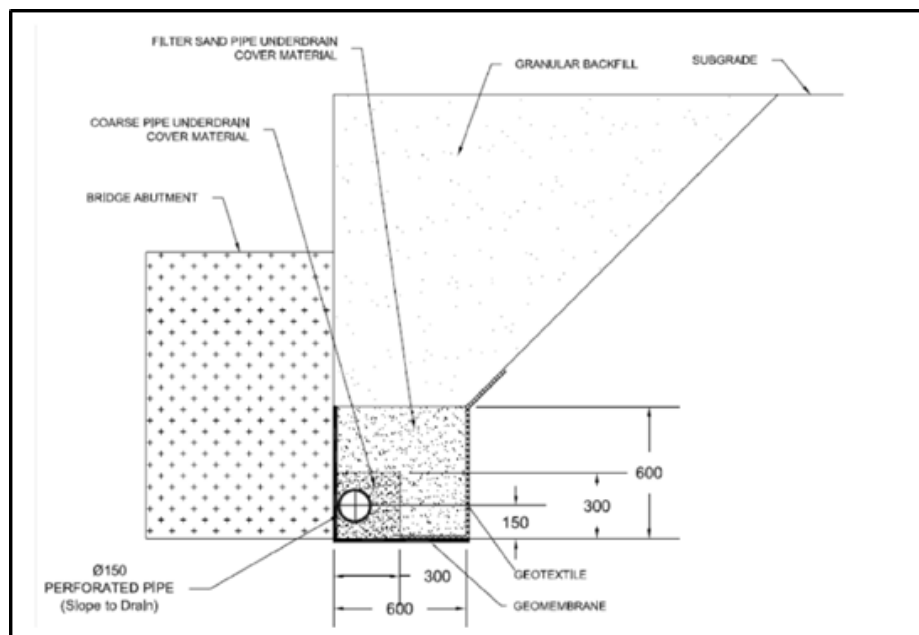
Thirty different bridges were inspected visually, with fifteen showing representative examples of erosion and drainage concerns. Common issues included large voids appearing under approach slabs and abutments, and surface drainage was categorized as universally poor, with separated joints or cracks allowing water infiltration. Staining on abutment walls indicated that soil loss was occurring through cracks in the abutment in some locations. Two bridges performed very well due to design changes in the drainage detailing. Shields Boulevard over I-35 included a neoprene sheet at the base of the abutment to block the hydraulic short circuit and prevent drainage from escaping under the abutment. Another example of poor detailing is that drain outlets, even when performing well, were allowing expelled water to flow back into embankments because of the outlet location. One recommendation was made to outlet drains near the bottom of slope walls into erosion-resistant drainage ways and to check and maintain all drainage systems regularly. Geomembranes can eliminate unwanted drainage paths and prevent short circuits under the abutment, as shown in Figure 2.20. Construction of embankments should involve a complete settlement analysis, which will illustrate the importance of the soil properties and identify issues with wetting-induced compression. Compaction should be made more accurate through the use of a relative density-based specification instead of a standard Proctor-based specification.

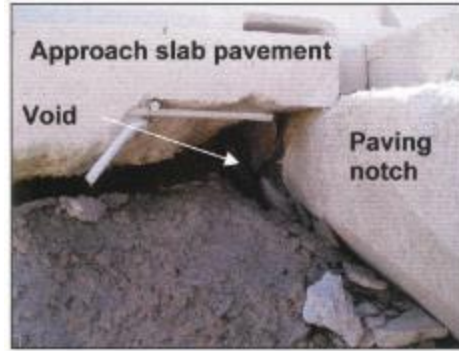
The findings presented above by Yasrobi et al. (2016) have been echoed by previous research. In a series of studies performed by White et al. (2005, 2007) that investigated 74 Iowa bridges to quantify common issues with failed approach slabs, it was determined that severe voids had developed under 25% of the inspected bridge approaches. In addition, severe erosion was present at 40% of the bridges, and 60% of the bridges had ineffective runoff. The majority of the bridges exceeded the recommended 1/200 slope proposed by Wahls (1990) and Long et al. (1998), and differential settlement of 2 to 6 in. was common at the end of the abutment wingwall. Runoff and erosion often accompany one another, as excess runoff typically leads to increased erosion underneath the approach slab. The erosion was found to typically leave a void ranging from 6 to 12 in. between the base of the slab and the geotextile-reinforced subbase (Figure 2.22).

**Figure 2.22. Voiding under approach slab**

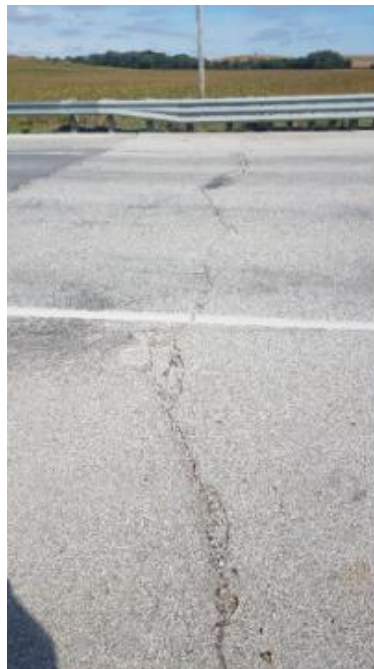
A similar study was performed by Nadermann et al. (2010), where it was observed that this temperature movement took the form of two patterns: a long-term cycle encompassing the general temperature movement throughout the year and a repeated short-term cycle as the temperature fluctuated throughout the course of each day. Again, while the tied connection observed in this study initially performed well, it was later shown to age poorly, excessively opening as time went on. The majority of the vertical tie bar connections investigated had not performed well in the long term, often opening more than twice their initial design width due to thermal movement. In addition, several of these bridges displayed transverse cracking similar to that shown in Figure 2.26, and it was hypothesized that this cracking and voiding would lead to inadequate drainage and further problems.

**Figure 2.26. Transverse cracking of approach**

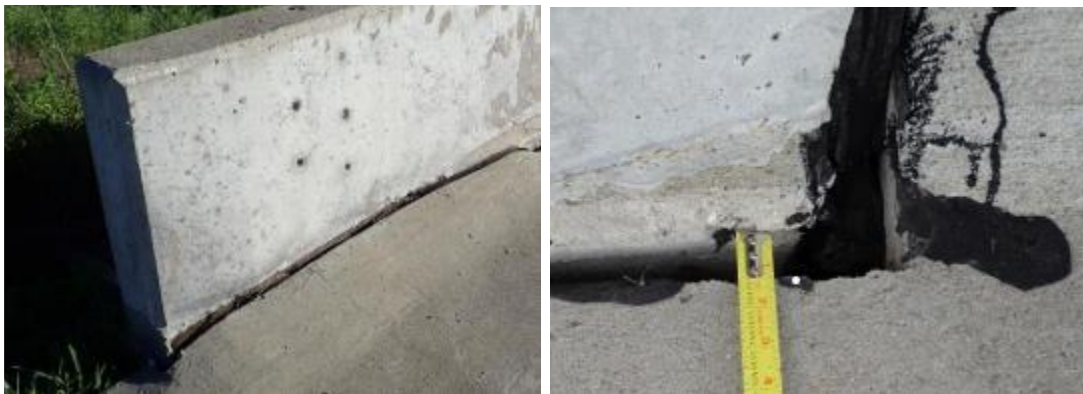
A second study with a similar intent was again conducted by WJE in 2018. In this case, the goal was to investigate the performance of 12 Iowa approach slabs with stub and integral abutments constructed between 2006 and 2015 following the implementation of design recommendations proposed by White et al. (2005). This second survey consisted of visual inspections and GPR and was supplemented by coring and borescope investigations to confirm the presence and extent of voiding. A large majority of the connection joints and expansion joints had fared poorly, differing from the design plans in opening width by as much as 3 in. The GPR and borescope inspections revealed similar performance to that documented in the 2011 report—the bridges with integral abutments displayed large voids adjacent to the abutments, likely from repeated thermal expansion and contraction. The approach slabs on these bridges were likely more susceptible to further erosion and damage as a result of these movement voids, such as the damage shown in Figure 2.27. However, it was recorded that many of these bridges were performing well structurally, although several did show signs of transverse cracking and pavement spalling. The maximum settlement and differential settlement were recorded as 1 in. and 0.4 in., respectively. Investigation of the performance of the stub abutment bridges displayed a stark contrast to the performance of the integrally connected bridges, with the stub abutment bridges showing much less voiding in general.

**Figure 2.27. Examples of voiding at integral abutment bridges**

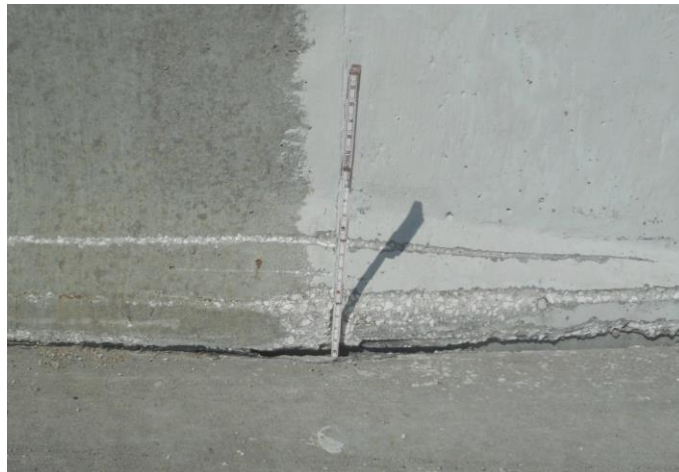
**Figure 2.28. Differential settlement at barrier**

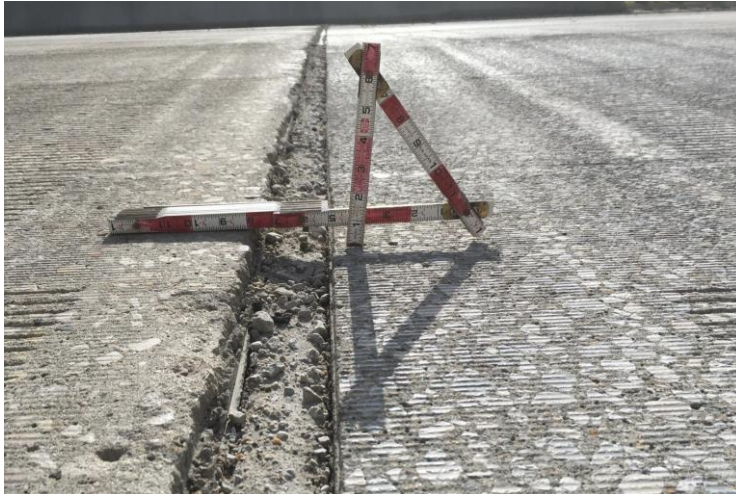
**Figure 2.29. Differential settlement at joint**

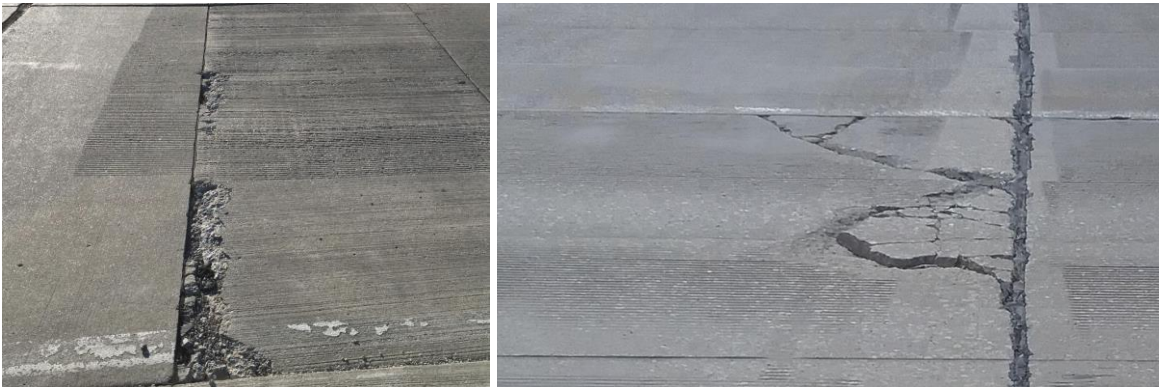
Spalling is another description recorded in the Bump Comments column. Figure 2.30 shows some common examples we saw and labeled as “Spalling.” This cracking of the pavement almost always resulted in a label of “Likely” in Bump Presence, as it appears to most likely cause a bump when a vehicle travels over it. Similar to spalling is the label “Abrasion at Joint.”

**Figure 2.30. Examples of spalling**

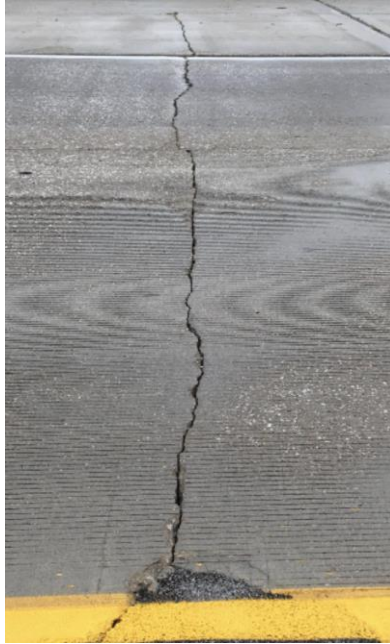
Another common description in the Bump Comments column is “Transverse Cracking.” This typically resulted in a label of “Likely” in the Bump Presence column. A transverse crack in the approach slab (Figure 2.31) usually appears to be significant enough to create a bump when a vehicle drives over it.

**Figure 2.31. Transverse cracking**

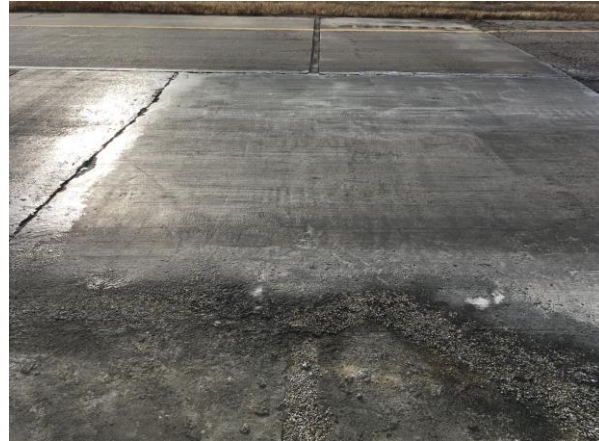
Large asphalt patches were observed a few times. Though this issue was rare, it would likely cause a bump in the bridge (Figure 2.32).

**Figure 2.32. Asphalt patch**

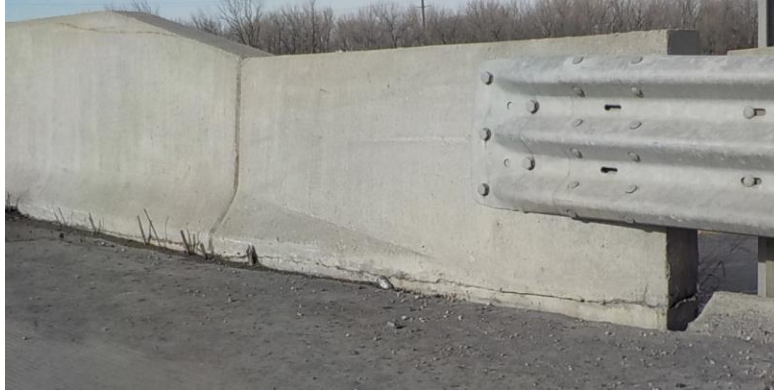
For the Settlement column, we looked for clear indications of settlement in the bridge structure and recorded a label of “No,” “Possible,” or “Likely” in the column. Cracking near or on the barriers was also an indicator of whether settlement had occurred. This can be seen in Figure 2.33 and Figure 2.34. Based on the clarity of the settlement, the terms “Slight” or “Clear” were also stated in the description.

**Figure 2.33. Cracking/Differential settlement at barrier**

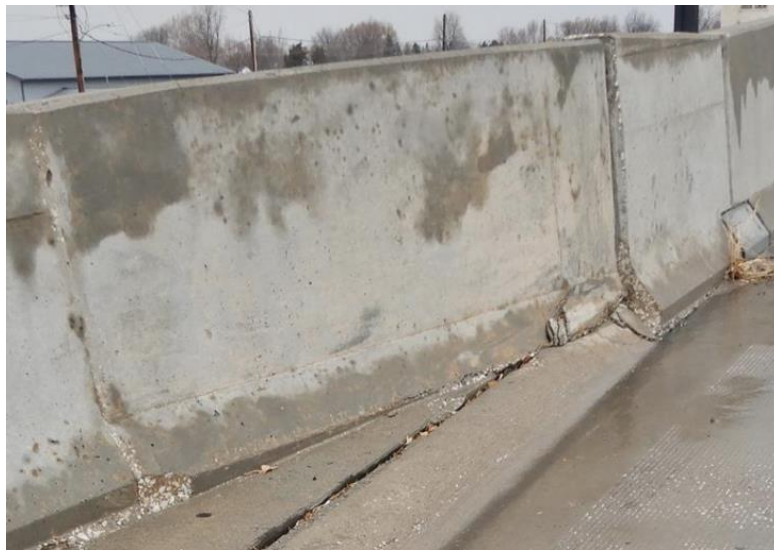
**Figure 2.34. Cracking at barrier**

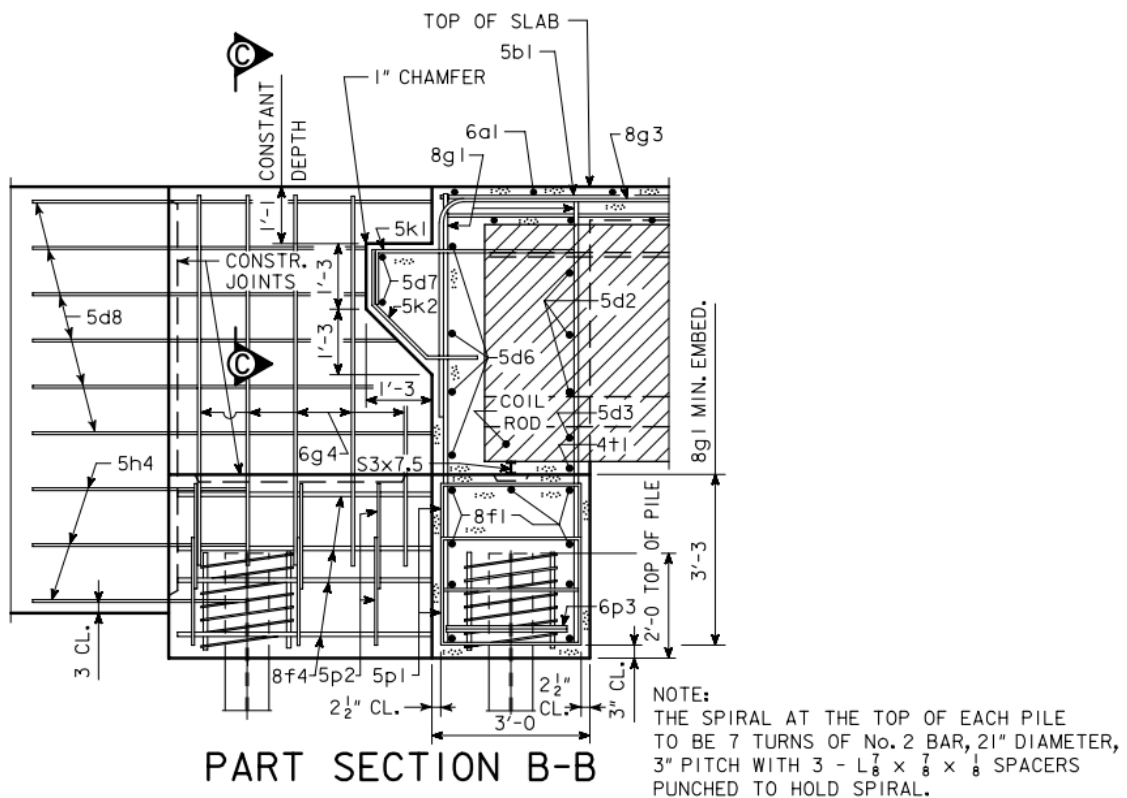
Next, we looked for the Abutment Type and Paving Notch Width. On the plan sheet, integral abutments most often appeared as they do in Figure 2.38. This is typically found midway through the plan sheets. In this example, the paving notch width is equal to 1 ft 3 in.

**Figure 2.38. Bridge plan sheet—abutment type**

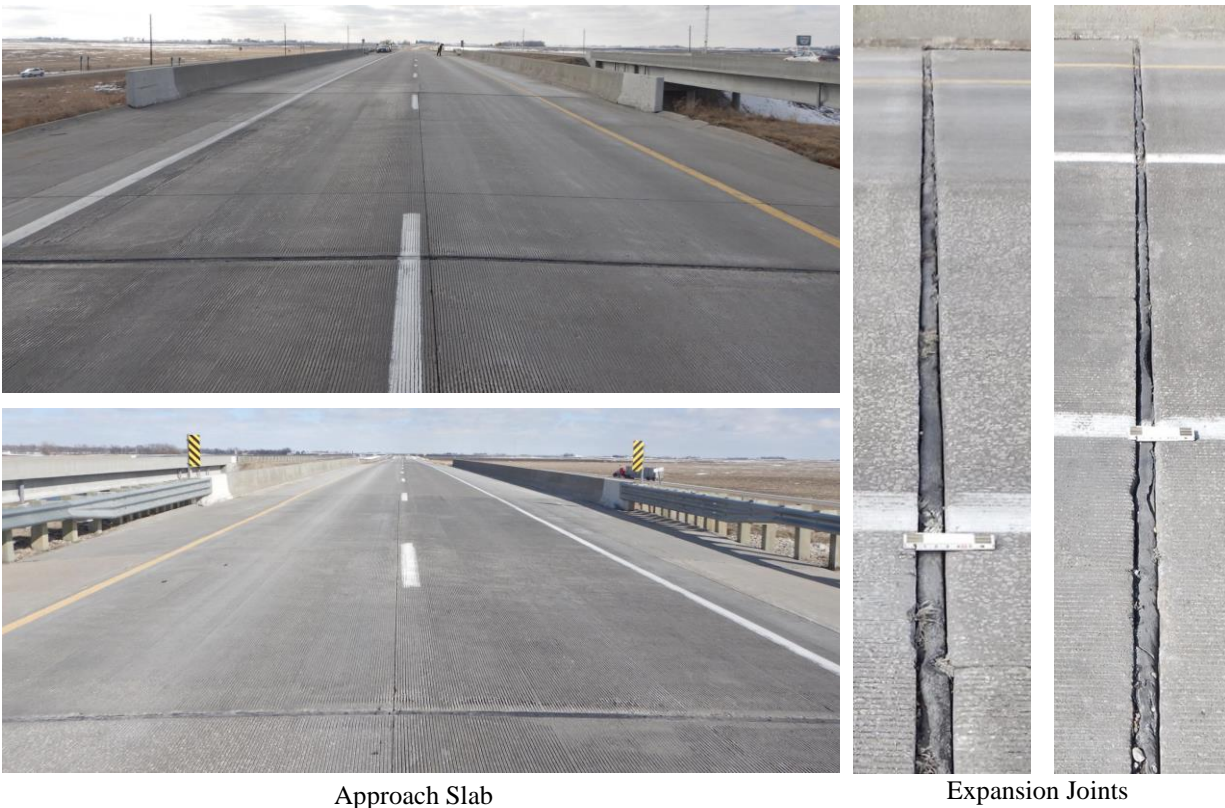
For the next step, we looked at photographs (Figure 2.40) from the most recent bridge inspection report to fill in information in the following columns: Bump Presence, Bump Comments, Settlement, Settlement Comments, Approach Slab Crack Presence, Cracking Location, Paving Notch Issues, Paving Notch Comments, Joint Issues, Joint Notes, and Additional Notes.

Looking at Figure 2.40, there is no clear evidence of transverse cracking, spalling, settlement, joint damage, or any other issues. This bridge appears to be in good condition. Looking at the photographs of the near and far expansion joints in the right-hand side of the figure, there is further evidence of good joint condition, no spalling, no settlement, and no cracking. The photographs of the barriers were also investigated to check for settlement or cracking at the barriers as well as erosion and any other issues (Figure 2.41). The four barrier photographs indicate that the barriers appear to be in good condition, with no signs of any issues.

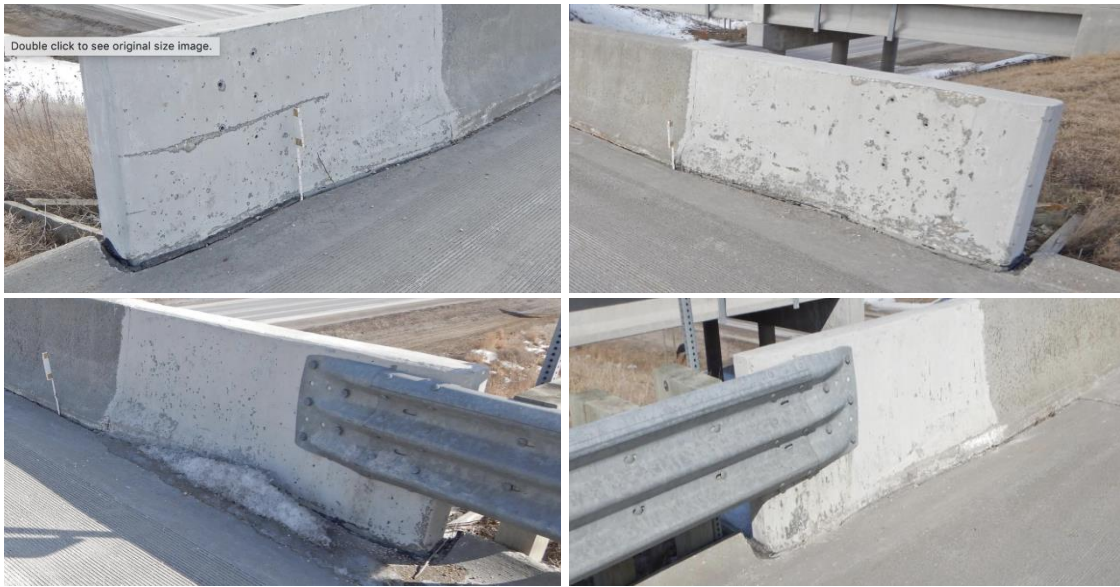
**Figure 2.41. Bridge inspection photographs—barriers**

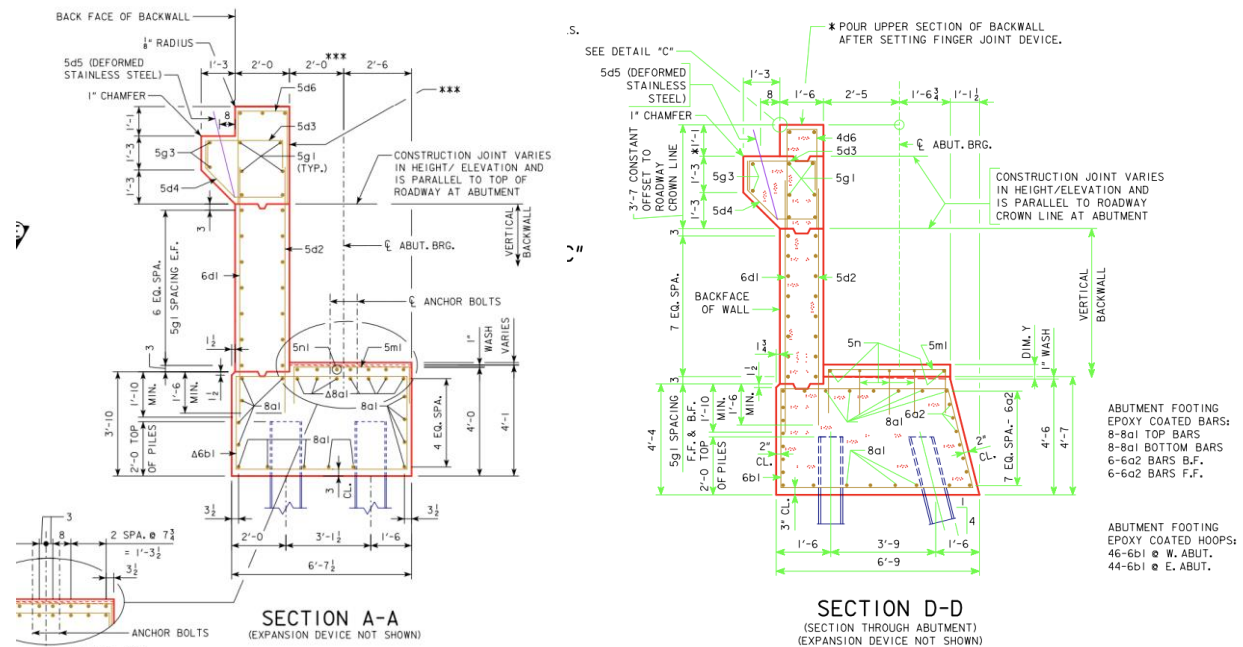
The other type of bridge abutment investigated was a stub abutment with either a strip seal or finger joint for the expansion joint. The same process described above was used to collect the general data and download the bridge plan sheets for the next two example bridges: a stub abutment bridge with a strip seal and a stub abutment bridge with a finger joint. For this type of abutment, the plan sheets show a design similar to the two plans presented in Figure 2.44.

**Figure 2.44. Bridges with stub abutments**

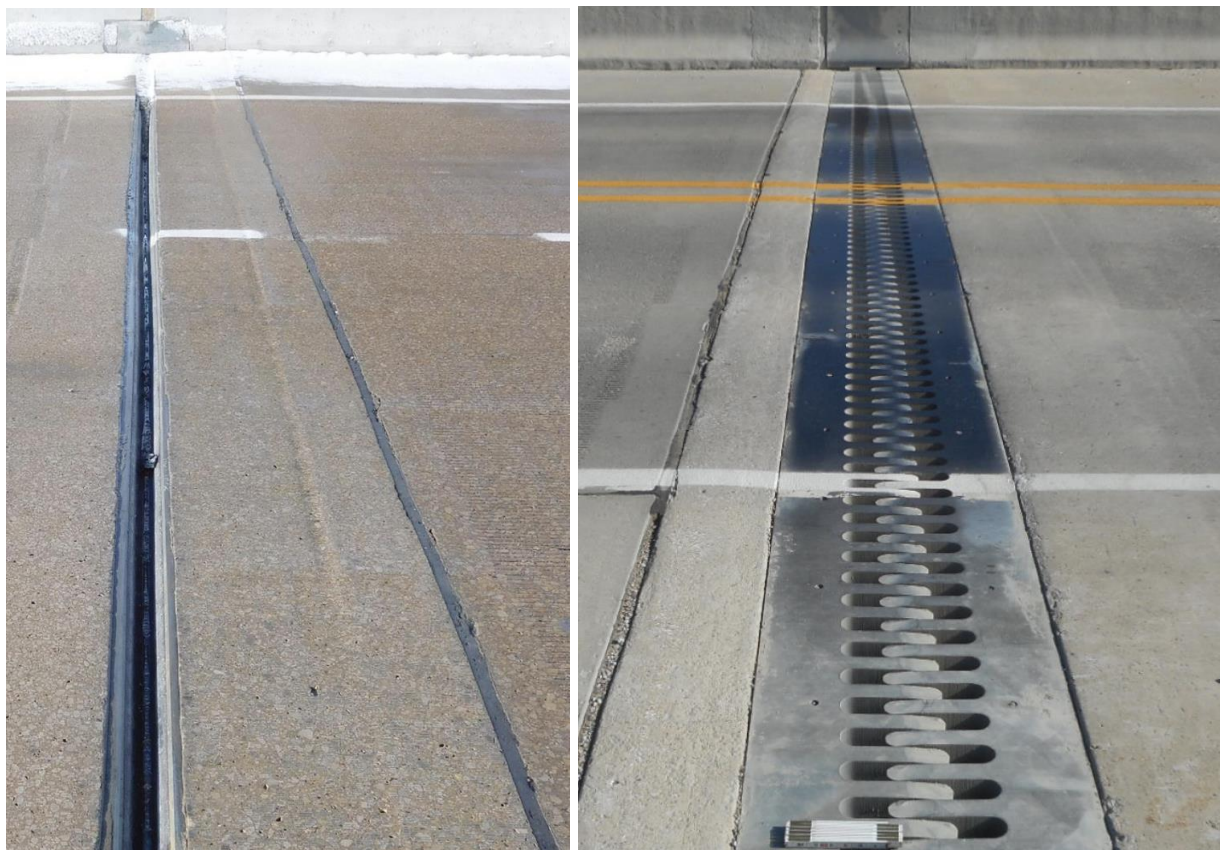
To determine whether the expansion joint is a strip seal or finger joint, we looked at photographs from the most recent inspection report. Figure 2.45 shows a strip seal expansion joint on the left and a finger joint on the right. These are both examples of expansion joints in very good condition. Neither appears to cause a bump when a vehicle passes over the joint. There is no apparent cracking, abrasion, or spalling, and the joint material looks to be in good condition with no debris.

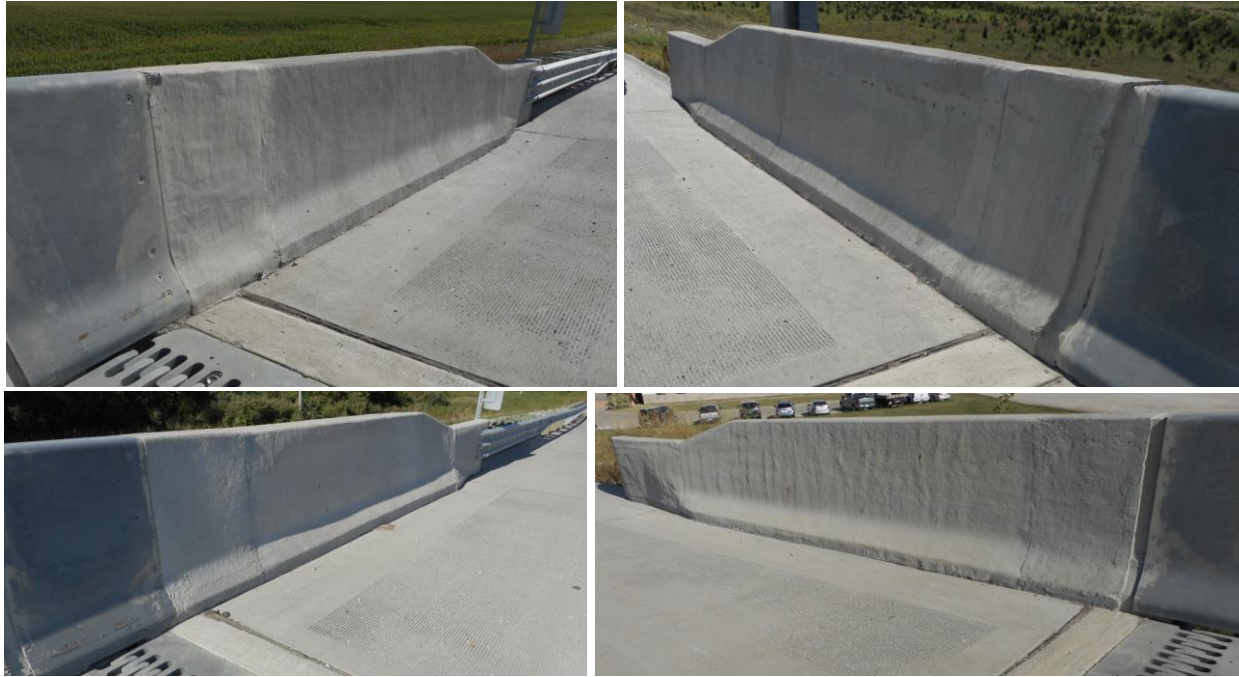
For the next step, we looked at more photographs of the bridges as well as the inspection sketches to see whether there are any issues with the bridges. As shown in Figure 2.47 for the

finger joint bridge, the barriers all look good, and there are no signs of settlement or cracking. The finger joint, as stated earlier, appears to be in good condition, and the inspection sheets provide no comments indicating otherwise. No photographs of the approach slab were provided, so we assumed that there is no transverse cracking or other issues with the approach.

**Figure 2.47. Bridge inspection photographs**

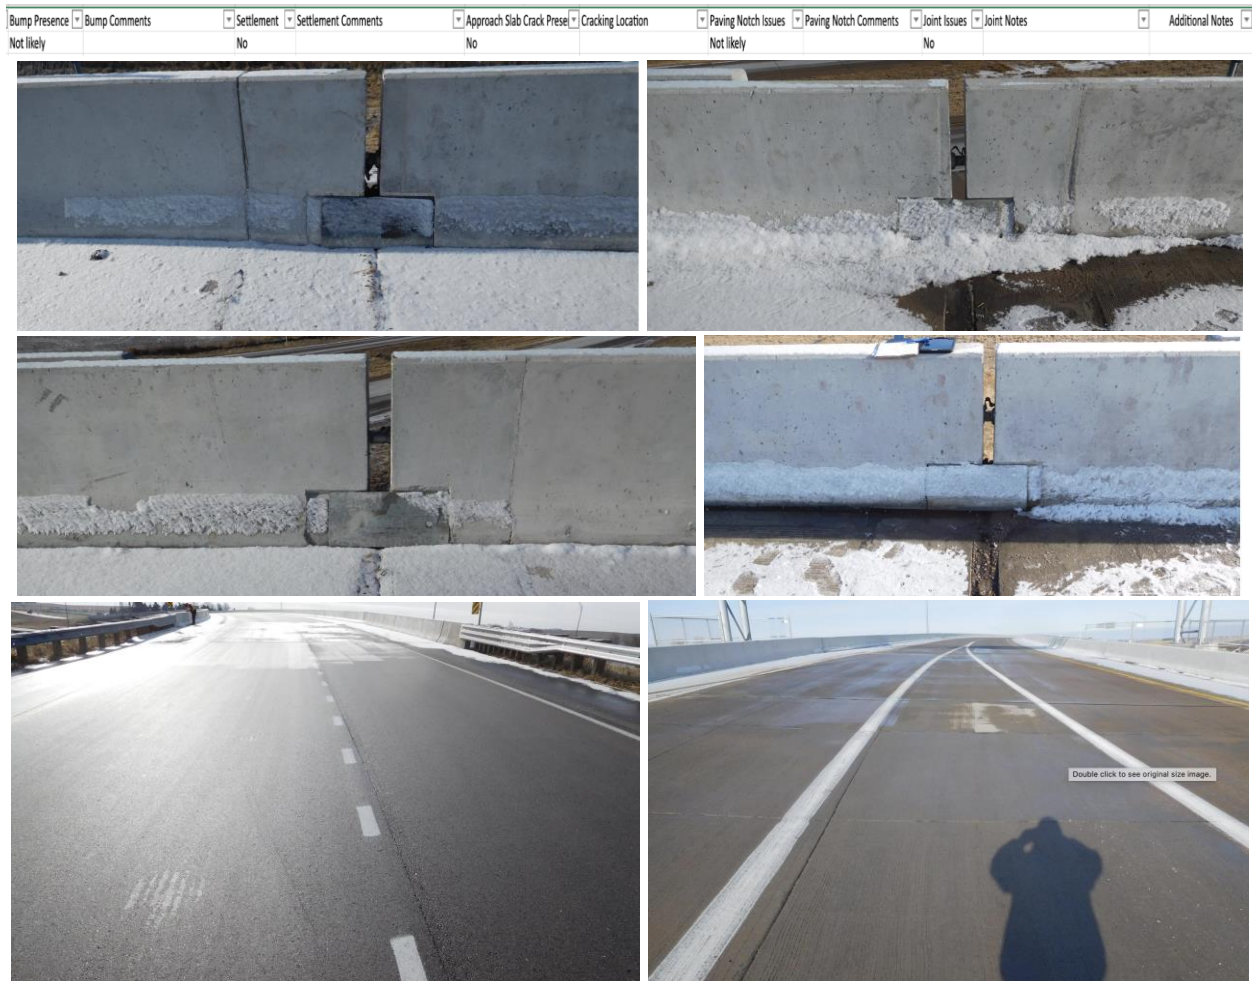
For the strip seal bridge, we carried out the same process of looking at photographs and the inspection sheets in order to determine whether any issues are present on the bridge (Figure 2.49). Looking at the barriers, there is no clear sign of cracking or settlement. As stated earlier, the joint appears to be in good condition, and there are no signs of cracking at the abutment. The inspection sheets confirm this good condition. The approach slabs show no signs of transverse cracking. Note that this bridge is a good example of an instance when we could not get entirely clear information from the photographs. The barriers in this example are covered in snow, and there were no past reports available.

**Figure 2.49. Bridge issues table and bridge inspection photographs**

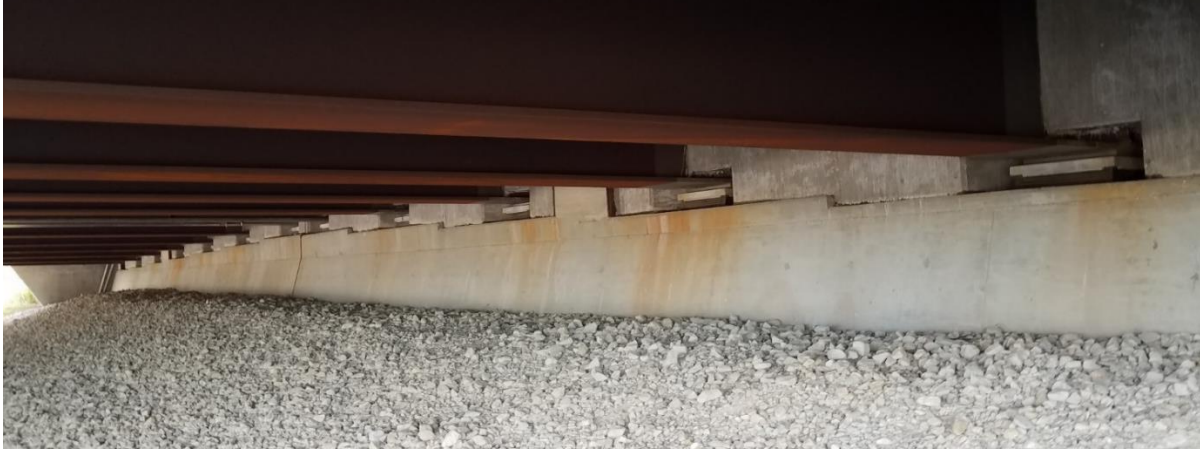
Both the north and south abutments had a large amount of rust-colored staining present below the bearings (Figure 3.2). At the corners, some water was still visible on the concrete surface (Figure 3.1, right). The source of the water was not readily apparent, but it was assumed it came through the abutment. Another possible source for the abutment staining could be that it happened during bridge construction if beams were placed and rain occurred before the bridge deck was placed to cover the beams. In that case, the water present at the corners could have been left over from a rain event before the time of inspection.

**Figure 3.2. North abutment face**

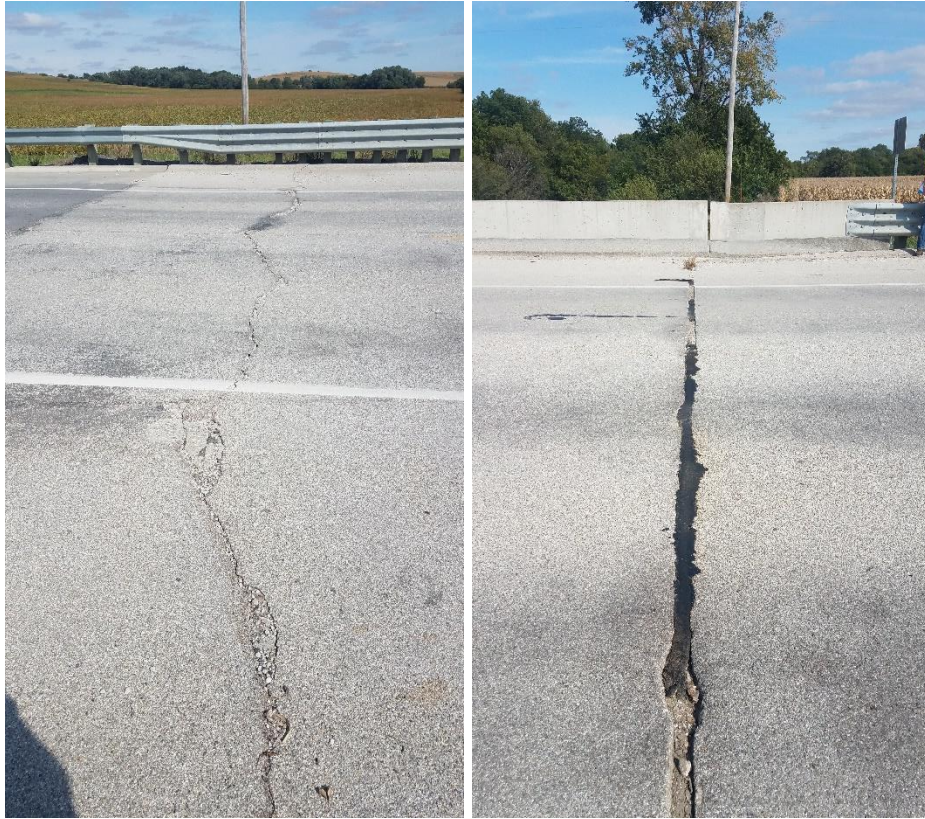
Beginning at the sleeper slab, the joints were in adequate condition. The approach slabs and the entire bridge deck were covered in a polymer overlay consistent with available plans. The west approach slab was badly cracked across its entire width (Figure 3.3, left). The joints at the abutments on both ends of the bridge were in poor condition, with large amounts of sealant missing and debris filling the voids (Figure 3.3, right). A 6 in. deep void was discovered at the abutment-to-approach-slab joint where it met the barrier in the southwest corner (Figure 3.4). Bridge surface water likely drains through the gap in the barrier instead of following the curb. The abutment faces did not have any staining, indicating that there does not appear to be any water leaking through the abutment. The embankment condition was good, with no obvious erosion except near the bridge piers.

**Figure 3.3. Transverse approach slab crack (left) and bridge-deck-to-approach-slab joint (right)**

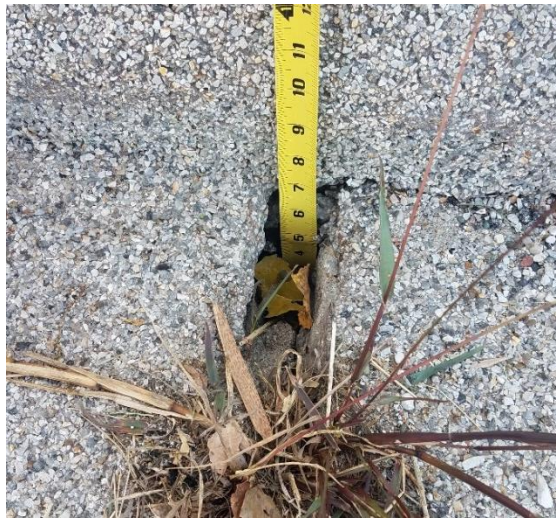
**Figure 3.4. Void at the intersection of bridge-deck-to-approach-slab joint and barrier**

The condition and performance of the joints between the wingwalls and the approach slab curbs appeared unsatisfactory on multiple occasions. Noted problems included a 6 in. deep void at the intersection of the approach to the deck joint and wingwall, separation of the approach slab and wingwall and opening of the joint, concrete cracking at the beginning of the approach slab curb, and frequent poor drainage resulting in buildup of debris at the beginning of the curb. The poor performance of the joints between the wingwalls and the approach slabs together with recommendations made based on a review of the literature indicate that barrier rails should be placed on top of the approach slab when the approach slabs are tied to the abutments. Strip seals are recommended for new construction of integral and semi-integral abutments. An example of a curb “kick-up” detail is provided, and a similar detail would be required to accommodate the continuous curb on the sleeper slab.

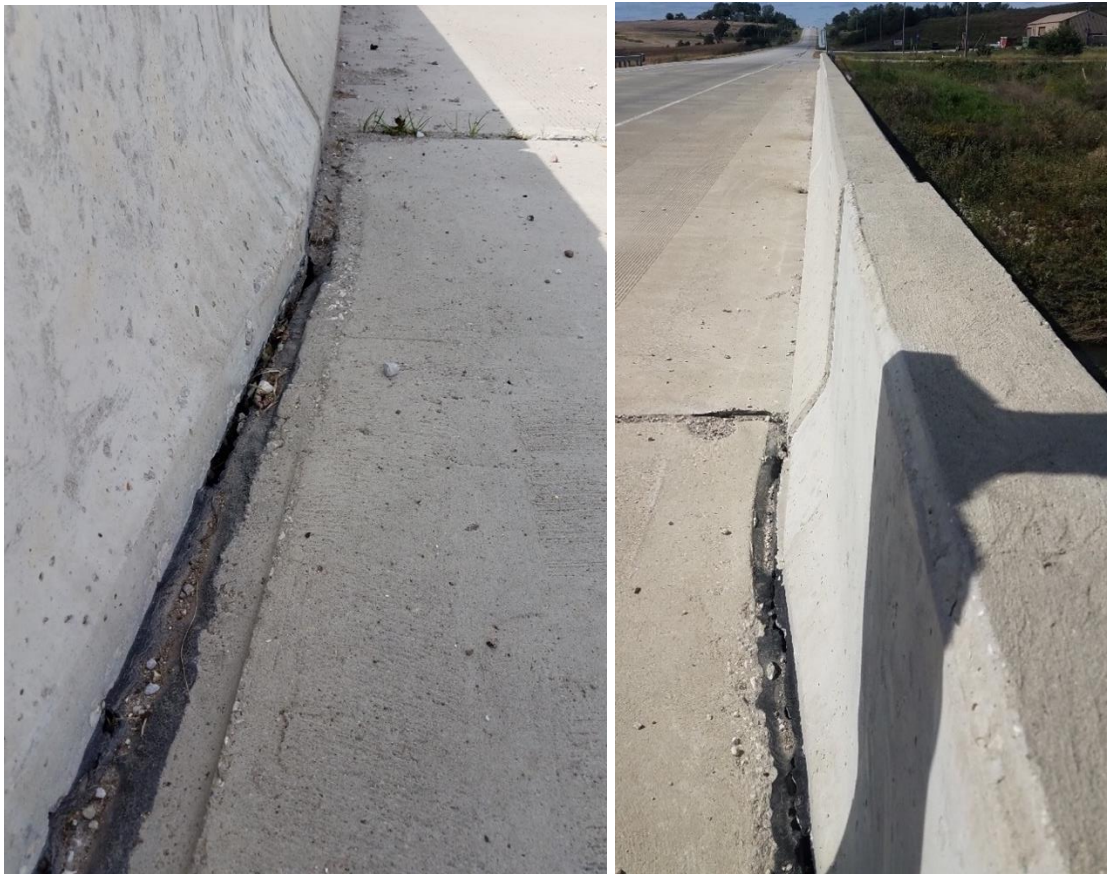
The pavement approaching the bridge from either direction and along the shoulder of the concrete panels was in poor condition and showed obvious settlement relative to the concrete. The joints at the end of the first approach slab section were in good condition, since there is no movement accommodated at that location. The east approach slab had a transverse crack near its eastern end. The abutment-to-approach-slab joints were in adequate or poor condition, with sealant missing and debris filling some of the joints. The curb joints between the approach slab and wingwall were in extremely poor condition, with sealant missing and large voids visible at each of the four corners of the bridge (Figure 3.5, left). The north wingwall at the east end of the bridge appeared to be moving away from the approach slab based on the gap present at the joint and misalignment of the barriers (Figure 3.5, right). The curb detail showing the E joint can be seen in Figure 3.6. The embankments were in good condition, and there was no staining on the abutment face. The bearings appeared to be working as intended.

**Figure 3.5. Approach-slab-to-wingwall joint showing separation (left) and misaligned wingwall and barrier (right)**

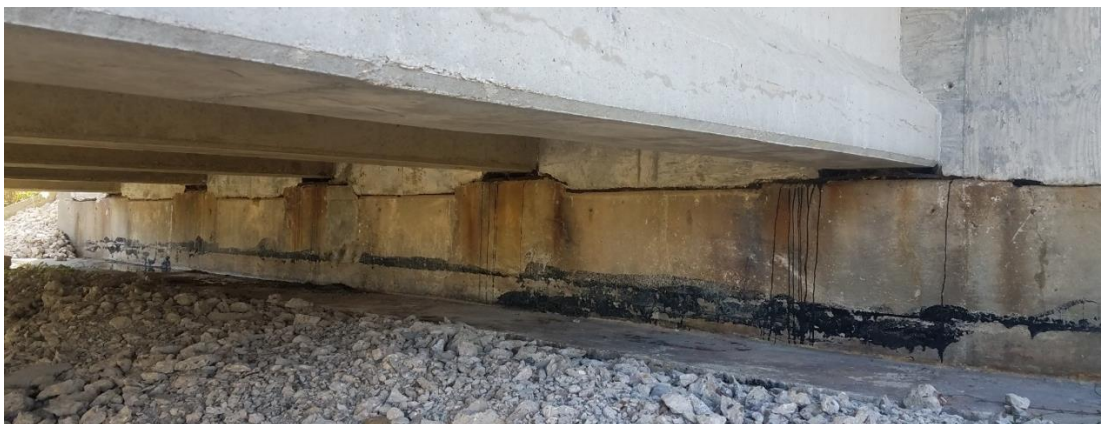
The sleeper-slab-to-approach-slab joints at both ends were in adequate condition, with some sealant missing and minor spalling. The approach slabs did not have any obvious cracking or settlement. The approach-slab-to-abutment joints were in good condition, with minor spalling at the north joint. The embankments and curbs were working as intended. Staining was visible on both the north and south abutment faces at each bearing location, but this appeared to be left over from before the rehabilitation and conversion to semi-integral abutments (Figure 3.7).

**Figure 3.7. Abutment face showing the new backwall on top of the old footing**

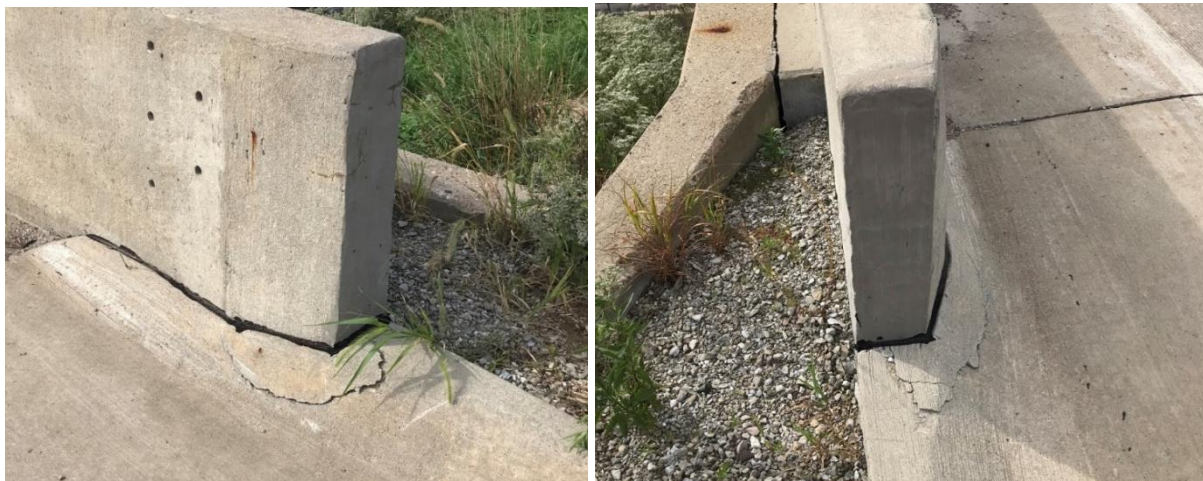
The northbound bridge was in generally good condition. Beginning at the ends, there was some joint sealant missing, and the joint between the transition slab and pavement was open on the north end. The approach-slab-to-transition-slab joints were all in good condition. The approach slabs had no major cracking or settlement and appeared to be performing well. At the south end, there was settlement of approximately 1 in. in the pavement meeting the concrete slabs in the shoulder. The drains exiting in the north embankment appeared shorter than they should be for proper drainage, as they are partially obscured by the embankment. The abutment was in good condition, with no visible staining. Minor cracking and spalling of the concrete were present at the wingwalls and the wingwall-to-approach-slab joints at the beginning of the curbs (Figure 3.8).

**Figure 3.8. Concrete cracking at the end of the wingwall (left) and additional cracking at the end of the wingwall (right)**

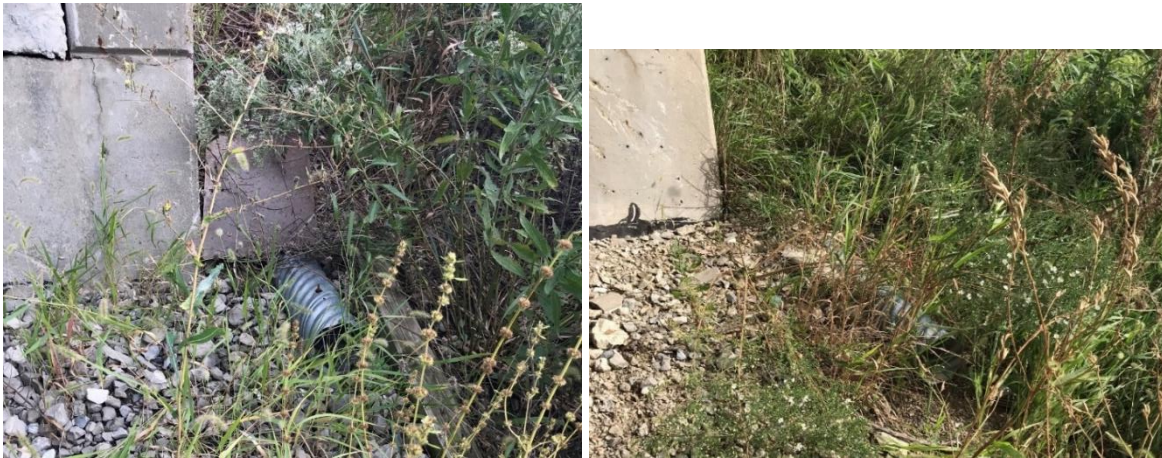
were very close to becoming blocked, with debris piling up at the outlet and the northwest drain completely closed (Figure 3.9). In areas with pavement shoulders, there was visible settlement relative to the concrete panels.

**Figure 3.9. Blocked embankment drainage (left) and additional blocked embankment drainage (right)**

Abutment drainage was largely free of debris and able to drain water from behind the abutments should it infiltrate the deck joints. A single bridge, 310 Jasper Southbound, had drain exits for which the openings were very close to becoming blocked, with debris piling up at the outlet and the northwest drain completely closed.

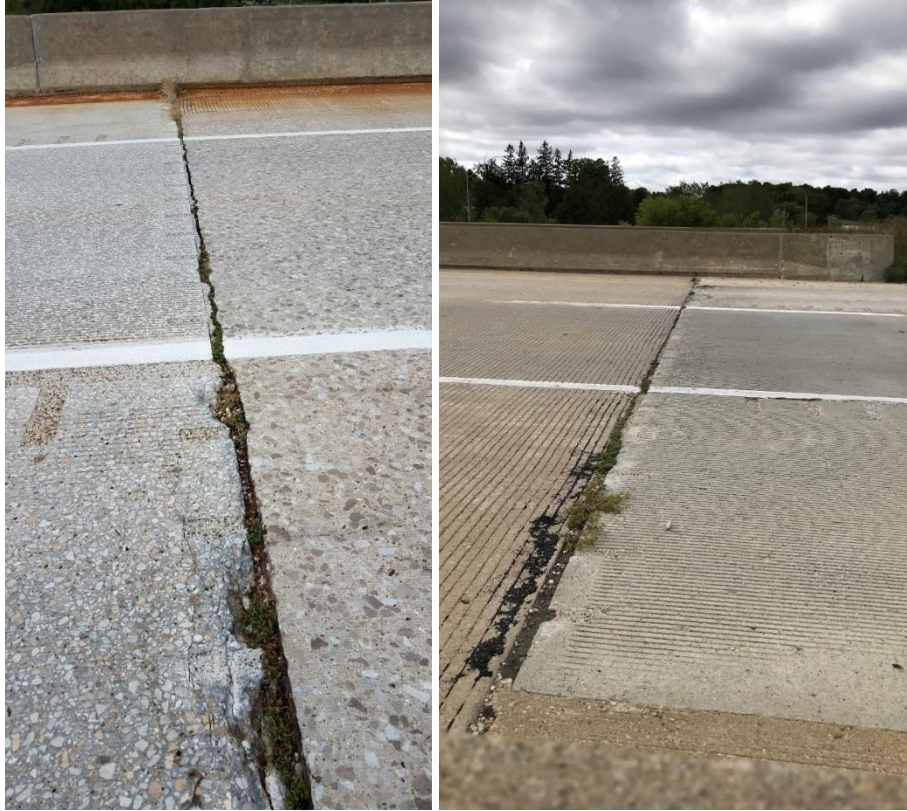
The EF joints between the approach slab and transition slab appeared to be in adequate condition, except for vegetation growing in the joints outside the traffic lanes. The approach slabs were also performing well except for some spalling on the north end (Figure 3.10).

**Figure 3.10. Deck-to-approach-slab joint showing severe spalling (left) and additional deck-to-approach-slab joint showing severe spalling (right)**

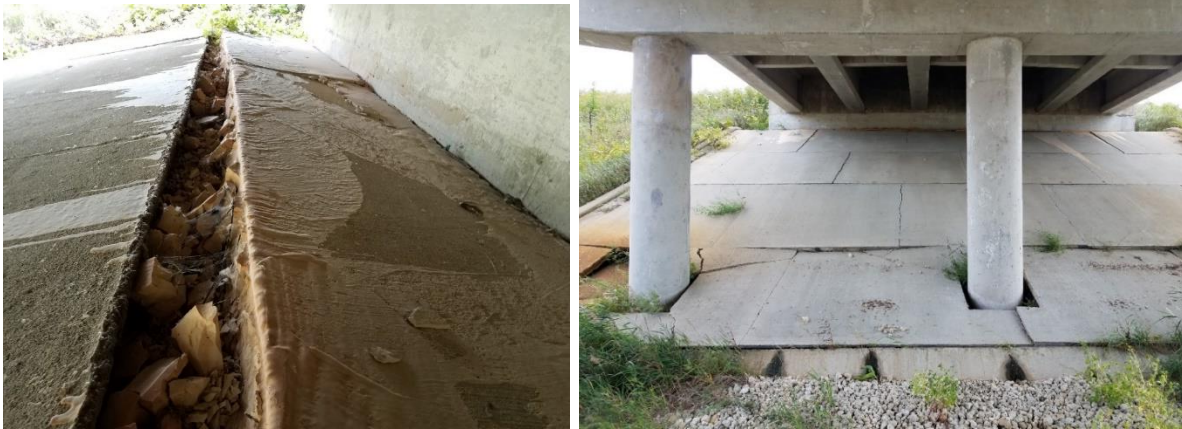
The embankments used concrete slope protection under the bridge. On the north end, there was a large gap between the inclined portion and flat section at the top of the embankment as if the entire concrete slope was sliding (Figure 3.11, left). The slope portion was otherwise intact. The south end was performing even worse, with a larger gap between the concrete slabs, broken sections around the pier columns, and vertical settlement based on markings on the abutment. Repair work had attempted to fill the joints, but the material was cracked into pieces and joints have continued to open.

**Figure 3.11. Typical embankment condition (left) and embankment condition at the abutment (right)**
