# Increase Service Life at Bridge Ends through Improved Abutment and Approach Slab Details and Water Management Practices

**Final Report  
October 2023**

**Sponsored by**  
Iowa Highway Research Board  
(IHRB Projects TR-722 and TR-739)  
Iowa Department of Transportation  
(InTrans Projects 17-605 and 17-637)

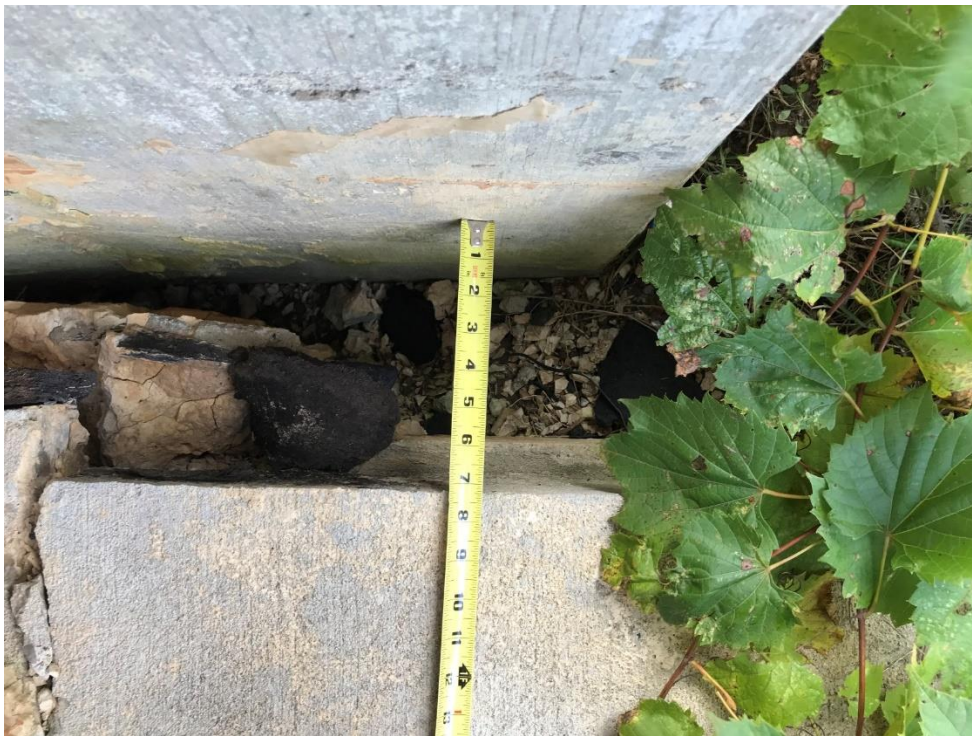
At the west corner of the south abutment, there was a large void at the corner of the abutment that measured 23 in. deep (Figure 3.12, Figure 3.13). The end of the tape measure used to assess the void was able to hook onto the underside of the concrete abutment.

**Figure 3.12. Horizontal void created by the embankment pulling away from the abutment**

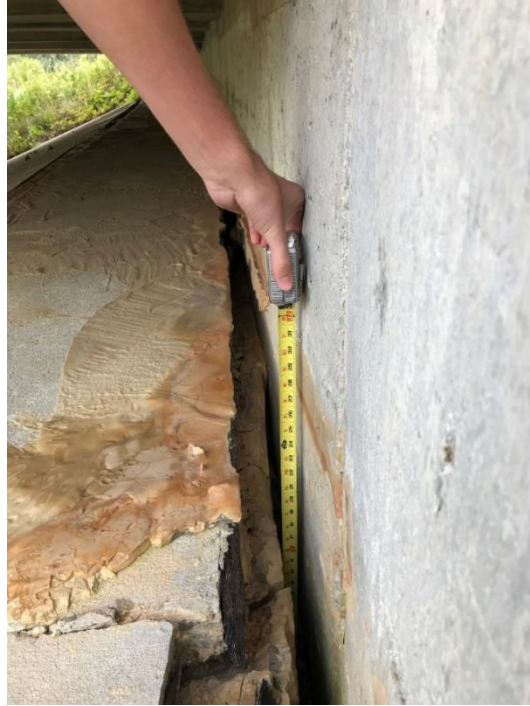
**Figure 3.13. Measuring tape showing the vertical depth of the void**

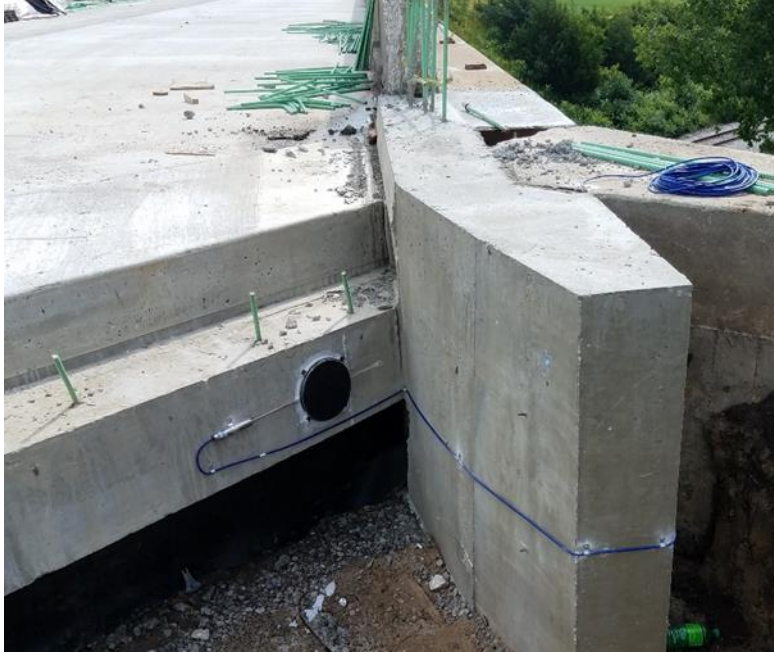
Sensor installation at Jasper County 118 began with placement of earth pressure sensors at the west abutment out of necessity due to construction sequencing. The contractor completed the bridge deck replacement first before constructing and pouring the semi-integral abutments. The abutment backwall was left exposed for earth pressure sensor installation before backfilling (Figure 4.4). Initially, the sensors were intended to be placed on the same longitudinal axis as the outer bridge girders; however, due to the extreme 45 degree skew of the bridge and working space limitations, they were placed closer to the center, with the outside edge of the sensor on the girder axis. The decision was made to shift all other sensors to the same axis for the sake of consistency. The earth pressure sensors were intended to illustrate how earth pressure along the backwall can vary due to skew.

**Figure 4.4. Jasper County 118—EP1-W earth pressure sensor after installation**

Each sensor had been prepared by attaching an adhesive neoprene layer to the face to help distribute load for granular particles. A thick layer of mastic adhesive was applied to the back of each sensor, and the sensor was pressed against the concrete surface, causing mastic to flow out from behind. While the sensor was held in place, holes were drilled using a hammer drill for each of the four tabs for attachment. Concrete screws attached the sensor to the concrete, and the excess mastic was removed from the edges. The wires were run around the abutment and kept tight to the concrete surface using small tabs and additional concrete screws. The final step included taking initial digit and temperature readings using a Geokon GK-404 readout unit on position B. The contractor was advised to use smaller 3/8 in. aggregate from a pile located on site to fill against the sensors.

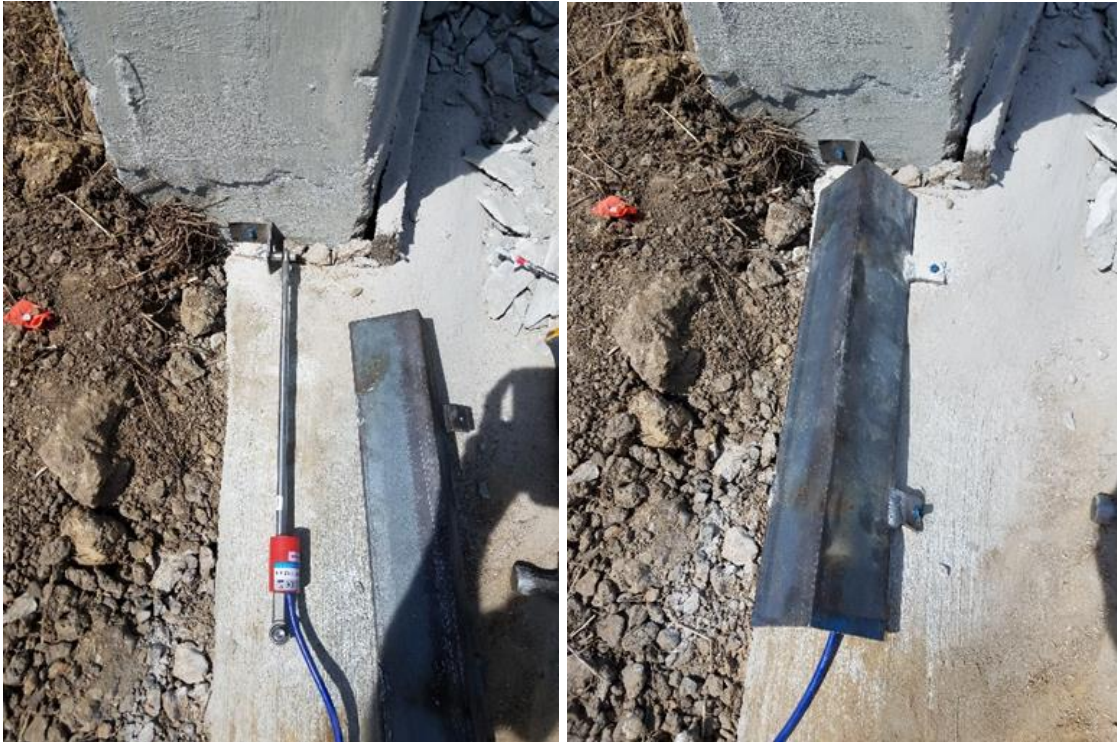
Crackmeters were installed at the approach slab surface with the approval of the Iowa DOT, and protective covers were fabricated using a steel angle to prevent damage by snowplows (Figure 4.6). Since the crackmeters were placed under the barrier, they would not be hit by traffic or snowplows. Crackmeters were installed per the Geokon manual and set at 25% of maximum extension. Since installation occurred in the summer, it was anticipated that the bridge would experience almost entirely contraction, thus opening the joints between the abutment and approach slabs.

**Figure 4.6. Jasper County 118—crackmeter without protective cover (left) and crackmeter with protective cover installed (right)**

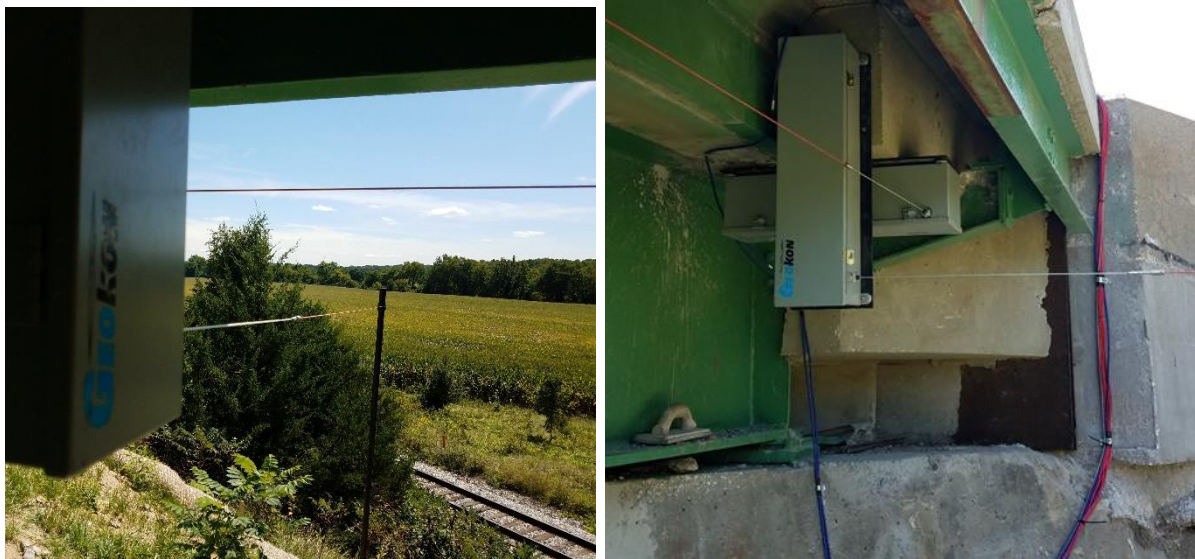
Since Jasper County 118 was only being partially reconstructed with no effect on the substructure, it was determined that a reference post should yield satisfactory results. During construction, a layer of embankment was removed and replaced to improve erosion protection, but the depth was limited. The method used a 1 1/2 in. steel pipe driven 5 ft into the ground to reach frost depth and act as a reference post (Figure 4.7, left). The Geokon 4427 sensor was attached to the bridge abutment using concrete screws and a coupler attached to a cable that spanned the distance to the reference post. At each acute bridge corner, two displacement meters measure in orthogonal directions to measure longitudinal and transverse displacement (Figure 4.7, right).

**Figure 4.7. Jasper County 118—displacement transducer with reference post (left) and longitudinal and transverse displacement transducers attached at the acute bridge corner (right)**

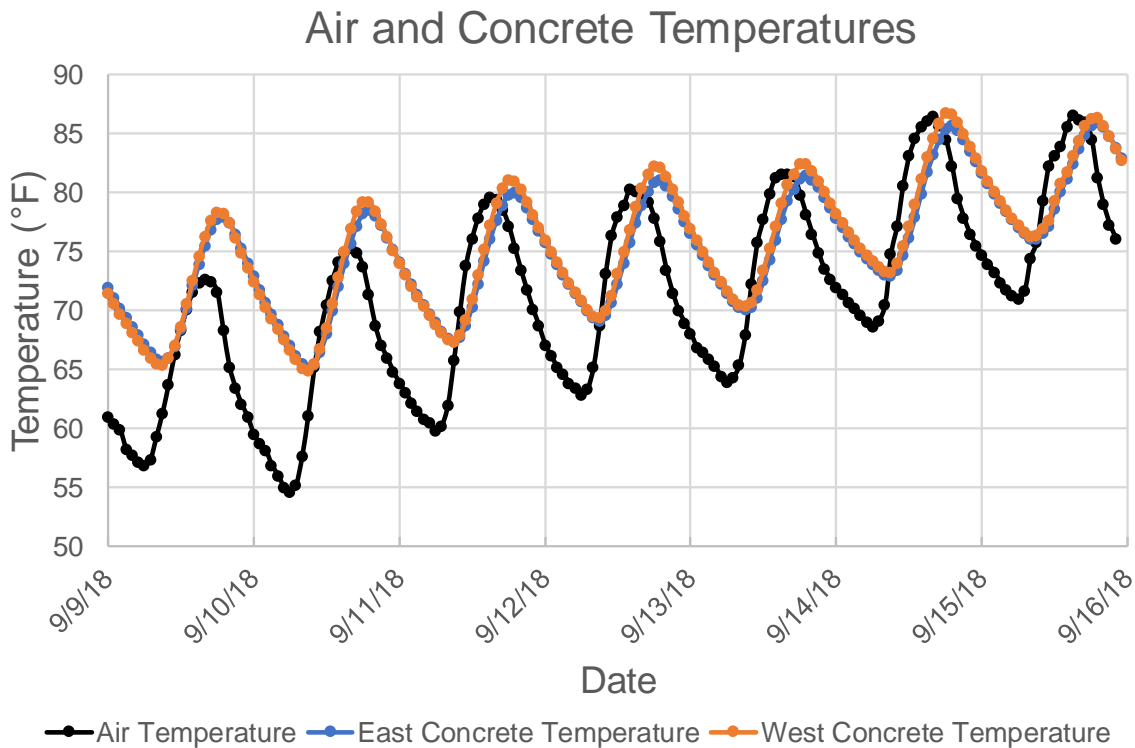
**Figure 4.12. Jasper County 118—air and concrete temperatures over time**

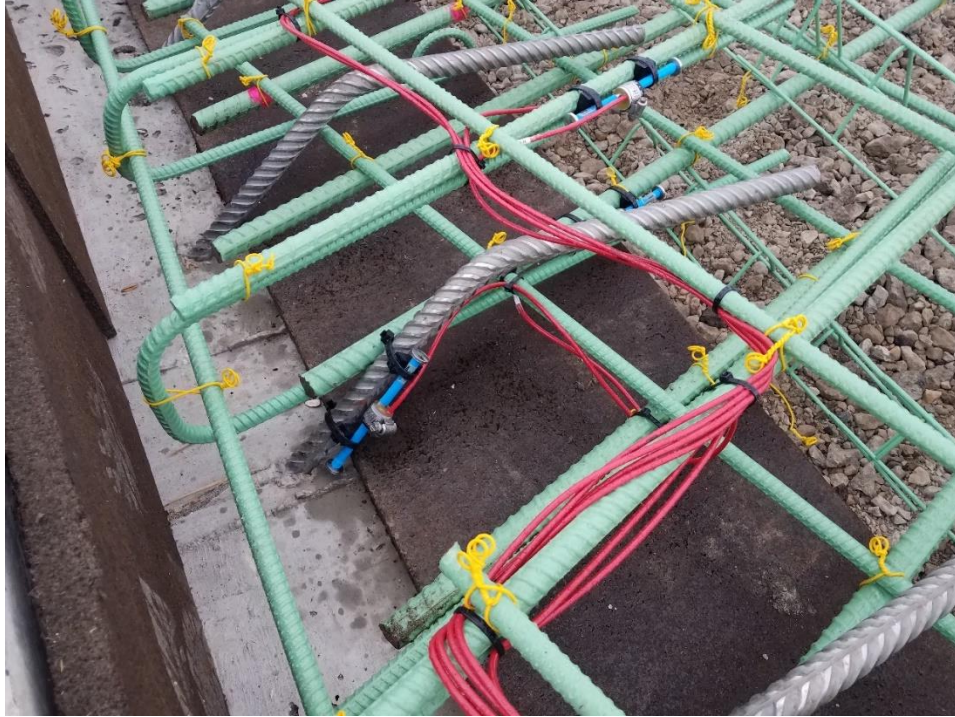
**Figure 4.26. Story County 118—strain gauges installed on the longitudinal rebar and tie bars**

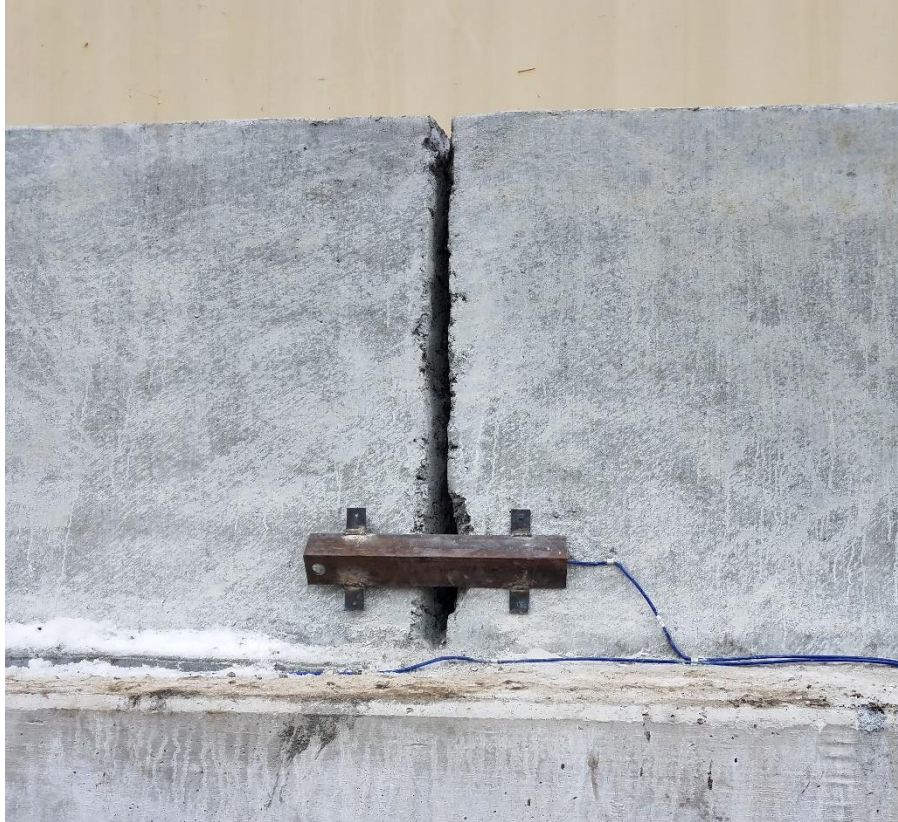
**Figure 4.27. Story County 118—crackmeter installation across the barrier rail joint**

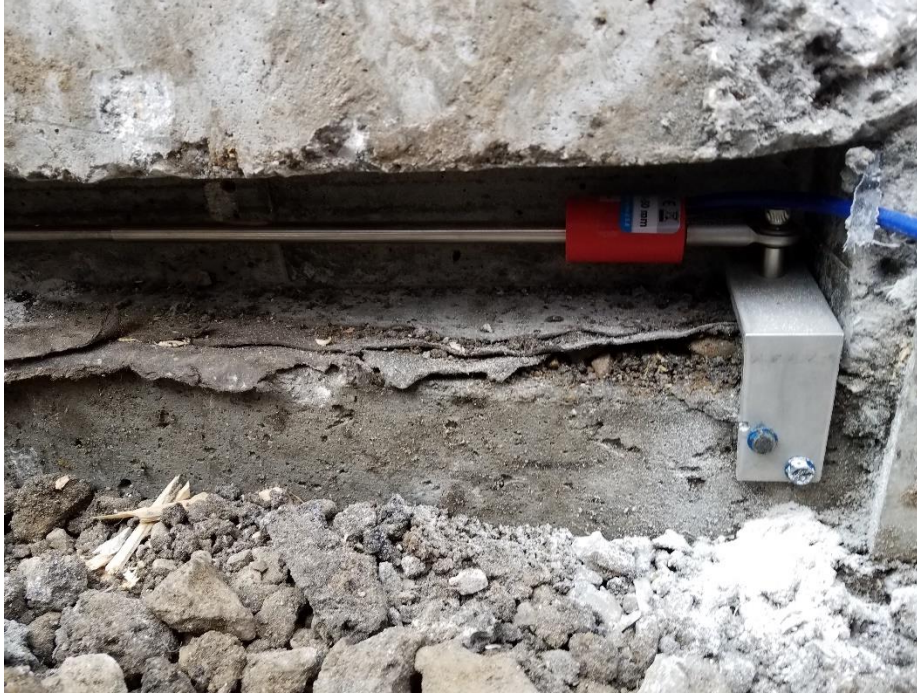
Four additional crackmeters were placed to measure the approach-slab-to-sleeper-slab joints. For the crackmeters to avoid interfering with the road surface, they were placed on the sides of the approach slabs (Figure 4.28). Wooden blocks were placed at the corners of the approach slabs where they overlapped with the sleeper slabs before the concrete was poured so the blocks could be pried out after curing to provide a space for the crackmeters. This location and method allowed for the crackmeters to be flush with the side of the slab and avoid interference with any posts driven into the soil to support the metal barrier railing. Accessing the blockout locations required digging large holes in two locations and breaking through a large amount of excess concrete in another. This excess concrete was left over as a result of the placement of the concrete barrier rail and had buried a bundle of strain gauge wires at one corner of the bridge. Fortunately, the concrete was broken up with no visible damage to the wires.

**Figure 4.28. Story County 118—crackmeter approach slab side blackout location**

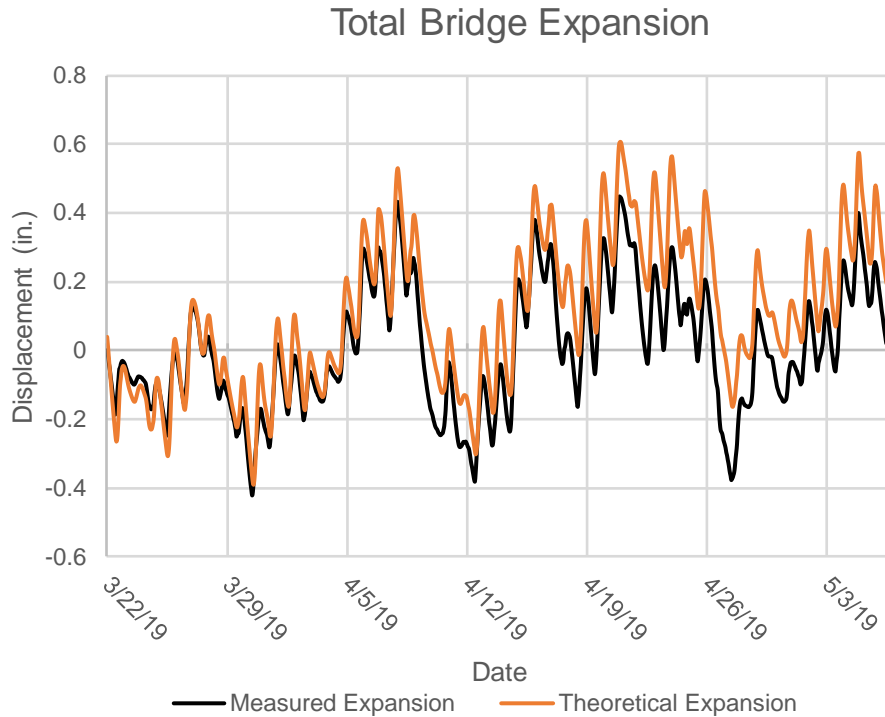
**Figure 4.30. Story County 118—measured and theoretical longitudinal bridge expansion**

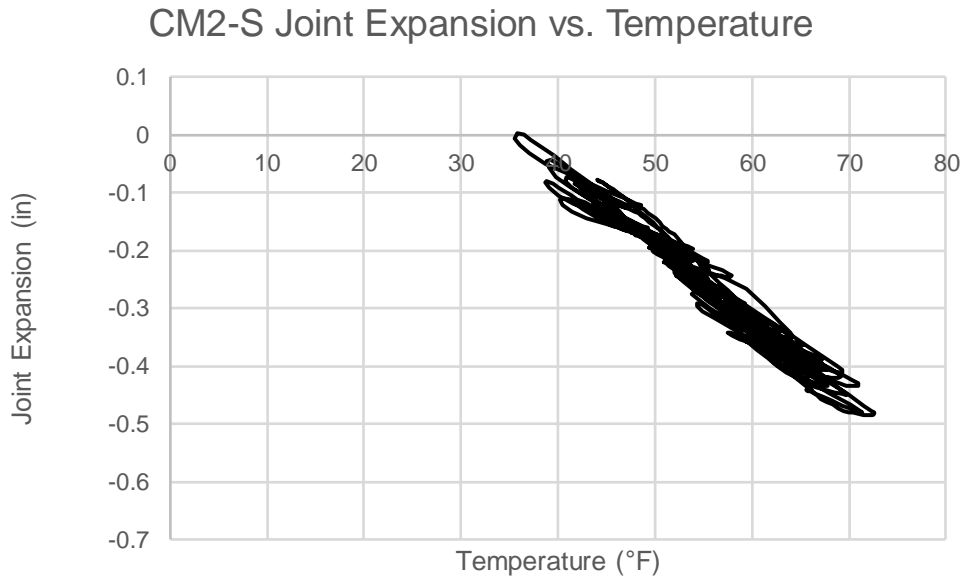
**Figure 4.33. Story County 118—approach-slab-to-sleeper-slab joint expansion**

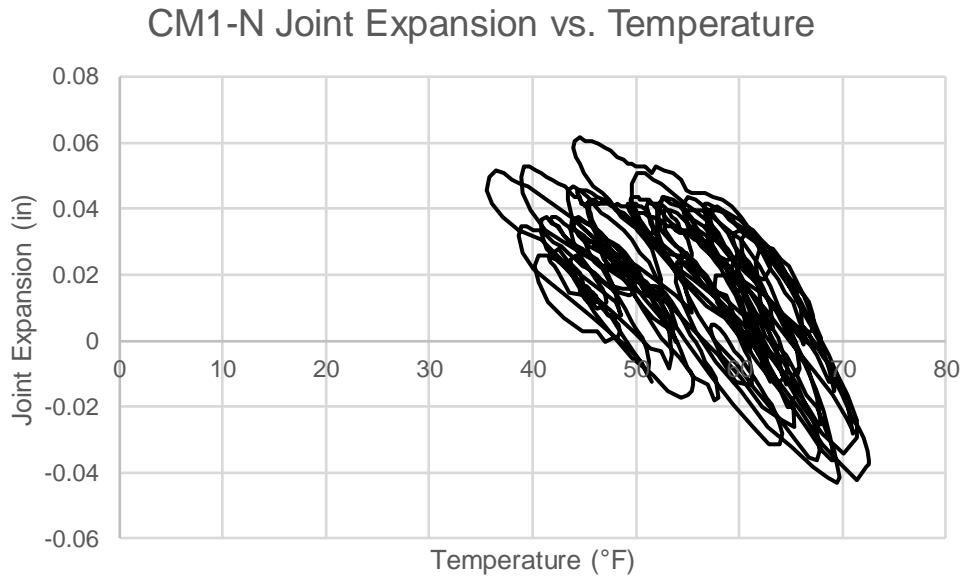
**Figure 4.34. Story County 118—bridge-barrier-to-approach-slab-barrier joint expansion**

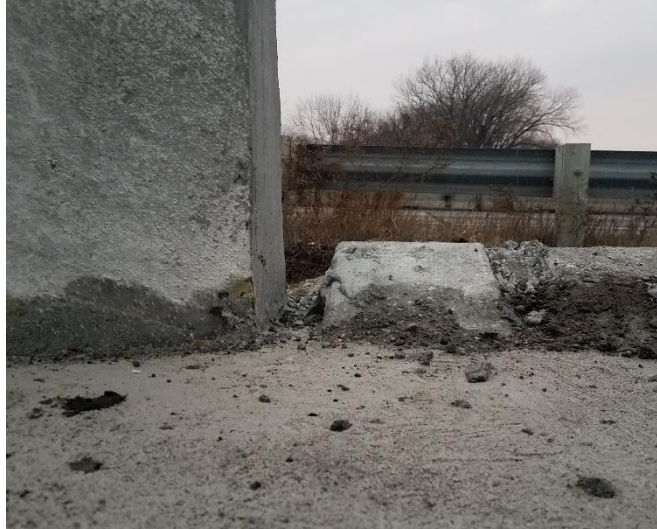
In the case of Story County 118, a section of the concrete barrier rail was placed on the approach slab to allow for drainage continuity and to direct water away from the bridge abutments and deck joints. The plans show the concrete curb formed up to the end of the barrier to create a continuous vertical surface. However, it appears that the formwork used for the barrier end has left a gap in the curb where it meets the barrier at each of the four corners of the bridge (Figure 4.40). Water will run through this gap into the embankment closer to the abutment than desired and avoid erosion control measures.

**Figure 4.40. Story County 118—curb gap at the barrier end (typical)**

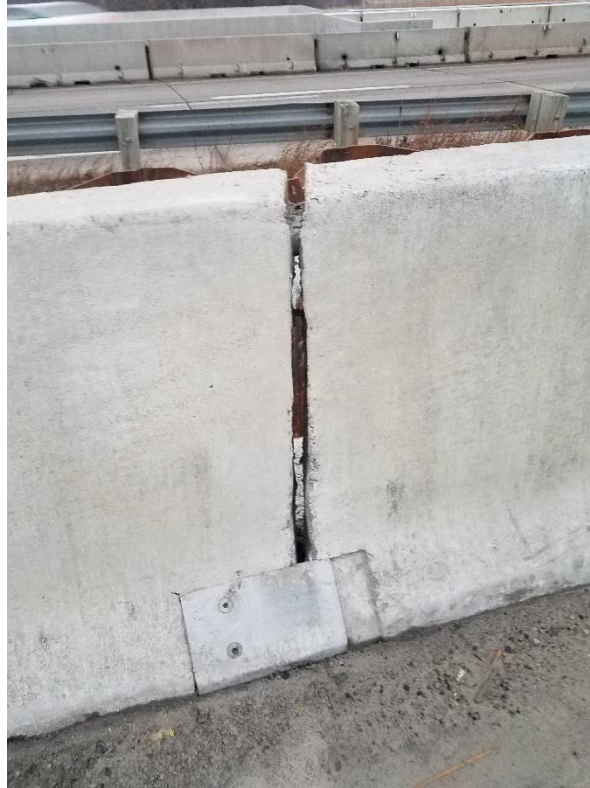
**Figure 4.41. Story County 118—open barrier joint (typical)**

The Story County 118 bridge was opened to traffic with an open joint lacking joint filler at each end of both barriers, as shown in Figure 4.41. However, the bridge plans indicate an E joint in the concrete barrier wall between the main section and the approach slab section (Figure 4.42). Crackmeters were installed at these locations since it was apparent that no further work would be completed. The open joints will allow snow and ice to fill the gaps, possibly expanding and damaging the surrounding concrete. The longitudinal rebar in the barrier appeared to be continuous across the joint in multiple locations, likely due to shifting during formation of the barrier. Vertical cracking appeared one month after bridge opening in the barrier near the joint location.

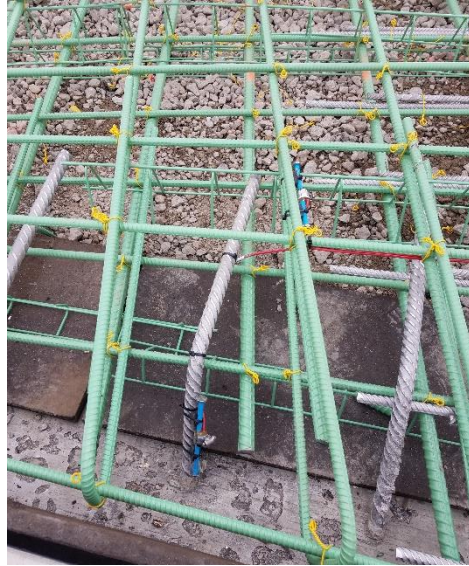
**Figure 4.43. Story County 118—approach slab modified subbase condition immediately before concrete pouring**

The approach slabs were poured directly onto the modified subbase fill without the use of the 4 mil polyethylene sheeting specified in the approach plans (Figure 4.43). Due to the large aggregate used for the modified subbase, there is a concern the concrete has penetrated the voids around the individual pieces and will cause an interlocking effect when the slab attempts to slide. This potential issue will become more apparent as time goes on and the tied approach connection is forced open by a slab that will not move as it was designed.

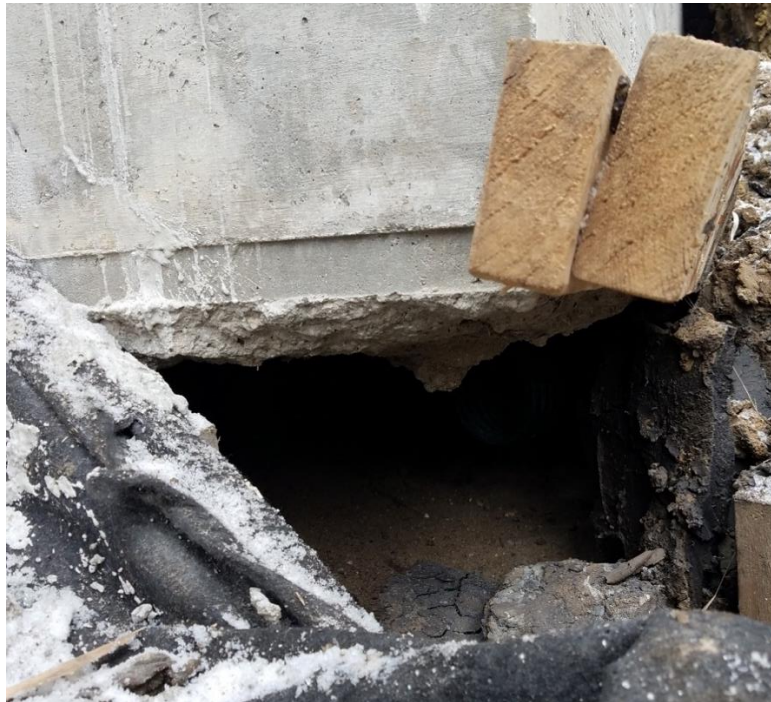
**Figure 4.44. Story County 118—large void under the south abutment corner**

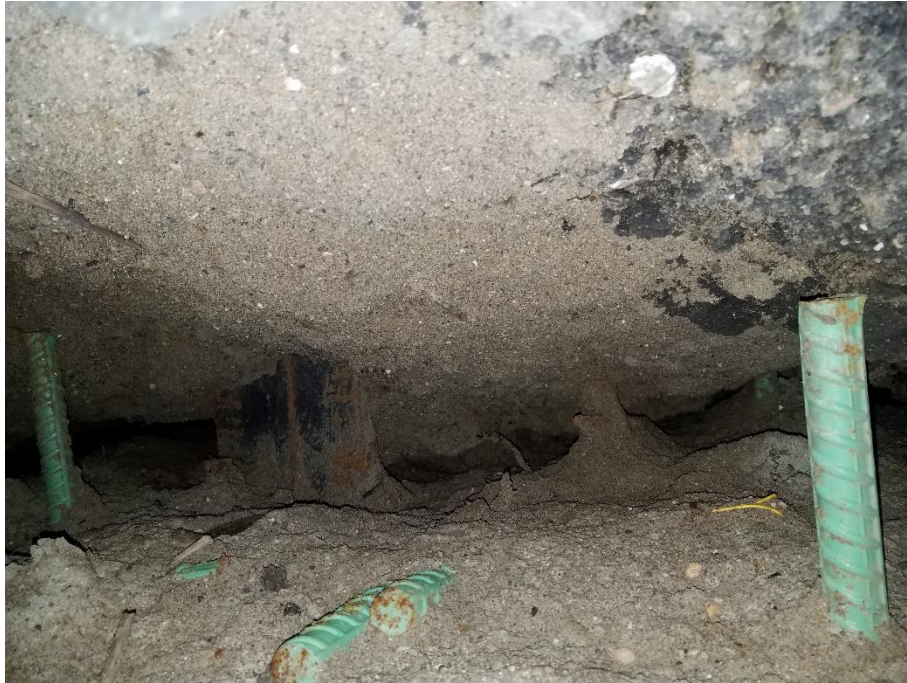
**Figure 4.45. Story County 118—visible exposed rebar and foundation pile**

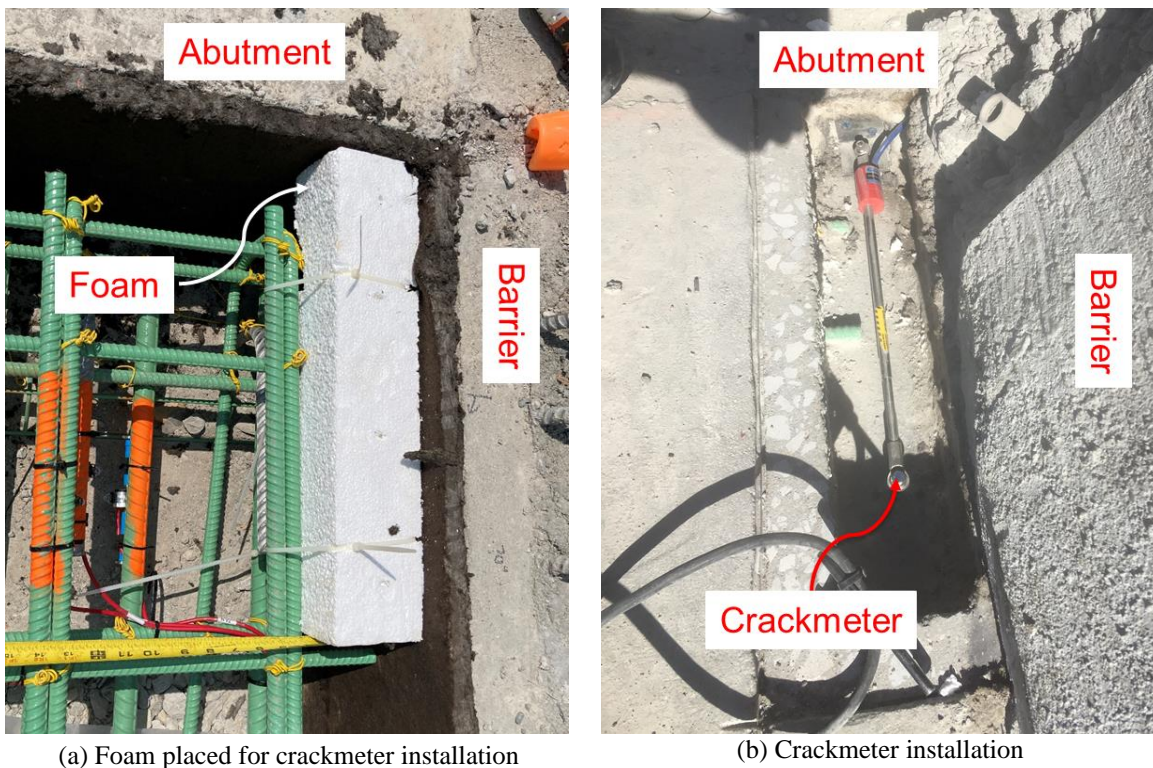
**Figure 4.50. Polk County 120—crackmeter installation across the abutment-to-approach-slab joint**

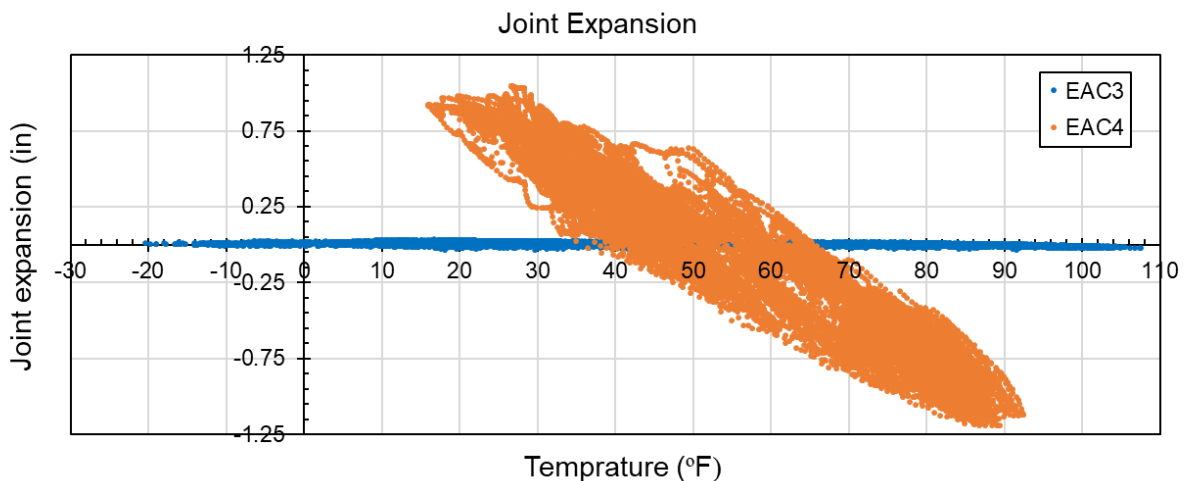
**Figure 4.52. Polk County 120—measured longitudinal bridge expansion at east end**

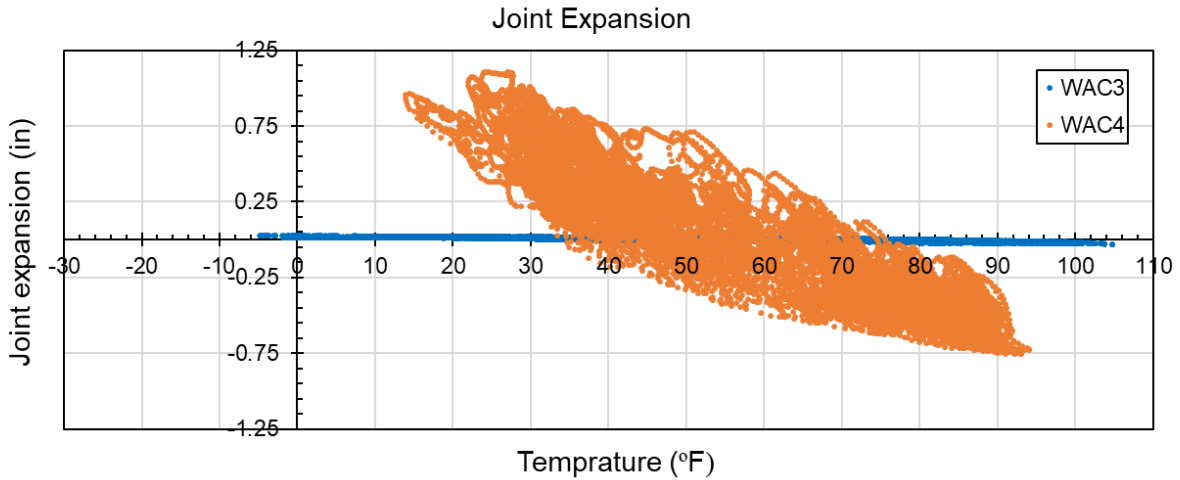
**Figure 4.53. Polk County 120—measured longitudinal bridge expansion at west end**

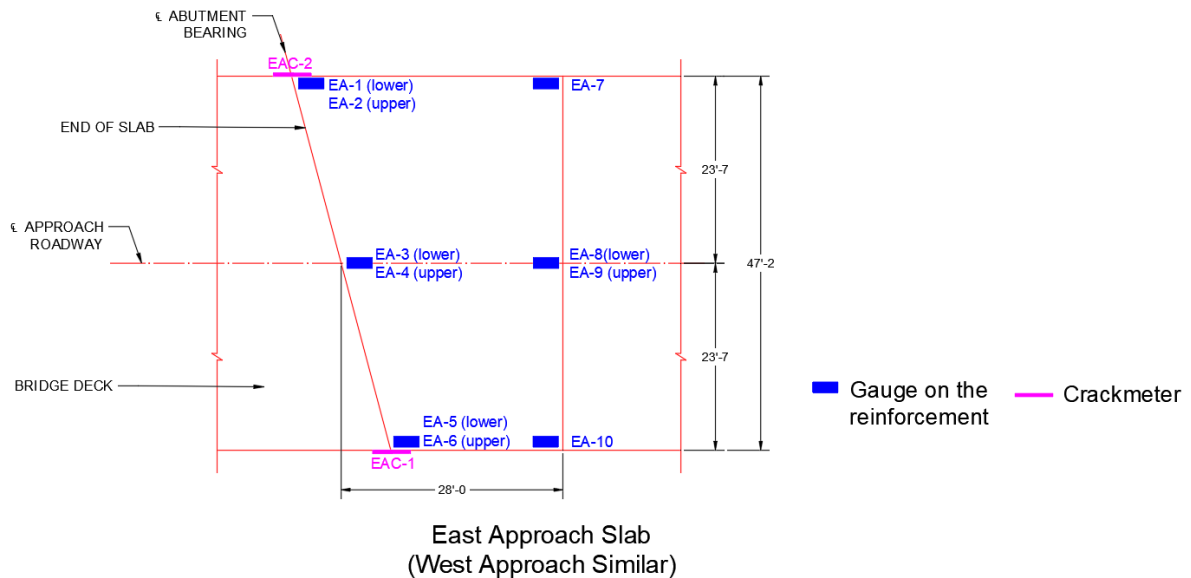
**Figure 4.63. Butler County 118—approach slab instrumentation plan**

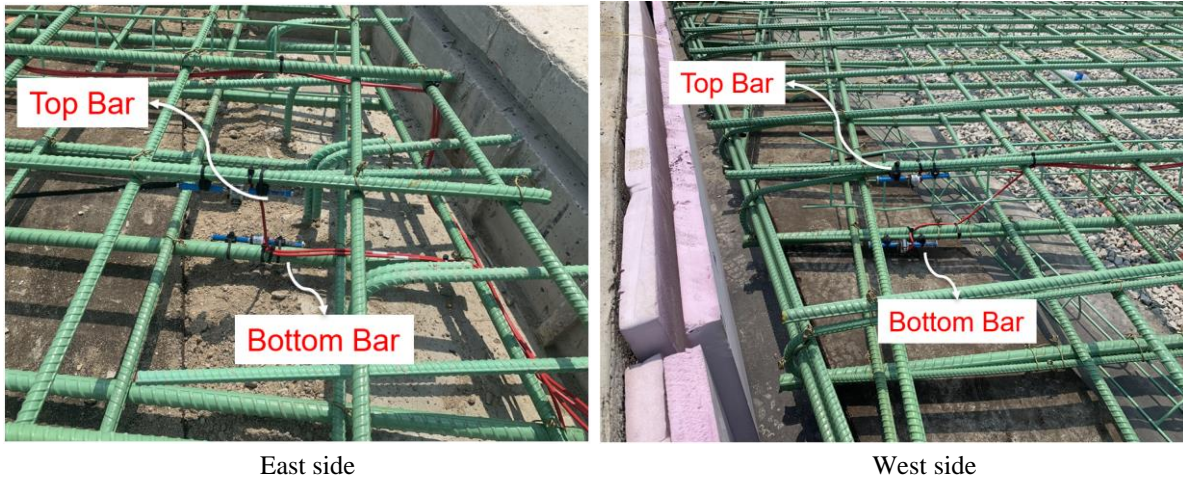
**Figure 4.64. Butler County 118—strain gauges installed on the longitudinal rebar**

Strain gauges were installed in a layout similar to that used for the previous bridges. Ten strain gauges were zip-tied to the top and bottom longitudinal bars to measure strains in the longitudinal direction. Figure 4.64 shows some photographs from the strain gauge installation process on the Butler County 118 bridge.

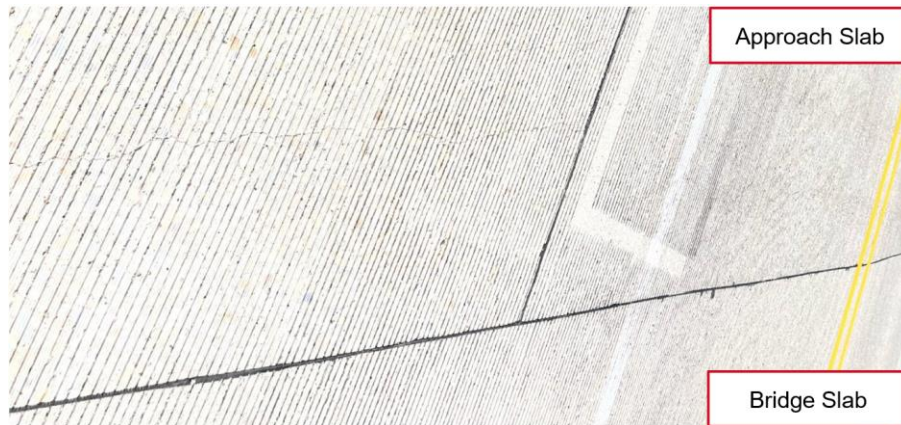
**Figure 4.73. Butler County 118—transverse crack on the east approach slab**

The high tensile strains of the top bars could be attributed to the minor transverse crack observed on the east approach slab along the joint between the approach slab and the abutment during the last visit to the bridge on May 30, 2023 (Figure 4.73). The connection's rigidity could also play a role in the crack's development. Additionally, the working room gap between the abutment diaphragm and the backwall pushes the backwall toward the middle part of the approach slab, which could make a detrimental pivot point if the approach slab ends up bearing on the backwall. The additional effects from the live loads and the settlement of the initial approach slab might increase the chance of forming a pivot point that could finally result in crack development.

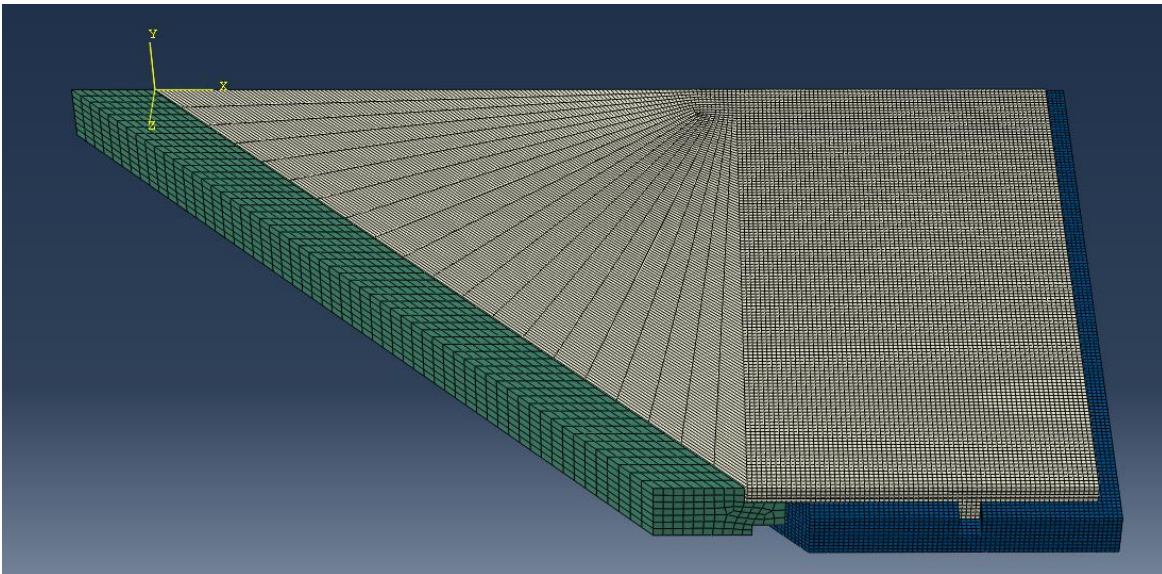
**Figure 5.3. Jasper County 118—finite element model mesh**

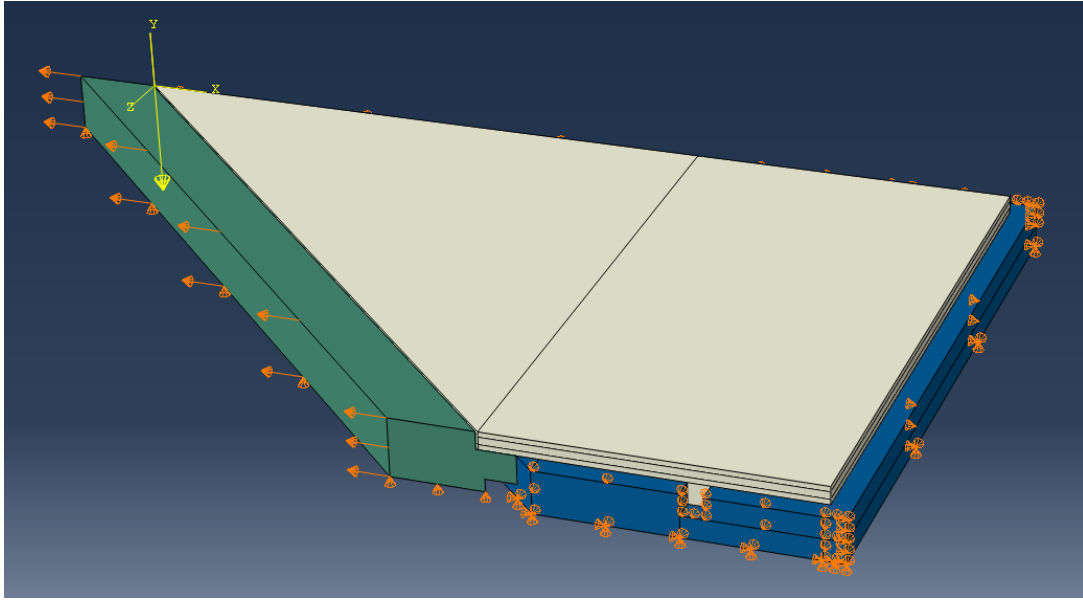
**Figure 5.4. Jasper County 118—finite element model boundary conditions**

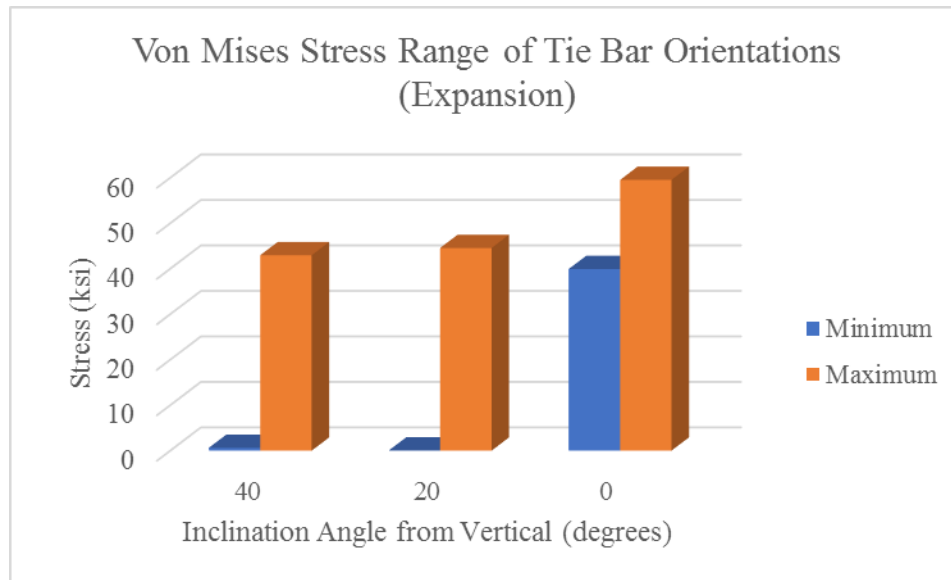
**Figure 5.29. Story County 118—tie bar study von Mises stresses (expansion)**

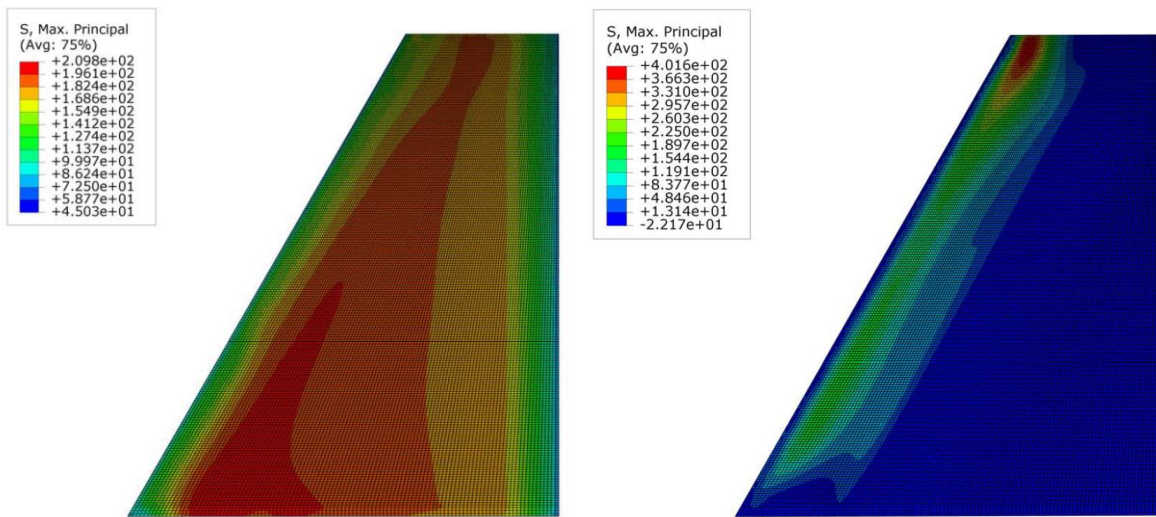
**Figure 5.33. Story County 118—concrete stress contours for 30 degree skew for contraction (left) and expansion (right)**

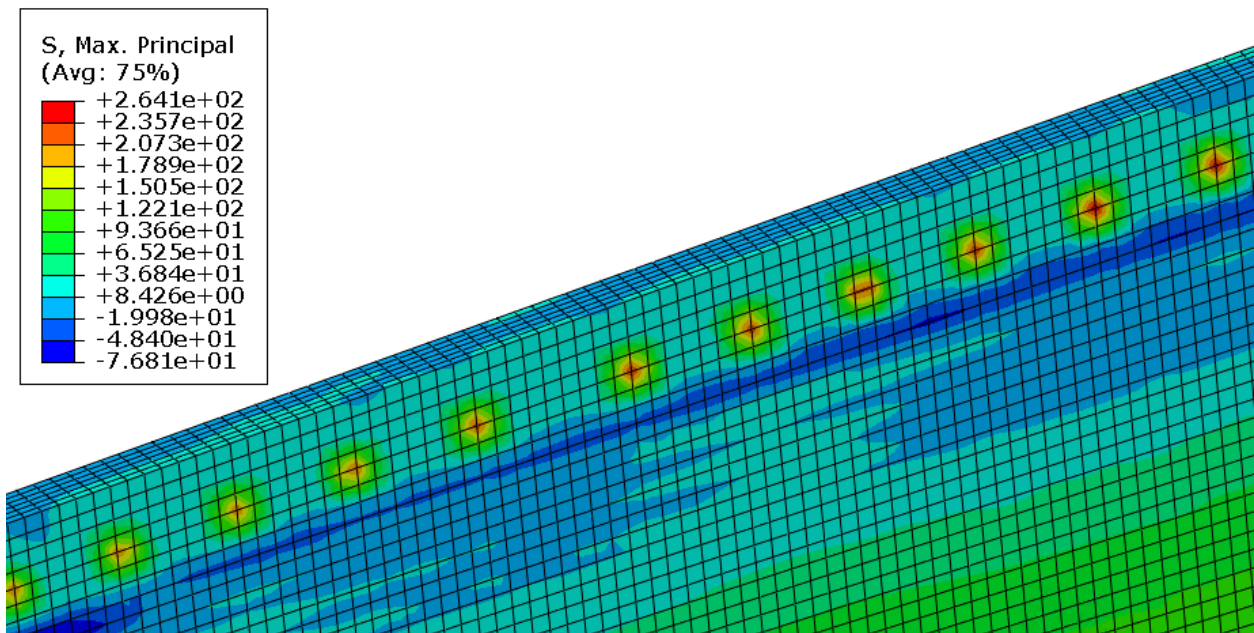
**Figure 5.43. Stress concentrations at dowel connection**

- While soil stiffness did not affect the concrete or tie bars stresses during bridge contraction, it was found that stiffer soil can considerably increase concrete and tie bar stresses (i.e., maximum values) at the full range of thermal expansion. Inclined tie bars experienced lower stresses than vertical tie bars during bridge contraction while pulling the approach slab. Concrete stresses showed no notable trends with regard to bar orientation. Also, the results of additional models indicated that, regardless of the magnitude of stress in the tied connection, there were stress concentrations at this connection point.

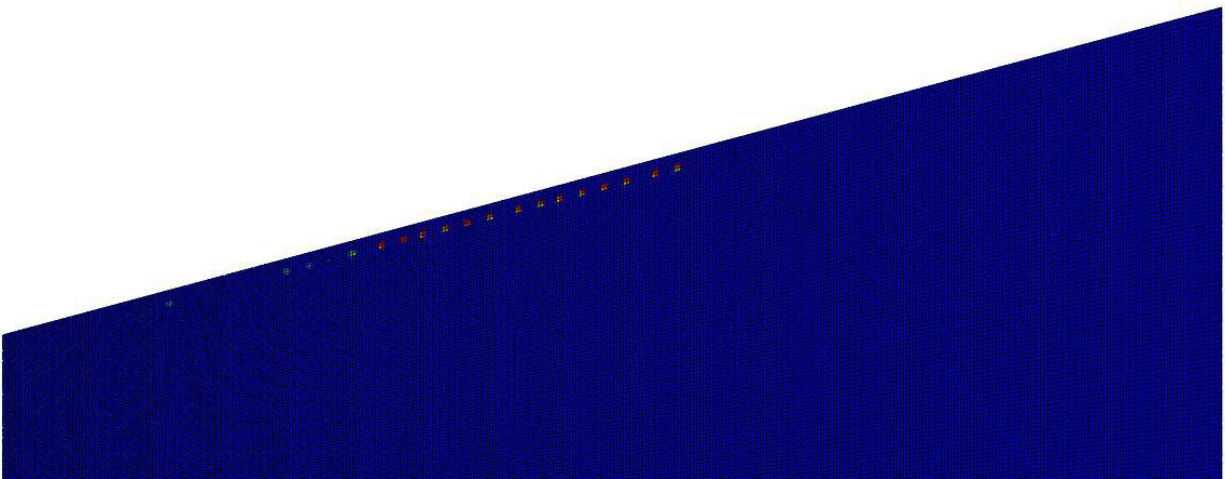
**Figure 5.49. Locations of damage-based failure in 16 ft void model**

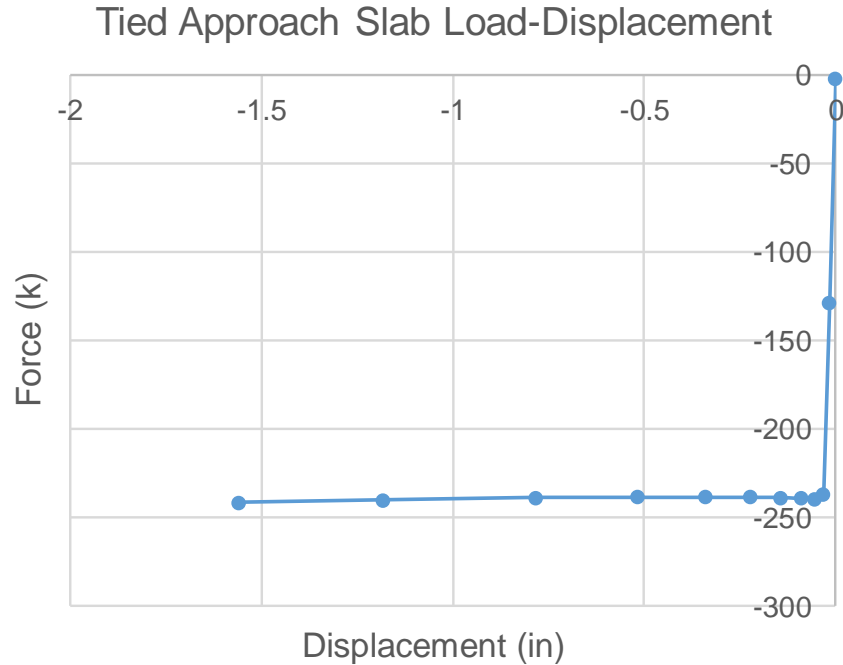
**Figure 5.52. Shelby County 118—load displacement plot**

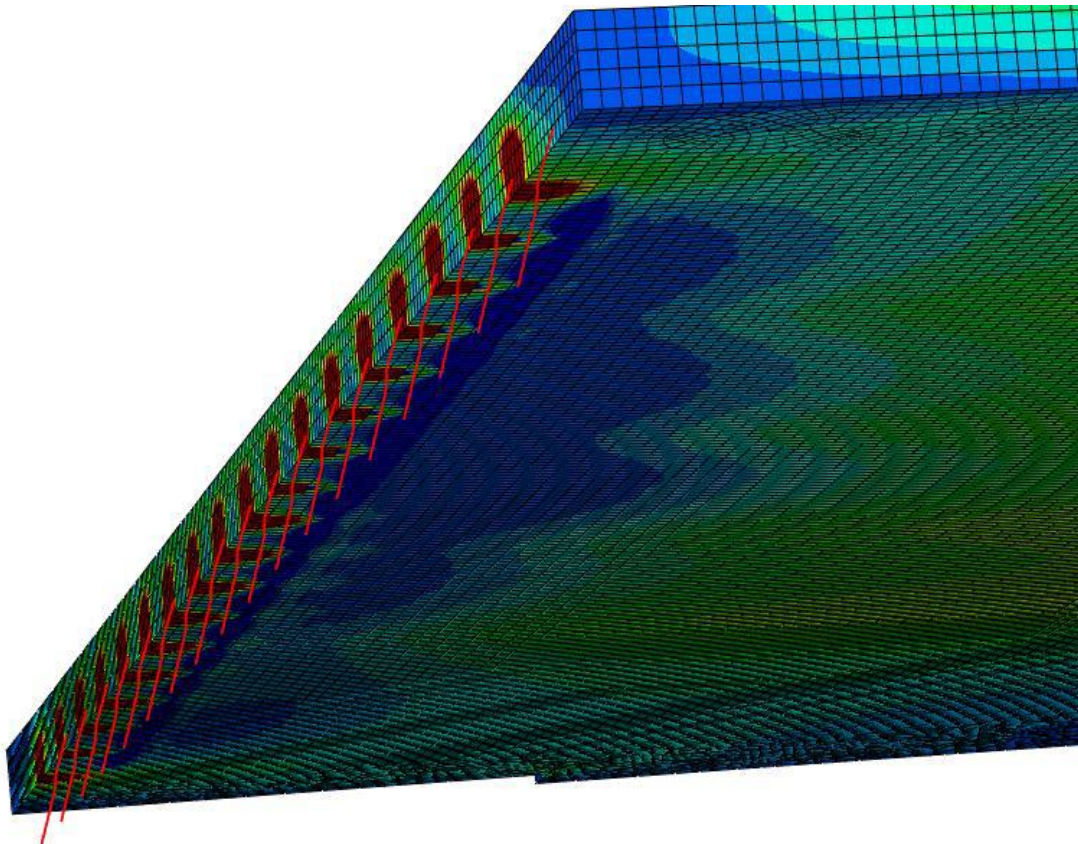
**Figure 5.67. Washington County—stress concentrations in dowels and precast panels**

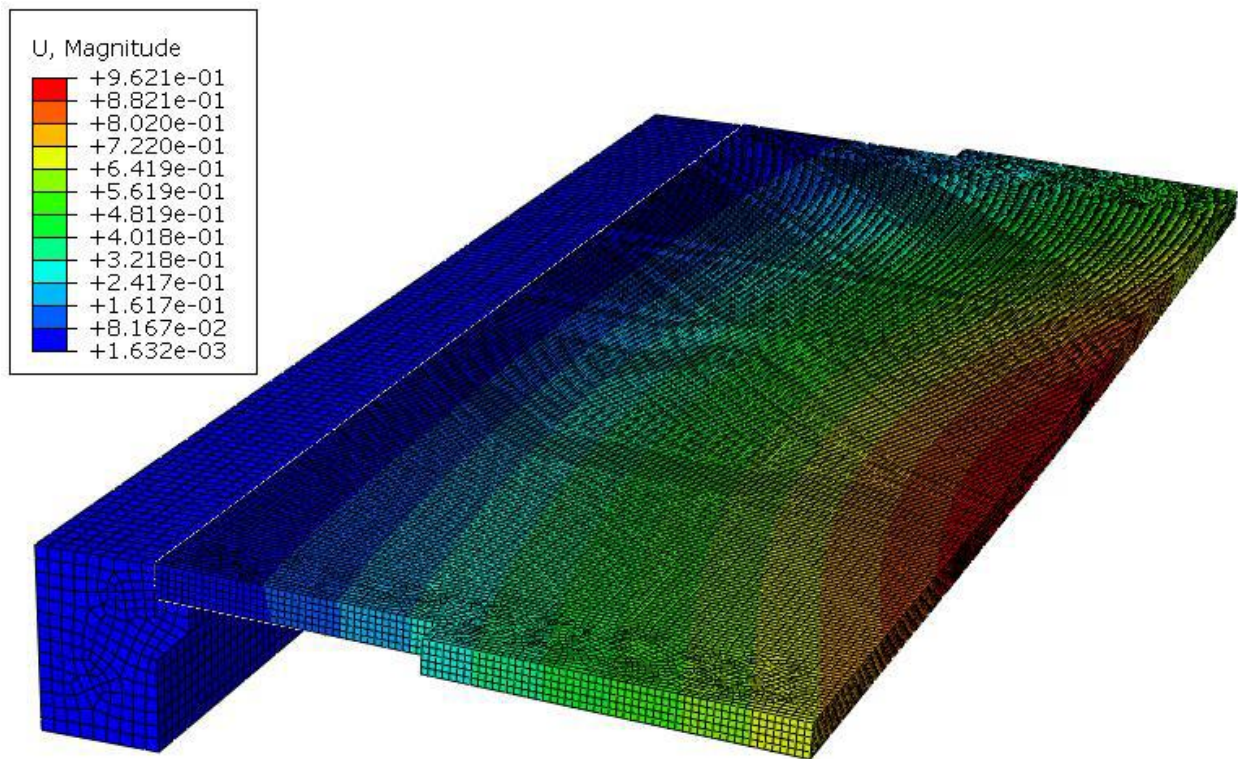
**Figure 5.68. Washington County—approach slab settlement**
