Interstate and Primary PCC Pavement Overlays Review

**Final Report
for
MLR-23-01**

December 2023
Construction & Materials Bureau

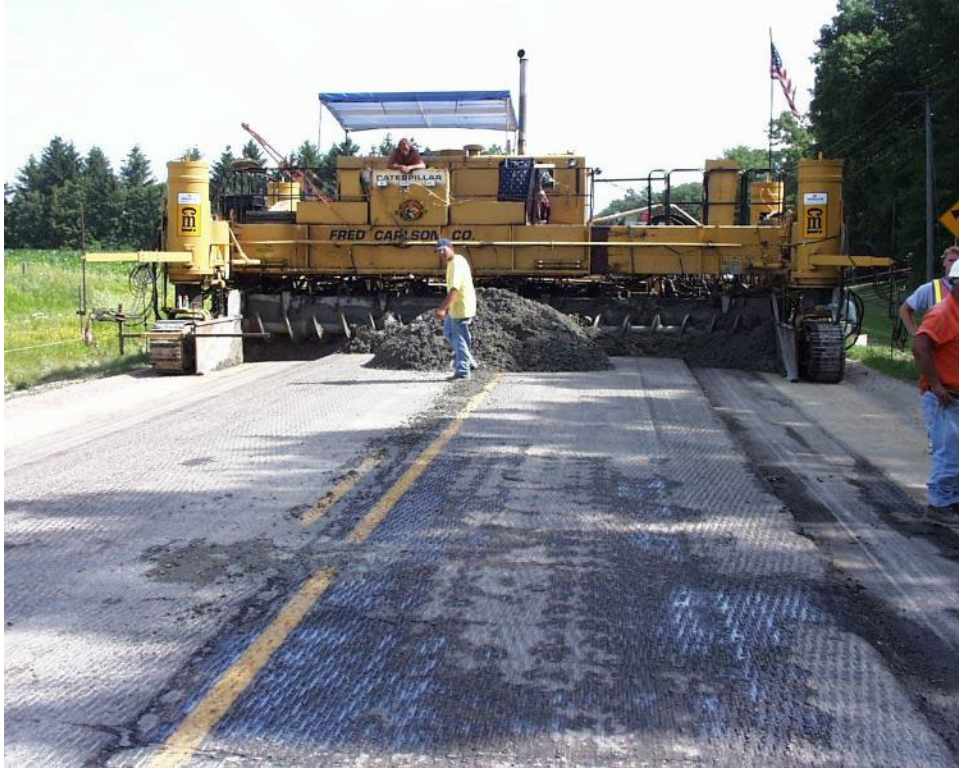
Figure 8 – Delaware IA 13 Unbonded Overlay Construction

The longitudinal joint former was used to form the joint between the widening units and overlay. There were issues with cracking within a short time period, due to lack of a formed joint. This coupled with the widening unit heaving caused issues on this overlay. In areas, the widening units are inversely sloped toward the outside wheel path making it difficult to remove snow.

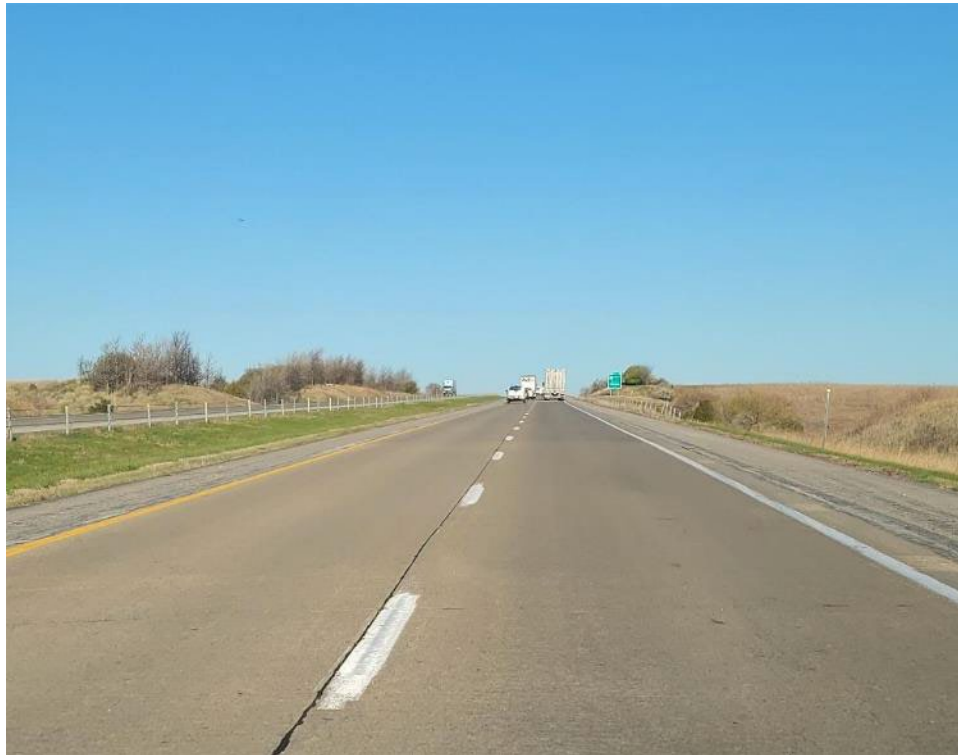
Figure 13 – Adair I-80 WB Whitetopping Overlay Paved 1979 (Picture 2023)

Another whitetopping project that has been in service for more than 40 years is the Adair County I-80 westbound overlay, in 1979. The design was to mill 8 inches of HMA and replace with 10 inches of PCC. Overall, the overlay is in good condition with a few patched areas. The pavement was diamond ground in 2020.

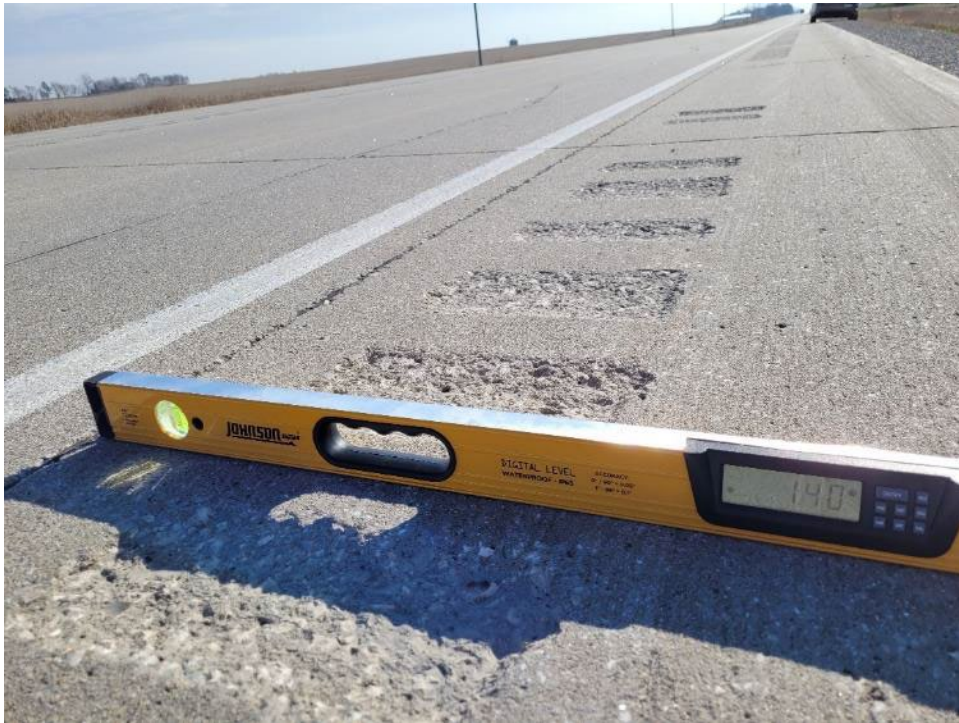
Figure 23 – Dallas US 169 UBOL Shoulder Cross Slope 1.40%

A thicker overlay did not seem to prevent the cracking with the longer reinforcing tie steel. On the Dallas US 169 unbonded overlay, this 7 inch unbonded overlay with 12 x 12-foot panels and tied shoulders with a 60-inch reinforcing bar exhibits quite a bit of longitudinal cracking. Most of the cracks have been sealed and there is very little patching. The cracking does not seem to affect the ride of the pavement, currently. The as constructed shoulder cross slope was 2 percent. Checking shoulder cross slope near the areas with longitudinal cracking indicated shoulder cross slope anywhere from 0.9% to 1.48%. Thus, the shoulders appear to heave, causing cracking off the end of the 60-inch reinforcing steel.

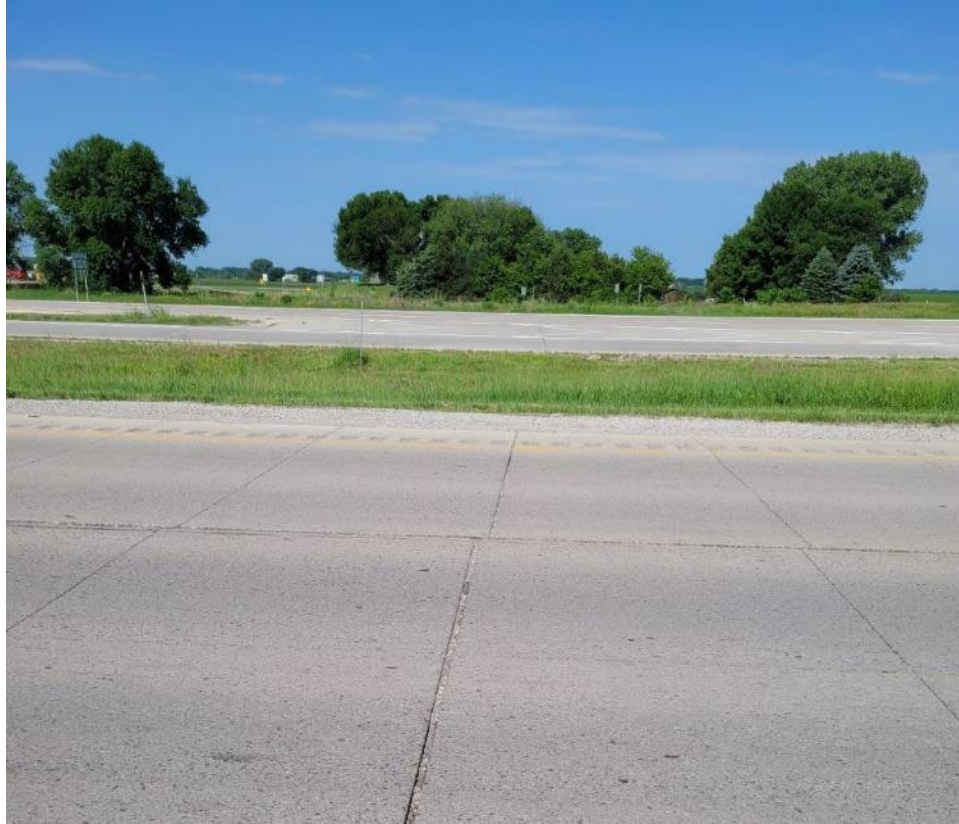
Figure 33 – Clay/Dickinson US 71 NB panels migrating in driving lane at BOP against HMA pavement.

During this review, several design features were noted that have impact on the performance of the overlay. One of the best features noted was using full depth pavement at the beginning (BOP) or end (EOP) of the project and transition between overlay types. Using full depth pavement at the BOP or EOP is especially important if the transition pavement is HMA. Using full depth pavement prevents the panels from migrating due to traffic.

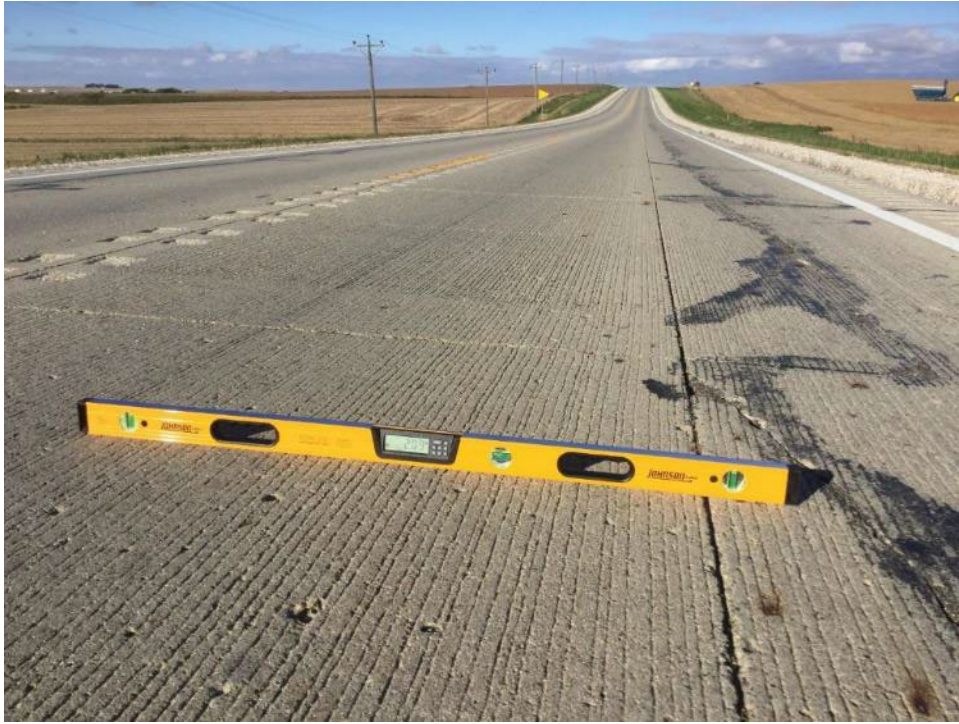
Quite a bit of longitudinal cracking showed up the next year after construction. It was noted that the outside shoulders appeared to be heaving based on the cross slope.

Driving lane panel cross slope 2.09%

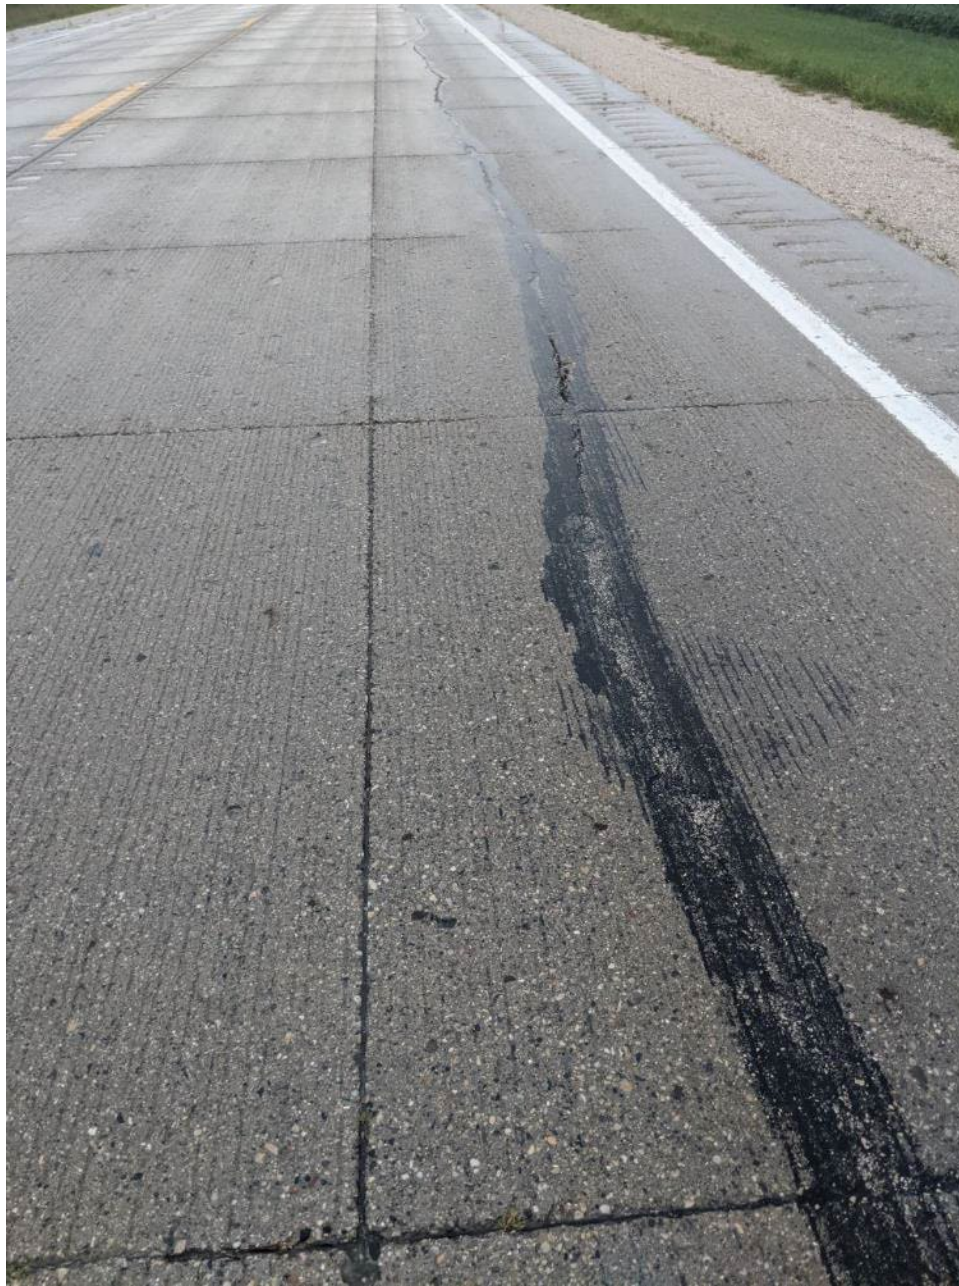
After most of the cracking occurred, the district filled the longitudinal cracks with hot pour sealant. Even with all the cracking that occurred early, the pavement continues to ride fairly well. There are likely areas that need to be patched.

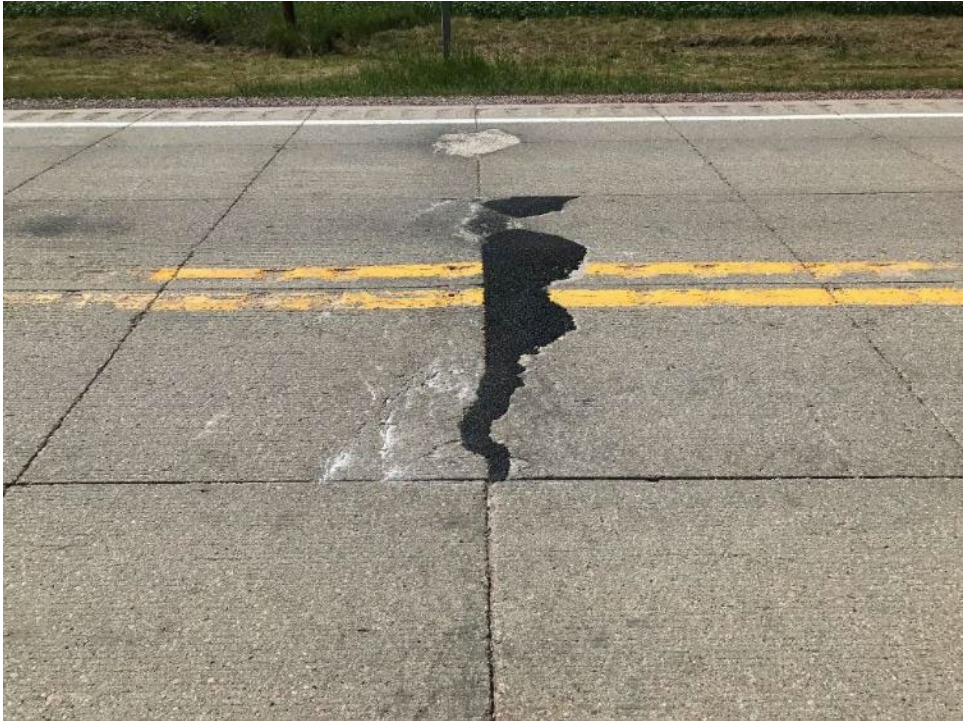
Panels moving, especially west of US 59. Maintenance placed patches with foam on either said to accommodate slab movement. We noted that now the slabs will move even more. District will let a patching project to ad full depth patches in areas to prevent slab migration.

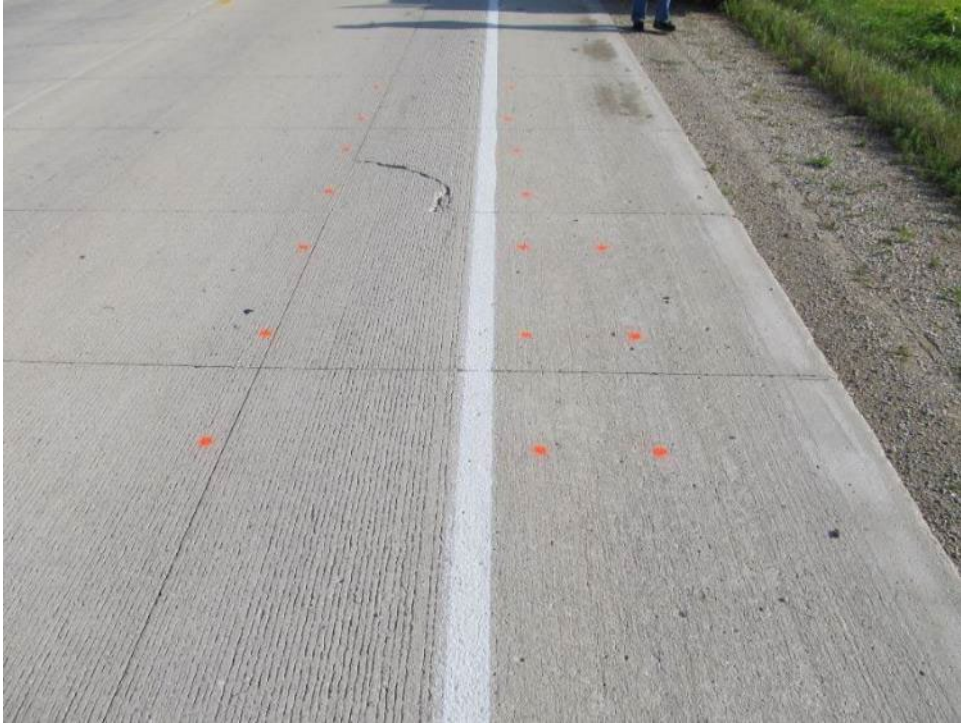
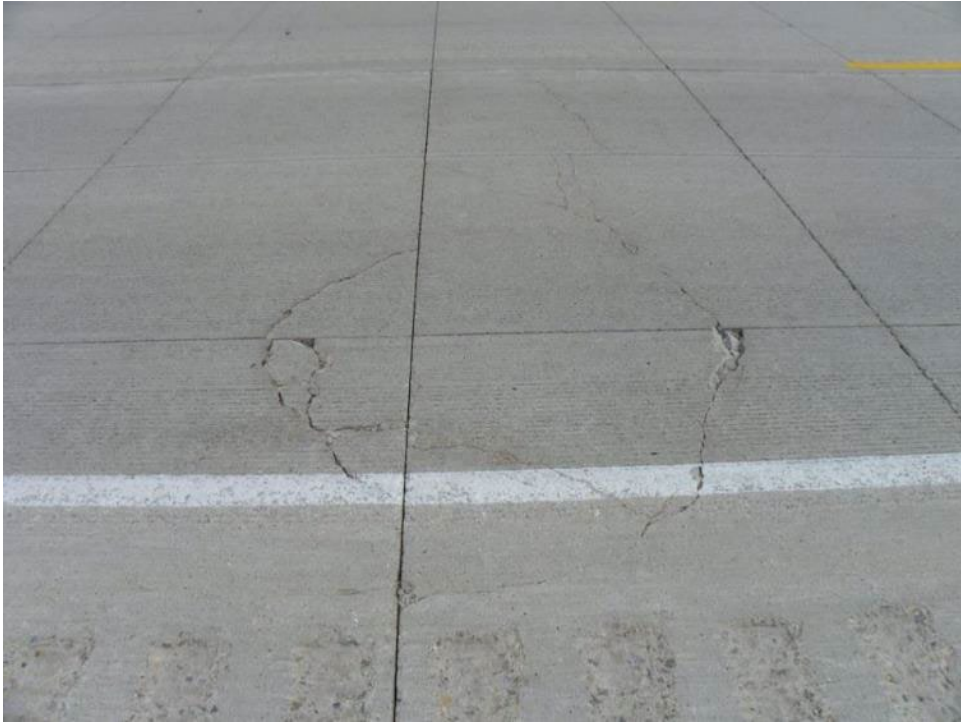
Areas of cracking and broken panels.

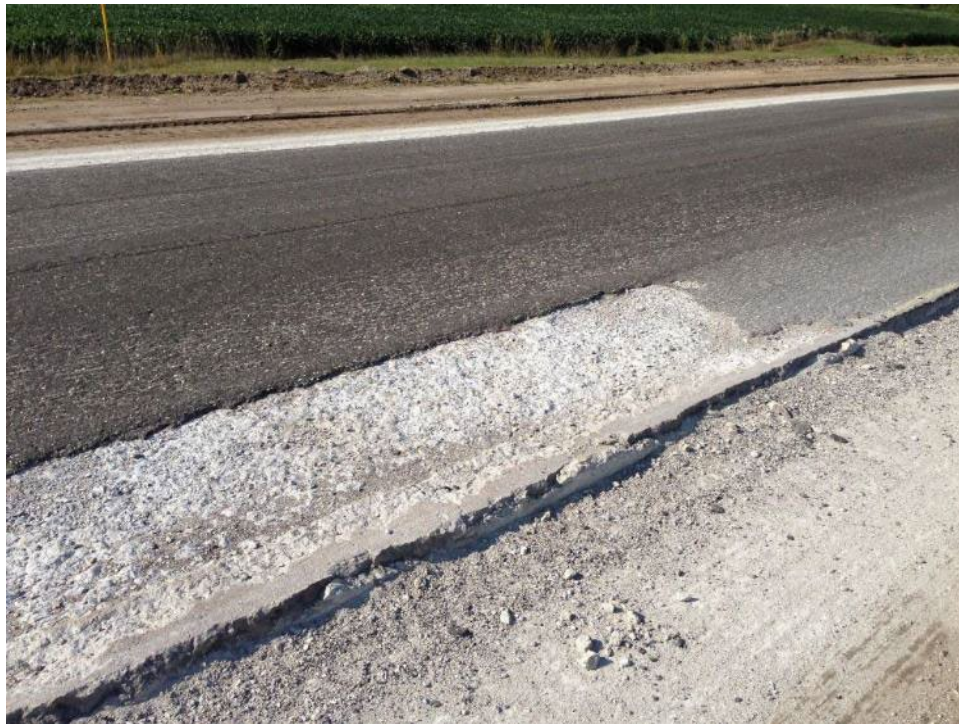
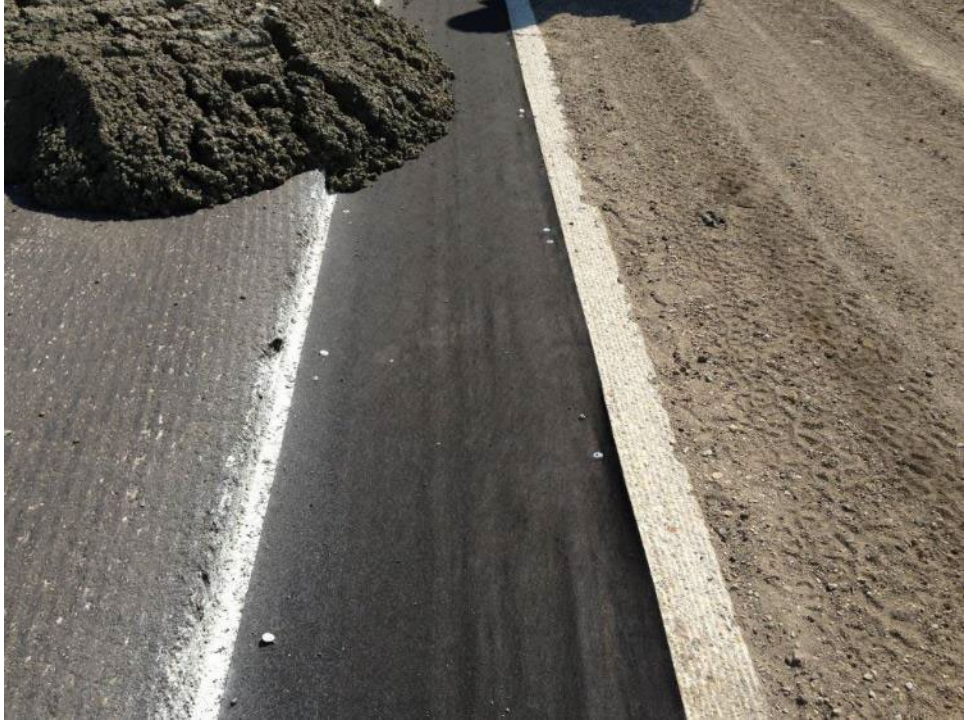
During milling operations, the mill removed HMA on the outside edge of the pavement in areas. Fabric interlayer was used to cover the exposed PCC pavement.

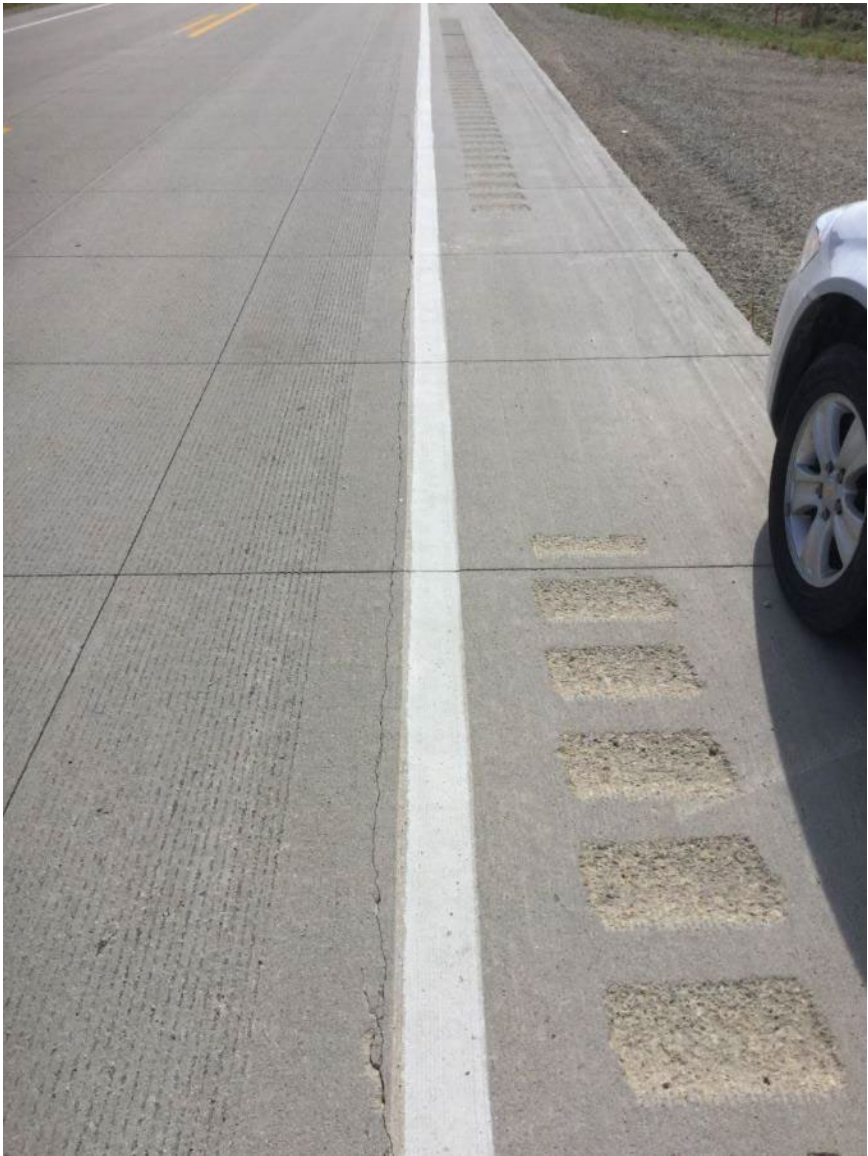
2017 – Cracking at 4 ft from edge. Location of old edge of widened pavement.

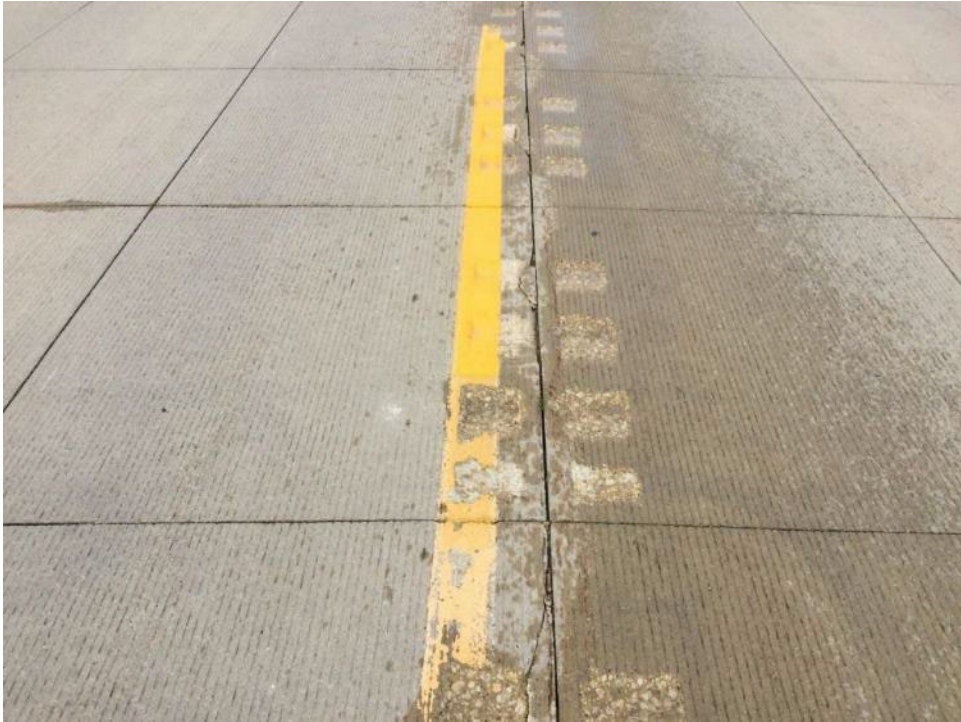
Cracking along paint line. Some patching.

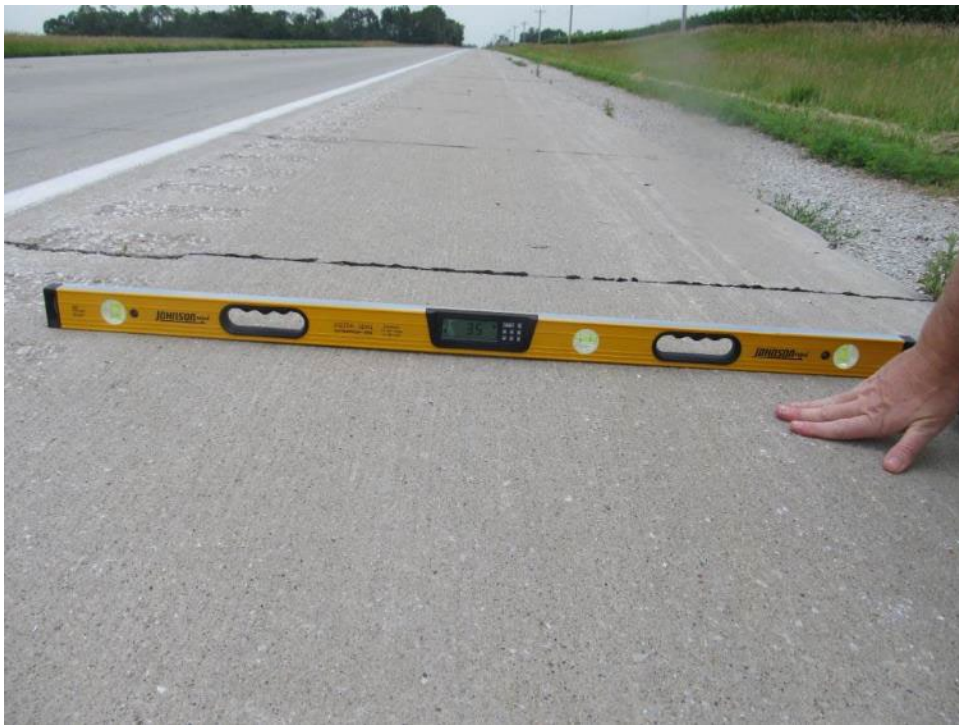
Longitudinal cracking in wheel path.

Shoulder cross slope 3.5%, Design 4%

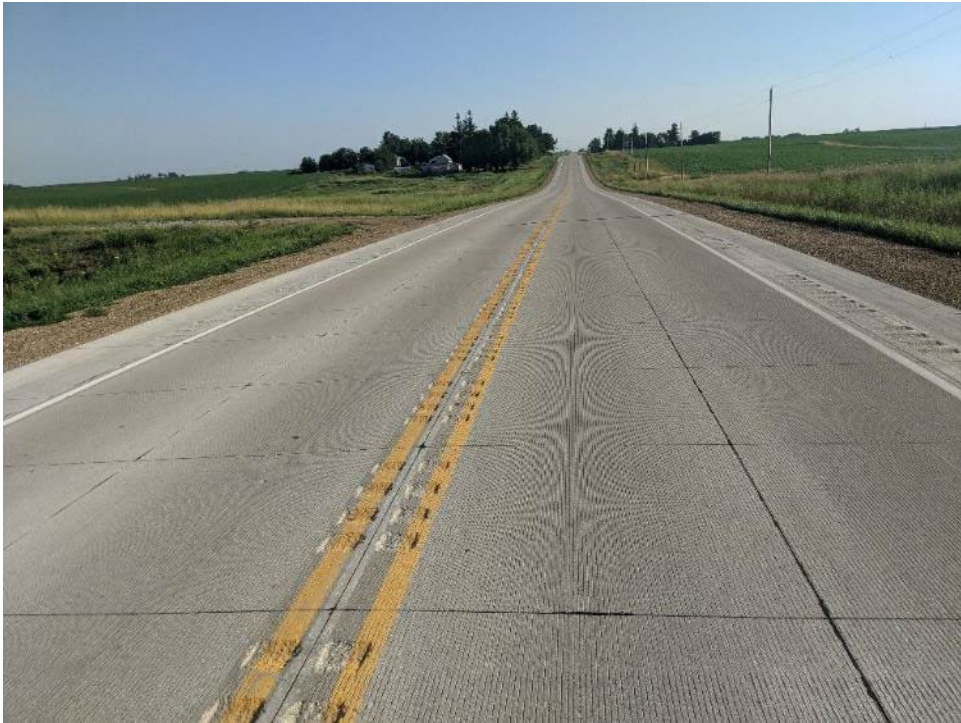
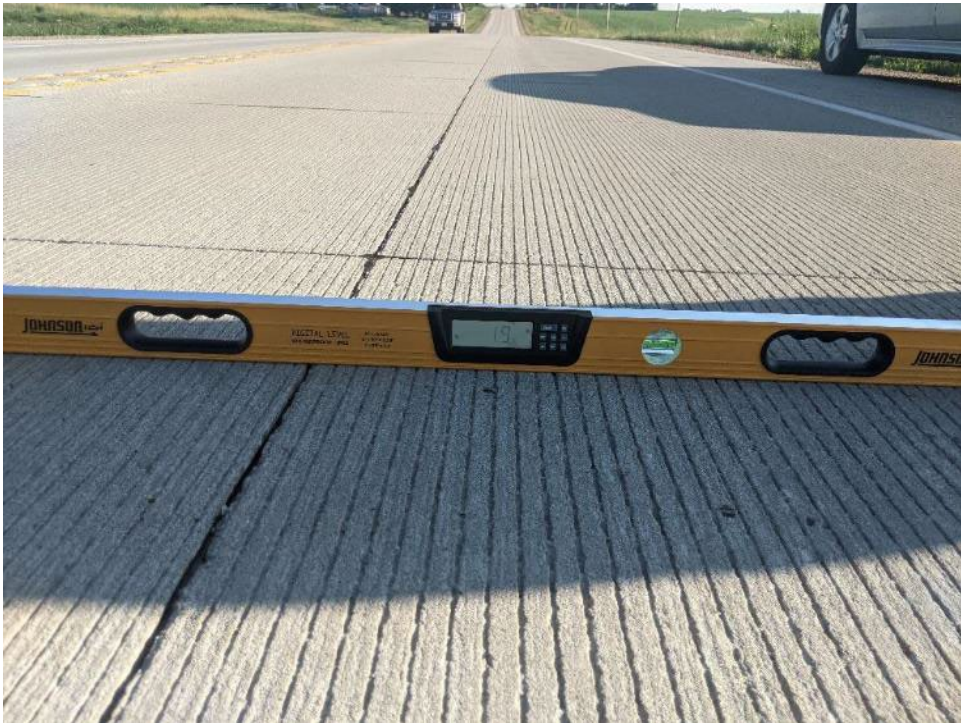
In very good condition. Shoulders do appear to be heaving, but no cracking due to no tie steel.

Sta 33+00 Mainline 1.9%
