Partially Grouted Revetment for Low-Volume Road Bridges

Final Report
March 2024

Sponsored by
Iowa Highway Research Board
(IHRB Project TR-710)
Iowa Department of Transportation
(InTrans Project 16-579)

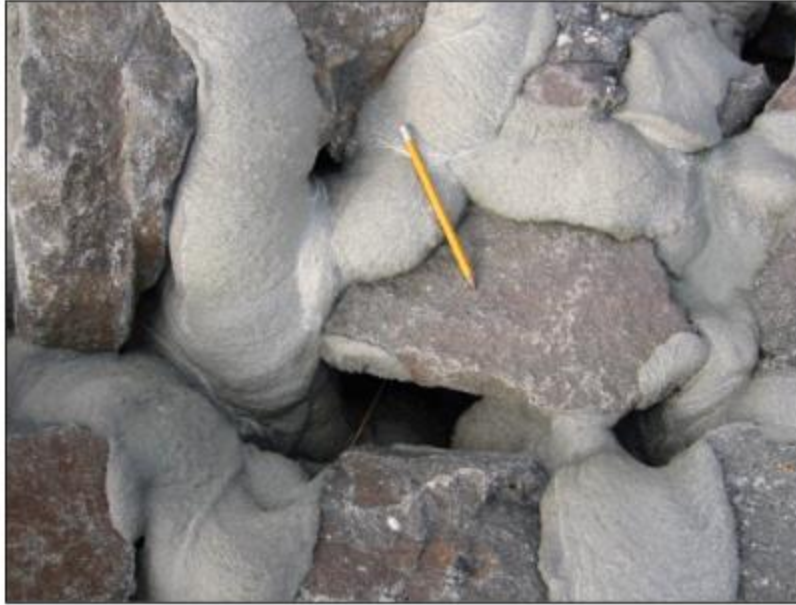
Partially grouted riprap is a system consisting of specifically size rocks, grouted together with 50 percent or less of the voids filled by the grout, as shown in Figure 7.

Figure 7. Partially grouted riprap

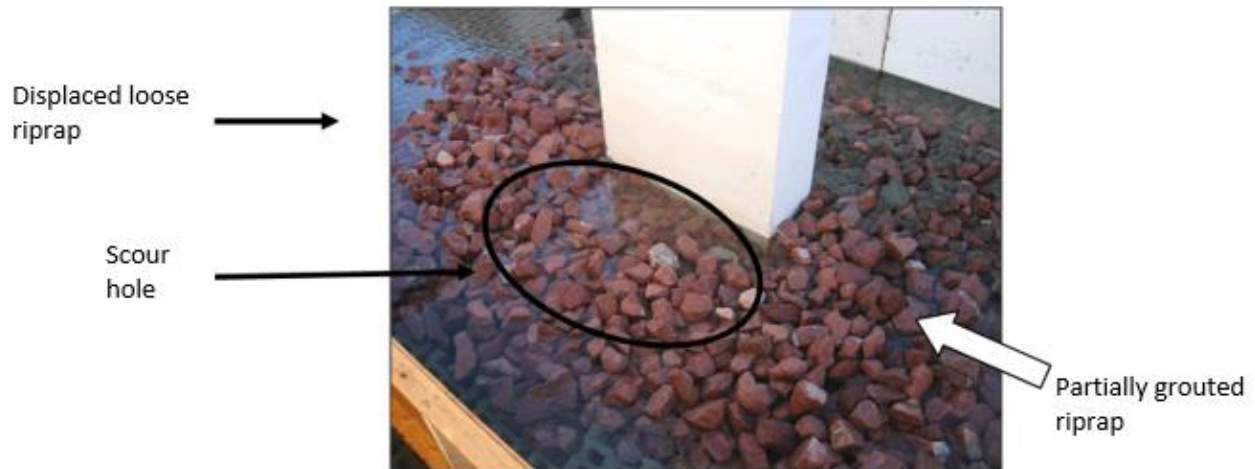
Laboratory studies have been conducted in the past to test the performance of conventional and partially grouted riprap. One such study involved prototype-scale tests of both partially grouted and loose riprap simultaneously (Lagasse et al. 2008). The results showed that the partially grouted riprap was undamaged, whereas the loose riprap experienced failure via particle erosion or displacement, as shown in Figure 8.

Figure 8. Laboratory test results on loose and partially grouted riprap

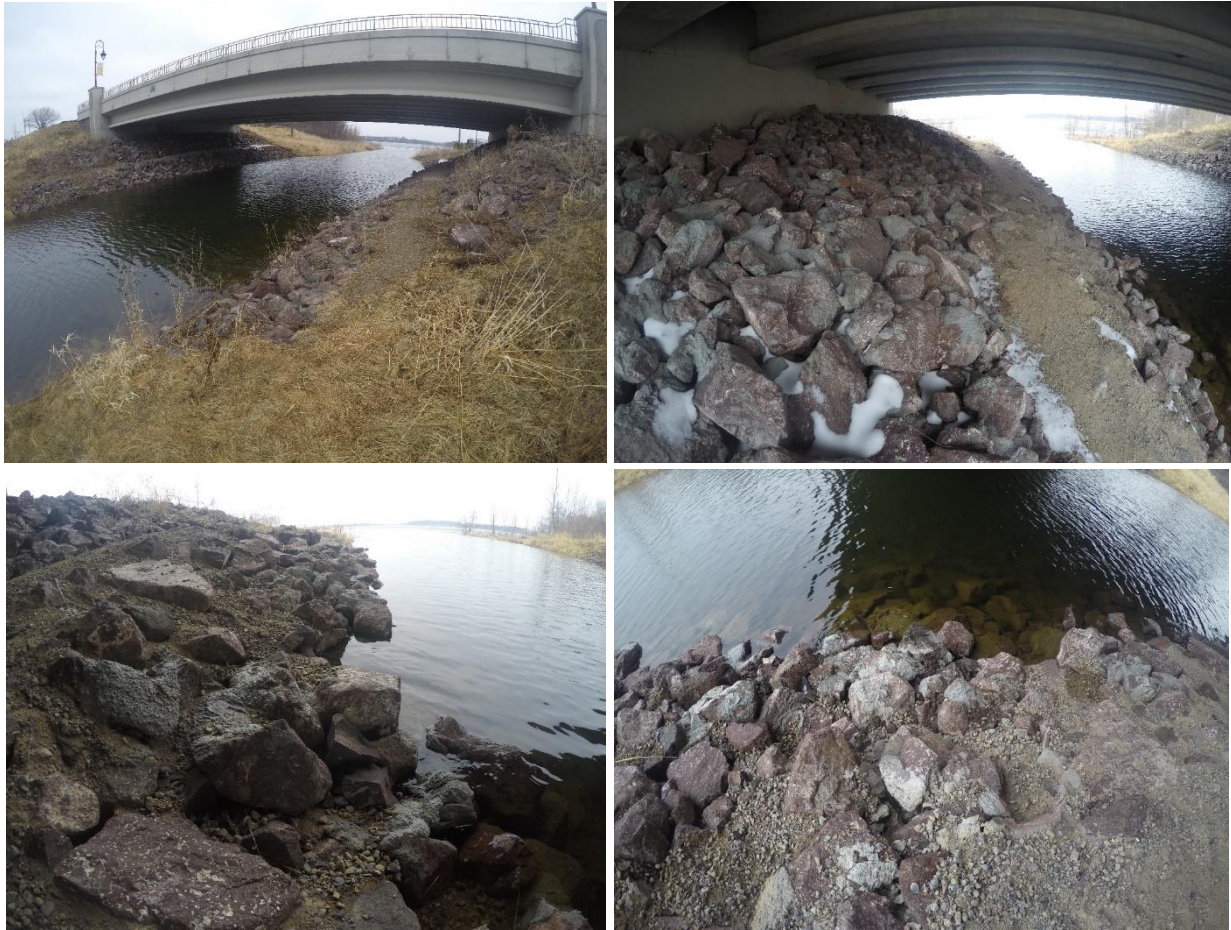
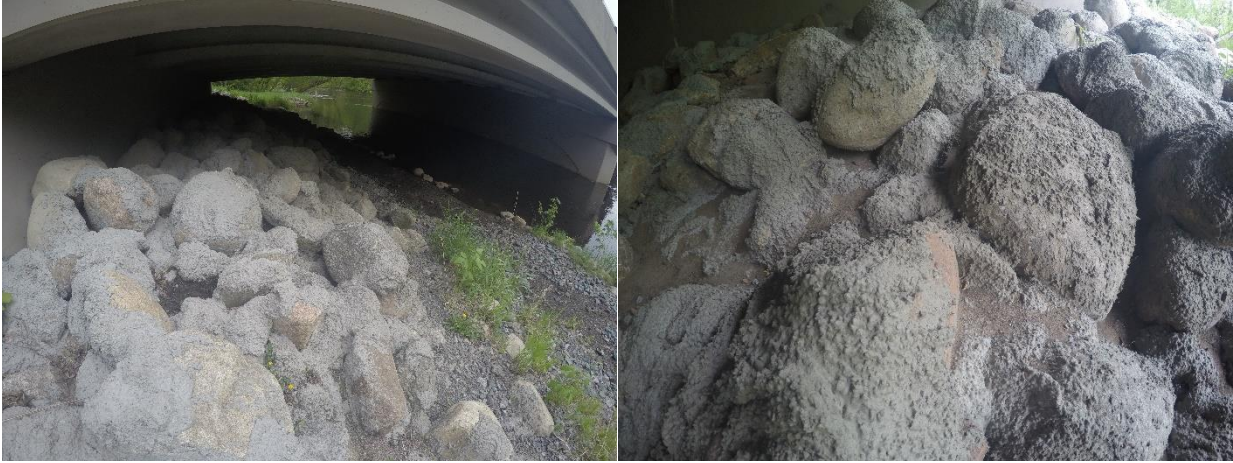
Four sites in Minnesota were visited and inspected to determine countermeasure performance. Photos from these sites are shown in Figure 16 through Figure 19.

Overall, partially grouted riprap was seen to perform well when it is grouted correctly. This same finding was conveyed via conversations with the Minnesota Department of Transportation (MnDOT). All of the systems were approximately five years old at the time of the field visits.

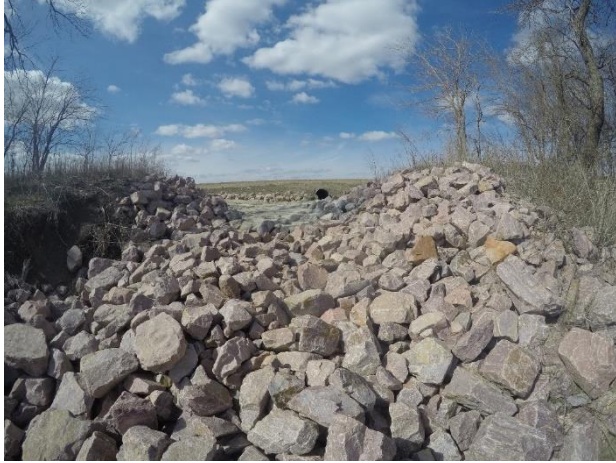
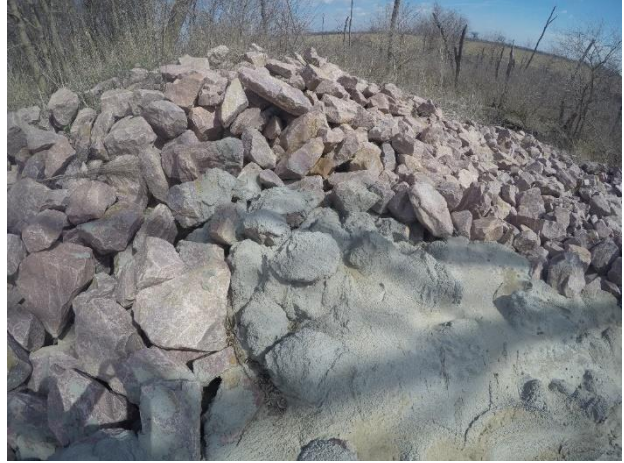
Figure 21. Loose riprap with some grouting in Woodbury County, Iowa

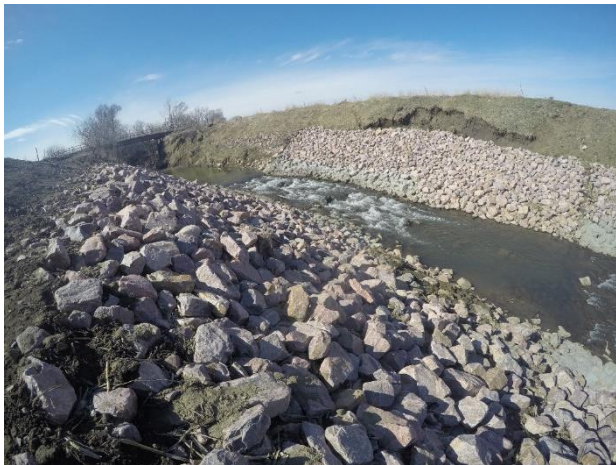
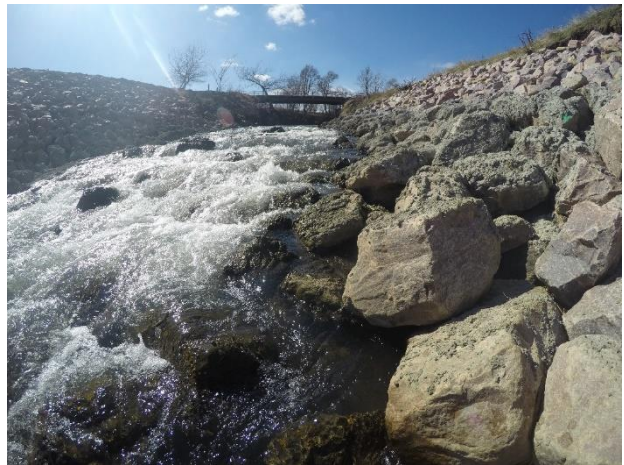
Figure 22. Grouted and loose riprap in Woodbury County, Iowa

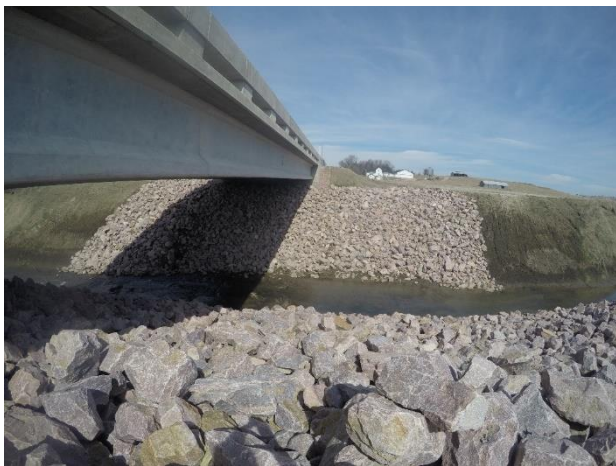
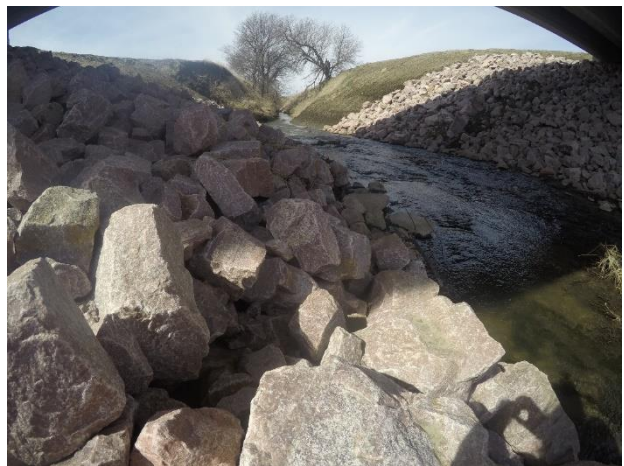
Figure 23. Recently installed loose riprap in good condition in Woodbury County, Iowa

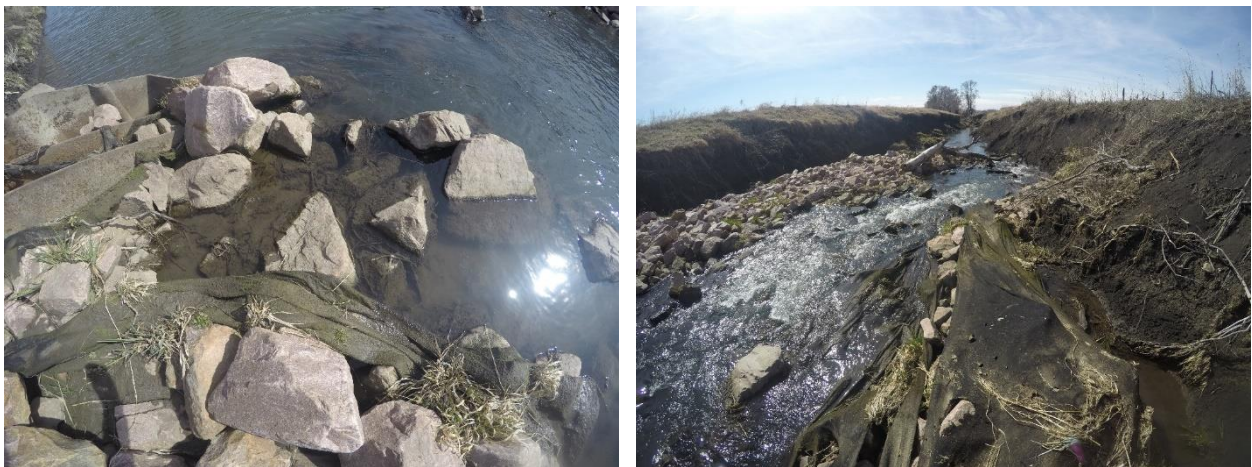
Figure 25. Failing stream grade control in Woodbury County, Iowa

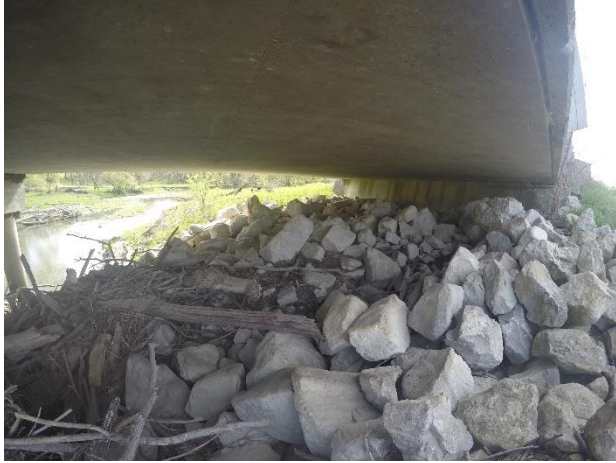
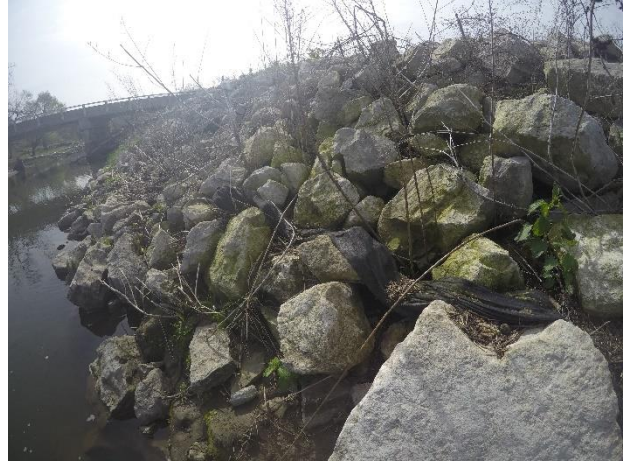
Figure 30. Loose riprap and failing fabric in poor condition in Madison County, Iowa

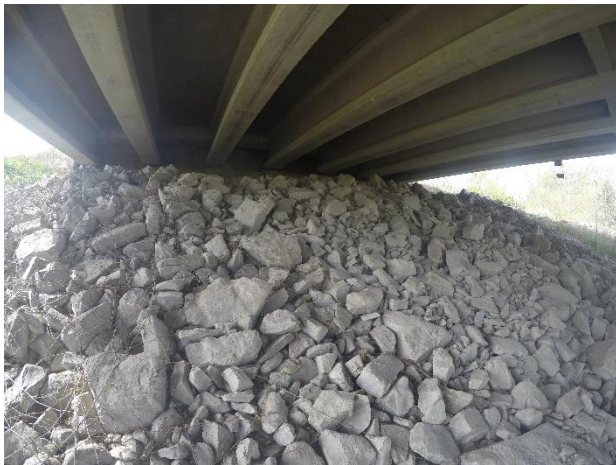
Figure 31. Undersized loose riprap in Madison County, Iowa

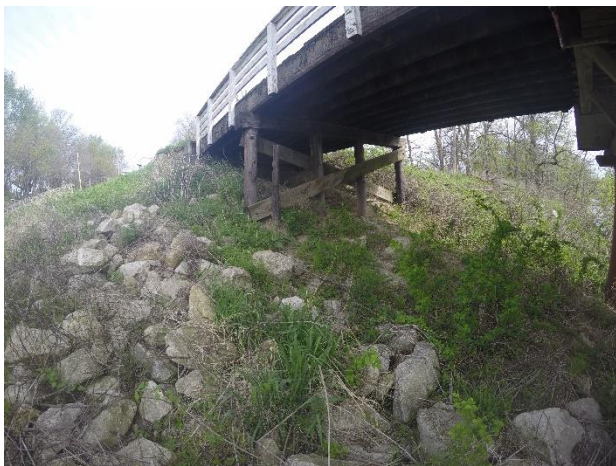
Figure 32. Loose riprap, many washed-away stones in Madison County, Iowa

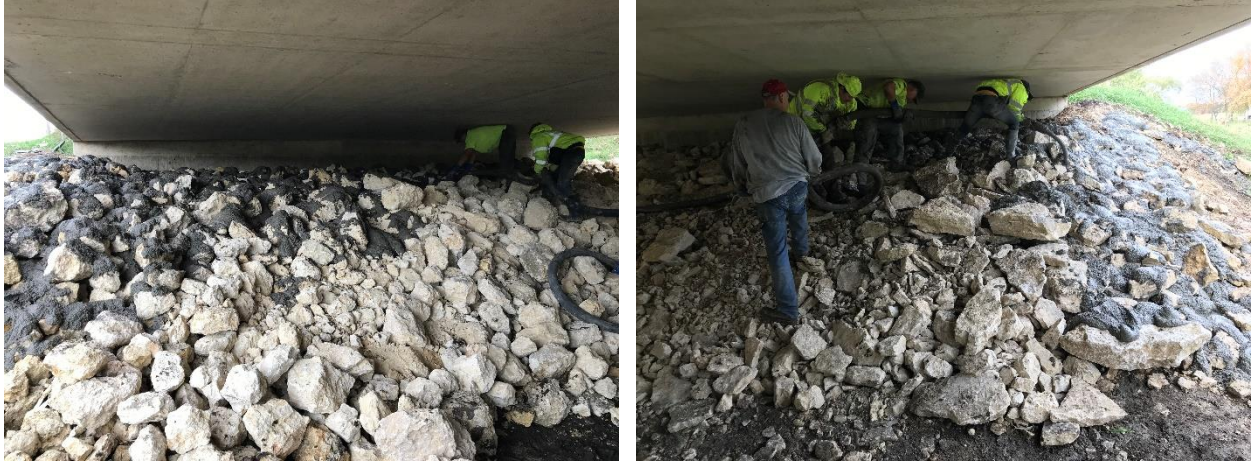
The pilot installation efforts in Buchanan County, Iowa, were selected to incorporate a number of variables that may affect performance. Two bridges were selected of similar design, in close proximity, and along the same channel. Bridge 1 had a revetment plan that would allow for the size/quality of the revetment stone to be compared when using the FHWA mix specifications. One bank used Class E revetment, while the other used recycled shotrock. Shotrock is considerably cheaper but includes a greater variety of stone sizes, including small gravel. Figure 33 shows the difference in stone properties associated with Bridge 1.

Figure 33. Grouting of Class E revetment (left) and shotrock (right) used for Bridge 1 in Buchanan County

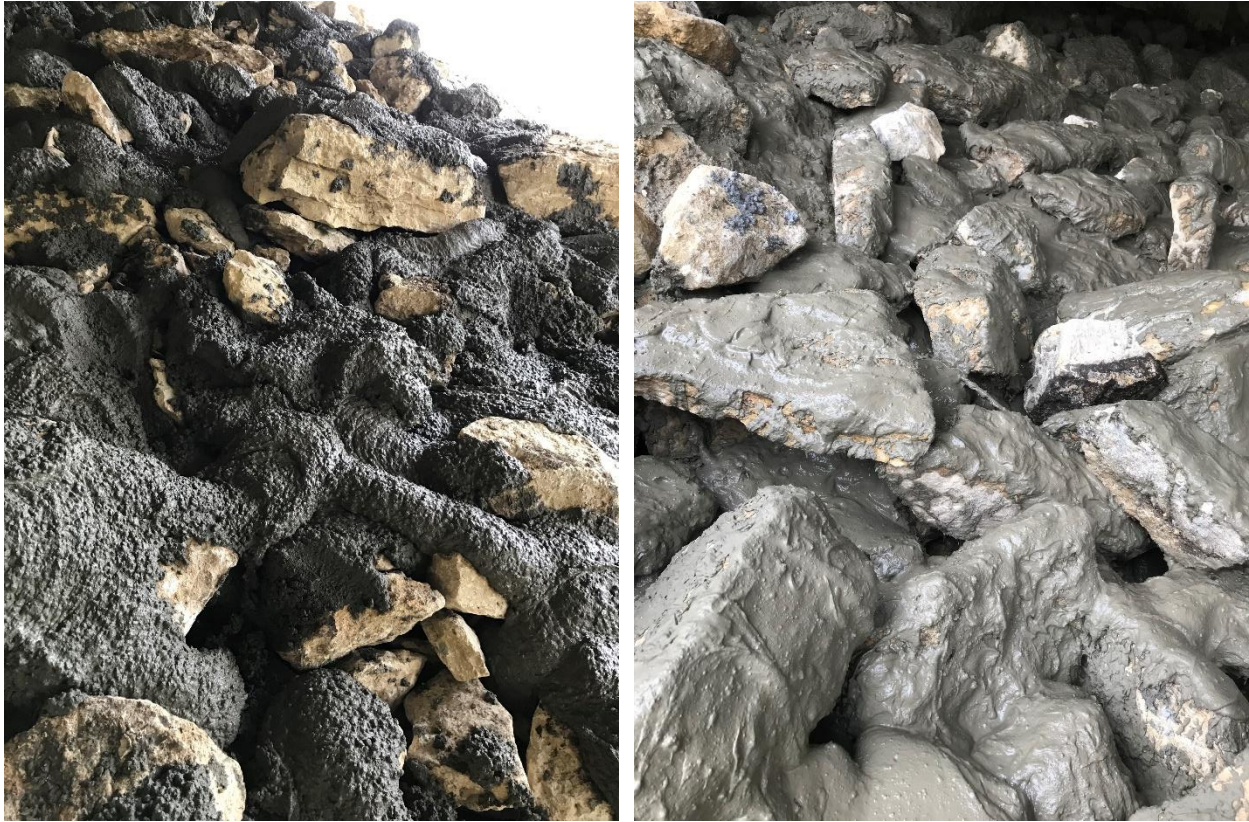
Photos showing the difference between the two mix designs are included in Figure 34.

Figure 34. Grout consistency of FHWA mix (left) and Buchanan County grout (right)

As evident from the photos, the grout used on Bridge 2 was significantly more flowable than that used for Bridge 1 due to the crusher chips found in the mix for Bridge 1. Because of this difference in consistency, different placement methods were used based on the pump capabilities. The two hose sizes used for placement are shown in Figure 35.

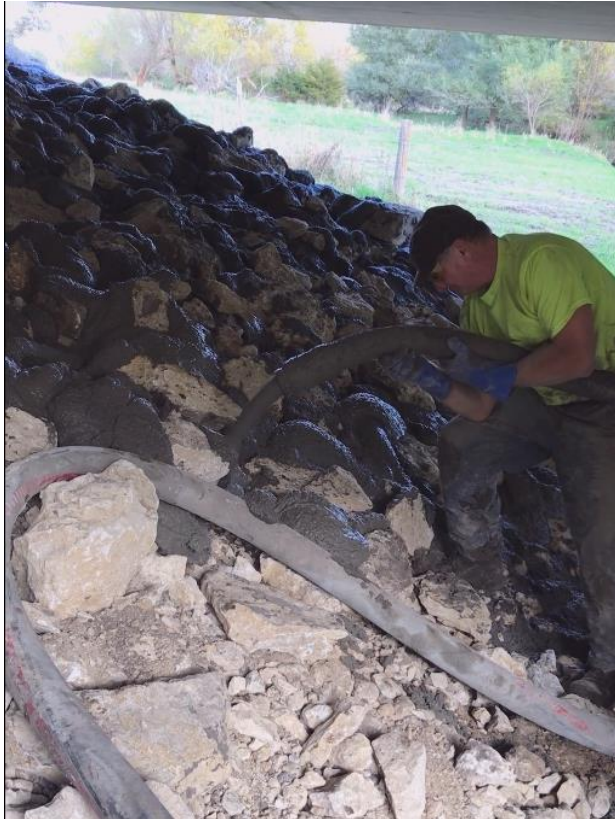
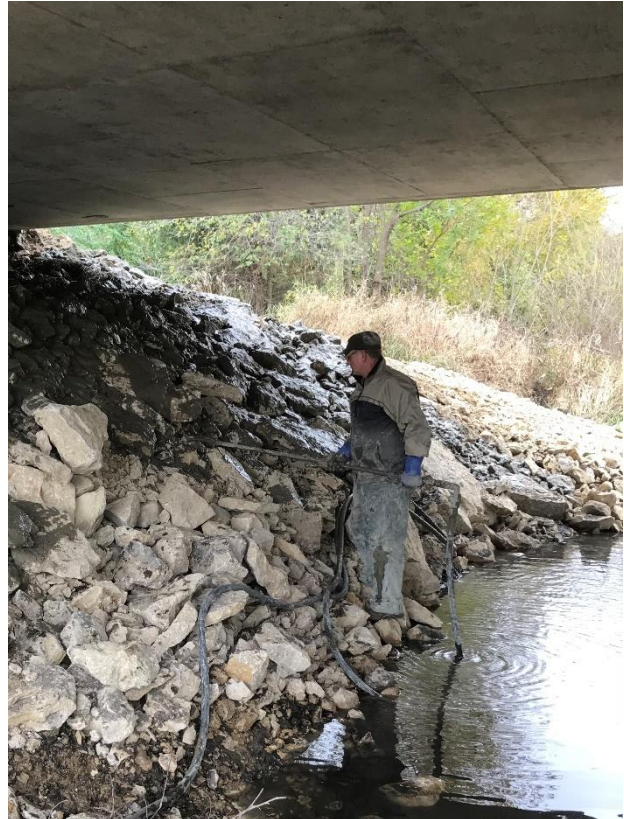
Figure 35. Grout placement of FHWA mix (left) and Buchanan County grout (right)

As expected, placement was more labor intensive when the large hose size was used due to the weight of the hose, often requiring multiple workers to help move it along. The condition of the two countermeasures shortly after placement is shown in Figure 36.

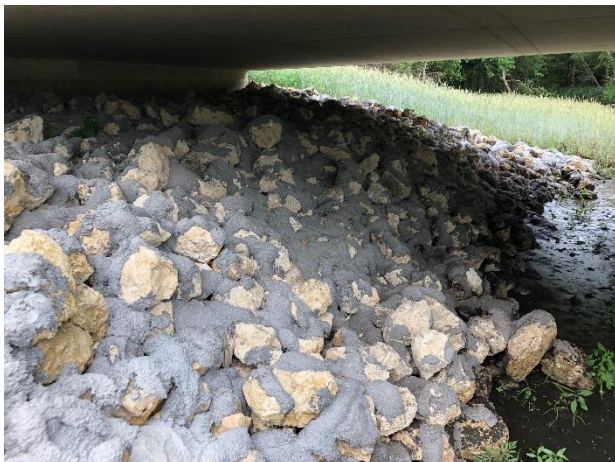
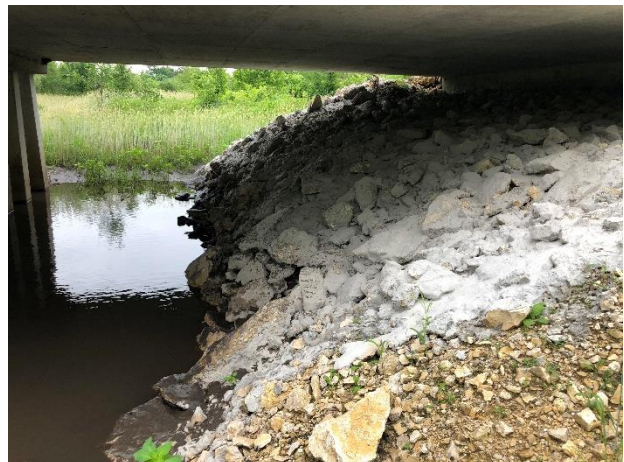
Figure 36. Condition shortly after placement for Bridge 1 (left) and Bridge 2 (right) in Buchanan County

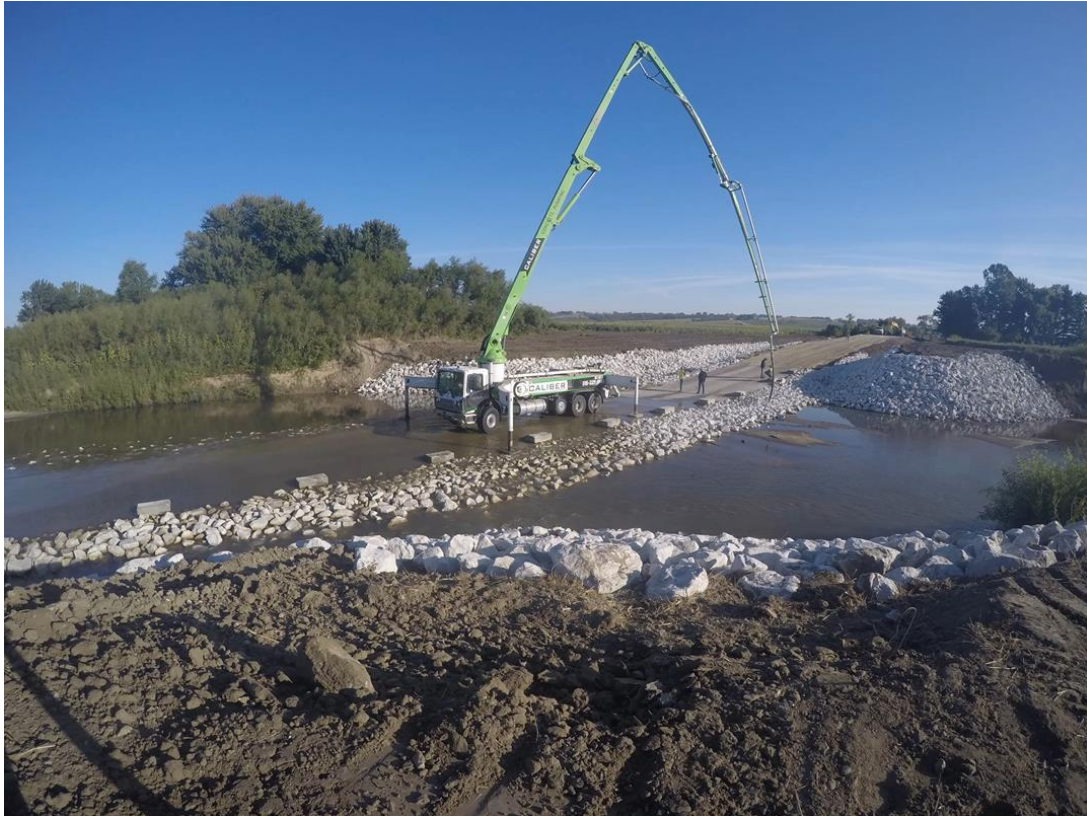
The pilot installation in Madison County, Iowa, was a new construction project involving a low water crossing that utilized the specified FHWA mix with Class E revetment. Due to the size of the project site (shown in Figure 37), a 4 in. hose size was used to get adequate reach with minimal pump setup locations given the costs associated with each move of the pump. Since placement did not involve maneuvering under a bridge deck, grouting was less labor intensive than under deck placement scenarios.

Figure 37. Low water crossing installation site in Madison County with pump shown

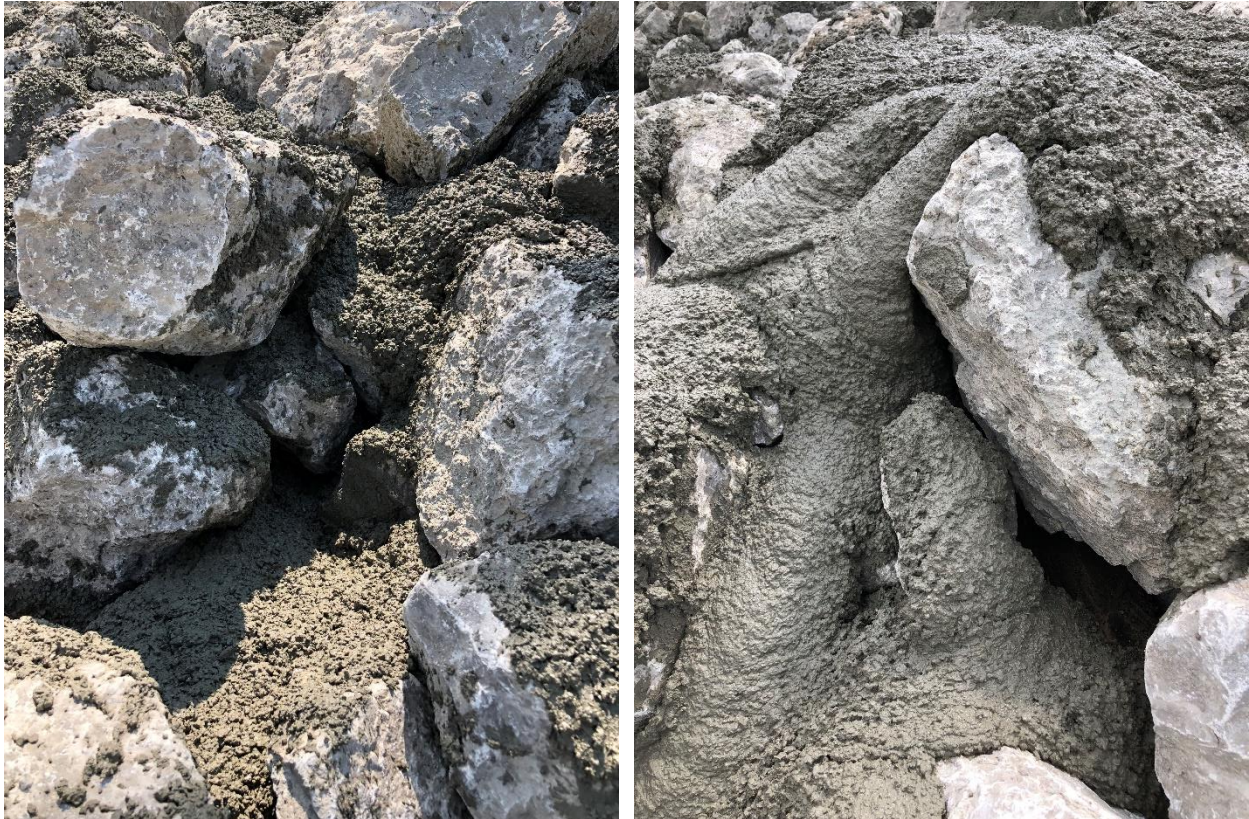
Figure 42. Initial grout consistency (left) and desired grout consistency (right) in Wayne County

As with the Madison County installation, it took a few trucks before the grout consistency was as desired (Figure 42). Placement was again significantly easier at this site than in Buchanan County since grouting took place prior to pouring of the deck. It would be preferred if the hose size were smaller, but, again, there were project constraints associated with pump availability.

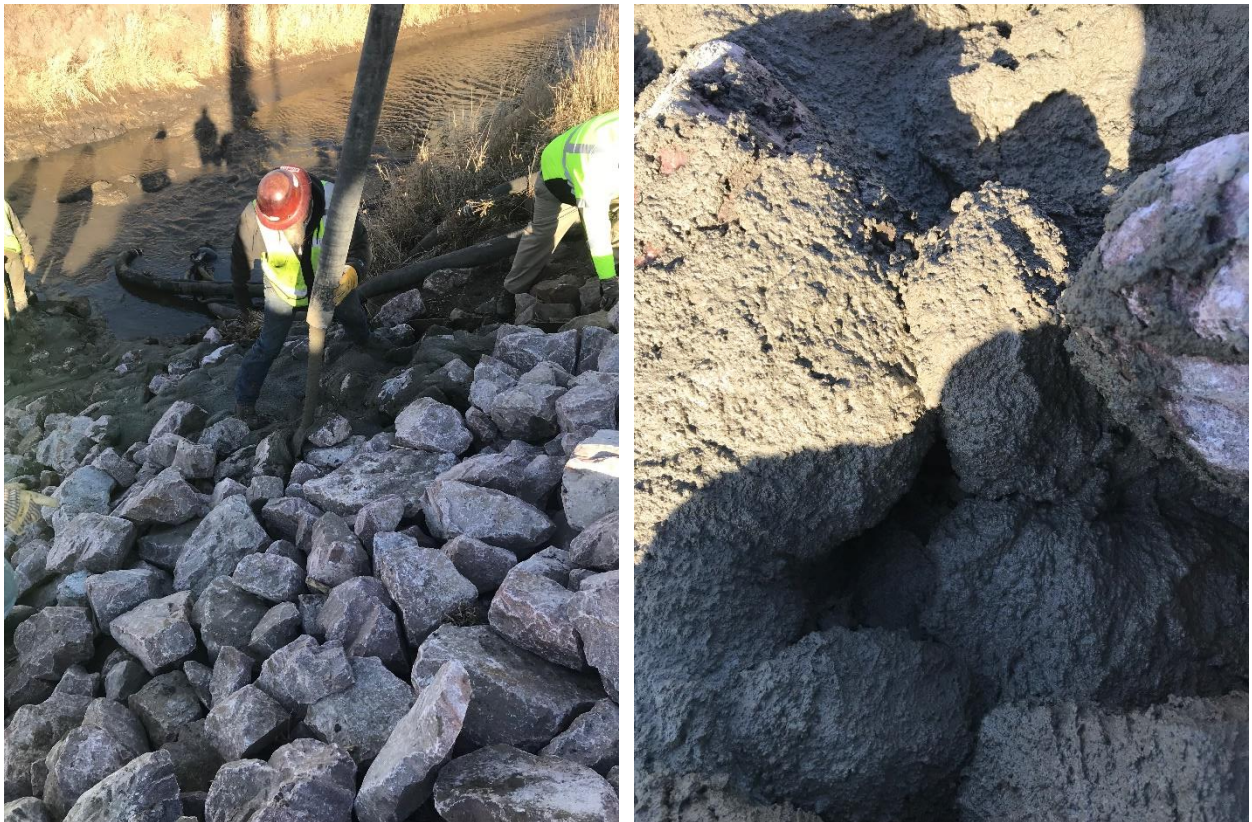
Photos of the grout consistency and placement method are included in Figure 44.

Figure 44. Woodbury County grouting (left) and grout consistency (right)
