**RIVER BANK
PROTECTION
STUDY**

WAPELLO, IOWA

REPORT ON
RIVER BANK PROTECTION STUDY
WAPELLO, IOWA

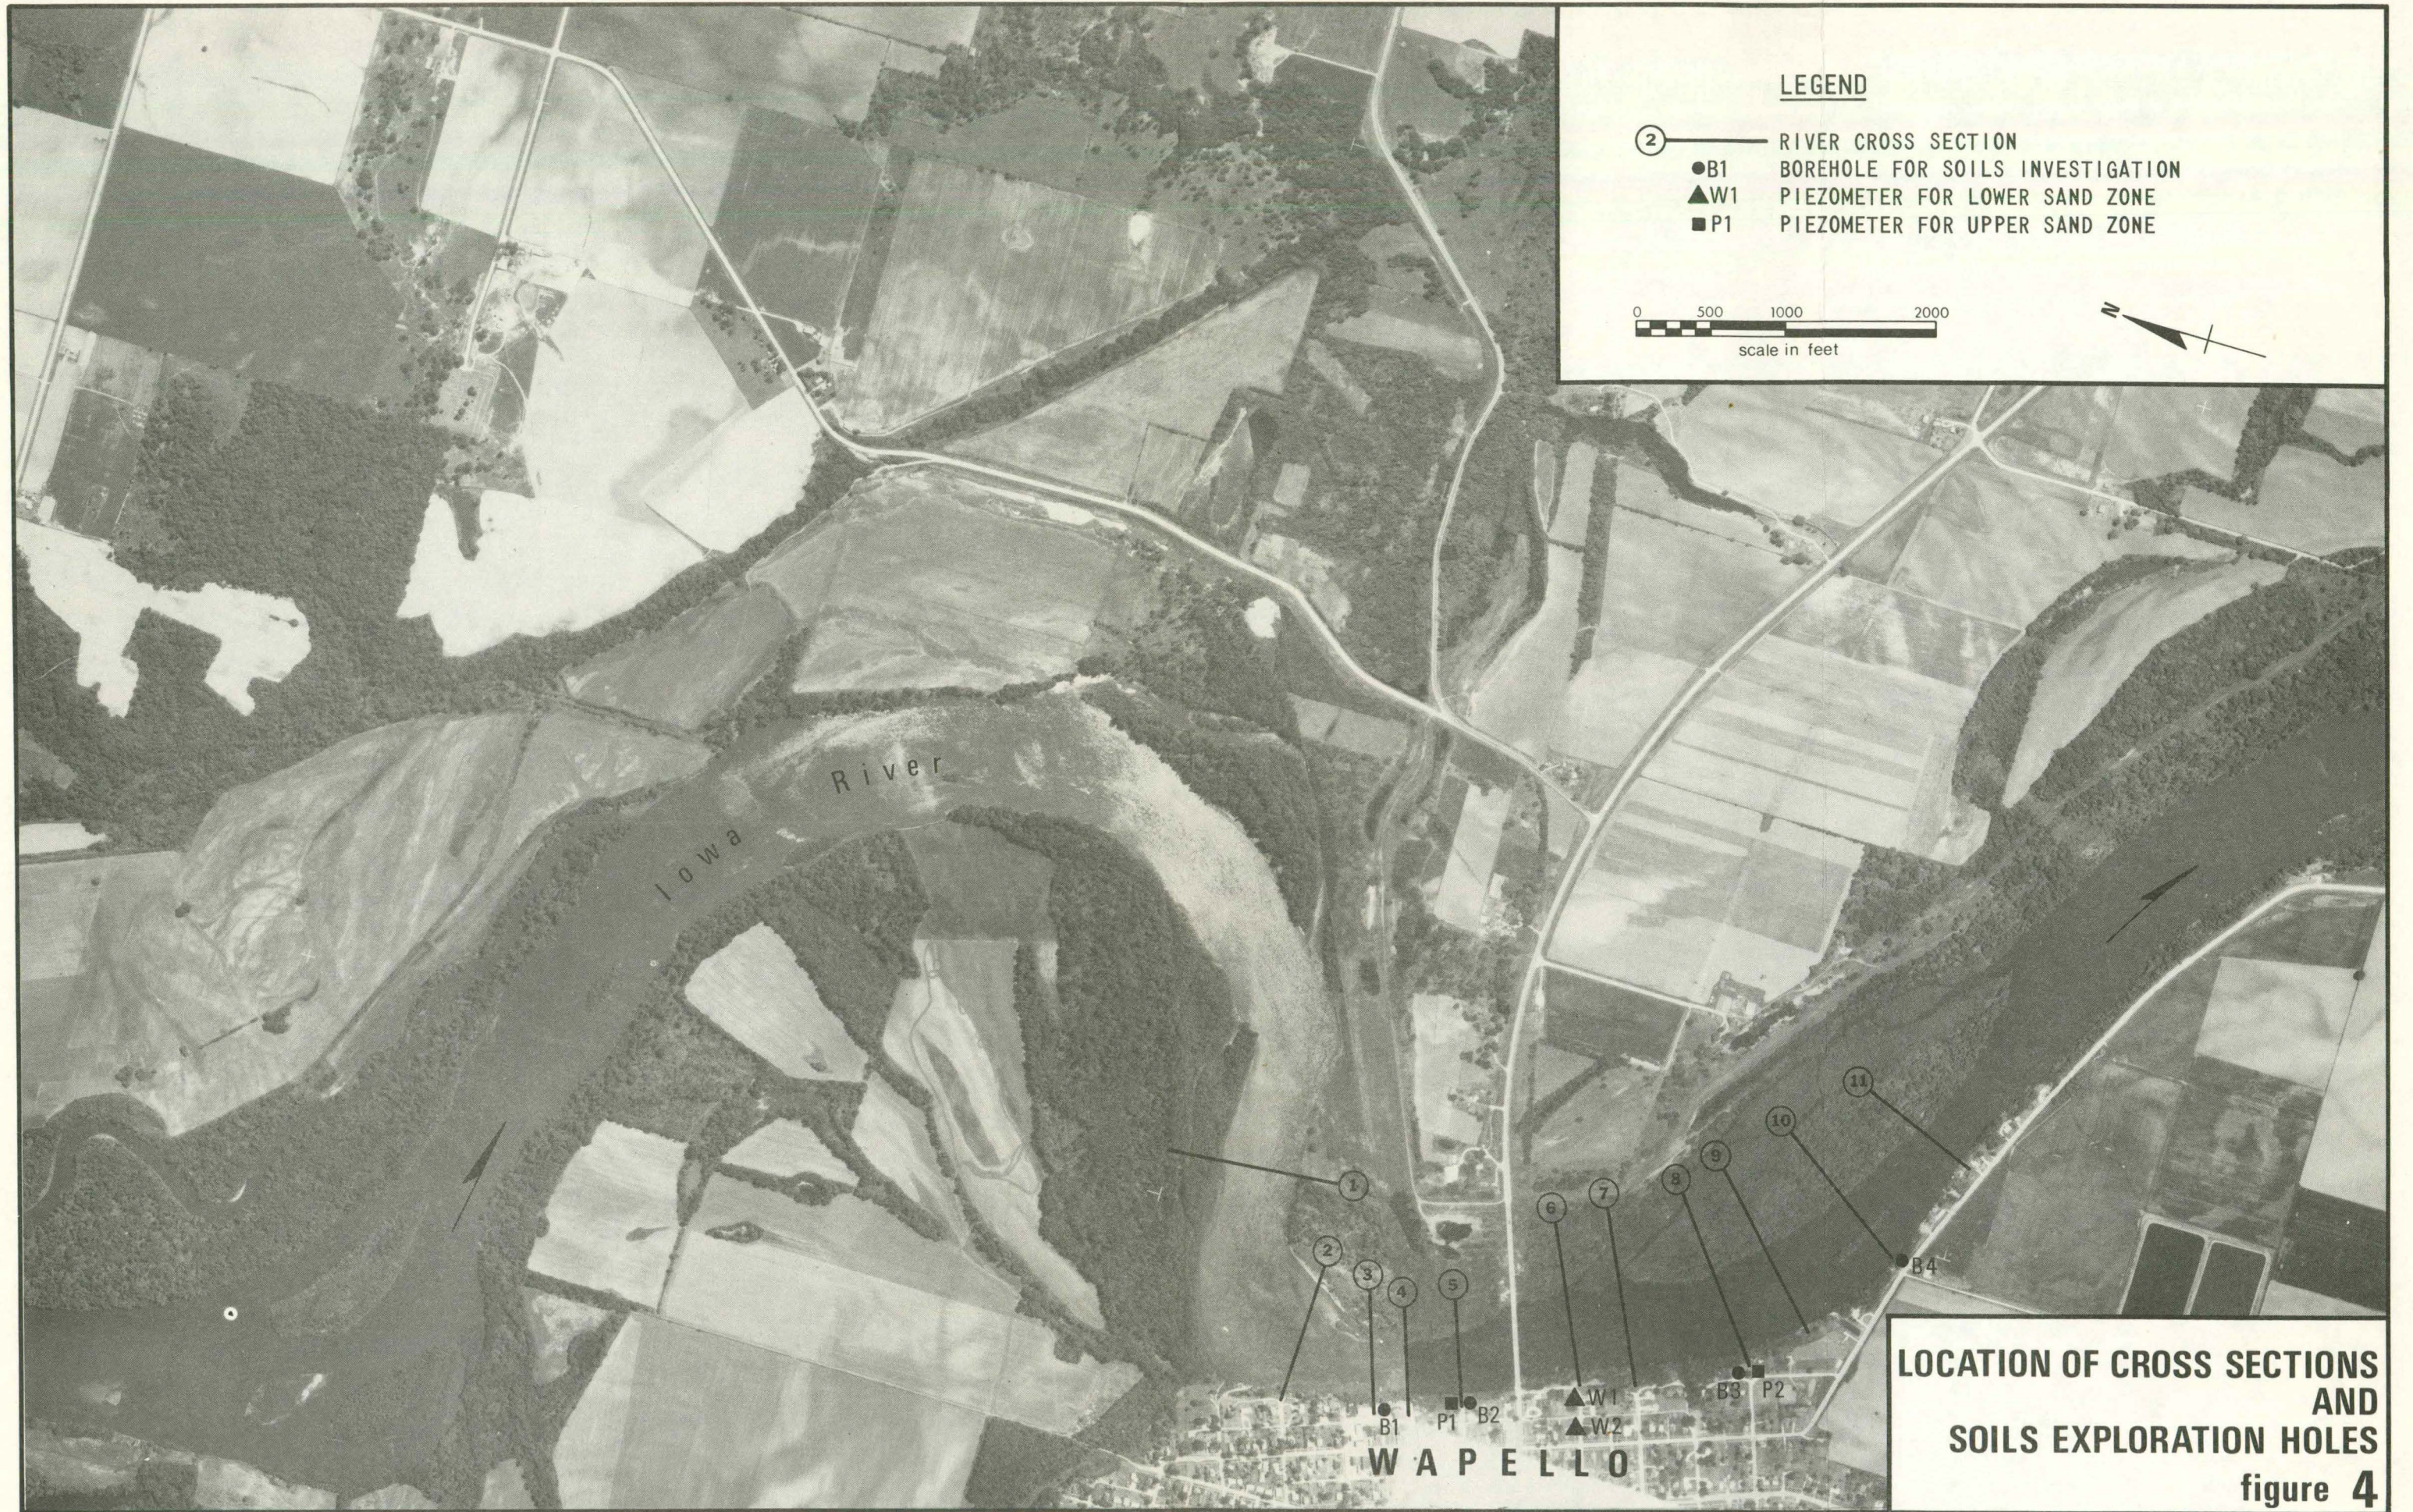
The firm of Soil Testing Services of Iowa, Inc. was selected to perform this soils testing work. A program of minimum reasonable soils exploration was arrived at in cooperation with and under the direction of Stanley Consultants. Soil Testing Services of Iowa, Inc. were to drill, sample, classify and log four boreholes extending well below the bottom of the river into the lower sand zone. They were to perform tests sufficient to establish the structural strength of each principal zone, analyze the stability of existing side slopes and describe measures for bank stabilization. Their principal recommendations together with recommendations which have been proposed from time to time by others have been further developed and are discussed in detail under the protection plans analyzed in this report. Copies of drilling logs are included as Appendix A to this report. Figure 4 shows the location of the boreholes.

Construction of these two piezometers (W-1 and W-2 on Figure 4) was completed in July 1974 and water levels have been recorded from July 30. At this time and during the period of record, river levels have been slowly subsiding. During the period, piezometric levels within the lower sand zone have been within 0.5 feet of river level at the further piezometer and show a gentle gradient (not exceeding .002) towards the river. Rainfall has been low during the period but little likelihood of strong flows within this sand zone, under normal conditions, is apparent. The possibility that failure in the upper sand zone might also be the result of perched ground water was next investigated.

Two additional piezometers (P-1 and P-2 on Figure 4) were constructed in the upper sand zone and extended down to the surface of the clay layer. Since construction, these have been virtually "dry holes." No appreciable water flow in the upper sands has been apparent since July of this year although some local failure close to P-1 has been experienced. There is little evidence of springs along the junction plane of the upper sand and the clay zone. One small spring was found at the boat launching ramp at Vernon Street about 1,000 feet downstream of the bridge. Water flow at this location was very small.

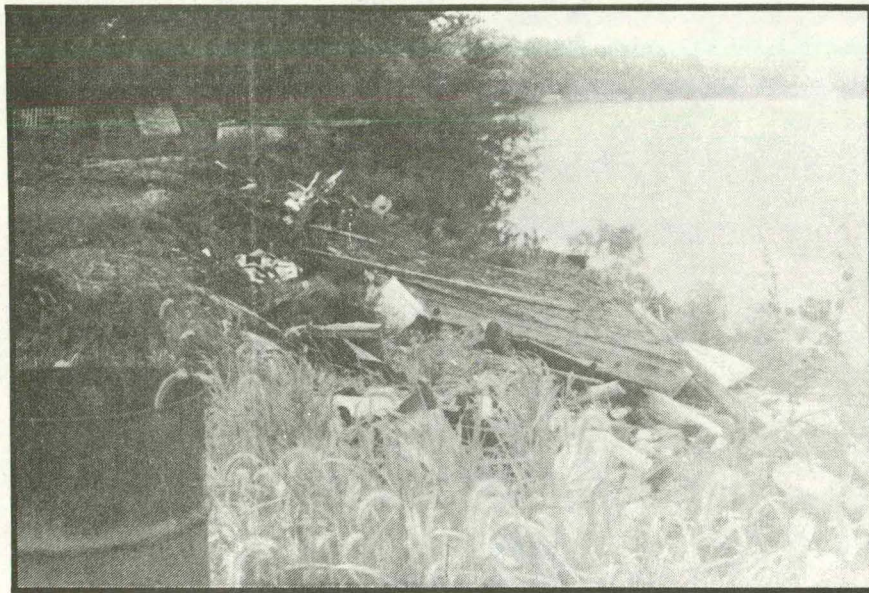
TYPICAL RIVER BANK, WAPELLO, IOWA

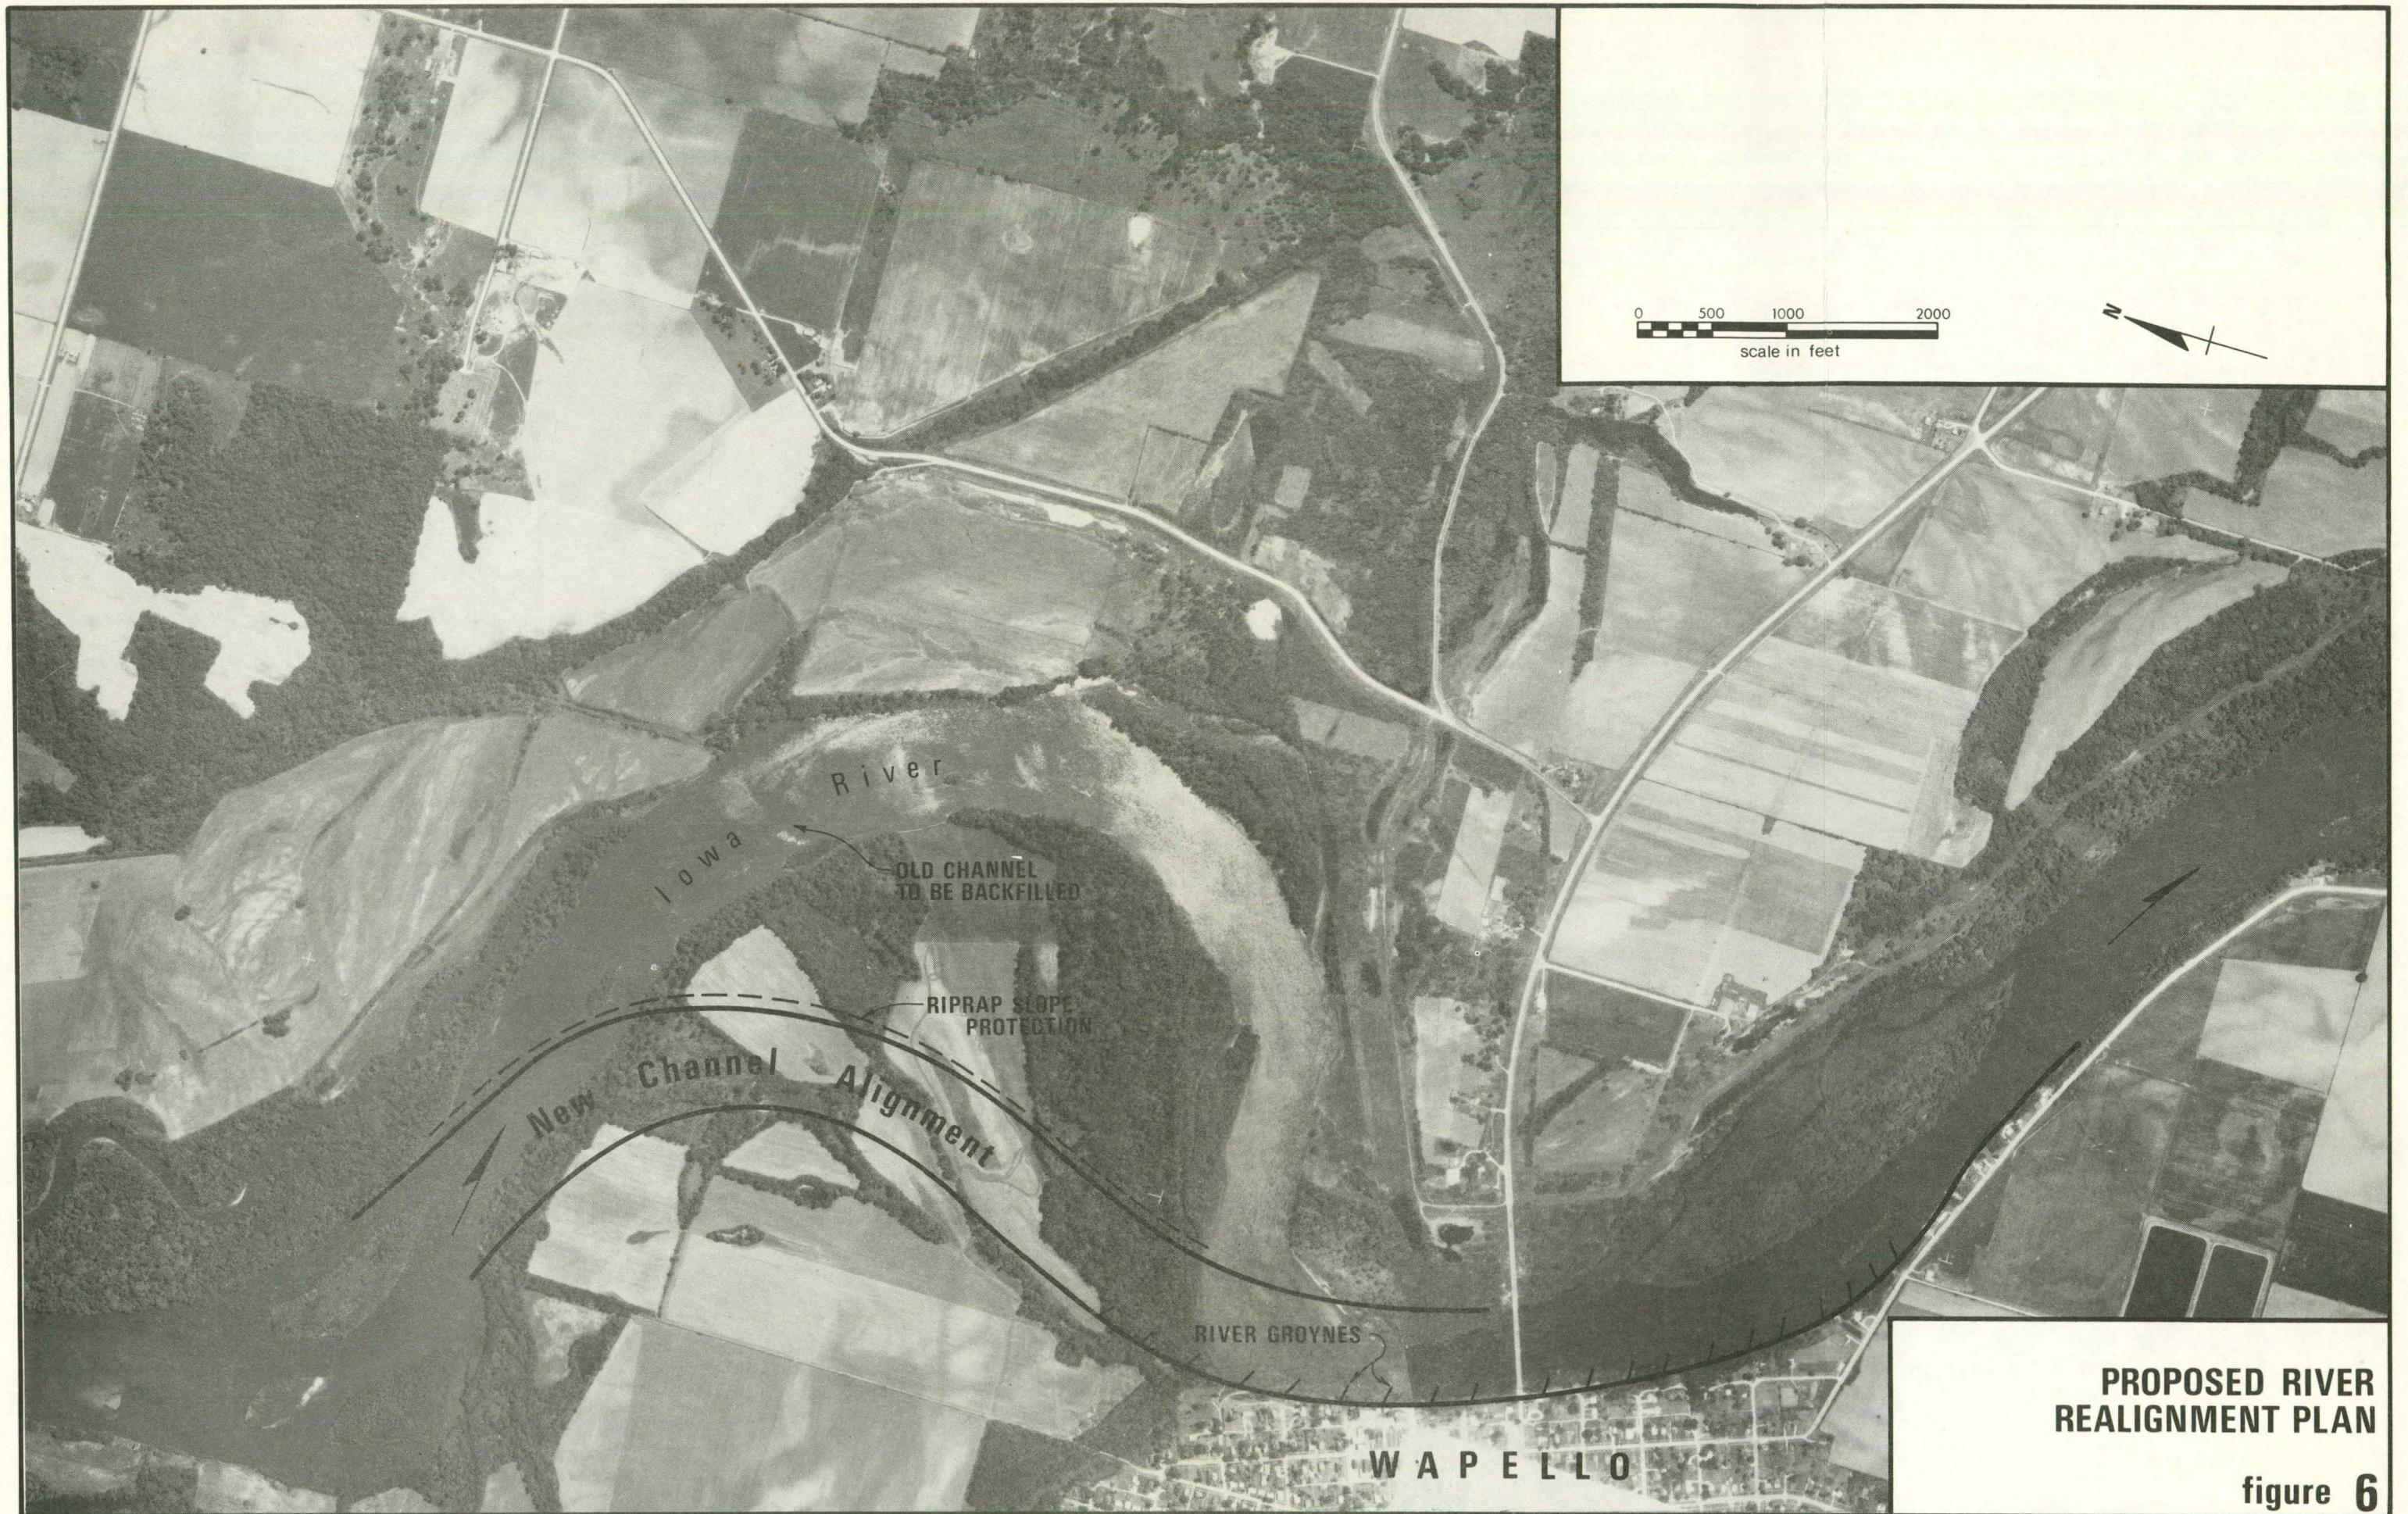
Such a plan is presented in Figure 6. The alignment shown represents a compromise short of the possible straight line cut-off which would involve more expensive excavation and loss of agricultural land. It is estimated that 2.9 million cubic yards of excavation would be required for the alignment shown on Figure 6. This material would be placed in the cut-off channel. An additional 2.9 million cubic yards of fill would be required to complete backfill of this channel.

straightened reach. Consequently, erosion of the new channel alignment would be expected and require protective revetment - particularly on the outer side slope. Ample toe protection of this revetment would be mandatory because of the probability of bed erosion. Cut-offs frequently tend to change the existing sequence of pools and bars in a stream. Downstream effects are not always predictable and additional downstream protection may be required to stabilize the downstream channel at critical locations.

Most important is the simple fact that channel straightening would not eliminate bank failure at Wapello. There is abundant evidence of recent riverbank failure at the end of Washington Street (the first street perpendicular to the river downstream of the bridge). Since this is at a point where the river channel is straight, and flow tends to be held straight by vane action of the bridge piers and is not likely to be adversely influenced by secondary currents from upstream meanders we have little reason to suppose that complete protection of the riverbank through Wapello could be accomplished without provision of bank protection through the town in addition to upstream channel straightening.

Since the same effect may be achieved at far less cost with the elimination of upstream channel straightening, this plan is not recommended. The Fisheries Section of Iowa Conservation Commission oppose this channel straightening plan but agree with the plan recommended in this report. Cost estimate for the total contract of a plan involving channel straightening and downstream bank protection is \$7,500,000.

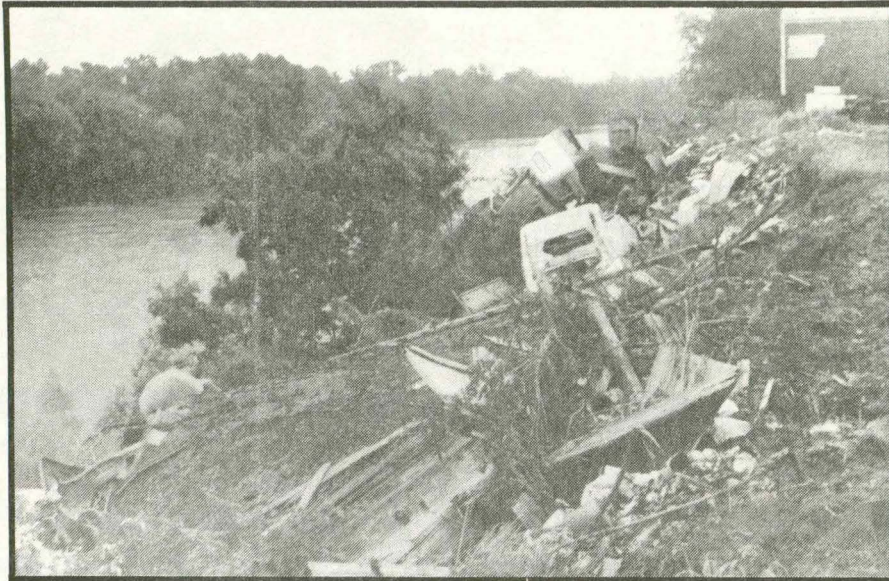
1. Remove unslightly rubble, dead vegetation, and trash previously dumped for bank stabilization. Exposed areas resulting from previous deposition of rubble on the upper slopes should immediately be seeded.

TRASH BANK PROTECTION, WAPELLO
