# FULL-SCALE VEHICLE CRASH TEST ON THE IOWA STEEL TEMPORARY BARRIER RAIL

TRANSPORTATION RESEARCH REPORT TRP-03-20-89

December, 1989

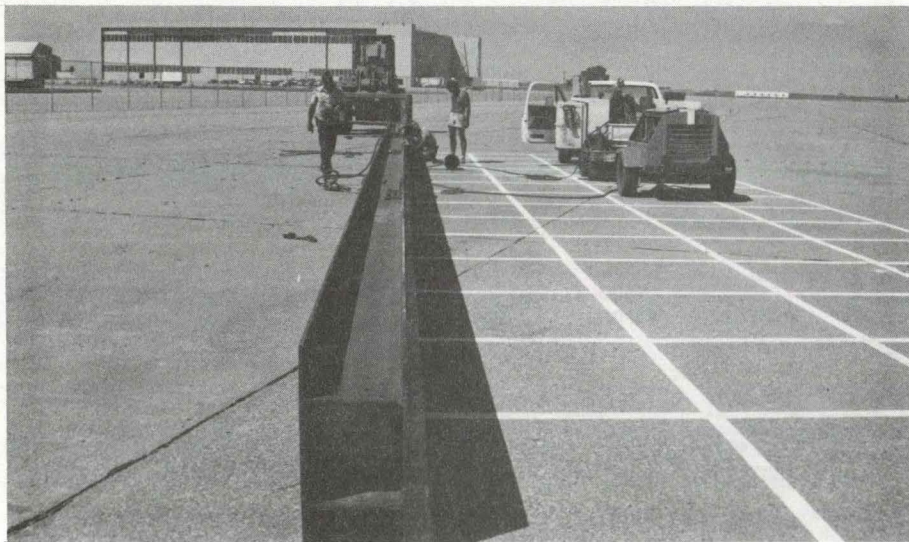
The design drawing details of the Iowa steel temporary barrier rail are shown in Figure 4, and photographs of the barrier being installed on the level concrete apron at the test site are shown in Figure 5.

FIGURE 5. PHOTOGRAPHS OF BARRIER RAIL INSTALLATION.

The overall test length of the barrier was 200 feet. The barrier was shop fabricated and transported to the test site in 20 foot length sections. The cross-section of the barrier consisted of two steel, stacked HP14x73 (A36) shapes with the edges of the flanges placed back to back and held together by welded steel straps spaced 5 feet on centers.

In order to increase the weight and stiffness of the barrier, the inside box section between the HP shapes was filled with concrete. The height of the barrier was 29 inches. The 20 foot length sections were bolted together with splice plates at the test site. The fill concrete stopped one foot short of each end of a section.

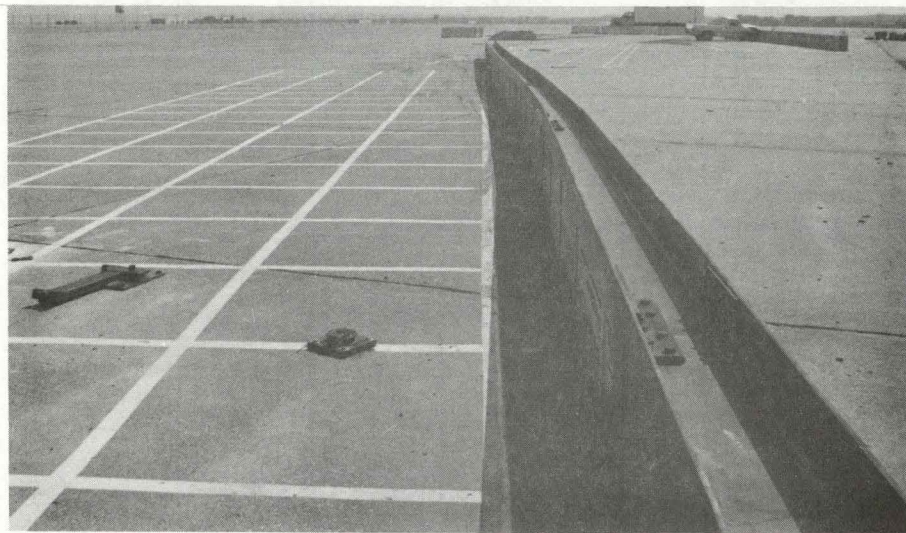
Photographs of the barrier after impact are shown in Figure 14 and a sketch of the displacements of the barrier bolted connections is shown in Figure 15. The maximum displacement of 17 9/16-inches occurred at the point of vehicle impact and connection Joint No. 5. Member 5-6, the first member downstream from the point of impact, was the only member to experience a permanent deformation. This deformation is 1/8-inch.

FIGURE 14. PHOTOGRAPHS OF BARRIER RAIL AFTER IMPACT.
