INVESTIGATION OF VIDEO CRACK & PATCH SURVEYING FOR PAVEMENT MANAGEMENT

FINAL REPORT
FOR
MLR-92-1

MAY 1992

Highway Division

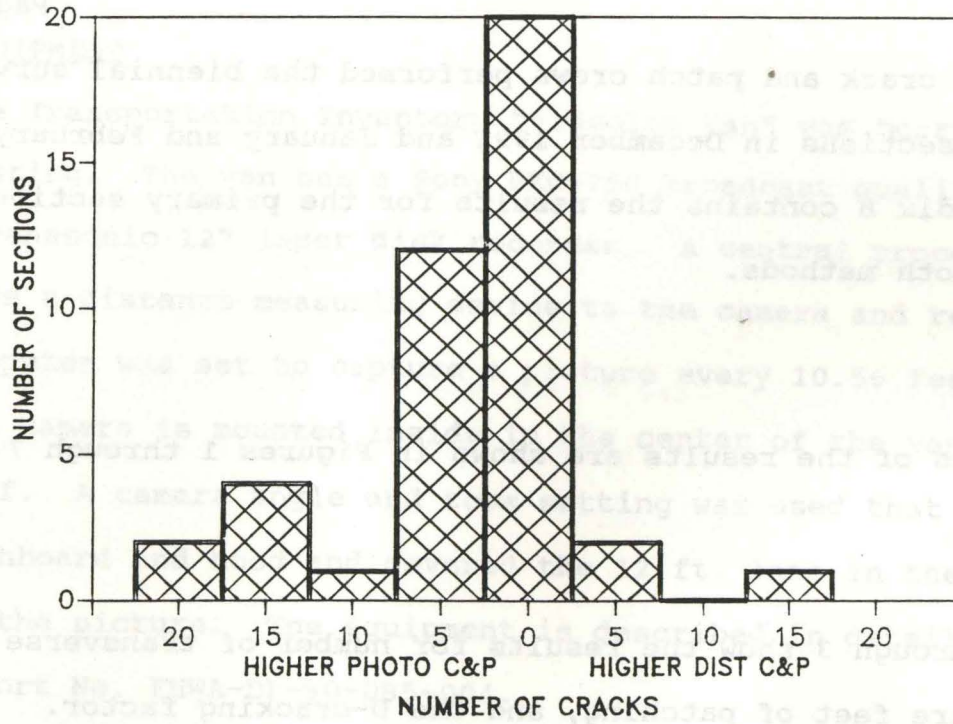
FIGURE 1. PCC SECTIONS—TRANSVERSE CRACKS

For transverse cracking (Figure 1), both surveys obtained about the same number of cracks for most sections. The video survey had more cracks on several sections. The videos were reviewed for errors. The person reducing the video apparently counted shadows, irregularities and staining as cracks. With the resolution of the picture; lighting conditions; and heavy texture, the difference is understandable. In the future, instructions will need to be given to only count cracks when the reviewer is sure.

Figures 1 through 3 show the results for number of transverse cracks, square feet of patching, and the D-cracking factor.

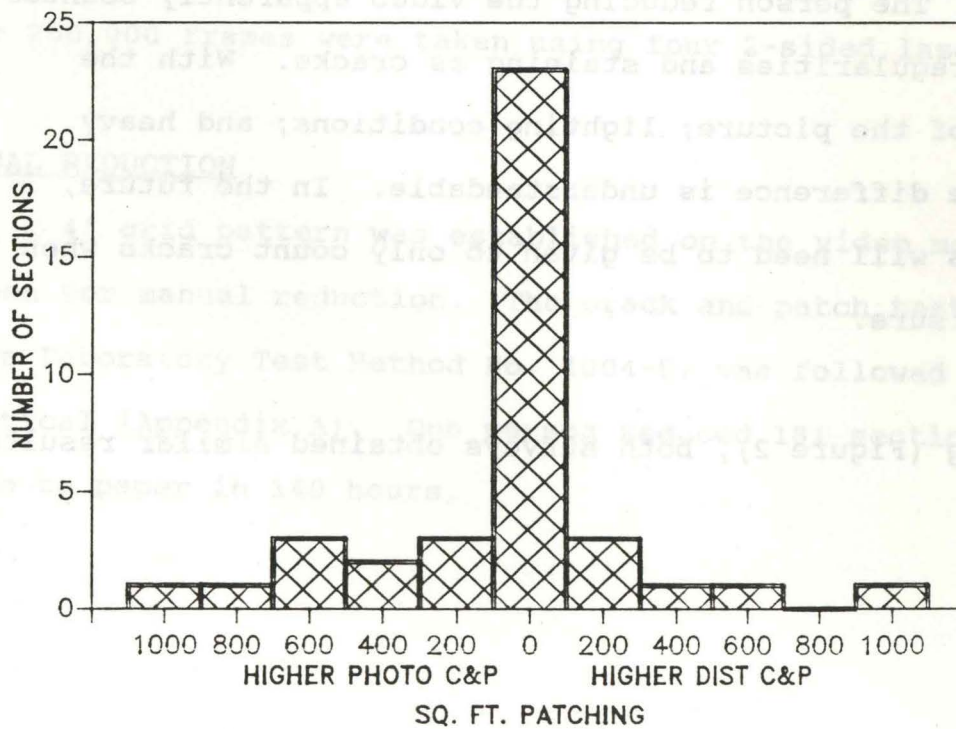
FIGURE 2. PCC SECTIONS—PATCHING

For patching (Figure 2), both surveys obtained similar results.

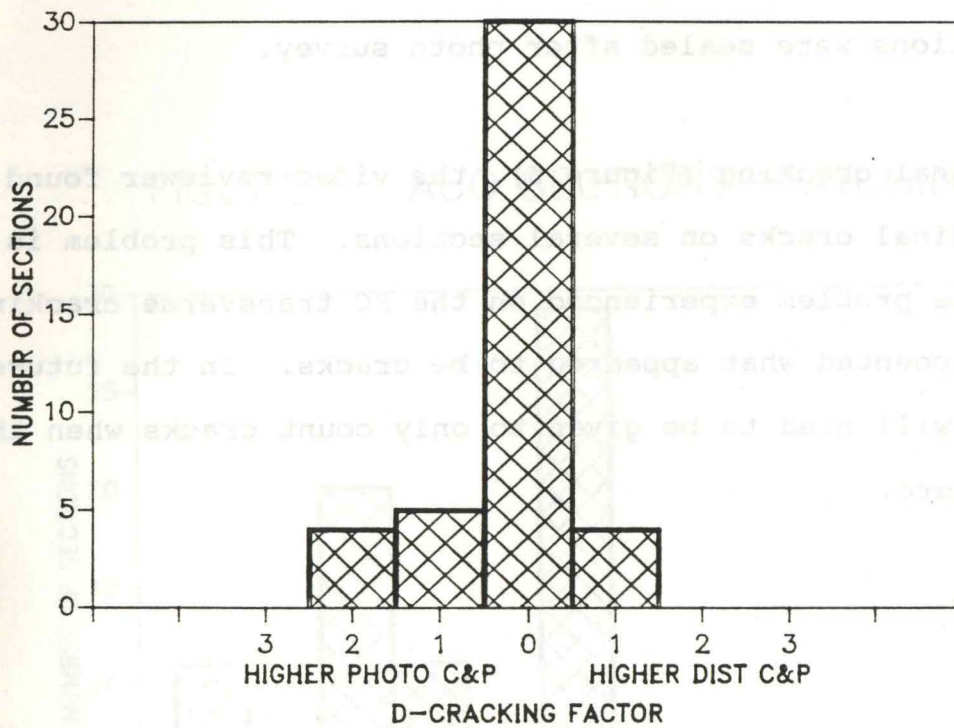
FIGURE 3. PCC SECTIONS—"D-CRACKING"

For the D-cracking factor (Figure 3), the results were the same for most of the sections. In a few cases, the reviewer rated the D-cracking higher than it should have been. With more experience and training, this difference could be reduced.

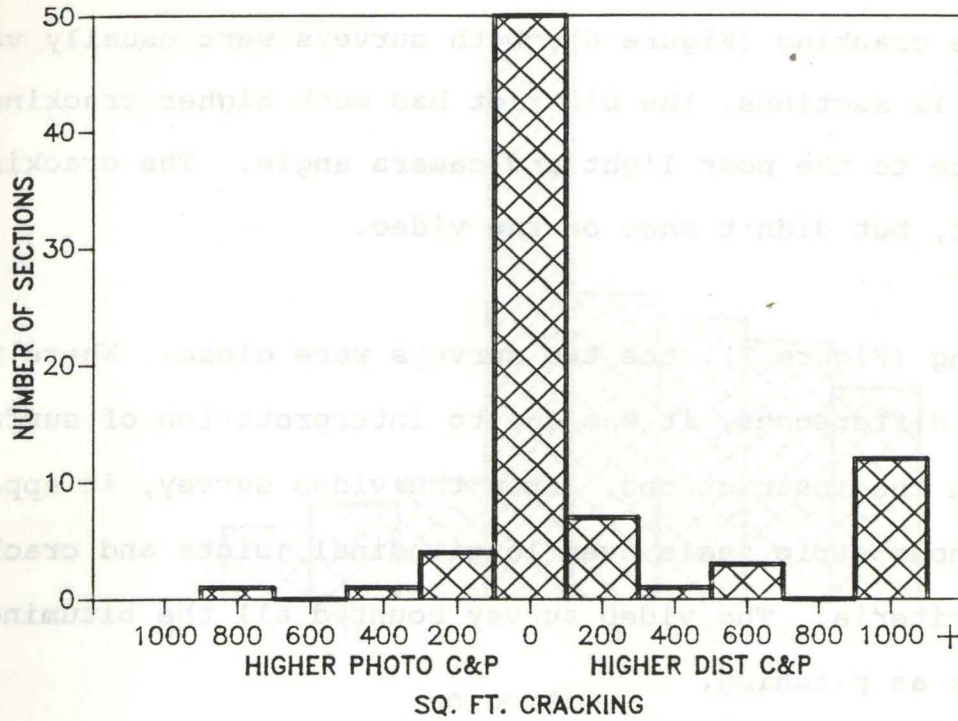
FIGURE 4. ACC SECTIONS—CRACKING

For fatigue cracking (Figure 6), both surveys were usually very close. On 12 sections, the District had much higher cracking. This was due to the poor light and camera angle. The cracking was present, but didn't show on the video.

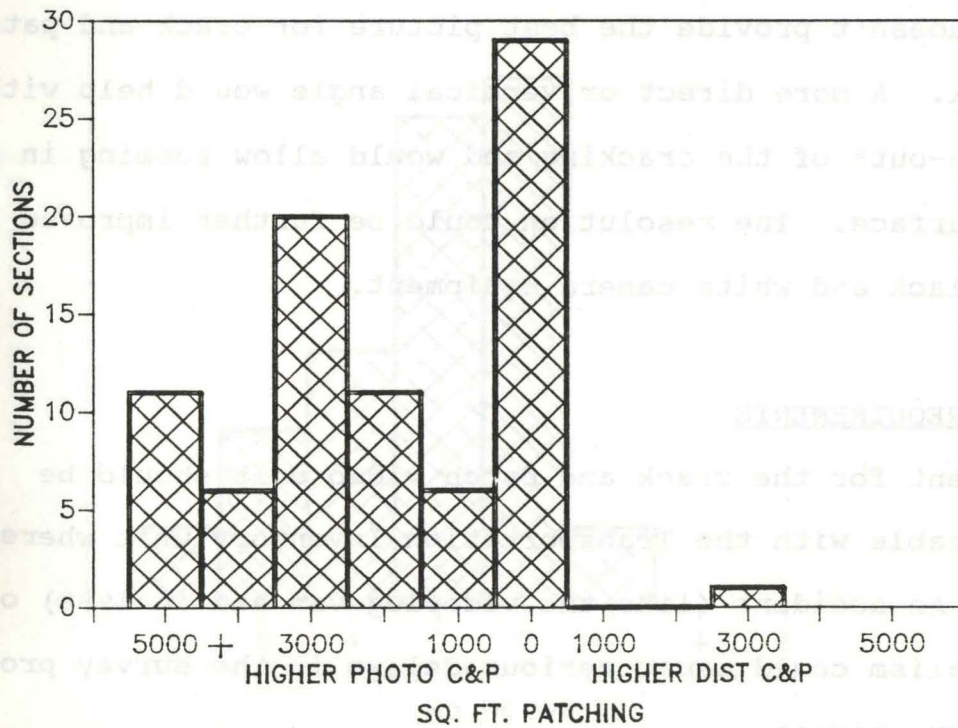
FIGURE 5. ACC SECTIONS—PATCHING

For patching (Figure 7), the two surveys were close. Where there were large differences, it was due to interpretation of surface patching in the instructions. From the video survey, it appears the bituminous strip seals over longitudinal joints and cracks meet the criteria. The video survey counted all the bituminous strip seals as patching.

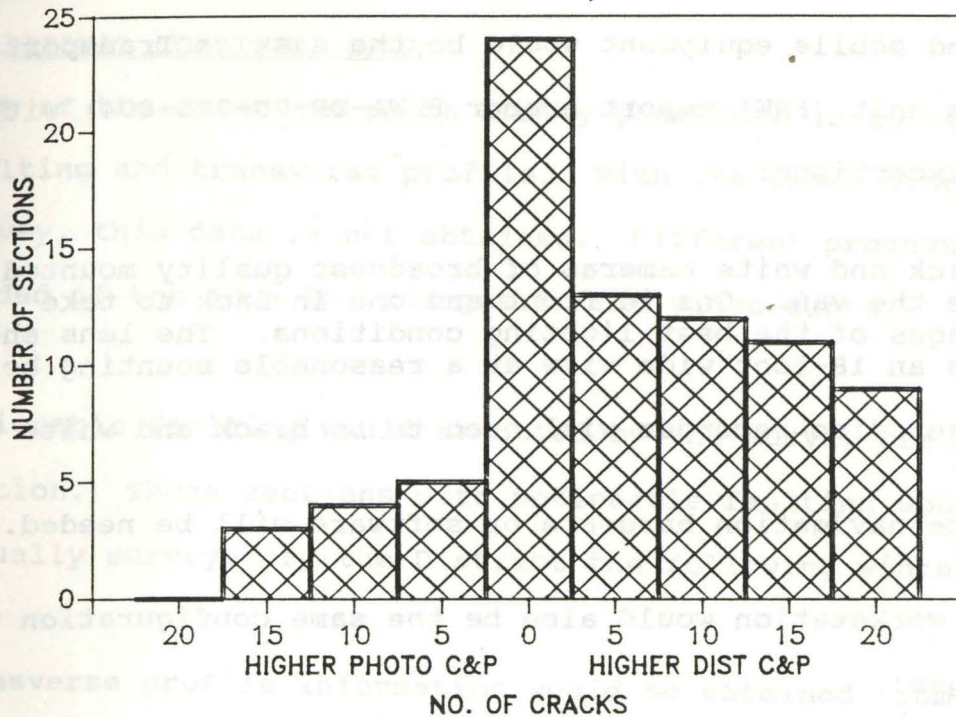
FIGURE 6. ACC SECTIONS—TRANSVERSE CRACKS

For transverse cracking (Figure 4), both surveys obtained about the same number for most sections. The district survey was higher on a few sections. No one reason explained the differences. The reasons for the differences are:

1. Cracks could not always be seen on the photos.
2. Some cracks developed after the photo survey.
3. Some sections were sealed after photo survey.

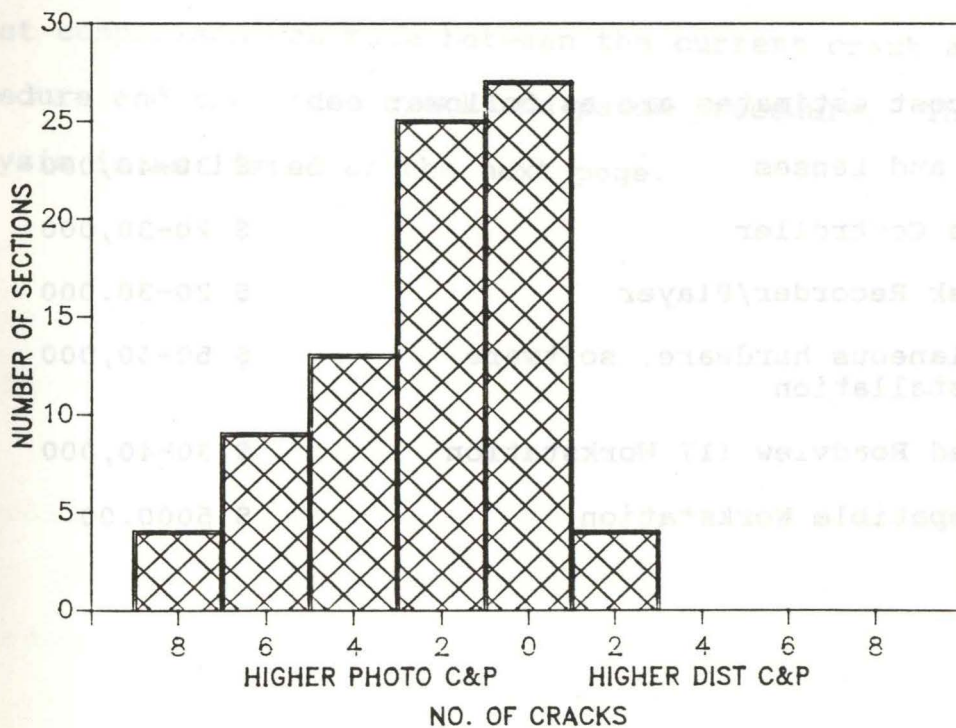
FIGURE 7. ACC SECTIONS—LONGITUDINAL CRACKS

For longitudinal cracking (Figure 5), the video reviewer found more longitudinal cracks on several sections. This problem is similar to the problem experienced on the PC transverse cracking. The reviewer counted what appeared to be cracks. In the future, instructions will need to be given to only count cracks when the reviewer is sure.

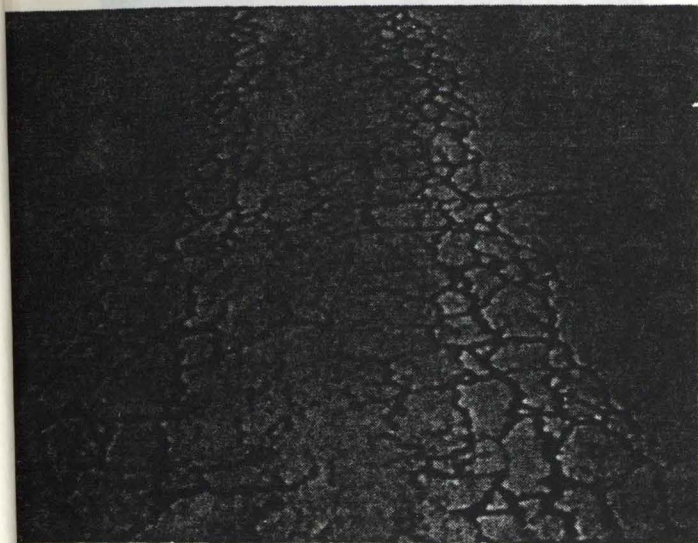
Figure 1

Cracking, C, is defined as the square feet per 1000 square feet of pavement surface exhibiting alligator or fatigue cracking. This type of cracking is defined as load related cracking which has progressed to the state where cracks have connected together to form a grid like pattern resembling chicken wire or the skin of an alligator. This type of distress can advance to the point where the individual pieces become loosened.

Alligator cracking

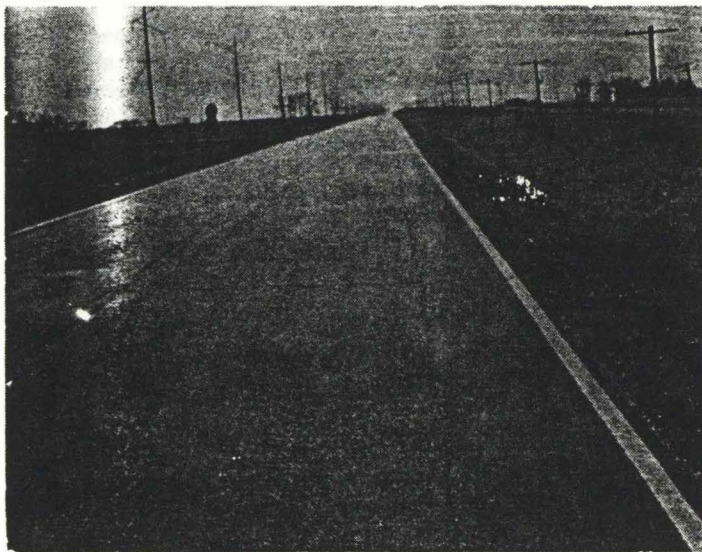
Figure 2

Cracking, L, is defined as the number of longitudinal (parallel to traffic flow) cracks which exceed 100 feet in length and 1) are open to a width of 1/4" over half their length or 2) have been sealed. If these cracks are observed to occur less than 3 feet from one another, the condition described under C should be looked for and if present reported instead of reporting the distress as longitudinal cracking.

Longitudinal Cracks

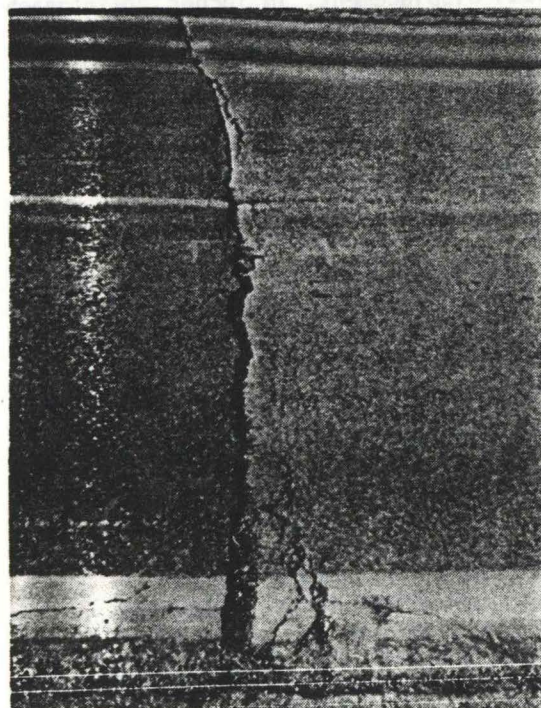
Figure 3

Cracking, T, is defined as the number of transverse (right angles to traffic direction) cracks that are open to a width of 1/4" over half their length or have been sealed. Random or diagonal cracks are ignored.

Faulting, F, is defined as the mean vertical displacement, in inches, measured with a 4-ft. straightedge.

Transverse Cracks and Faulting

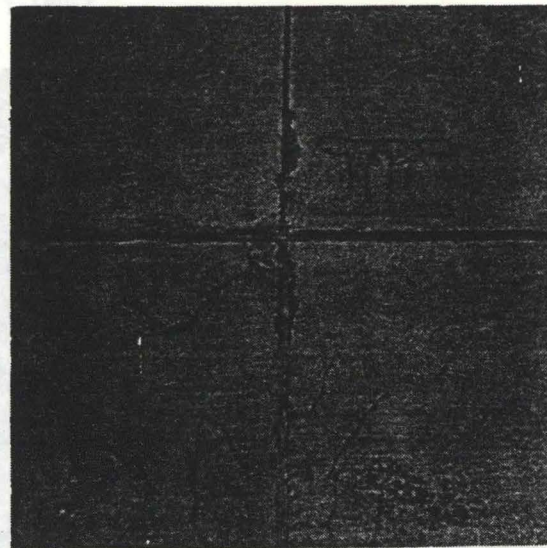
Figure 4

D-cracking, D, refers to a characteristic pattern that can develop in portland cement concrete. Initially, the occurrence of D-cracking may be preceded and accompanied by staining of the pavement surface near joints and cracks. However, not all stained joints and cracks develop D-cracking. D-cracked concrete will first exhibit fine parallel cracks adjacent to the transverse and longitudinal joints at the interior corners. The D-cracks will bend around the corner in a concave or hourglass pattern. As the D-cracking progresses, the entire length of the transverse, longitudinal and random cracks will be affected. The cracked pieces may become loose and dislodged under the action of traffic. The occurrence of D-cracking in the check sections will be rated on a point scale as described in the Test Procedure section.

D-cracking - Initial stages

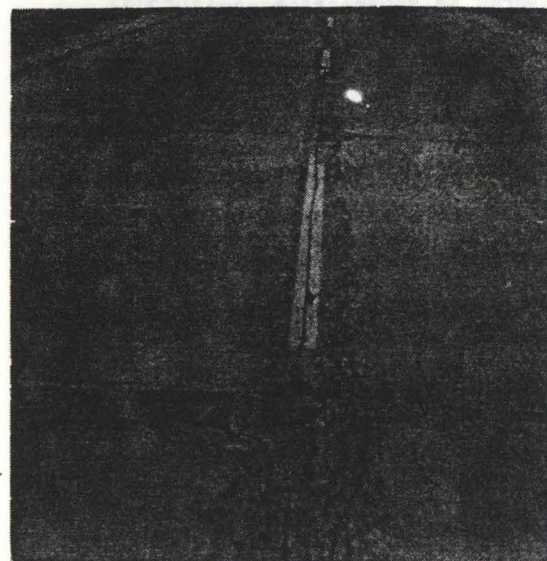
Figure 5

D-cracking - All joints affected

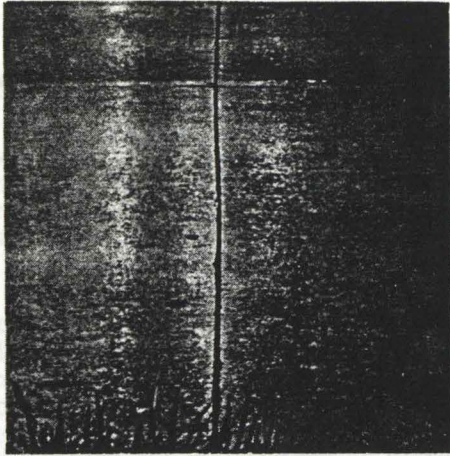
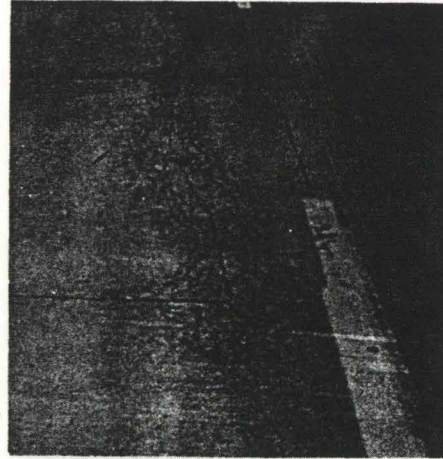
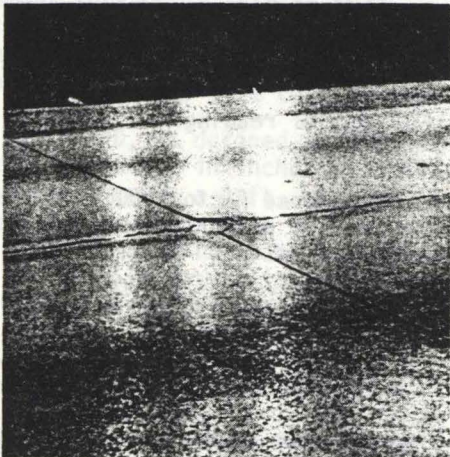
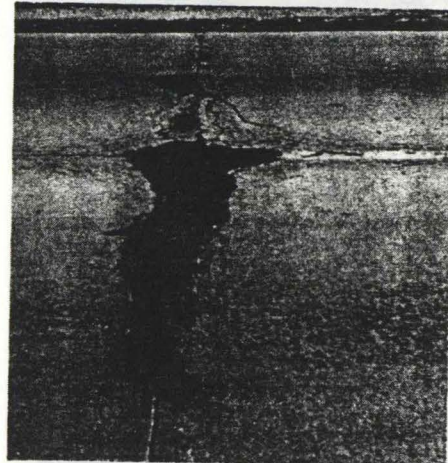
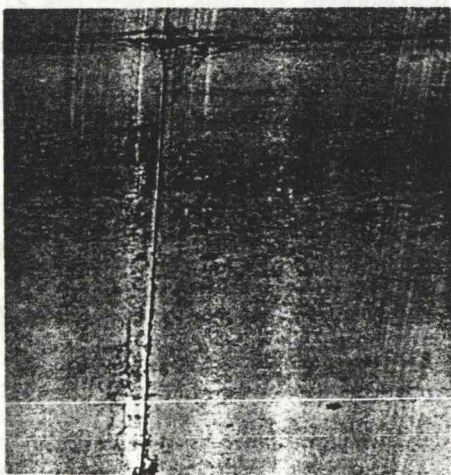
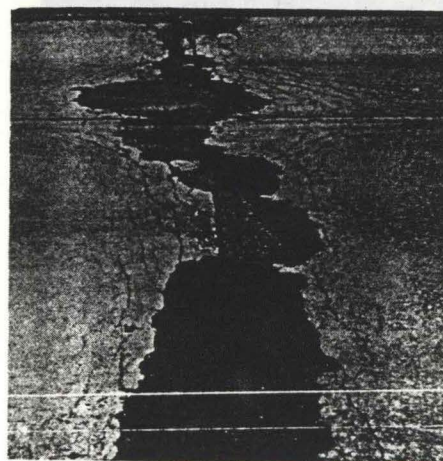
Figure 6. Examples of D-crack occurrence Factors

- 0 = No D-cracking noticeable.
- 1 = D-cracking is evident at most joints and has progressed across width of slab. Pavement is in sound condition and no maintenance is required due to D-cracking.
- 2 = D-cracking is evident at most joints and has progressed across width of slab. Pavement is in sound condition and no maintenance is required due to D-cracking.
- 3 = D-cracking is evident at virtually all joints and random cracks. Minor raveling and spalling are occurring and traffic is causing some loosening of cracked pavement. Some minor maintenance of spalled areas is required.
- 4 = D-cracking very evident as in 3 above. Spalling and removal by traffic has progressed to point that regular maintenance quality of pavement is now noticeable.

5 = D-cracking has continued to progress at sites identified in 3 above and requires regular maintenance patching. Full depth patches may be necessary. Ride quality has deteriorated to point where reduced driving speed is necessary for comfort and safety.

The D crack Occurrence Factor (DOF) in the test section will be evaluated and assigned a numerical rating based on the following description.
