**Iowa Highway Research Board
Project HR - 87**

**Subgrade Insulation
To Prevent
Soil Freezing**

August 1964

**Research Department
Iowa State Highway Commission**

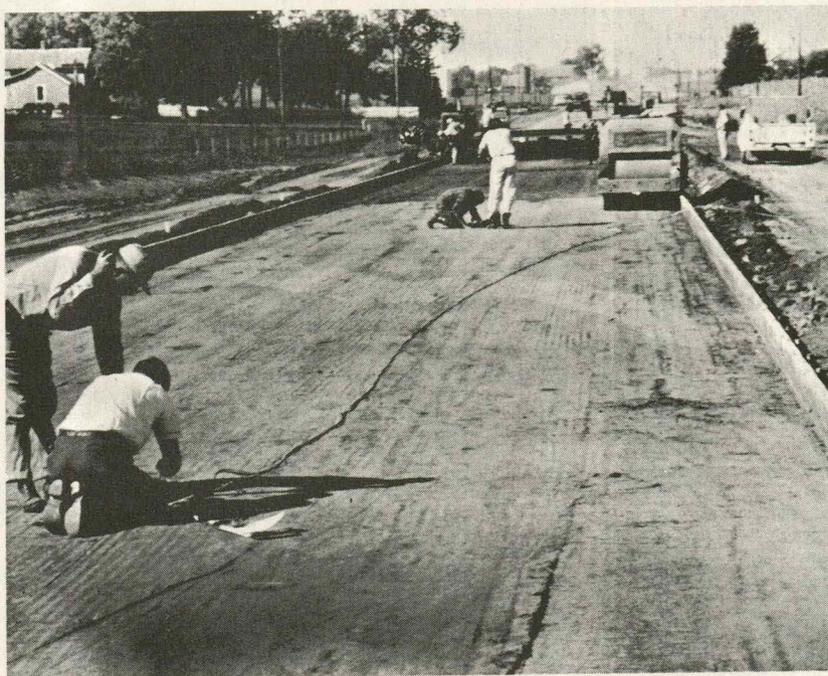
Photo 1: Installing the first thermocouple wires.

As soon as the pavement forms were in place and the subgrade cut and compacted, the first group of thermocouples was installed at various depths in the subgrade. This was followed by the placing of the Styrofoam between the forms. The Styrofoam was in the form

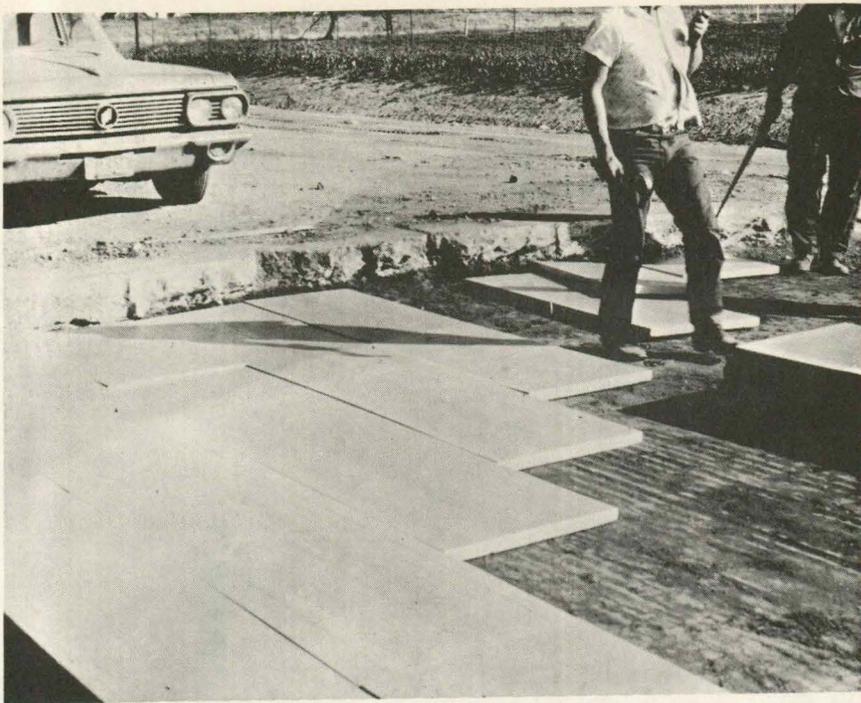
Photo 2: Placing 1½" Styrofoam on the Subgrade.

The original plans call for coring out three feet of the subgrade and backfilling with selected granular material. The excavation and backfilling was eliminated on the east 250 ft. of the reconstruction section. Instead, one and one-half inches of Styrofoam was placed directly below the pavement on the subgrade and in the shoulders at a 2:1 slope. The remaining 200 ft. was not changed and serves as a control section.

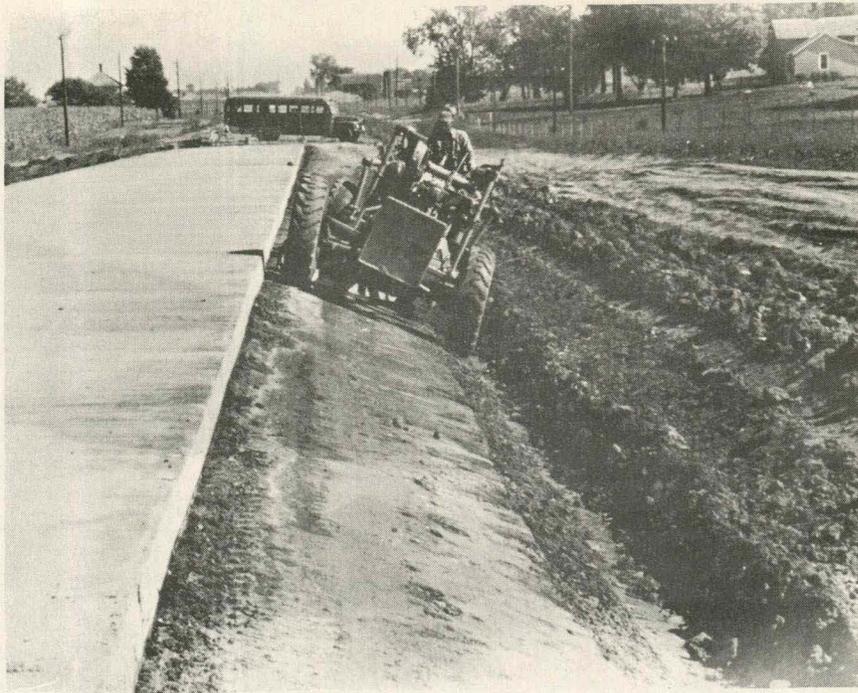
Photo 6: Cutting the 2:1 Shoulder Slope for the Styrofoam.

The next day, after the paving forms had been removed, the 2:1 slope was cut on the shoulders. Styrofoam was then placed along the slope and the shoulder was constructed. Thermocouples were placed in the shoulder at various depths in the soil below and above the Styrofoam.

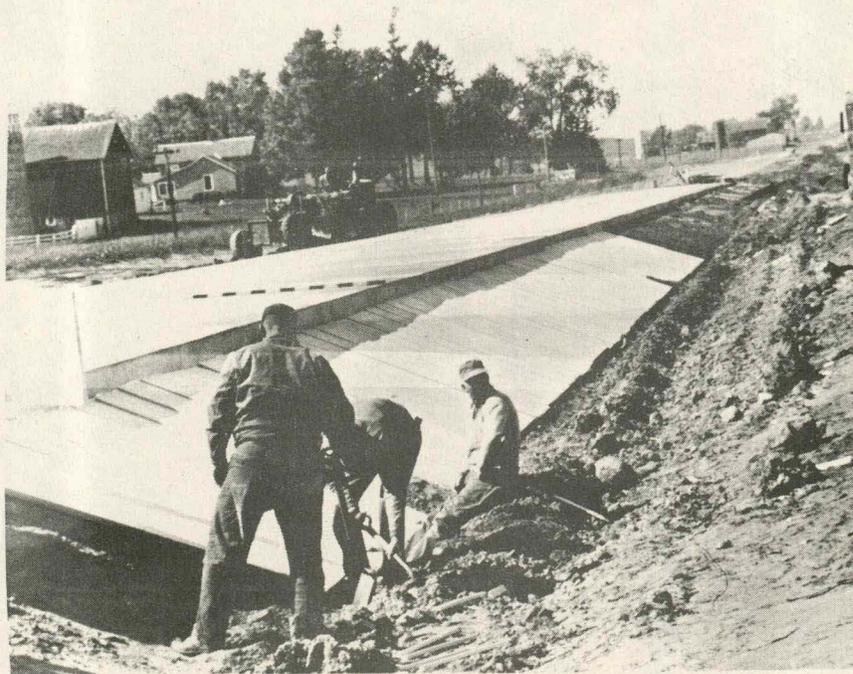
Photo 7: Styrofoam being placed on the 2:1 Slope in the Shoulder.
