DEVELOPMENT OF A TL-3 F-SHAPE TEMPORARY CONCRETE MEDIAN BARRIER

MIDWEST ROADSIDE SAFETY FACILITY

MwRSF Research Report No. TRP-03-64-96

October 1996

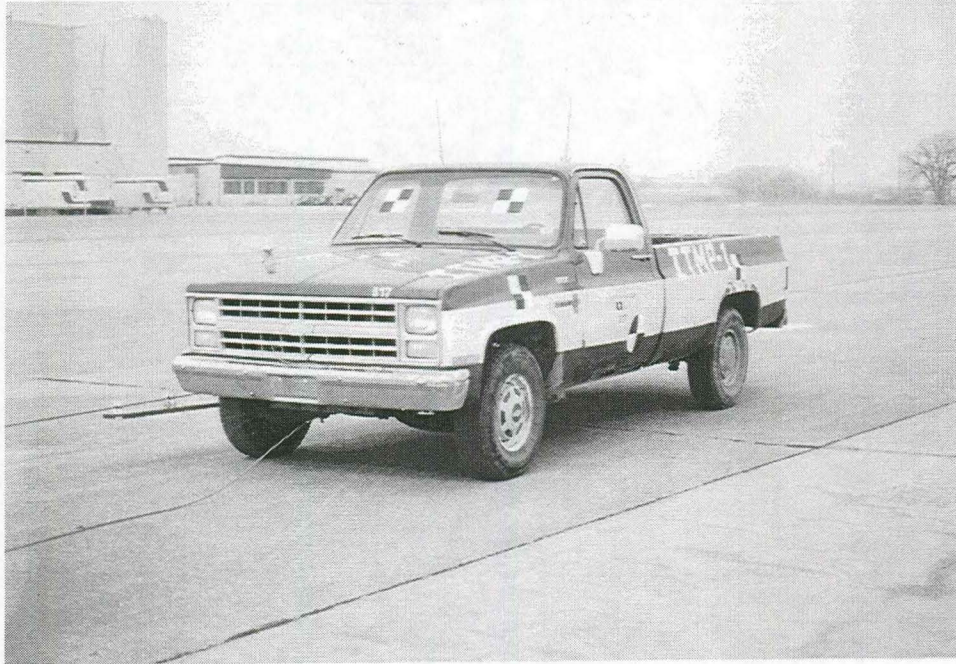
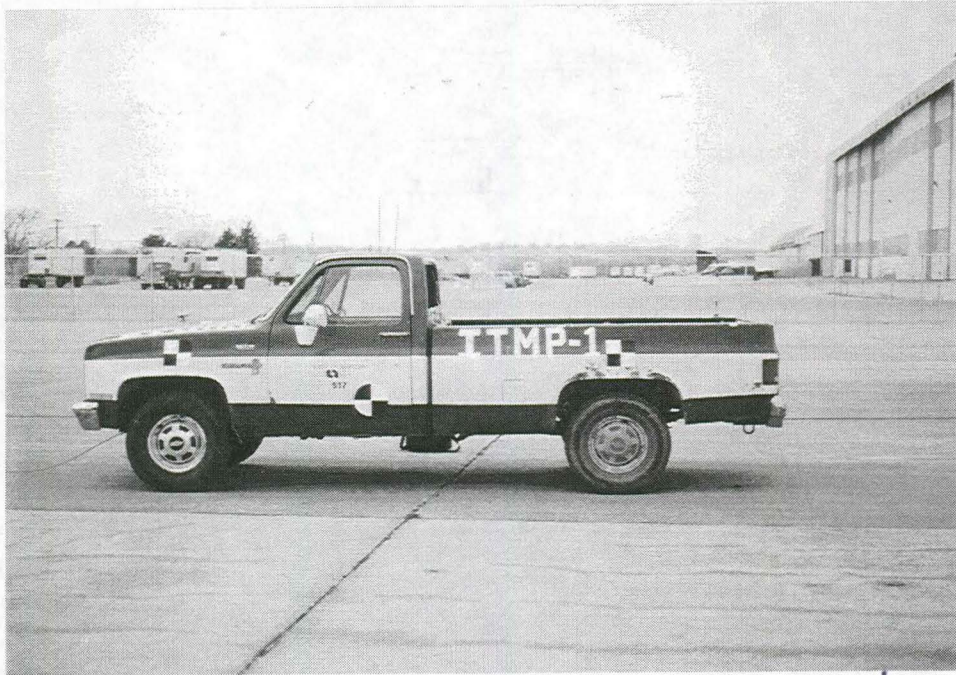
Figure 5. Test Vehicle, Test ITMP-1

For test ITMP-1, a 1985 Chevrolet C-20 $\frac{3}{4}$ -ton pickup truck was used as the test vehicle. The test inertial and gross static weights were 2,000 kg. The test vehicle is shown in Figure 5, and vehicle dimensions are shown in Figure 6.

Date: 3/5/96 Test Number: ITMP-1 Model: C-20
 Make: Chevrolet Vehicle I.D.#: 1GCGC24M9FS189789
 Tire Size: LT235/85R16 Year: 1985 Odometer: 74023

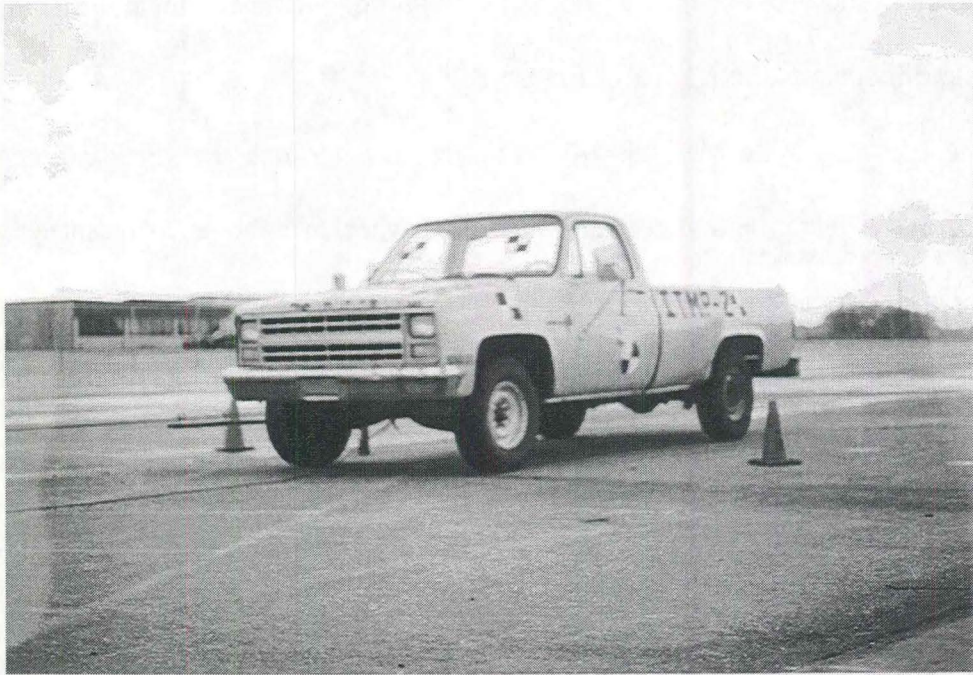
Figure 7. Test Vehicle, Test ITMP-2

Date: 5/9/96 Test Number: ITMP-2 Model: Custom Deluxe
 Make: CHEVY Vehicle I.D.#: 1GCEC24H56F423544
 Tire Size: LT235/85R16 Year: 1986 Odometer: 93561

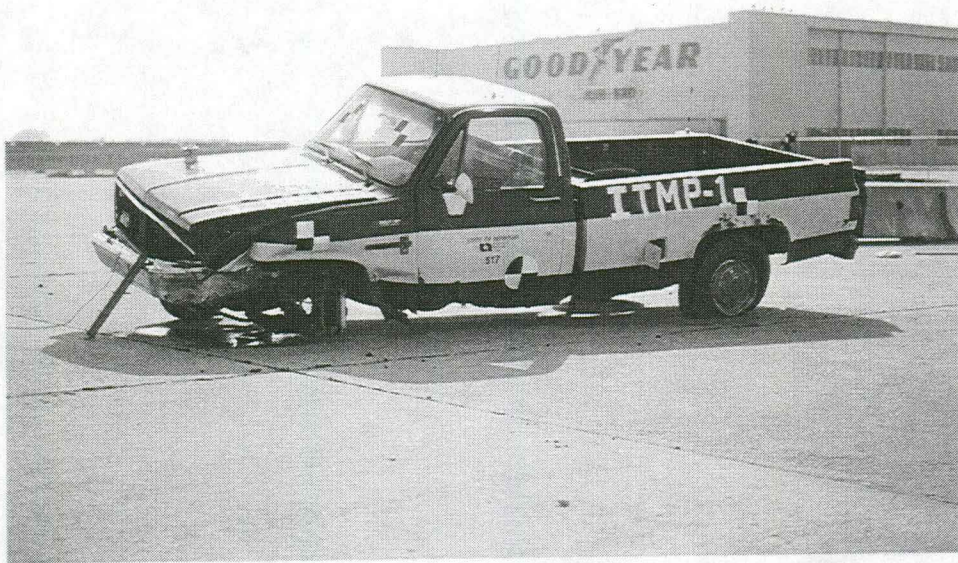
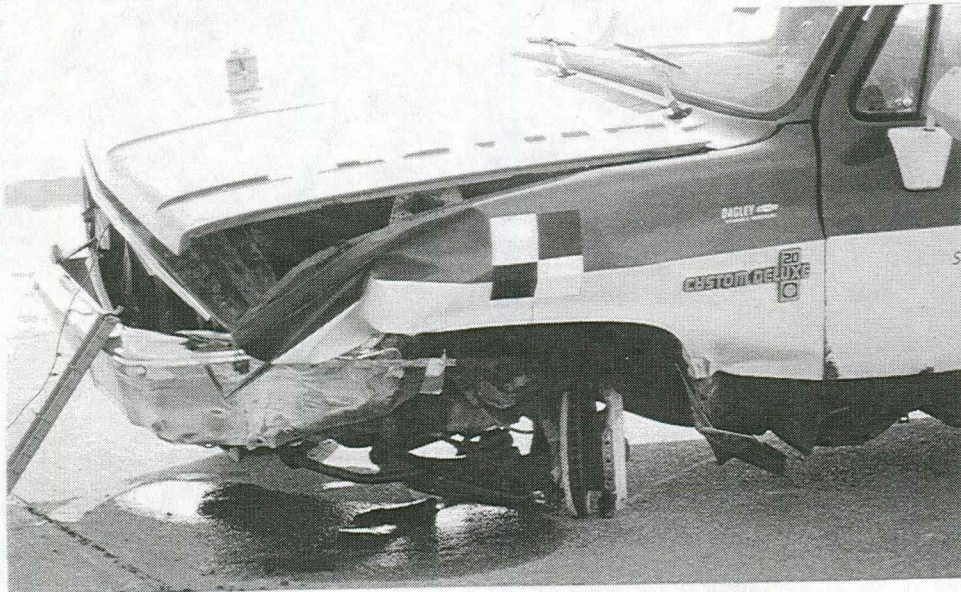
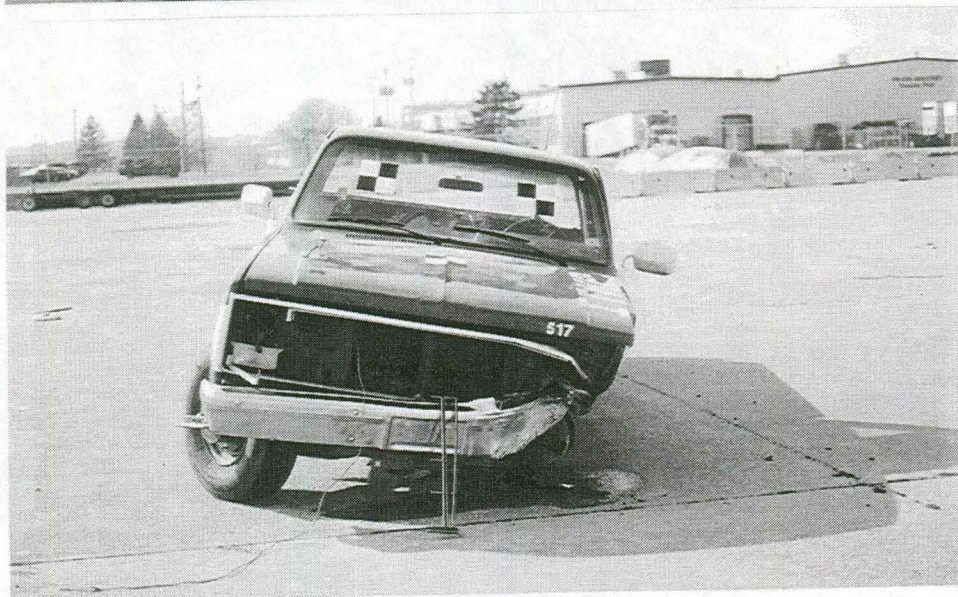
Figure 18. Vehicle Damage, Test ITMP-1

Vehicle damage was moderate, as shown in Figure 18. The front bumper and left-front quarter panel were crushed inward. The left-front wheel assembly was dislodged during the impact as the outer steel rim fractured from the inner region attached to the wheel hub. The steel frame was slightly bent inward near the front with a slight twist along its length from front to rear. Maximum occupant compartment deformations to the floorboard were 127 mm of longitudinal displacement near the center firewall region and a vertical displacement of 32 mm and 51 mm near left-side floorpan and center hump, respectively. The deformations to the floorboard were judged insufficient to cause serious injury to the vehicle occupants.

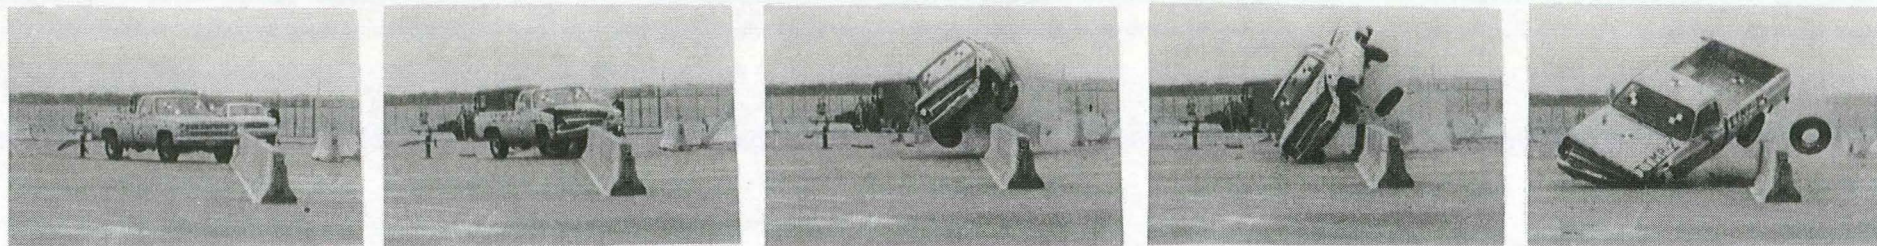
- Test Number ITMP-2
- Date 5/9/96
- Appurtenance F-Shape Concrete Median Barrier
- Total Length 81.52 m
- Barrier
 - Length 3800 mm
 - Height 810 mm
 - Base Width 570 mm
 - Top Width 200 mm
- Connection
 - Type Pin and Rebar
 - Pin Diameter 31.8 mm
 - Rebar Diameter 20 mm
- Vehicle Model 1986 Chevrolet C-20 2WD
 - Curb Weight 2,011 kg
 - Test Inertial Weight 2,005 kg
 - Gross Static Weight 2,005 kg
- Vehicle Speed
 - Impact 100.3 km/hr
 - Exit NA

- Vehicle Angle
 - Impact 27.1 deg
 - Exit NA
- Vehicle Snagging None
- Vehicle Stability Marginal
- Occupant Ridedown Deceleration
 - Longitudinal 7.6 G's < 20 G's
 - Lateral (not required) 10.5 G's
- Occupant Impact Velocity (Normalized)
 - Longitudinal 7.2 m/s < 12 m/s
 - Lateral (not required) 5.3 m/s
- Vehicle Damage Moderate
 - TAD¹⁵ 1-LFQ-5
 - SAE¹⁶ 01LFEW3
- Vehicle Stopping Distance 55.15 m downstream
19.86 m lateral
- Barrier Damage Minimal
- Maximum Deflections
 - Permanent Set 1.14 m
 - Dynamic 1.15 m

The 2,005-kg pickup truck impacted the concrete barrier (Design No. 2) at a speed of 100.3 km/hr and an angle of 27.1 degrees. A summary of the test results and the sequential photographs are shown in Figure 26. Additional sequential photographs are shown in Figure 27. Documentary photographs of the crash test are shown in Figures 28 and 29. It is noted that five additional barrier sections were placed on the upstream end of the installation to provide extra weight for resisting longitudinal barrier movement.

The analysis of the test results for test ITMP-2 showed that the barrier contained and redirected the vehicle with significant pitch and roll. Minor deformations to the occupant compartment were evident but not considered excessive enough to cause serious injuries to the occupants. The vehicle remained upright both during and after the collision. Therefore, test ITMP-2 conducted on design no. 2 was determined to be acceptable according to the NCHRP Report No. 350 criteria.

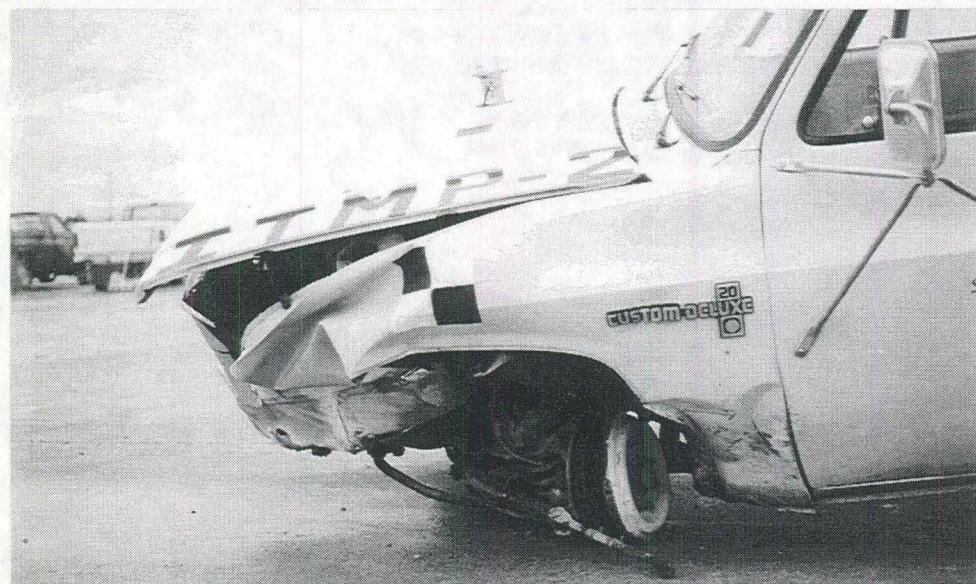
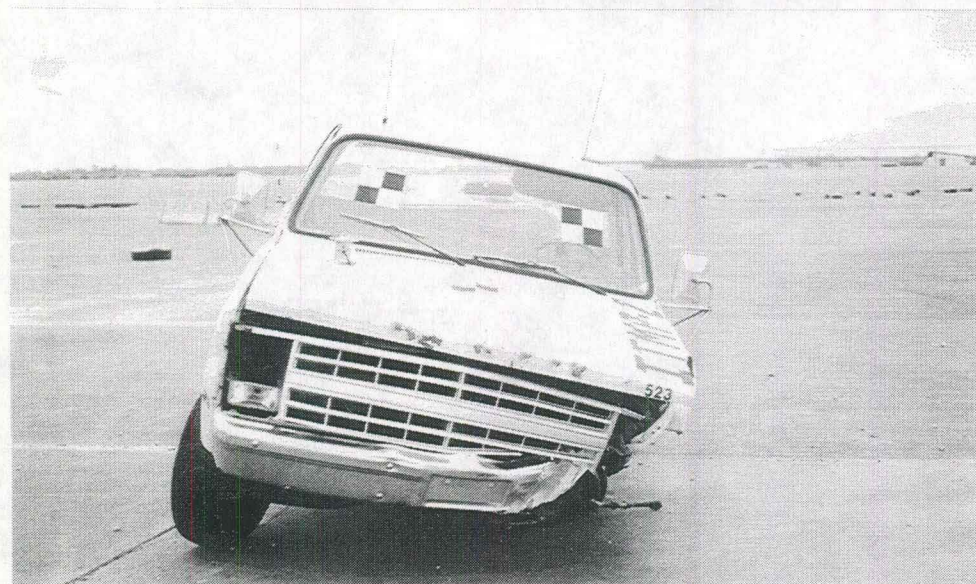
Figure 31. Vehicle Damage, Test ITMP-2

Vehicle damage was moderate, as shown in Figure 31. The front bumper and left-front quarter panel were crushed inward. The left-front wheel assembly was dislodged during the impact as the outer steel rim fractured from the inner region attached to the wheel hub. The steel frame was bent inward near the front with a significant twist along its length from front to rear. Maximum occupant compartment deformations to the floorboard were 55 mm of lateral displacement near the firewall and both a vertical and longitudinal displacement of 38 mm near the center hump behind the gear shift. The deformations to the floorboard were judged to be insufficient to cause serious injury to the vehicle occupants.

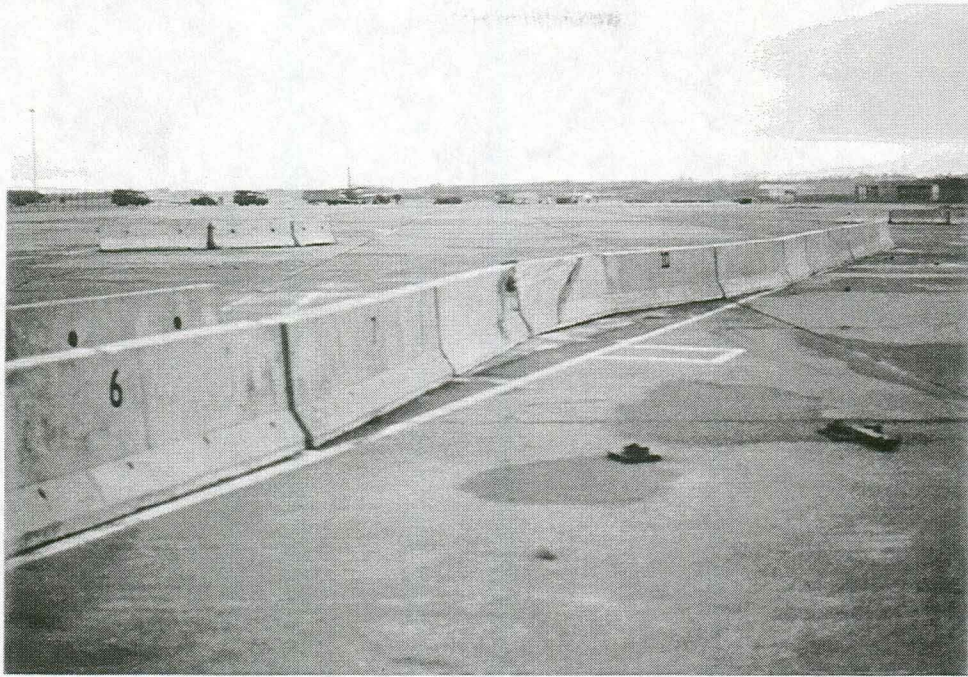
Figure 32. Barrier Damage, Test ITMP-2

Barrier damage was minor, as shown in Figures 32 through 34. Concrete damage was mostly cosmetic, consisting of tire marks, scrapes, gouges, and minor spalling. Nine steel pins were also deformed, ranging from slight to extensive. The maximum permanent set deflection of the barrier was 1.14 m.

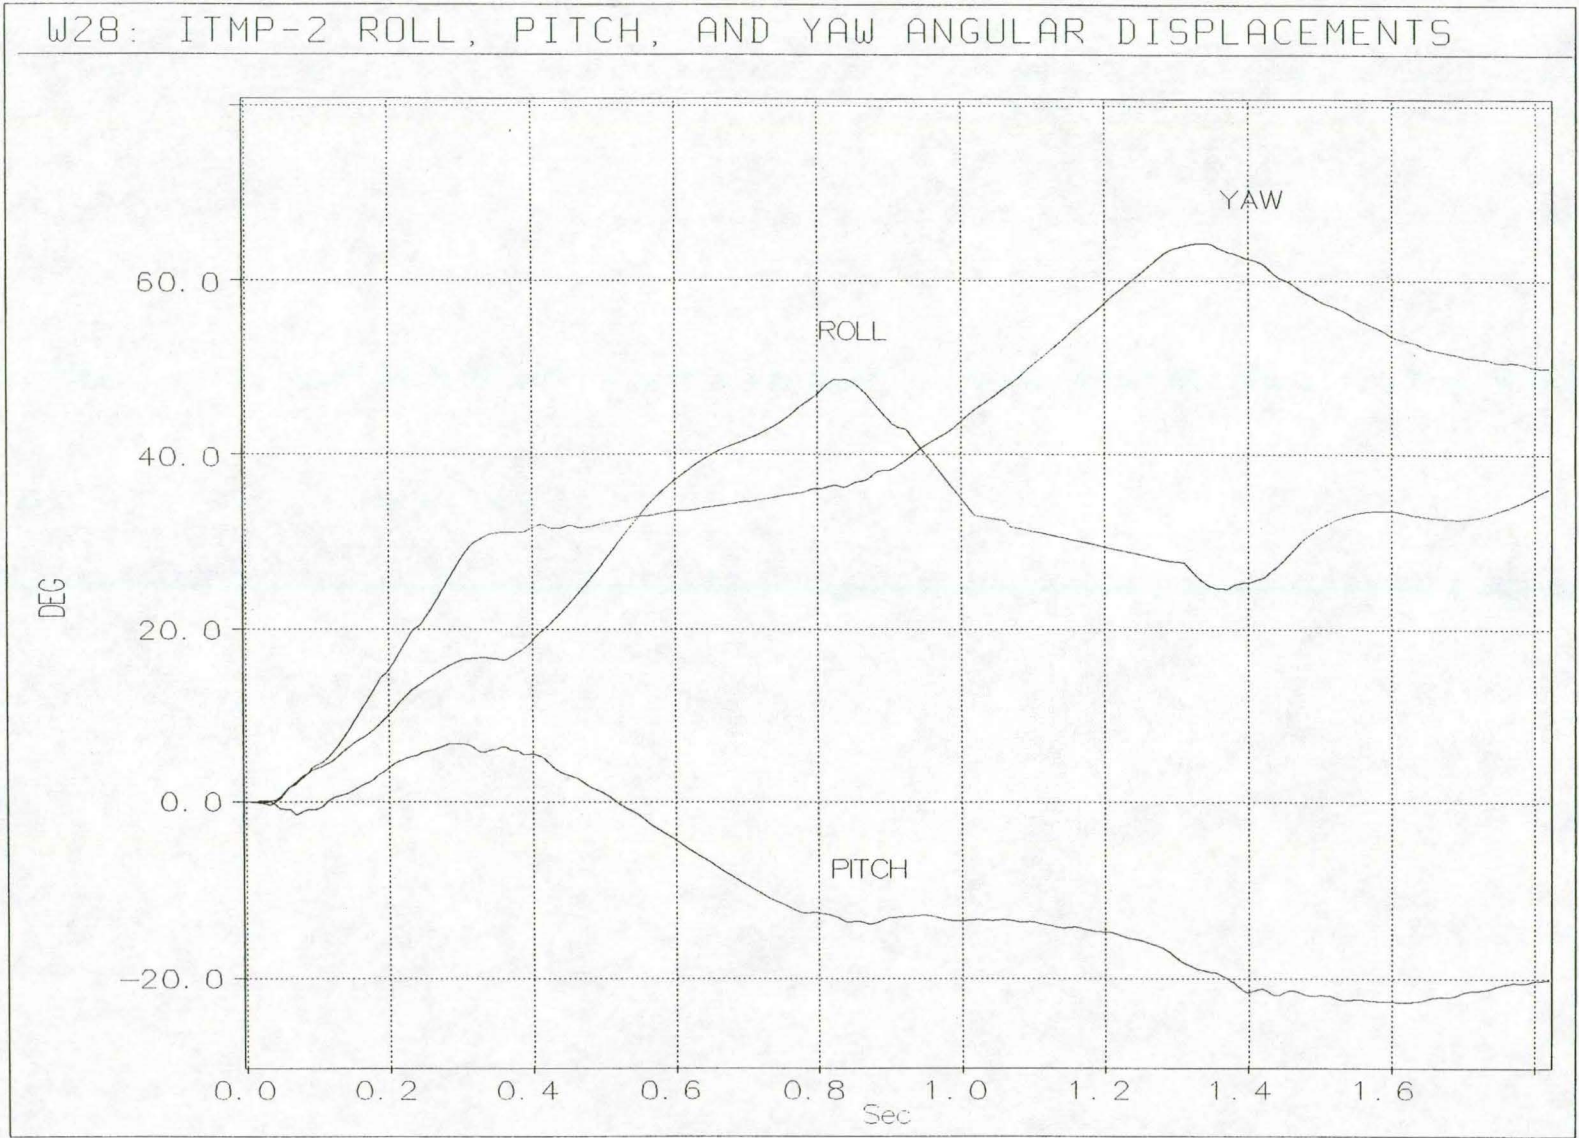
Figure B-1. Graph of Roll, Pitch, and Yaw Angular Displacements, Test ITMP-2

A Humphrey 3-axis rate transducer with a range of 250 deg/sec in each of the three directions (pitch, roll, and yaw) was used to measure the rates of motion of the test vehicle. The rate transducer was rigidly attached to the vehicles near the center of gravity of the test vehicle. Rate transducer signals were received and conditioned by an onboard Series 300 Multiplexed FM Data System built by Metraplex Corporation. The multiplexed signal was then transmitted by radio telemetry to a Honeywell 101 Analog Tape Recorder. Computer software, "EGAA" and "DADiSP" were used to digitize, analyze, and plot the rate transducer data.
