# FULL-SCALE VEHICLE CRASH TEST ON THE IOWA TEMPORARY CONCRETE BARRIER RAIL HALF-SECTION

TRANSPORTATION RESEARCH REPORT TRP-03-014-88

December, 1988

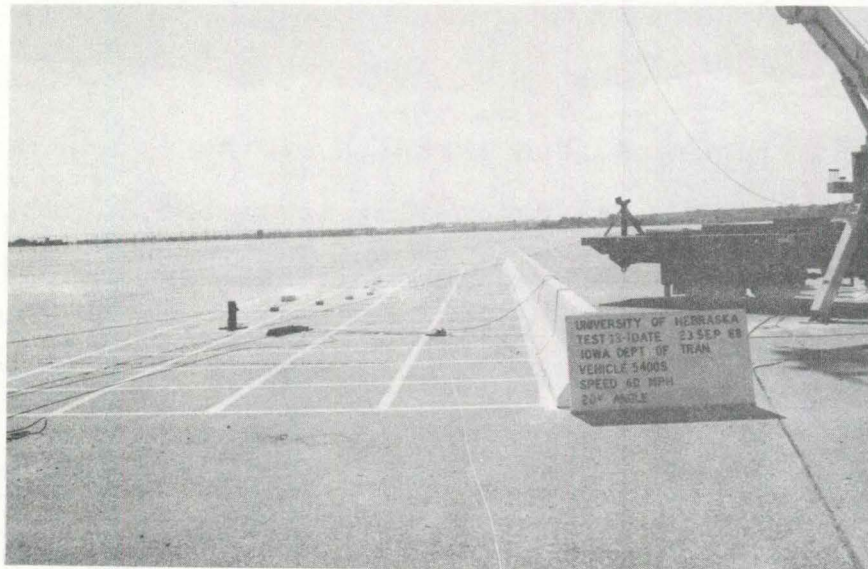
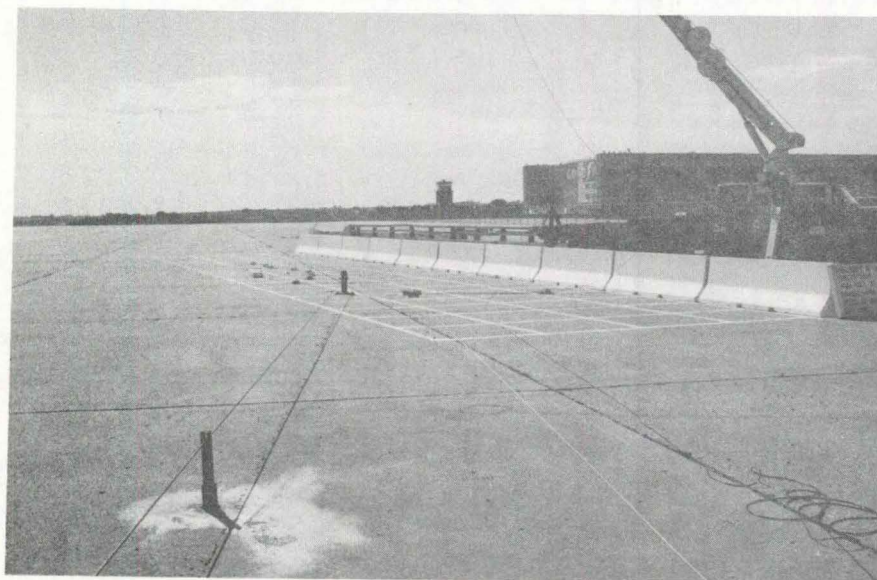
FIGURE 4. PHOTOGRAPHS OF VEHICLE GUIDANCE SYSTEM

A vehicle guidance system, developed by Hinch (3), was used to steer the test vehicle. Photographs of the guidance system

are shown in Figure 4, and a sketch of the guidance system is shown in Figure 2. The guide-flag, attached to the vehicle's front-left wheel and the guide cable, was sheared off (at the distances stated above) before impact with the Temporary Concrete Barrier Rail Half-Section. The 3/8-in. diameter guide cable was tensioned to 3,000 lbs., and it was supported laterally and vertically every 100 ft. by hinged stanchions. The hinged stanchions stood upright while holding up the guide cable. When the vehicle passed, the guide-flag struck each stanchion and knocked it to the ground. The vehicle guidance system was approximately 1,500 ft. in length.

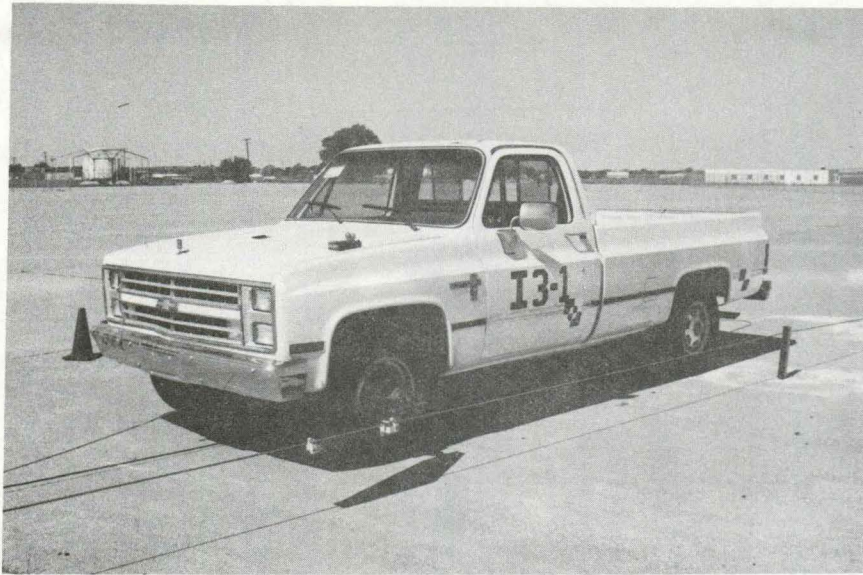
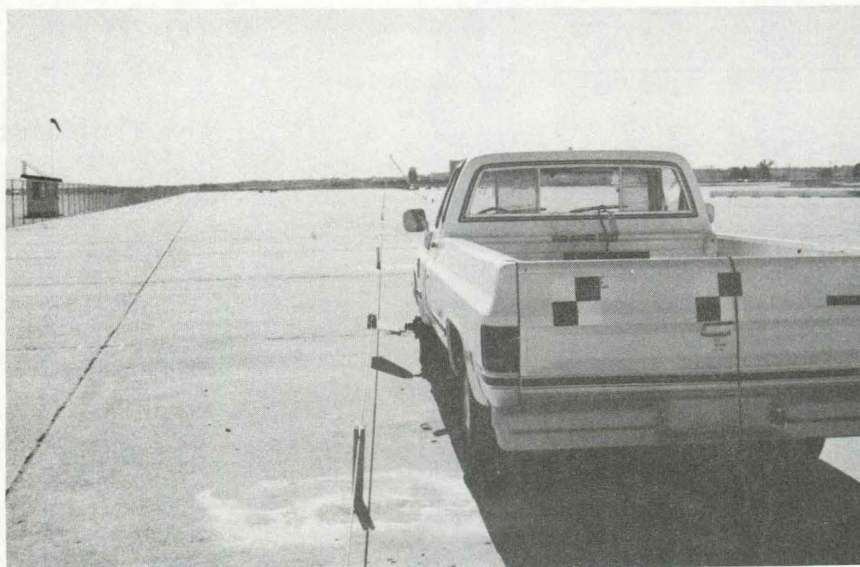
FIGURE 7. PHOTOGRAPHS OF TEST VEHICLE

Three 8-in. square, black and white checkered targets were placed on the centerline of the top of the test vehicle. The middle target was placed over the center of mass. The front and rear targets were placed 5 ft. ahead and 6 ft. behind, the center of mass, respectively. The targets were used in the analysis of the high speed film. In addition to the roof targets, side and rear targets were also placed at known distances to aid in the evaluation process.

Two 5B flash-bulbs were mounted on the front hood of the test vehicle to record the time of impact with the temporary concrete barrier rail on the high-speed film. The flash bulbs were fired by a pressure tape switch mounted on the front face of the bumper.

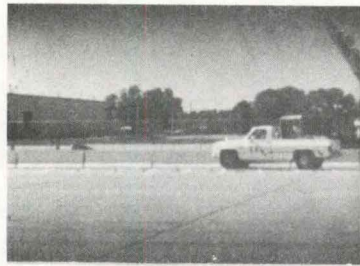
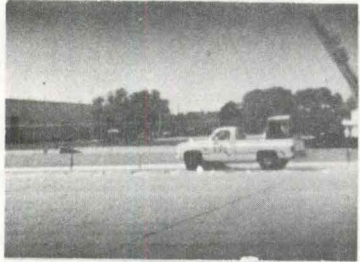
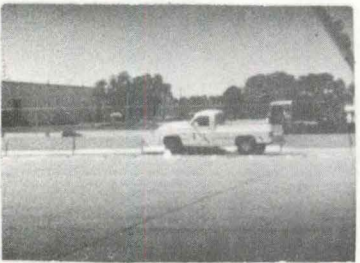
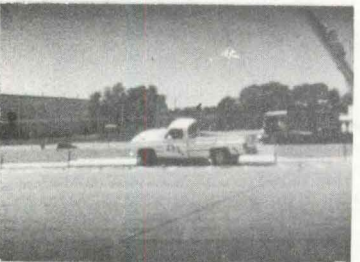
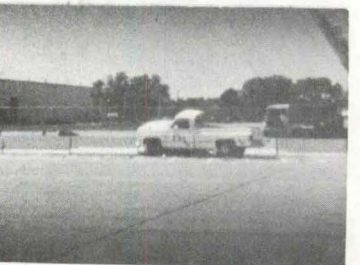
FIGURE 14(a). TIME-SEQUENTIAL PHOTOGRAPHS

Test I3-1 was conducted with a 5,386 lb. pickup under the impact conditions of 62.3 mph and 20 degrees. A summary of the test results is shown in Figure 13. The sequential photographs are shown in Figures 14(a) and (b).

Upon impact with the temporary concrete barrier rail, the right front corner of the vehicle began to crush inward at approximately 0.042 sec. At this time, it was also evident that the crack in barrier No. 6 began to form. At about 0.063 sec, the right front wheel started to climb over the barrier rail.

The fracture of the concrete on the end of barrier No. 7 occurred when the front bumper impacted the concrete section corner as the vehicle passed over the top. The time-sequence was between 0.115 and 0.130 sec. The vehicle bumper damage due to the corner of barrier No. 7 is shown in Figure 15(a) and (b).

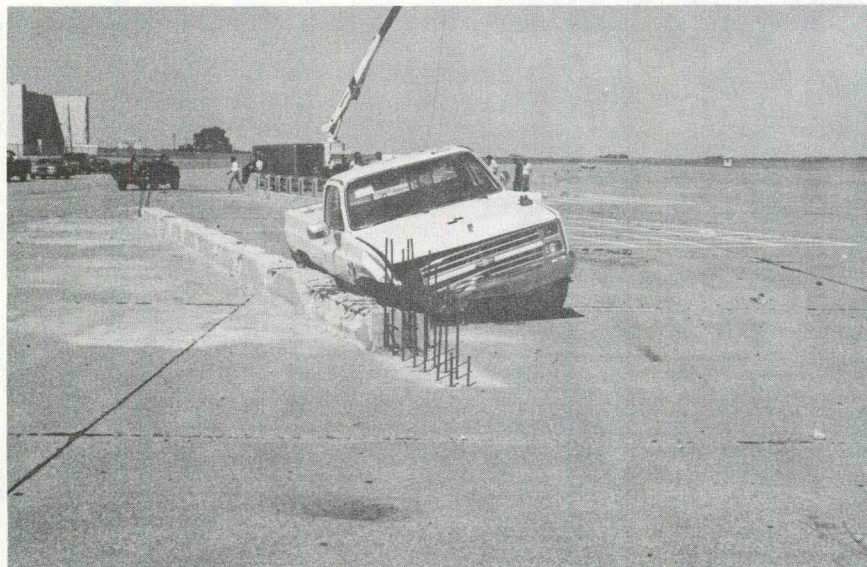
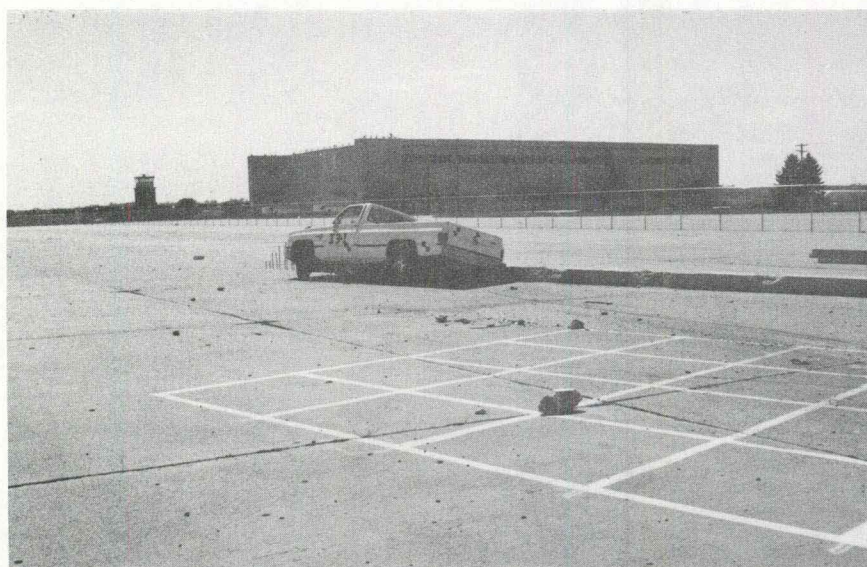
FIGURE 15. VEHICLE DAMAGE, TEST I3-1

Photographs of the vehicle damage are shown in Figure 15. As evident, the vehicle damage was marginal. The TAD and VDI damage classifications are shown in Figure 13. Photographs of the extensive damage to the barrier rail are shown in Figures 16 and 17. During the crash test, medium-size pieces of concrete were thrown away from the barrier.
