MISSISSIPPI RIVER FLOOD PLAIN INFORMATION

Mile 549.4 To Mile 608.5

BY CORPS OF ENGINEERS,
U.S. ARMY

OCTOBER 1974

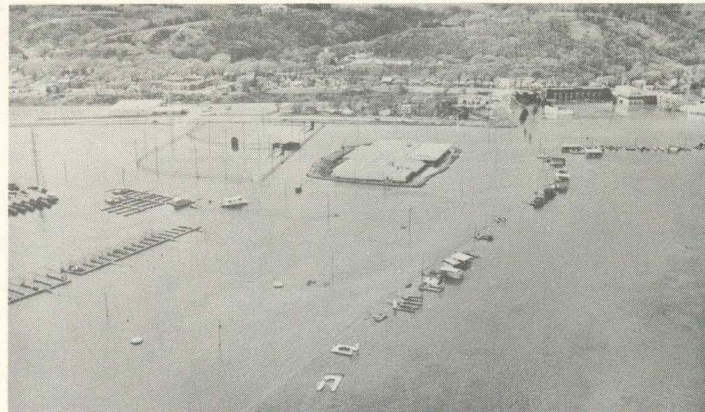
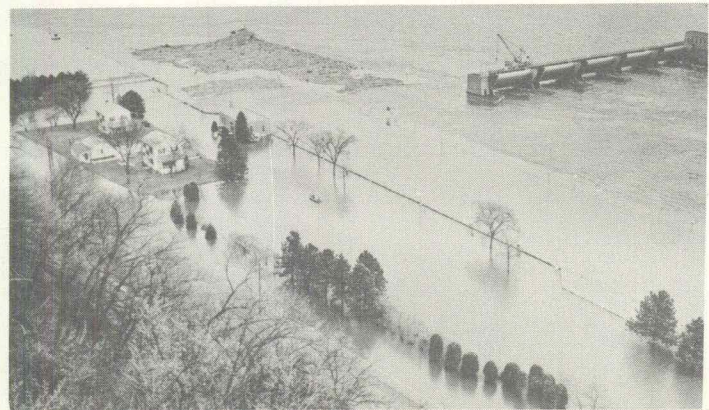
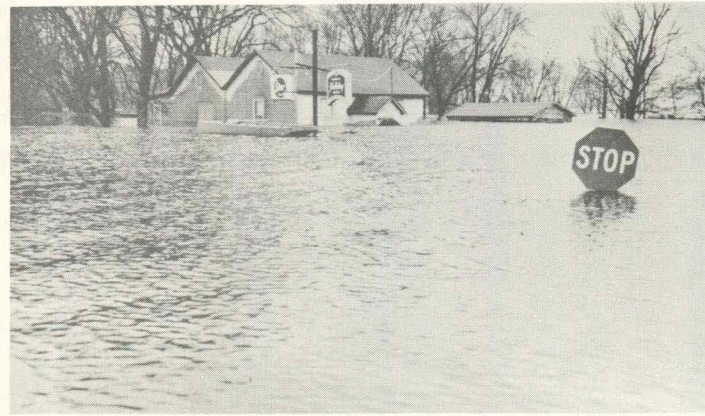
Figure 8. Photographs of flooding in April, 1965. Upper left: Dubuque, Iowa, looking north from the west end of Julien Dubuque Bridge. Upper right: Northeast Dubuque, Iowa, looking at the municipal water works. Riverdale Bowl is located near center of photograph. Lower left: View from Eagle Point Park of Lock and Dam No. 11, looking upstream. Lower right: Wisconsin side at highway 61 north of East Dubuque, Illinois.

Flood scenes for selected floods are shown in Figures 6 through 9.

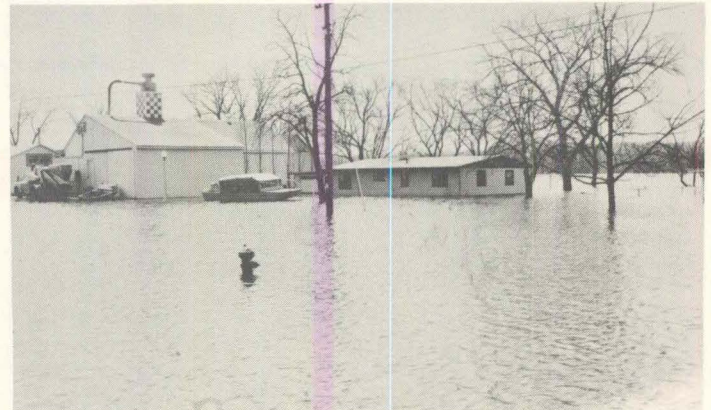
Figure 9. Flooding in April-May 1965 along Mississippi River. Upper left: View at Specht's Ferry, Iowa, looking southeasterly. Both buildings in the background have been removed. Upper right: Cassville, Wisconsin, Dairyland Electric Plant looking north. Lower left: Looking north on highway 133 at Cassville, Wisconsin. Lower right: Walz Lumber Company at Cassville, Wisconsin.

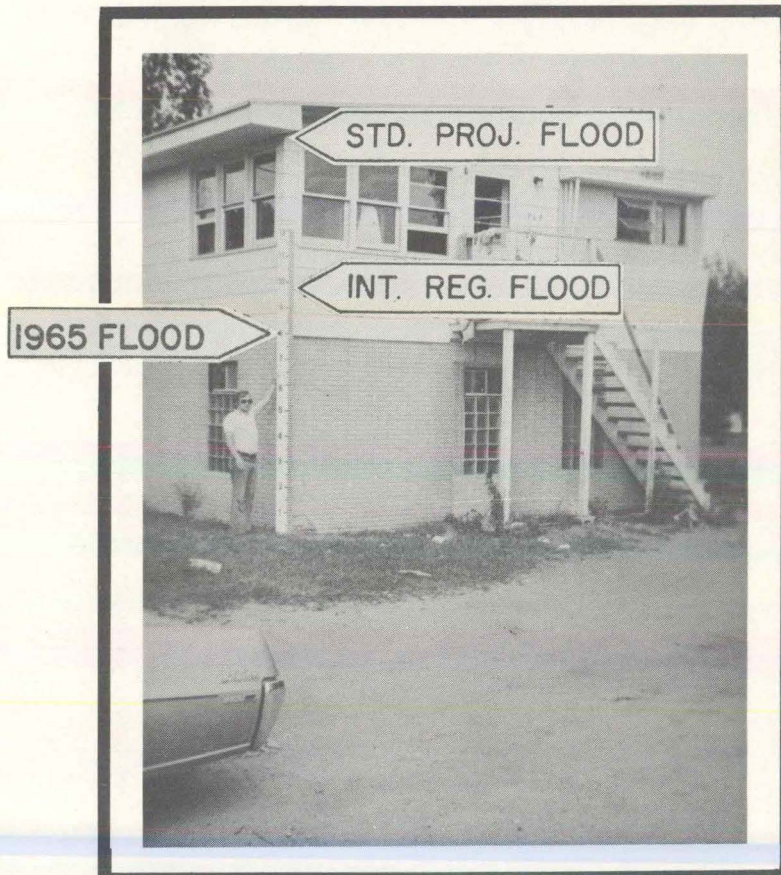
Figure 13. East Dubuque, Illinois, 707 Bastan Road, Mile 579.0.

Photographs, future flood heights - The following photographs in Figures 10 through 23 indicate the expected Intermediate Regional and Standard Project Flood levels at various locations in the study reach.

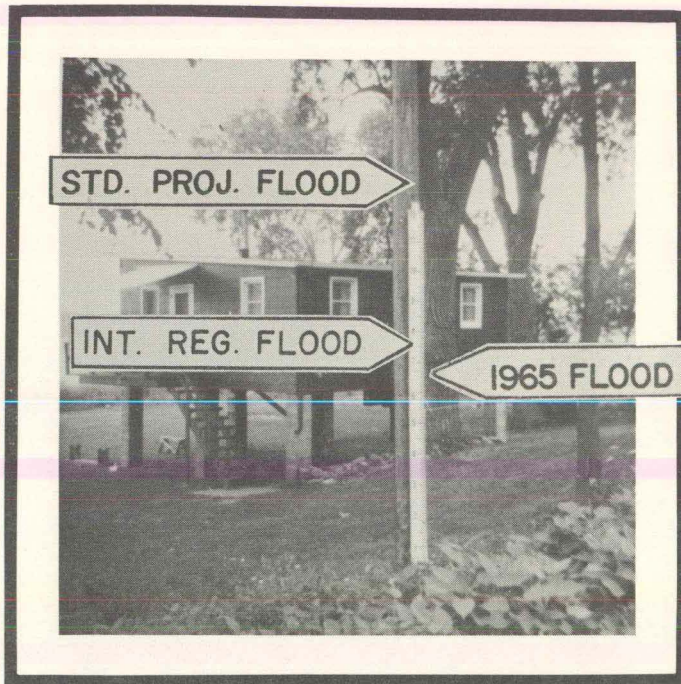
Figure 20. Specht's Ferry, Iowa, Mile 592.0. Corps of Engineer gages are located here and upstream approximately 0.3 mile.

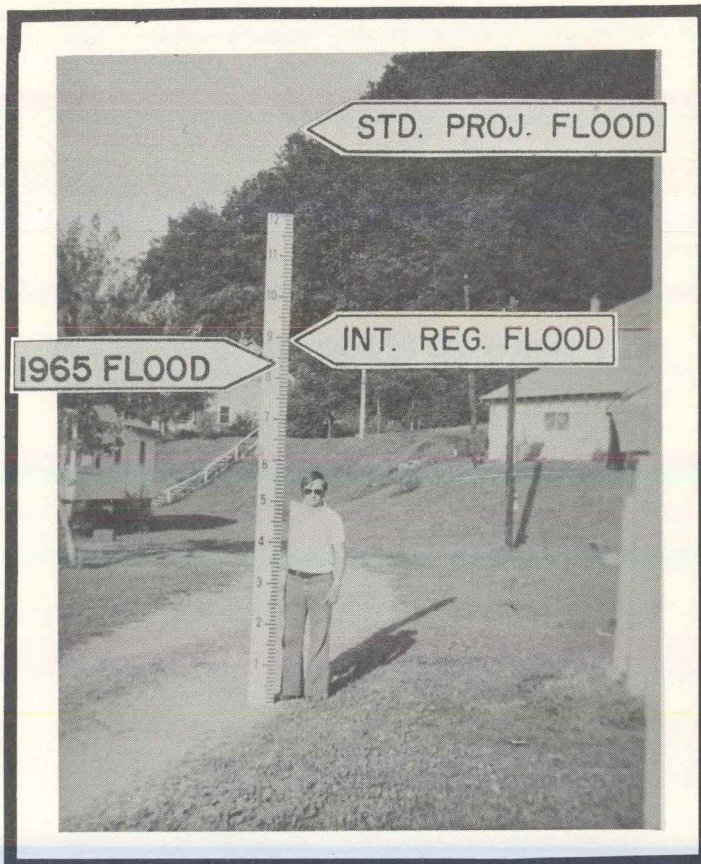
Figure 21. North Buena Vista, Iowa, at the west end of mobile home park, Mile 603.5.

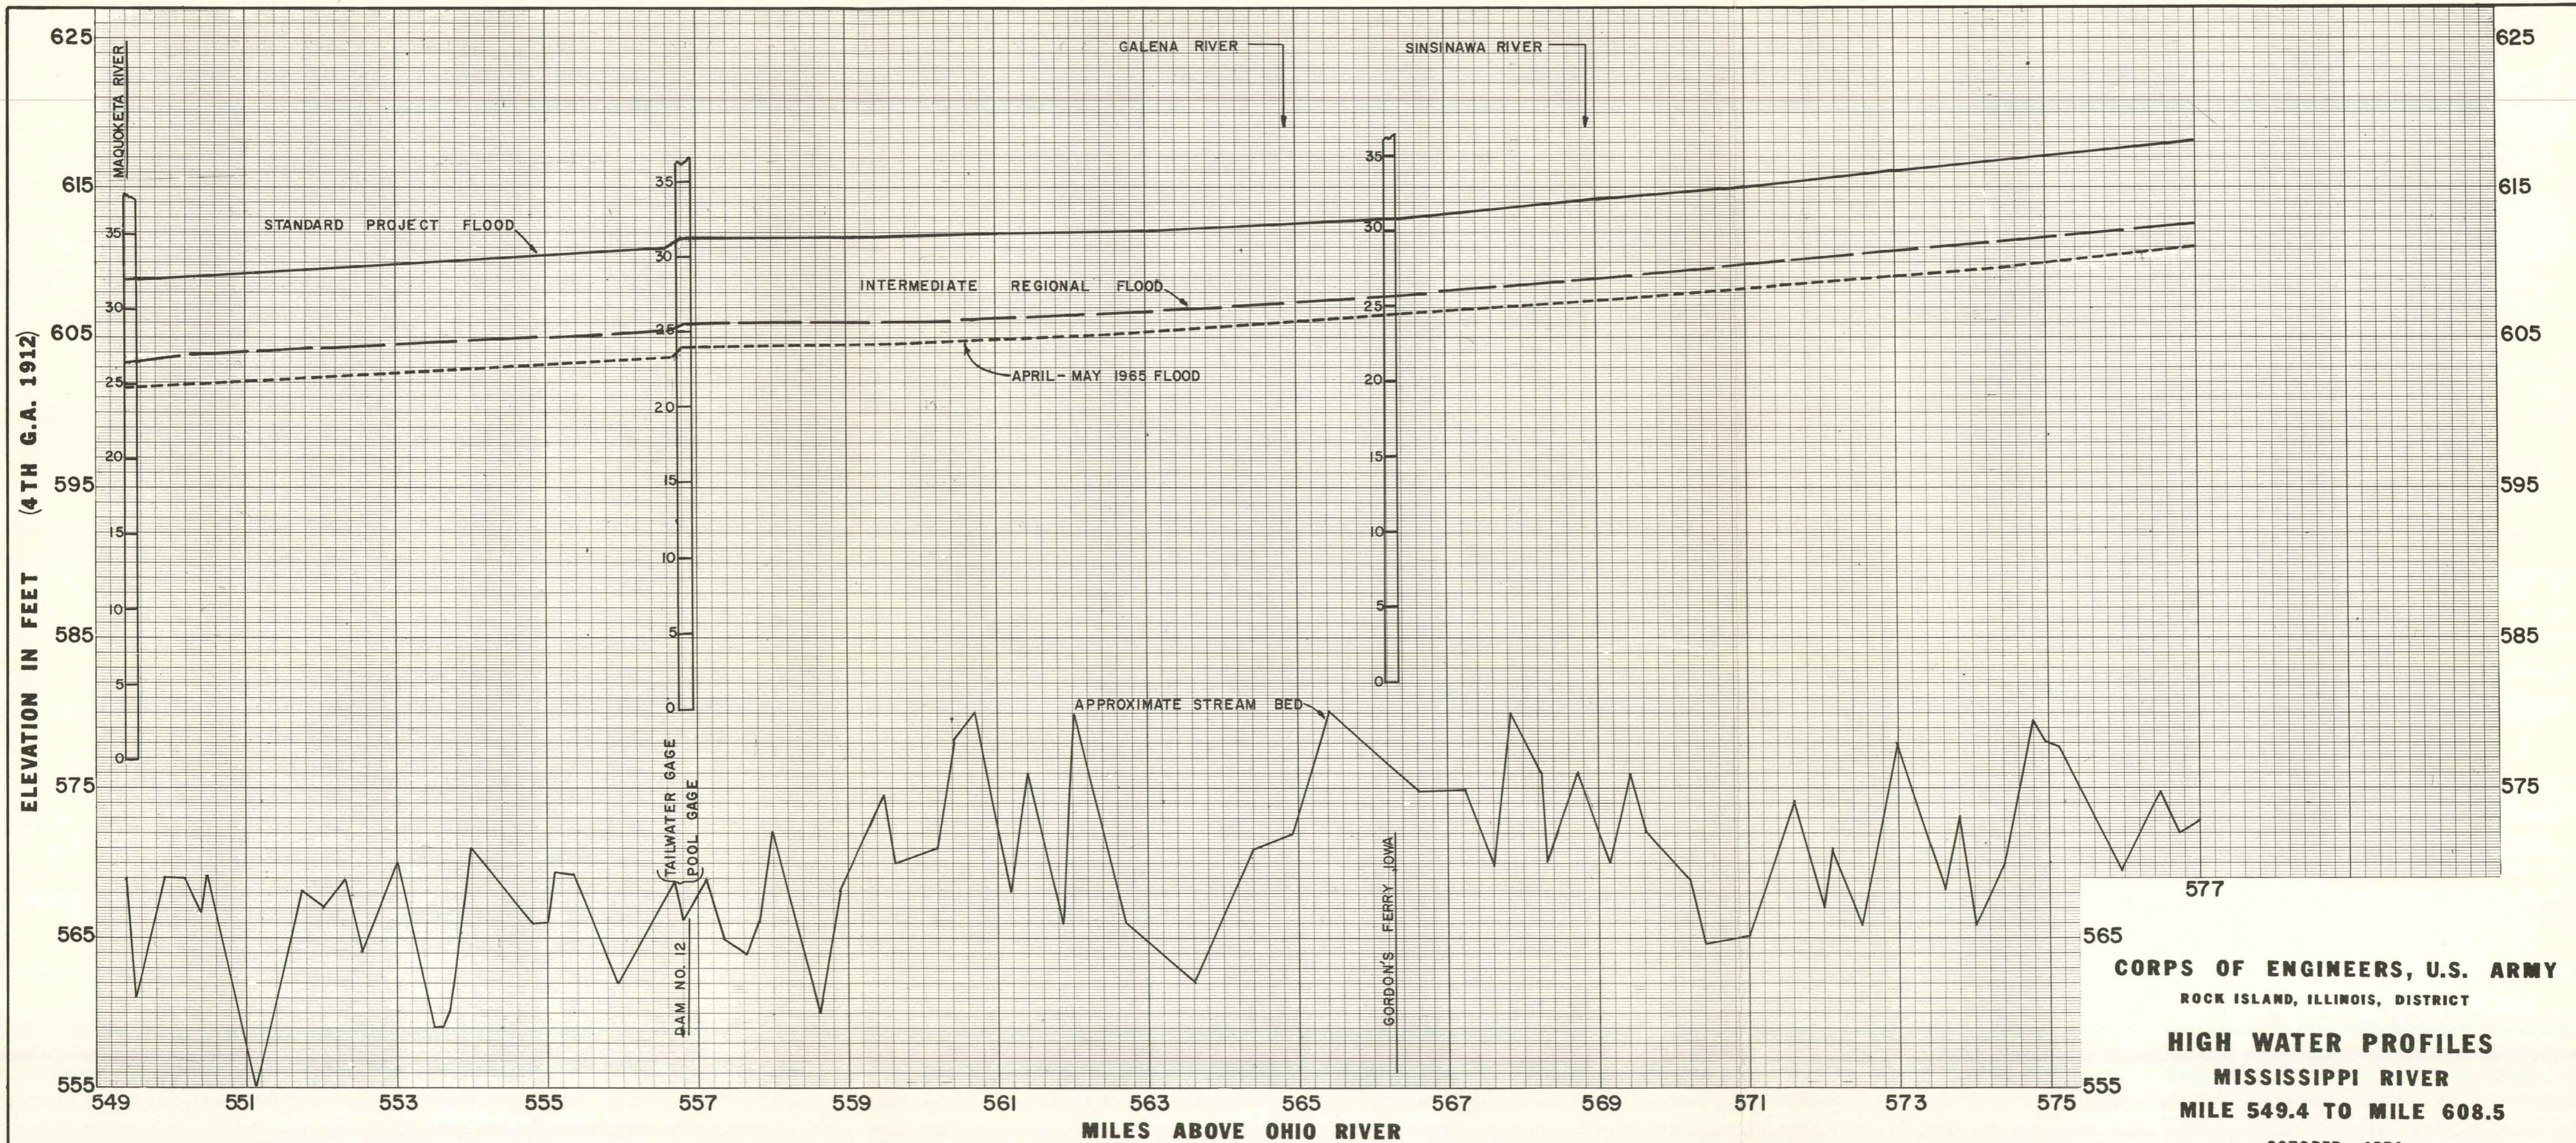
CORPS OF ENGINEERS, U.S. ARMY
 ROCK ISLAND, ILLINOIS, DISTRICT
HIGH WATER PROFILES
MISSISSIPPI RIVER
MILE 549.4 TO MILE 608.5
 OCTOBER 1974

Flooded areas and flood damages - Plate 2 is the index map to Plates 3 through 6 showing flooded areas in the study reach. Areas that would be flooded by the Intermediate Regional and Standard Project Floods are shown in detail on Plates 3 through 6. The actual limits of these overflow areas may vary somewhat from those shown on the maps because the contour interval and scale of the maps do not permit precise plotting of the flooded area boundaries. The areas that would be flooded by the Intermediate Regional and Standard Project Floods include agricultural, commercial, industrial, and residential developments and the associated streets, roads, and private and public utilities. Considerable damage to these facilities would occur during an Intermediate Regional Flood. However, due to the wider extent, greater depths of flooding, higher velocity flow and longer duration of flooding during a Standard Project Flood, damage would be even more severe than during an Intermediate Regional Flood. During a Standard Project Flood, the Dubuque Local Flood Protection Project levees are assumed to hold with emergency flood fighting measures. Plates 7 and 8 show water surface profiles of the Intermediate Regional and Standard Project Floods. Depth of flow in the channel can be estimated from these illustrations. Plate 9 shows a measured cross section at the Julien Dubuque Bridge.

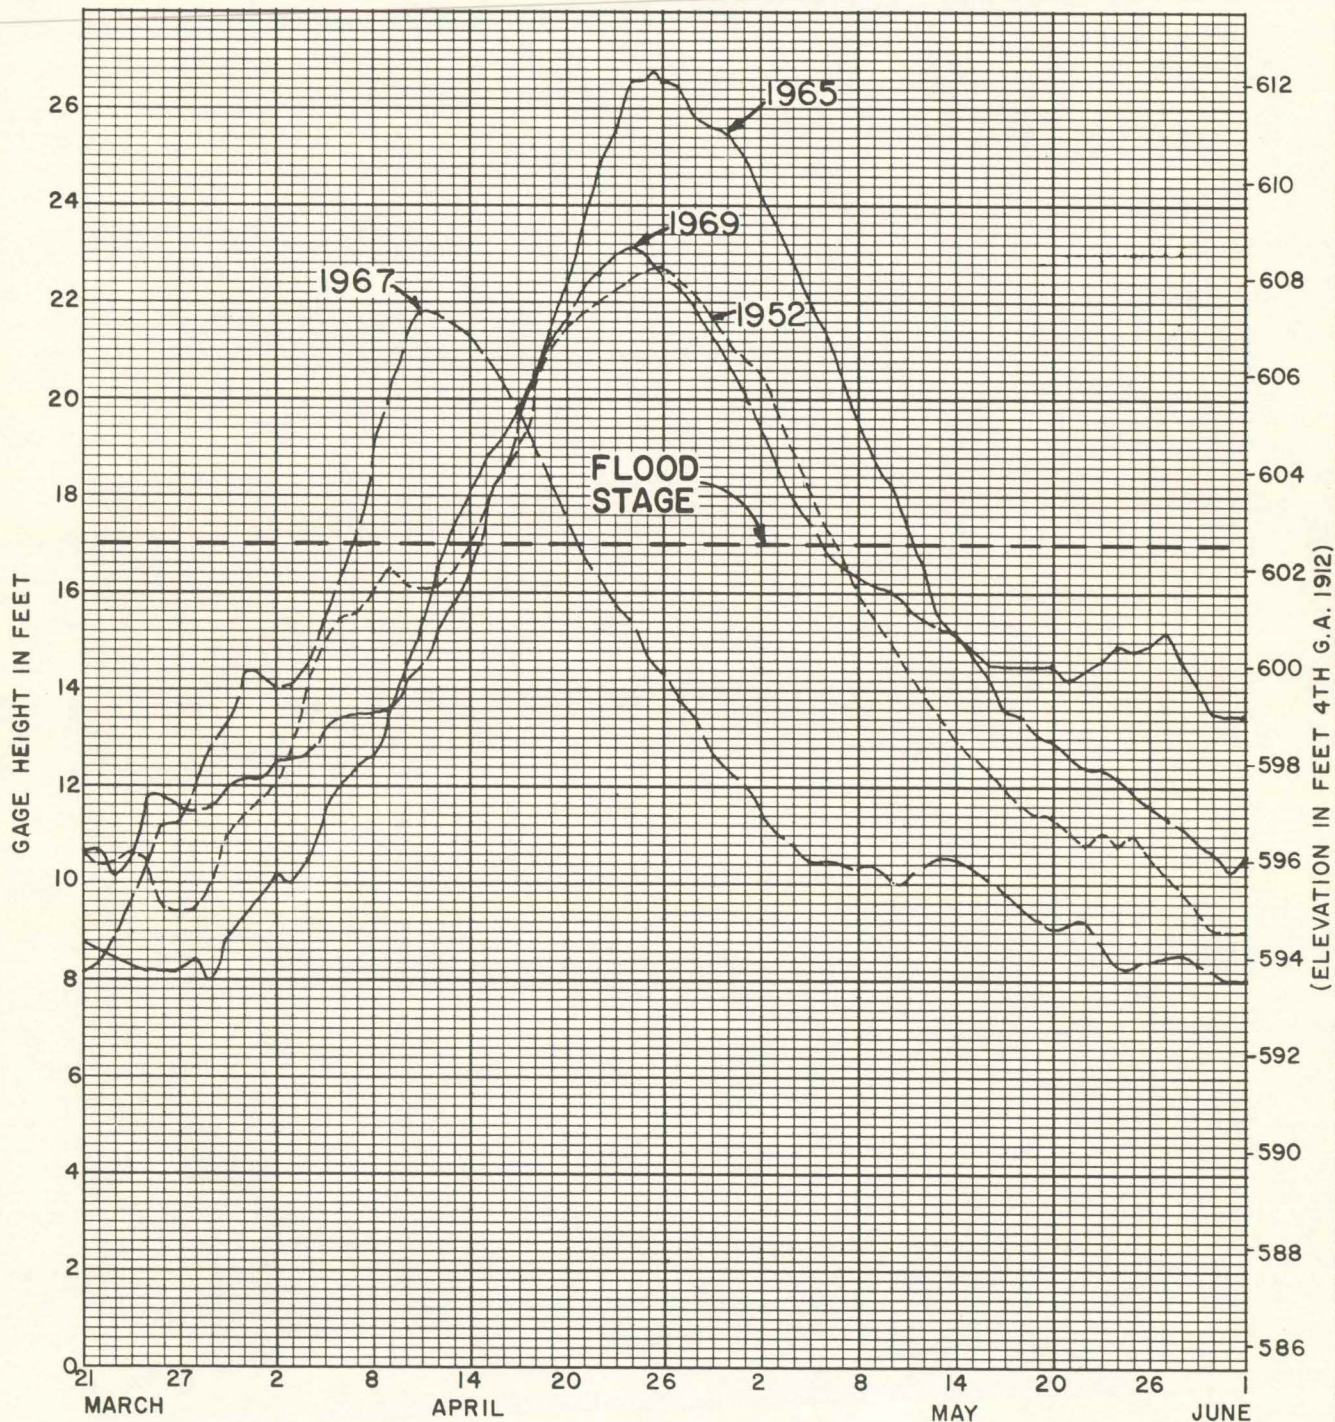
1952, 1965, 1967, 1969

WEATHER BUREAU STREAM GAGE
AT RIVER MILE 579.9

The five major elements governing the magnitude of snowmelt floods are fall precipitation, frost depths, snow depth, rate of snowmelt, and amount of additional precipitation during the snowmelt period. During the snowmelt floods of 1952, 1965, 1967, and 1969, the river rose from low water to flood stage in 17, 14, 16, and 28 days, respectively. Rise from flood stage to peak stage occurred in 12, 13, 4, and 10 days, respectively. Maximum rate of rise of 2 foot per day occurred during the 1965 flood. The duration of the rise above flood stage was 23, 29, 14, and 21 days, respectively. Stage hydrographs for these floods are shown on Plate 10.
