Research Project Number TPF-5(367)

INVESTIGATION, CRASH TESTING, AND EVALUATION OF A MASH TL-4 PRECAST CONCRETE BRIDGE RAIL

MIDWEST ROADSIDE SAFETY FACILITY

MwRSF Research Report No. TRP-03-476-24

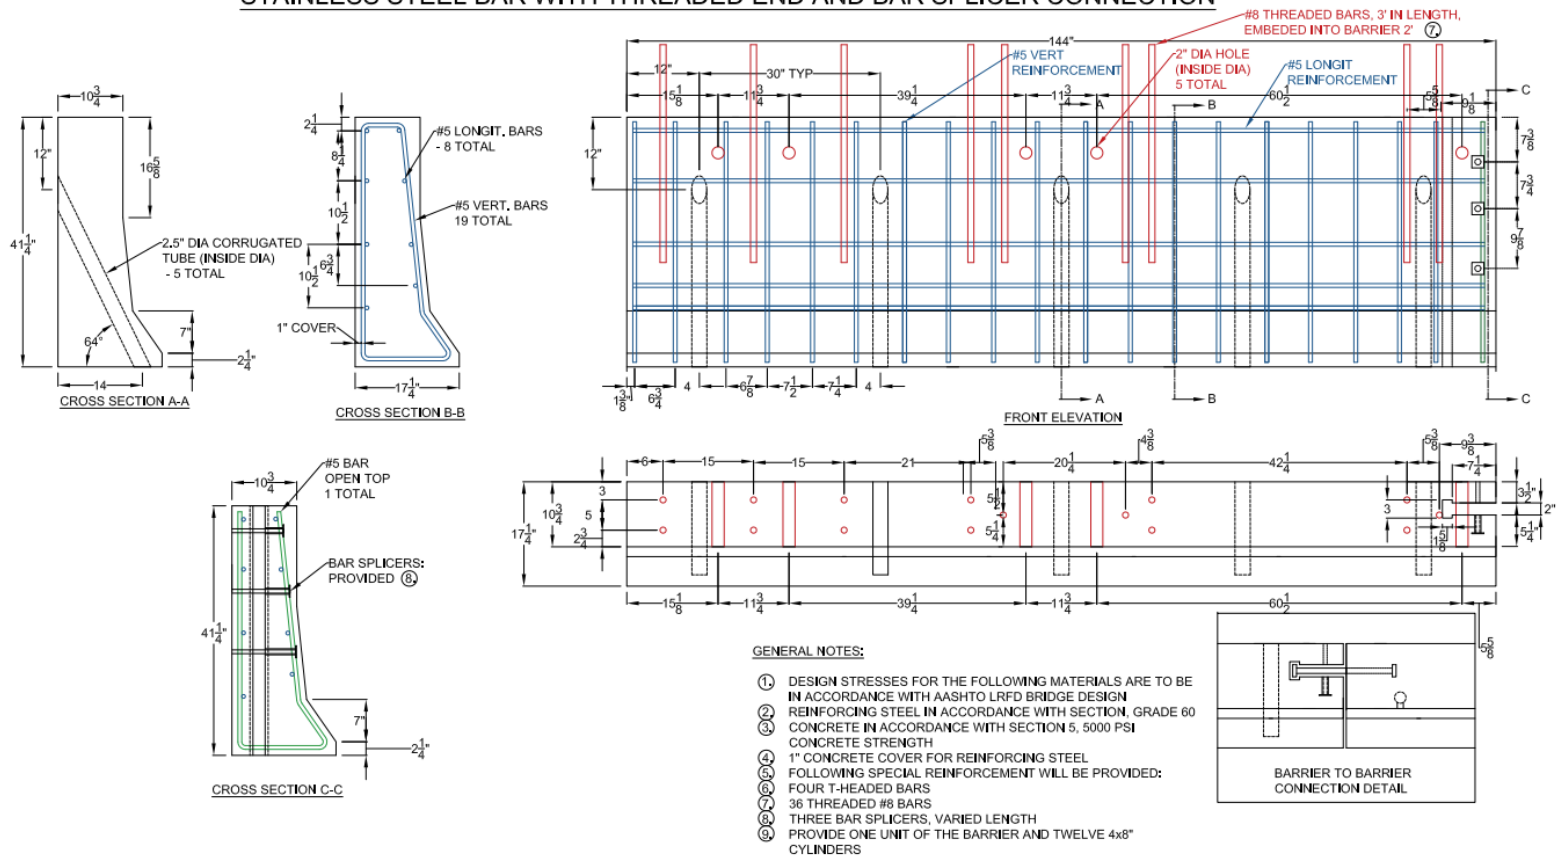
Figure 1. Detailed Prefabricated Barrier Drawings, Dimensions in Inches [2]

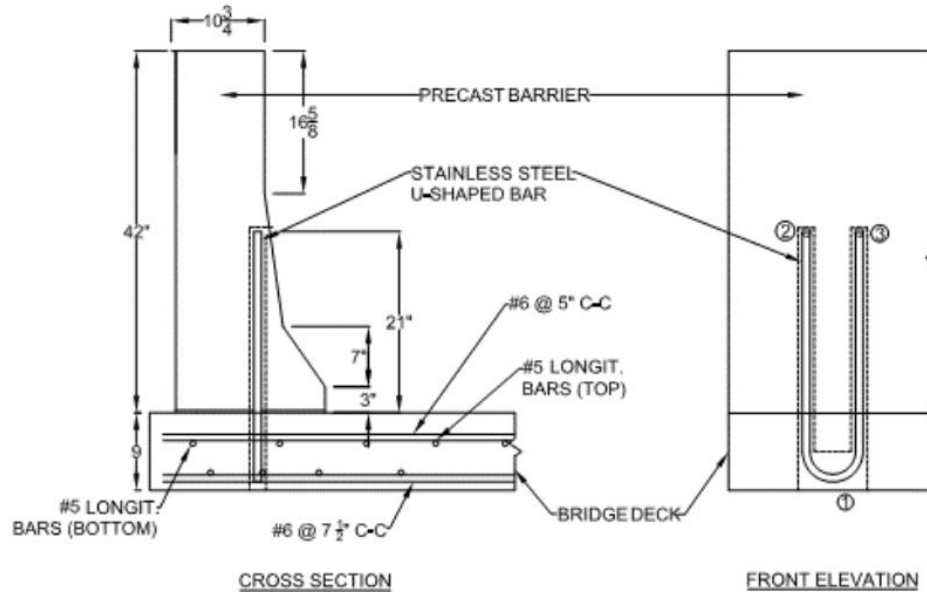
Figure 13. Iowa State University U-bar Connection Between Precast Barrier and Deck (all dimensions are in inches) [1]

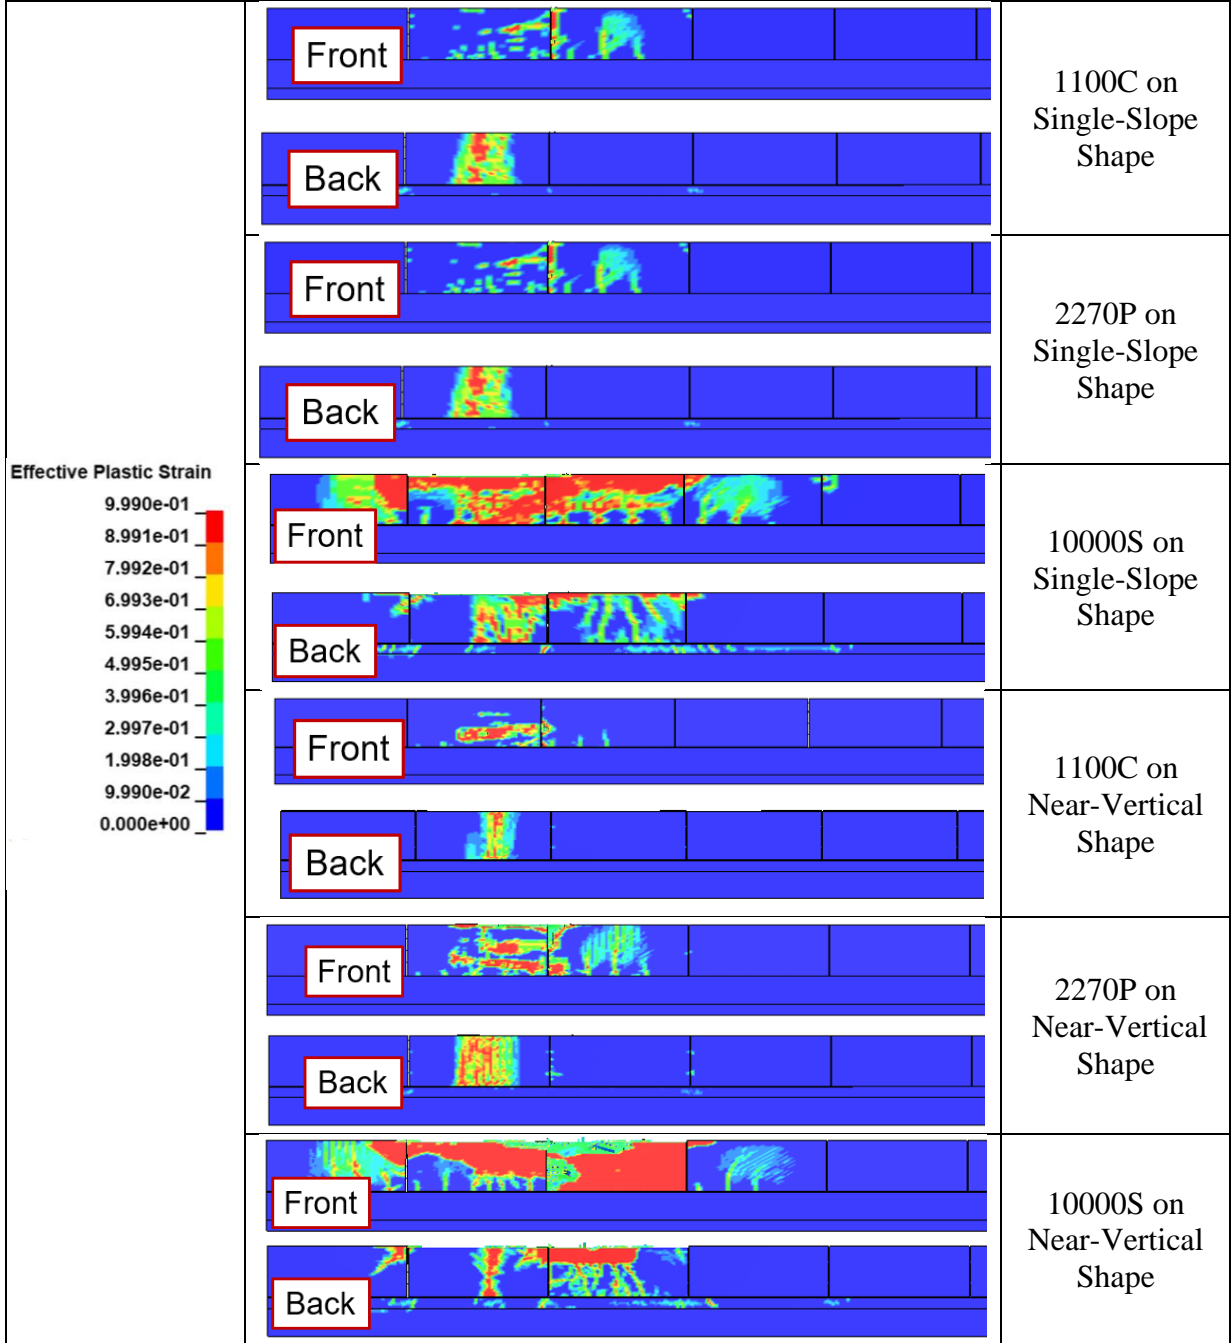
Figure 19. Concrete Damage Contours for Selected Simulations, Impact at Mid-Span of Barrier No. 2

The general effect of different vehicle impacts on the barriers were first assessed by analyzing the concrete damage contours, as depicted in Figure 19, for an impact at the mid-span of barrier no. 2. The damage value increased whenever the material was undergoing yielding, meaning it accumulated when the stress state was beyond the yield surface. This figure clearly illustrated that the damage predominantly occurred at the second and third barriers, which were the locations of the collisions. Among the impacting vehicles, the 10000S vehicle caused the most significant damage and displacement in the impact zone. This notable damage was primarily due to the vehicle 10000S's greater mass and impact severity. Further, the increased center of gravity (C.G.) height of the 10000S vehicle resulted in a higher lateral load and, consequently, a greater overall moment exerted on the barrier/bridge railing and the deck.

Additionally, it was observed that the barriers' traffic-side surface suffered more damage than the back-side face. Moreover, in the case of the near-vertical barriers, generally, more damage was seen on the barrier-to-barrier joint connections compared to what was observed in the single-slope barriers. These joint connections experienced higher stresses due to the specific geometry and configuration of the near-vertical barrier design. Greater impact force for the near-vertical barriers was likely due to decreased vehicle roll and climb, resulting in more energy dissipated through lateral load. It is worth noting that in all tested conditions, the impacting vehicles collided with the barriers twice. The initial collision involved the vehicle's front bumper, followed by a secondary collision involving the side of the vehicle near the quarter panel or the back of the cargo box (tail slap). Throughout the impact simulations, the barriers gradually returned to a lesser displacement from their peak displacement, indicating some degree of elastic rebound after the impact event.

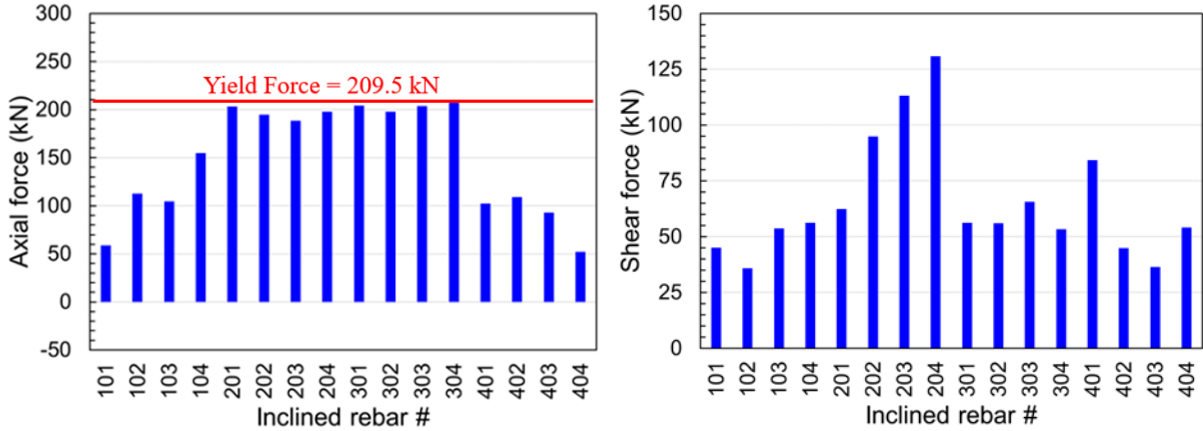
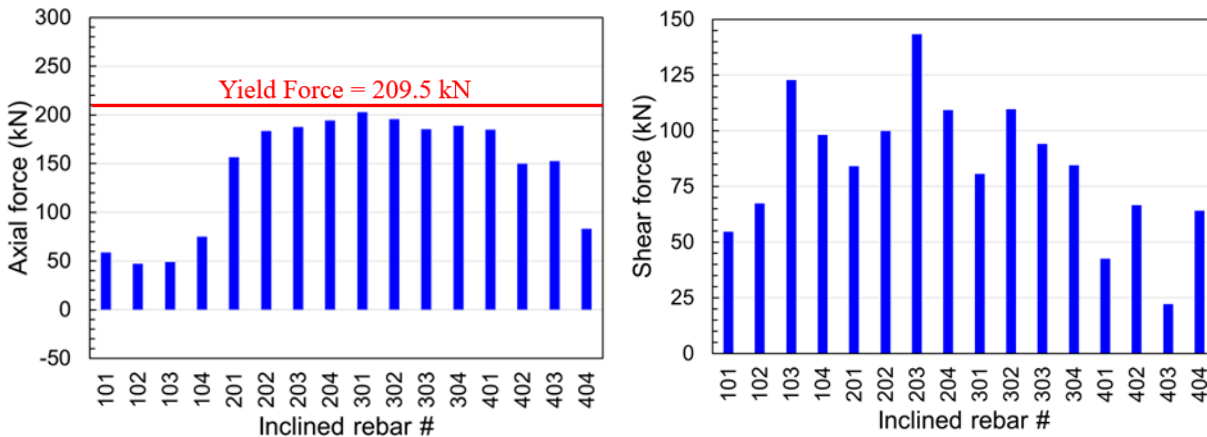
Figure 20. Maximum Observed Axial and Shear Forces in Single-Slope Barrier Shape – 10000S Vehicle Impact: (a) Impact at Mid-Span; (b) Impact at 3/4-span; and (c) Impact at a Joint. Note that the plot depicts maximum observed forces regardless of time and the inclined bars are named using the generalized name 101 through 404.

Figure 20 illustrates the maximum axial and shear forces observed in inclined rebars within the single-slope barriers during impacts involving the 10000S vehicle. It is important to note that the diagrams showcasing the forces acting on the rebars can be found in Appendix A. As shown, the location of the maximum forces experienced by the rebars varies based on the impact location. For instance, when the impact occurs at the joint between barrier nos. 2 and 3, the rebar in barrier no. 4 reaches a maximum axial force of approximately 182.08 kN (40.93 kip). However, in other impact locations, the maximum axial force in the same rebar was approximately 100.00 kN (22.48 kip). This observation highlights the influence of different impact points on the distribution of forces within the single-slope barrier system. The impact location determines which rebars bear the highest axial forces. This information was considered when determining the critical impact point for physical testing. Note the plot in Figure 19 depicts the maximum observed axial and shear forces regardless of time. These forces were plotted at a time when axial forces are maximum in a rebar and shown in Appendix A.

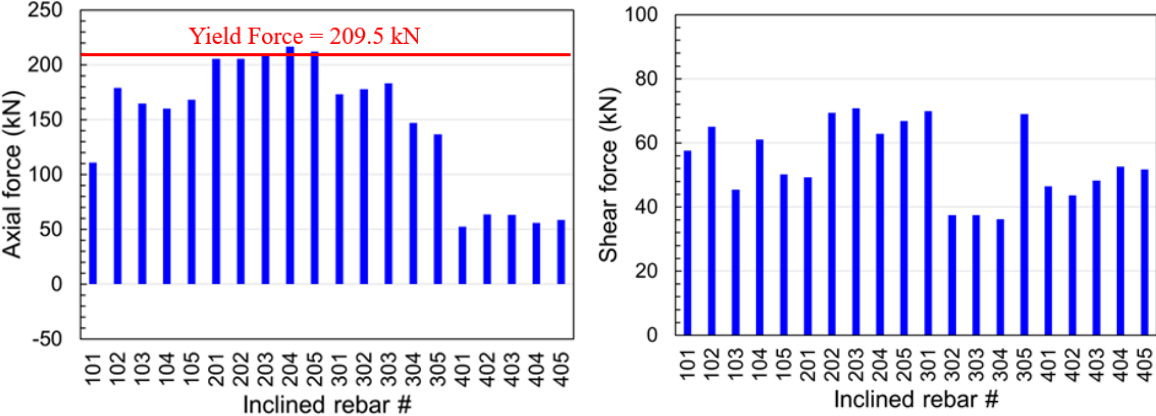
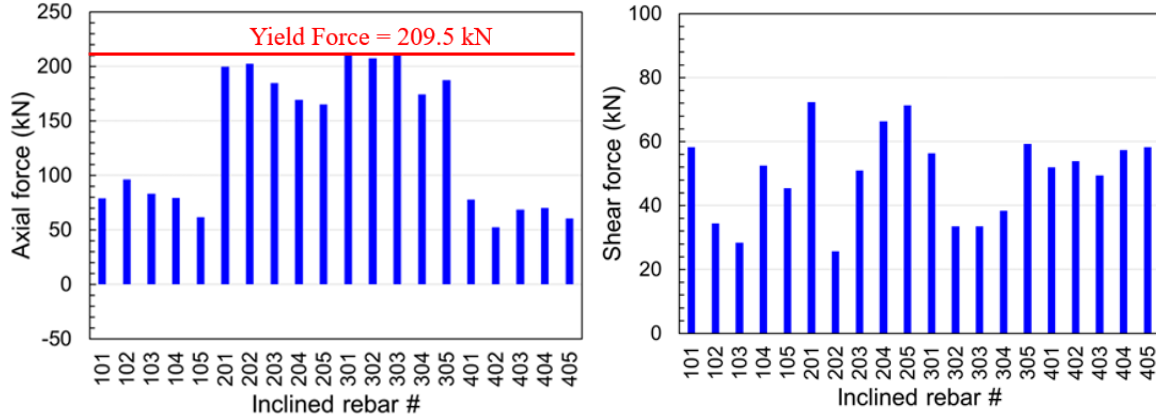
Figure 21. Maximum Observed Axial and Shear Forces in Near-Vertical Barrier Shape – 10000S Vehicle Impact: (a) Impact at Mid-Span; (b) Impact at 3/4-span; and (c) Impact at a Joint. Note that the plot depicts maximum observed forces regardless of time and the inclined bars are named using the generalized name 101 through 405.

Figure 21 shows the maximum axial and shear forces observed in inclined rebars within the near-vertical barrier shape during impact from 10000S vehicle. This figure similarly established that the location of the maximum forces on the reinforcement bars were influenced by the impact location. For instance, an impact at 3/4-span location yielded a peak axial force of approximately 236.5 kN (53.17 kip). in the rebar of barrier no.2. Conversely, alternative impact points resulted in a peak axial force of approximately 212.2 kN (47.70 kip) in the same rebar. This pattern reiterates the substantial influence of varying impact locations on the force distribution within the near-vertical bridge railing system.

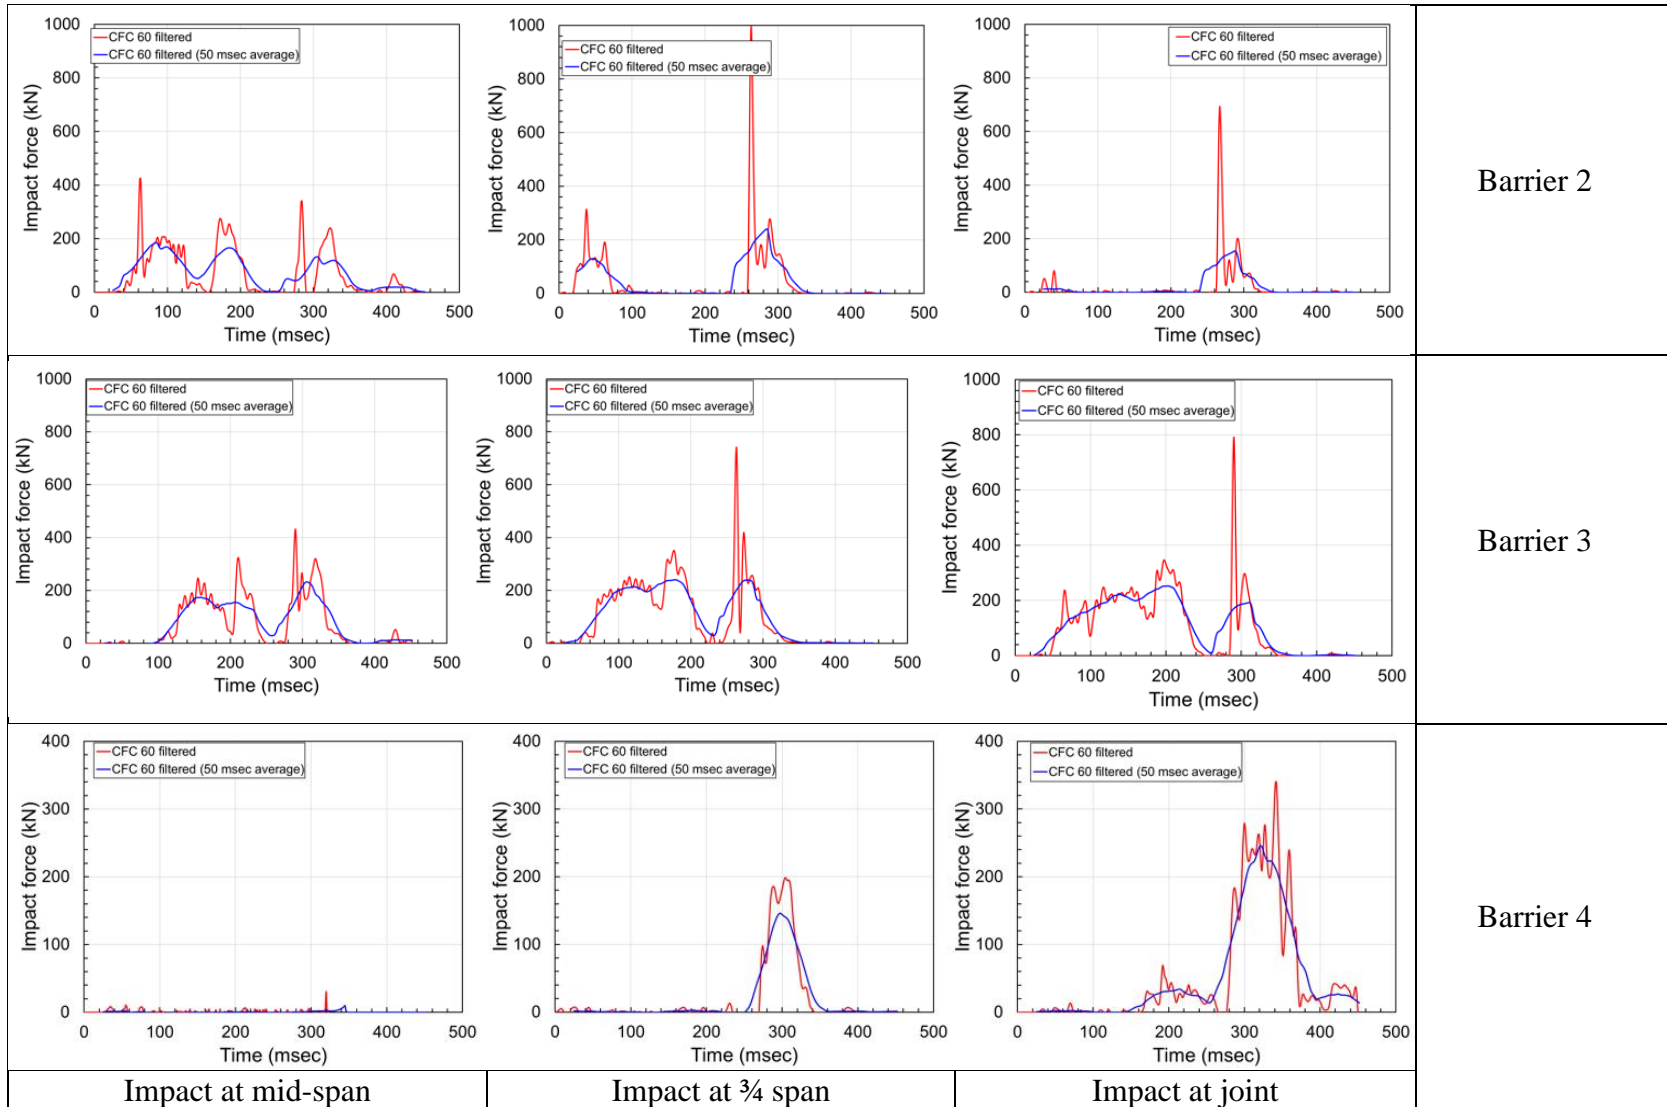
Figure 24. Impact Force-Time History – 1000S Vehicle Impact with Single-Slope Barrier

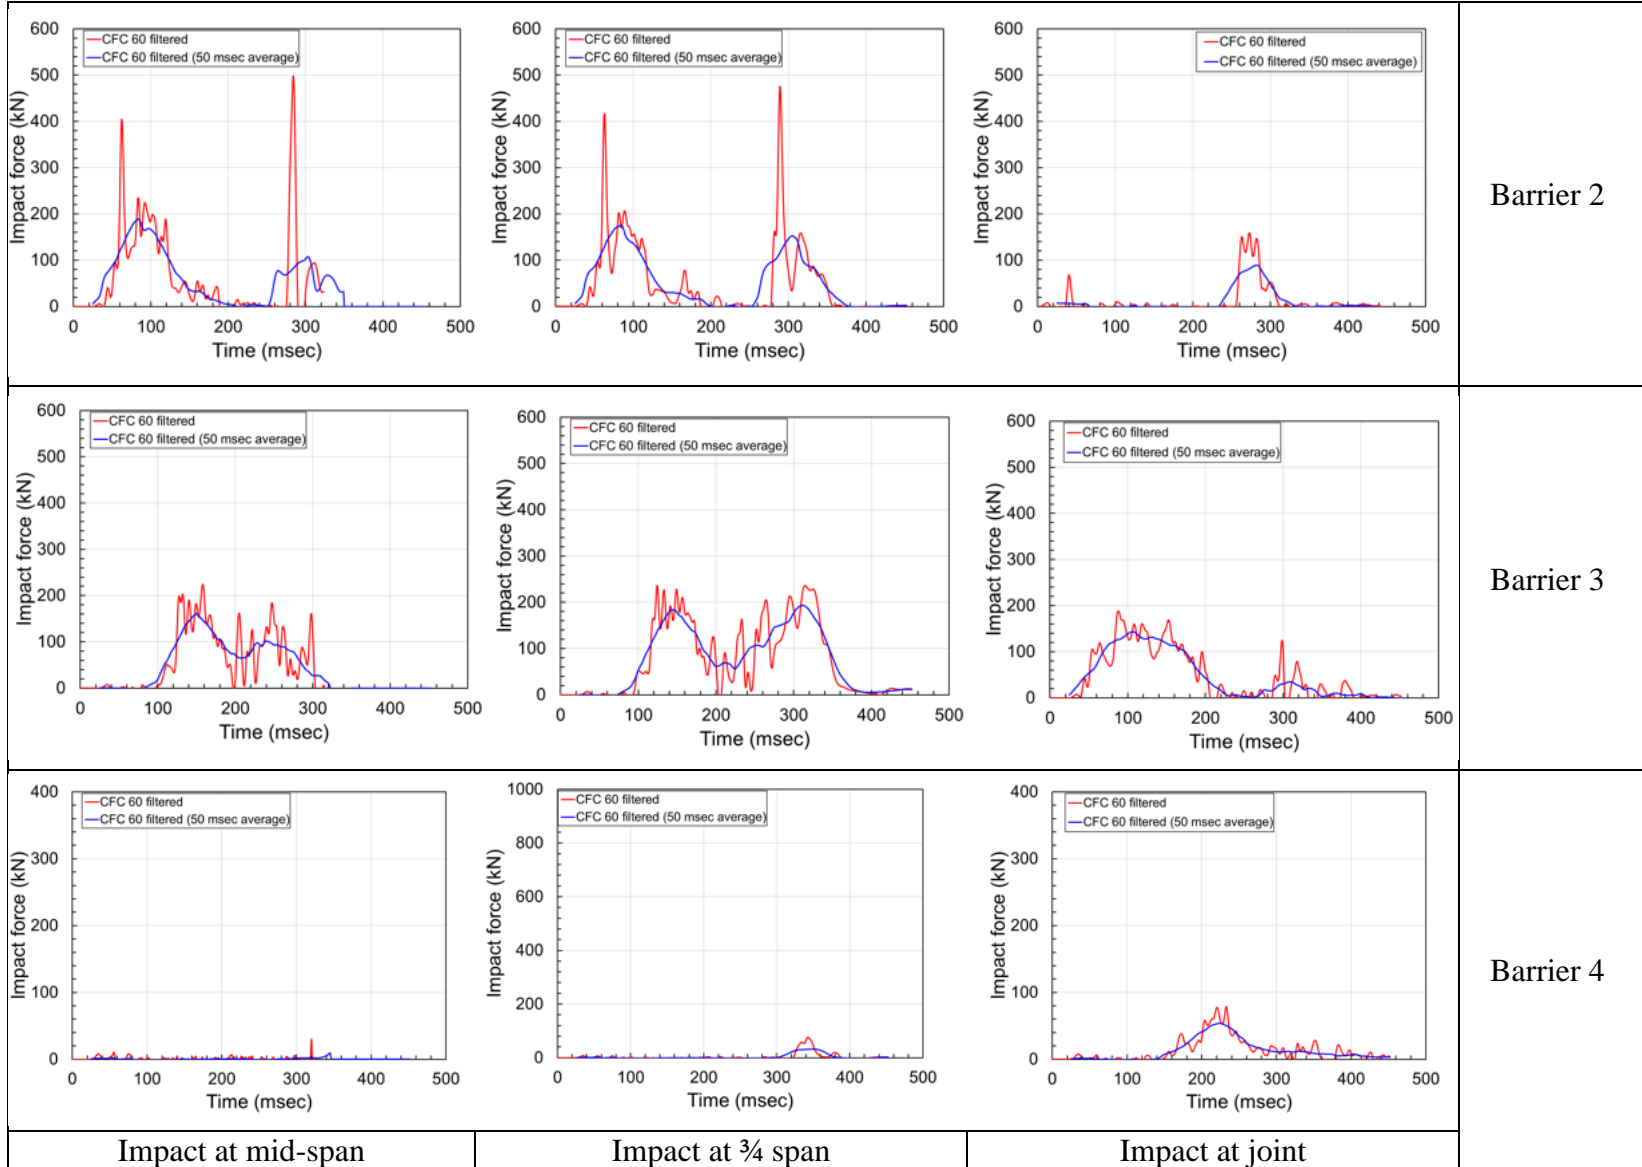
Figure 25. Impact Force-Time History – 1000S Vehicle Impact with Near-Vertical Barrier

Figure 25 further elucidates the force-time histories of the 10000S vehicle model during a collision with the near-vertical barrier. The location of the impact point exerted a conspicuous influence on the force dissipation across different barrier segments. Impacts at the mid-span and $\frac{3}{4}$ -span locations primarily funnel to barrier no. 2, which experienced the highest impact loads, while barrier no. 4 registered the smallest. Conversely, impacts localized at the joint between barrier nos. 2 and 3 resulted in peak force to barrier no. 3. The complete datasets of the impact force-time histories for the 1100C and 2270P vehicle models collisions with near-vertical barrier are archived in Appendix C.

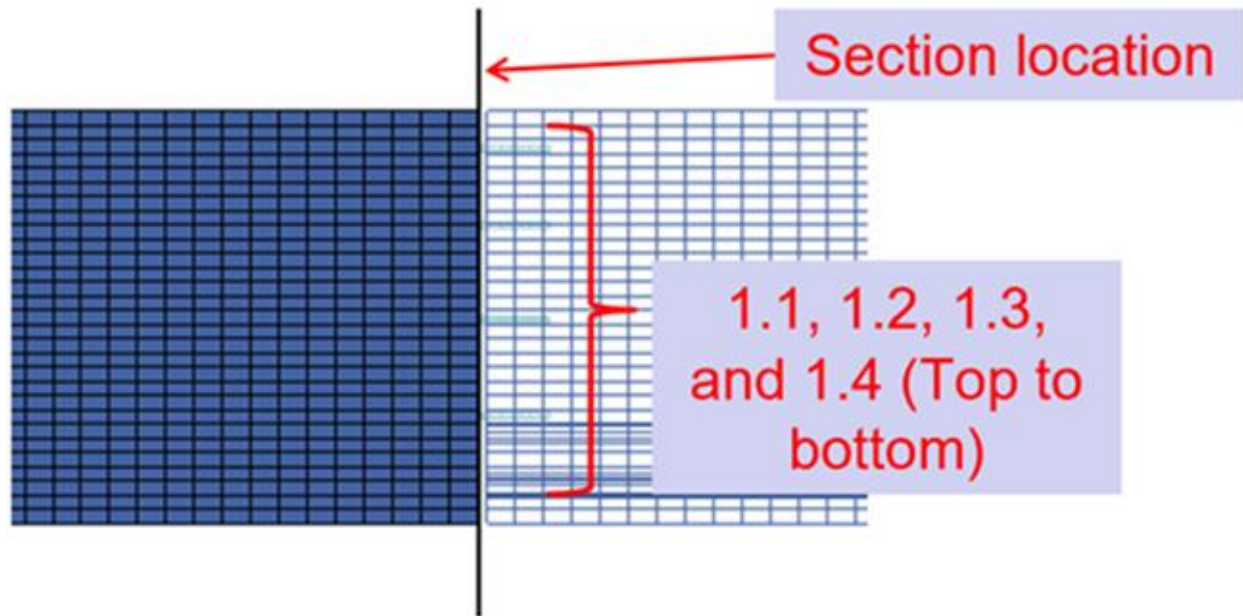
Figure 26. Section Location and Number of the Joint-Spanning Rebar

To analyze the joint between the barrier ends, data recording cross sections were placed at each joint location. These cross sections served the purpose of measuring the shear and tensile forces developed at the joints. The locations of these cross sections and the corresponding numbers assigned to the joint connection rebar can be found in Figure 26. Figures 27 through 29 present the axial stress-time histories on the joint rebars for different barriers numbered 1 to 4, indicating no yielding of the rebars. Data shown corresponds to the 10000S vehicle impacting the single-slope barrier at the mid-span, $\frac{3}{4}$ -span, and joint. The complete axial force-time and von-Mises-time histories for 1100C, 2270P, 10000S vehicle collisions with single-slope and near-vertical barriers can be found in Appendix D.

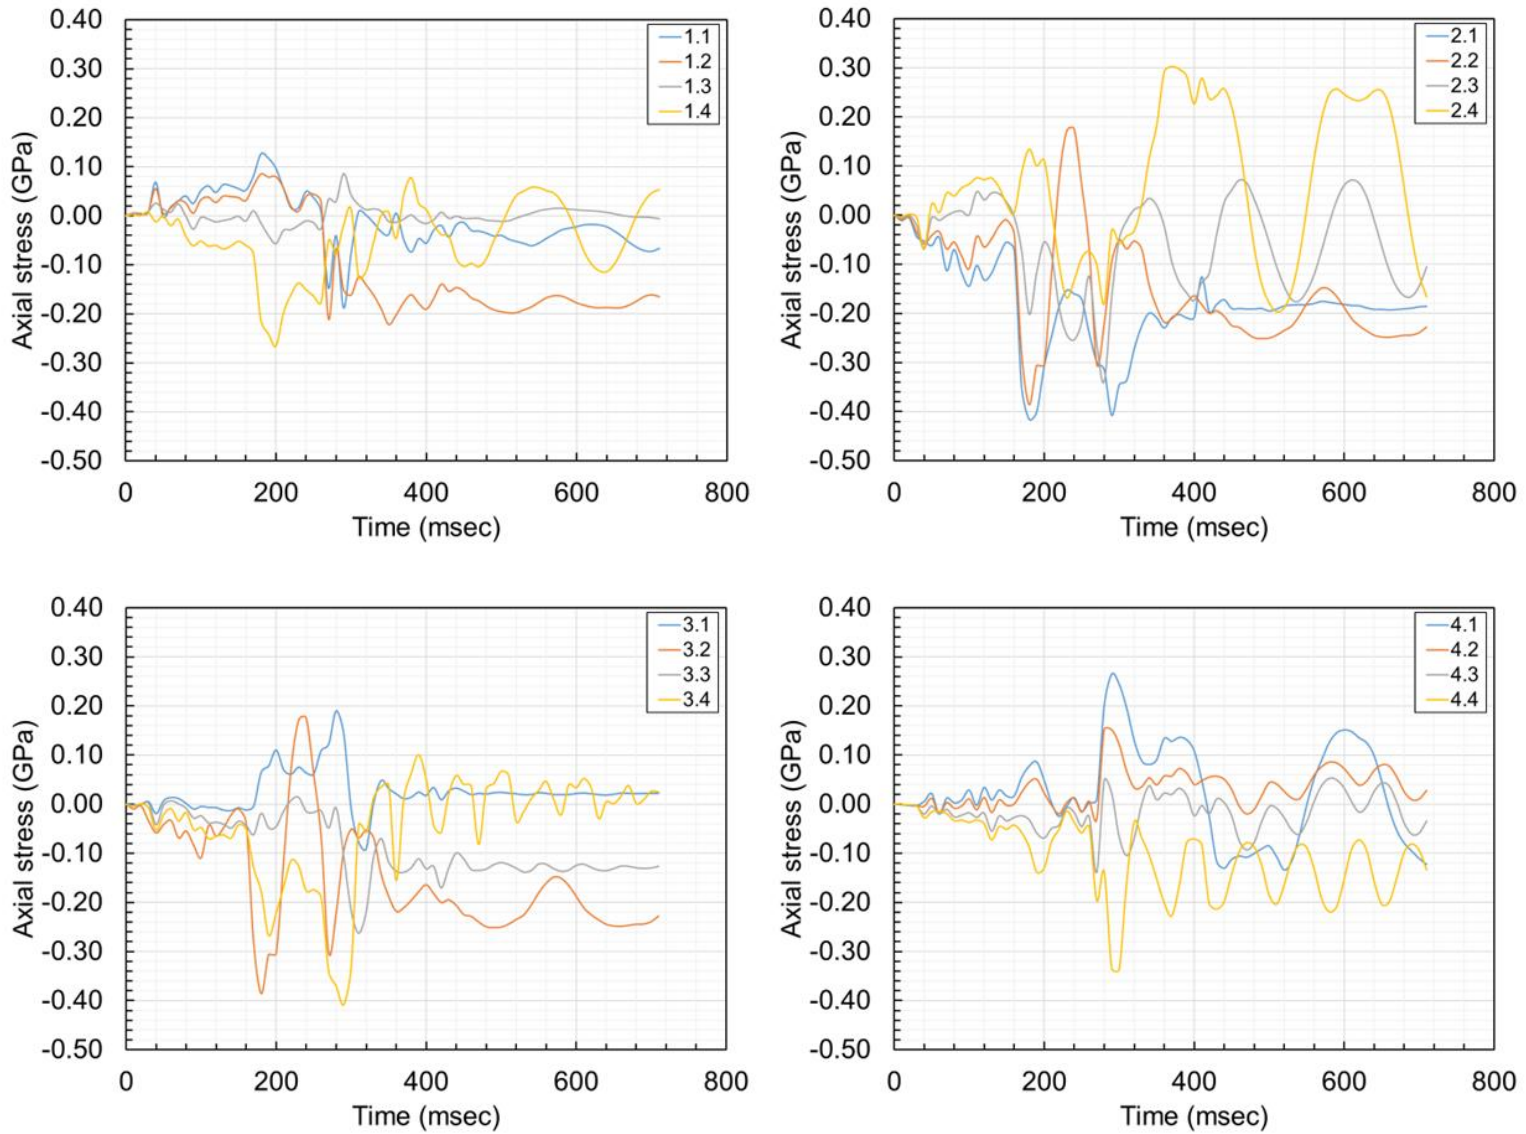
Figure 27. Axial Stress Developed in Joint-Spanning Rebar – 10000S Vehicle Impact at Mid-Span – Single-Slope Barrier

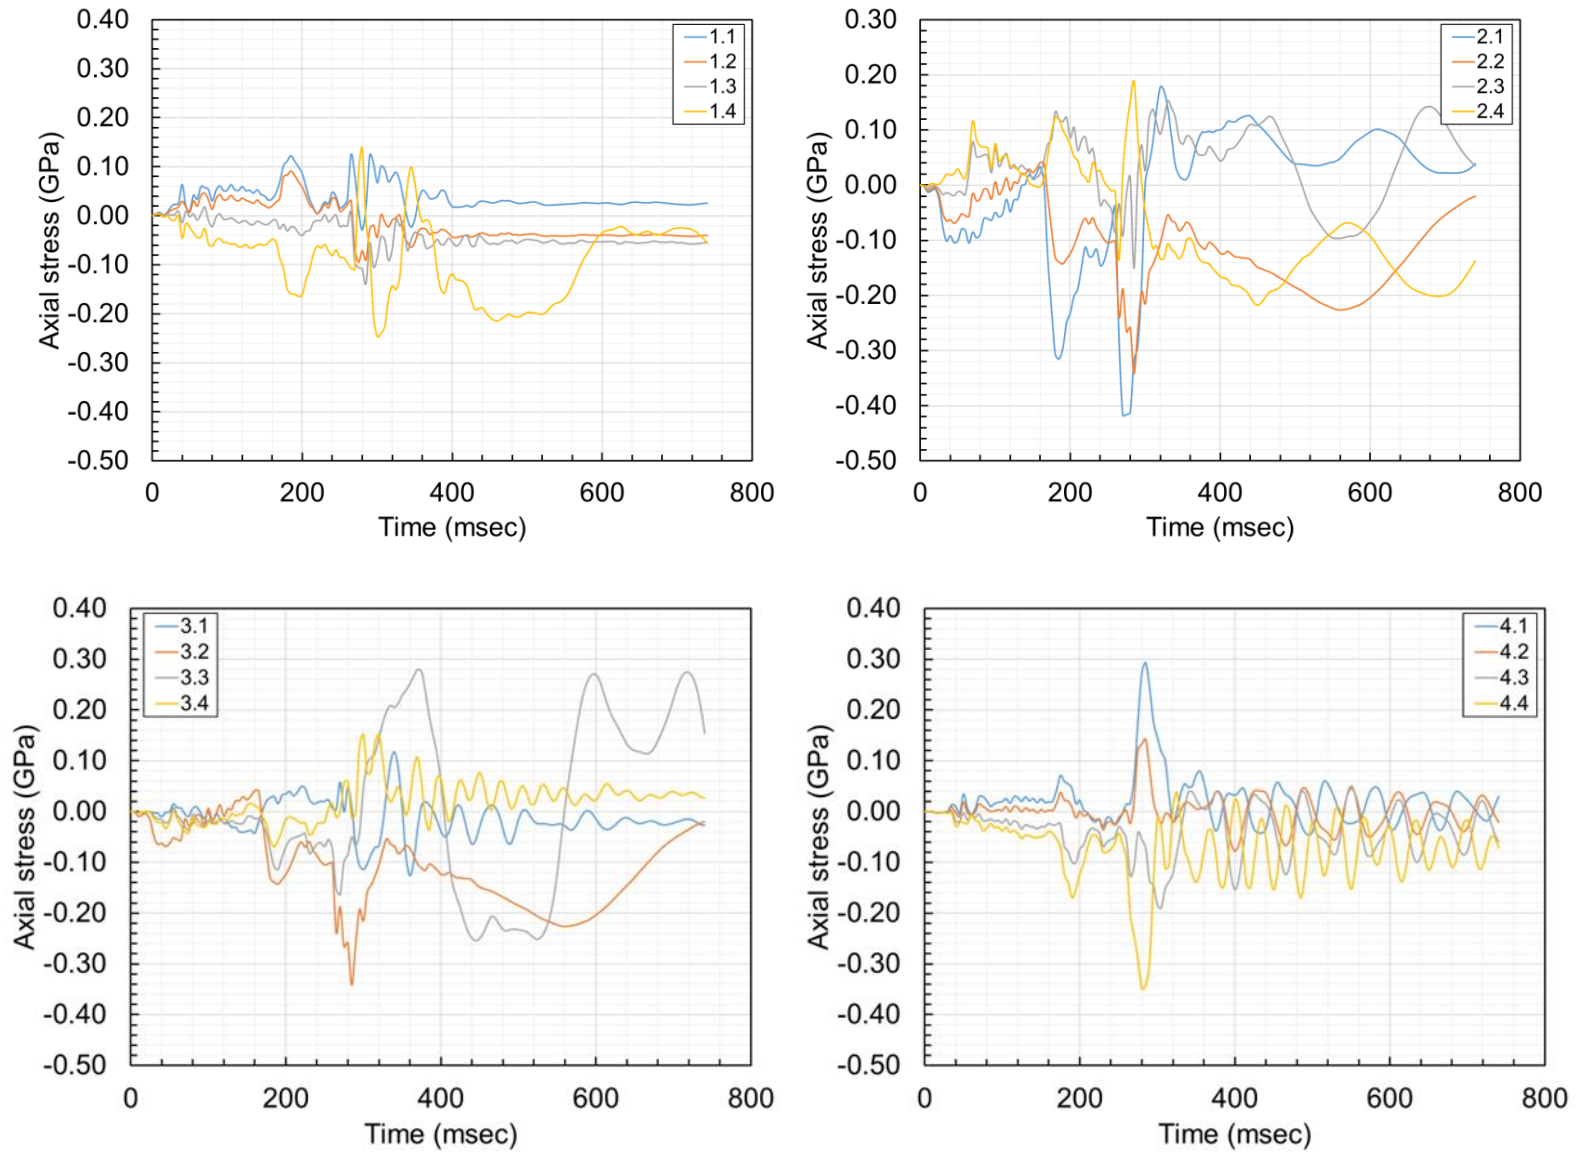
Figure 28. Axial Stress Developed in Joint-Spanning Rebar – 10000S Vehicle Impact at 3/4 -Span – Single-Slope Barrier

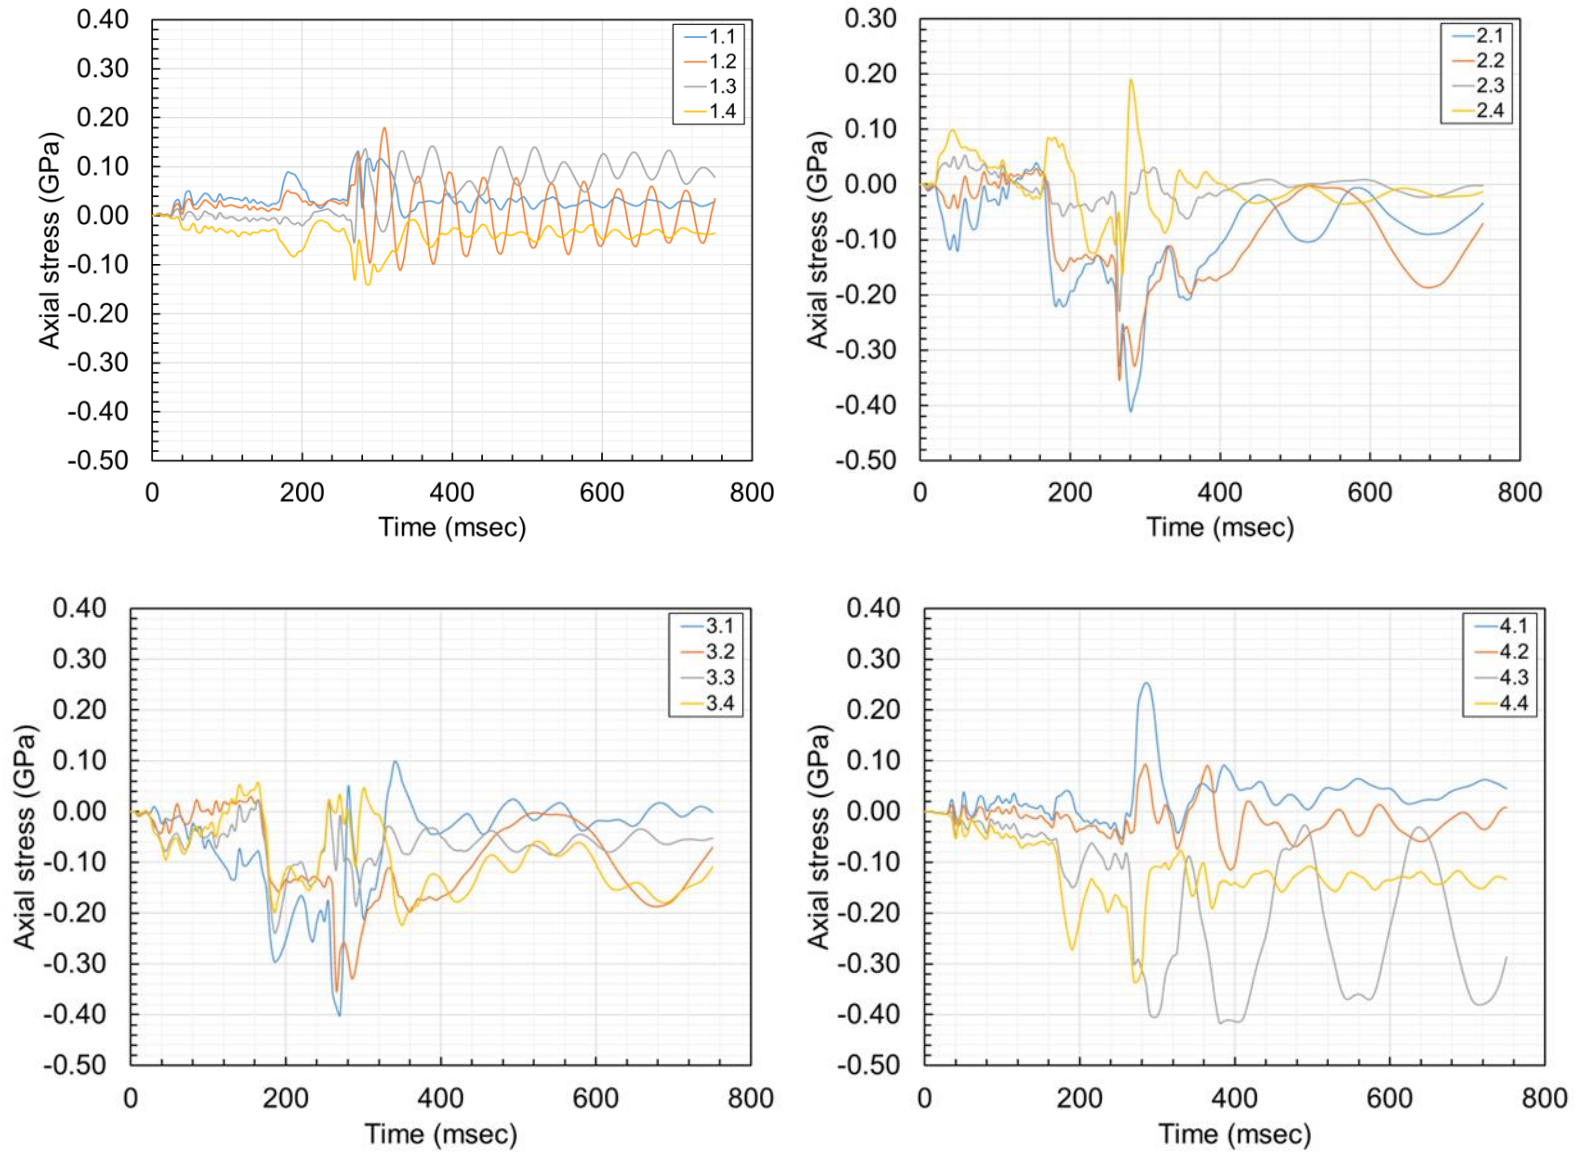
Figure 29. Axial Stress Developed in Joint-Spanning Rebar – 10000S Vehicle Impact at Joint – Single-Slope Barrier

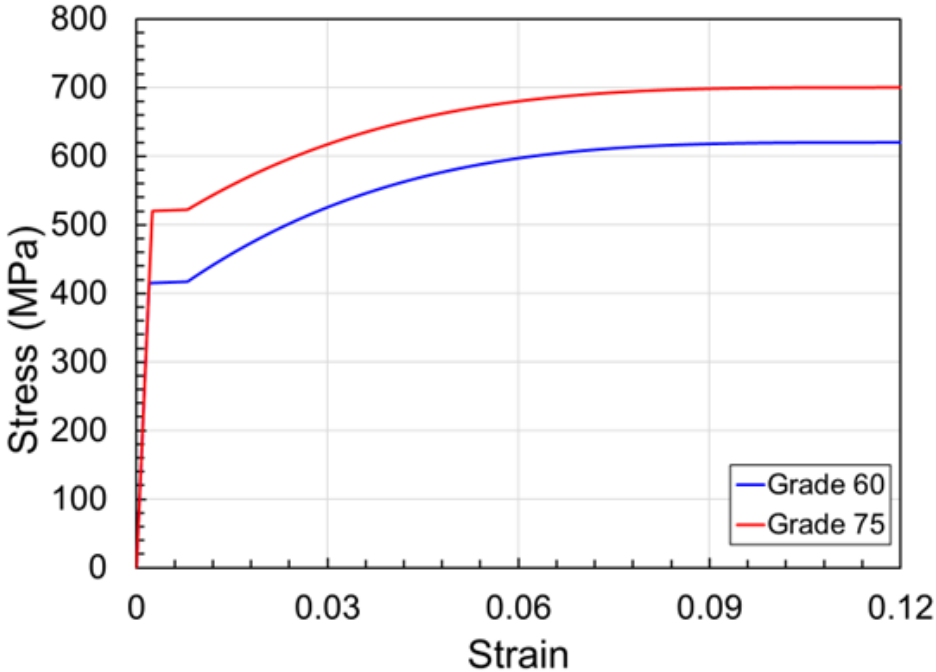
Figure 32. Stress vs. Strain Curves of Grade 60 and Grade 75 Bars [21]

To determine the mechanical response of inclined reinforcing bars, comprehensive stress analyses were conducted on Grades 60 and 75 reinforcement bars, as depicted in Figure 32. For inclined bars of Grade 60, the anticipated yield strength was quantified as 415 MPa (60 ksi), while the ultimate tensile strength was expected to be 620 MPa (90 ksi). In contrast, Grade 75 bars manifested superior mechanical characteristics, with an estimated yield strength and ultimate tensile strength of 520 MPa (75 ksi) and 720 MPa (105 ksi), respectively.

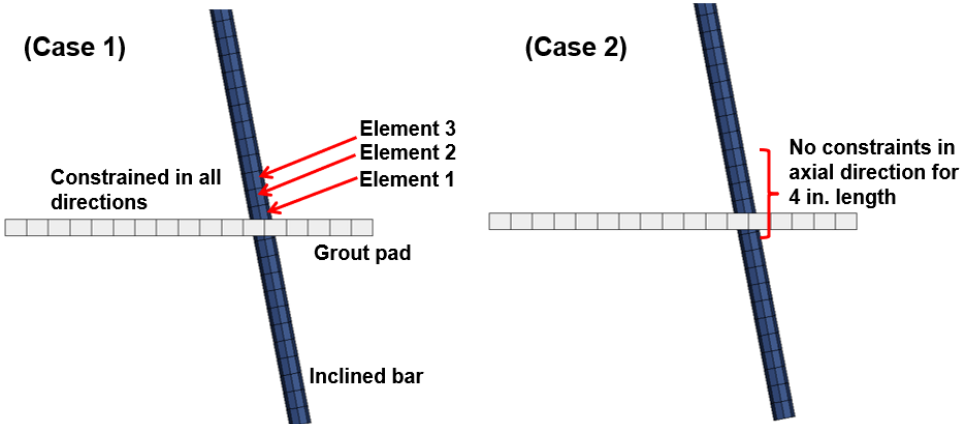
Figure 33. Constraint Conditions Between Inclined Bars and Barrier Above Grout Pad

Stress distribution profiles were assessed along the longitudinal axis of the inclined bars in proximity to the deck interface. Two specific constraint conditions were employed to evaluate the interaction between the inclined bars and the overlying barrier in the presence of grout: (1) a fully constrained condition in all spatial dimensions (Case 1) and (2) an axially unconstrained condition over a length of 4 in. (Case 2), as illustrated in Figure 33.

A selection of three distinct elements (Element 1, Element 2, and Element 3) was chosen to determine the stress magnitudes localized within the inclined bars. This multi-element approach enabled an understanding of the mechanical behavior of these specialized reinforcing elements under varied constraint conditions.

Figures 34 through 37 present the von Mises stress distribution within selected elements – specifically Element 1, Element 2, and Element 3 as identified in Figure 33– subjected to the impact of a 10000S vehicle at a $\frac{3}{4}$ -span of barrier segment no. 2 of the single-slope barrier. A comparison between two distinct constraint conditions, Case 1 and Case 2, is presented for Grades 60 and 75 steel inclined bars.

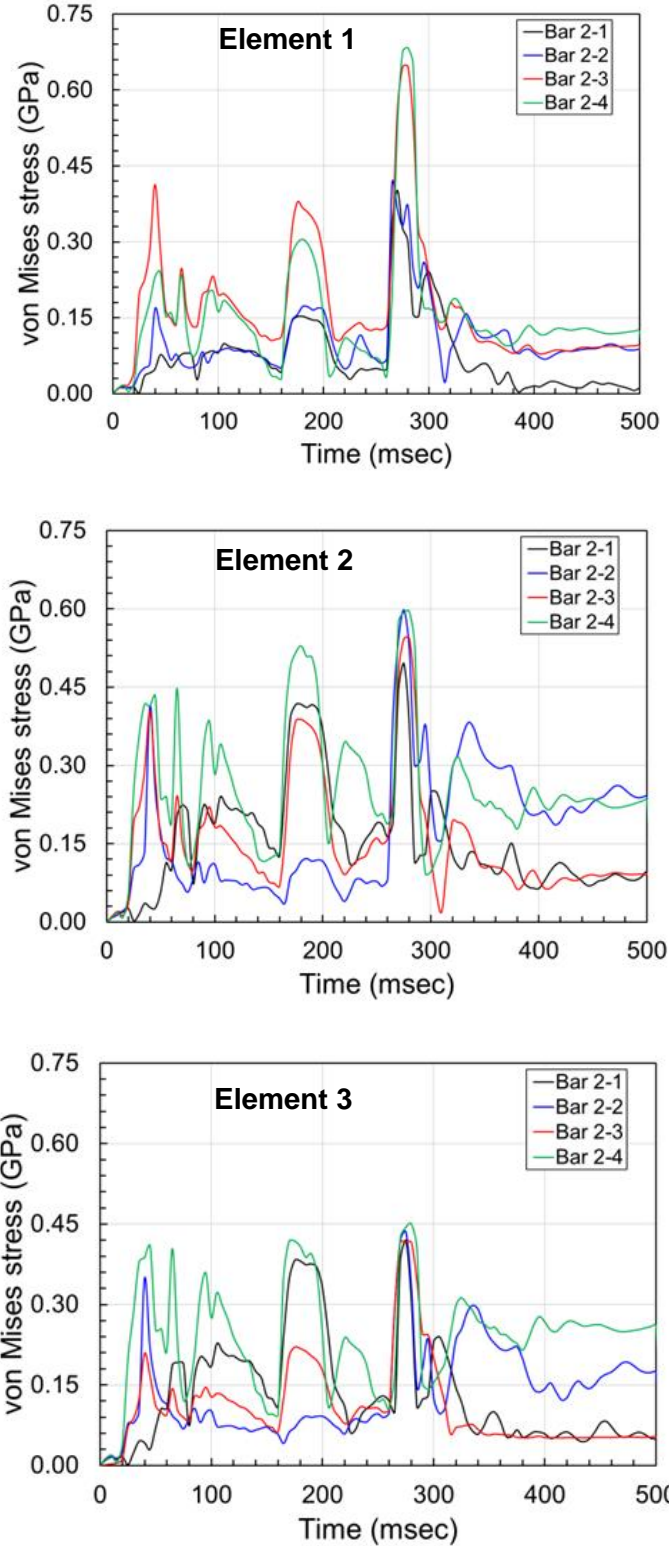
Figure 34. Von Mises Stress Time Histories in Grade 60 Inclined Bars – 10000S Vehicle Impact at $\frac{3}{4}$ -Span (Case 1) – Single-Slope Barrier

For Grade 60 inclined bars under Case 1 constraint condition, peak (von Mises) stress values were observed at 680 MPa (98.6 ksi), 600 MPa (87.0 ksi), and 460 MPa (66.7 ksi). In contrast, under the Case 2 constraint condition, the maximum stress levels were quantified as 640 MPa (92.2 ksi), 670 MPa (97.2 ksi), and 530 MPa (76.9 ksi). For Grade 75 inclined bars, Case 1 constraint yielded stresses at 660 MPa (95.7 ksi), 660 MPa (95.7 ksi), and 530 MPa (76.9 ksi); while Case 2 constraint condition led to stress levels of 690 MPa (100.1 ksi), 760 MPa (110.2 ksi), and 580 MPa (84.1 ksi).

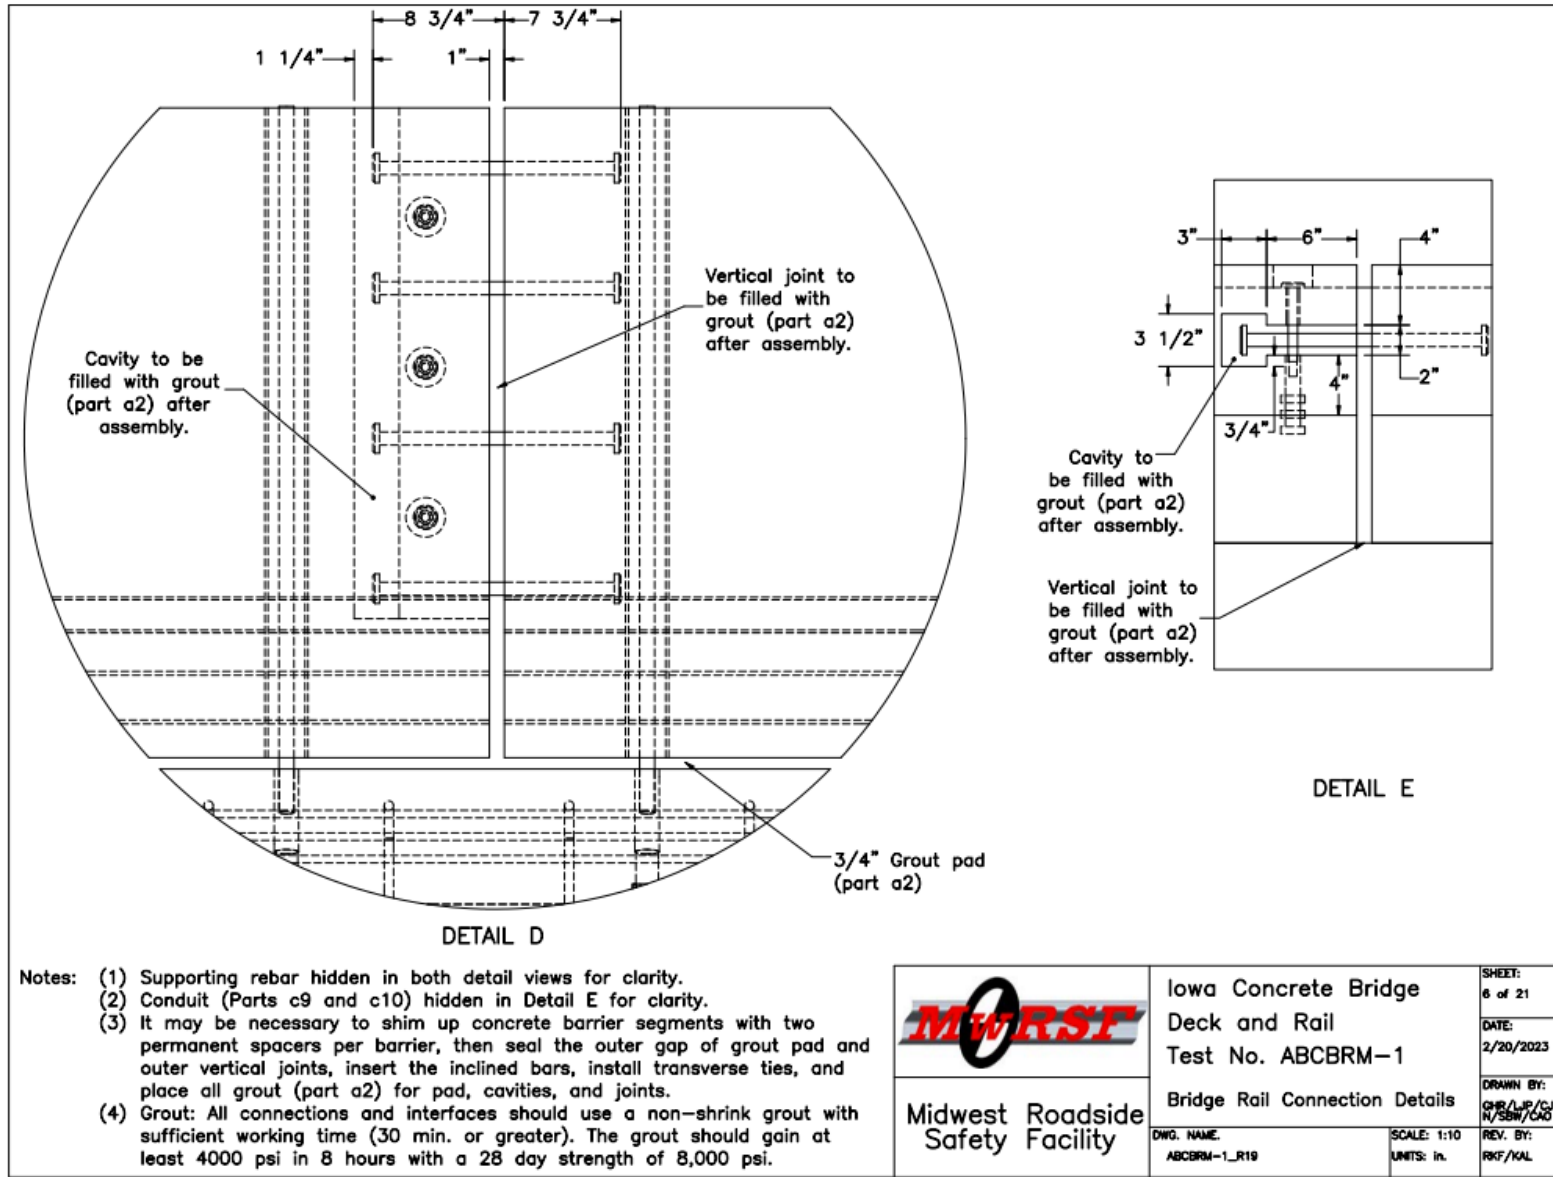
Figure 43. Bridge Rail Connection Details, Test No. ABCBRM-1
