Research Project Number TPF-5(367)

INVESTIGATION, CRASH TESTING, AND EVALUATION OF A MASH TL-4 PRECAST CONCRETE BRIDGE RAIL

MIDWEST ROADSIDE SAFETY FACILITY

MwRSF Research Report No. TRP-03-476-24

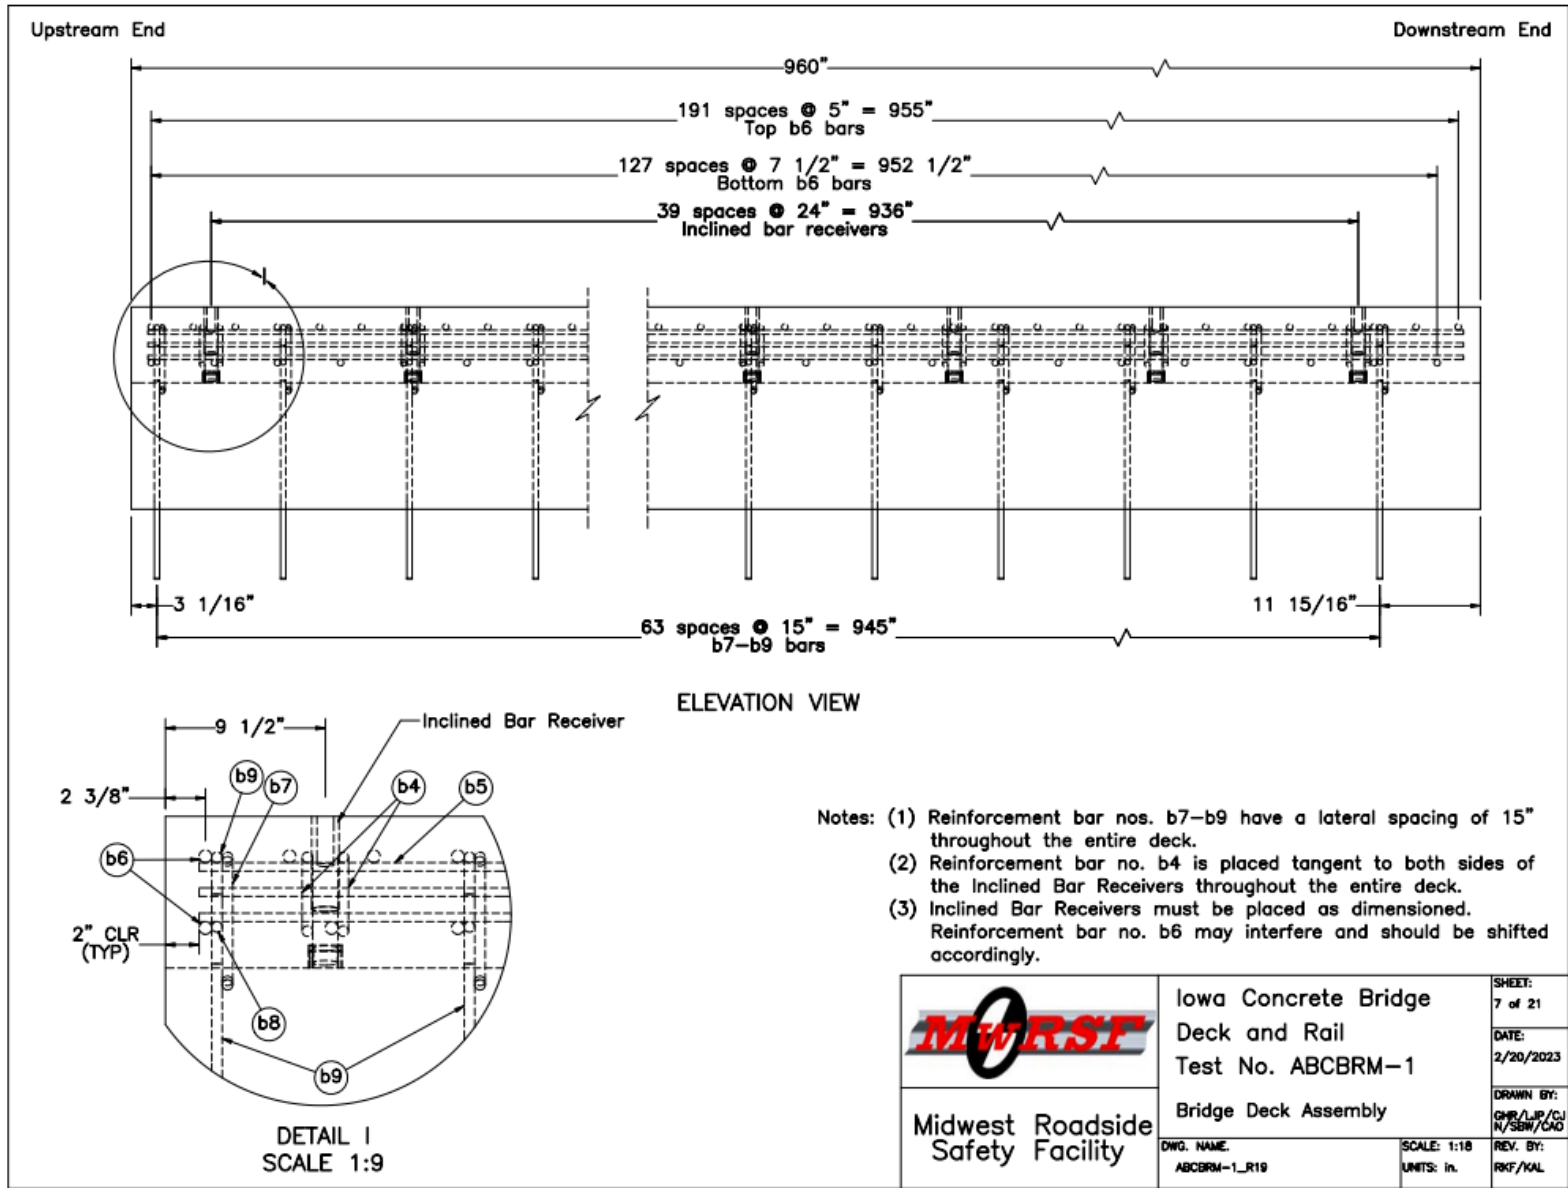
Figure 44. Bridge Deck Assembly, Test No. ABCBRM-1

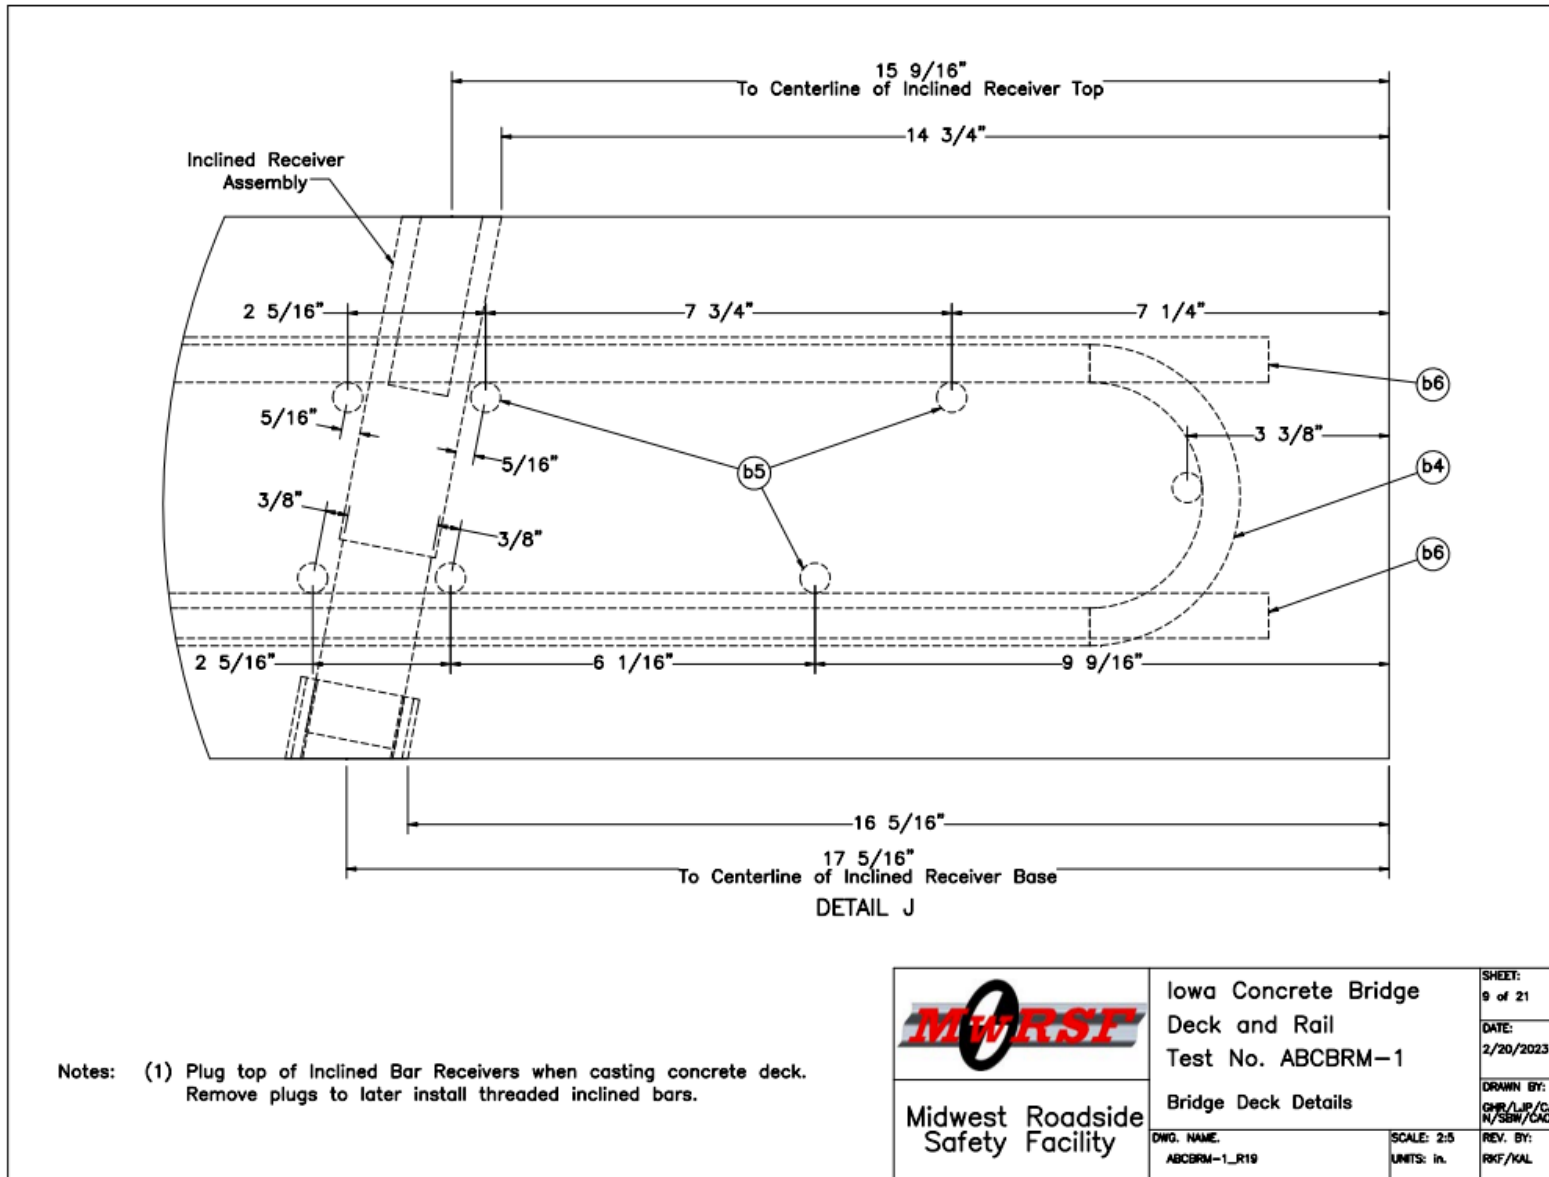
Figure 46. Bridge Deck Details, Test No. ABCBRM-1

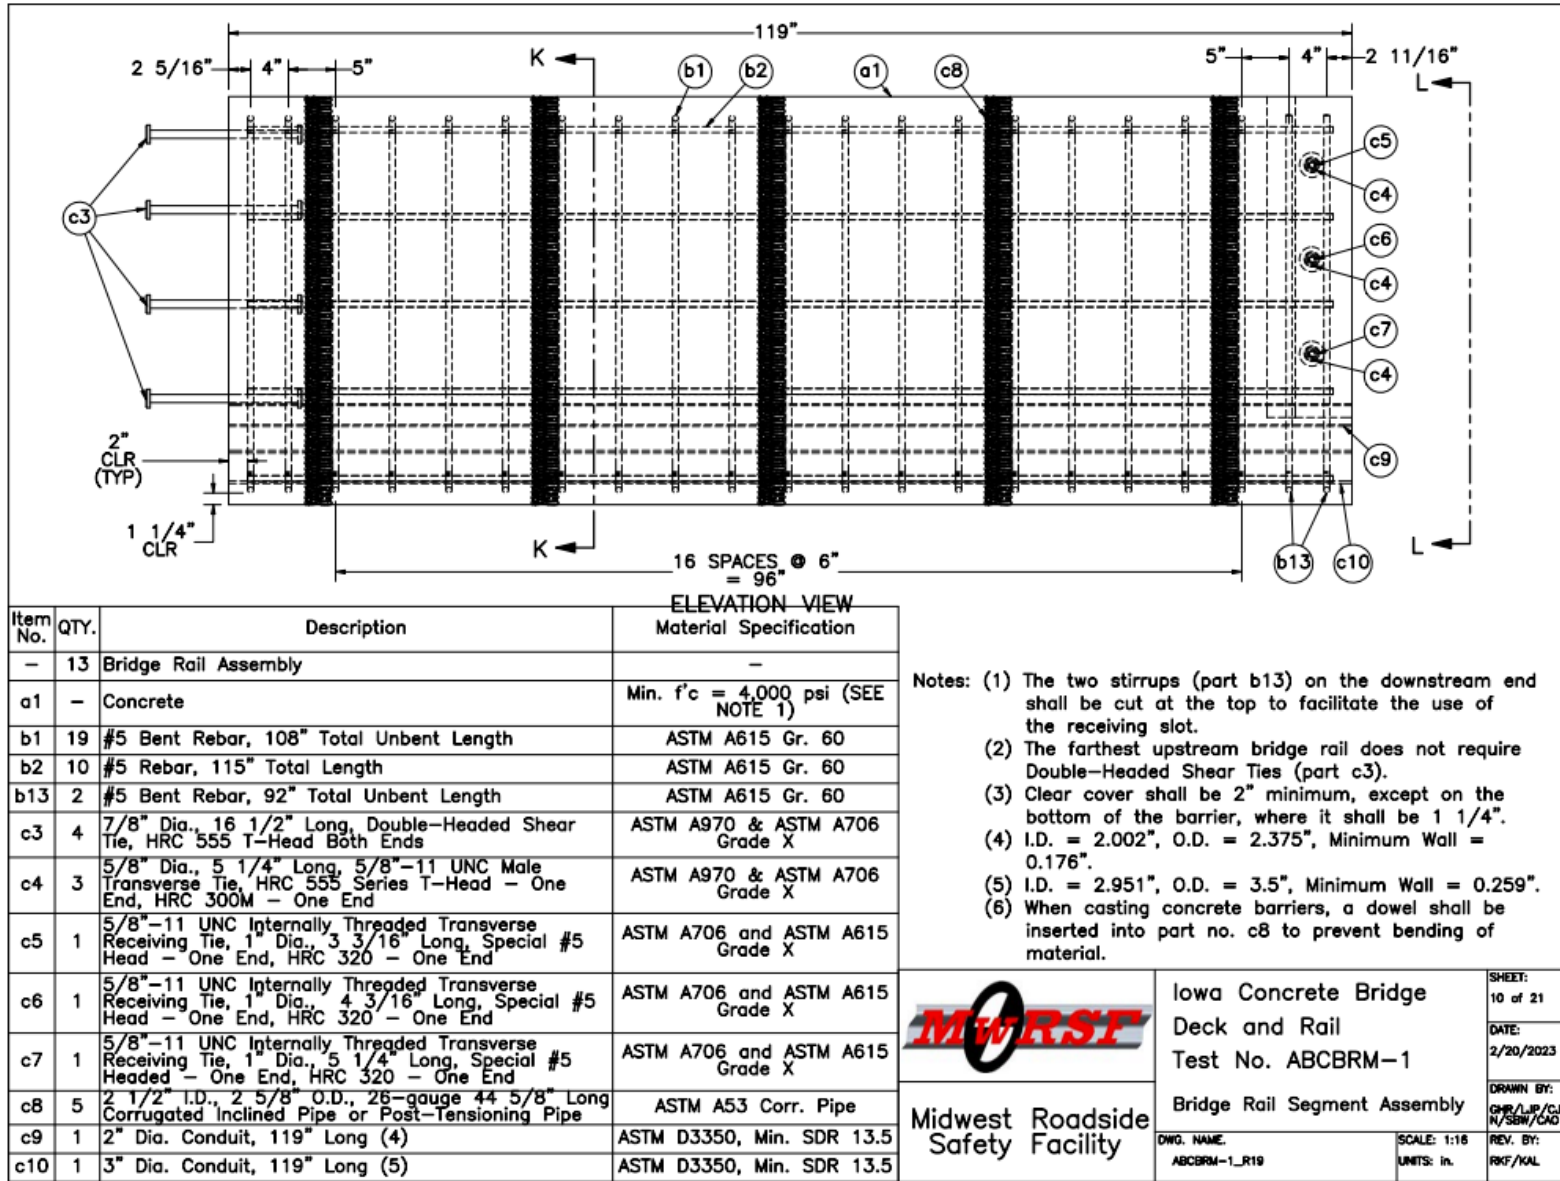
Figure 47. Bridge Rail Segment Assembly, Test No. ABCBRM-1

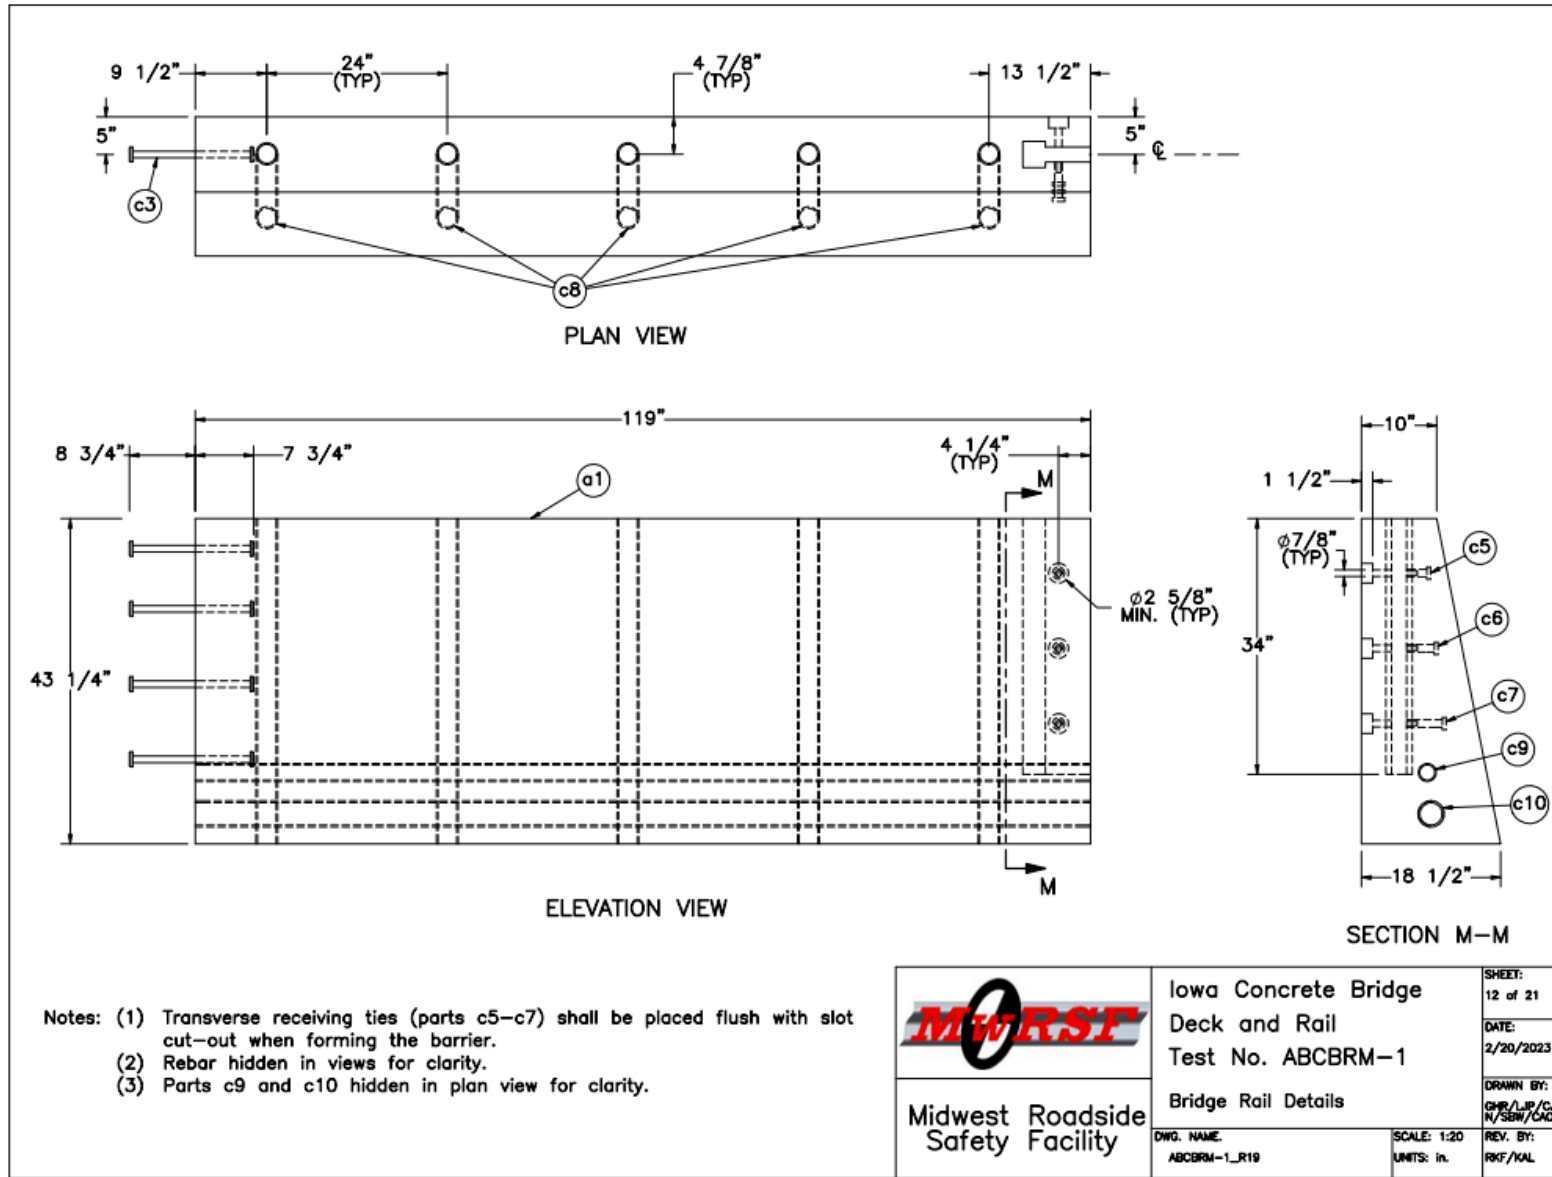
Figure 49. Bridge Rail Details, Cont., Test No. ABCBRM-1

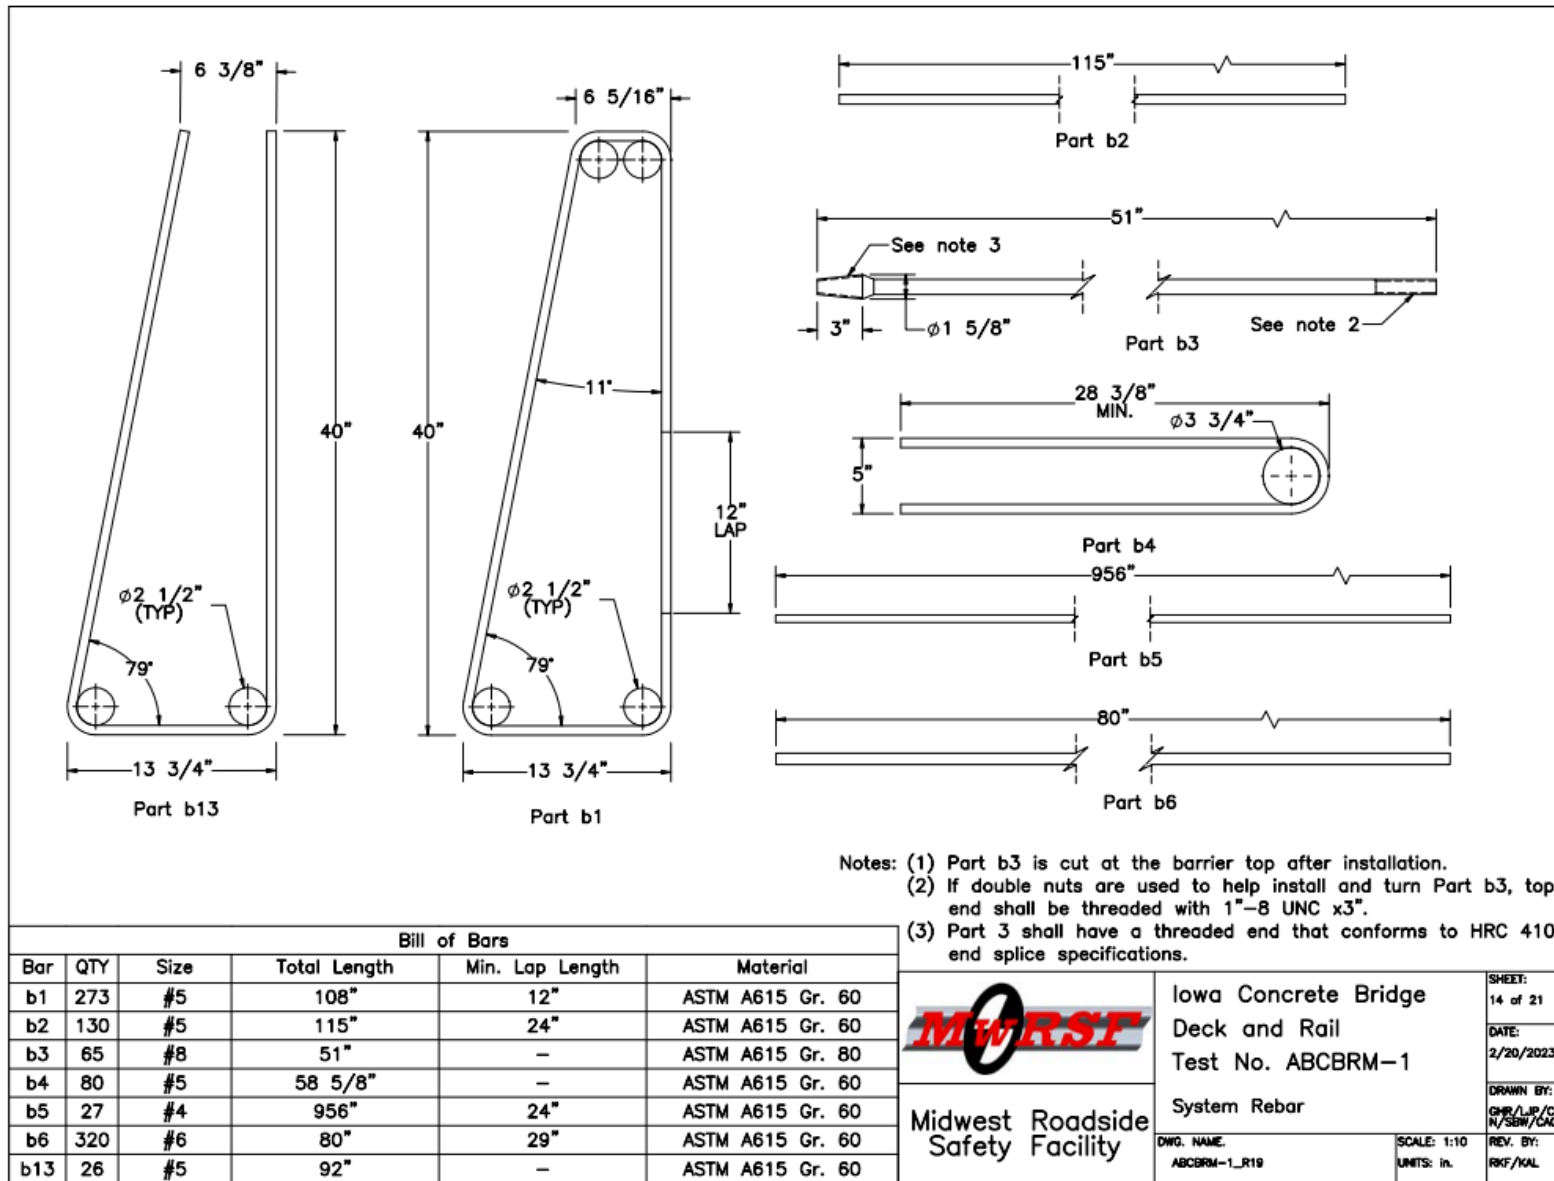
Figure 51. System Rebar, Test No. ABCBRM-1

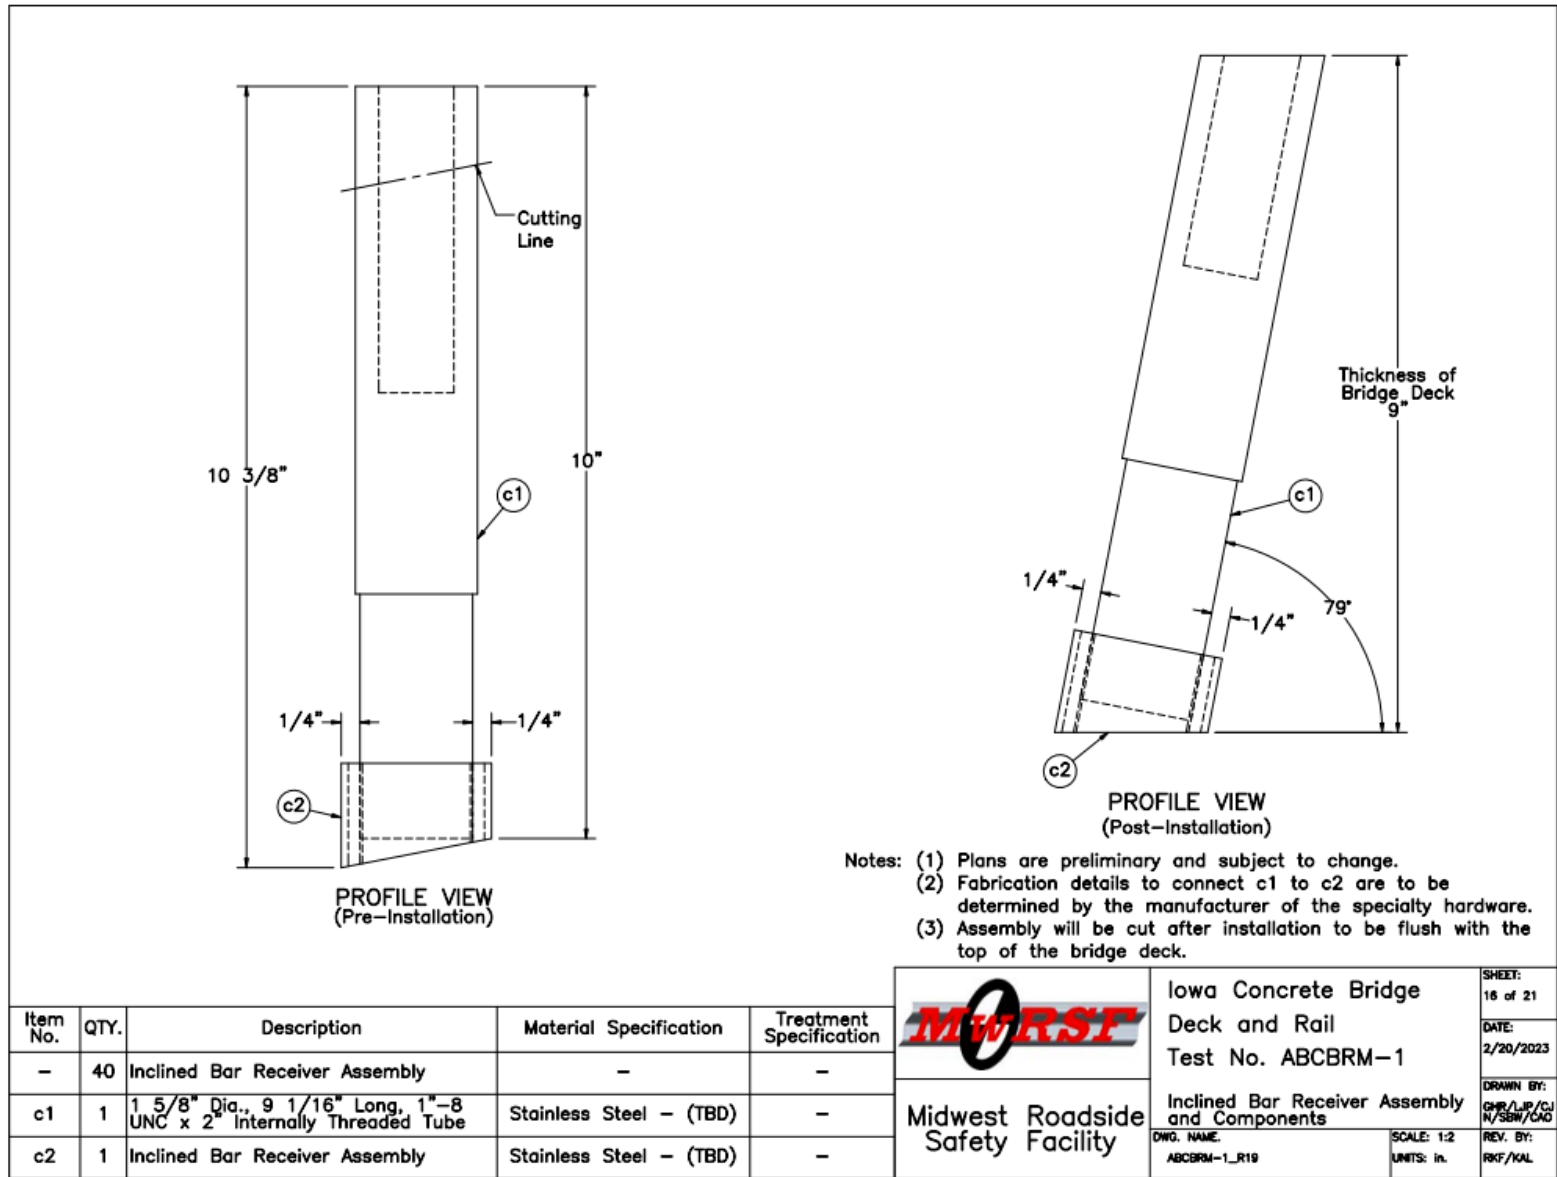
Figure 53. Inclined Bar Receiver Assembly and Components, Test No. ABCBRM-1

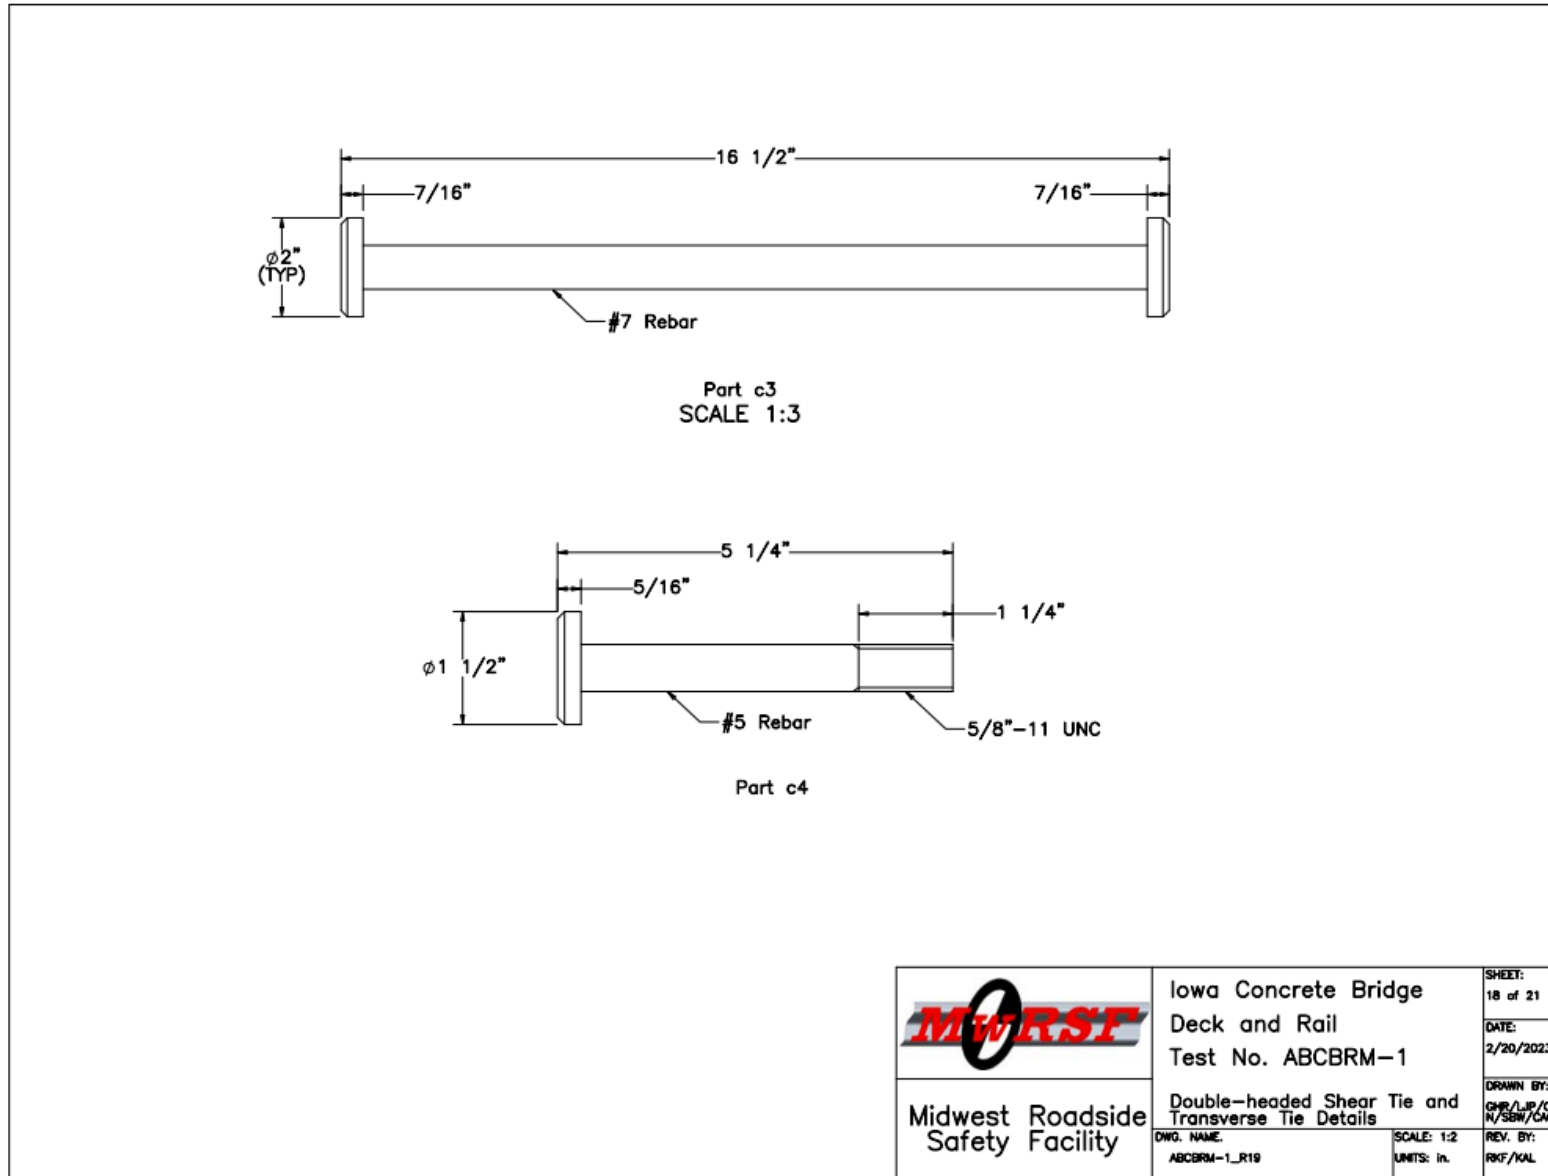
Figure 55. Double-Headed Shear Tie and Transverse Tie Details, Test No. ABCBRM-1

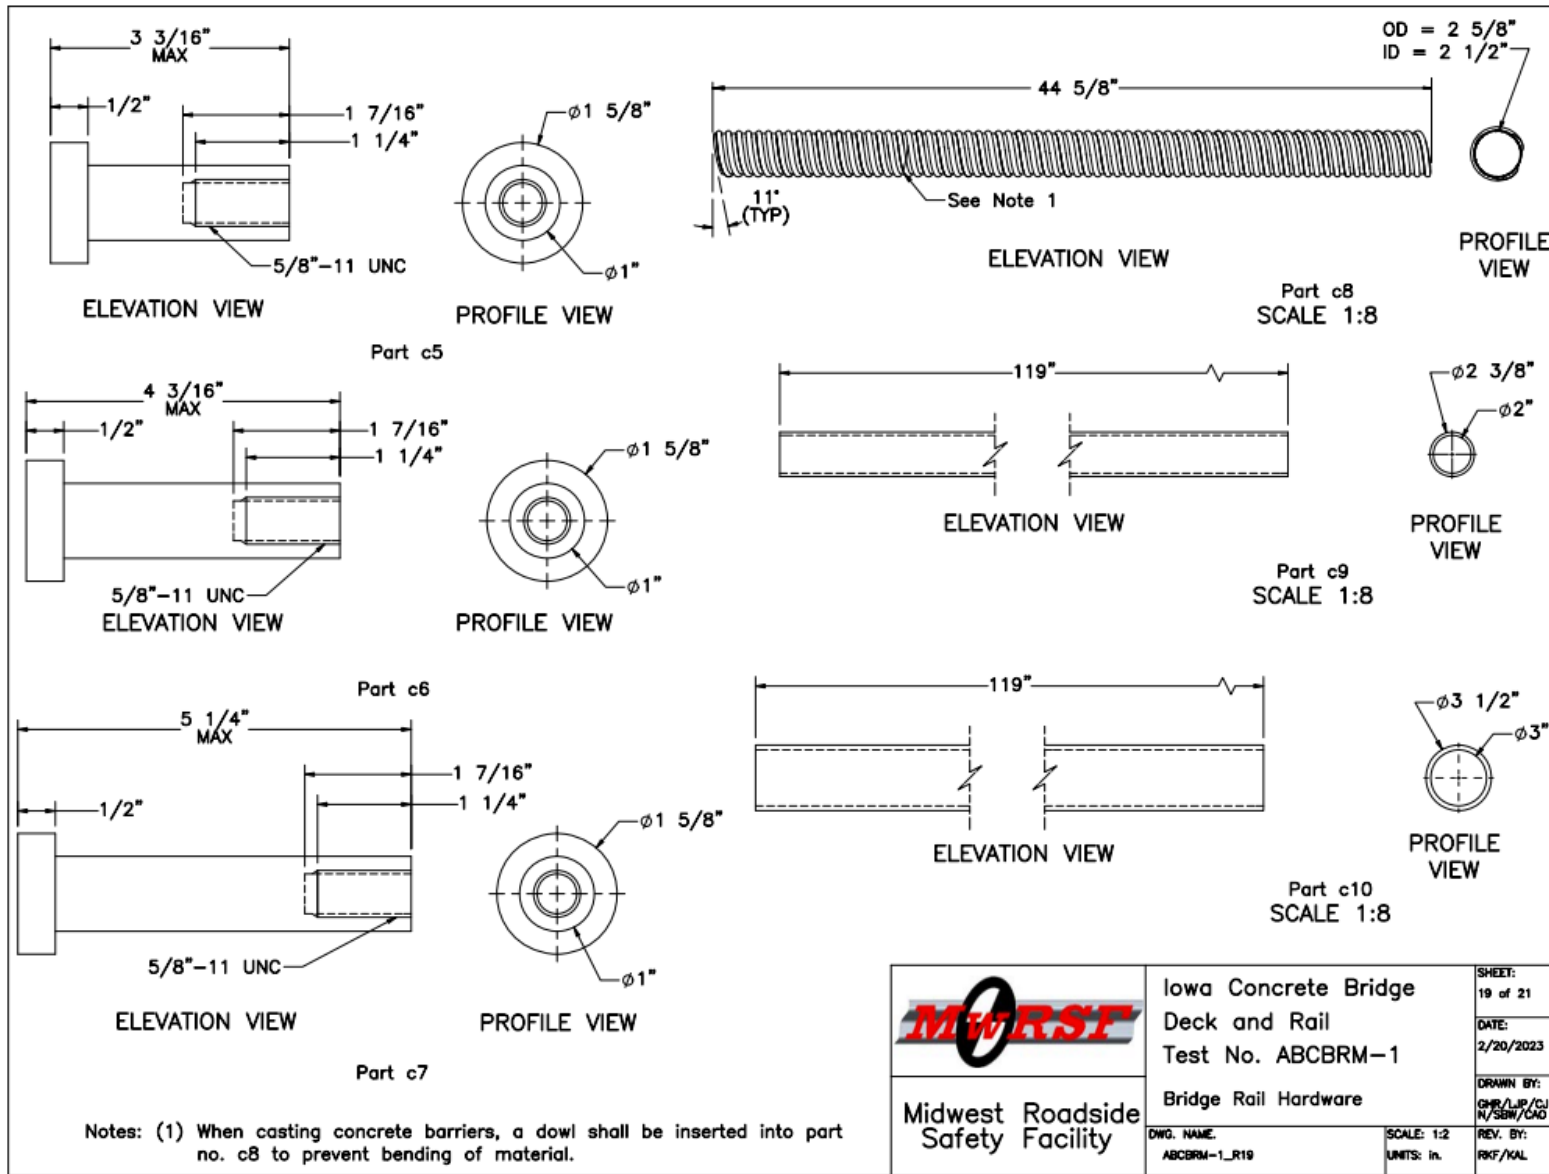
Figure 56. Bridge Rail Hardware, Test No. ABCBRM-1

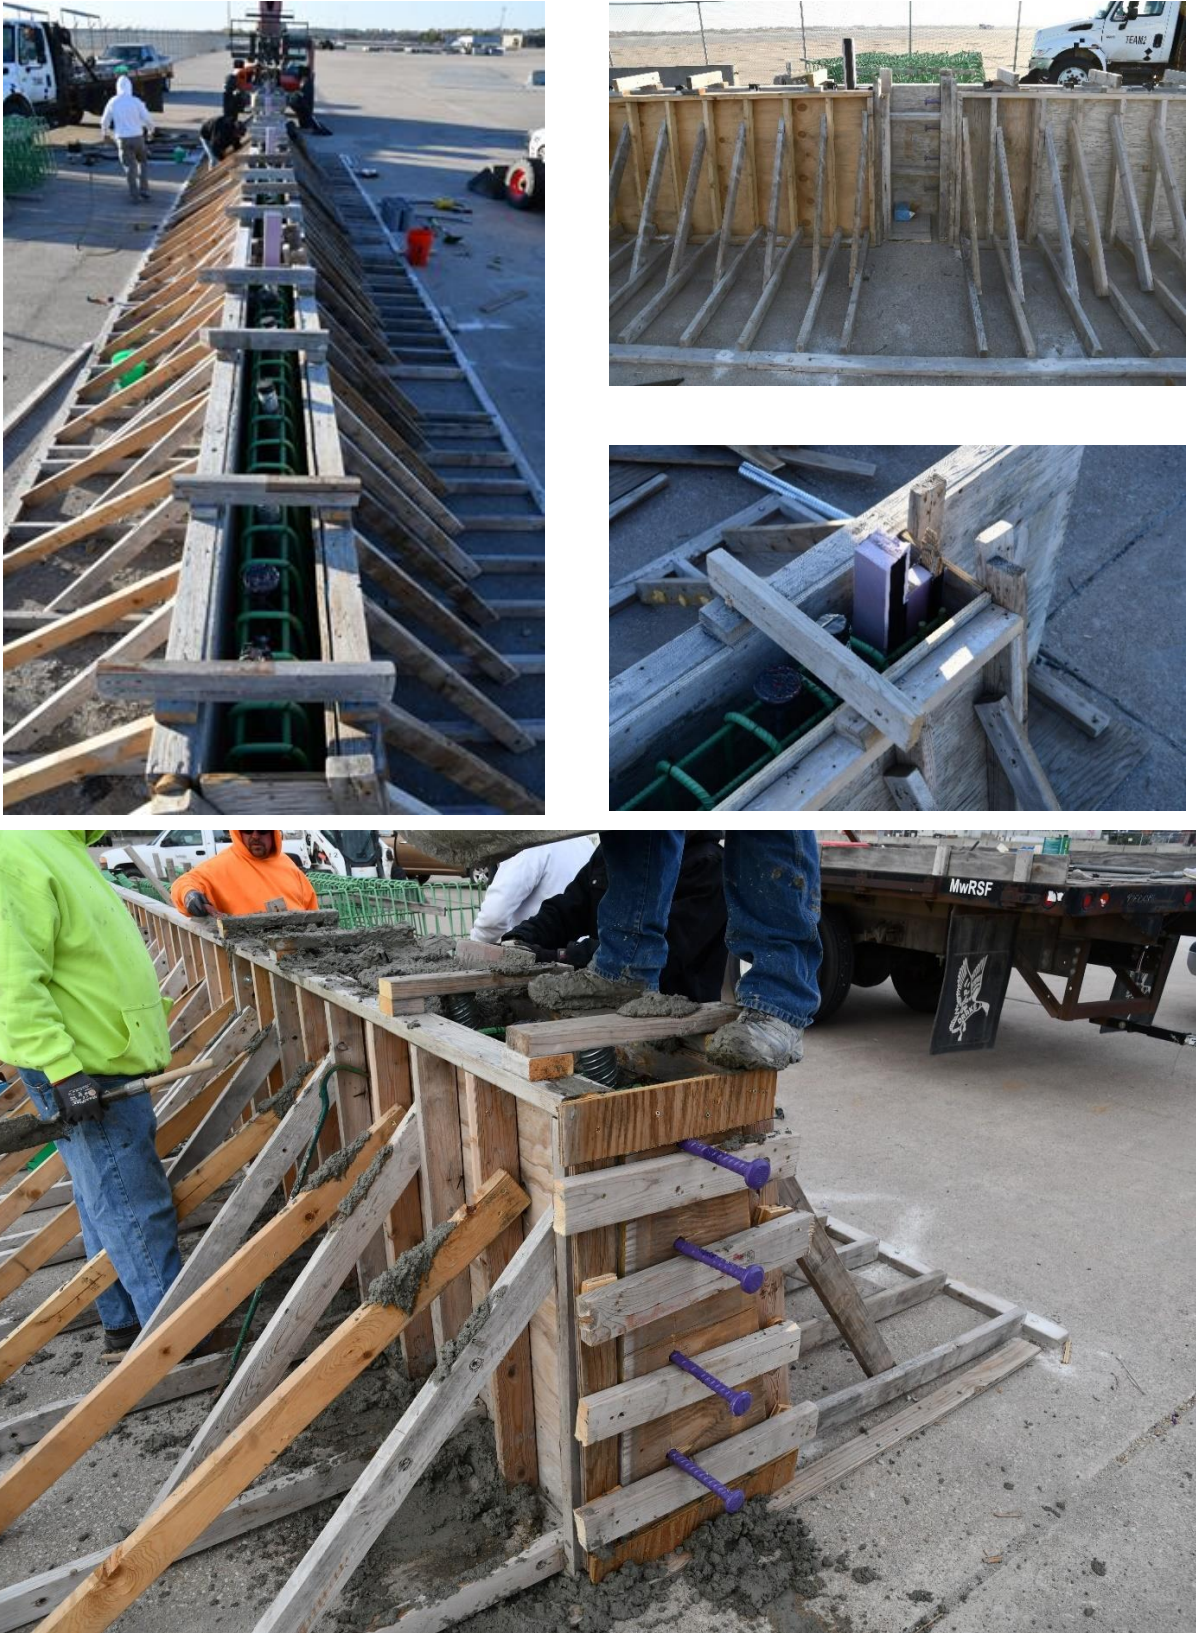
Figure 62. Precast Concrete Barrier Construction Prior to and During Concrete Casting

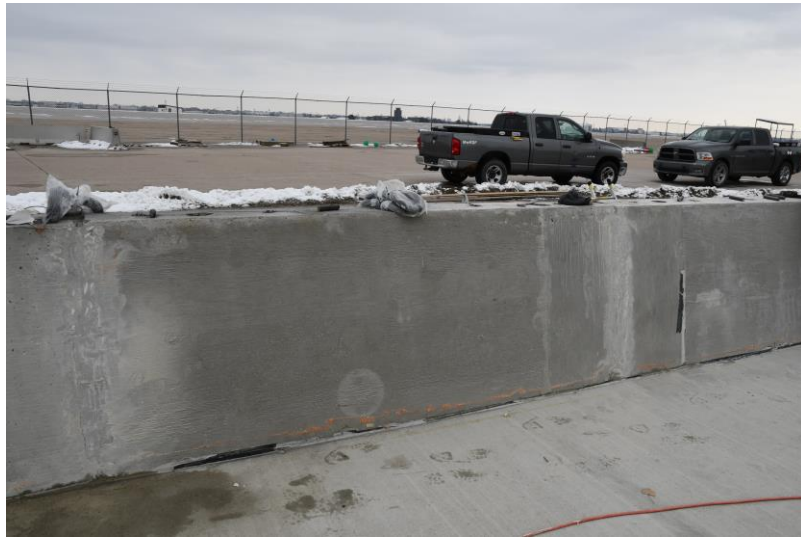
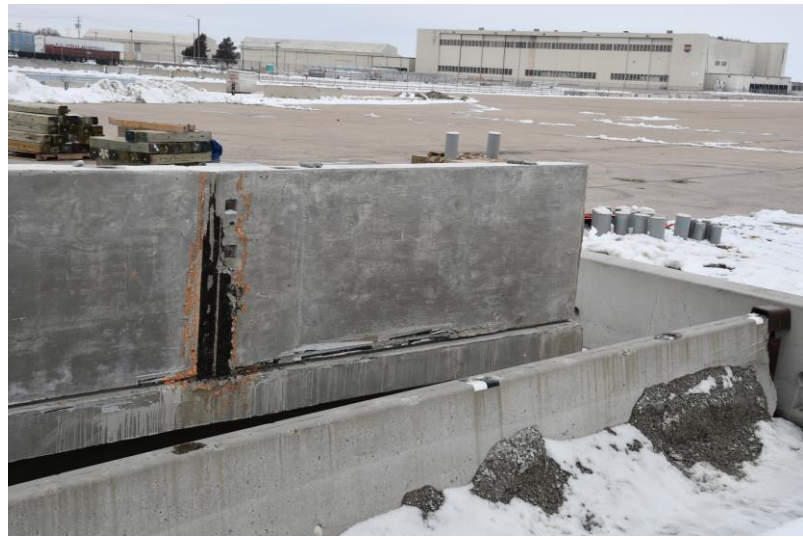
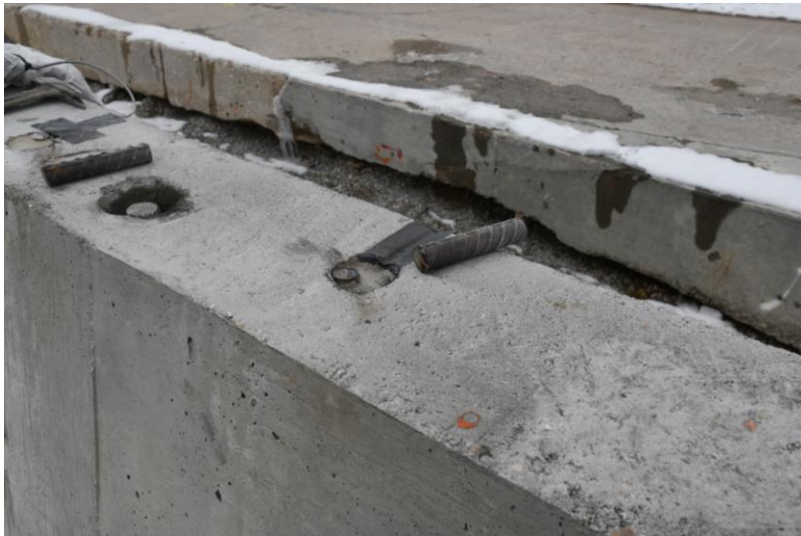
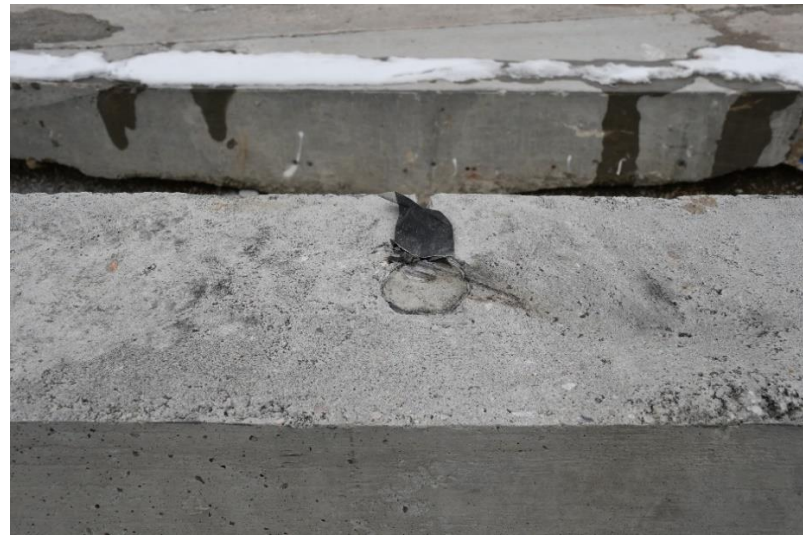
Figure 71. Inclined Bars After Grout Application

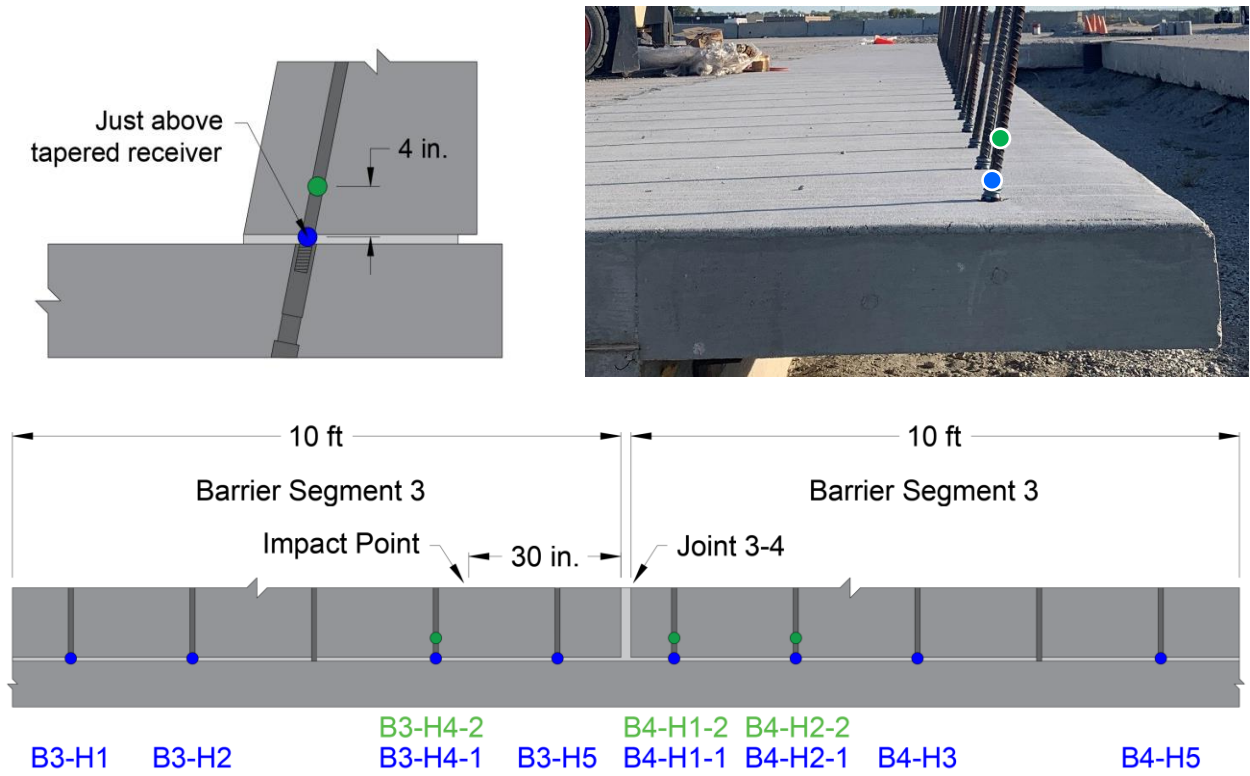
Figure 78. Inclined Bar Strain Gauge Locations

Strain gauges were applied to inclined bars in barrier segments 3 and 4, as shown in Figure 78. Eight strain gauges were installed near the deck surface, just above the tapered receiver welded to the bottom edge of the inclined bars. Three additional strain gauges were installed 4 in. above the lower strain gauges.

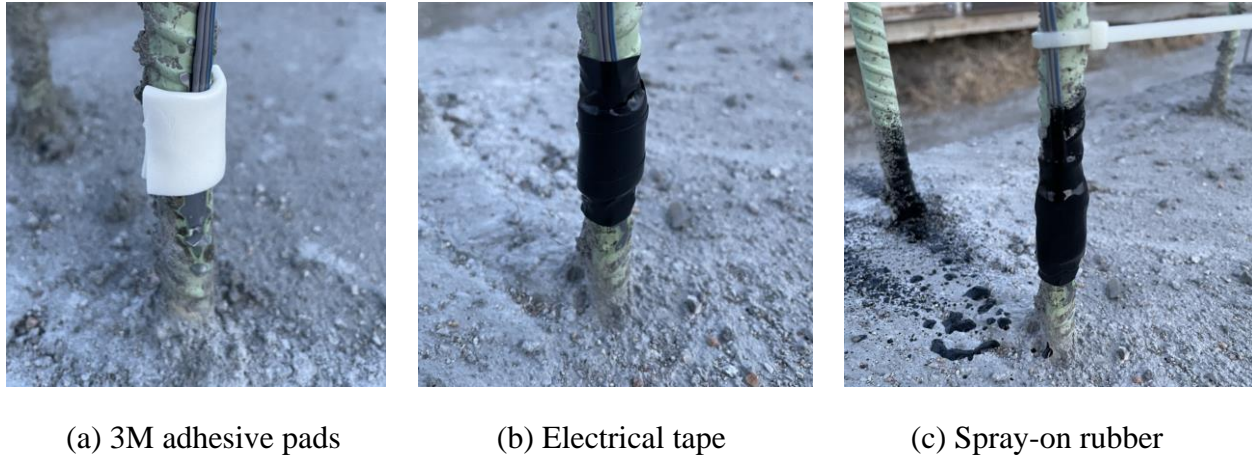
Figure 79. Strain Gauge Protection System

Strain gauges were installed using the methodology and products recommended by Micro-Measurements for application to steel rebar. First, bar ribs were removed, and the resulting flat surfaces were smoothed using a die grinder. Then, 36-grit pads were used to remove bar ribs, 100-grit pads were used to flatten the resulting surface, and 3M 7480 and 7515 pads were used to further smooth the surfaces. The surfaces were then prepared using CSM-5 degreaser, MCA acid conditioner, and MN5A neutralizer. Gauges were applied using Micro-Measurements M-Bond 200 adhesive and catalyst.

Basic moisture protection was provided by applying M-Coat A polyurethane over the adhered strain gauges. A generic system was used to provide mechanical and further moisture protection. First, 3M adhesive pads were placed over the strain gauge and exposed lead wires. Then, the adhesive pads and surrounding areas were wrapped in electrical tape, and the entire regions are sealed with FlexSeal sprayable rubber coating. Application steps for this generic protection system are shown in Figure 79. It should be noted that the photograph in Figure 79 were taken from a different system. However, the procedure used for the system tested herein was identical. A generic protection system was used in lieu of proprietary systems sold by TML and Micro-Measurements due to material unavailability.

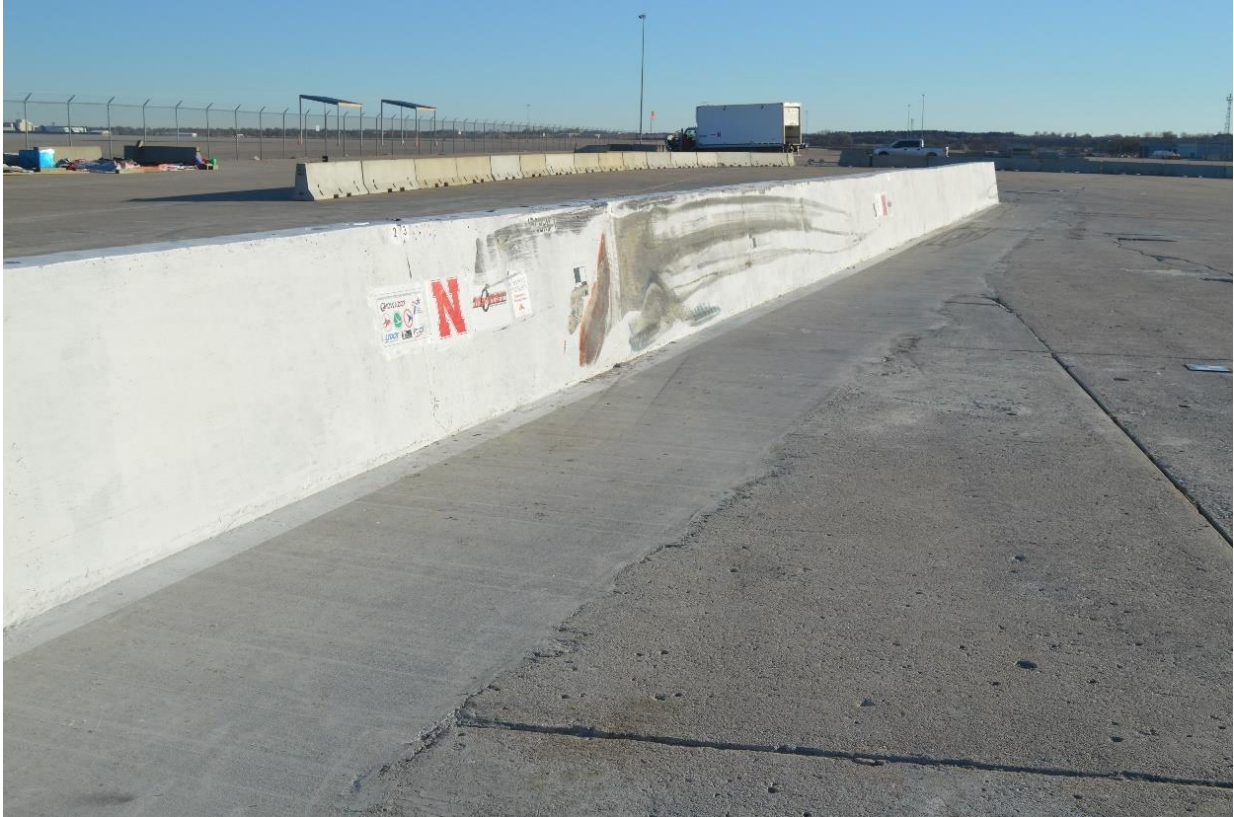
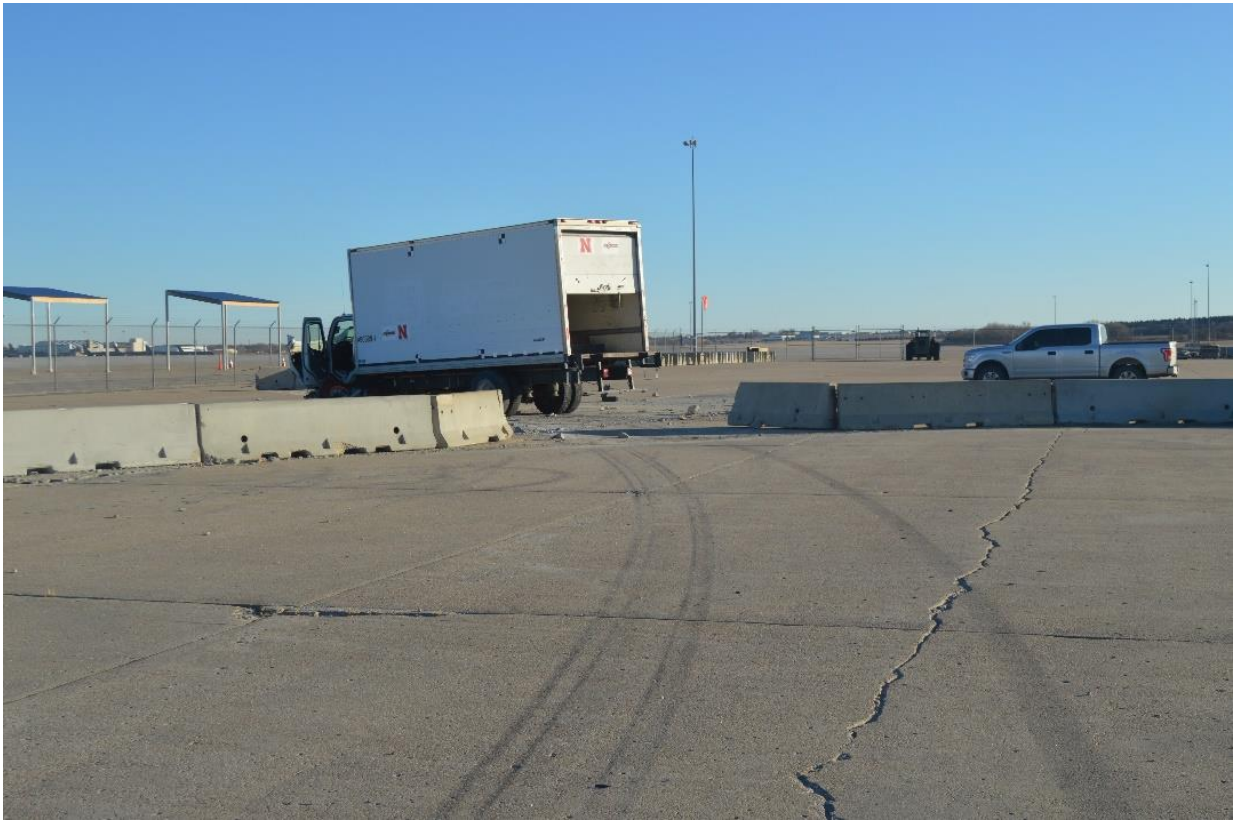
Figure 88. Vehicle Final Position and Trajectory Marks, Test No. ABCBRM-1
