Research Project Number TPF-5(367)

INVESTIGATION, CRASH TESTING, AND EVALUATION OF A MASH TL-4 PRECAST CONCRETE BRIDGE RAIL

MIDWEST ROADSIDE SAFETY FACILITY

MwRSF Research Report No. TRP-03-476-24

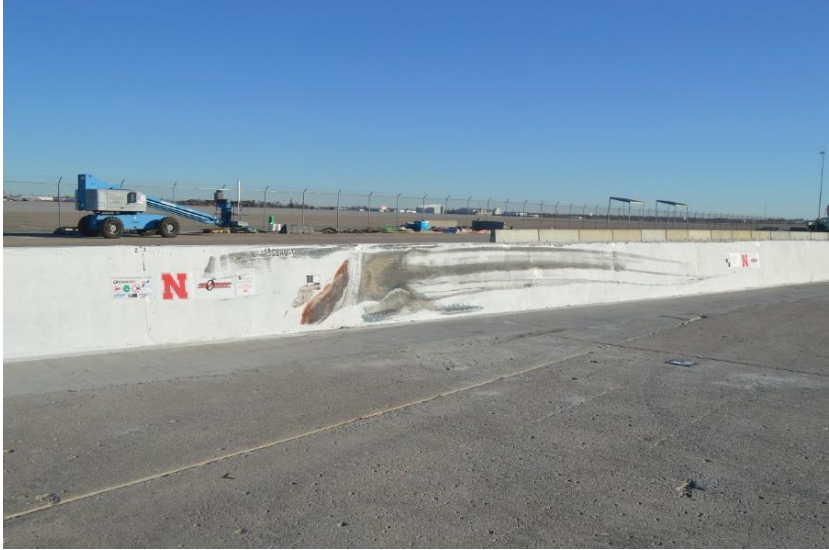
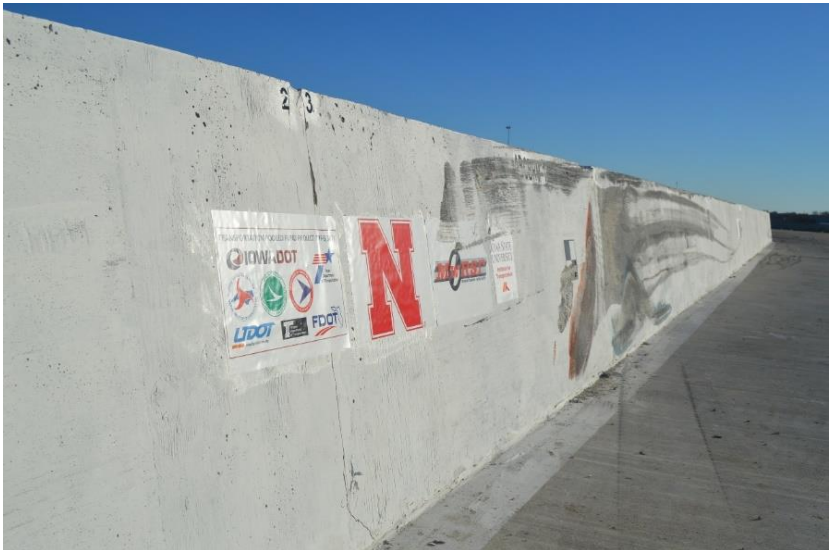
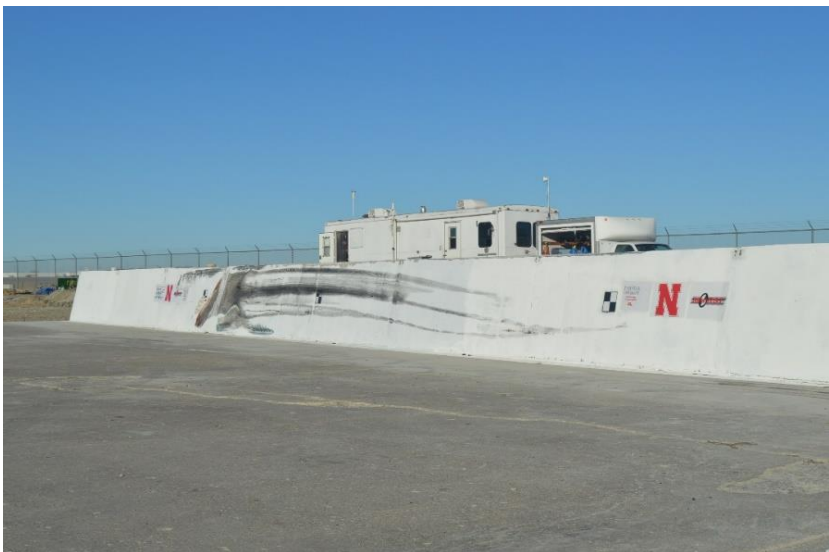
Figure 89. Overall System Damage, Test No. ABCBRM-1

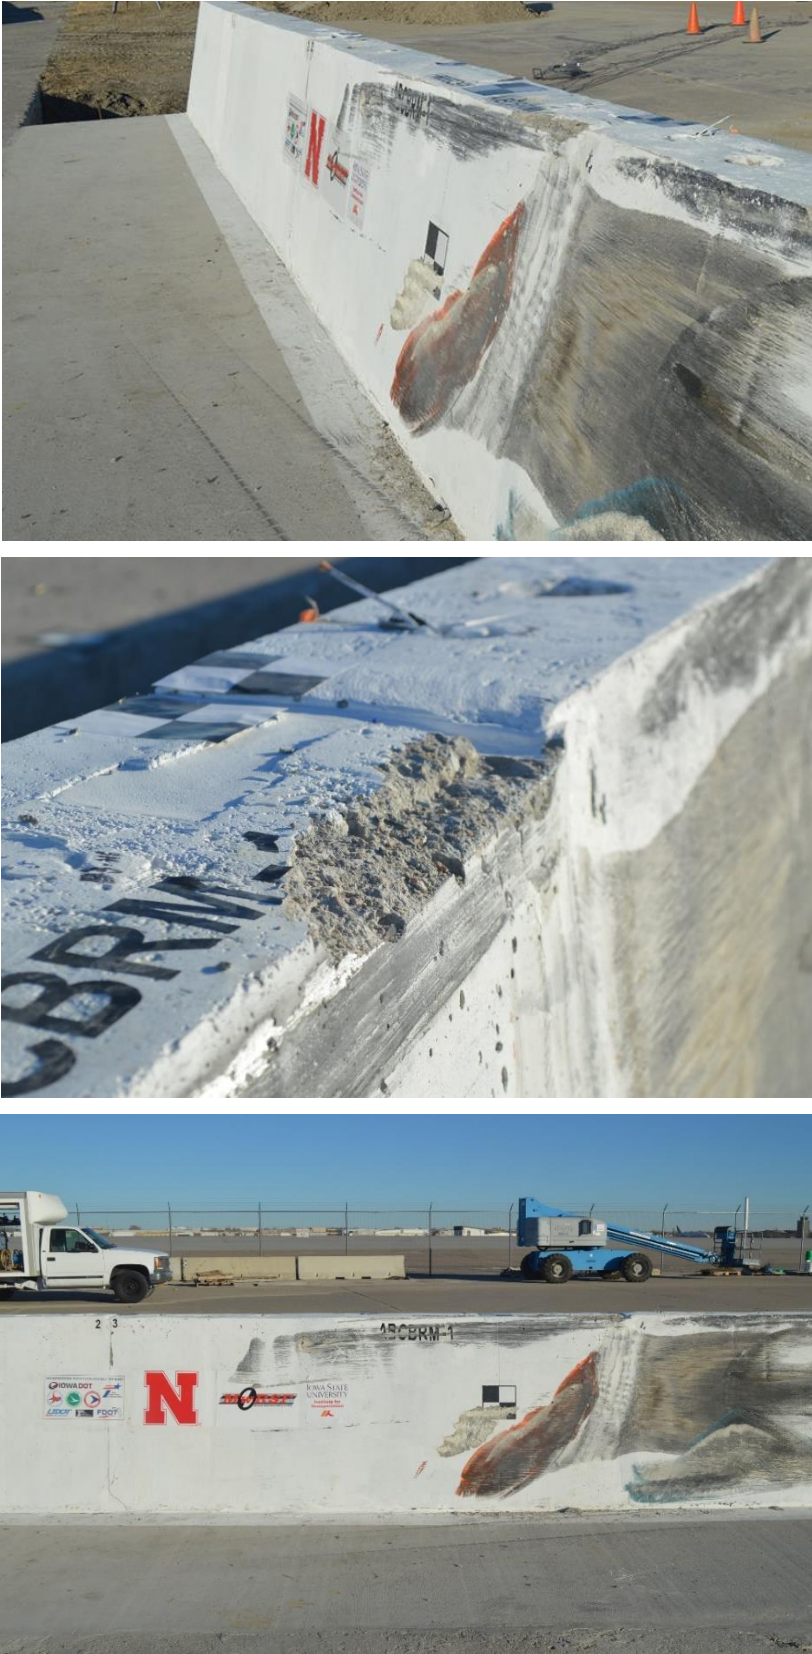
Figure 90. System Damage, Downstream Gouge Details, Test No. ABCBRM-1

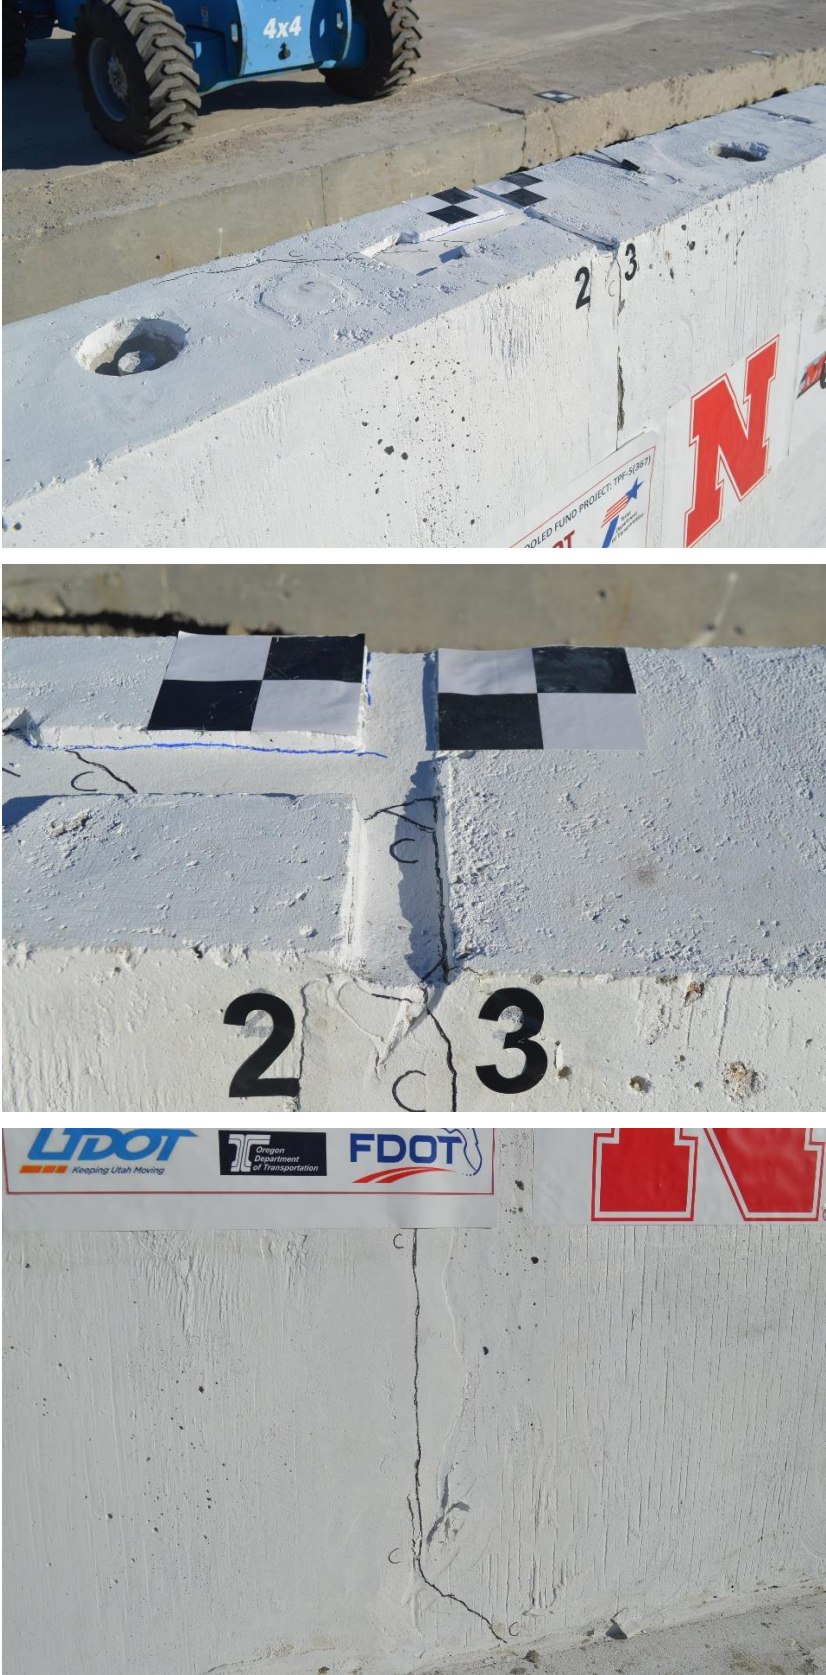
Figure 91. System Damage, Barrier Segment Nos. 2 and 3, Test No. ABCBRM-1

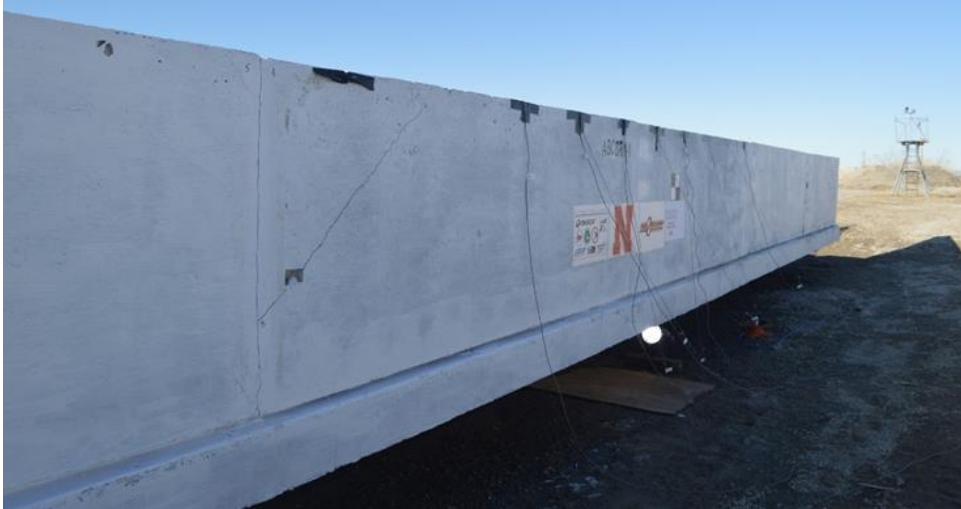
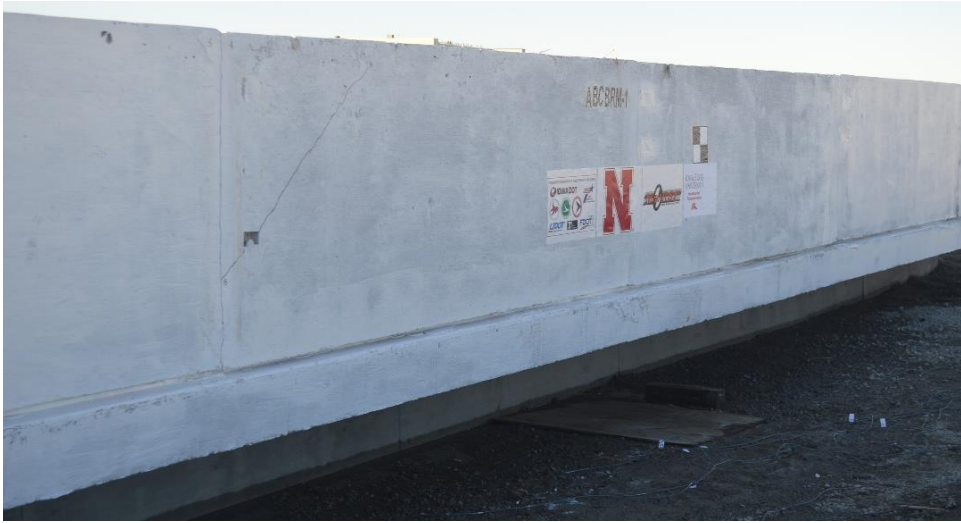
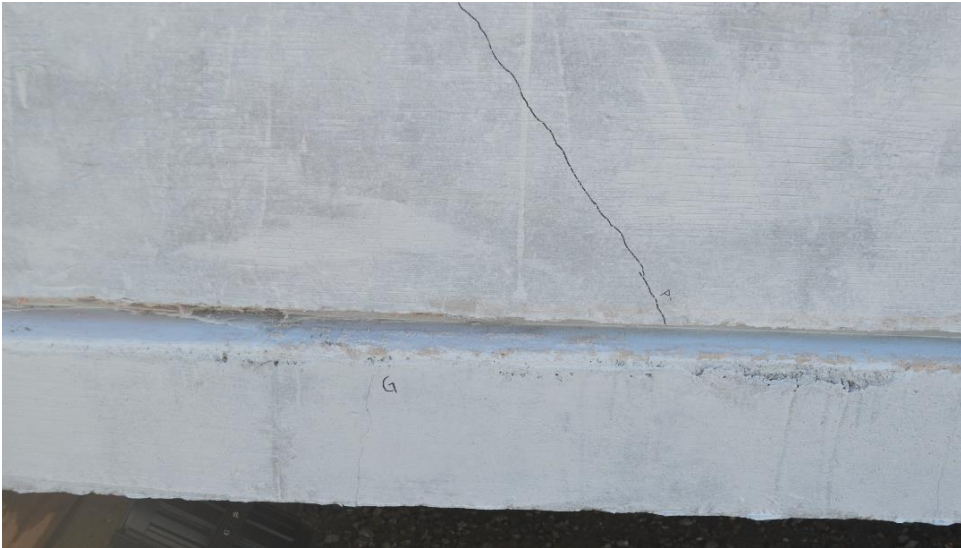
Figure 92. System Damage, Backside of Bridge Rail, Test No. ABCBRM-1

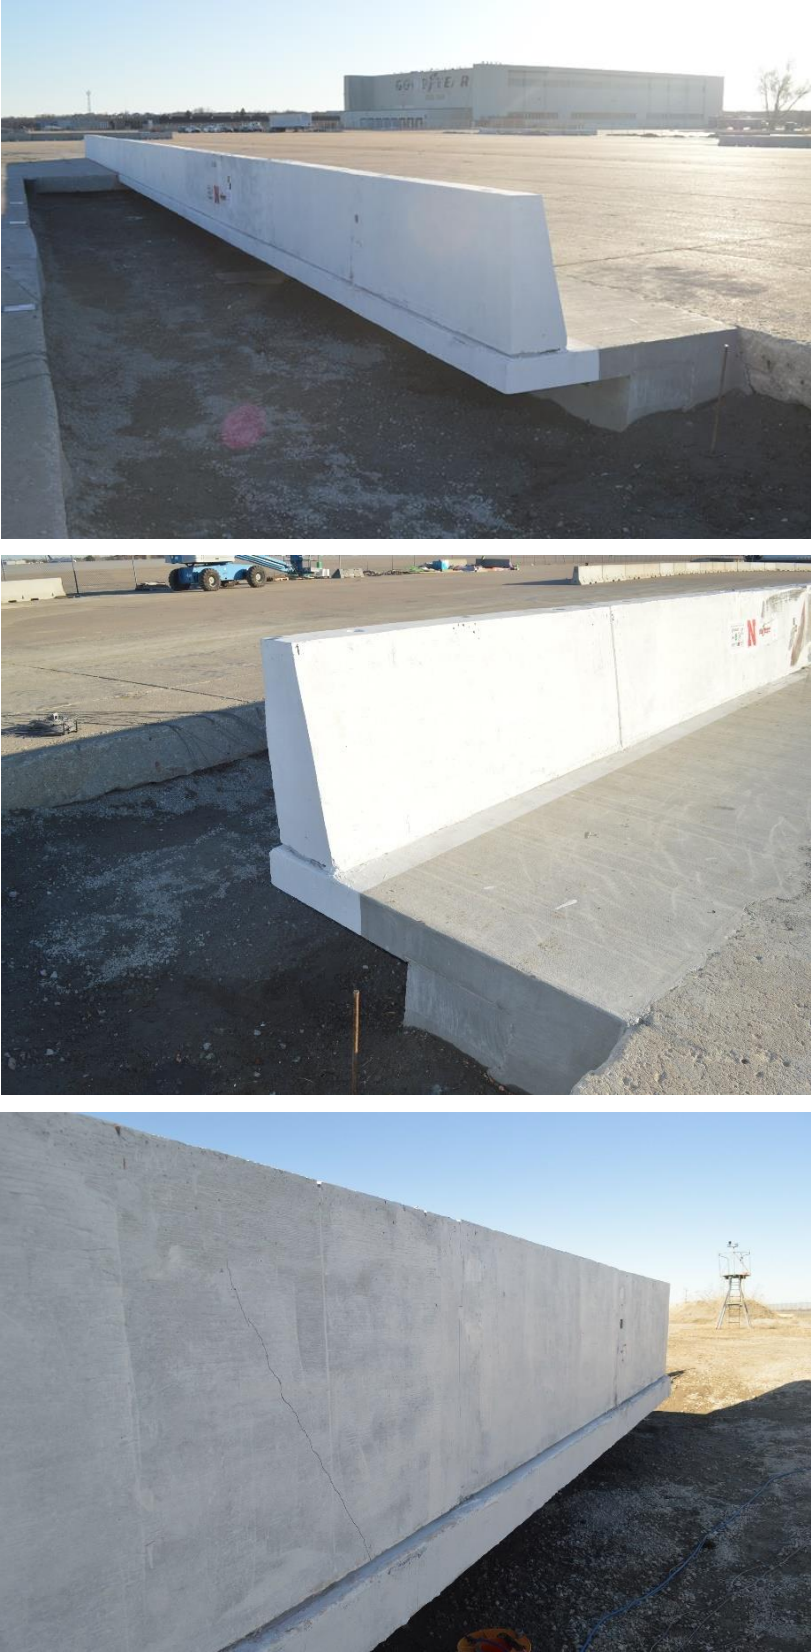
Figure 93. Deck Damage, Test No. ABCBRM-1

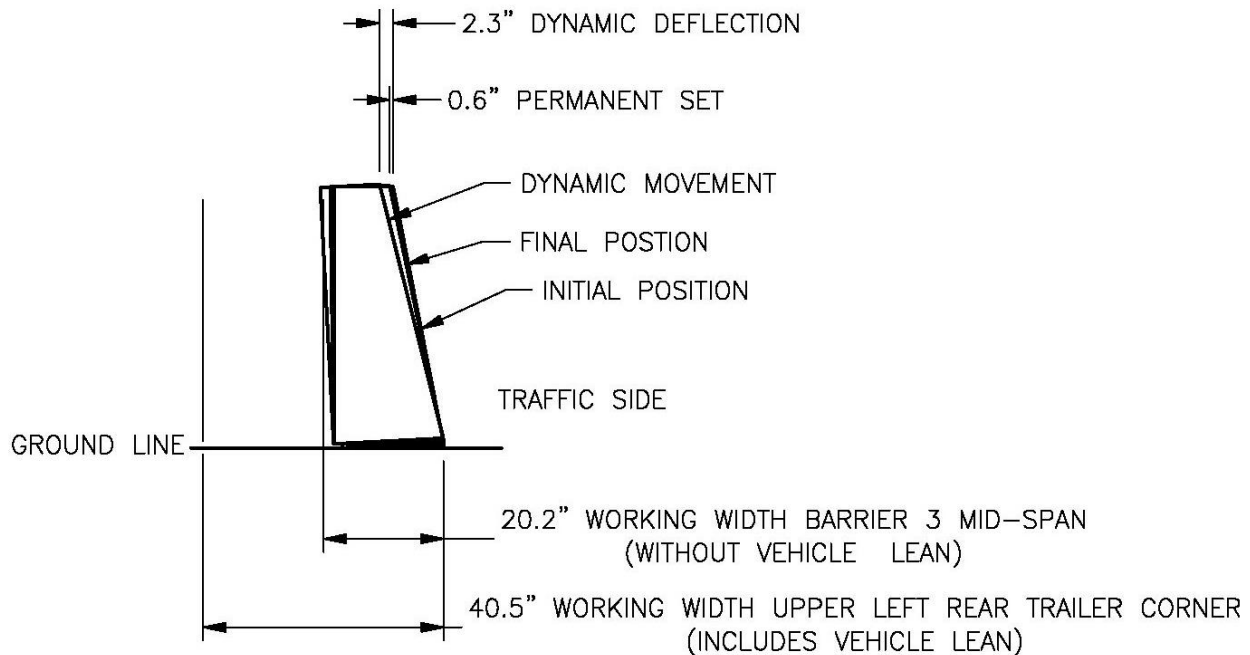
Figure 94. Permanent Set, Dynamic Deflection, and Working Width, Test No. ABCBRM-1

The maximum lateral dynamic barrier deflection, including deck flexure, was measured to be 2.3 in. This deformation occurred 7 ft – 6 in. (i.e., mid-span of barrier no. 3) downstream from the point of impact, as determined via high-speed digital video analysis. Post-impact, both the deck overhang and the barrier reverted back to their original positions, indicating a permanent set of 0.6 in. The working width of the system ascertained through high-speed digital video analysis, was determined to be 40.5 in. A schematic detailing the permanent set, dynamic deflection, and working width can be referred to in Figure 94.

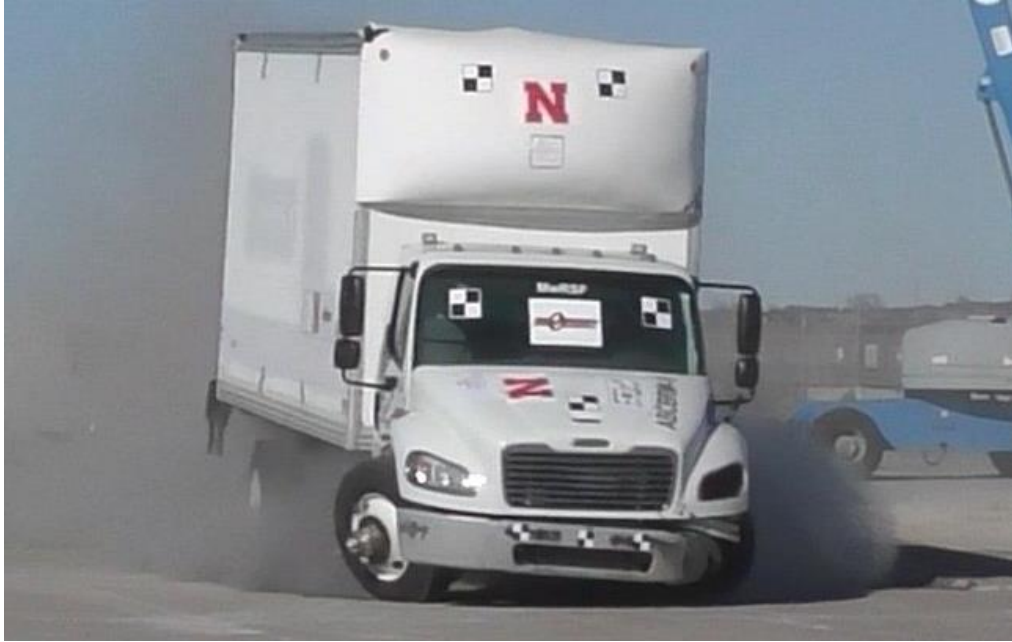
Figure 95. Vehicle Damage after Primary Impact

The primary collision with the precast concrete bridge railing system caused relatively minor damage to the vehicle, predominantly localized to the left-front corner. Deformation and inward indentation characterized the left side of the front bumper. The left fender experienced an upward push and an inward dent. Deformations and gouging were evident on the left-front and left-rear wheel assemblies, including each wheel's steel rim. The rear bumper on the left side showed dents and scuffing. Further, the right-side box door dislodged from its hinges. Figure 95 depicts the damages inflicted on the vehicle during the primary impact with the bridge rail system, showing that the vehicle was able to continue rolling downstream on all wheels.

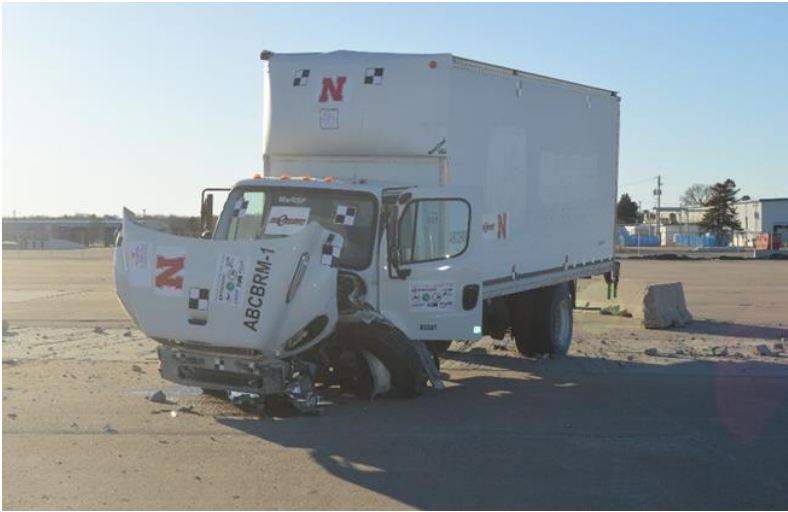
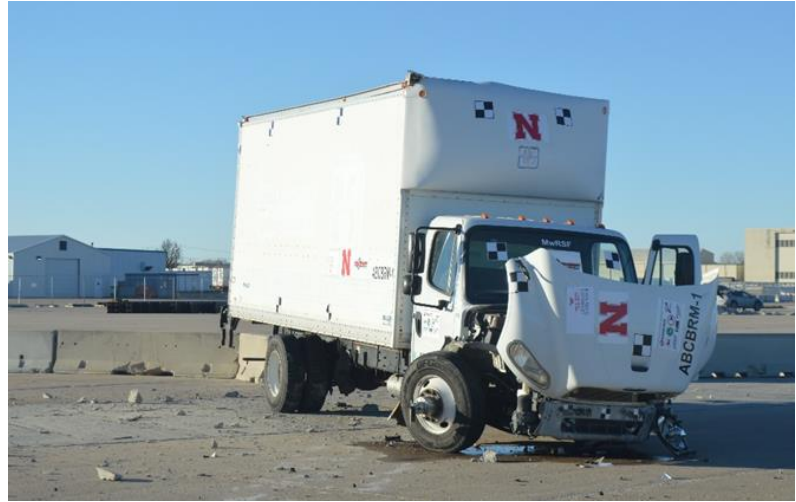
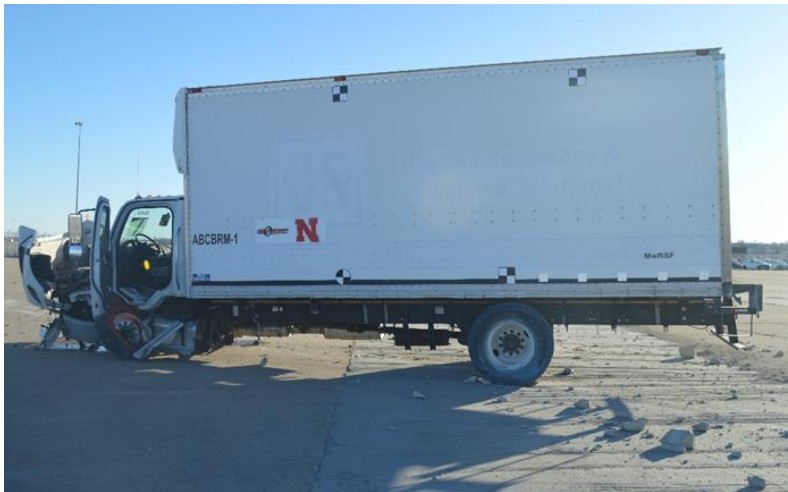
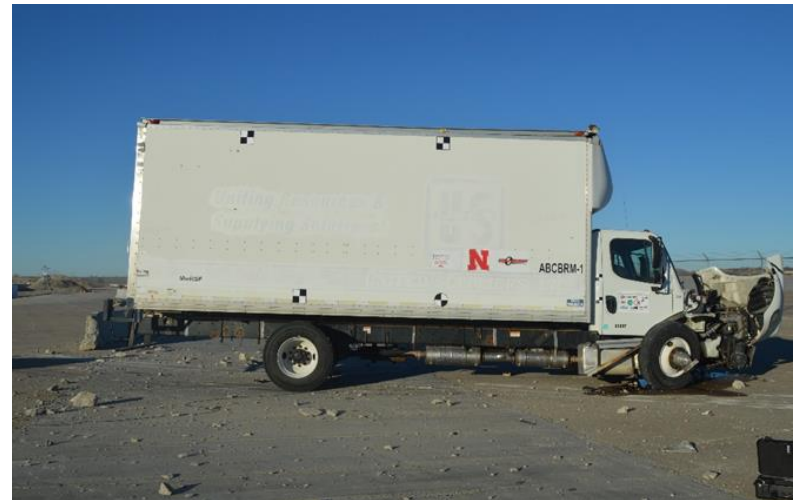
Figure 96. Vehicle Damage, Test No. ABCBRM-1

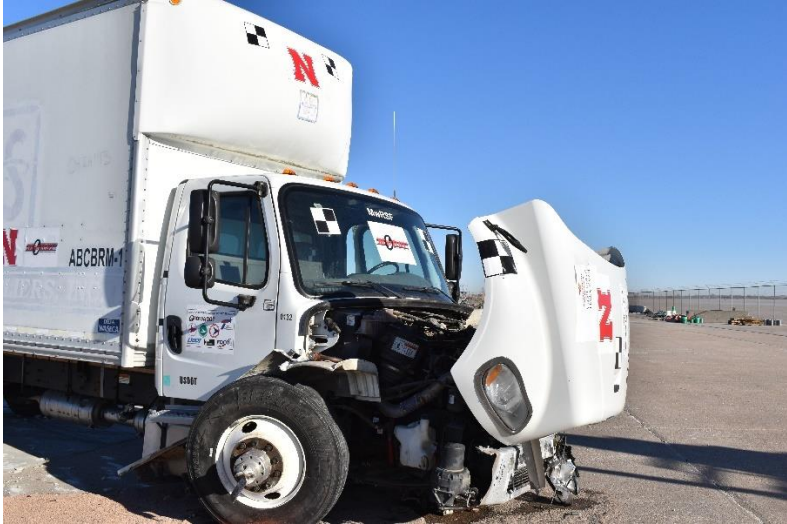
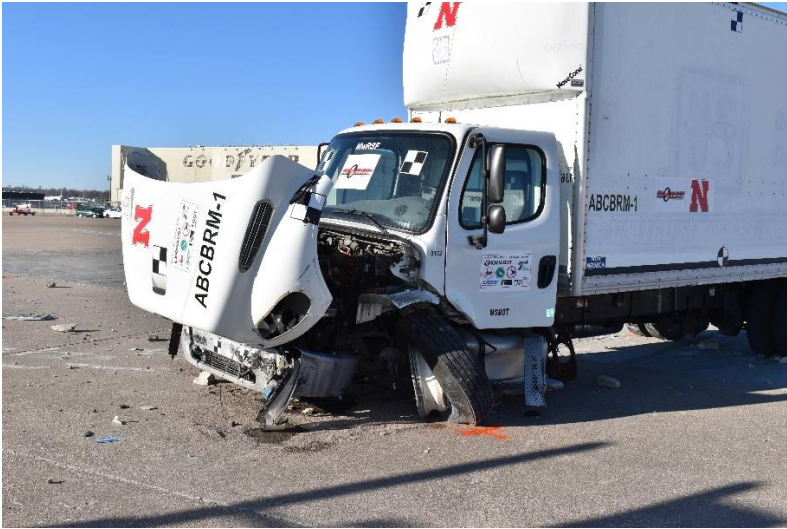
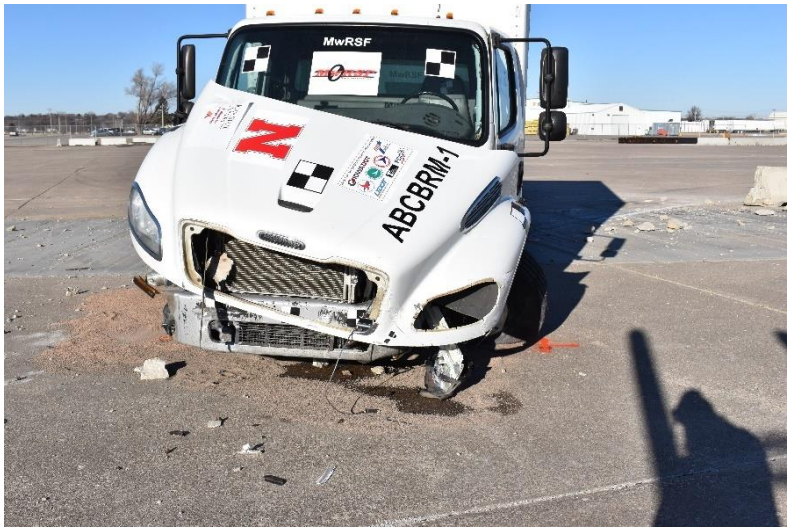
Figure 97. Vehicle Damage – Front End, Test No. ABCBRM-1

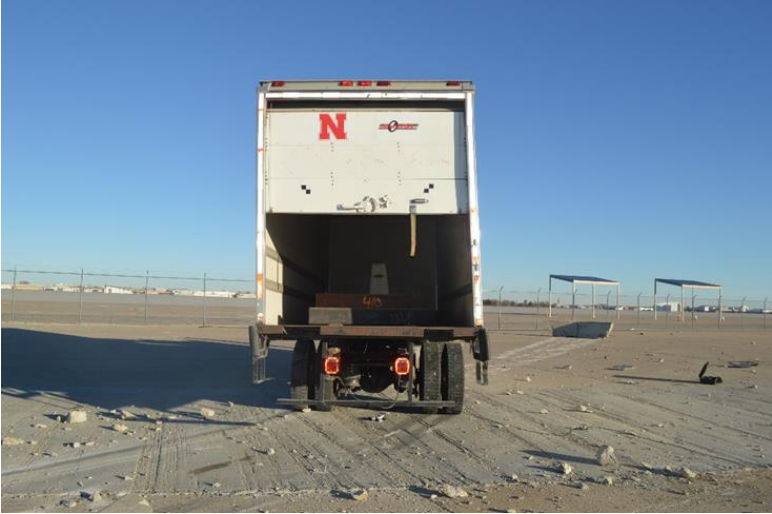
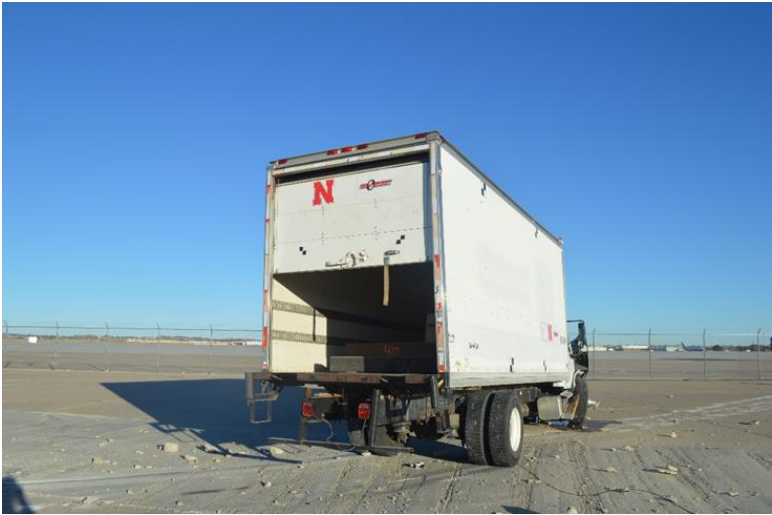
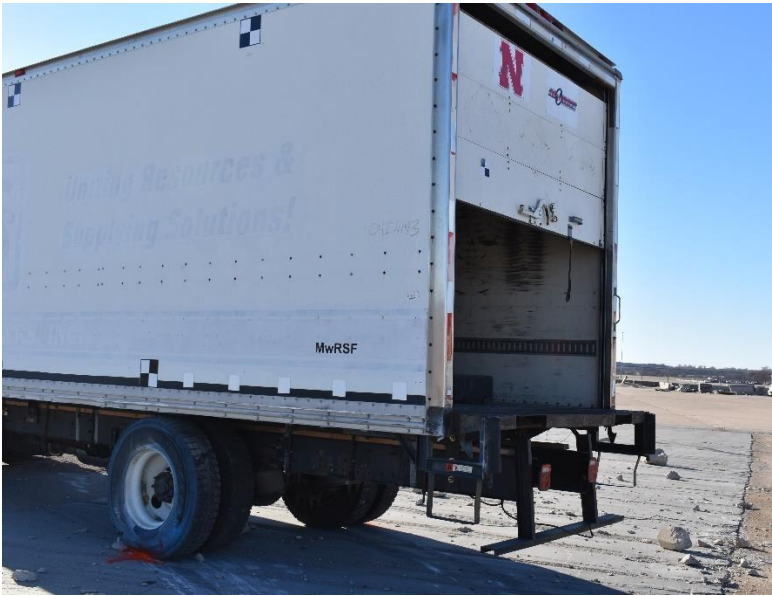
Figure 98. Vehicle Damage – Rear, Test No. ABCBRM-1

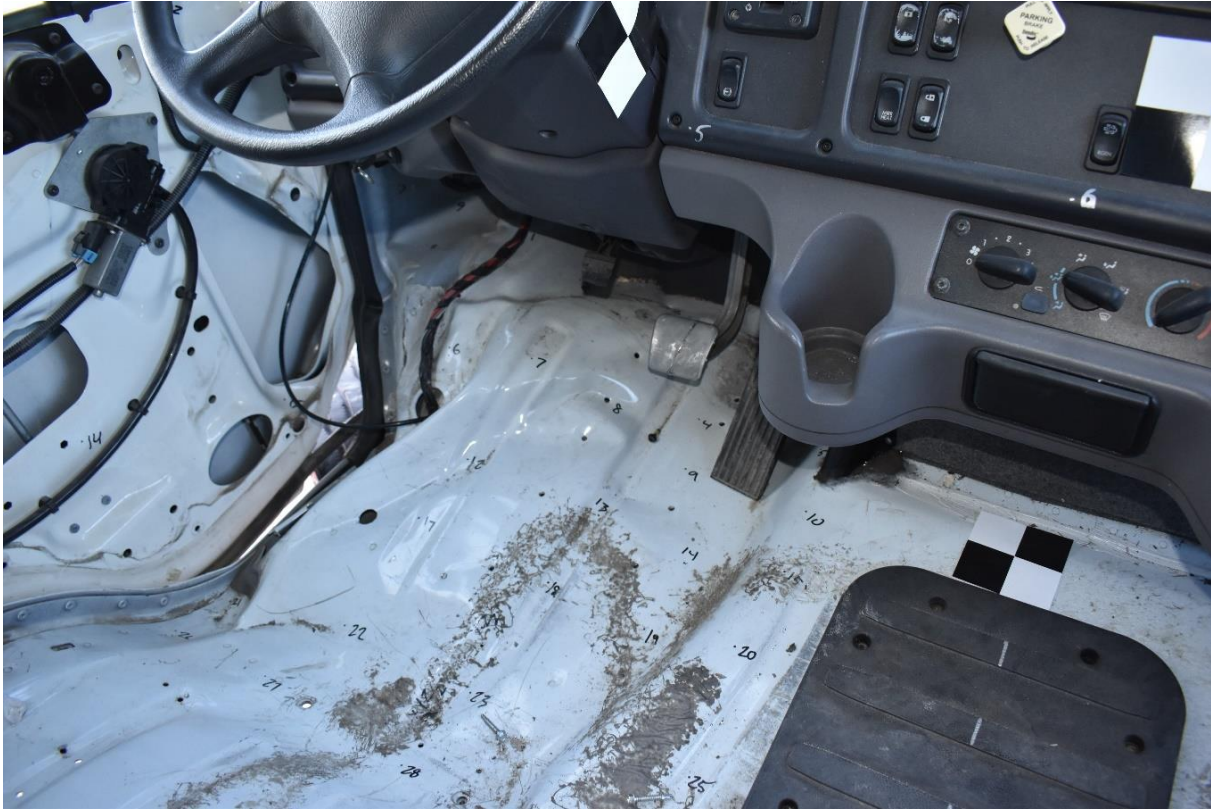
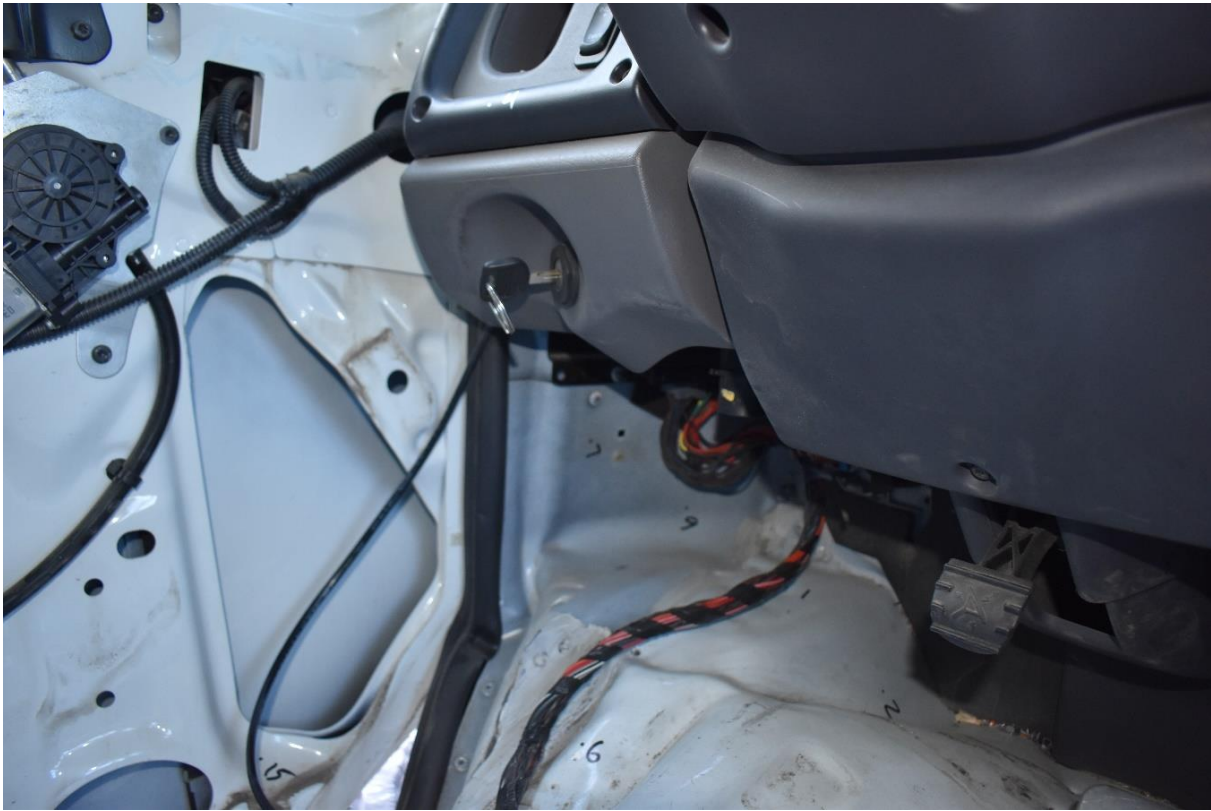
Figure 99. Post-Test Floor Pan Photos, Test No. ABCBRM-1

The floor pan deformation and seam opening near the left-front corner of the floor pan, illustrated in Figure 99, were sustained during the secondary impact as the front axle and wheel were driven backward and under the occupant compartment. As such, this deformation was not included in the safety evaluation of the precast bridge railing system. Thus, in test no. ABCBRM-1, none of the deformation limits set by MASH were exceeded. Outward deformations, represented by negative values in Table 16, do not account for crush toward the occupant and are thus not evaluated by MASH criteria.

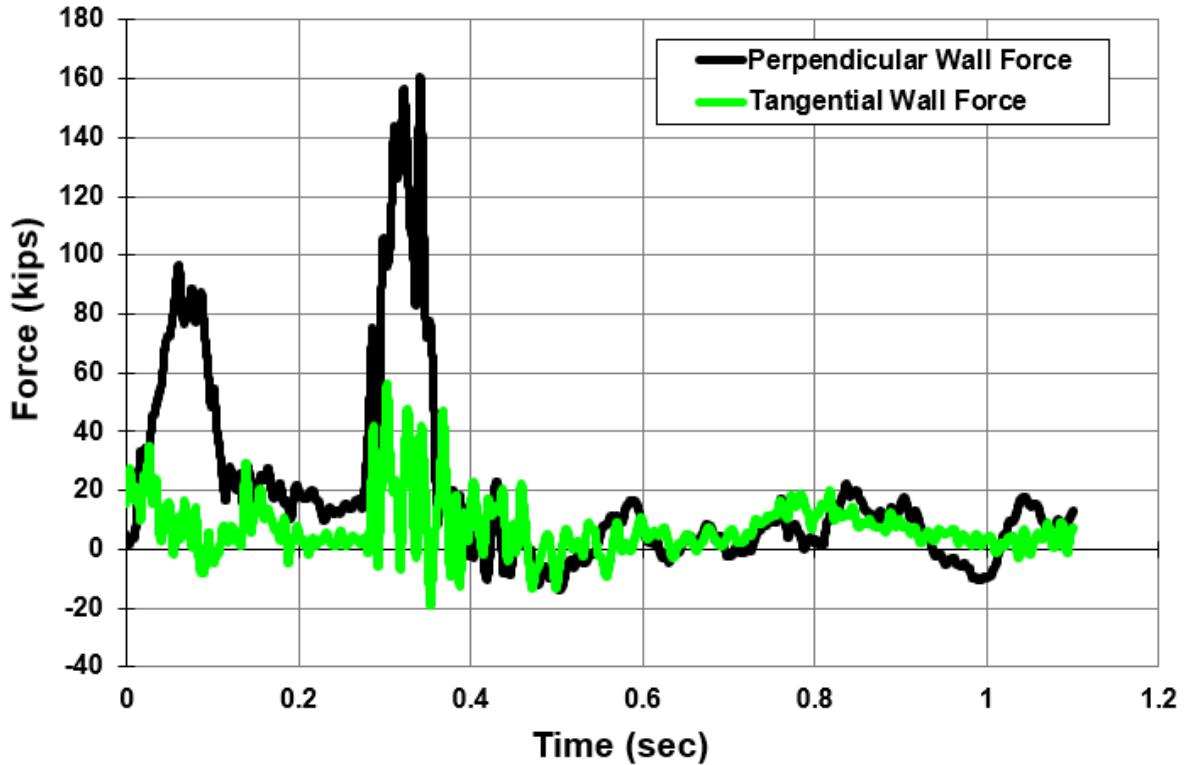
Figure 100. Perpendicular and Tangential Impact Forces, Test No. ABCBRM-1

The SLICE-2 (primary) unit measured a maximum perpendicular (or lateral) impact load of 160.3 kips, applied to the barrier at 0.341 seconds post-impact. A peak frictional load of 55.4 kips was noted at 0.304 seconds after impact. Notably, these recorded impact loads were higher than those typically observed in previous MASH TL-4 crash tests into deformable bridge rails, which often ranged from 95 to 110 kips [29-34]. However, MwRSF researchers recently developed a 36-in. tall, MASH TL-4 optimized near-vertical, concrete bridge rail for the Midwest Pooled Fund Program, suited for an 8-in. thick reinforced concrete deck. That test demonstrated a maximum lateral impact load of 153 kips on the barrier, 0.275 seconds post-impact, as recorded by the SLICE-2 unit [33].

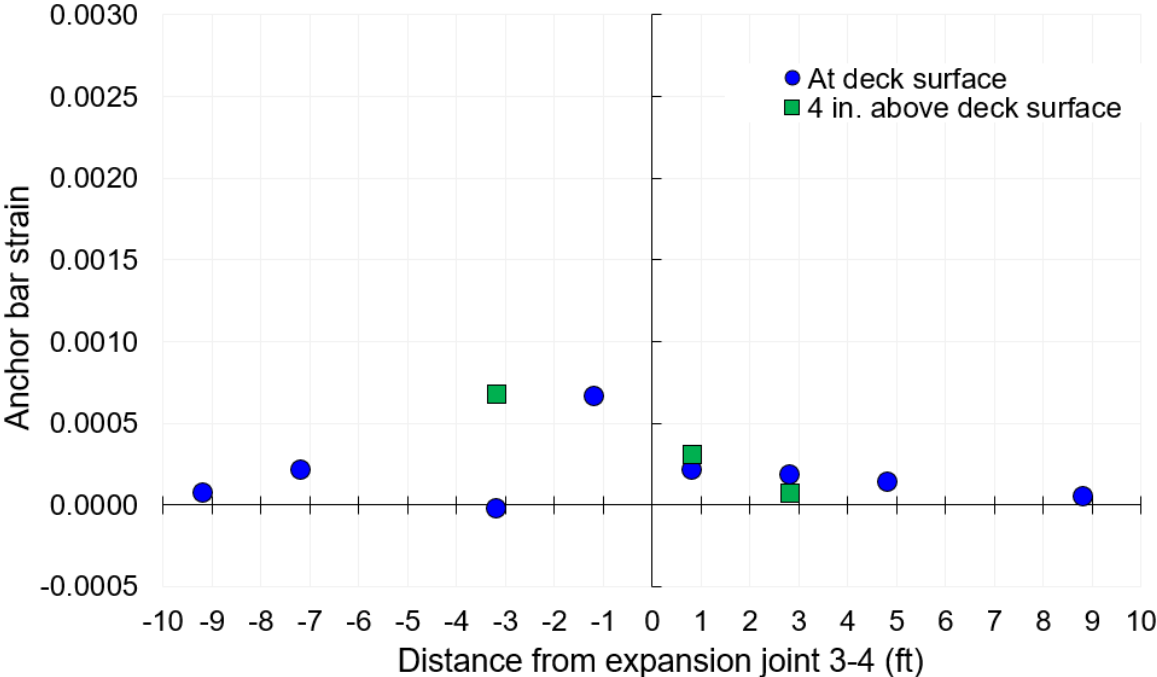
Figure 102. Inclined Anchor Bar Strains at Peak Cab Impact Load (43 ms)

The as-tested inclined bar yield stress, as indicated by mill certifications, was 87.3 ksi. Assuming an elastic modulus of 29,000 ksi, the as-tested yield strain was 3,010 $\mu\epsilon$. Therefore, the strain gauge data collected during the crash test suggests that none of the inclined bars were strained beyond their yield point. This result is consistent with the minimal lateral deflection measured during the test, as well as the minor concrete damage observed after the test, which was superficial and limited to hairline cracking.

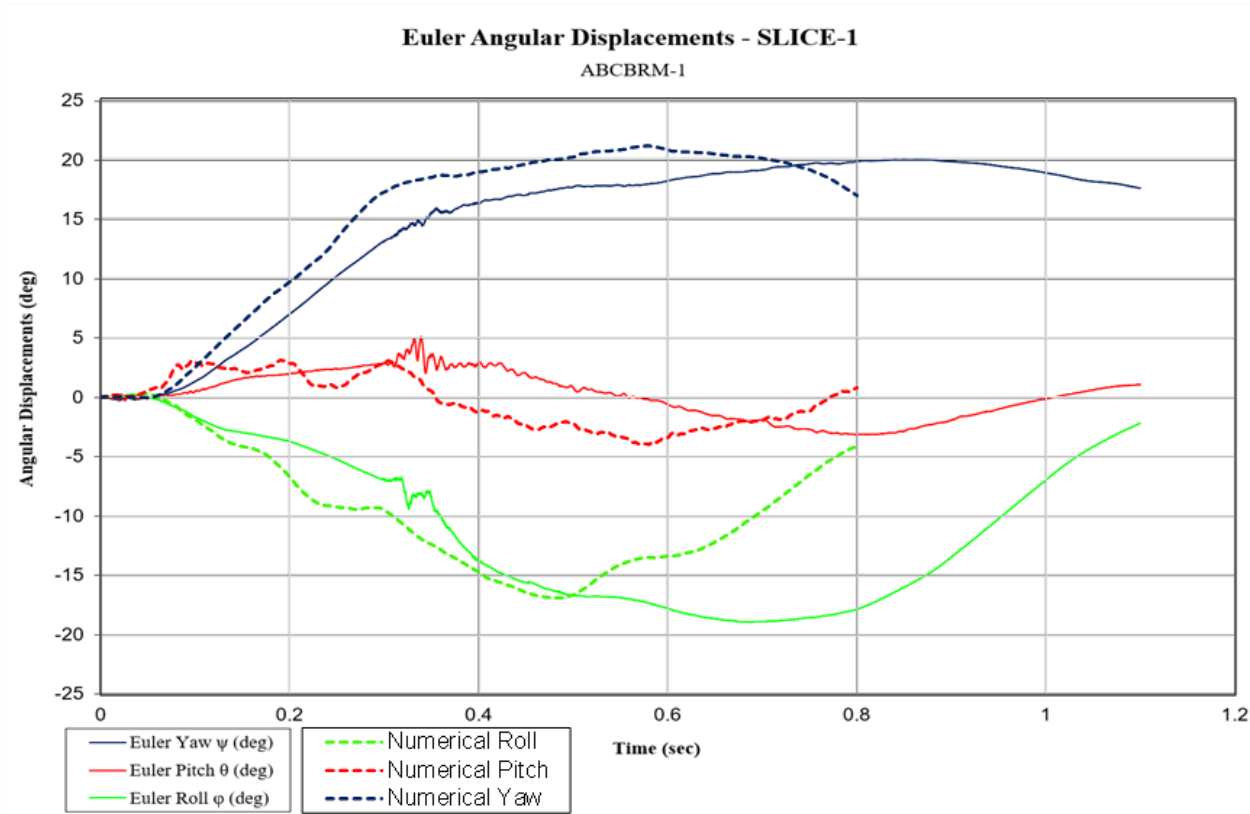
Figure 105. Angular Displacements of the Vehicle from LS-DYNA Simulation and Physical Testing

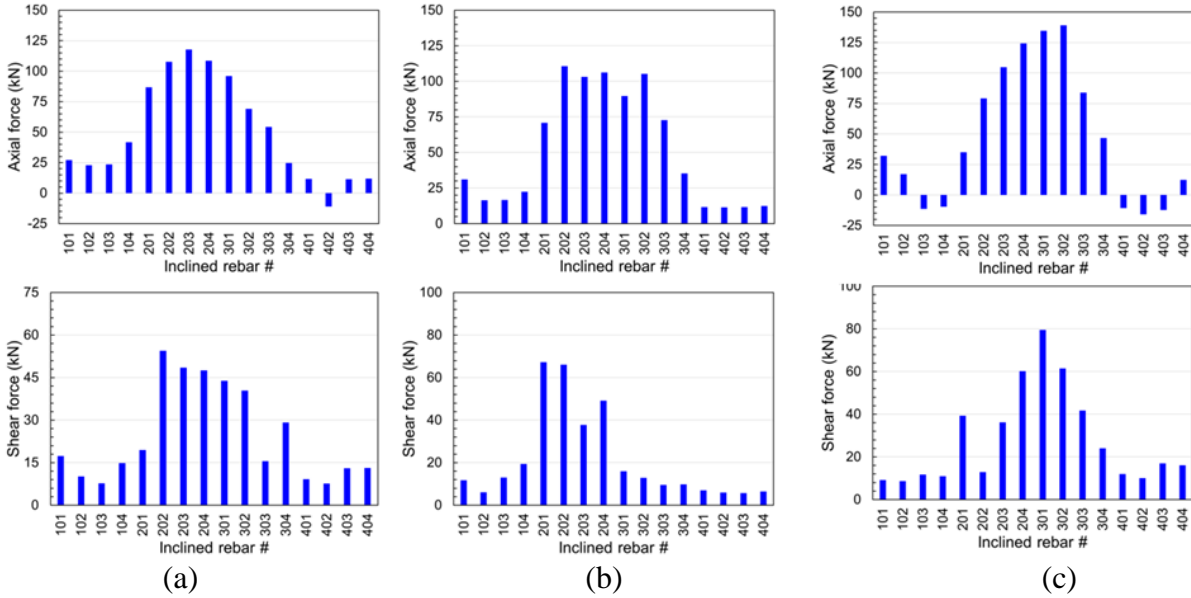
Figure A-1. Maximum Axial and Shear Forces in Inclined Rebars, 1000C Vehicle Impact with Single-Slope Barrier (SSB): (a) Impact at Mid-Span; (b) Impact at 3.6 ft Upstream of Joint; and (c) Impact at Joint

The recorded maximum axial and shear forces observed in inclined bars within the single-slope and near-vertical barriers are provided in this appendix. The plots depict the maximum observed forces regardless of time.

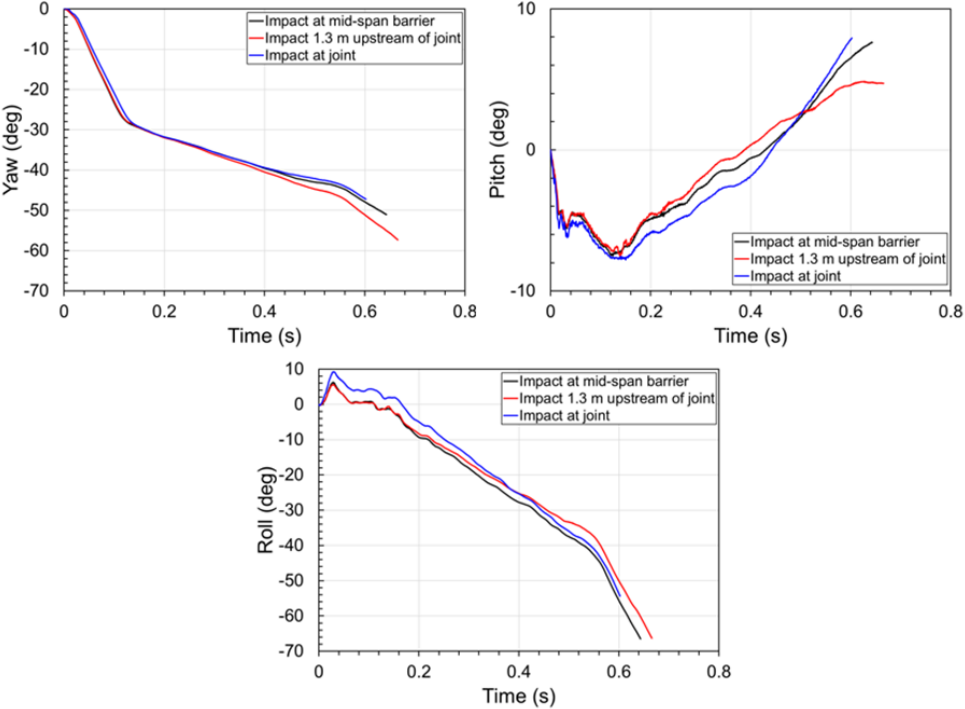
Figure B-1. Angular Displacement-Time History and Recommended Vehicle Coordination System (SSB: 1100C)

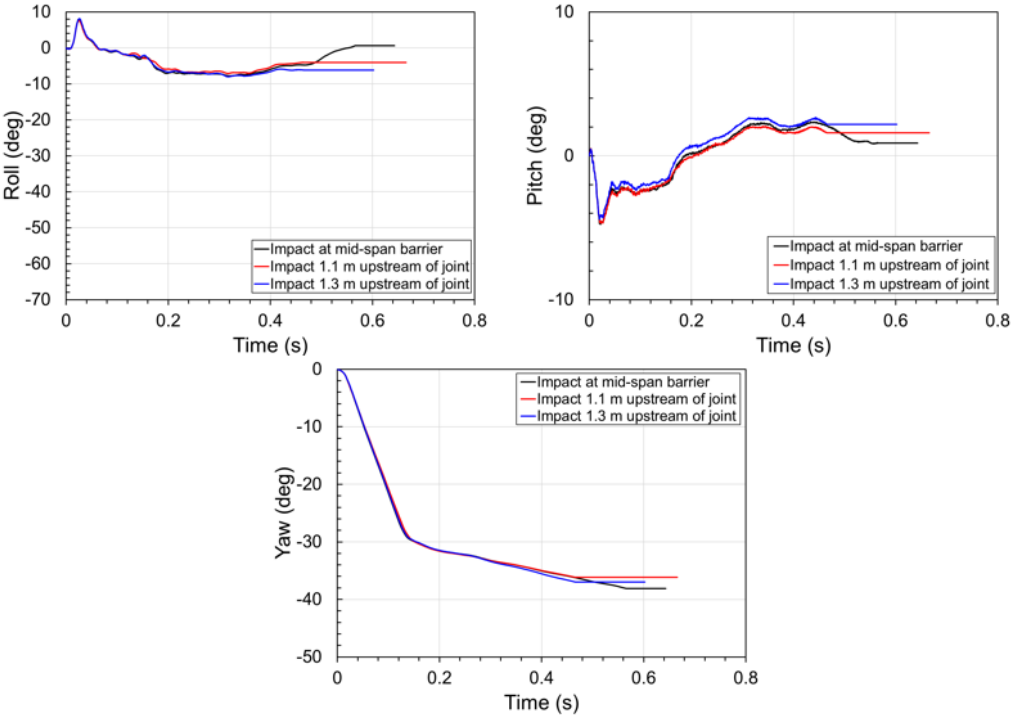
Figure B-2. Angular Displacement-Time History and Recommended Vehicle Coordination System (NVB: 1100C)

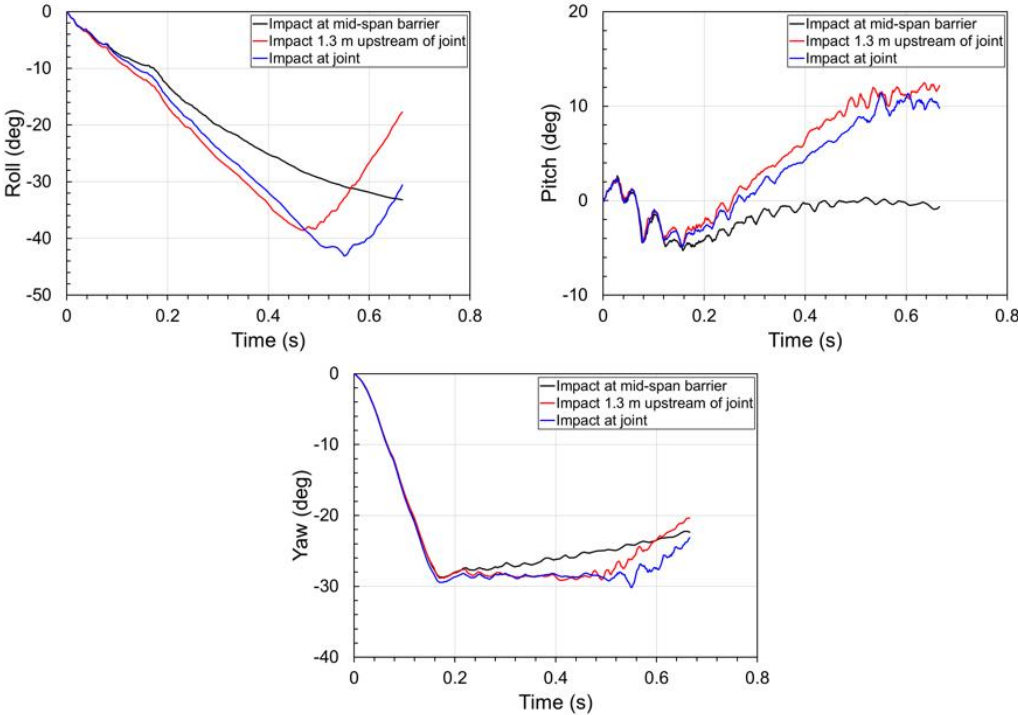
Figure B-3. Angular Displacement-Time History and Recommended Vehicle Coordination System (SSB: 2270P)

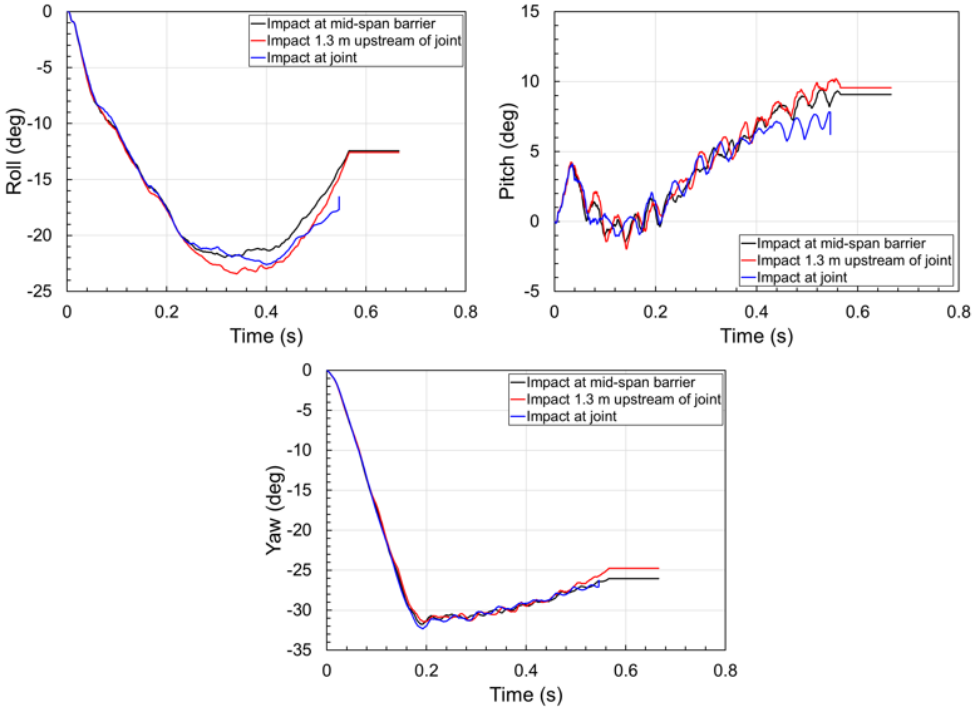
Figure B-4. Angular Displacement-Time History and Recommended Vehicle Coordination System (NVB: 2270P)
