Research Project Number TPF-5(367)

INVESTIGATION, CRASH TESTING, AND EVALUATION OF A MASH TL-4 PRECAST CONCRETE BRIDGE RAIL

MIDWEST ROADSIDE SAFETY FACILITY

MwRSF Research Report No. TRP-03-476-24

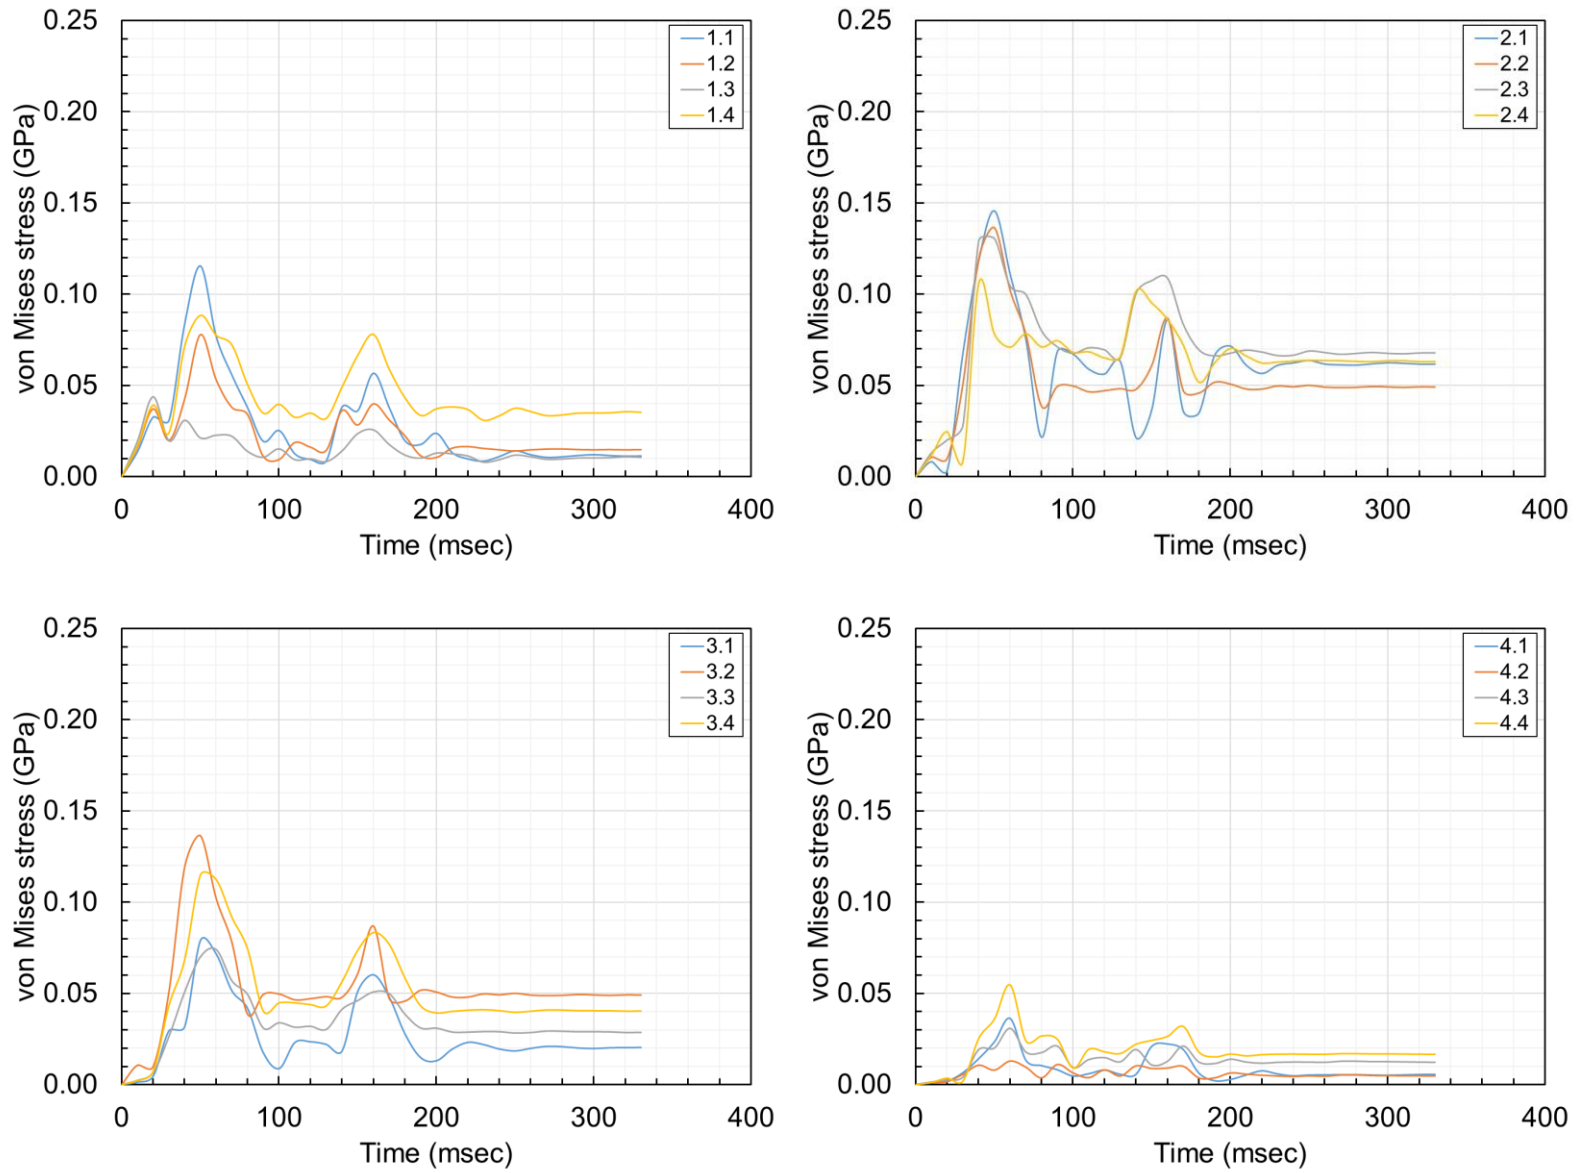
Figure D-2. Von-Mises Stress Developed in Joint-Spanning Rebar – 1000C Vehicle Impact at Mid-Span – Single-Slope Barrier

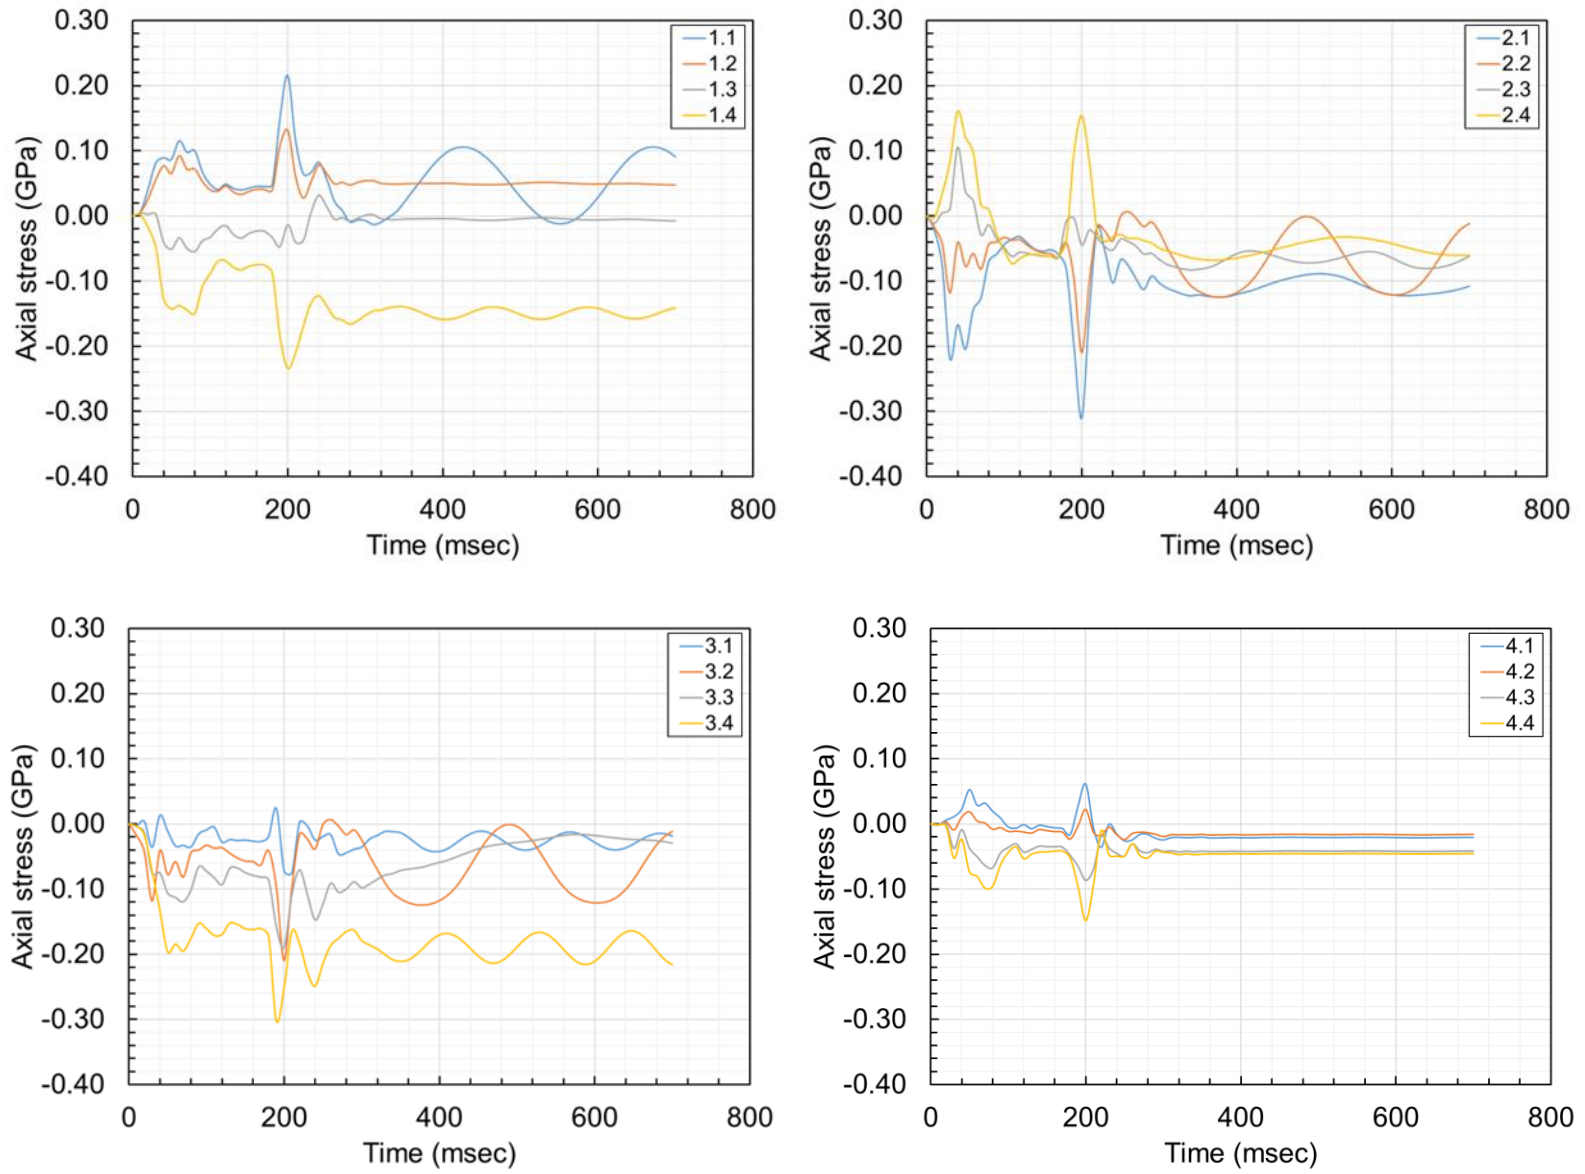
Figure D-3. Axial Stress Developed in Joint-Spanning Rebar – 2270P Vehicle Impact at Mid-Span – Single-Slope Barrier

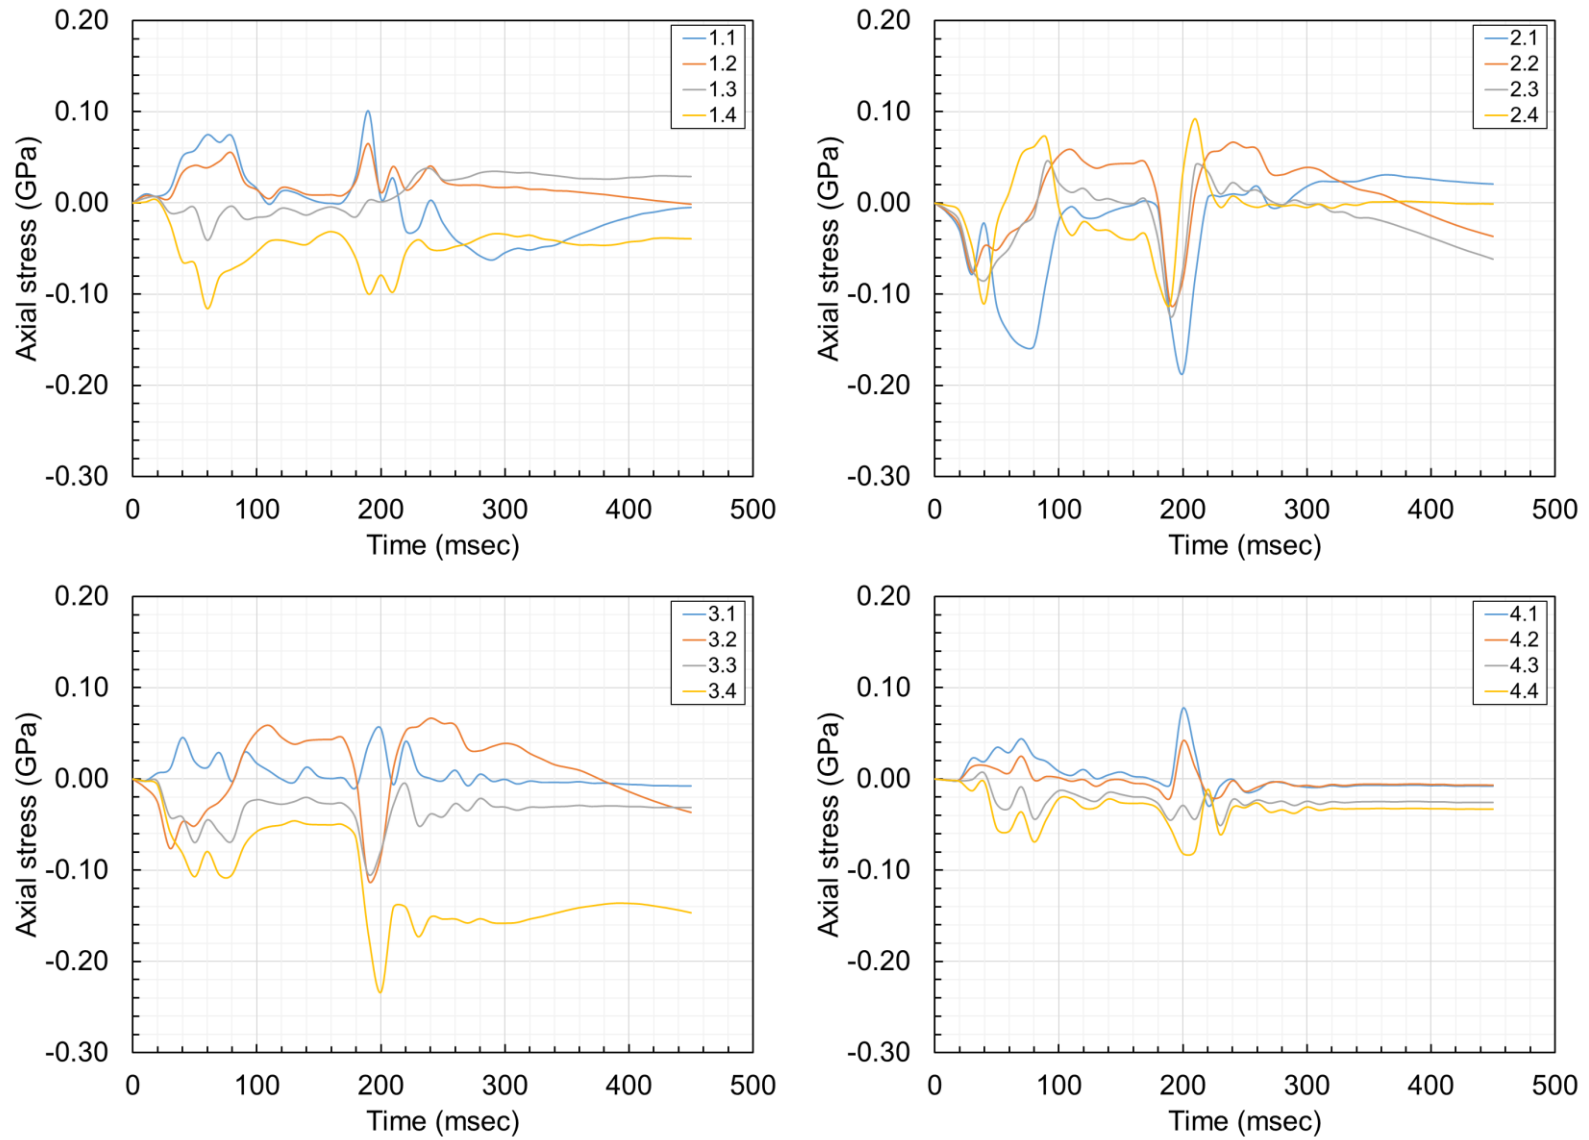
Figure D-5. Axial Stress Developed in Joint-Spanning Rebar – 2270P Vehicle Impact at 4.3 ft Upstream from a Joint – Single-Slope Barrier
