DEVELOPMENT OF A TL-3 F-SHAPE TEMPORARY CONCRETE MEDIAN BARRIER

MIDWEST ROADSIDE SAFETY FACILITY

MwRSF Research Report No. TRP-03-64-96

December 1996

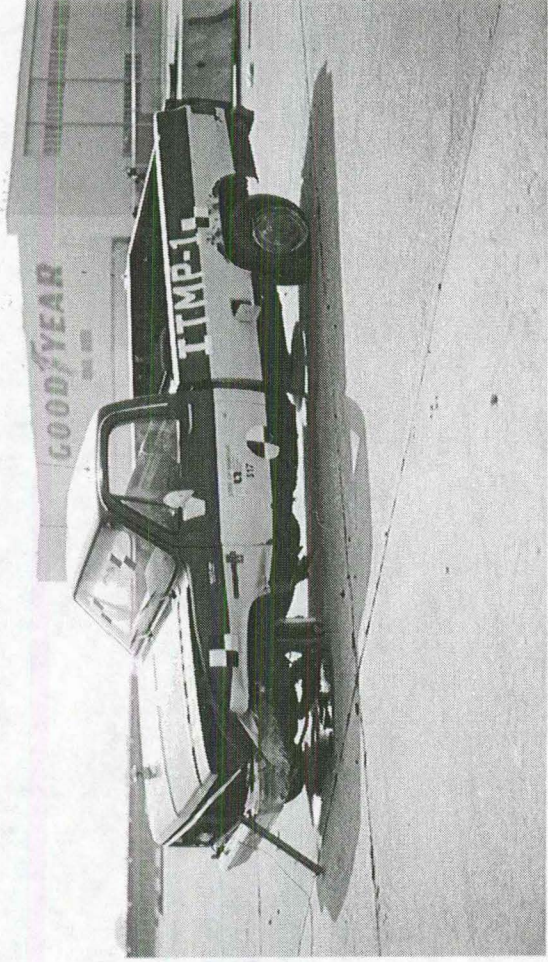
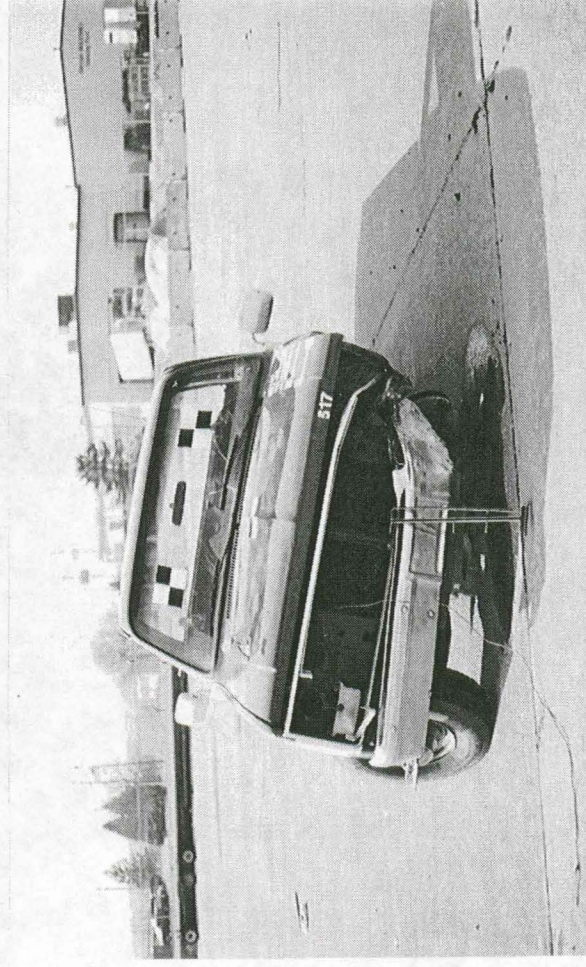
Figure 18. Vehicle Damage, Test ITMP-1

Vehicle damage was moderate, as shown in Figure 18. The front bumper and left-front quarter panel were crushed inward. The left-front wheel assembly was dislodged during the impact as the outer steel rim fractured from the inner region attached to the wheel hub. The steel frame was slightly bent inward near the front with a slight twist along its length from front to rear. Maximum occupant compartment deformations to the floorboard were 127 mm of longitudinal displacement near the center firewall region and a vertical displacement of 32 mm and 51 mm near left-side floorpan and center hump, respectively. The deformations to the floorboard were judged insufficient to cause serious injury to the vehicle occupants.

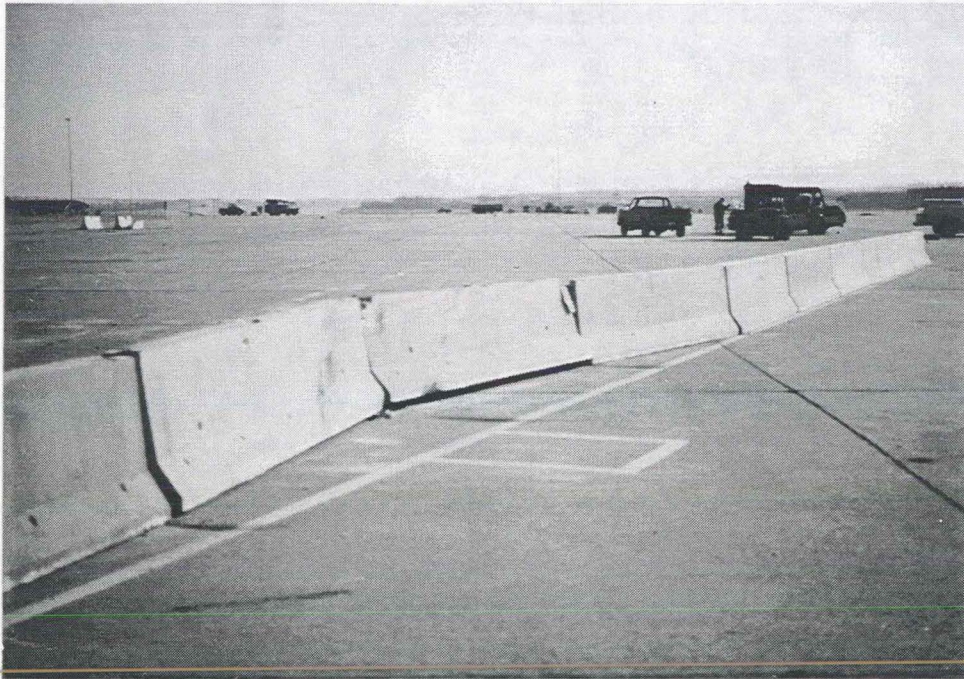
Figure 19. Barrier Damage, Test ITMP-1

Barrier damage was extensive, as shown in Figures 19 through 22. Concrete damage consisted of tire marks, scrapes, gouges, spalling, and fractured concrete pieces. The ends of barriers nos. 7 through 10 were cracked and fractured at various locations, and two cracks were also observed to extend through barrier no. 9. Ten of the steel connector pins were also deformed, ranging from slight to extensive. The maximum permanent set deflection of the barrier was 0.99 m.

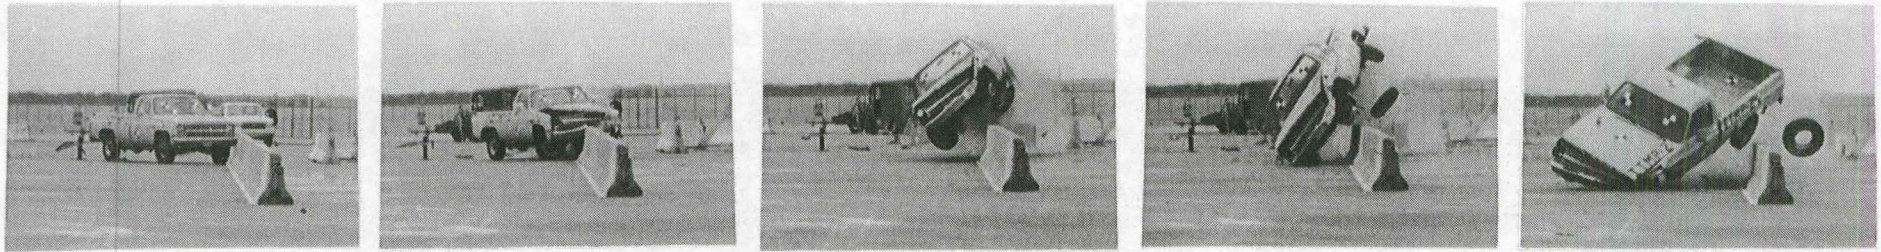
Figure 26. Summary of Test Results and Sequential Photographs, Test ITMP-2

- Test Number ITMP-2
- Date 5/9/96
- Appurtenance F-Shape Concrete Median Barrier
- Total Length 81.52 m
- Barrier
 - Length 3800 mm
 - Height 810 mm
 - Base Width 570 mm
 - Top Width 200 mm
- Connection
 - Type Pin and Rebar
 - Pin Diameter 31.8 mm
 - Rebar Diameter 20 mm
- Vehicle Model 1986 Chevrolet C-20 2WD
 - Curb Weight 2,011 kg
 - Test Inertial Weight 2,005 kg
 - Gross Static Weight 2,005 kg
- Vehicle Speed
 - Impact 100.3 km/hr
 - Exit NA

- Vehicle Angle
 - Impact 27.1 deg
 - Exit NA
- Vehicle Snagging None
- Vehicle Stability Marginal
- Occupant Ridedown Deceleration
 - Longitudinal 7.6 G's < 20 G's
 - Lateral (not required) 10.5 G's
- Occupant Impact Velocity (Normalized)
 - Longitudinal 7.2 m/s < 12 m/s
 - Lateral (not required) 5.3 m/s
- Vehicle Damage Moderate
 - TAD¹⁵ 1-LFQ-5
 - SAE¹⁶ 01LFEW3
- Vehicle Stopping Distance 55.15 m downstream
19.86 m lateral
- Barrier Damage Minimal
- Maximum Deflections
 - Permanent Set 1.14 m
 - Dynamic 1.15 m

The 2,005-kg pickup truck impacted the concrete barrier (Design No. 2) at a speed of 100.3 km/hr and an angle of 27.1 degrees. A summary of the test results and the sequential photographs are shown in Figure 26. Additional sequential photographs are shown in Figure 27. Documentary photographs of the crash test are shown in Figures 28 and 29. It is noted that five additional barrier sections were placed on the upstream end of the installation to provide extra weight for resisting longitudinal barrier movement.

The analysis of the test results for test ITMP-2 showed that the barrier contained and redirected the vehicle with controlled lateral displacement of the barrier. Minor deformations to the occupant compartment were evident but not considered excessive enough to cause serious injuries to the occupants. The vehicle remained upright both during and after the collision and with significant vehicle roll, pitch, and yaw angular displacements. Therefore, test ITMP-2 conducted on Design No. 2 was determined to be acceptable according to the NCHRP Report No. 350 criteria.

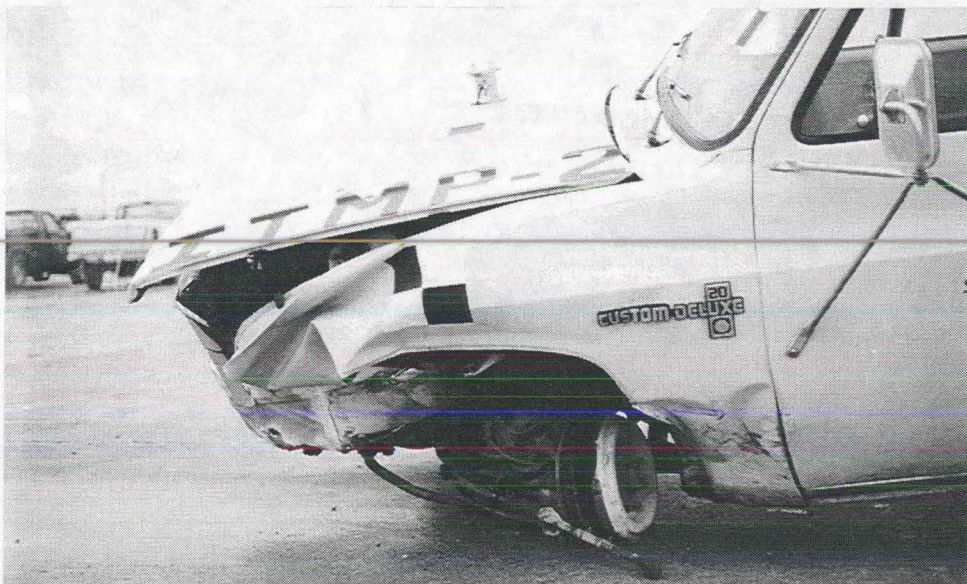
Figure 31. Vehicle Damage, Test ITMP-2

Vehicle damage was moderate, as shown in Figure 31. The front bumper and left-front quarter panel were crushed inward. The left-front wheel assembly was dislodged during the impact as the outer steel rim fractured from the inner region attached to the wheel hub. The steel frame was bent inward near the front with a significant twist along its length from front to rear. Maximum occupant compartment deformations to the floorboard were 55 mm of lateral displacement near the firewall and both a vertical and longitudinal displacement of 38 mm near the center hump behind the gear shift. The deformations to the floorboard were judged to be insufficient to cause serious injury to the vehicle occupants.

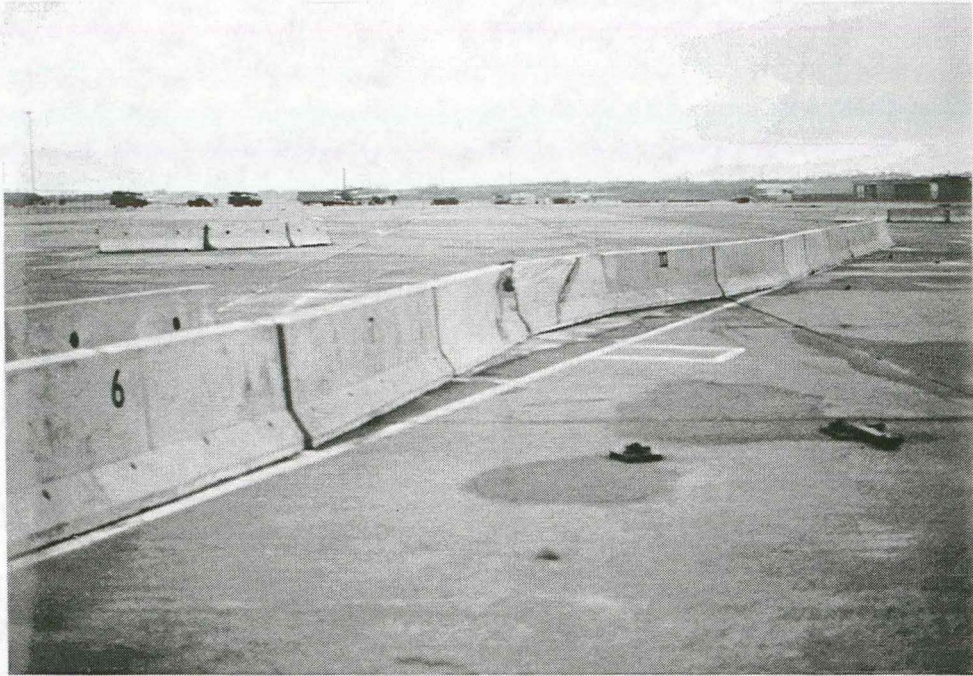
Figure 32. Barrier Damage, Test ITMP-2

Barrier damage was minor, as shown in Figures 32 through 34. Concrete damage was mostly cosmetic, consisting of tire marks, scrapes, gouges, and minor spalling. Nine steel pins were also deformed, ranging from slight to extensive. The maximum permanent set deflection of the barrier was 1.14 m.

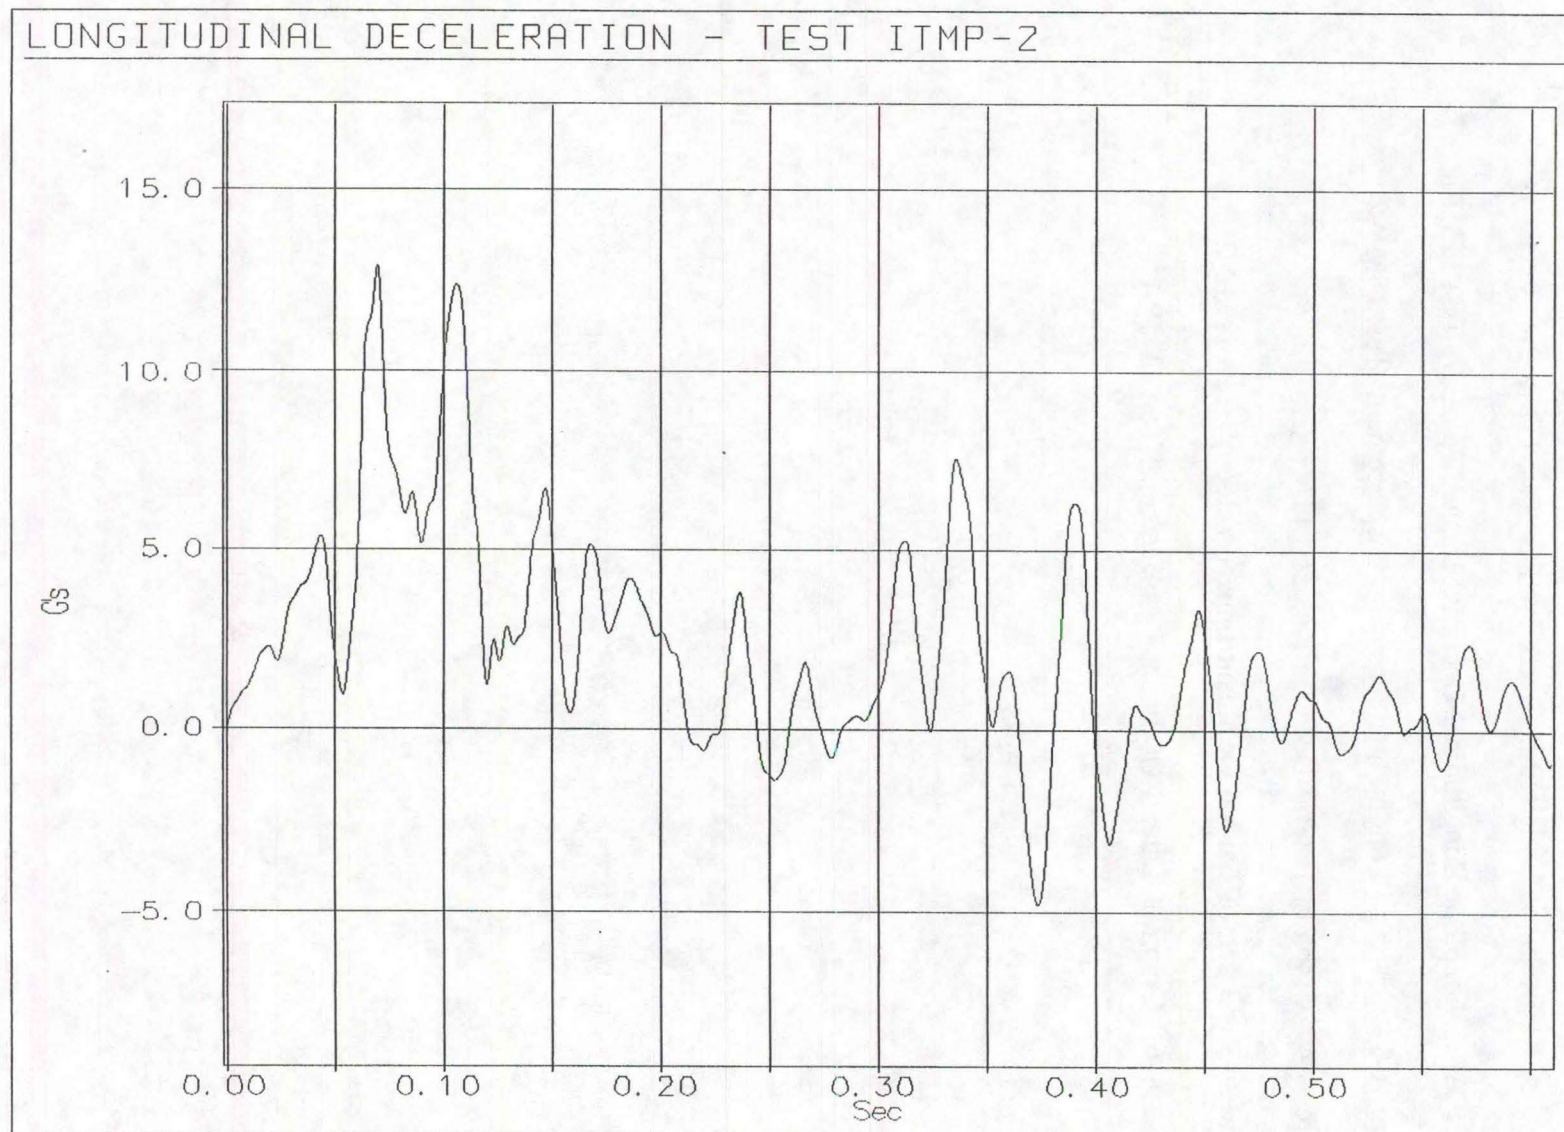
Figure A-1. Graph of Longitudinal Deceleration, Test ITMP-2

The normalized longitudinal and lateral occupant impact velocities were determined to be 7.2 m/sec and 5.3 m/sec, respectively. The maximum 0.010-sec average occupant ridedown decelerations in the longitudinal and lateral directions were 7.6 g's and 10.5 g's, respectively. It is noted that the occupant impact velocities and occupant ridedown decelerations were within the suggested limits provided in NCHRP Report No. 350. The results of the occupant risk, determined from accelerometer data, are summarized in Figure 26. Results are shown graphically in Appendix A. The results from the rate transducer are shown graphically in Appendix B.

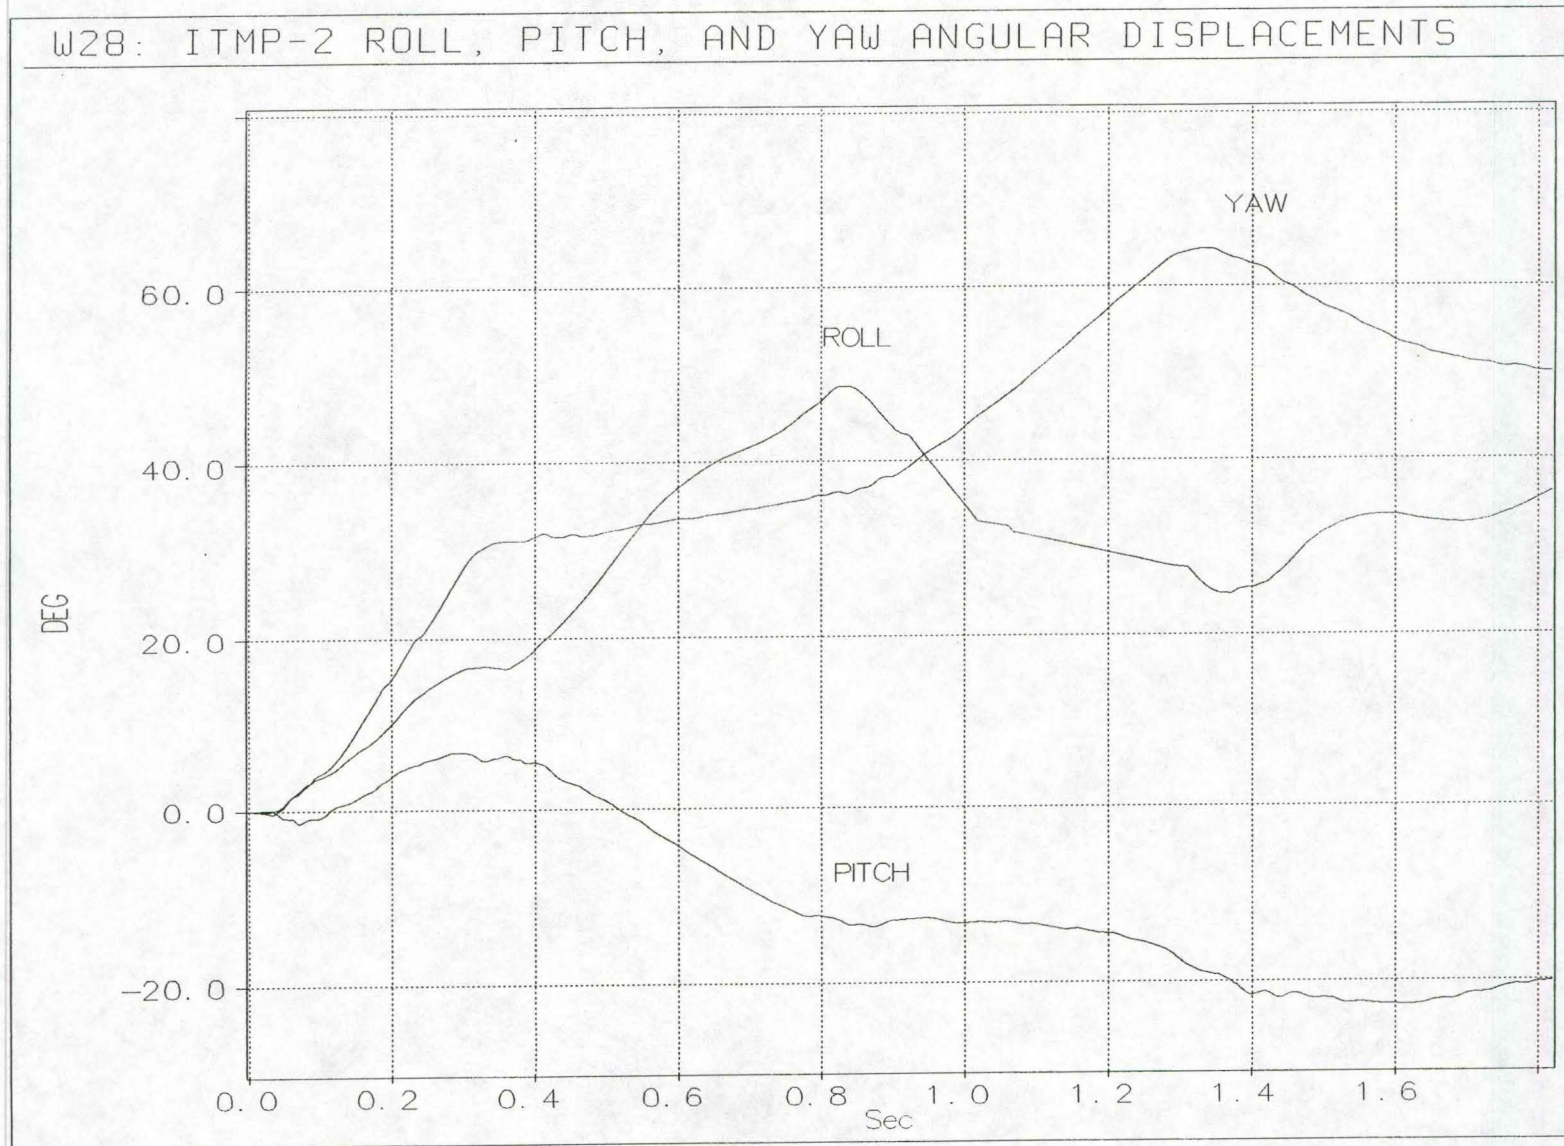
Figure B-1. Graph of Roll, Pitch, and Yaw Angular Displacements, Test ITMP-2

A Humphrey 3-axis rate transducer with a range of 250 deg/sec in each of the three directions (pitch, roll, and yaw) was used to measure the rates of motion of the test vehicle. The rate transducer was rigidly attached to the vehicles near the center of gravity of the test vehicle. Rate transducer signals were received and conditioned by an onboard Series 300 Multiplexed FM Data System built by Metraplex Corporation. The multiplexed signal was then transmitted by radio telemetry to a Honeywell 101 Analog Tape Recorder. Computer software, "EGAA" and "DADiSP" were used to digitize, analyze, and plot the rate transducer data.
