# Test and Evaluation Report

## Testing and Evaluation of the I-235 Pedestrian Bridges

January 6, 2006

**Iowa Department  
of Transportation**

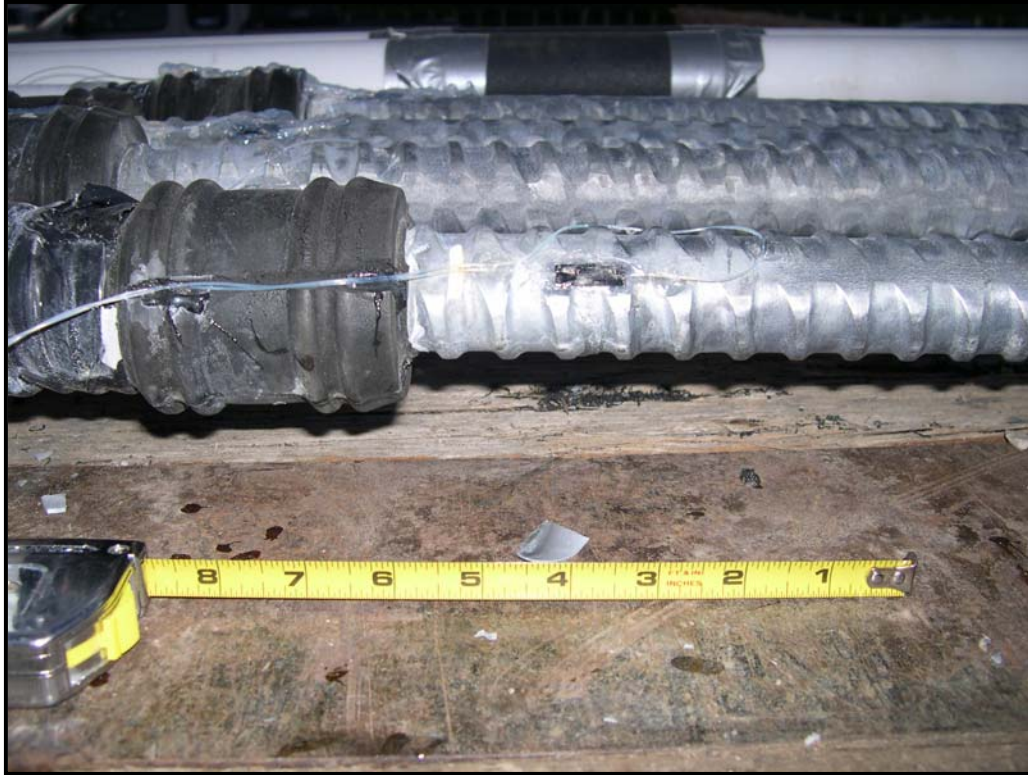
Figure 1. Fiber optic sensor attachment to hanger rod

Each hanger rod was instrumented with an Avensys surface-mountable, Fiber Bragg Grating fiber-optic strain sensor (FOS). The sensors were glued to the rod approximately 3 inches below the bottom of the HDPE sheathing (as shown in Figure 1) using a high strength cyanoacrylate adhesive. It was intended that these sensors could be connected in series and thus a simultaneous reading of each sensor on the bridge could be obtained.

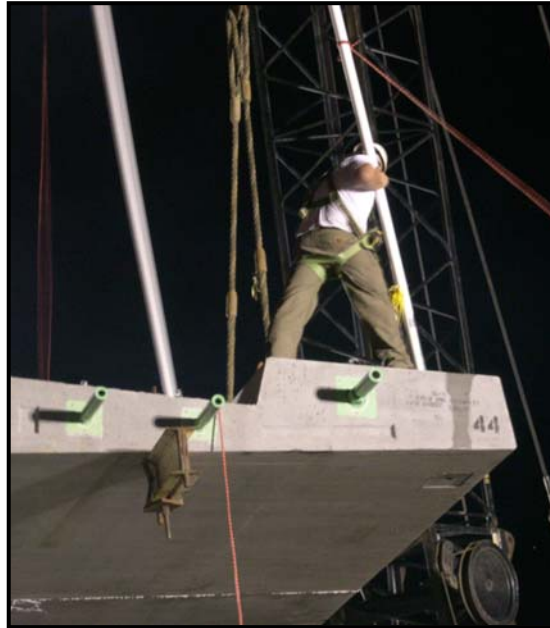
Figure 2. Installation of instrumented hanger rod in 44<sup>th</sup> Street Bridge

The construction process for the concrete deck panels required that the instrumented hanger rods be inserted through trumpet pipes as the panels were lifted into position (see Figure 2). The construction crew responsible for building the bridge was requested to use as much care as possible to protect the sensors during installation, but in a number of cases, the sensors were damaged and became unusable.

On the 44<sup>th</sup> Street Bridge, only 13 of 28 sensors could be read at any time during the construction process. The construction-related damage to the FOS also eliminated the possibility of connecting the sensors in series. Instead, all FOS data was collected by manually reading each sensor individually each time a panel was installed.

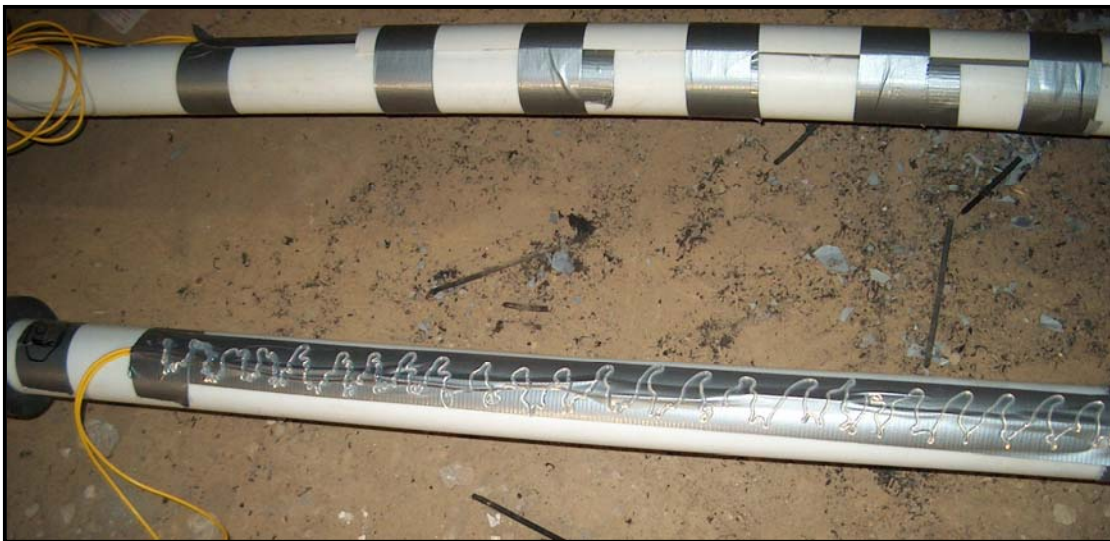
Figure 3. Improved sensor protection system used at 40<sup>th</sup> Street Bridge

It was evident that a more effective system of protecting the fiber optic sensors was needed. The research team added an outer covering of PVC pipe and silicone caulk (see Figure 3) to protect the sensors from the abrasion and impact loads applied during normal construction activities. These improved increased the “survival rate” to 31 of a total 36 sensors installed on the 40<sup>th</sup> Street Bridge.

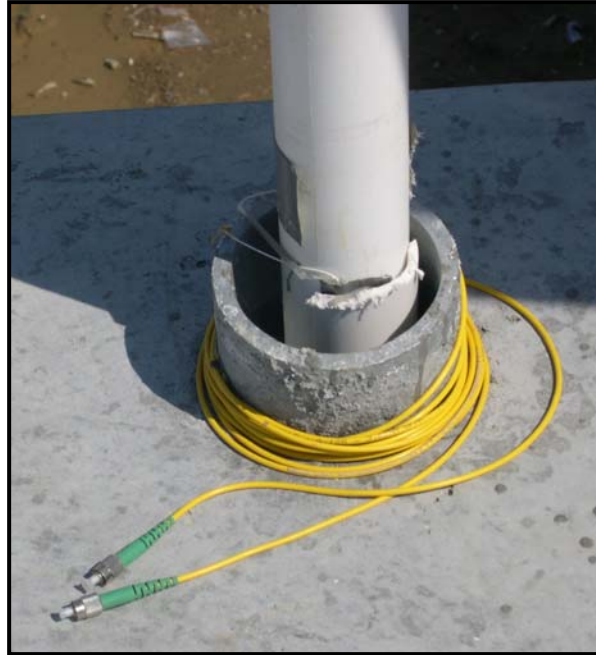
Figure 4. Fiber optic sensors left in position on completed bridge

The functioning fiber optic sensors on both bridges were left in place (see Figure 4) and are protected from weather and UV degradation by a galvanized steel trumpet pipe cover (see Figure 5).

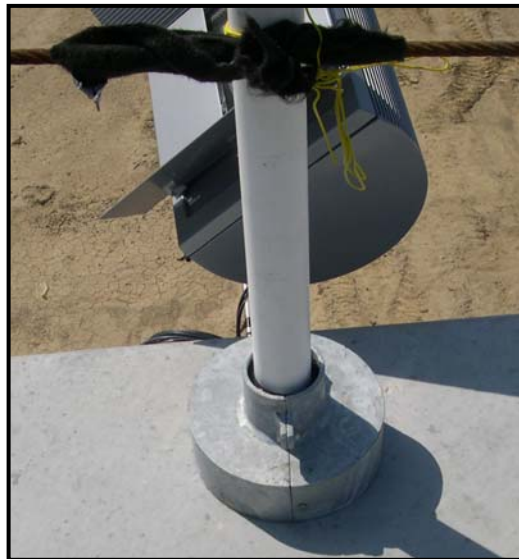
Figure 5. Galvanized trumpet pipe cover provides UV protection for FBG sensors leads

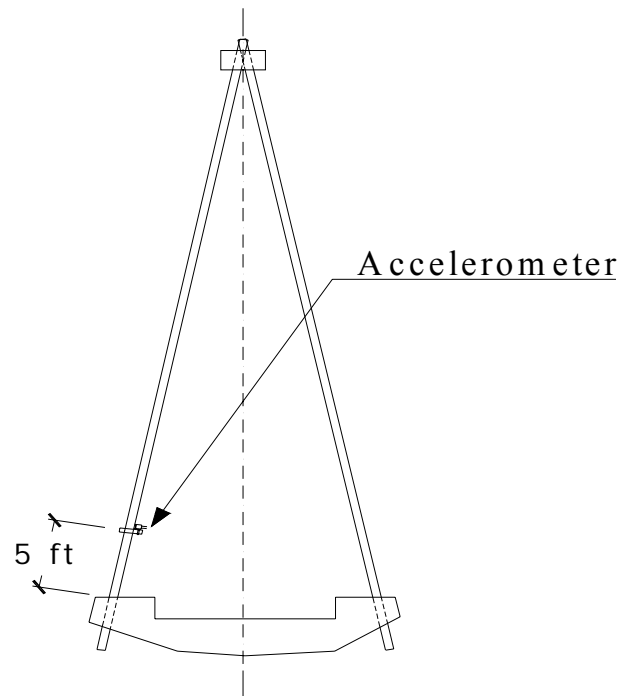
Figure 6. Typical section of bridge showing position of accelerometer mounted on hanger rod

In order to supplement the data collected using the fiber optic strain sensors, the research team elected to collect free vibration data for each hanger rod used on the 40<sup>th</sup> Street Bridge. The researchers used a PCB model 393 U353B33 accelerometer attached to the hanger rod approximately 5 feet above the deck level as shown in Figure 6. The accelerometer was oriented with its primary axis perpendicular to the centerline of the bridge.

The acceleration record for each hanger was collected by manually exciting the hanger using a suddenly applied, horizontal force or displacement approximately 4 feet above deck level. The force or displacement was applied perpendicular to the bridge centerline. Natural frequencies from the free vibration record were obtained and used to calculate the hanger force. This method is referred to as the Free Vibration Method (FVM) in this report. Each time a deck panel was installed, the research team collected vibration data from each active hanger rod.

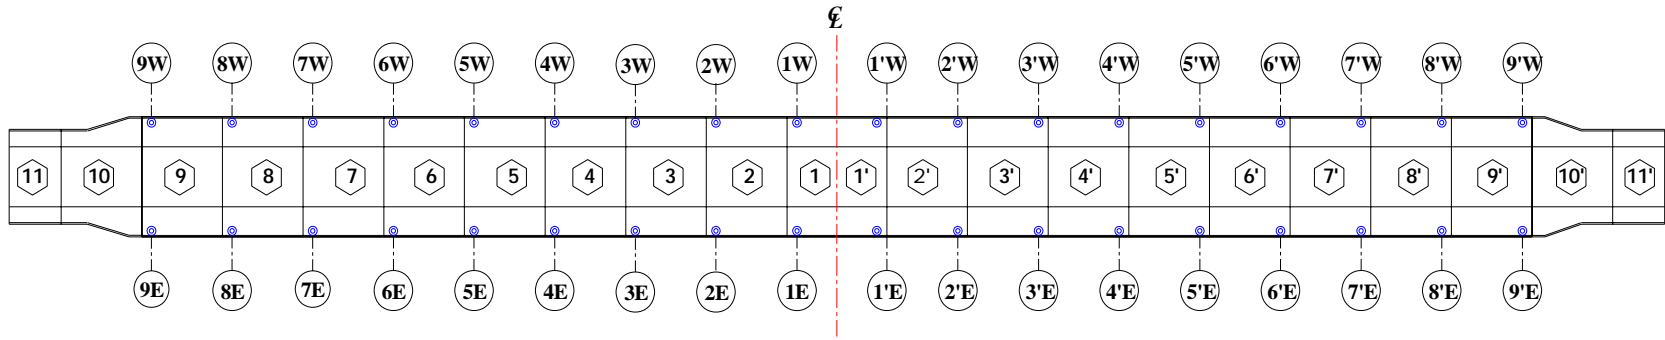
Figure 7. Precast panel layout – 40<sup>th</sup> Street Bridge

The 40<sup>th</sup> Street Bridge contains a total of 22 precast concrete panels, while the 44<sup>th</sup> Street Bridge contains a total of 20 precast concrete panels. The precast panel layout and numbering system for the two bridges are presented in Figures 7 and 8 respectively.

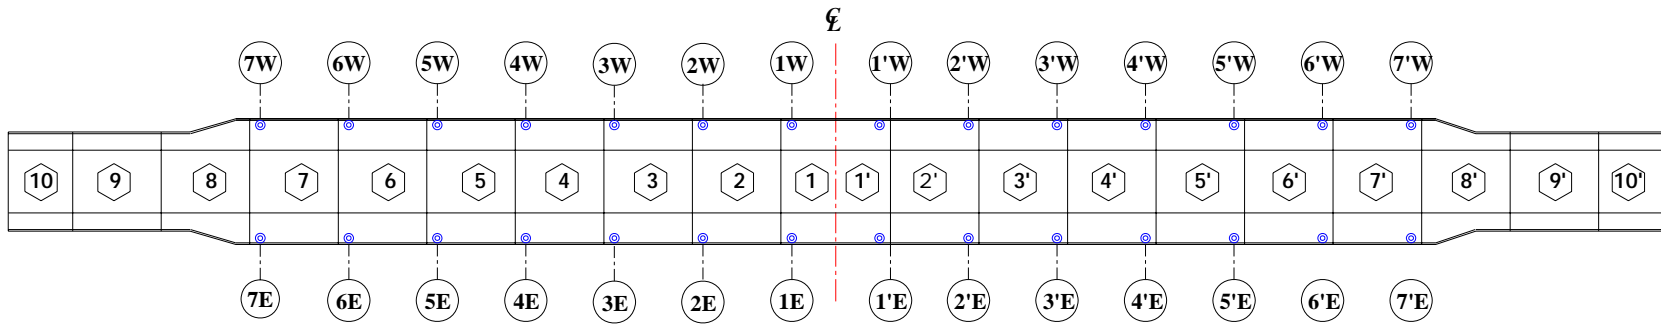
Figure 8. Precast panel layout – 44<sup>th</sup> Street Bridge

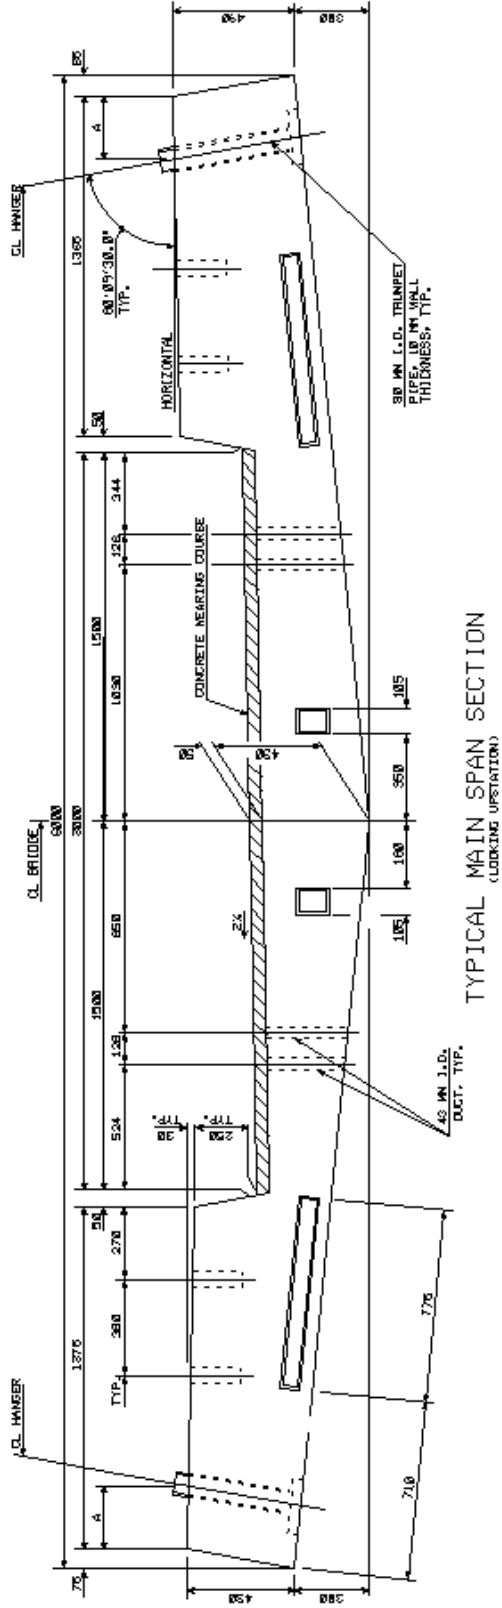
Figure 9. Precast deck panel typical section

The precast panel cross section is not symmetrical about the longitudinal centerline of the bridge (see Figure 9). In order to promote bridge deck drainage, the panels were cast such that the eastern side of the panel is considerably heavier than the western side. Due to this unsymmetrical shape, the deck panels, when erected and supported from the hanger rods, and before the deck system was complete, did not hang directly below the longitudinal centerline of the bridge. In fact, these panels were observed to hang as much as 28 inches west of their intended position.

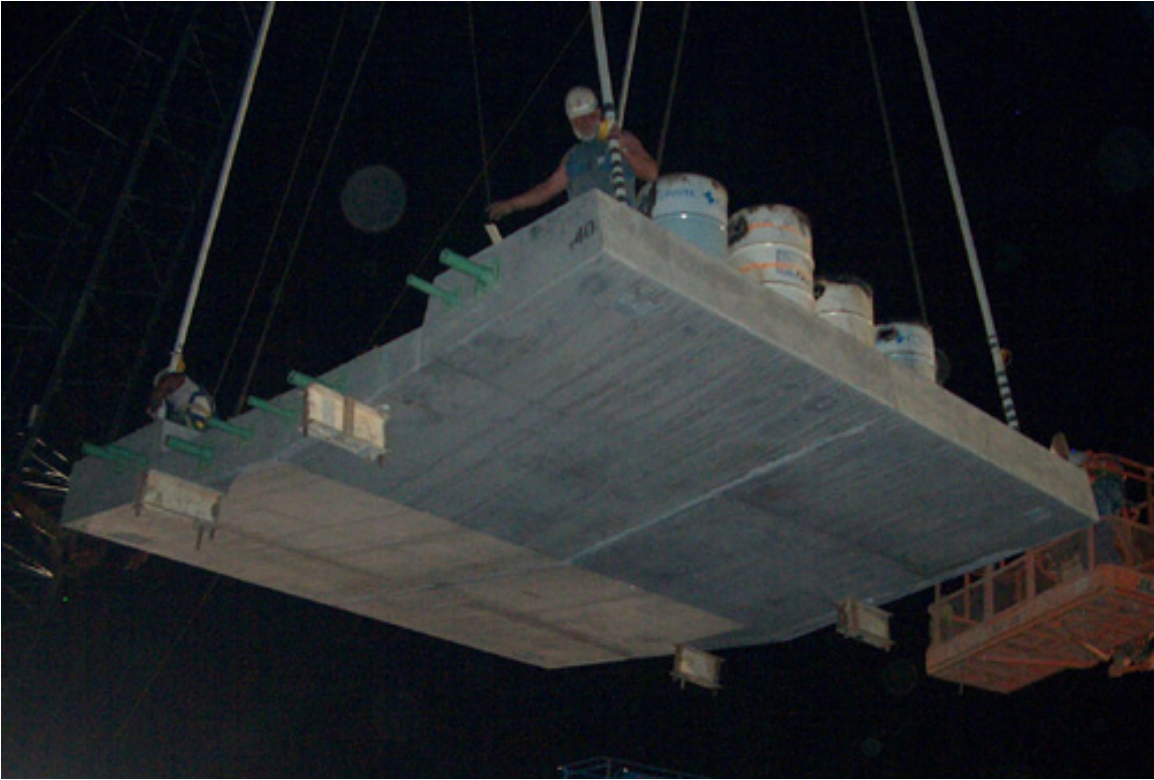
Figure 10. Sand-filled barrels used as ballast during erection of 40<sup>th</sup> Street Bridge panels

The contractor for the 40<sup>th</sup> Street bridge used a series of sand-filled barrels as ballast on the west side of the deck panels, which caused the panels to hang much closer to their intended position relative to the bridge centerline.

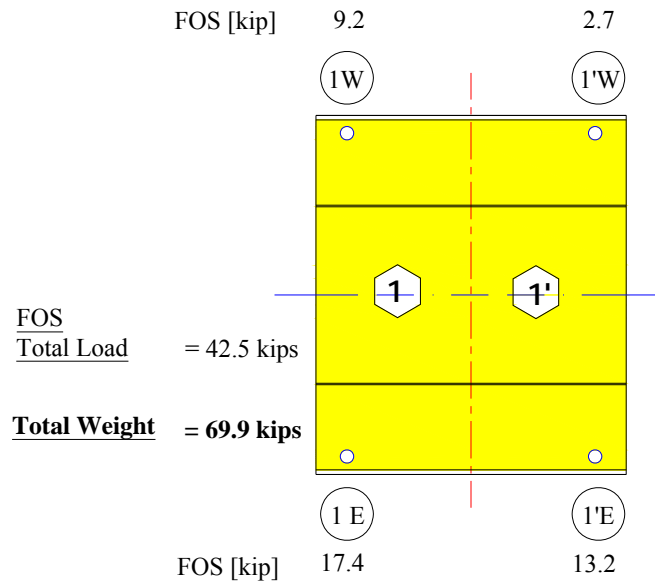
Figure 11. Stage 1 hanger forces from fiber optic sensors

Stage 1. The estimated dead load of the Stage 1 deck panel (with the added ballast) is 69.9 kips. Based upon the FOS strain data, the sum of the four hanger forces was calculated as 42.5 kips, which is only approximately 60% of the total dead load. Only at hanger 1E is the force obtained reasonably close to the theoretical dead load expected to be carried per hanger (17.5 kip). The calculated force at hanger 1'W is significantly lower than expected and the calculated hanger 1W force is also smaller than expected (Figure 11).

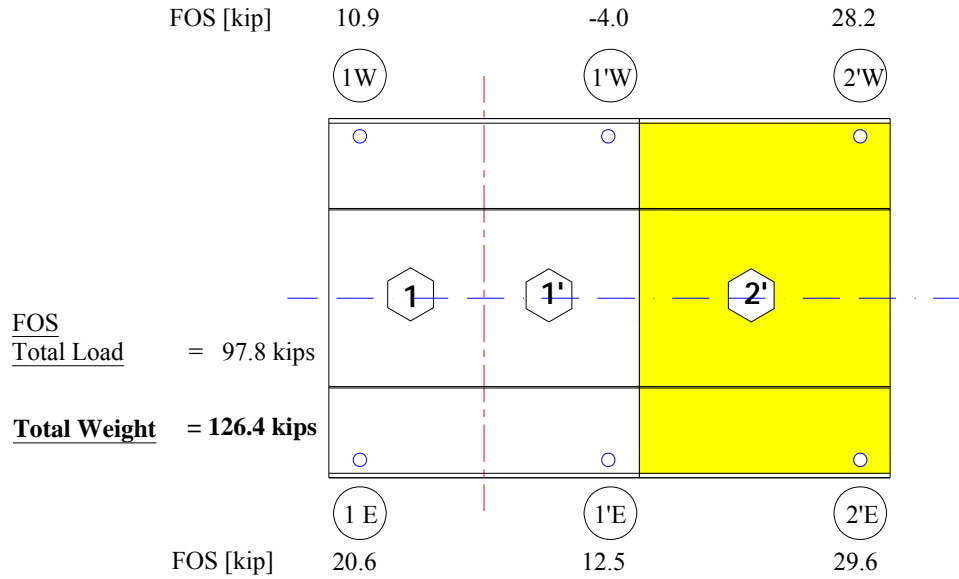
Figure12. Stage 2 hanger forces from fiber optic sensors

Stage 2. After placement of the Stage 2 deck panel, the estimated dead load was 126.4 kips. As shown in the figure, the summation of the six hanger forces was 97.8 kips (approximately 77% of the total dead load). Regarding hanger 1E, again the force computed is close to the expected load carried per hanger (21.1 kips). The hanger forces calculated in the two new hangers (2'W and 2'E) associated with the newly placed deck panel seemed very reasonable (28.2 kips and 29.6 kips, respectively) (Figure12).

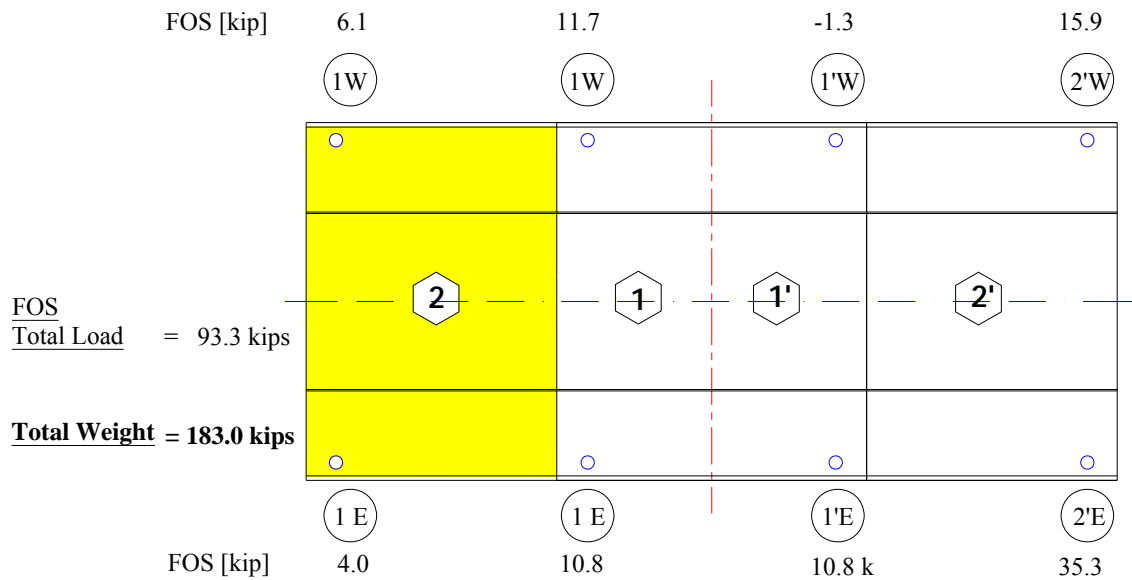
Figure 13. Stage 3 hanger forces from fiber optic sensors

Stage 3. The summation of the eight hanger forces for Stage 3 construction was 93.3 kips, compared to an estimated dead load of 183.0 kips. This represented only 51% of the estimated dead load. Several of the FOS away from the added deck panel appeared to give reasonable results (e.g. at hangers 2'W and 2'E), but in general there was concern about the lack of consistency of the results using the FOS (Figure 13).

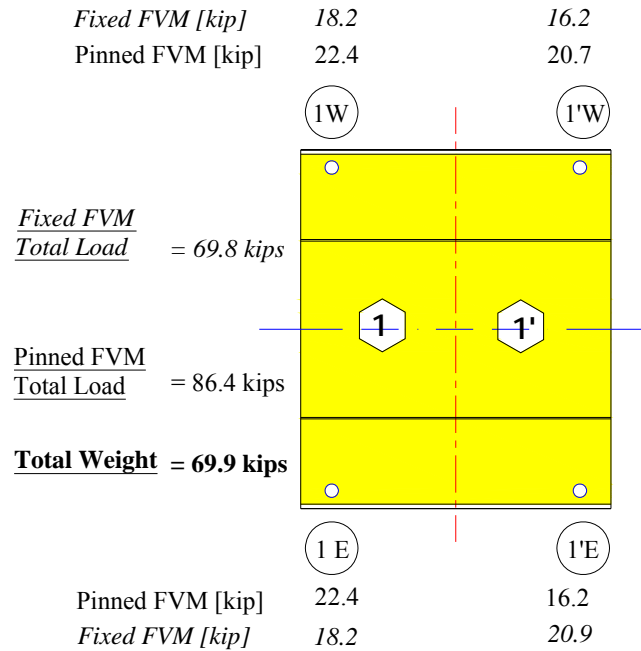
Figure 14. Stage 1 hanger forces from free vibration method

Stage 1. The estimated dead load of the panel (including ballast) was approximately 69.9 kips. The calculated forces for the four hangers was 69.8 kips and 86.4 kips, respectively, for the fixed and the pinned conditions. The four hanger forces were relatively similar and correlation with the estimated theoretical hanger forces (based on equal distribution of dead load to all hangers) of 17.5 kips was relatively good.

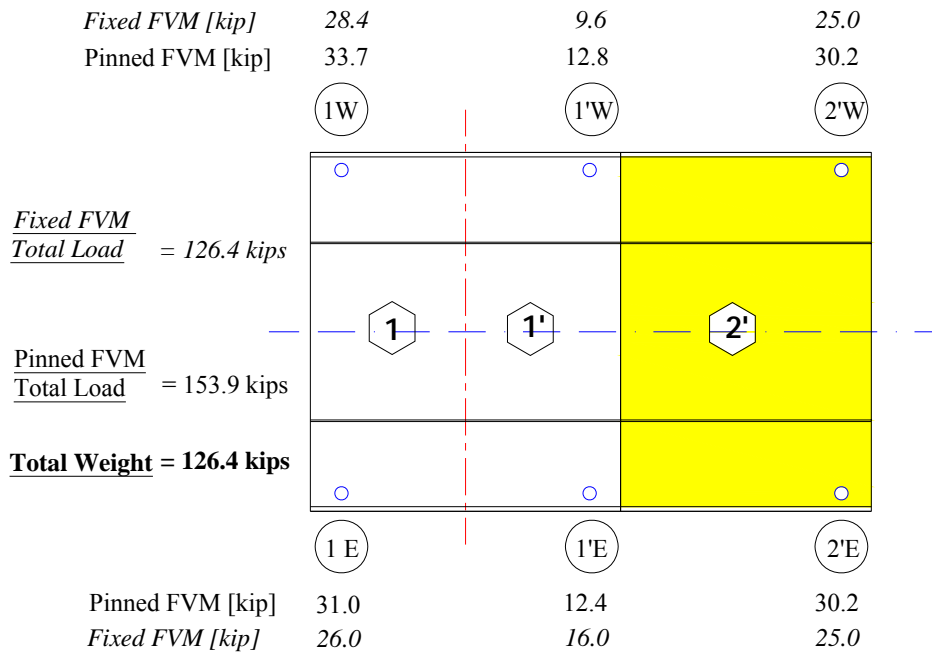
Figure 15. Stage 2 hanger forces from free vibration method

Stage 2. The summation of the six hanger forces at the completion of Stage 2 was 126.4 kips and 153.9 kips, respectively, for the fixed and pinned conditions. This compares with the total estimated dead load of the panels of 126.4 kips. Note that the hanger forces in 1'W and 1W were reduced after the second panel was placed, while the other four hanger forces increased in magnitude.

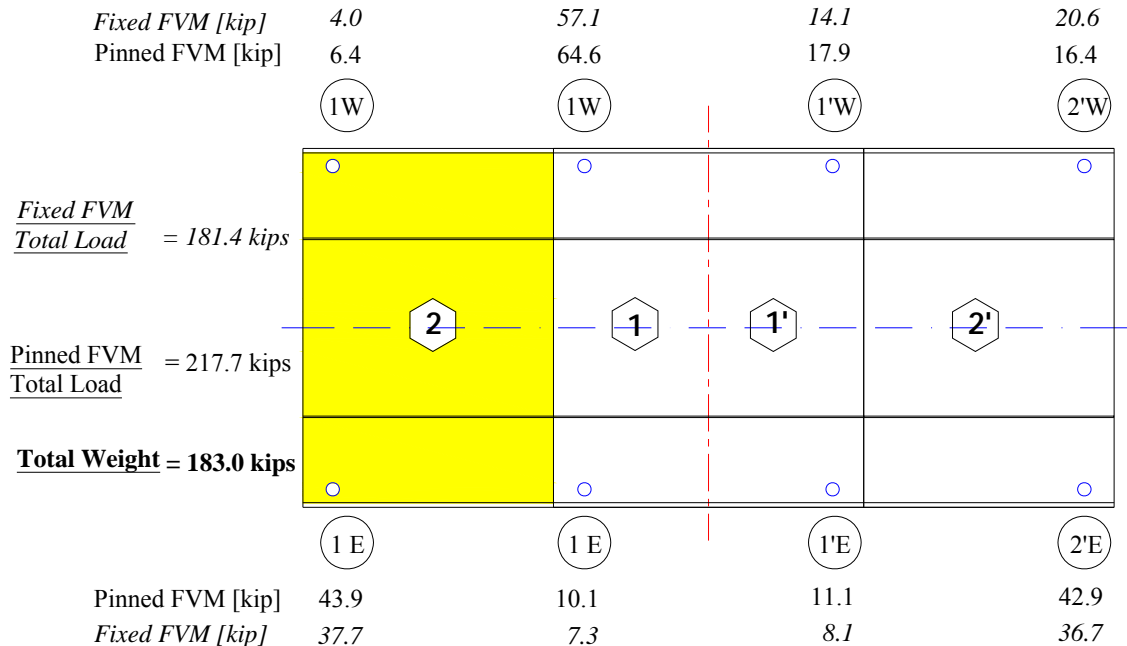
Figure 16. Stage 3 hanger forces from free vibration method

Stage 3. After placement of the Stage 3 deck panel, the estimated dead load was approximately 183.0 kips. In comparison, the calculated forces for the six hangers was 181.4 kips and 217.7 kips, respectively, for the fixed and pinned conditions. It is interesting to note that hanger 1W (one of the newly placed hangers) was very lightly loaded compared to expectations (4.0 kips for the fixed condition). In contrast, hanger 1E carried 36.7 kips for the fixed condition. There was a considerable non-uniform redistribution of hanger forces throughout the three panels at the end of the Stage 3 construction, with significant hanger force unbalances noted at several panel point pairs (e.g. 1W and 1E, and 2'W and 2'E).

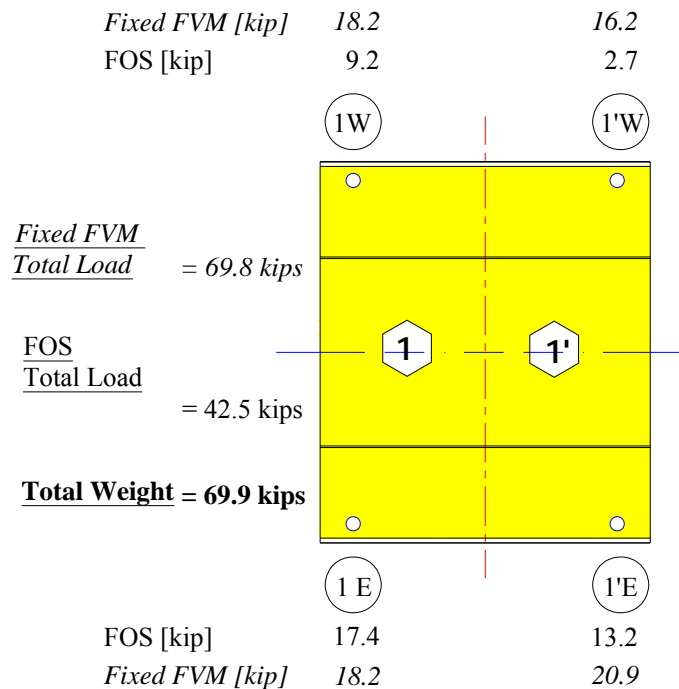
Figure 17. Correlation of Stage 1 hanger forces from free vibration and FOS data

- The correlation between the FOS and vibration hanger force data is significant at hanger 1'W. The correlation is also relatively poor at hanger 1W. The other two hangers (1E and 1'E) show relatively good force correlation.

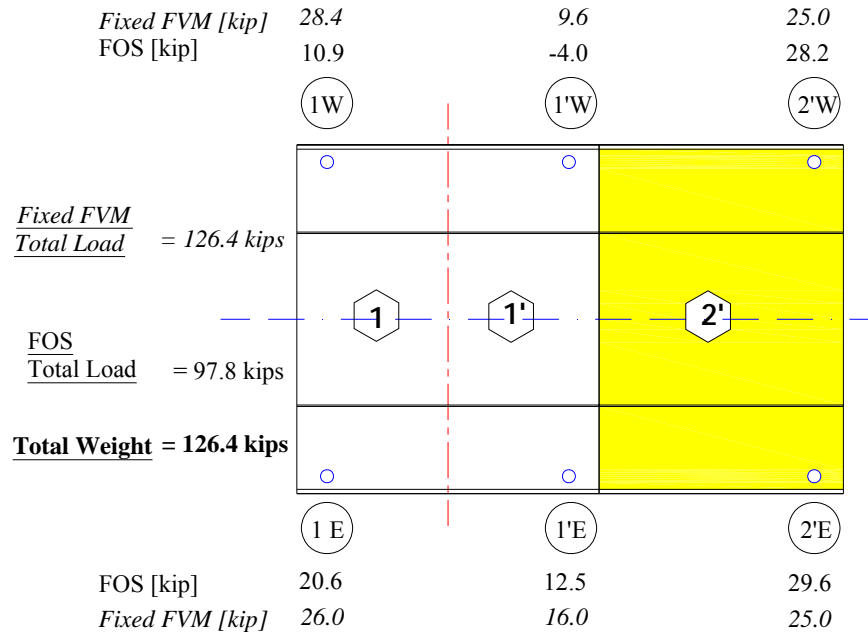
Figure 18. Correlation of Stage 2 hanger forces from free vibration and FOS data

- Note for Stage 2 that the hanger forces in 2'W and 2'E (newly added hangers) were very similar.
- It's interesting to note that while the Stage 1 correlation of forces in Hanger 1'W was very poor, the change in force in the hanger (reduction of approximately 6 kips) was very similar during Stage 2 construction.

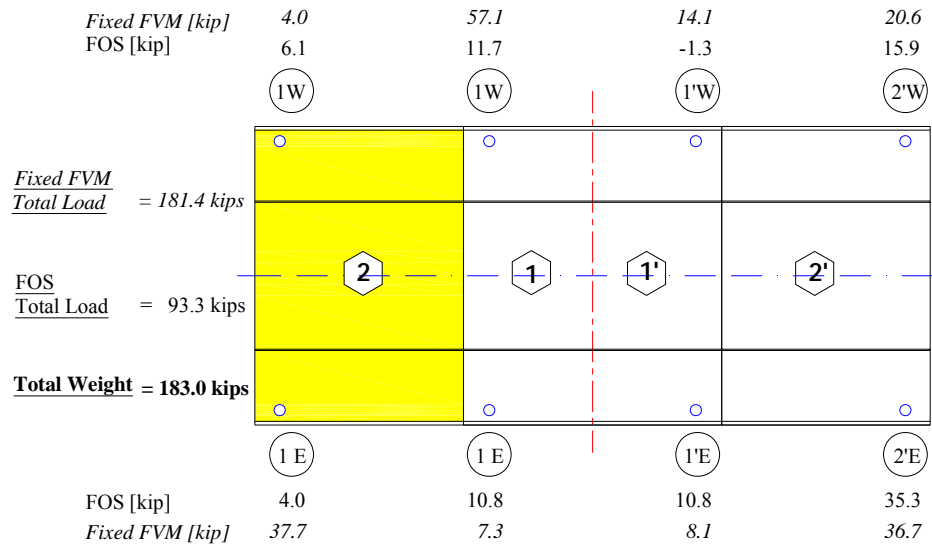
Figure 19. Correlation of Stage 3 hanger forces from free vibration and FOS data

- Note that for Stage 3 construction the correlation in hanger force for 2W was relatively good.
- Note that the hanger force correlation at 2'W and 2'E was still quite good as noted above for Stage 2 construction.
- Also note how the change in hanger force at 1'W from Stage 2 and 3 were similar (i.e., increased approx. 3 to 5 kips). This was similar to observation at the same hanger noted above for Stage 2 construction

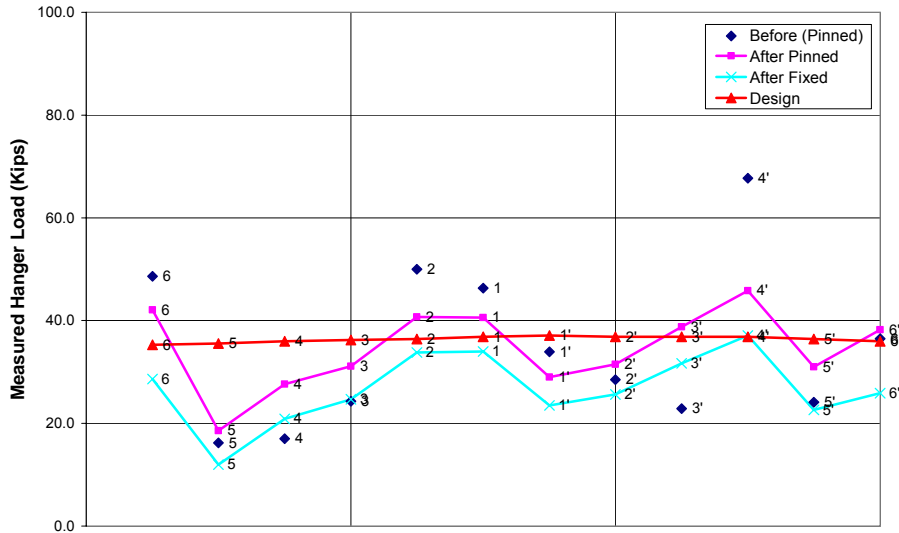
Figure 20. Hanger forces for east arch of the 44<sup>th</sup> Street Bridge after adjustment

Figure 20 shows a plot of the hanger forces for the East Hangers based on the vibration data to illustrate the redistribution of the hanger forces after adjustment. The target design forces for each hanger are also shown for comparison. As noted the adjustments eliminated the outliers relative to the design values and improved the overall distribution of the forces.
