RETROFIT METHODS FOR DISTORTION CRACKING PROBLEMS IN PLATE GIRDER BRIDGES

Iowa DOT Project TR-436
CTRE Project 99-50

Final Report • January 2003

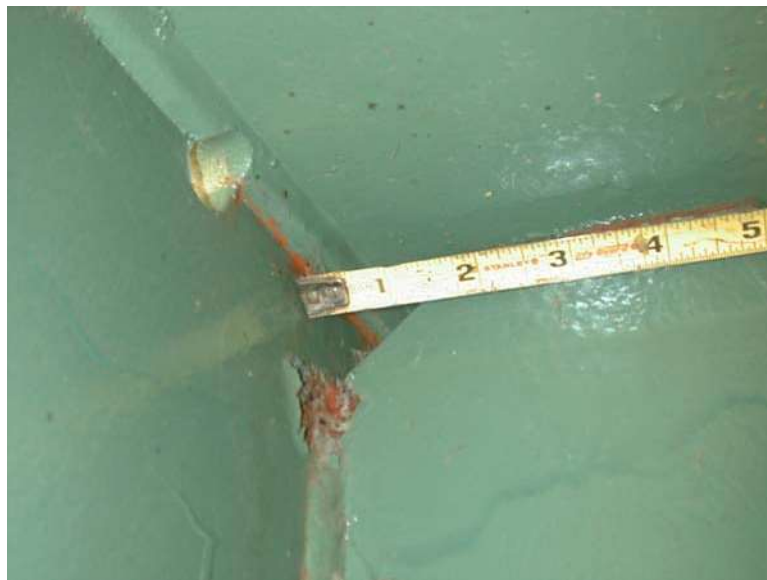
Figure 2.7. Photograph of typical web gap.

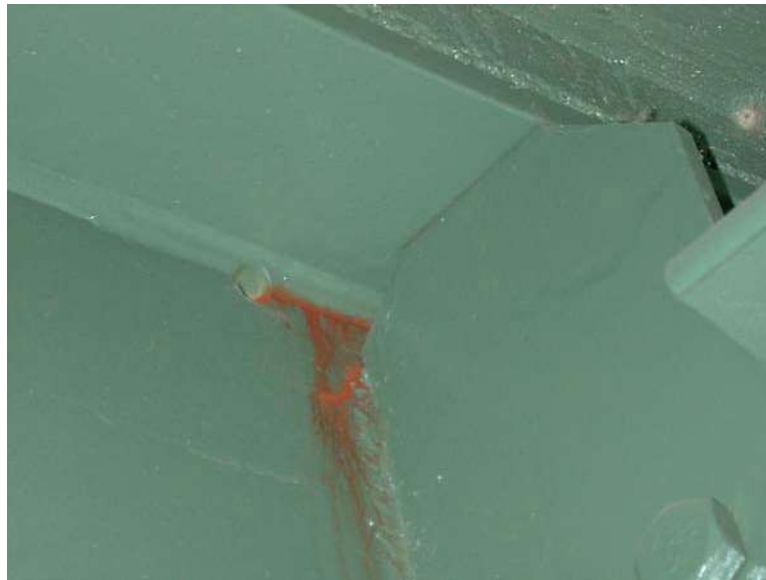
Figure 2.11. Photograph of typical drilled hole retrofit in a web.

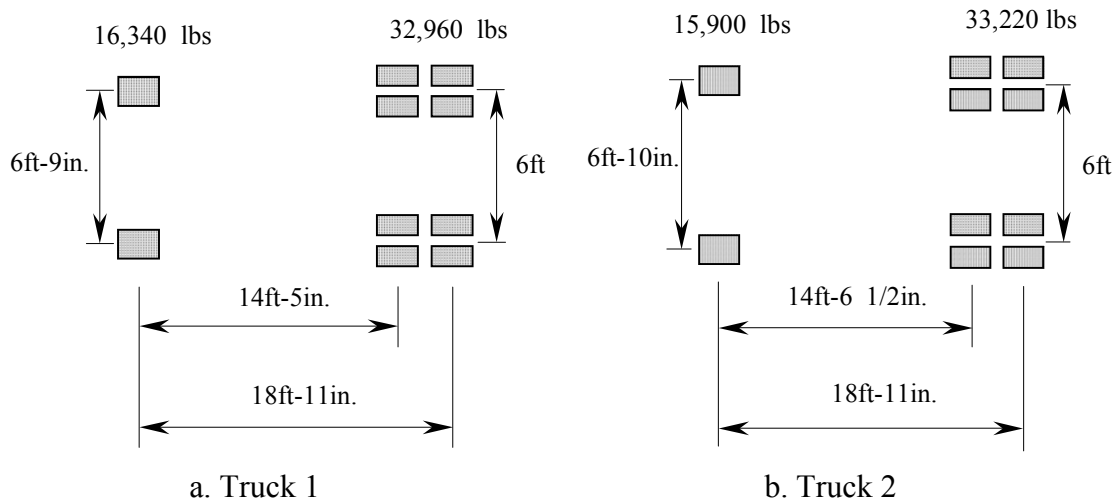
Figure 2.16. Test truck configuration.

Information on the standard Iowa DOT three-axle dump trucks used to load test the bridge is shown in Figure 2.16. The average width of a load truck was 6 feet between the rear duals, and the length was approximately 18 feet between the front and rear axles. The trucks were loaded with sand to near 50,000 lbs. Truck 1 weighed 49,300 lbs and Truck 2 weighed 49,120 lbs.

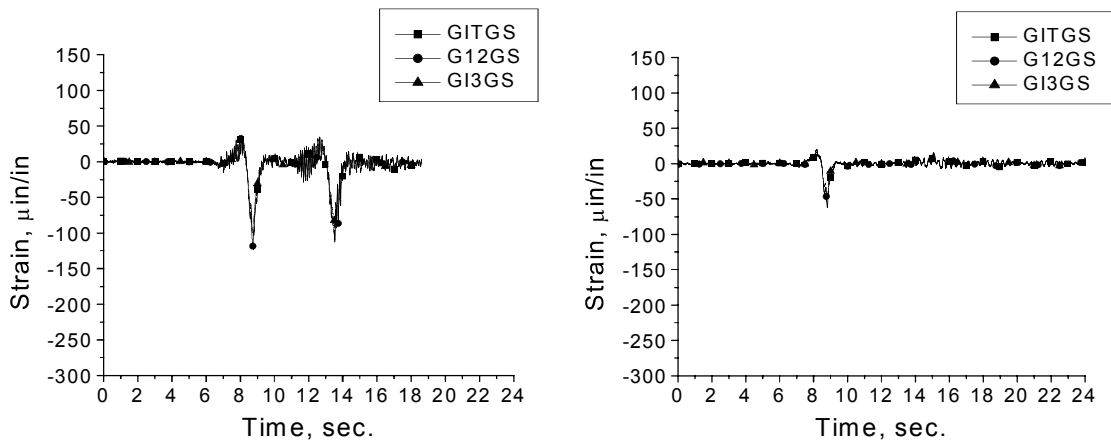
a. Gradient gage labels.

b. All bolts tight.

c. Bottom row bolts tight.

d. All bolts loose.

Figure 2.20 shows the strain in the north side of the G2 web gap. The location of the load trucks is the same as the previous figure. The gage positions in the web are also illustrated in Figure 2.20.

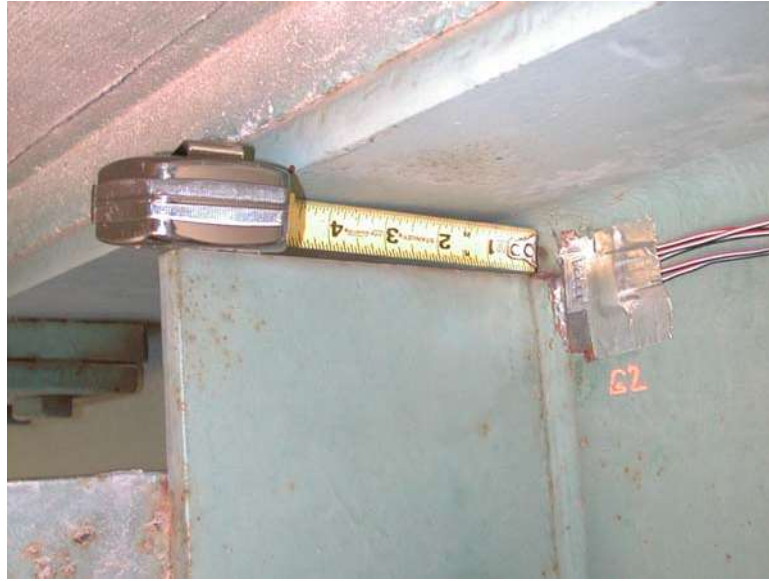
Figure 3.7. Typical web gap in negative moment region.

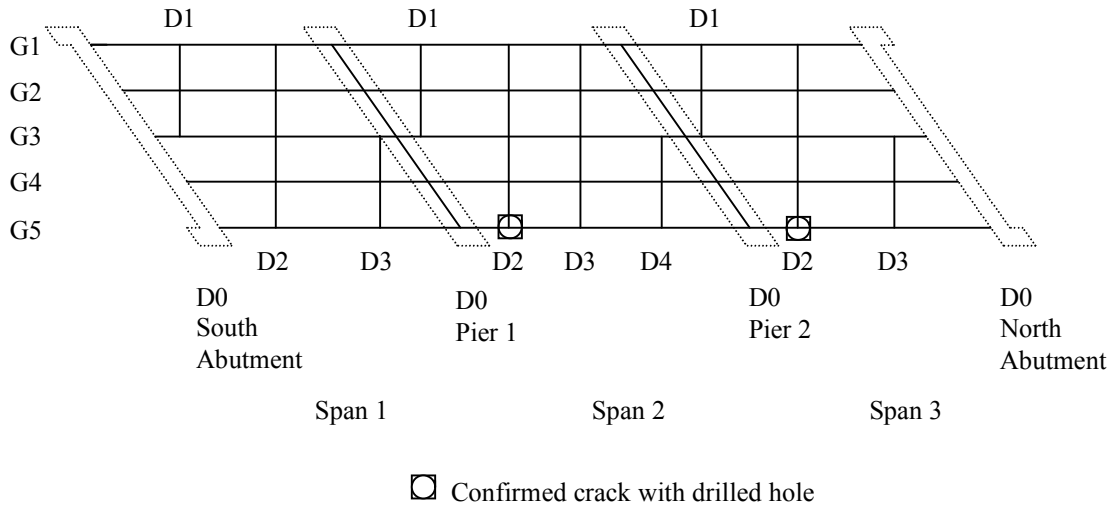
Figure 3.10. Confirmed crack and drilled hole retrofit locations.

Typically, the girders in the negative moment regions have a much higher frequency of fatigue cracking due to the composite action of the top flange with the concrete deck above the web gap and no stiffener weld to the top flange. Exterior girders also tend to have a higher frequency of fatigue than interior girders. Bridge 2700.0R035 exhibits these common arrangements of fatigue cracking, as depicted in Figure 3.10.

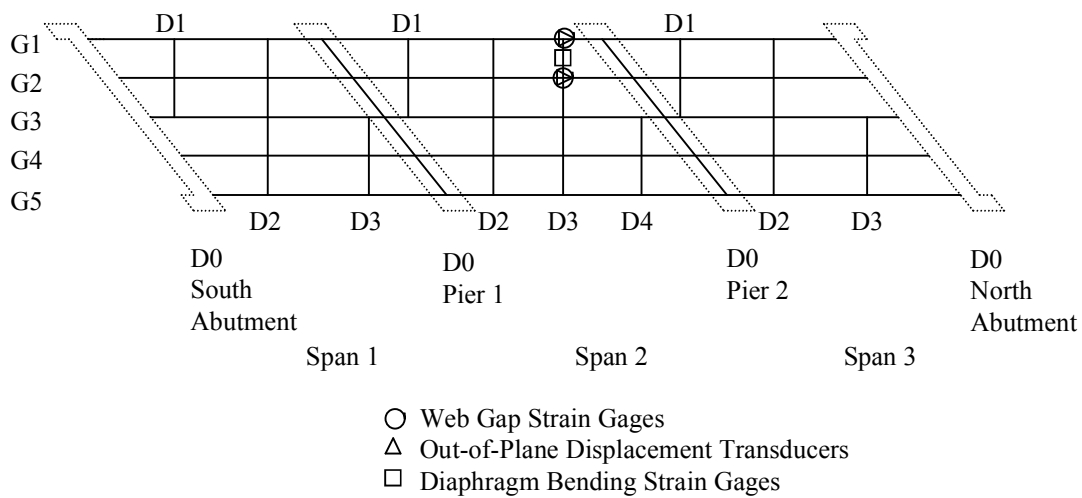
Figure 3.12. Plan view of gage placement.

A negative moment region on an exterior and interior girder was selected for testing. A location adjacent to Pier 2, with minimum existing fatigue damage, was used. A combination of strain gages and displacement transducers were installed to determine the behavior of the bridge. Figure 3.12 shows the instrumentation installed at D3 in Span 2. The data from these gages were collected by an Optim Electronics Megadac data acquisition system (DAS) at a sampling rate of 30 hertz.

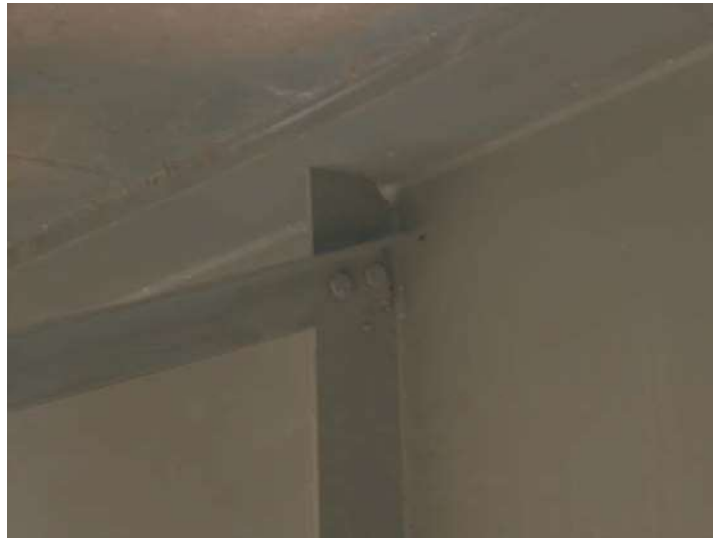
Figure 4.6. Photograph of typical web gap.

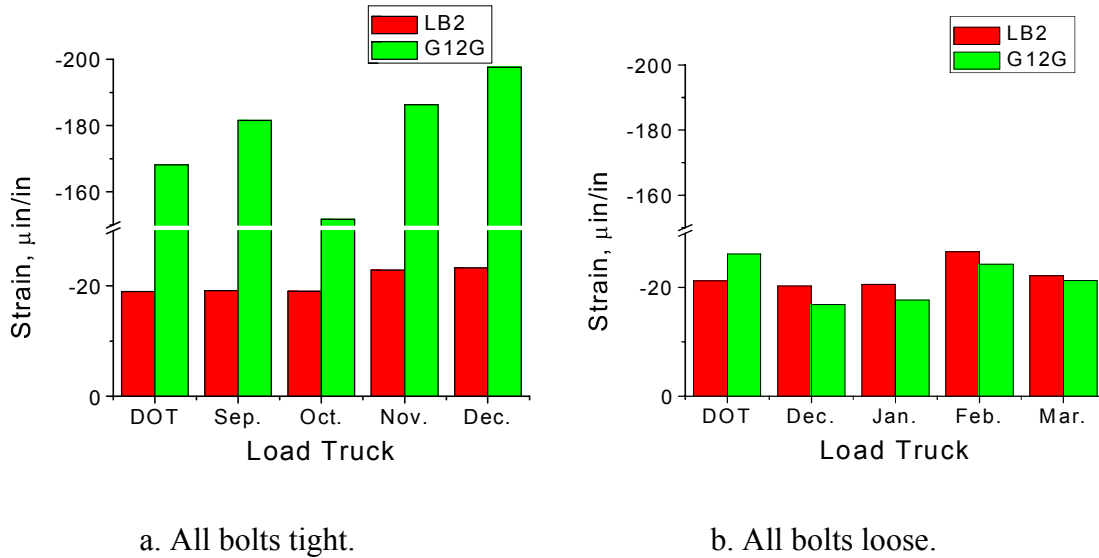
Figure 4.20. Maximum G1 web gap strains and G2 longitudinal strains for individual truck loadings.
