Bridges Designed for Minimum Maintenance

Report No. TR-791

FINAL REPORT

February 11, 2025
WJE No. 2020.5065

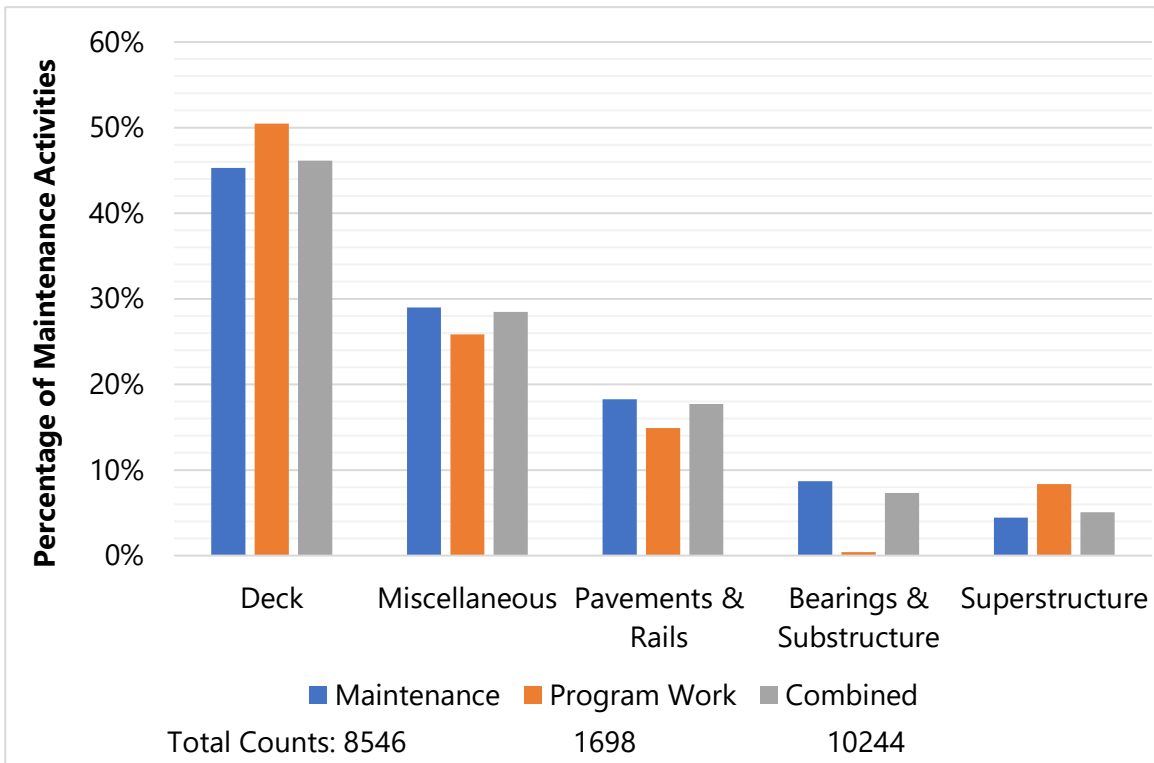
As shown in Figure 4, most bridge maintenance is related to deck repairs (46% of total maintenance) and miscellaneous maintenance (28%); miscellaneous maintenance includes activities such as, berm erosion, tree and brush removal, and flood debris removal. Maintenance related to pavement & rails, bearings & substructure, and bridge superstructure accounted for 18%, 7%, and 5% of all the maintenance entries, respectively.

Figure 4. Maintenance Activities by Category

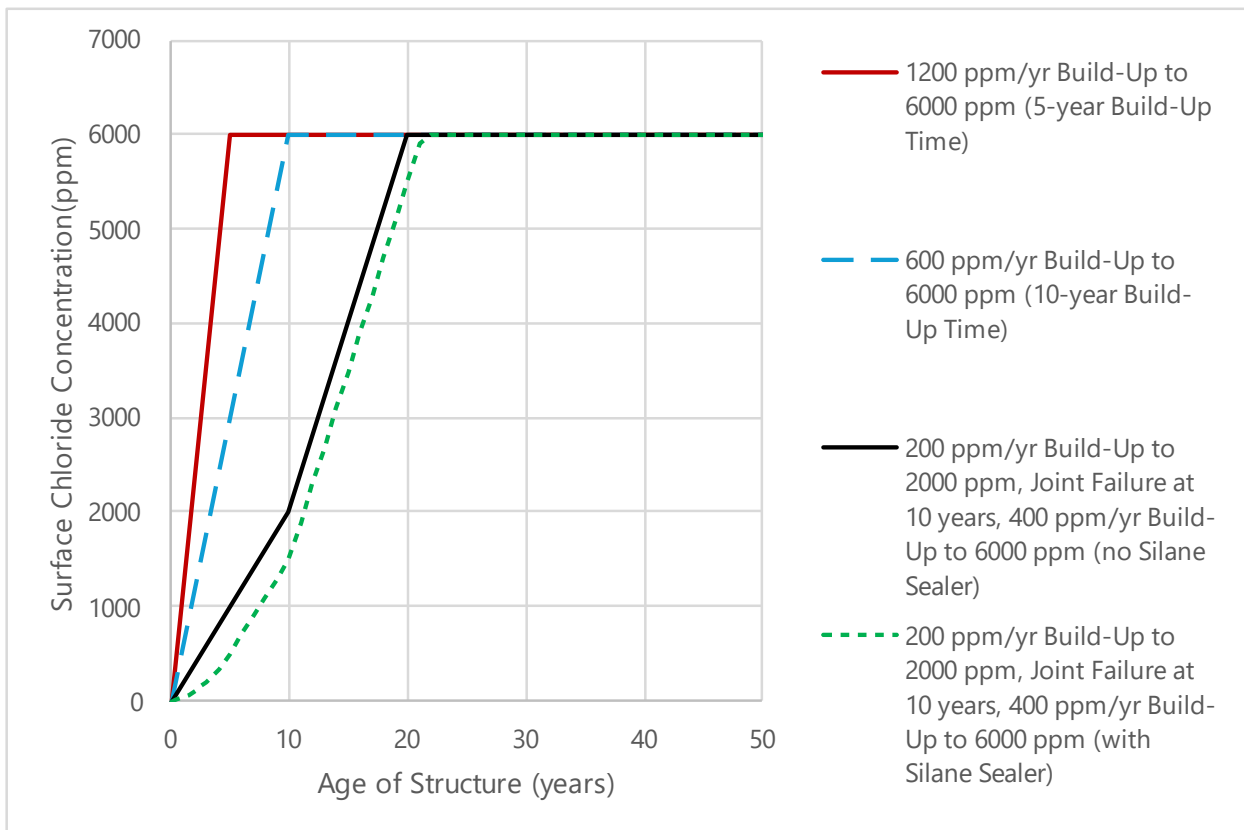
Figure 55. Conceptual illustration of build-up times for various chloride exposures, shown for first 50 years of service.

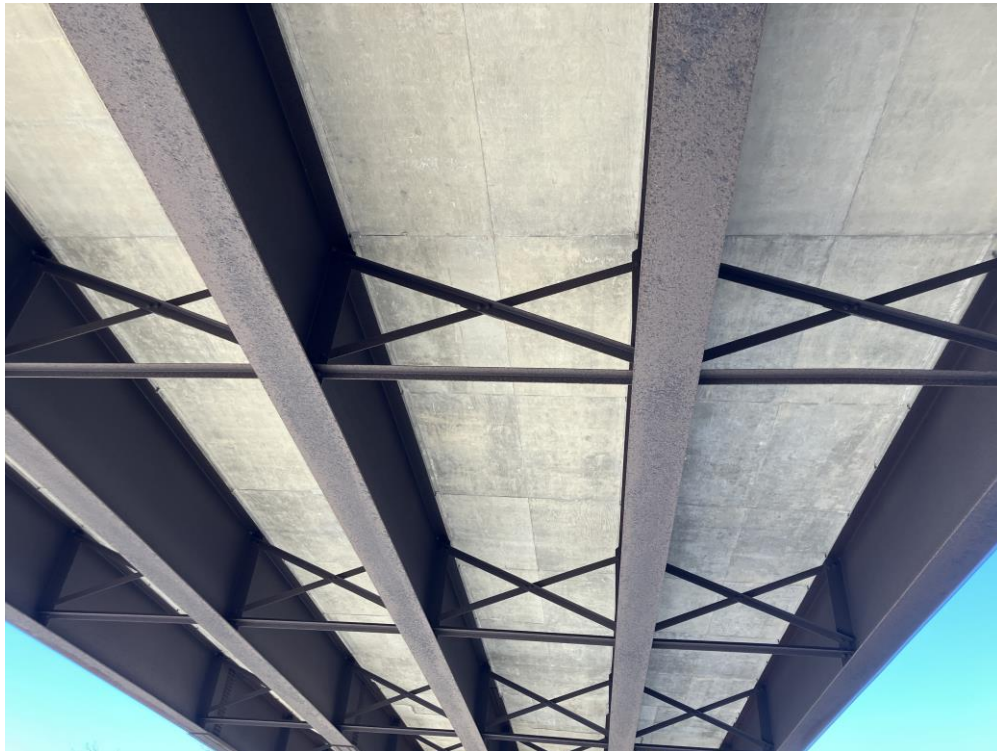
Figure 68. Photograph of the typical appearance of the floor system of No. 606750, dated December 12, 2023, from NBI inspection records.

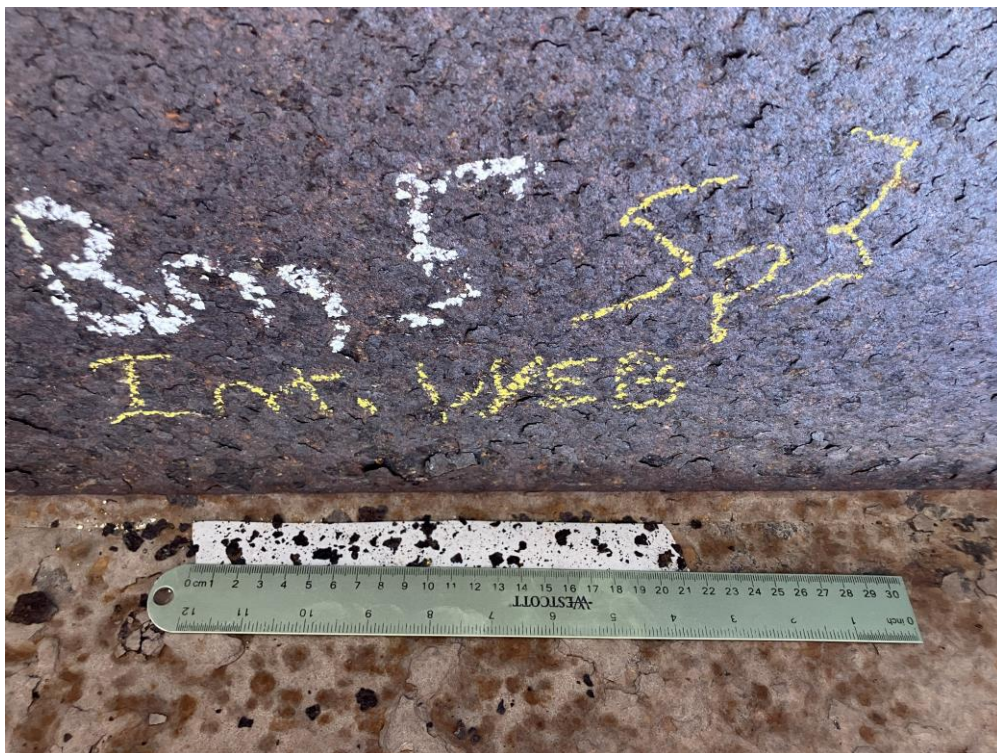
Figure 69. Photograph of a tape test conducted on the web of an interior beam belonging to No. 606750, dated December 12, 2023, from NBI inspection records.

Element-level inspection data from 2015, the year in which the general condition rating of the superstructure decreased to 6, show that the entire superstructure of the bridge was classified as belonging to Condition States 2 or 3 due to the presence of corrosion. Similarly, 56% of the quantity for the weathering steel protective coating (Element 851) was classified as Condition State 3 and 44% was classified as Condition State 2. Photographs from visual inspections show that the bottom flange has a poor patina (Figure 68) and tape tests on the beam webs demonstrated that the patina is not providing protection (Figure 69). This performance can be explained by the low clearance of the bridge over a principal arterial route with relatively high traffic and truck traffic volumes and a high posted speed limit in an urban environment, even though the site does not meet the criteria for an inferior deicing chemical environment, as defined by McConnell et al. (2024), nor the set of site requirements set by the Iowa DOT to qualify the bridge for a more extensive paint system. Additionally, areas adjacent to the beam ends embedded in the concrete abutment are experiencing corrosion (Figure 70) and paint peeling (Figure 71). The relatively sheltered conditions at the abutments are likely contributing to this observed deterioration.

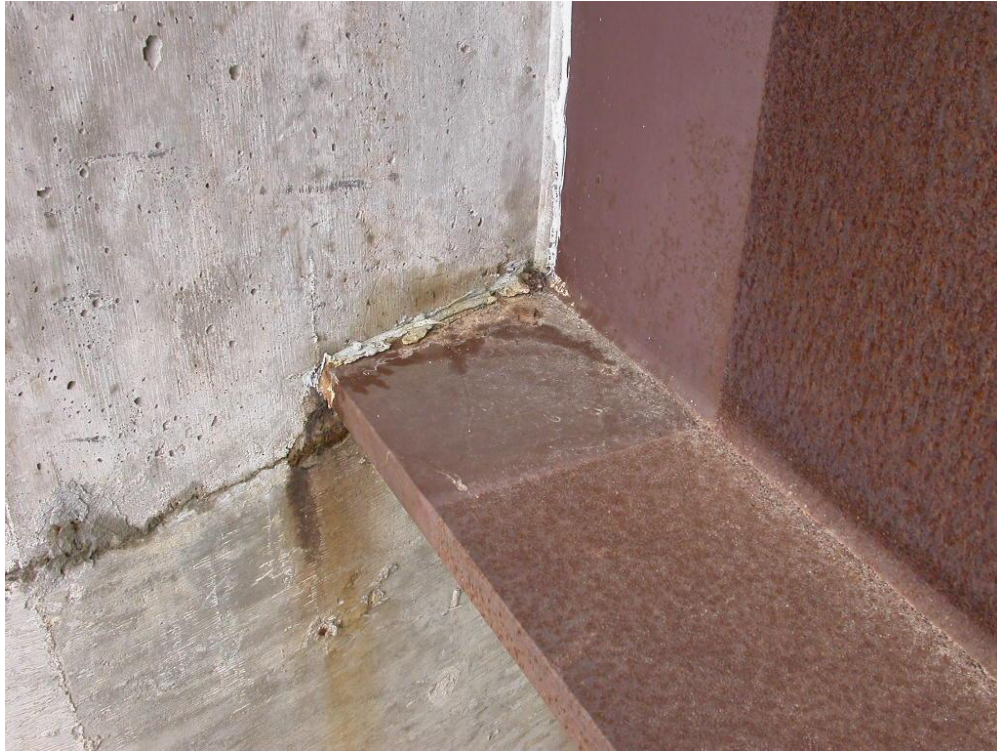
Figure 70. Photograph of rust products implying corrosion at an abutment belonging to No. 606750, dated May 6, 2015, from NBI inspection records.

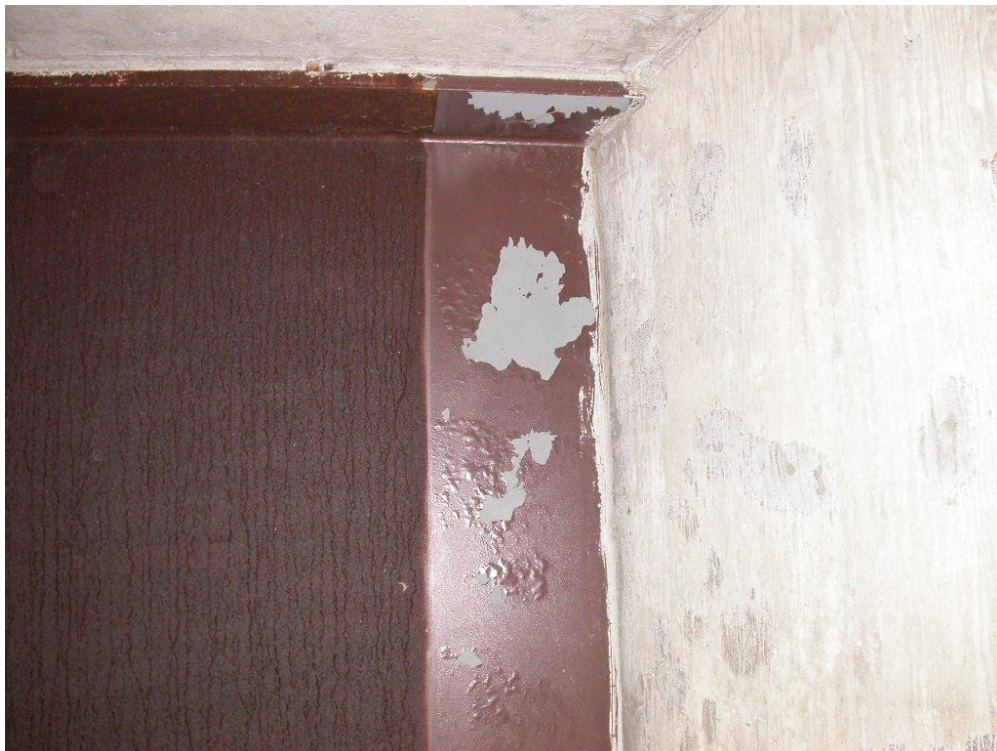
Figure 71. Photograph of peeling paint adjacent to an abutment belonging to No. 606750, dated May 6, 2015, from NBI inspection records.

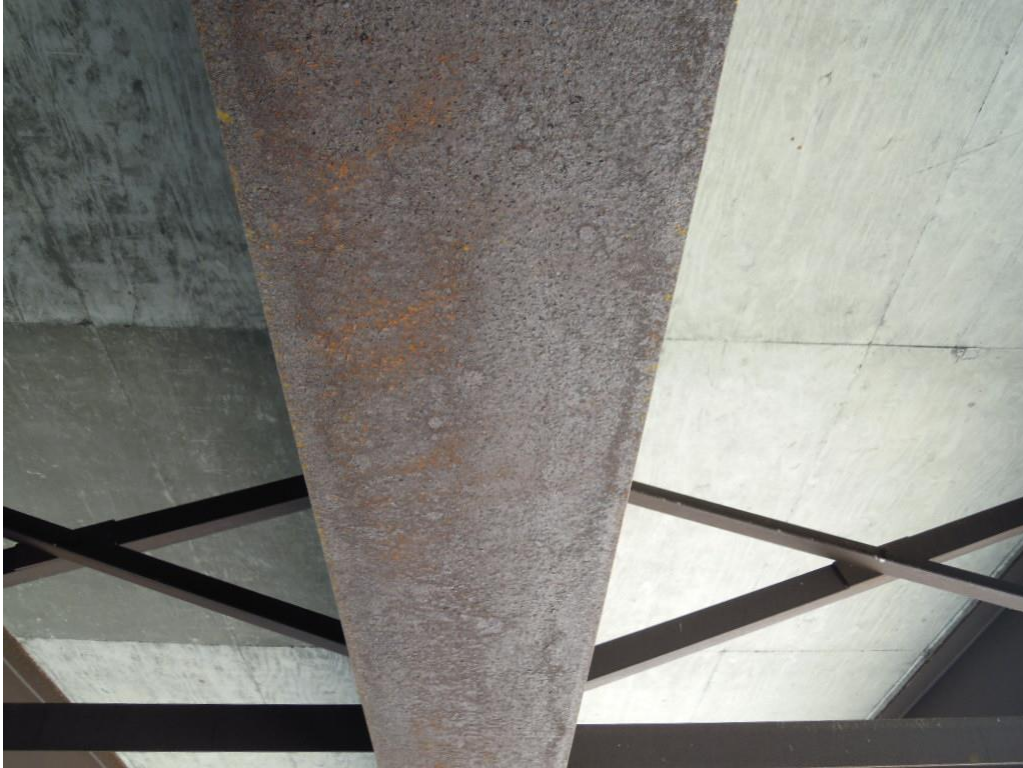
Figure 73. Photograph of typical “light flaking rust above roadways” on underside of a bottom flange of a girder belonging to No. 609280, dated September 29, 2010, from NBI inspection records.

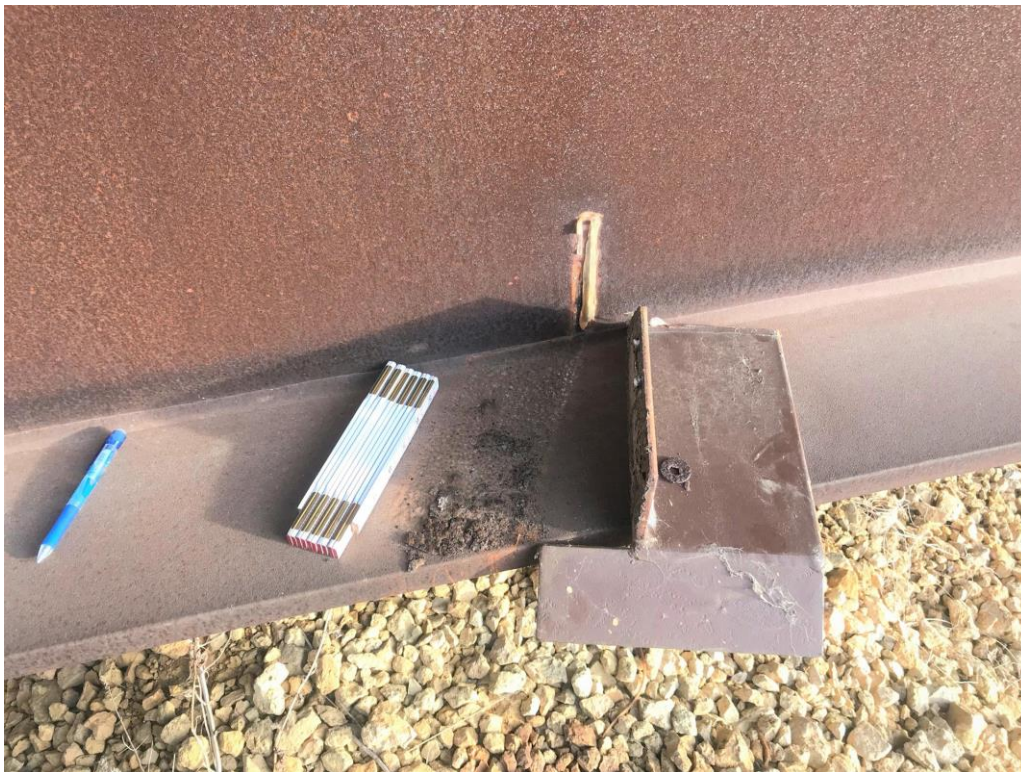
Figure 76. Photograph of a loose deflector plate on No. 606750, dated December 23, 2019, from NBI inspection records.

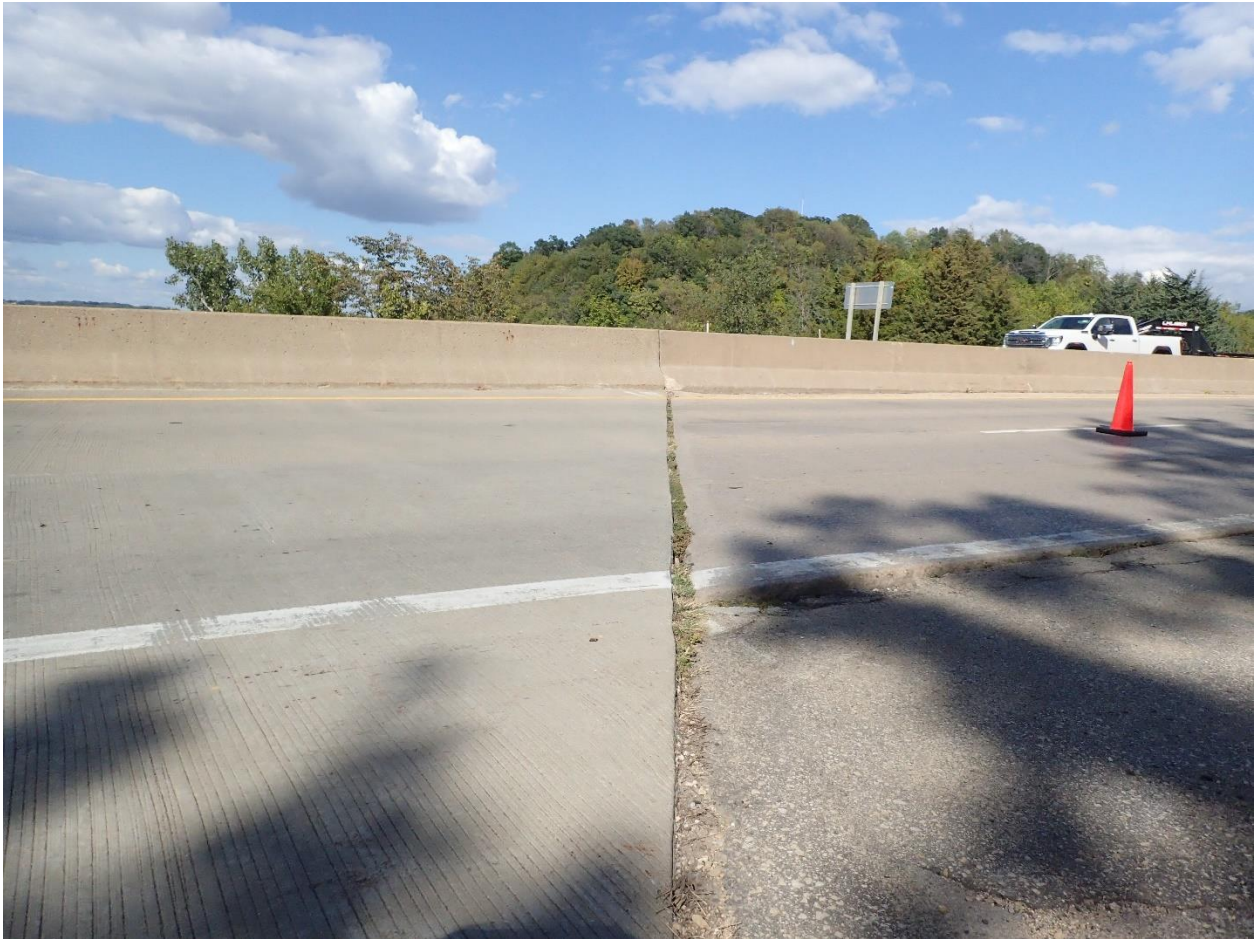
Figure 77. Pourable joint on US 62 over Mississippi River that has become an open joint

Description and Classification. Pourable seal joints, a type of field-formed joint, are closed expansion joints that typically consist of a viscous adhesive and pourable waterproof silicone installed with backer rods to prevent the sealant from flowing down into the joint. The most common seal material utilized is either silicone and/or polyurethane (Baker Engineering & Energy, 2006). Pourable seal joints are traditionally used on shorter spans where the joint movement is 3/16 inch or less (National Cooperative Highway Research Program, 2003). However, newer systems are suggested by manufacturers for larger movements depending on the sealant material (National Cooperative Highway Research Program, 2003). Manufacturers allow installment for skews up to 45 degrees; however, some states limit installment at a max skew of 30 degrees or less.

Service Life and Performance. The service life expectancy of a pourable seal joint ranges between 5 to 10 years (D.S. Brown, 2016) depending on various parameters including initial construction workmanship, selected manufacturer sealant product, joint nosing material selection, environmental factors, truck traffic volumes, and maintenance protocols. According to a national survey of bridge owners and agencies (Baker Engineering & Energy, 2006), the estimated average service life of pourable seal joints is 11.50 years. This average is based on survey responses from 25 state agencies and two Canadian provinces. It was reported (Baker Engineering & Energy, 2006) that the estimated service life of pourable joints and compression seals are comparable while the cost of poured seals is only a fraction of compression seals. However, in another survey (Chang & Lee, 2001) in the state of Indiana and neighboring states, the estimated average service life of pourable joints is 5.56 years. The state of Arizona Department of Transportation has found favorable results with the practice of replacing compression seal joints that have failed in service with pourable seal joints (Baker Engineering & Energy, 2006). On the other hand, Montana Department of Transportation has reported that pourable silicone joints have performed very poorly in Montana and should be avoided, when possible, in rehabs and never used in new construction. Common failure modes of pourable seal joints include bond failures, sealant rupture, and traffic impact if the joint is poured too high. A summarized list of advantages and disadvantages for pourable seal joints is presented below.

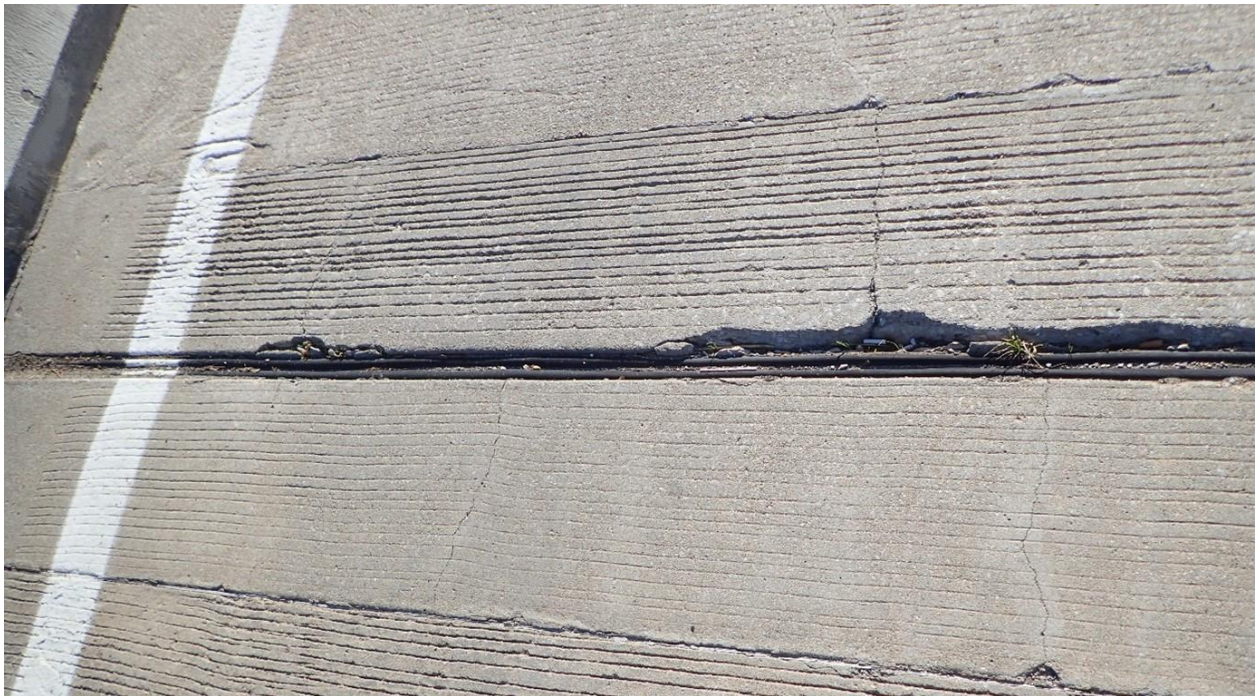
Figure 78. Compression seal joint in SR 46 Eastbound over East Fork White River

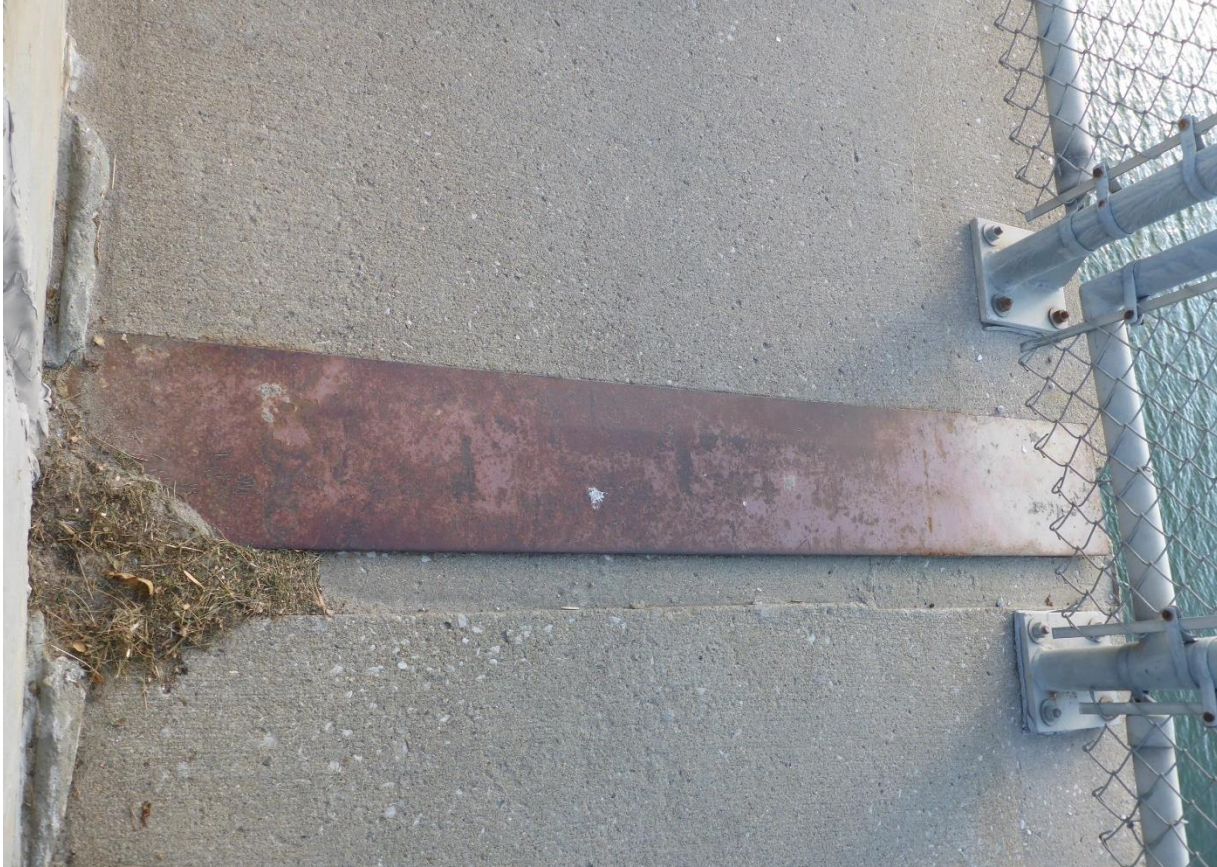
Figure 79. Sliding plate joint in sidewalk on Iowa 926 over the Des Moines River

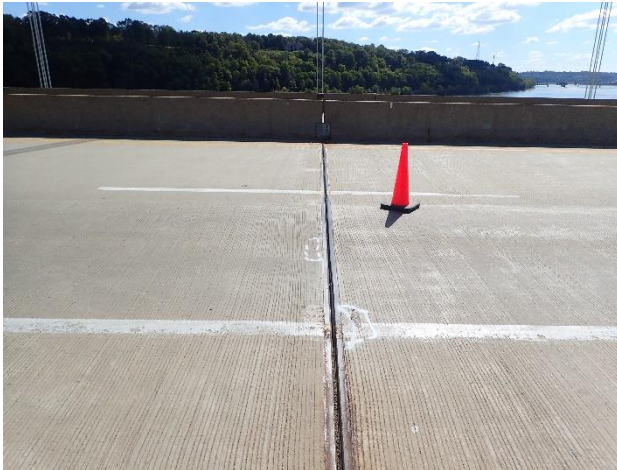
Figure 80. Strip seal joint in US 61 over Mississippi River

Description and Classification. Strip seal joints are a closed expansion joint consisting of steel retainer rails, i.e. steel extrusions embedded in the header concrete, a neoprene gland in-between the steel retainer rails, and a lubricant/adhesive to facilitate the installation of the gland and to seal the gland in the extrusions (Bolluyt, Kau, & Greiman, 2001). The neoprene gland serves as a water barrier protecting the structural elements below the joint from surface runoff, de-icing salts, chemicals, debris, and deleterious materials (Bolluyt, Kau, & Greiman, 2001). The neoprene gland can be anchored mechanically to the extrusion rails or by adhesives. The steel extrusion rails are typically fabricated in 20 to 40 feet lengths and are field spliced as required in-situ (Baker Engineering & Energy, 2006). The maximum skew angle limit reported by manufacturers is 45 degrees; however, movement capacity reduces with skews past 30 degrees. The longitudinal movement range of strip seal joints varies slightly between manufacturers but can go up to 5 inches (Bolluyt, Kau, & Greiman, 2001). Span length limitations are directly dependent on the skew, superstructure type, and maximum thermal movements.

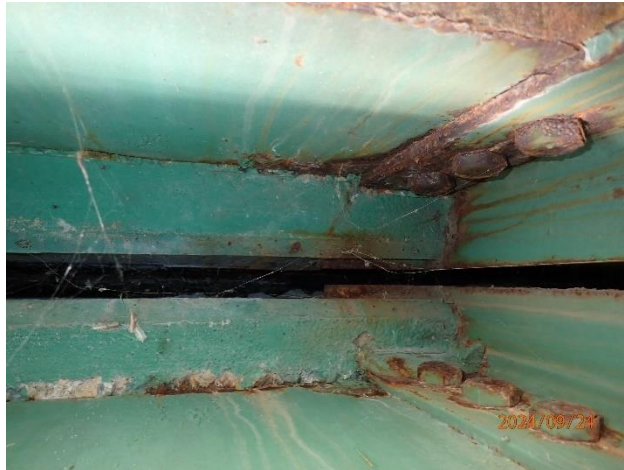
Figure 81. Underside of strip seal joint in US 61 over Mississippi River

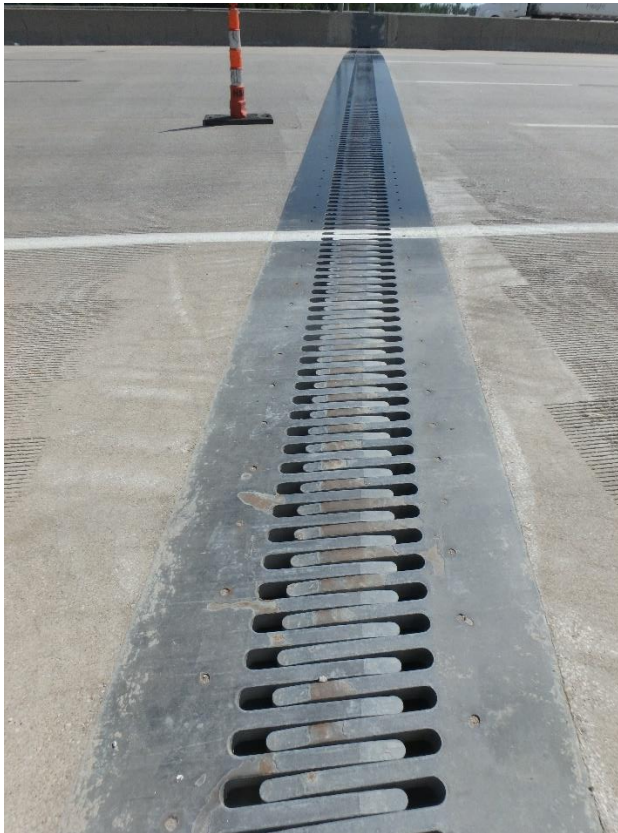
Figure 82. Finger joint on I-80 Westbound over Missouri River

Description and Classification. Finger joints are open expansion joints that are fabricated from steel plate and are installed in cantilever or propped cantilever configurations. The steel fingers are designed to support traffic loads and slide past each other accommodating longitudinal movement of the bridge. Typically, the steel fingers are designed with a slight taper downward toward the end of the fingers to avoid snowplow blade impact. Steel finger joints do not provide a seal, and a drainage trough is most often installed below the joint to collect any surface runoff (Chang & Lee, 2001). Finger joints can be designed for longitudinal movements greater than 4 inches (National Cooperative Highway Research Program, 2003) and skews up to 45 degrees, though they are not recommended for skewed bridges as they tend to lock up (Arora and Associates, P.C., 2019). Span length limitations are dependent on the skew, superstructure type, and maximum thermal movements of the bridge.

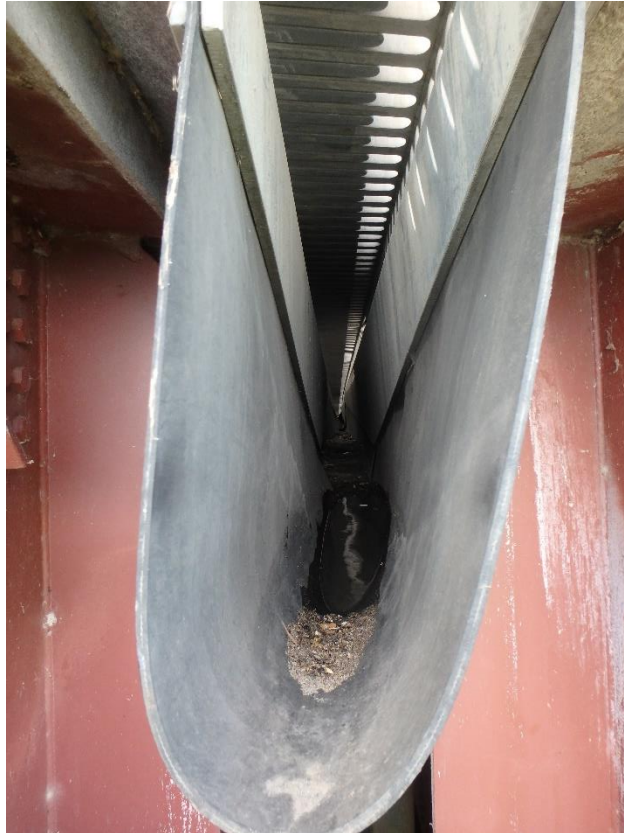
Figure 83. Neoprene trough beneath finger joint on I-80 Westbound over Missouri River

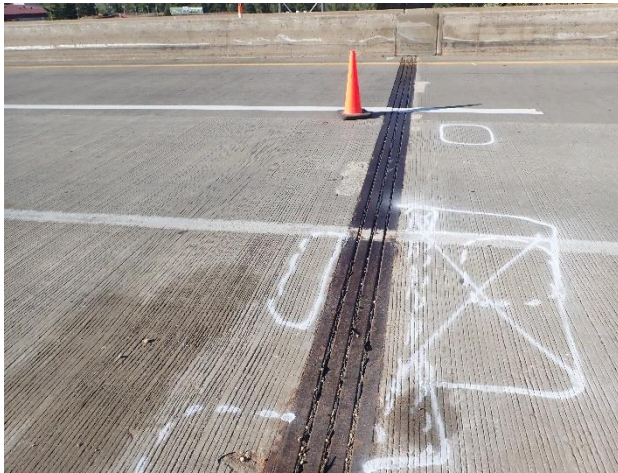
Figure 84. Modular joint on US 61 over Mississippi River

Description and Classification. Modular joints are closed expansion joints consisting of two or more preformed compression seals or neoprene glands fixed between transverse load distribution members. Modular joints are complex mechanical devices that are deeper than most other joint systems. The depth required to accommodate a modular joint essentially prevents the joint from being an option for a retrofit. The joints are generally shipped to the construction site for installation in a completely assembled configuration (Dornsife, 2000). The longitudinal movement range of modular joints range between 4 to 30 inches (Baker Engineering & Energy, 2006).

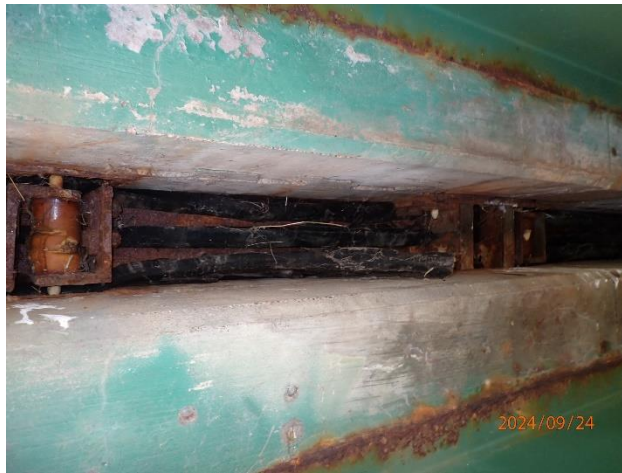
Figure 85. Underside of modular joint

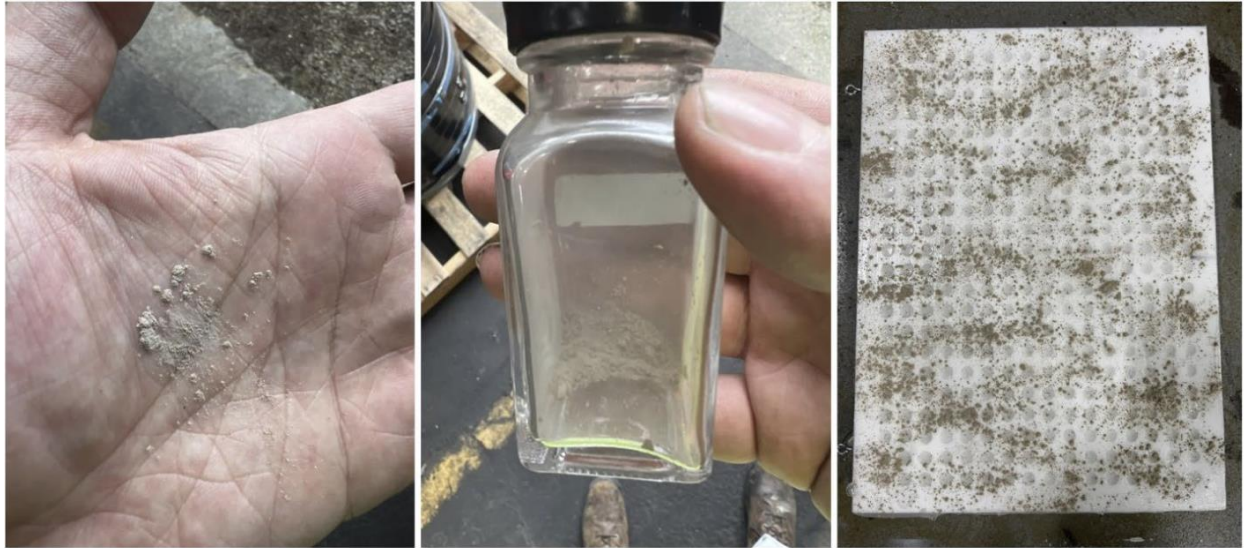
Figure 44. Pre-test photographs of PF3 specimen sprinkled with a light amount of dust prior to testing.

Figure 90. Reproduction of Figure 44 from Nejad and McGormley, 2024 demonstrating amounts of dust required to drastically change coefficients of friction on PTFE sliding surfaces

Service Life and Performance. Sliding surfaces have a service life between 20 to 25 years before replacement is required. Factors affecting wear life include sliding speeds, contact pressure, mating surface roughness, and contamination of the sliding interface. Lubrication of the PTFE is a method to significantly reduce the coefficient of friction (Azizinamini, et al., Design Guide for Bridges for Service Life, 2014). Research (Nejad & McGormley, 2024) showed that even small amounts of dust contamination can

result in a factor of 10 increase in the friction coefficient of PTFE bearing. A summarized list of advantages and disadvantages for bearing sliding surfaces is presented below.

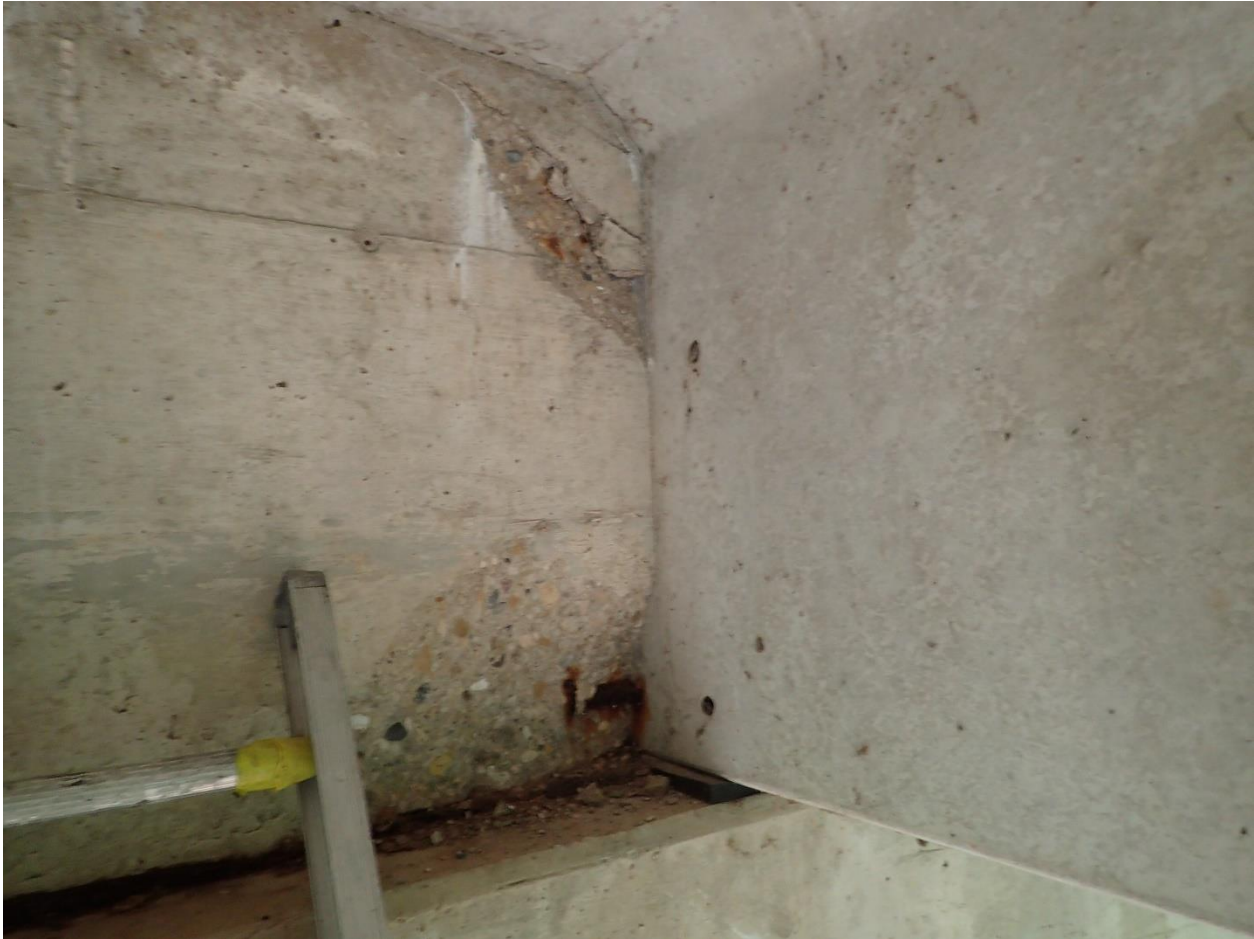
Figure 91. Plain elastomeric bearing pads on the Carr-Thompson Bridge in Lake Forest, IL

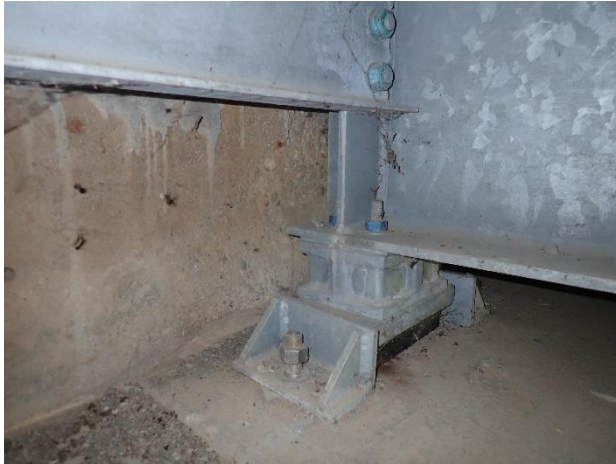
Figure 92. Steel-reinforced elastomeric bearing on Deerpath Road over East Skokie Ditch in Lake Forest, IL

Description and Classification. Steel-reinforced elastomeric bearing pads are a type of elastomeric bearing consisting of a neoprene or natural rubber pad combined with reinforcing internal steel shim plates. As vertical load and movement requirements increase, reinforcing steel plates are incorporated within the multiple layers of elastomer to form a laminated reinforced elastomeric assembly (Azizinamini, et al., Design Guide for Bridges for Service Life, 2014). The addition of internal steel reinforcing plates allows for higher compressive design stresses and higher translation and rotation capacities as the internal bonded steel shims resist bulging of the unit (AISC, 2022). Steel-reinforced bearing pads are rated to accommodate 50 to 750 kips of load with up to 4 inches of movement and 0.02 radians of rotation. On their own, steel-reinforced elastomeric bearing pads can accommodate high truck movements.

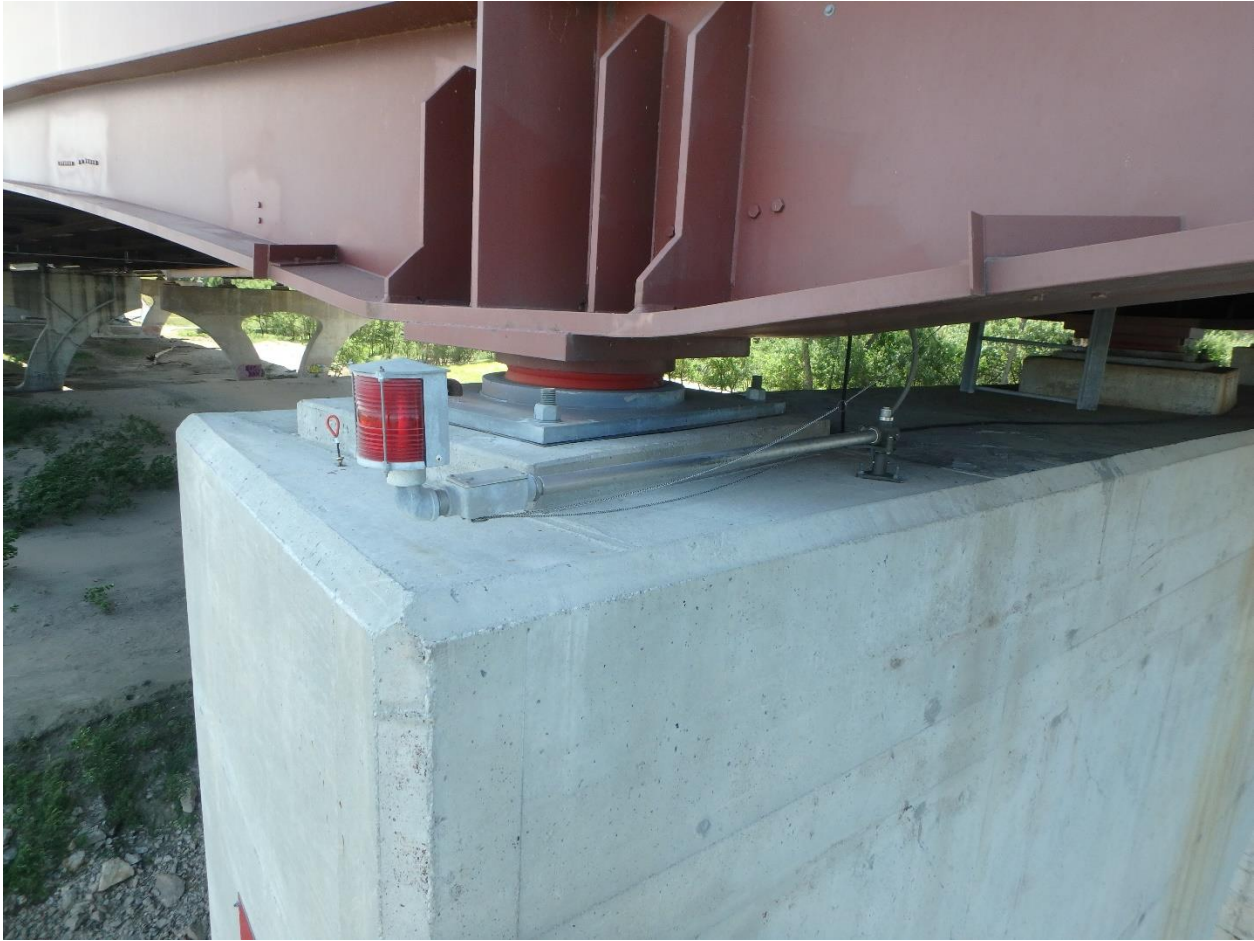
Figure 94. Disc Bearing on I-80 Westbound Bridge over Missouri River

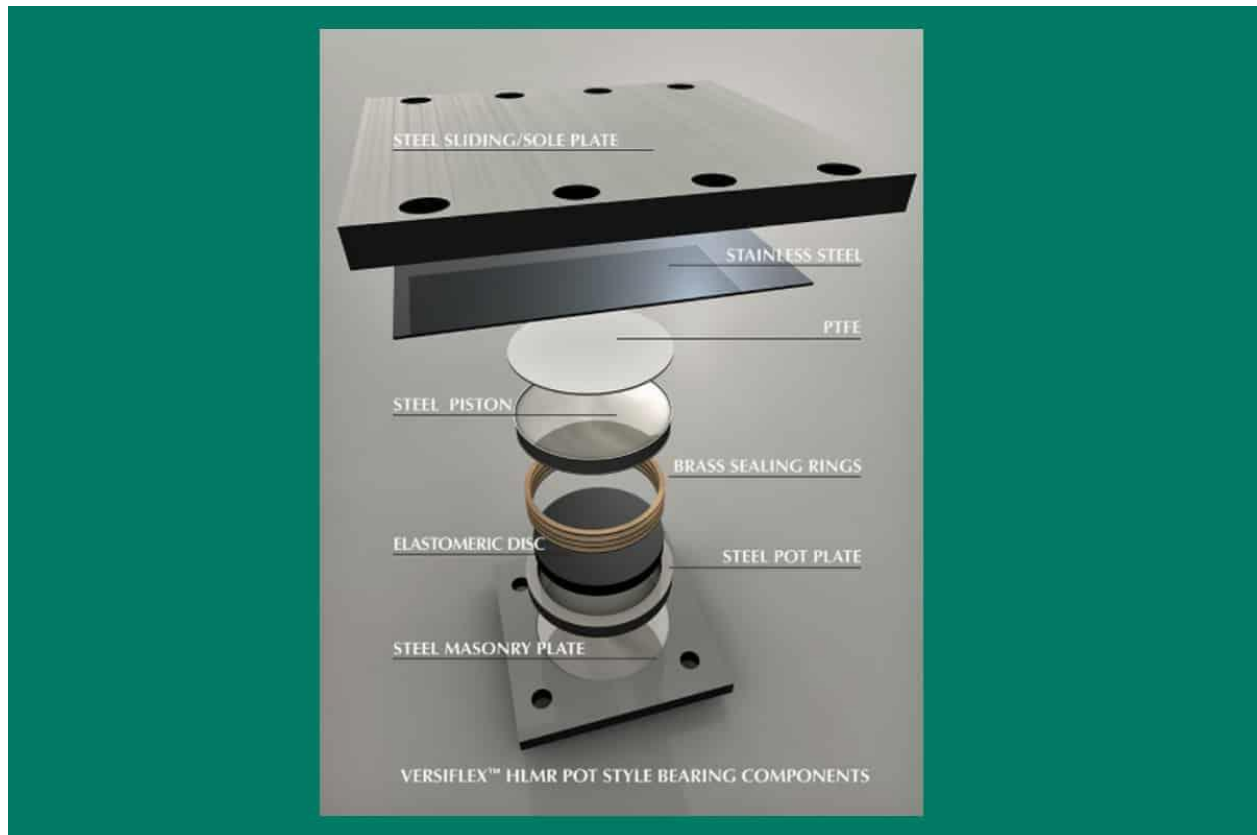
Figure 95. Exploded view of pot bearing (D.S. Brown, 2022)

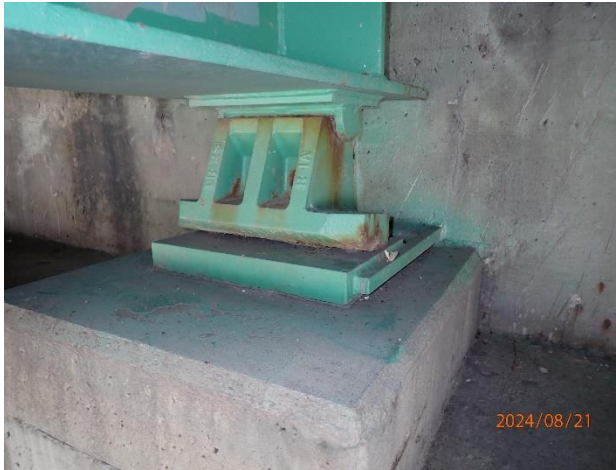
Figure 96. Rocker bearing on US 77 over Missouri River

Description and Classification. Steel rocker bearings can be designed using many different configurations. Conventionally bearings that utilize two distinct steel components pinned together with the upper component fixed to the superstructure while the bottom component has a curved lower section such that it can 'rock' across a bearing plate on the pier or abutment are referred to as rocker bearings. Rocker bearings have a load capacity range of 50-750 kips and a high capacity for rotation. In bridges that use rocker bearings for expansion, similarly shaped bearings referred to as fixed shoes or fixed shoe bearings that are pinned together in the same manner, but lack a curved rocking surface and are instead anchored to the substructure, are often used at fixed bearings.

Service Life and Performance. Rocker and fixed shoe bearings, when properly installed and maintained, can have a service life of over 100 years (Azizinamini, et al., Design Guide for Bridges for Service Life, 2014). However, the rocker bearings feature steel exposed to the elements and have historically displayed corrosion that causes pins to lock up, inducing large forces and possible damage to abutments. Galvanizing, metalizing, or high-performance paint systems can be utilized to mitigate corrosion threats (Arora and Associates, P.C., 2019). These expansion bearings risk toppling over when facing excessive translations. A summarized list of advantages and disadvantages for steel rocker bearings is presented below.

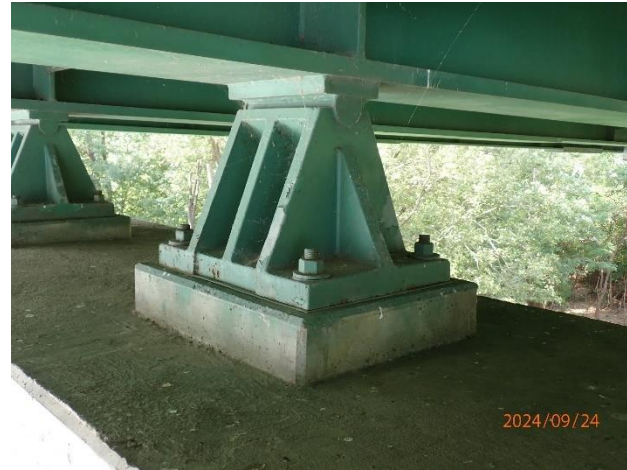
Figure 97. Fixed shoe on US 61 over Mississippi River

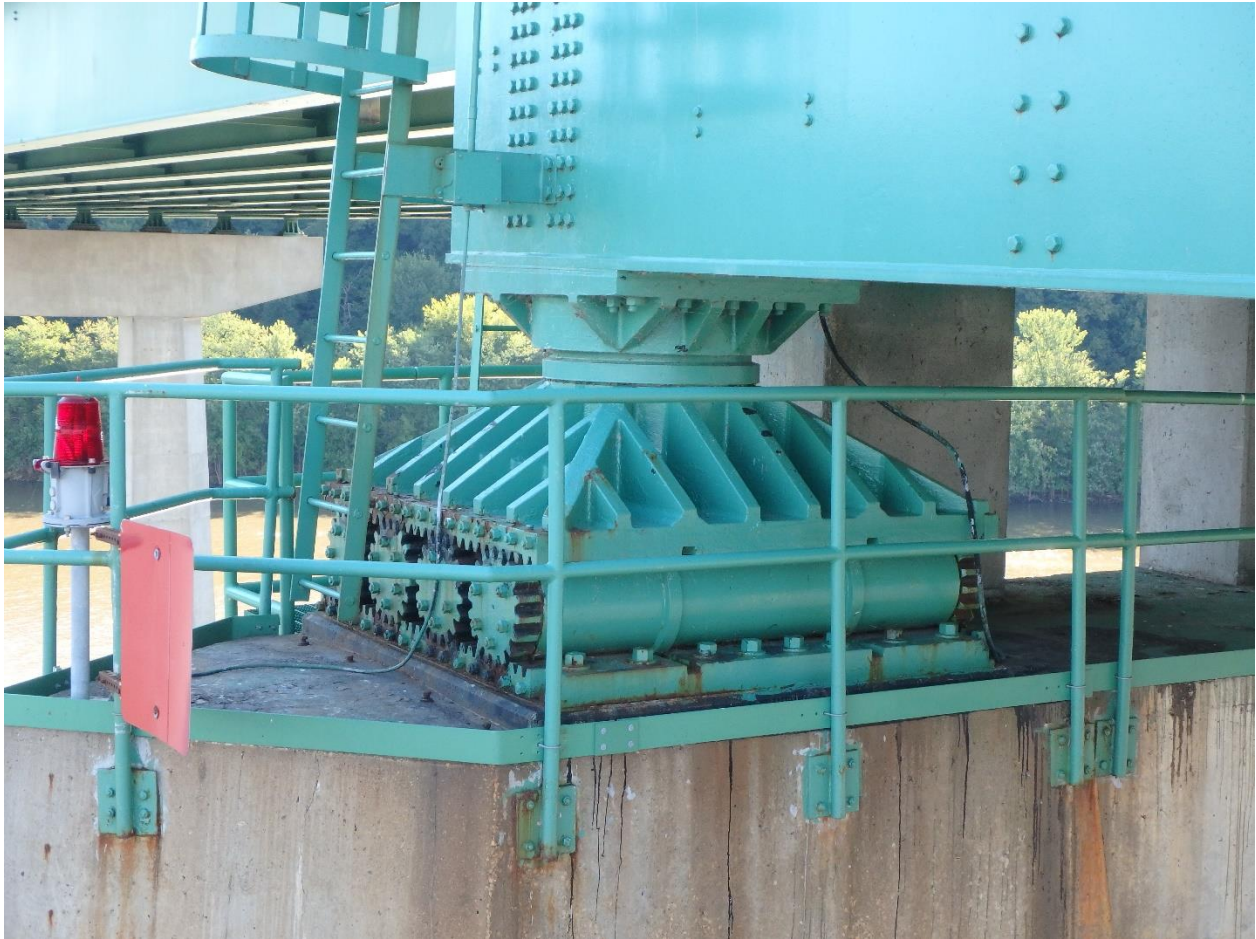
Figure 98. Roller bearing beneath tied-arch on US 61 over the Mississippi River

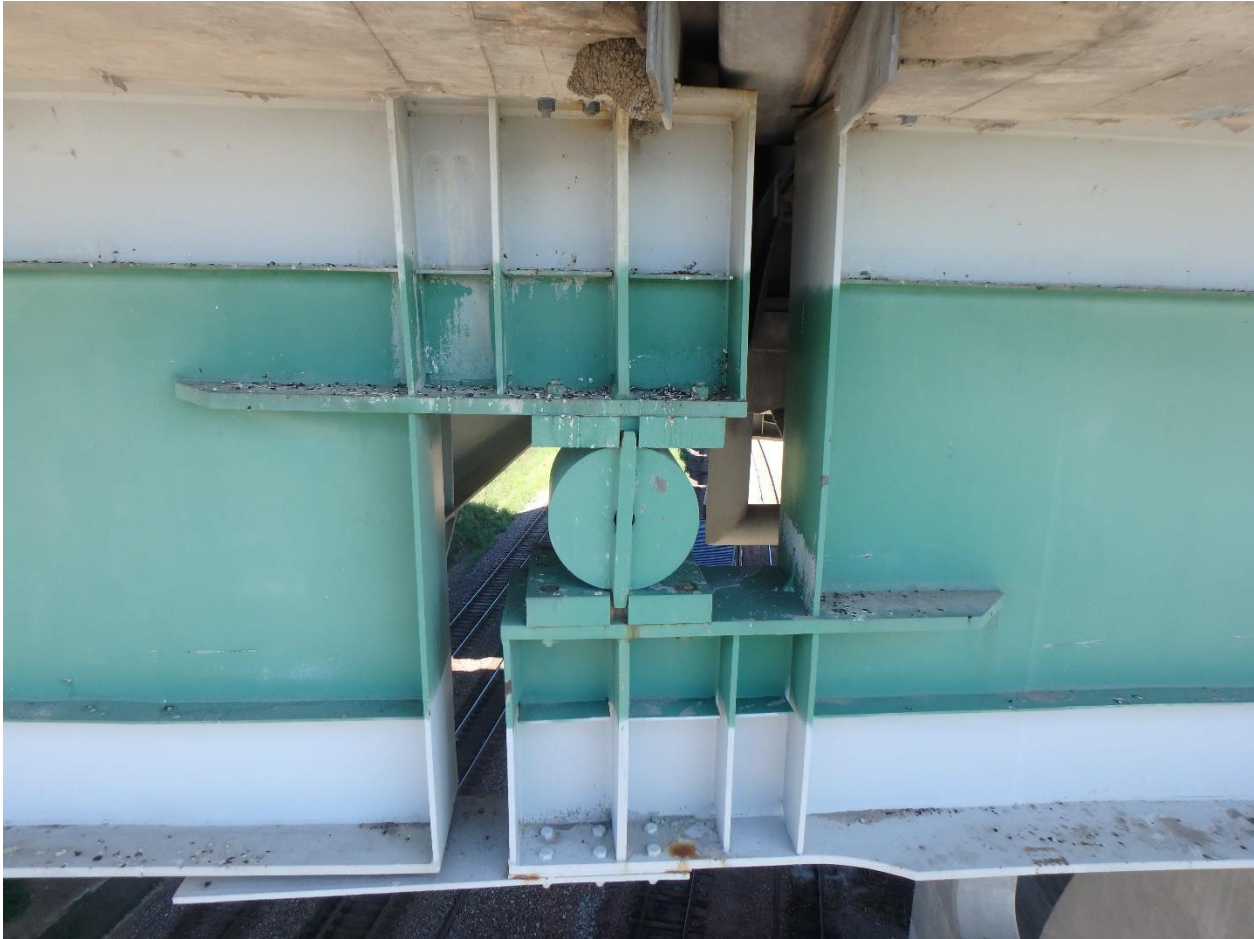
Figure 99. Roller hinge bearing on I-80 Eastbound over the Missouri River
