Bridges Designed for Minimum Maintenance

Report No. TR-791

FINAL REPORT

February 11, 2025
WJE No. 2020.5065

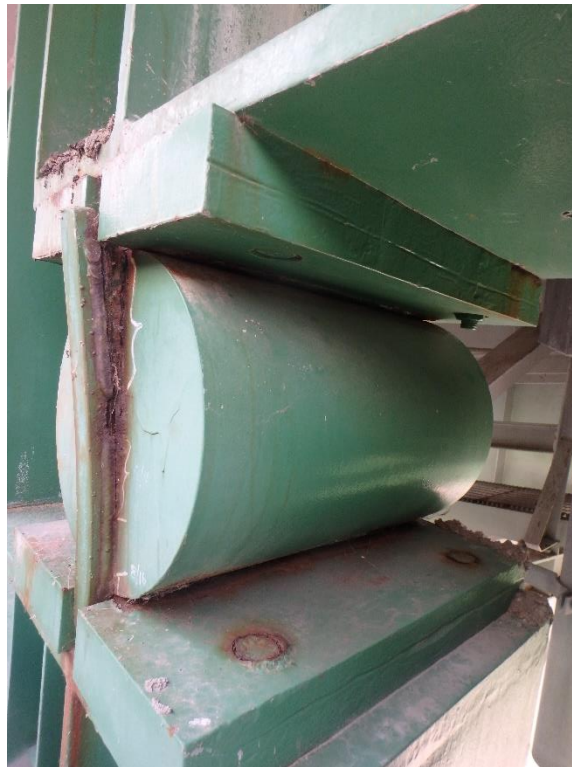
Figure 100. Pack rust and weld cracking at pintle bars in roller hinge bearings on I-80 Eastbound over the Missouri River
