Field Testing of Railroad Flatcar Bridges Volume II: Multiple Spans

Final Report
August 2007

Sponsored by
the Iowa Department of Transportation
and
the Iowa Highway Research Board (Project TR-498)

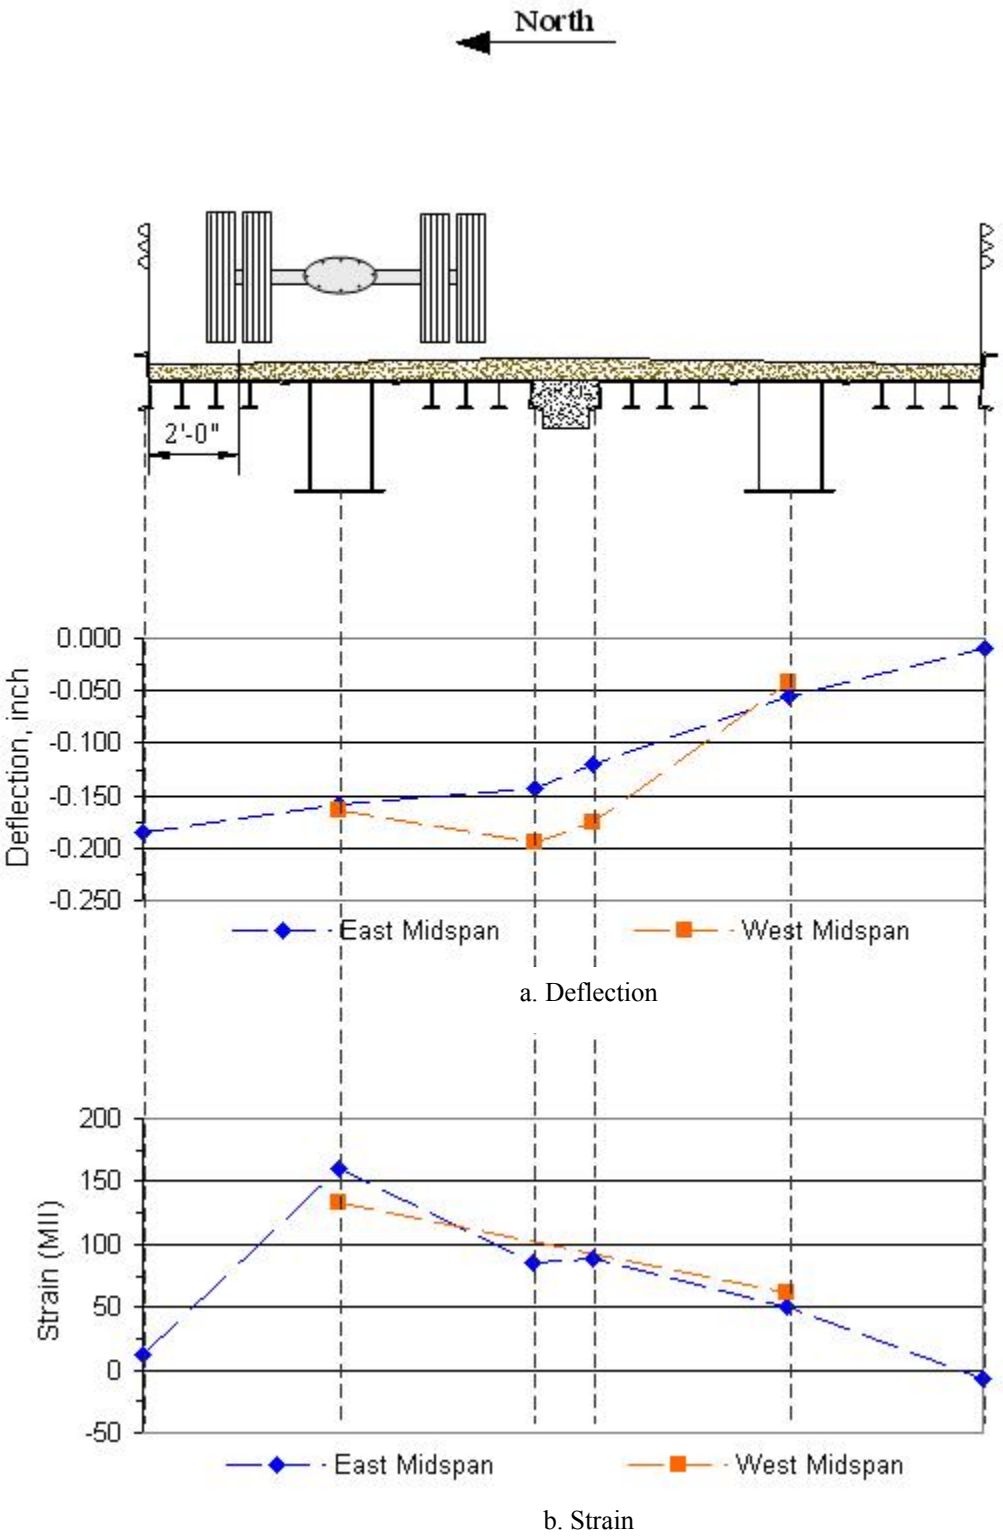
Figure 2.11. BCB4 Lane 1 midspan live load deflections and strains

cross section. The maximum midspan strain that occurred as a result of the load test was 160 microstrain (4.6 ksi). Adding the dead load strain (stress) value of 78 microstrain (2.2 ksi) increases the total maximum strain (stress) occurring at the east midspan to 238 microstrain (6.8 ksi), approximately 35% of the allowable 19.8 ksi (683 microstrain) limitation.

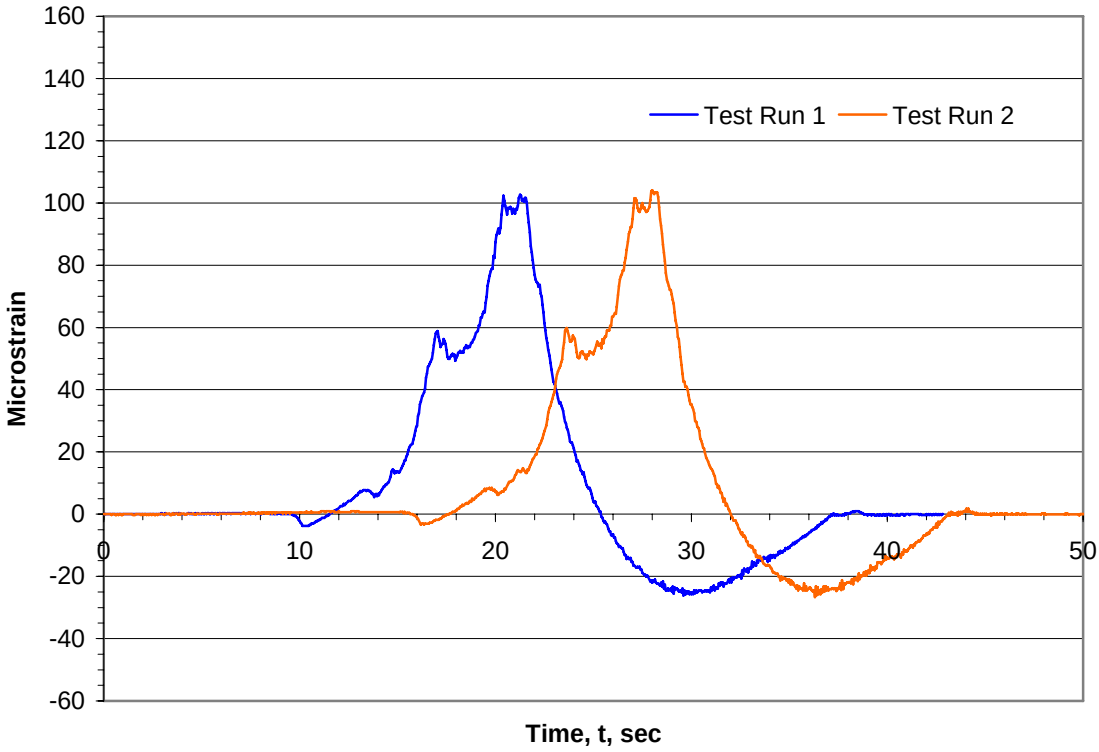
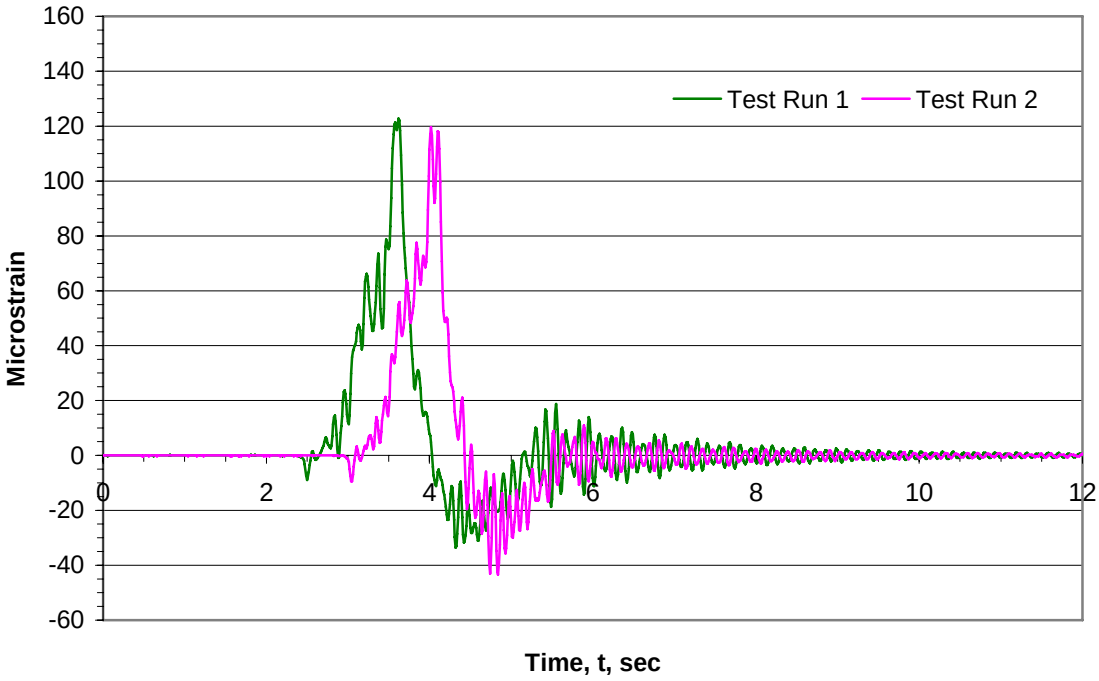
Figure 2.14. BCB4 dynamic amplification of strains

The dynamic amplification was calculated by comparing the maximum strains for the main girders in each span. The dynamic amplification for BCB4 was calculated to be approximately 20%. The dynamic amplification for the south girder at the east midspan location is shown in Figure 2.14.

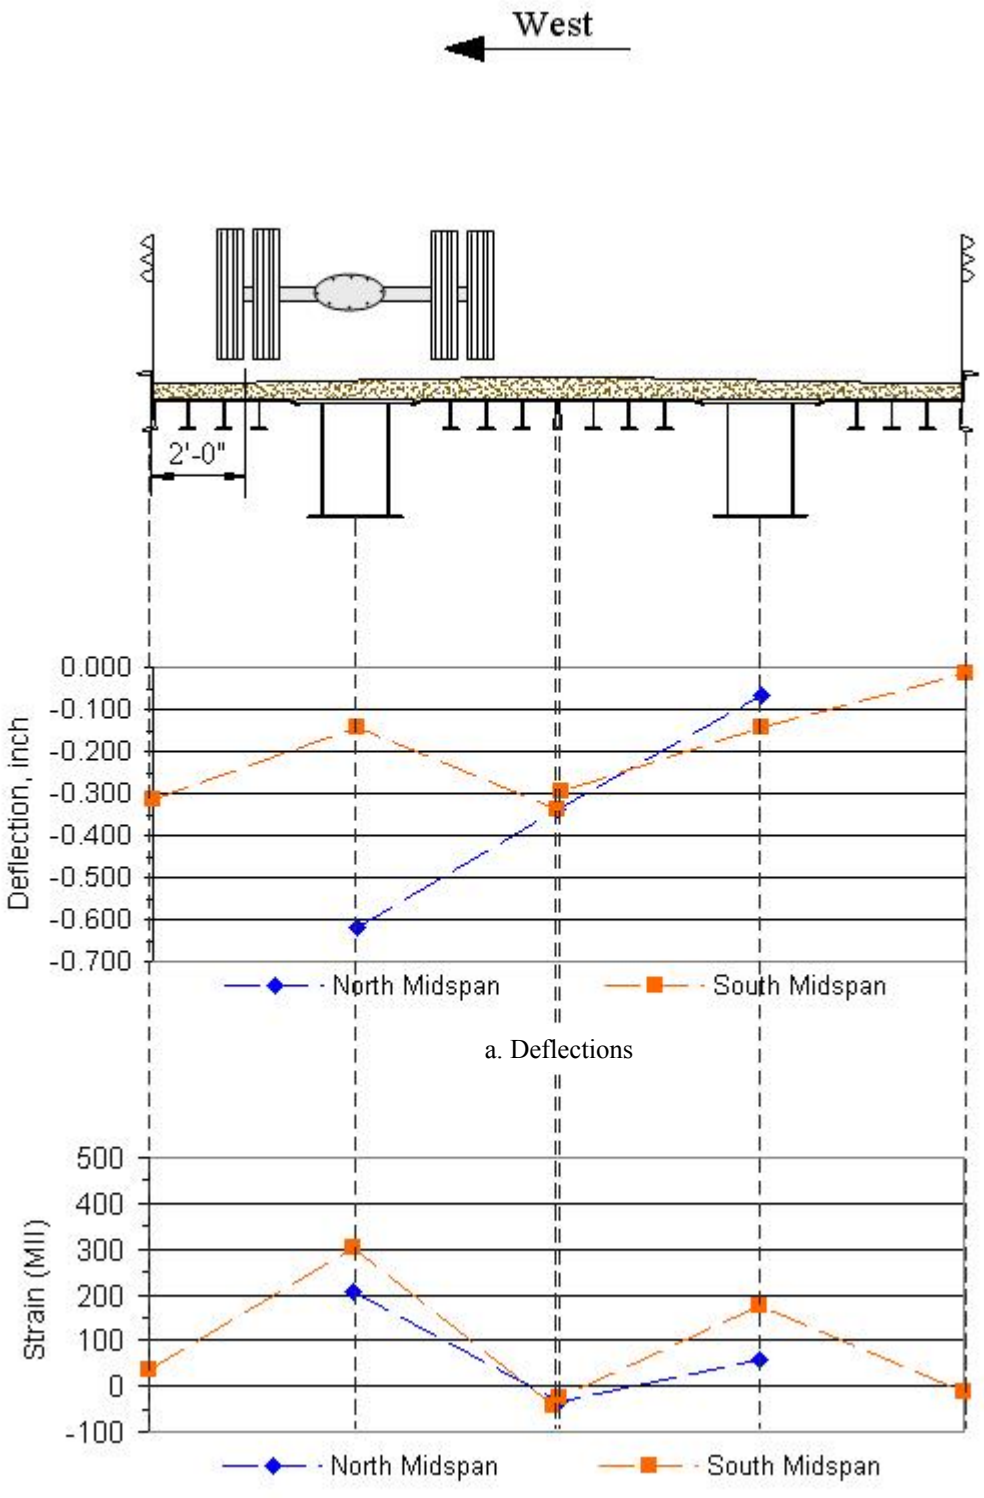
Figure 3.12. BCB5 Lane 1 midspan live load deflections and strains

The strains and deflections measured for each midspan locations are presented in Figures 3.12 – 3.14 for each of the three test lanes. Dashed lines have been added to provide a hypothetical linear trend line between the data points. The maximum midspan live load strain that occurred as a result of the field load test was 412 microstrain (11.9 ksi). Adding the dead load strain (stress) value of 70 microstrain (2.0 ksi) increases the total strain (stress) occurring in the bridge to 482 microstrain (14.0 ksi), which is approximately 71% of the allowable 19.8 ksi (683 microstrain).

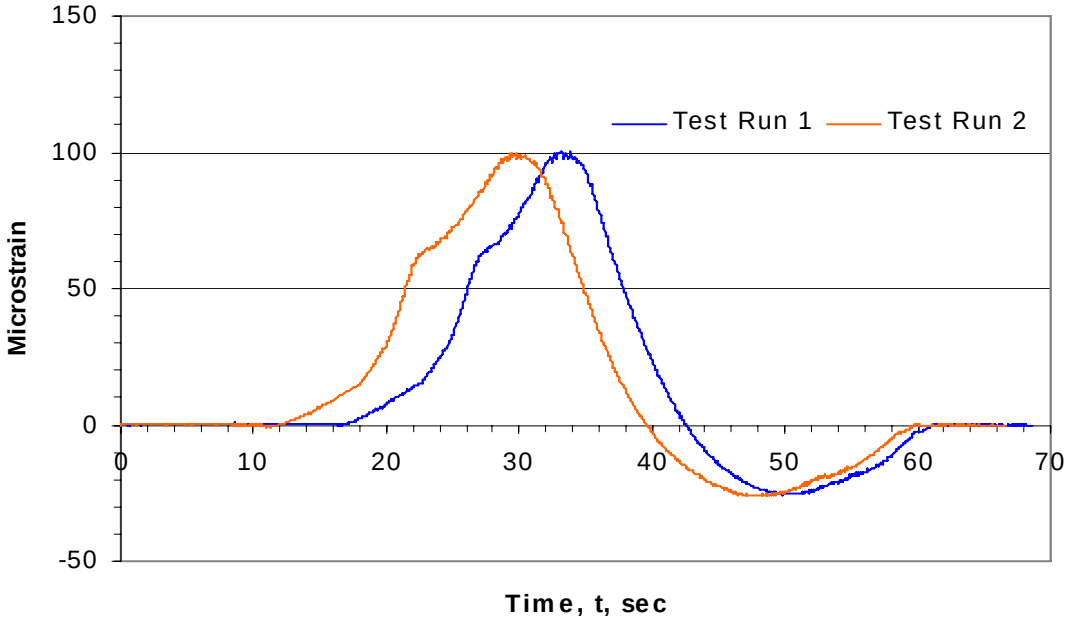
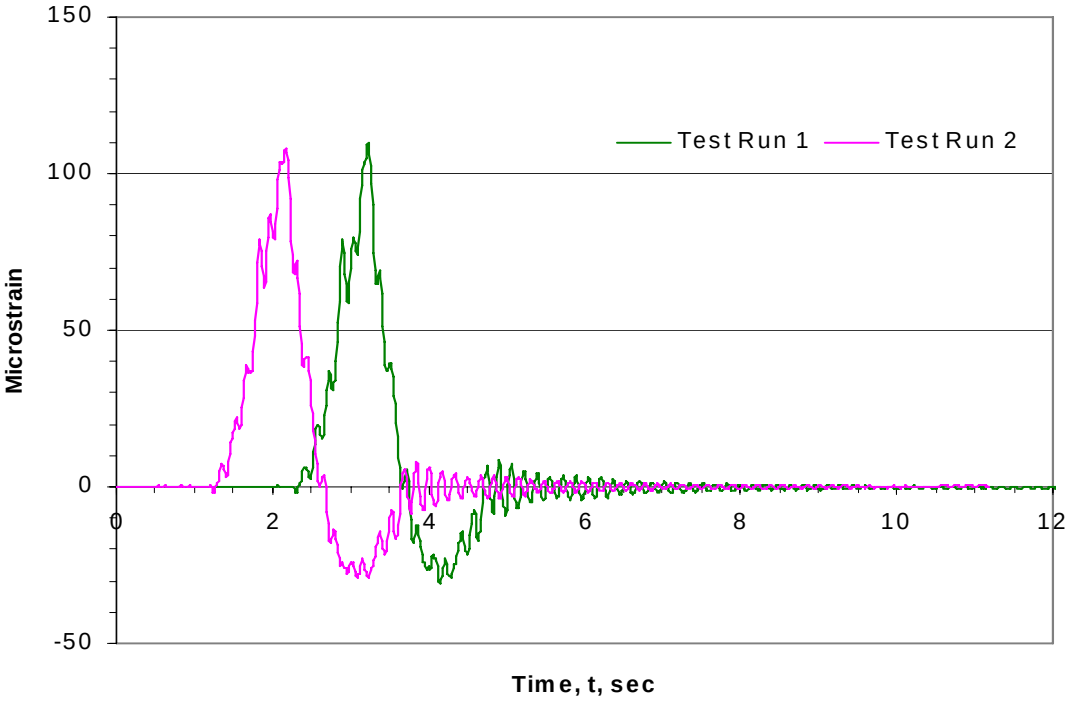
The dynamic amplification was calculated by comparing the maximum strains in the main girders in each span. The resulting dynamic amplification for BCB5 was determined to be approximately 10%. The dynamic amplification of strains for the East girder at the North midspan location are shown in Figure 3.15.

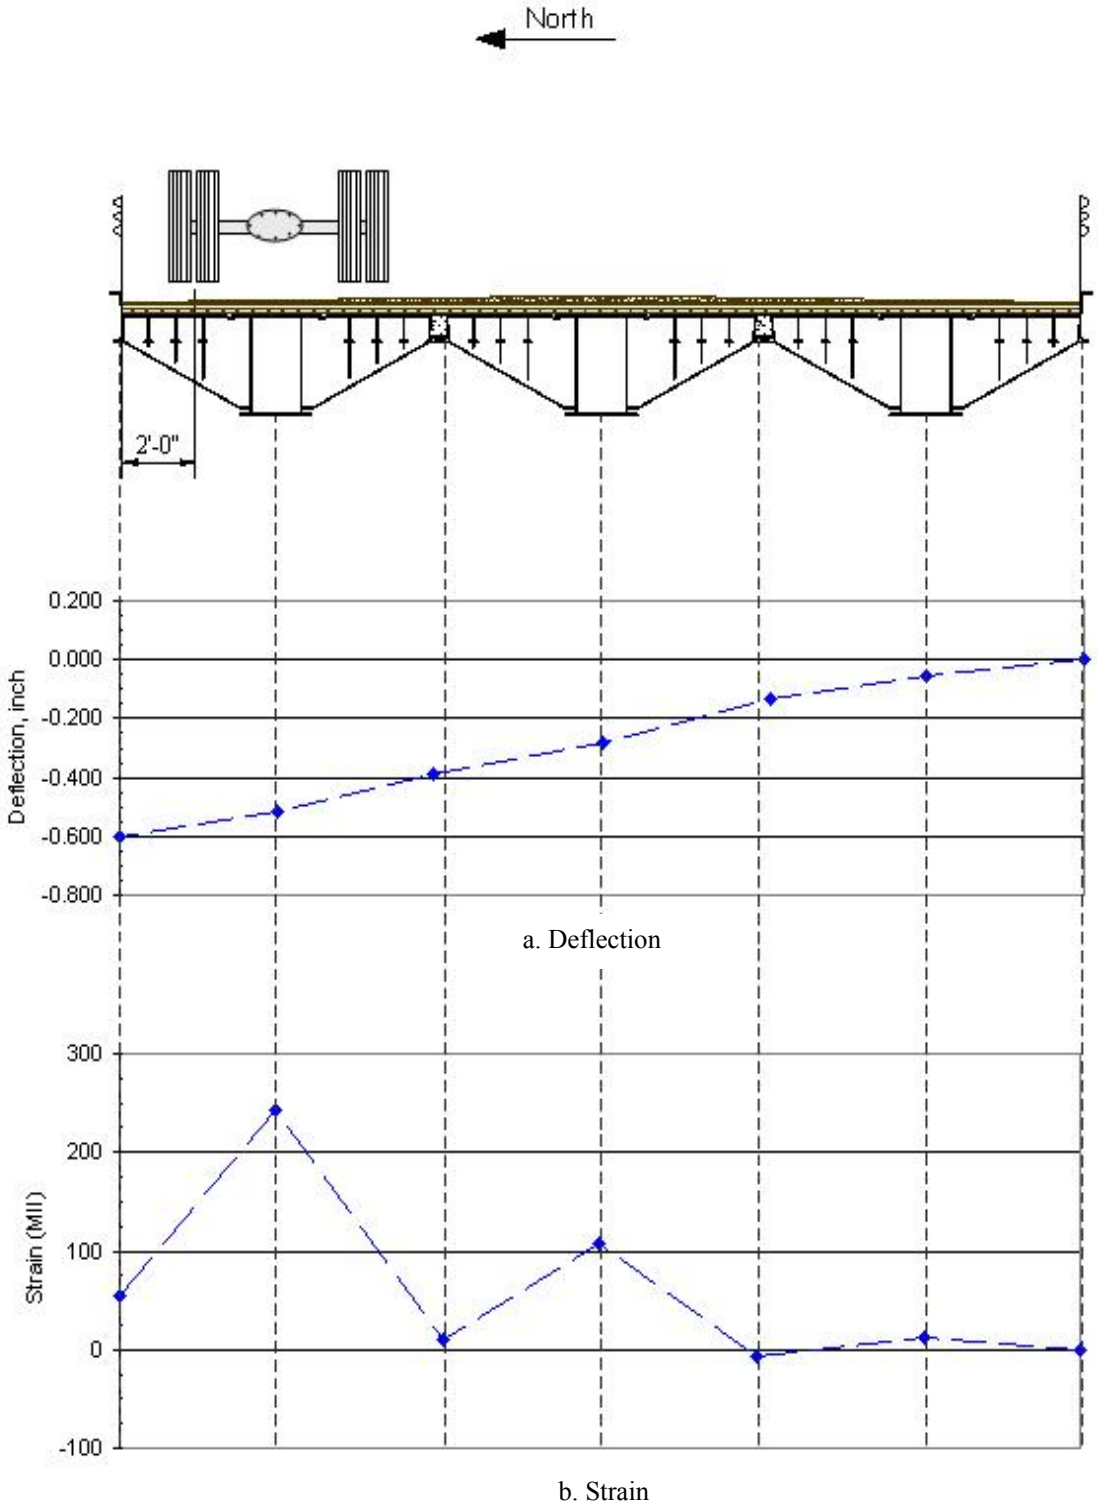
Figure 4.10. WCB3 Lane 1 midspan live load deflections and strains

As was done for previous RRFC bridges, an adjustment factor was used to increase the results from the test vehicle to those of an HS-20 truck, the likely design vehicle for the bridge. This adjustment factor was determined using the same methodology as was used previously in TR-498 Volume 1 [11]. The adjustment factor for WCB3 was 1.443. Using this value, the projected maximum total strain for an HS-20 truck on WCB3 becomes 586 microstrain (17.0 ksi), which is still below the allowable value of 19.8 ksi (683 microstrain). Using the same extrapolation approach, the maximum live load deflection increases to 0.88 inches, still within the AASTHO guidelines.

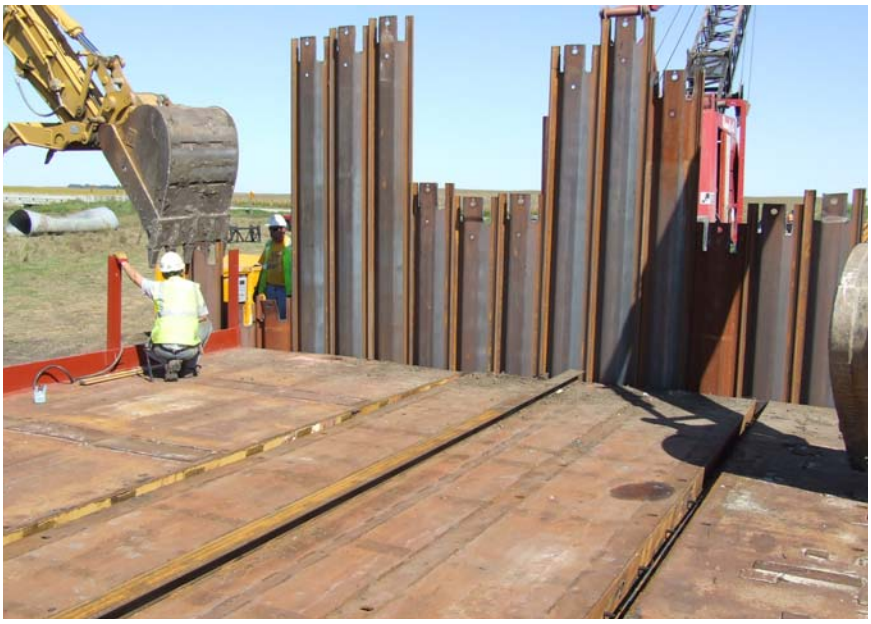
Figure B.6. East abutment after driving

The sheet pile sections used for the WCB3 abutment were approximately 0.21 inches in thickness. These sections were readily available to Winnebago County and satisfied the requirements for the stresses that resulted from soil retention. However, when construction started on the abutments, it was soon realized that the sections were not substantial enough to withstand the forces that the vibrating pile driving equipment was exerting on the sections. This inadequacy resulted in two things. First, extra care had to be taken not to buckle the portion of the sheet pile sections within the jaws of the vibrator (Figure B.5). Second, it was not possible to drive the sheet pile sections to the design depth. Instead, the sections were driven to rejection (just before the portion in the jaws buckled). This was deemed satisfactory by on-site personnel as the rejection depth varied only plus/minus two feet from the original depth. Figure B.6 shows the sheet pile sections at the east abutment just after driving. After the pile sections were driven, the sections were cut off to provide a level top section.

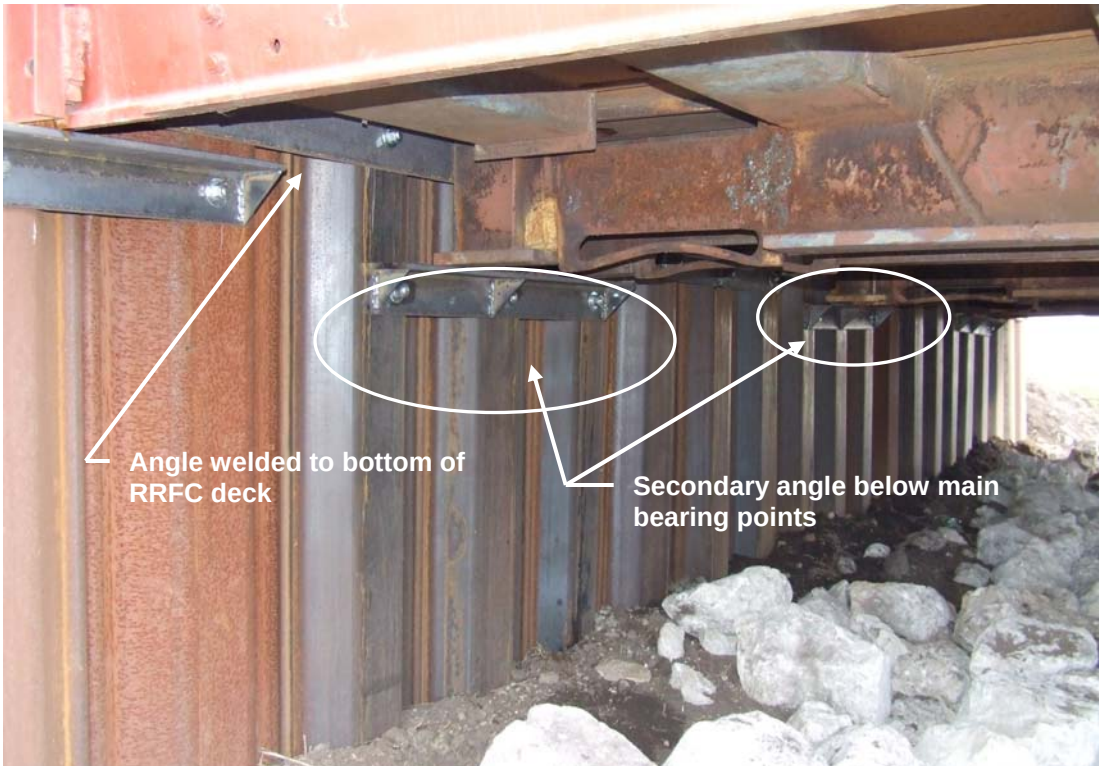
Figure B.8. Secondary angle attached below main bearing points

Due to a misunderstanding between the parties involved, a 5 inch x 3 inch x 1/2 inch angle was welded to the bottom of the deck of the RRFCs (Figure B.7) before the placement of the flatcars. This angle was proposed to represent the connection between the bridge superstructure and the abutments. However, after review by Iowa State University, additional stiffened angles 4 inch x 4 inch x 1/2 inch were added below the main bearing points (girders and longitudinal connections) as shown in Figure B.8. These angles were smaller than the angles discussed in Section B.1.4 because the top angle took a portion of the load. No connection was made between the additional angles and the bridge superstructure.

After the placement of the angles and before the placement of the backfill material, 3/4 inch diameter bolts were used to connect the angles to the sheet pile sections. No protection was provided for the bolts against the environment. In future bridges, it is recommended to provide some type of protection for the bolts to reduce (or eliminate) corrosion due to the contact with the backfill material. After the bolts were tightened, the abutments were backfilled with fill available on site. A recommendation for future sheet pile abutments would be the use granular select fill for backfill.

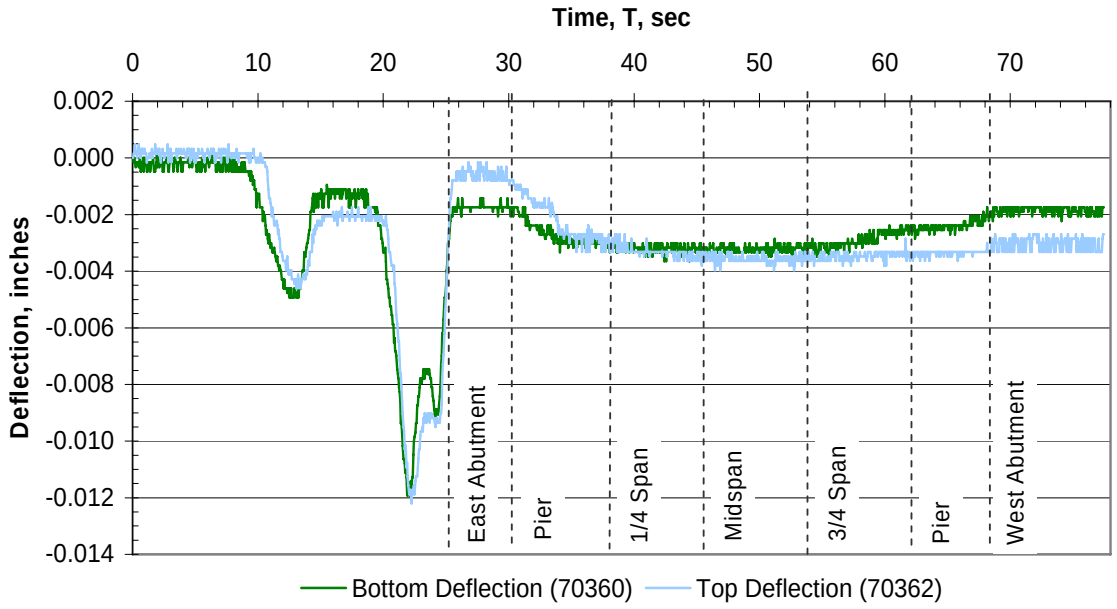
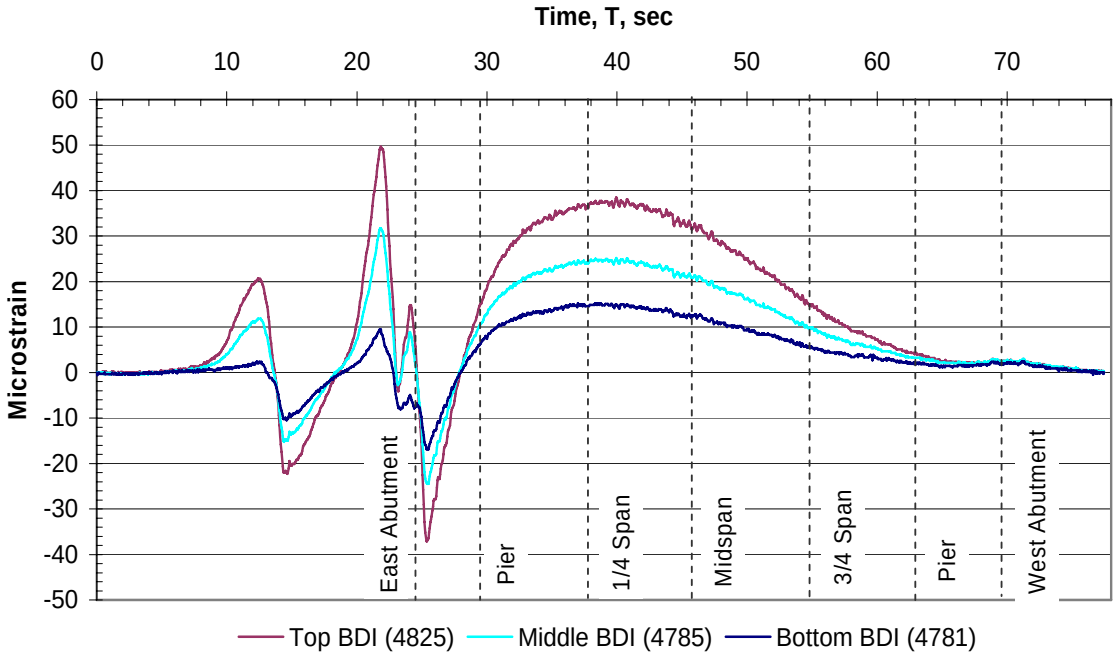
Figure B.14. Soil push at east abutment

Overall, the recorded live load strains and deflections were small. For the load tests conducted, the measured live load strains were all below an absolute value of 75 microstrain (2.2 ksi). The maximum vertical deflection was -0.011 inches, occurring at the west abutment. For deflections other than the vertical deflections (i.e. displacements transverse to traffic flow and in the direction of the bridge), the maximum deflection was -0.012 inches, occurring at the east abutment in the direction of the bridge (due to soil push).

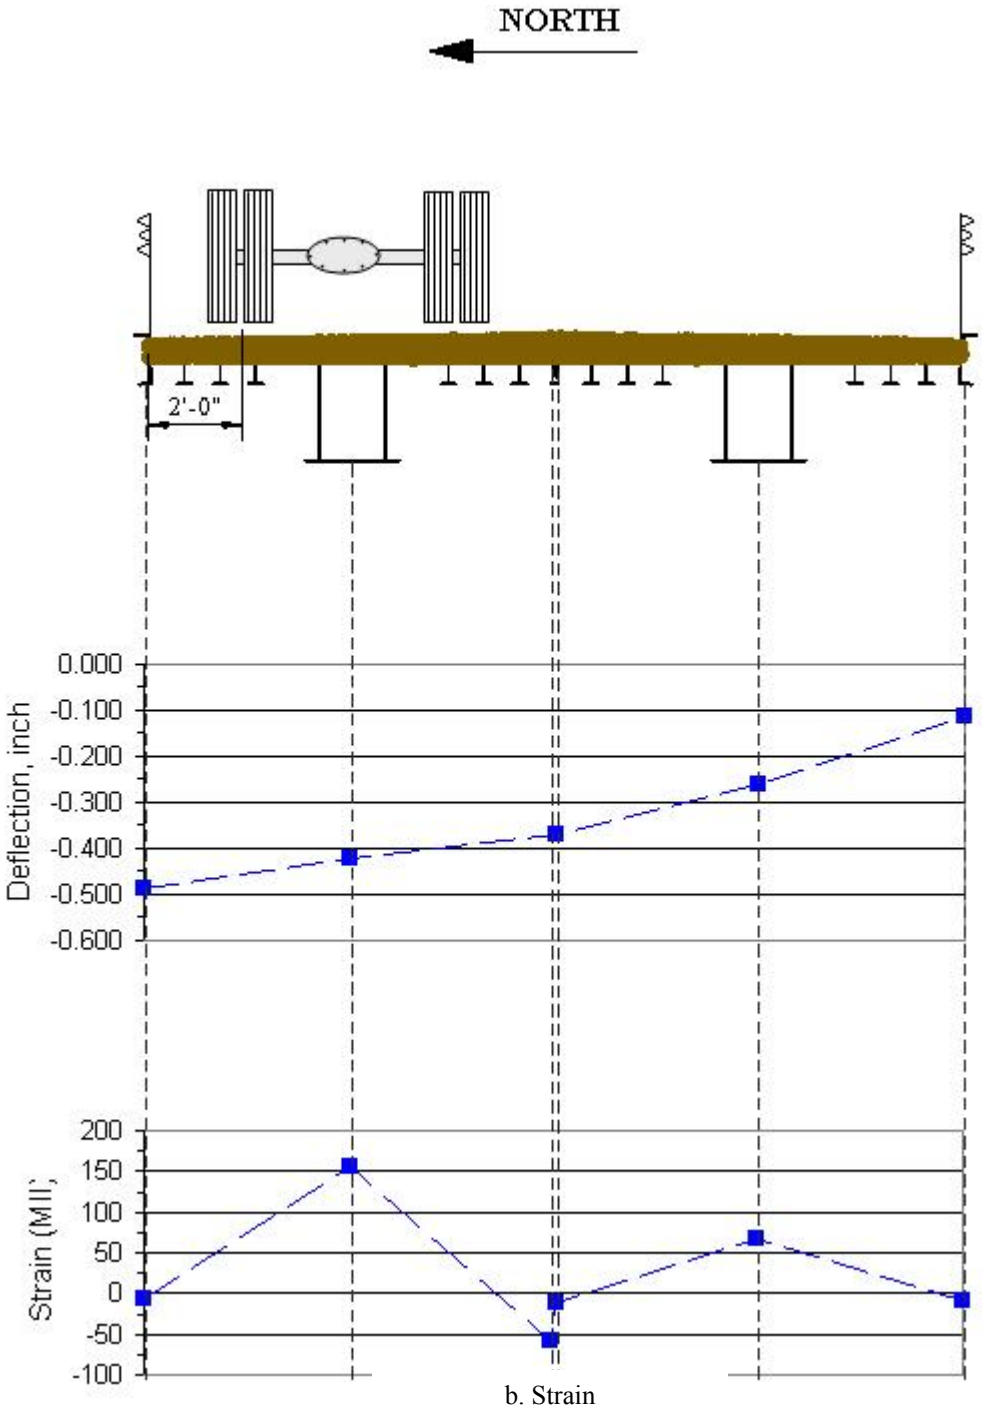
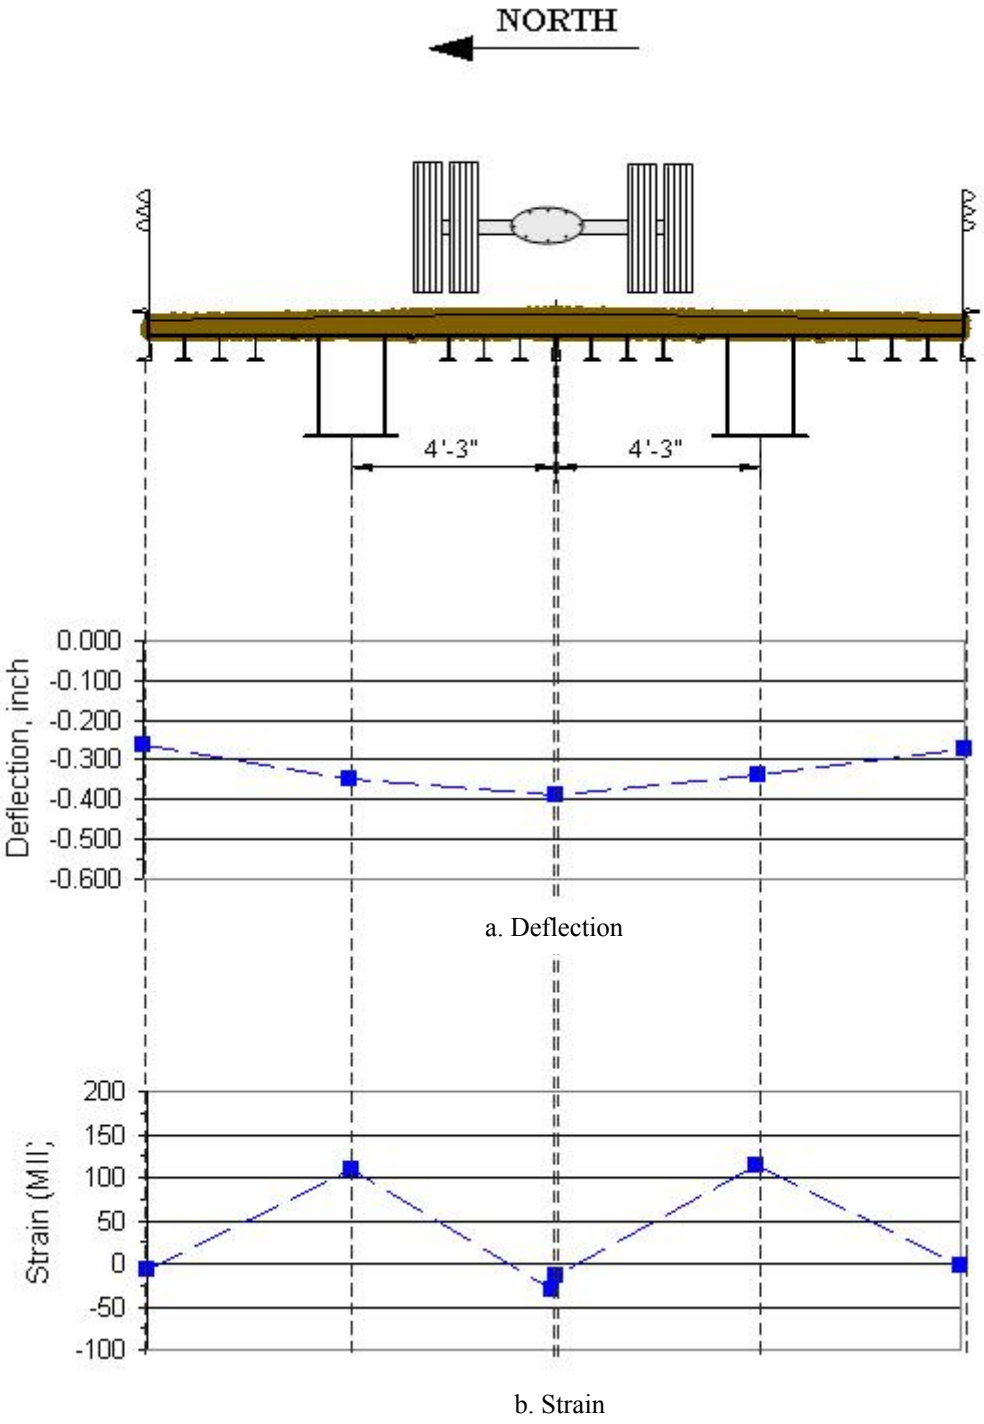
Figure D.11. WINNRRFC Lane 2 midspan live load deflections and strains

The maximum live load tensile strain that occurred at midspan as a result of the load test was +156 microstrain (+4.5 ksi) with the test vehicle positioned in Lane 1. After applying the calculated dead load strain (stress), +313 microstrain (+9.1 ksi), the tensile strain (stress) occurring at the bridge midspan was increased to +469 microstrain (+13.6 ksi), or approximately 69% of the 19.8 ksi (683 microstrain) allowable limit. Midspan compressive strains (both live load and dead load) were significantly less than the tension strains and are therefore not reported.

The AASHTO LRFD Bridge Design Specification recommends a maximum allowable live load deflection of 'span'/800 for legal truck loads [5]. Using this criterion and assuming an abutment face to abutment face span length of 66'-0", the maximum allowable live load deflection for the main span of the WINRRFC bridge is 0.99 inches. The maximum midspan live load deflection for the test vehicle was 0.517 inches, or approximately 52% of the recommended limitation.
