# **Evaluation of Long-Term Field Performance of Cold In-Place Recycled Roads:**

## **Field Distress Survey**

**Final Report  
May 2007**

**Sponsored by**  
the Iowa Highway Research Board  
(IHRB Project TR-502)  
and  
the Iowa Department of Transportation  
(CTRE Project 03-160)

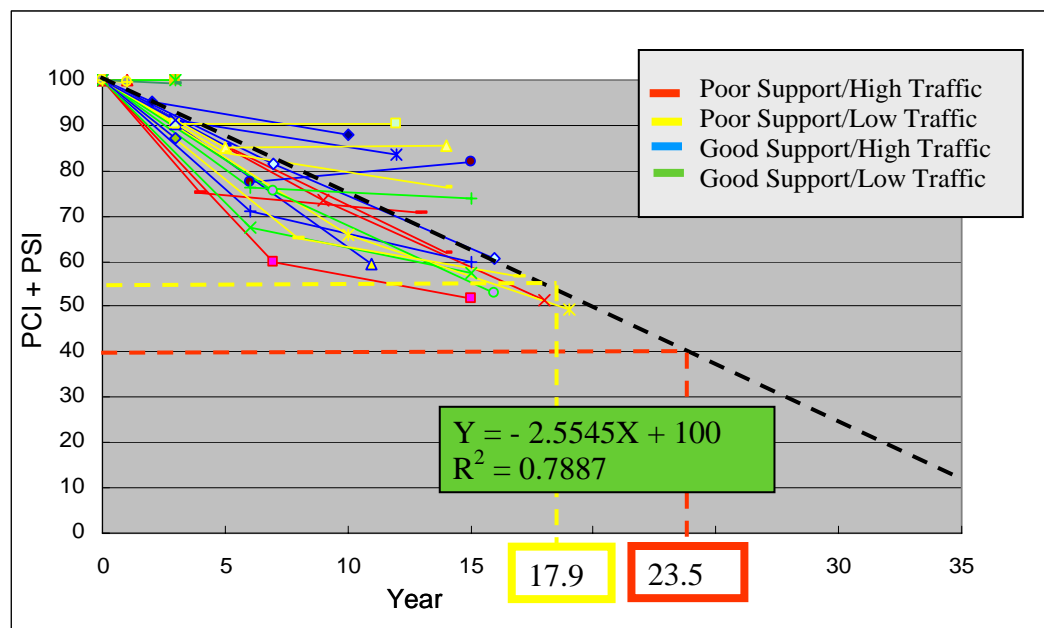
**Figure 3.1. Performance curve of the average of PCI and PSI based on distress surveys**

In Figure 3.1, the averages of the PSI and PCI values for each road, based on the two surveys performed on the 18 oldest sections and the 8 newest sections, are plotted against pavement age. As the figure shows, the regression equation,  $Y = - 2.5545X + 100$  ( $R^2 = 0.7887$ ), predicts that the service life of a CIR road would be between 17.9 and 23.5 years. It is assumed that the service life of the road ends when the average of the PCI and PSI values indicates a fair condition (a range from 55 to 40), and it is predicted that the roads will reach a value of 55 in 17.9 years and a value of 40 in 23.5 years.

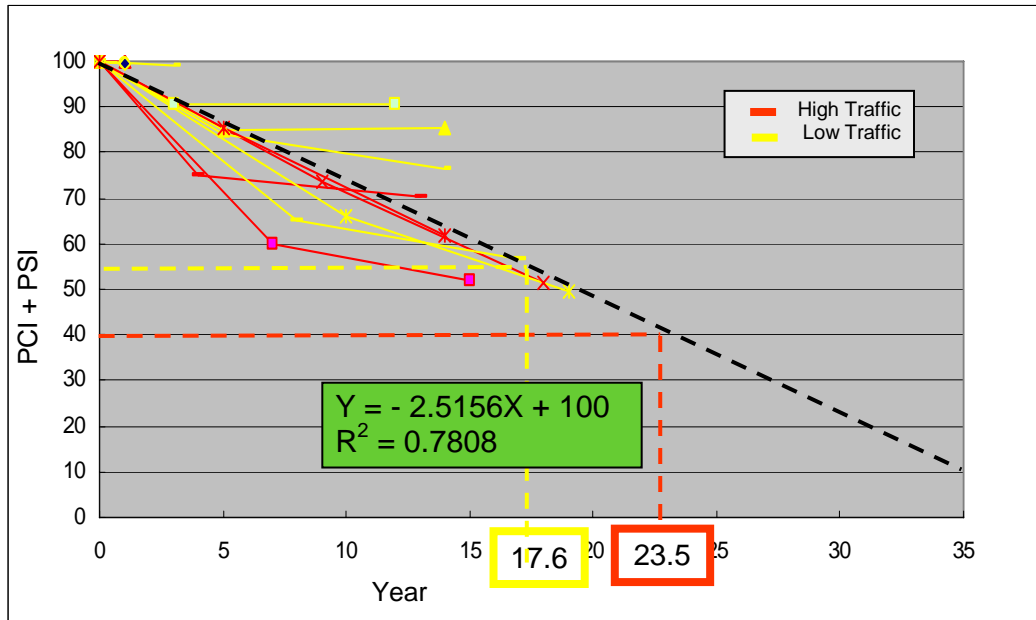
**Figure 3.2. Performance curve of test sections with poor subgrade support**

In Figure 3.2, the average of the PCI and PSI values collected from the sections with poor subgrade support are plotted against age. As the figure shows, the regression equation,  $Y = -$

$2.5156X + 100$  ( $R^2 = 0.7808$ ), predicts that the service life of a CIR road would be between 17.6 and 23.5 years. It is assumed that the service life of the road ends when the average of the PCI and PSI values indicates a fair condition (a range from 55 to 40), and it is predicted that the roads will reach a value of 55 in 17.6 years and a value of 40 in 23.5 years. As shown in Figure 3.2, the test sections with a high traffic volume seemed to deteriorate faster than those with a low traffic volume.

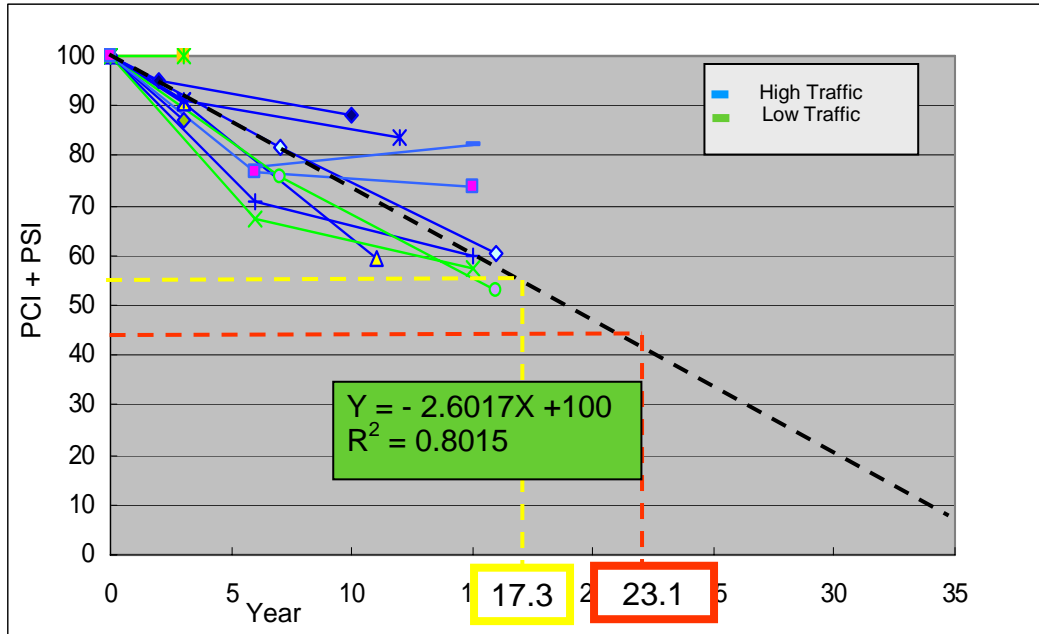
**Figure 3.3. Performance curve of test sections with good subgrade support**

In Figure 3.3, the average of the PCI and PSI values collected from the sections with good subgrade support are plotted against age. As the figure shows, the regression equation,  $Y = -2.6017X + 100$  ( $R^2 = 0.58015$ ), predicts that the service life of a CIR road would be between 17.3 and 23.1 years. It is assumed that the service life of the road ends when the average of the PCI and PSI values indicates a fair condition (a range from 55 to 40), and it is predicted that the roads will reach a value of 55 in 17.3 years and a value of 40 in 23.1 years. As shown in Figure 3.3, the test sections with a high traffic volume seemed to deteriorate faster than those with a low traffic volume. It seems significant that the performance of the test sections with good subgrade support is similar to that of test sections with poor subgrade support.

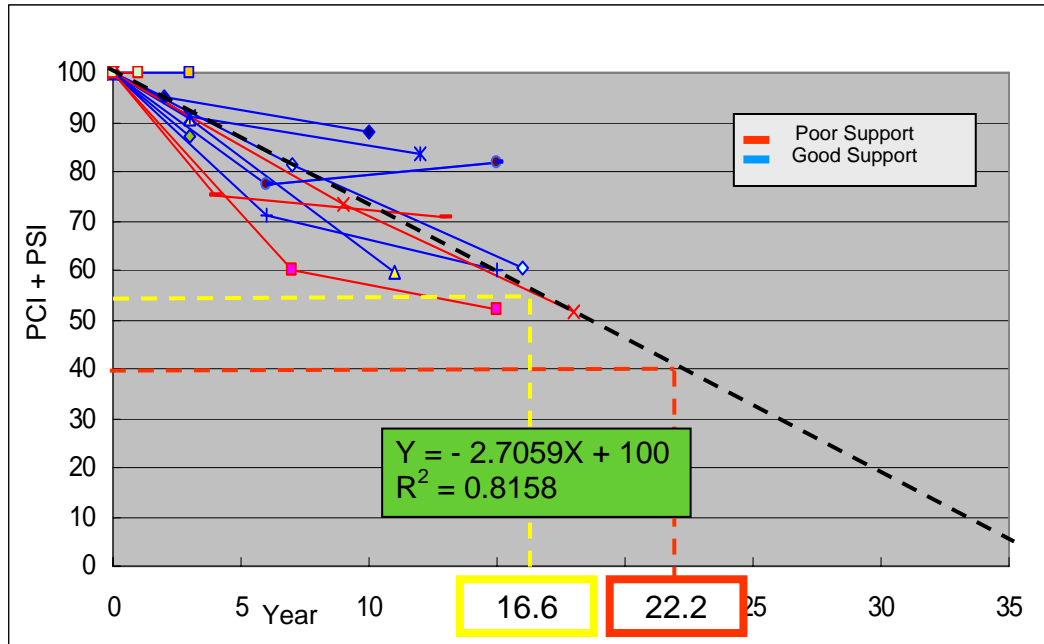
**Figure 3.4. Performance curve of test sections with high traffic levels**

In Figure 3.4, the average of the PCI and PSI values collected from the sections with a high traffic volume are plotted against age. As the figure shows, the regression equation,  $Y = -2.7059X + 100$  ( $R^2 = 0.8158$ ), predicts that the service life of a CIR road would be between 16.6 and 22.2 years. It is assumed that the service life of the road ends when the average of the PCI and PSI values indicates a fair condition (a range from 55 to 40), and it is predicted that the roads will reach a value of 55 in 16.6 years and a value of 40 in 22.2 years. As shown in Figure 3.4, the test sections with poor subgrade support seemed to deteriorate faster than those with good subgrade support.

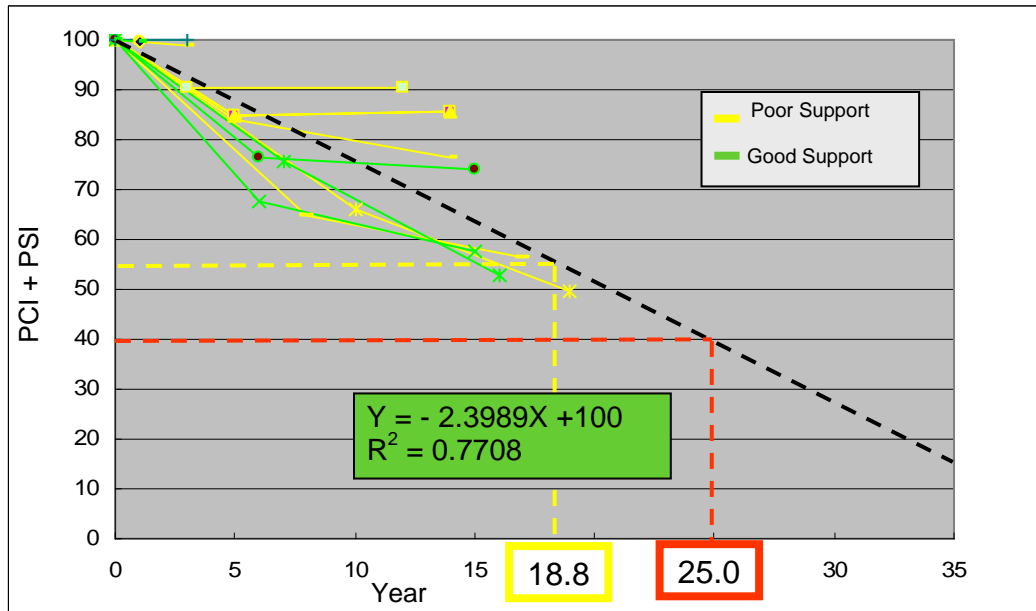
**Figure 3.5. Performance curve of test sections with low traffic levels**

The average PCI + PSI values collected from the sections with a low traffic volume are plotted against age in Figure 3.5. As the figure shows, the regression equation,  $Y = -2.3989X + 100$  ( $R^2 = 0.7708$ ), predicts that the service life of a CIR road would be between 18.8 and 25 years. It is assumed that the service life of the road ends when the average of the PCI and PSI values indicates a fair condition (a range from 55 to 40), and it is predicted that the roads will reach a value of 55 in 18.8 years and a value of 40 in 25 years. It is interesting to note that the service life of the test sections under low traffic volumes is slightly longer than that of the test sections with high traffic volumes.

Figure 3.5 also shows that, contrary to common sense, the test sections with good subgrade support seemed to deteriorate faster than those with poor subgrade support. It can be postulated that, under low traffic volumes, subgrade support has no influence on the performance of CIR pavements.

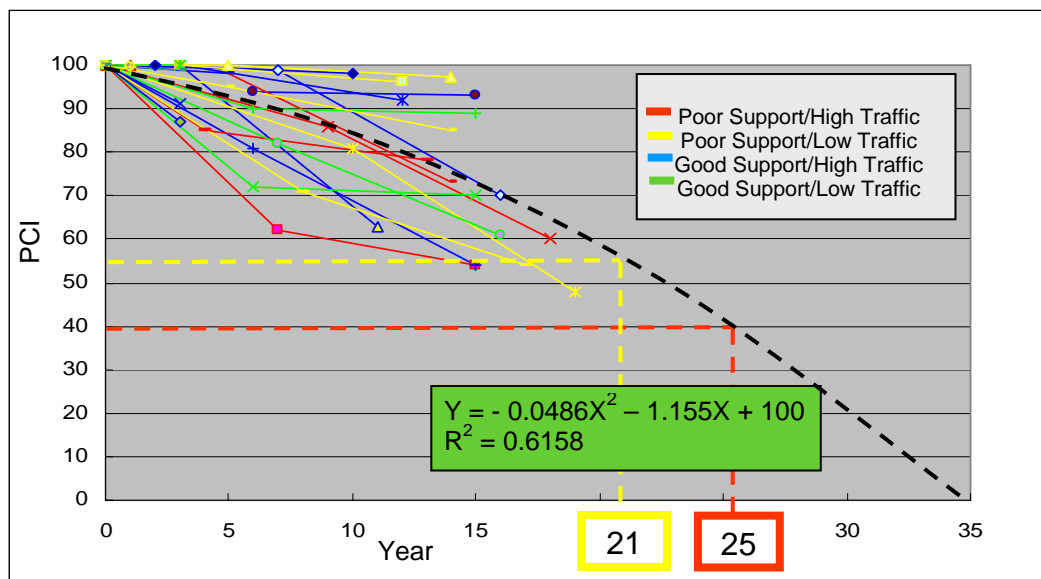
**Figure 3.6. PCI performance curve based on distress surveys**

In Figure 3.6, the PCI values collected from the two surveys performed on the 18 oldest sections and the 8 newest sections are plotted against the pavement age. As the figure shows, the regression equation,  $Y = -0.0486X^2 - 1.155X + 100$  ( $R^2 = 0.6158$ ), predicts that the PCI of the CIR roads would indicate a fair condition (PCI ranging from 55 to 40) between 21 and 25 years, respectively. Although the  $R^2$  value is somewhat less than the one based on the average of the PCI and PSI values, the predicted service life is slightly higher.

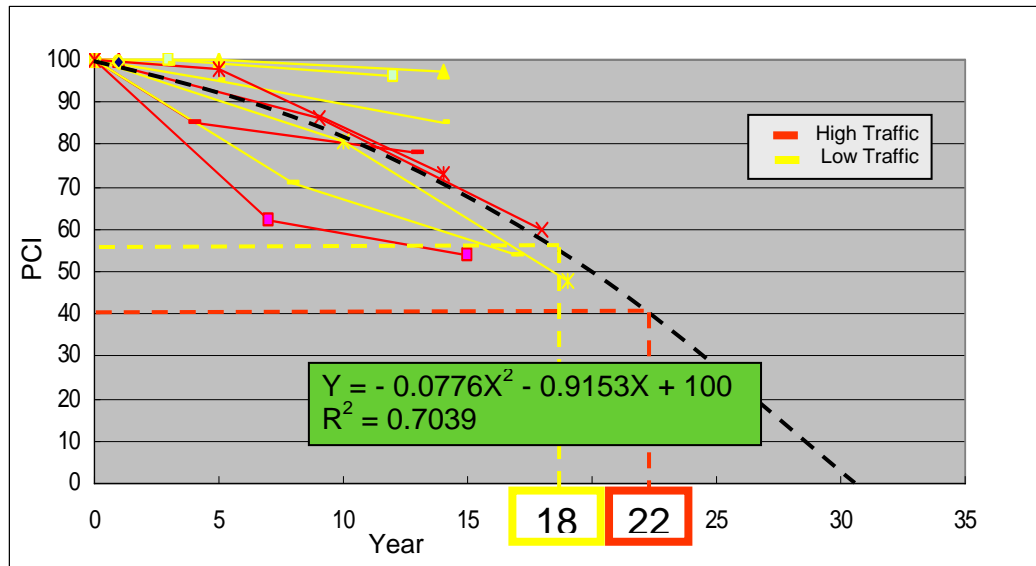
**Figure 3.7. PCI performance curve of test sections with poor subgrade support**

In Figure 3.7, the PCI values collected from the sections with poor subgrade support are plotted against age. As the figure shows, the regression equation,  $Y = -0.0776X^2 - 0.9153X + 100$  ( $R^2 = 0.7039$ ), predicts that the PCI of the CIR roads would indicate a fair condition (PCI ranging from 55 to 40) between 18 and 22 years, respectively. These values are very similar to the ones based on the average of the PCI and PSI values. As shown in Figure 3.7, the test sections with a high traffic volume seemed to deteriorate faster than those with a low traffic volume.

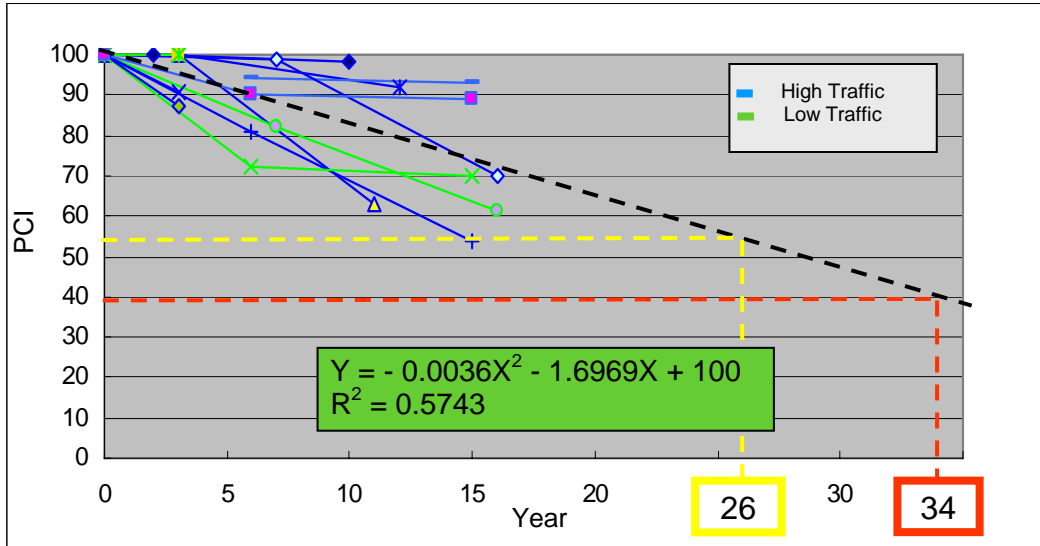
**Figure 3.8. PCI Performance curve of test sections with good subgrade support**

In Figure 3.8, the PCI values collected from the sections with good subgrade support are plotted against age. As the figure shows, the regression equation,  $Y = -0.036X^2 - 1.6969X + 100$  ( $R^2 = 0.5743$ ), predicts that the PCI of the CIR roads would indicate a fair condition (PCI ranging from 55 to 40) between 26 and 34 years, respectively. It is interesting to note that the predicted service life of the test sections with good subgrade support is much longer than that of the test sections with poor subgrade support. Figure 3.8 shows that, although there are limited number of data points, the test sections with a low traffic volume seemed to deteriorate faster than those with a high traffic volume. It can be postulated that the performance of pavements with good subgrade support is not affected by the traffic level.

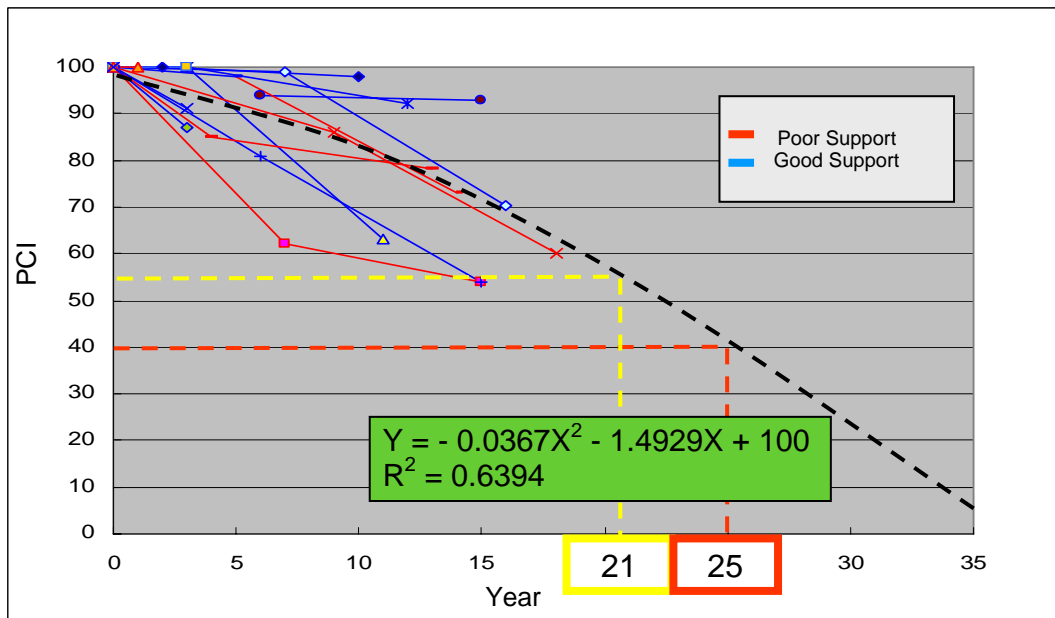
**Figure 3.9. PCI performance curve of test sections with high traffic levels**

In Figure 3.9, the PCI values collected from the sections with a high traffic volume are plotted against age. As the figure shows, the regression equation,  $Y = -0.0367X^2 - 1.4929X + 100$  ( $R^2 = 0.6394$ ), predicts that the PCI of the CIR roads would indicate a fair condition (PCI ranging from 55 to 40) between 21 and 25 years, respectively. As shown in Figure 3.9, the test sections with poor subgrade support seemed to deteriorate faster than those with good subgrade support.

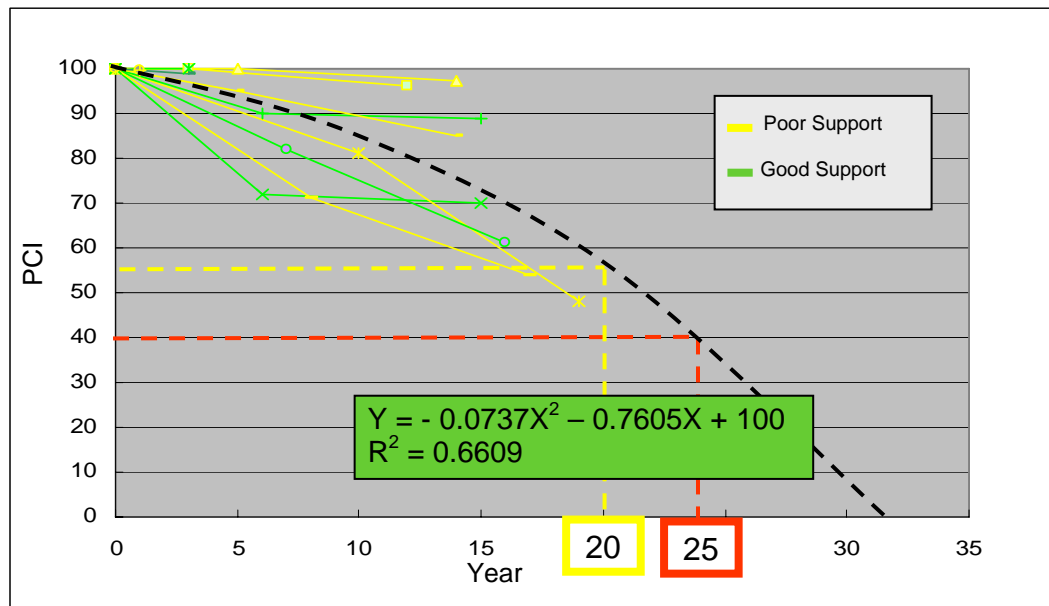
**Figure 3.10. PCI performance curve of test sections with low traffic levels**

In Figure 3.10, the PCI values collected from the sections with a low traffic volume are plotted against age. As the figure shows, the regression equation,  $Y = -0.0737X^2 - 0.7605X + 100$  ( $R^2 = 0.6609$ ), predicts that the PCI of the CIR roads would indicate a fair condition (PCI ranging from 55 to 40) between 20 and 25 years, respectively. It is interesting to note that the service life of the test sections under a low traffic volume is very similar to that of the test sections with a high traffic volume.

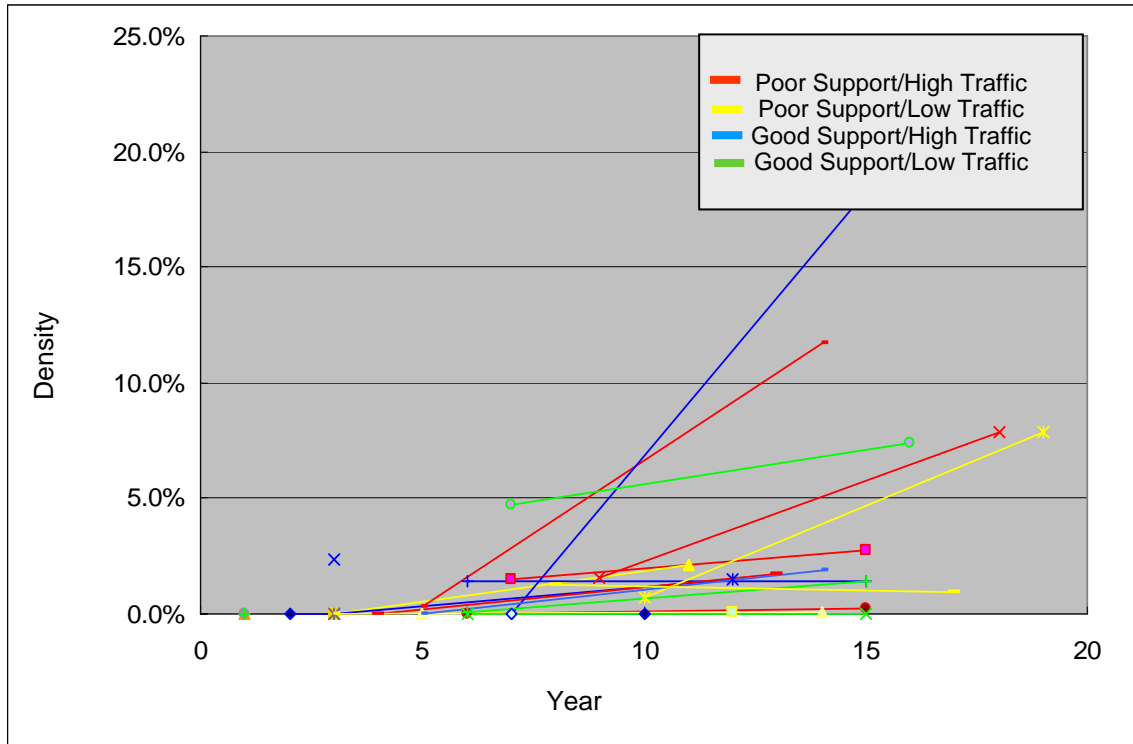
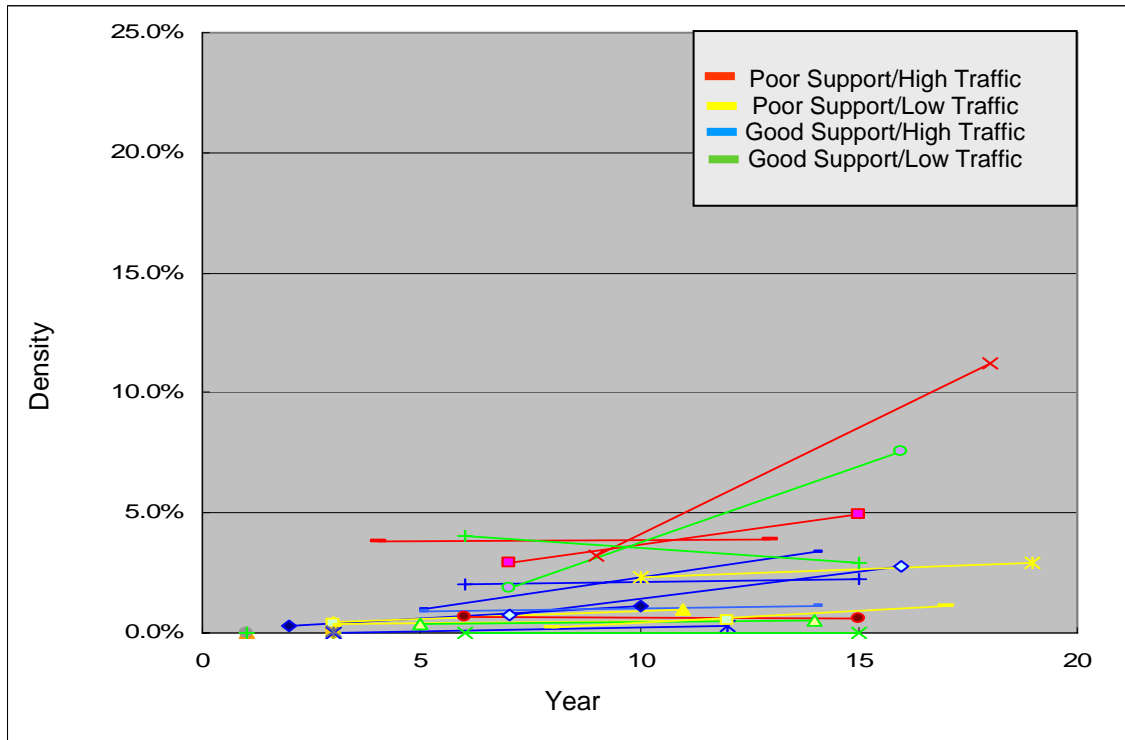
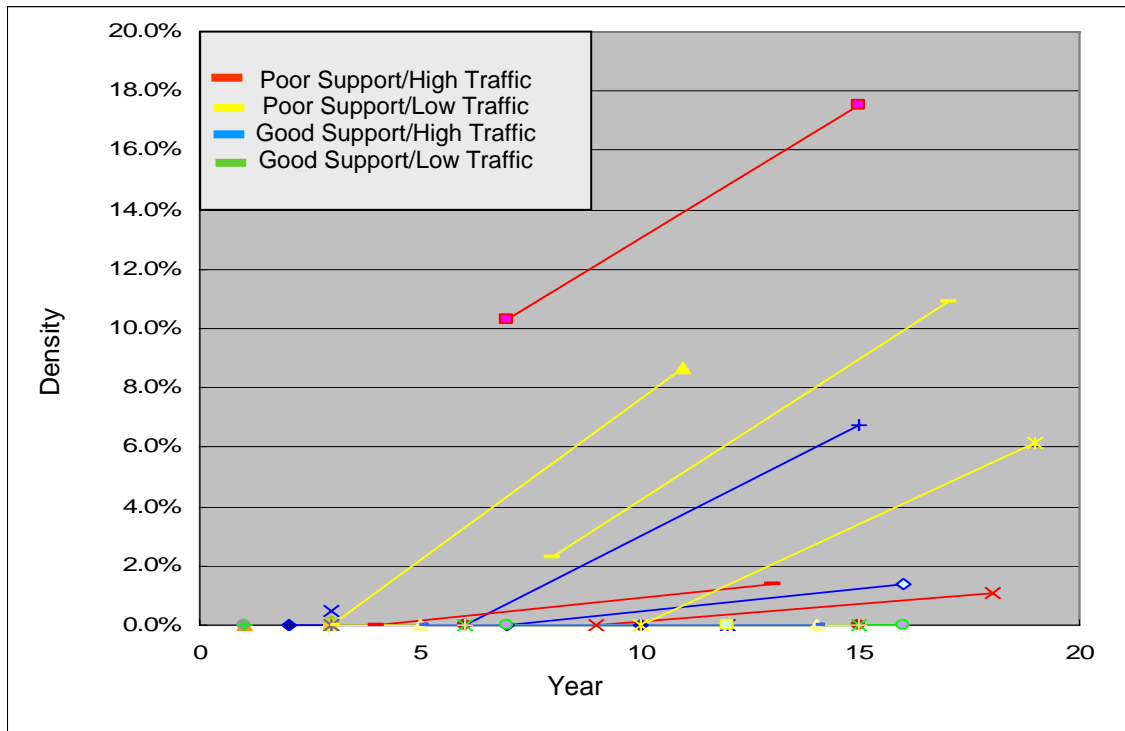
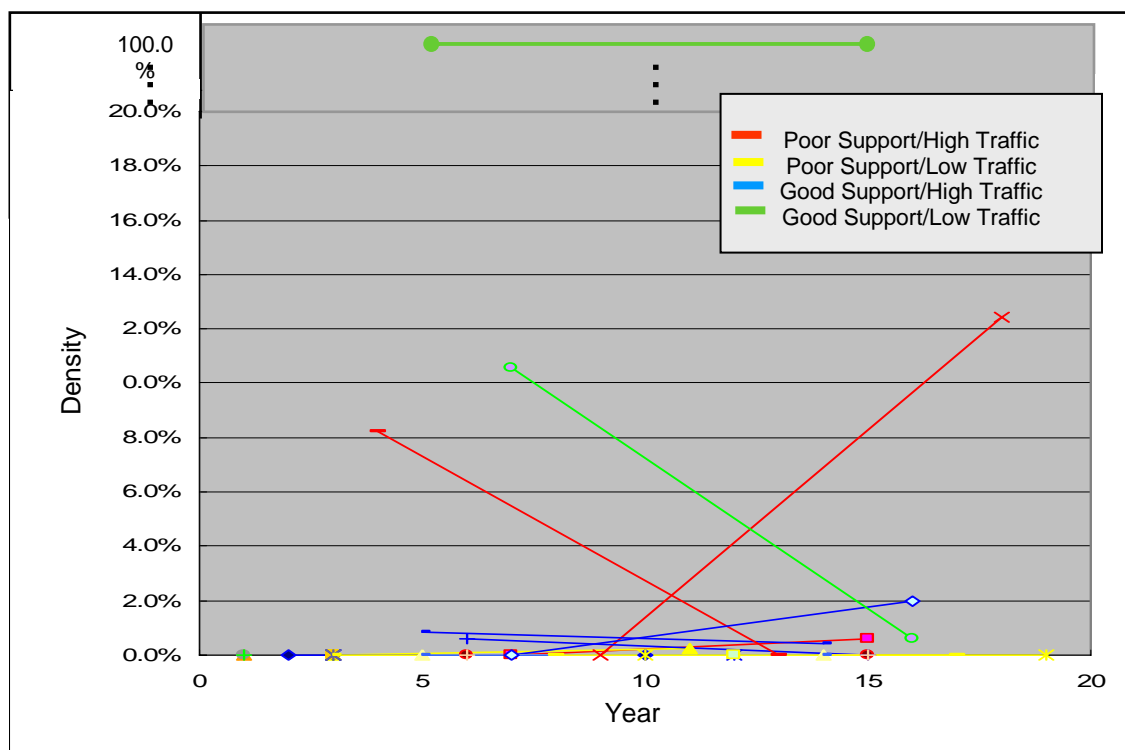
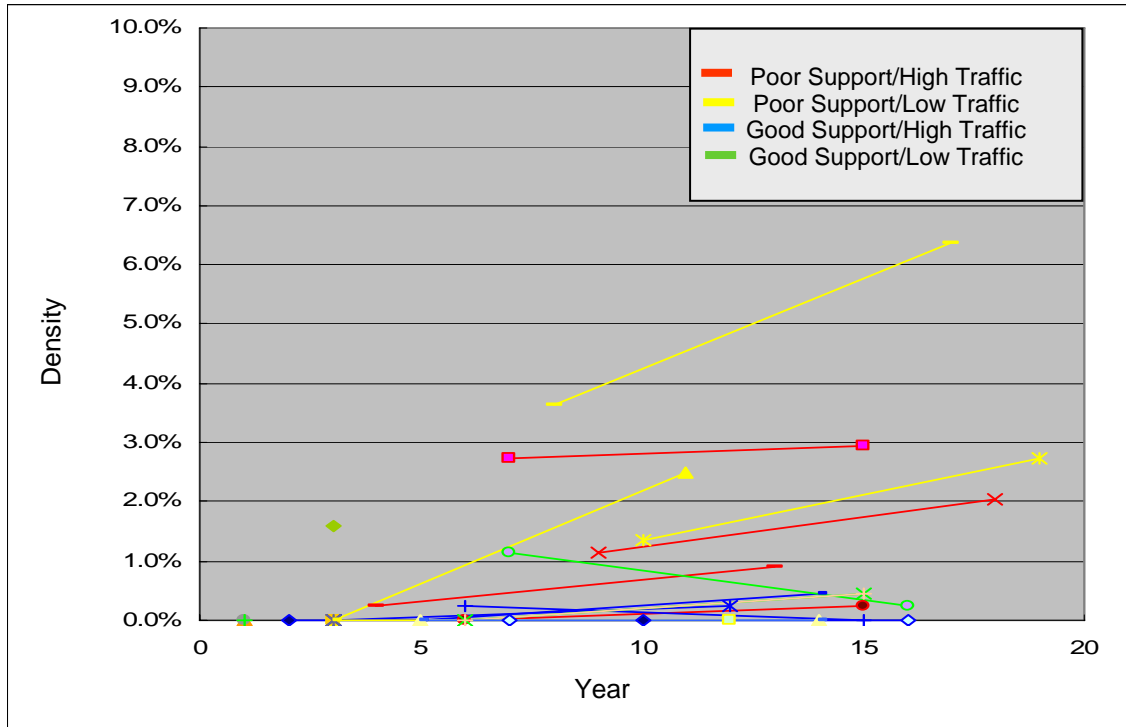
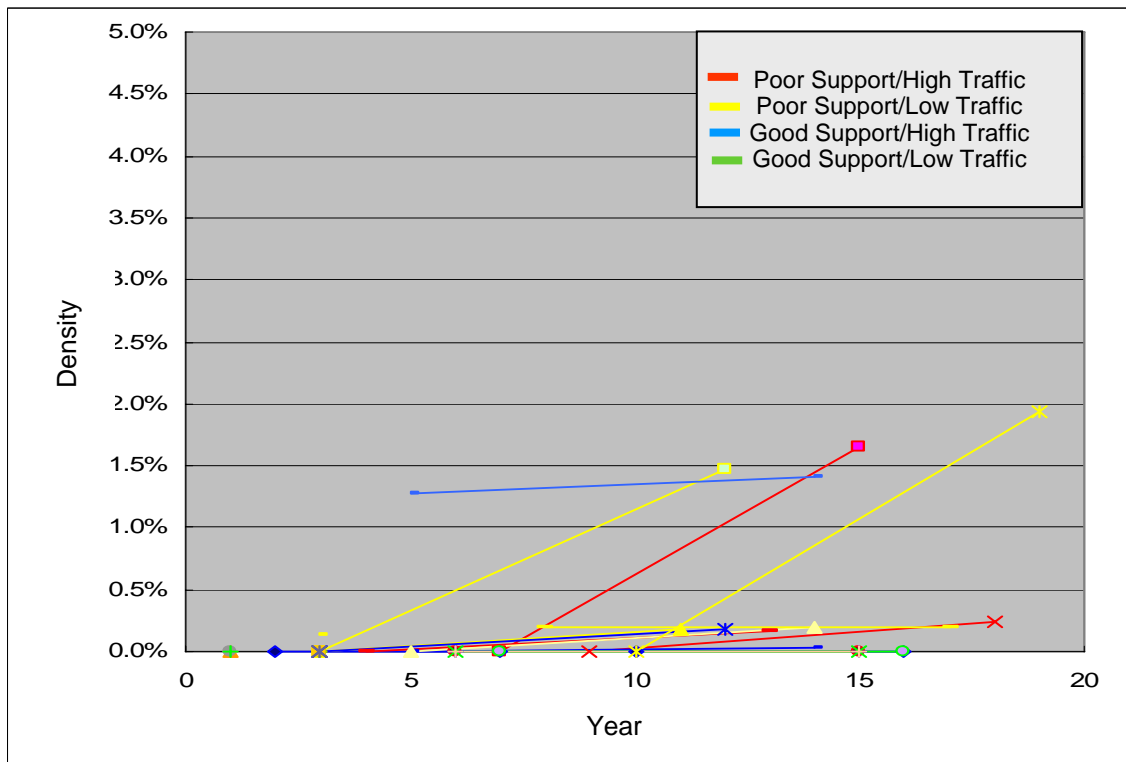
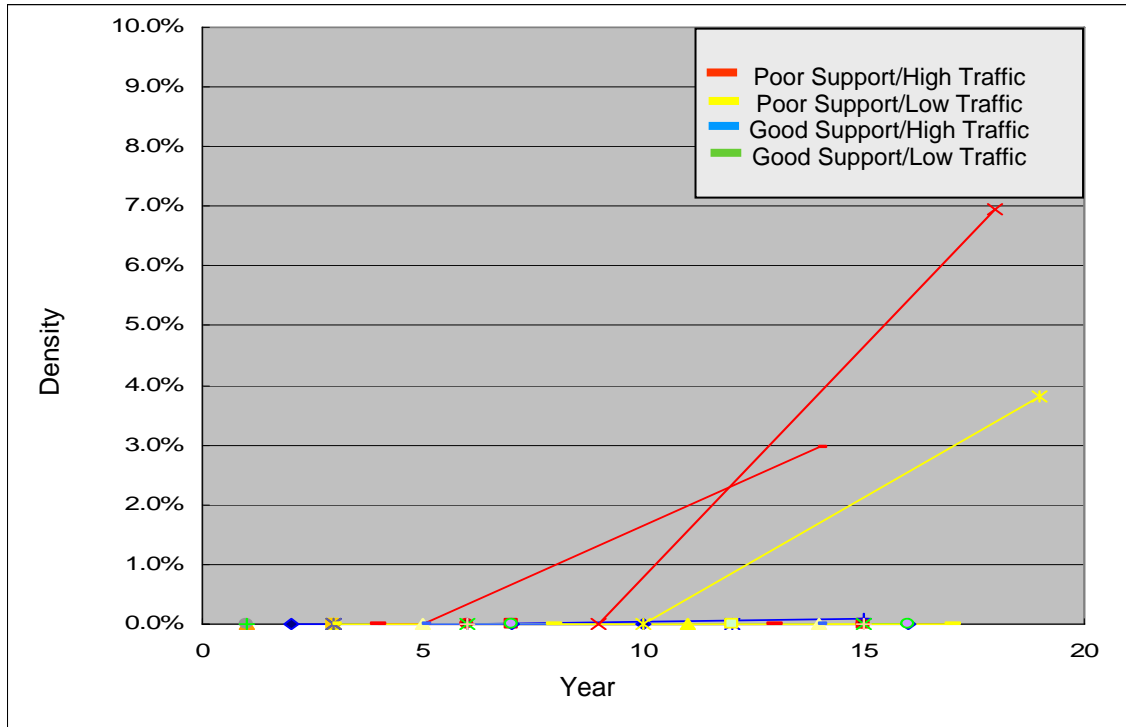
In Figures 3.11 through 3.17, pavement age is plotted against individual distresses, longitudinal cracking, transverse cracking, alligator cracking, block cracking, rutting, edge cracking, and patching, respectively. These figures are also categorized by a combination of subgrade support levels and traffic volumes. As discussed above, longitudinal and alligator cracking increased in most sections over time, while transverse cracking changed little. As shown in Figure 3.14, block cracking decreased in some pavement sections due to its possible transformation into alligator cracking and/or its rather vague definition. As can be seen from Figures 3.15, 3.16, and 3.17, rutting, edge cracking, and patching seemed to increase predominantly in the sections with poor subgrade support.

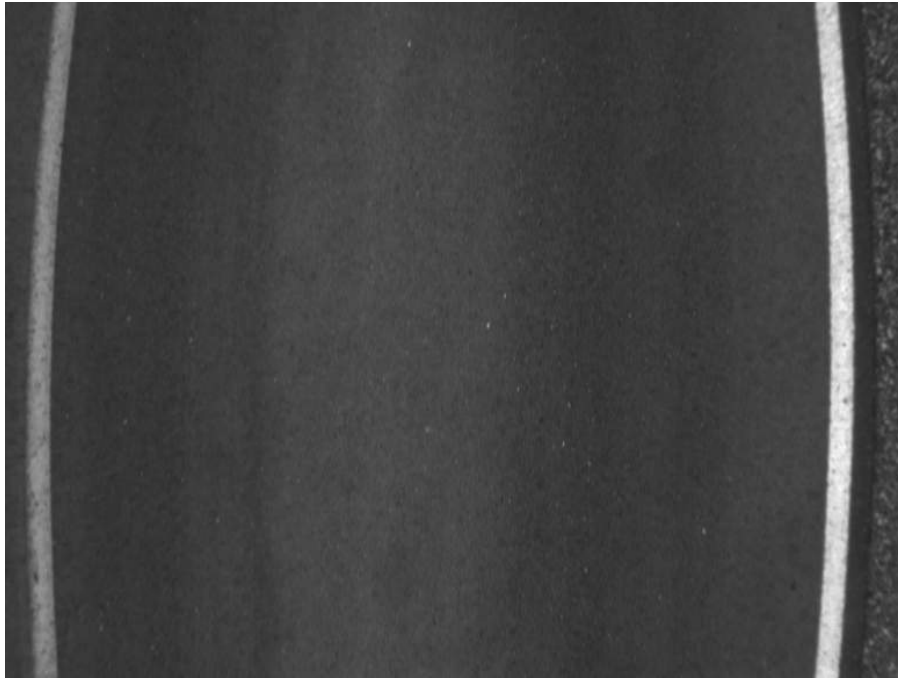
**Figure A.22.4. Sample image in N 58 test section, Carroll County**

On February 13, 2005, distress survey was conducted using an AICS and a rutting device and the survey results are summarized in Table A.22.1. As shown in Table A.22.1, no cracking appeared on the test section. The test section exhibited a PSI value of 100, a PCI value of 100 resulting in
