**USE OF
LONGITUDINAL SUBDRAINS
IN THE
3R PROGRAM**

**FINAL REPORT
Project HR-509**

**Highway Division
December 1981**

VERNON J. MARKS
RESEARCH ENGINEER
515/239-1447

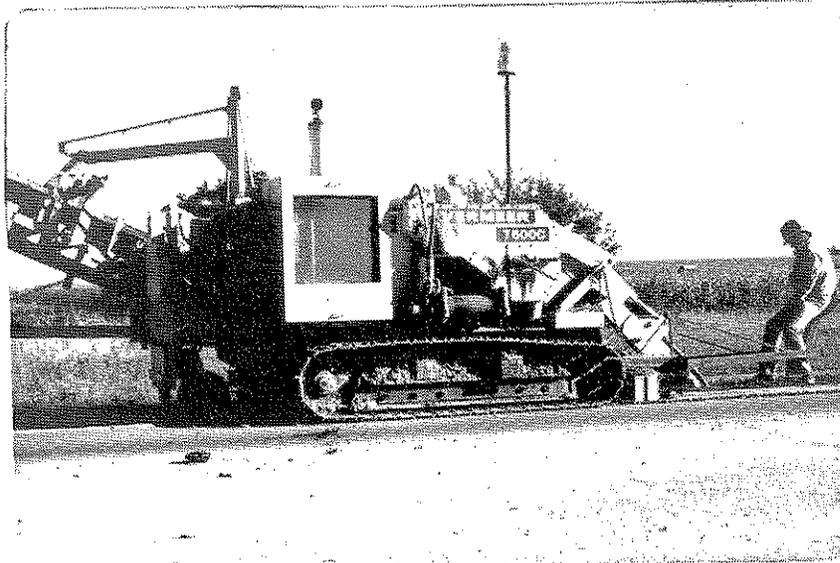
Figure 1: Vermeer T-600C Trencher

The first operation utilized a Vermeer T-600C (Figure 1) trencher to cut the one foot wide, 2 foot deep trench. Initially, this trencher was equipped with a disc cutter wheel (Figure 2) to aid in maintaining proper alignment. Later, this was of questionable benefit. The trencher cut very neat side walls and alleviated some initial concern that chunks might be torn from the asphalt concrete shoulder surfacing. It was, however, relatively severe to the trencher's cutting teeth.

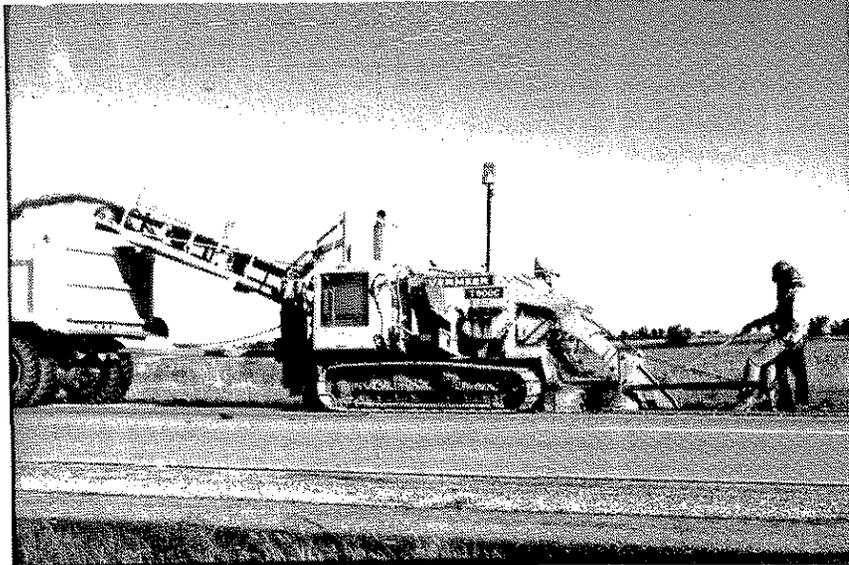
Figure 3: Loading Excavated Material.

A side elevator of the trencher deposited the material directly into trucks (Figure 3).

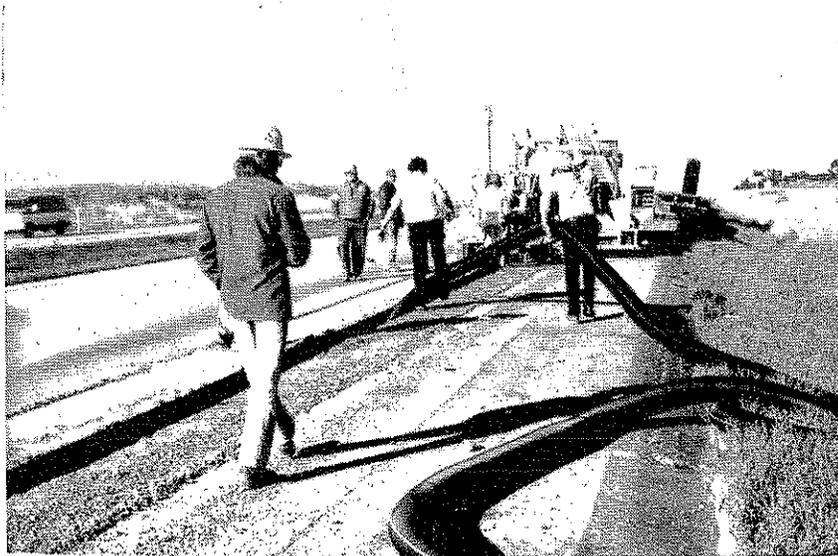
Figure 4: Hand Placement of the Tubing

Polyethylene tubing deteriorates if exposed to sunlight and therefore, a note on the plans required protected storage even though the producer claimed that an additive would protect the tubing for up to six months. The tubing was placed in the trench manually (Figure 4).

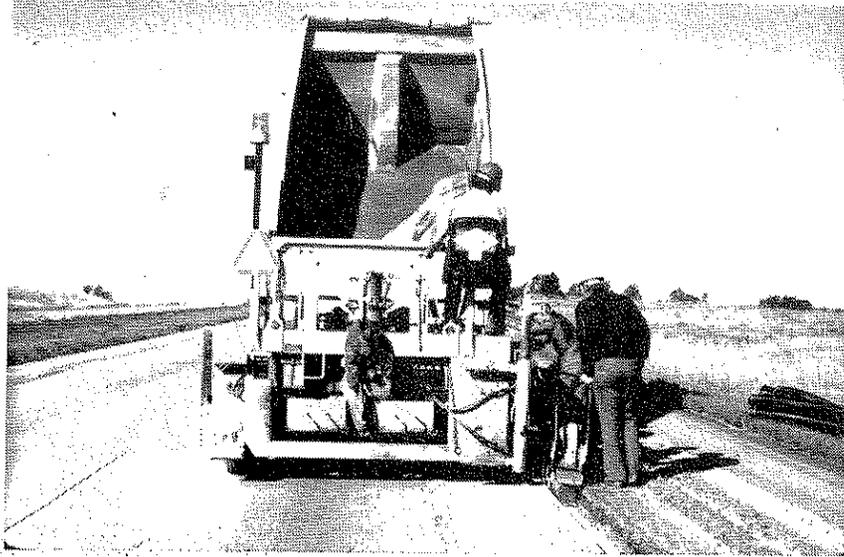
Figure 5: Blawnox RW-38 Placing Porous Backfill

The next operation in the train was the proper placement of the porous backfill material using a Blawknex RW-38 road widener (Figure 5) with a special box attachment. This operation caused the most problems and required special attention. With proper modifications, the tubing was threaded through a guide in the special attachment and the 3" bedding beneath the pipe was achieved. A vibrating pan unit (Figure 6) was attached to the special box for compaction of the porous backfill.
