Pilot Construction Project for Granular Shoulder Stabilization

Final Report
September 2013

Sponsored by
Iowa Highway Research Board
(IHRB Project TR-634)
Iowa Department of Transportation
(InTrans Project 11-405)

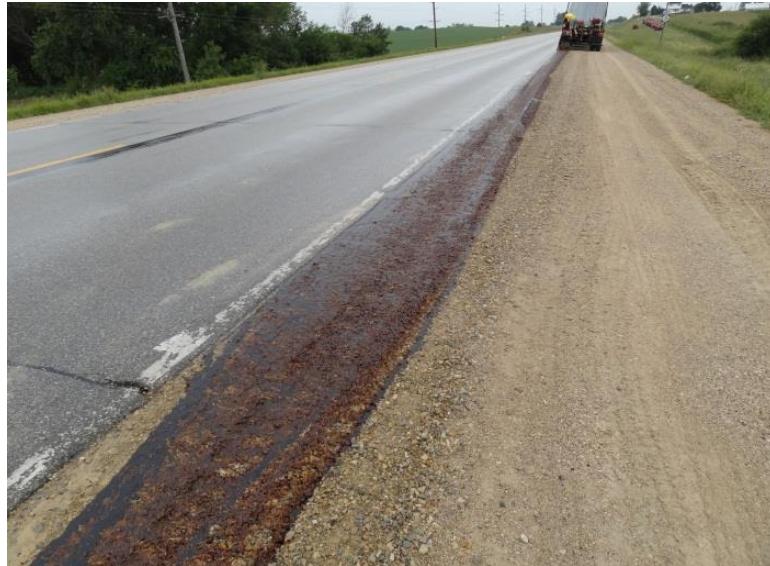
Figure 12. Spraying in the rain on IA 3 near Allison, Iowa

On August 18, 2011, rain occurred during the time that the application process was executed around Allison and Shell Rock. Figure 12 shows the result of the soapstock application on the westbound (WB) shoulder of IA 3 nearby and east of Allison during the rain.

The rain became heavy in the afternoon, so work was suspended until the next day. Apparently, the rain did have some negative effect on the treatment, because many of the locations where soapstock was applied during the rain performed poorly compared to other work locations in post observations.

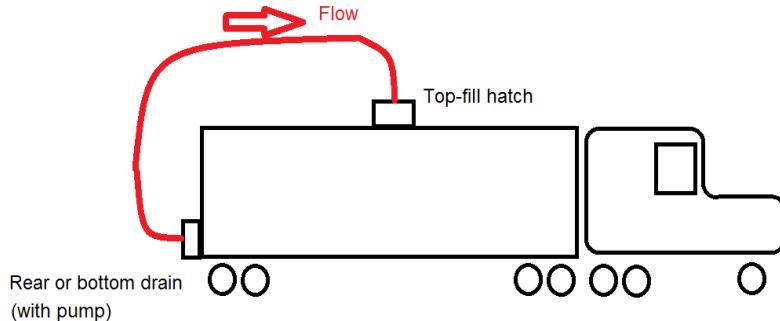
Figure 17. Recirculating soapstock to provide more consistent density (Harris 2011)

One action drew researchers' attention when Boer used the plastic pipe and pump to recirculate soapstock from the bottom to the top of the storage tank (Figure 17). The day before this action, the treatment showed inconsistent results between the morning and afternoon work session, which was believed to be a consequence of soapstock segregation. According to Boer, material with low viscosity tends to settle to the bottom, while material with high viscosity tends to flow to the top. After the soapstock was circulated, its viscosity was more consistent, so it could be distributed evenly and provide better performance.

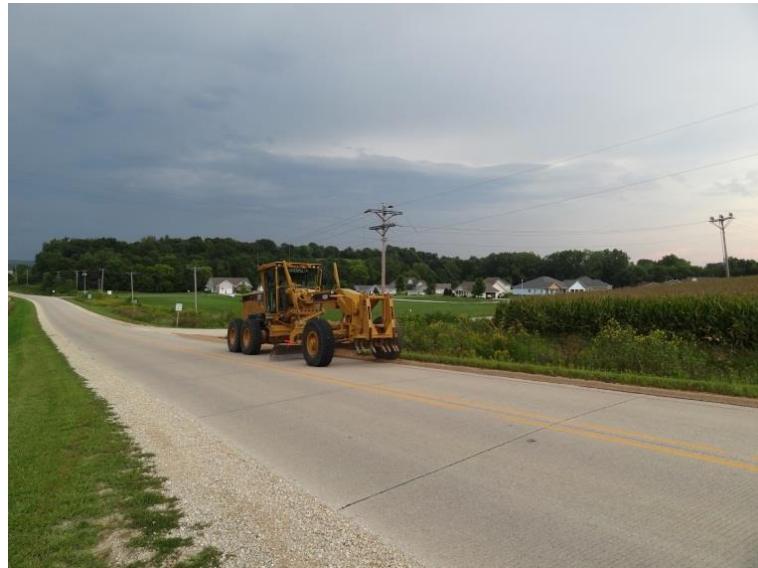
Figure 18. Grader bladed over the shoulder applied with sand

While applying soapstock onto Fayette County Road (CR) W-51, the county maintenance crew developed an alternate method for placing sand over the soapstock. A county truck placed sand on the white line by using an edge rut chute. Then, the motor grader bladed sand over the surface on which the soapstock was applied (Figure 18).

This procedure worked well for places where the shoulder surface was lower than the pavement, but not for places where the shoulder surface was higher than the pavement. The newly-applied soapstock on higher shoulder surfaces was scraped off the shoulder by the motor grader blade.

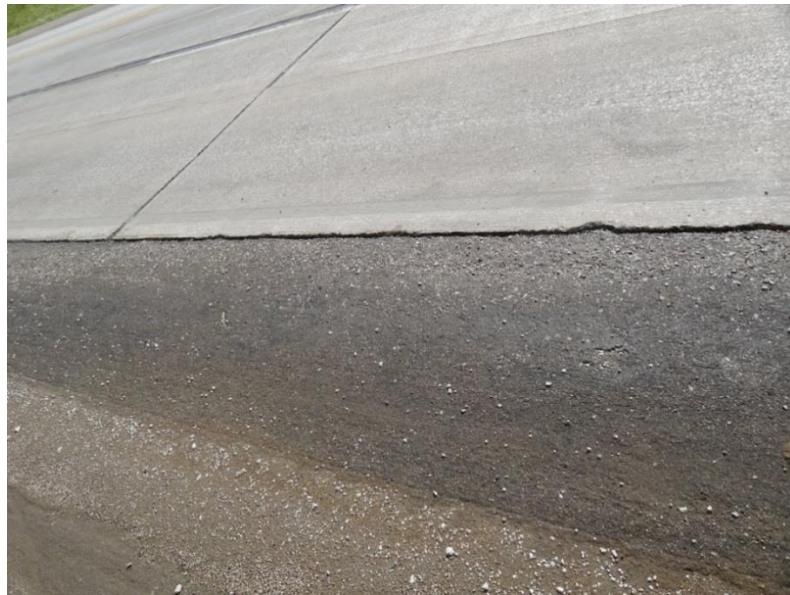
Figure 20. Southbound shoulder of US 169 south of Algona, Iowa

Figure 20 provides an example of good shoulder performance for this area. This shows a section of the US 169 shoulder adjacent to the SB lane just south of Algona, where a thin layer of soapstock remained firmly on the shoulder. Another example is shown in Figure 21. The shoulder section was on US 18 near Garner with a thicker layer of soapstock on surface.

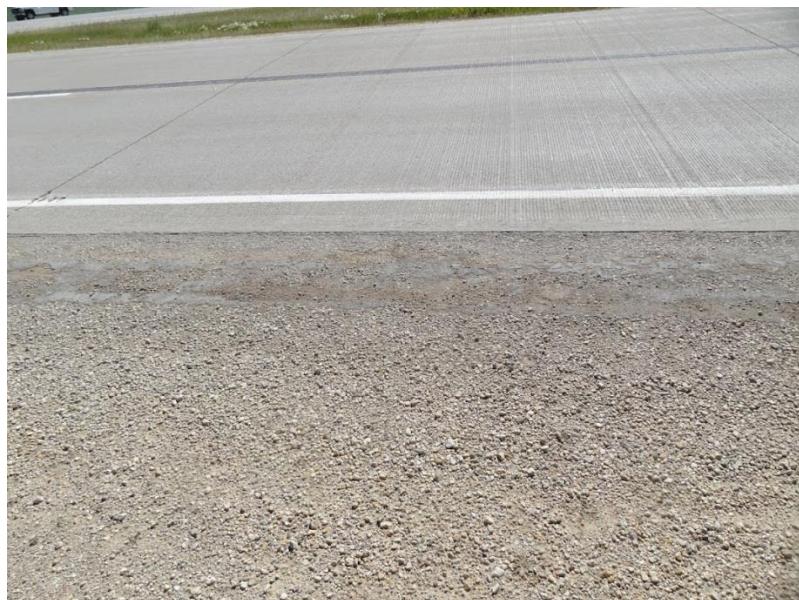
Figure 25. Southbound outside shoulder of US 63 near Denver, Iowa

Figure 24 provides an example of good shoulder performance for this area. This shows a shoulder section of IA 3 on adjacent to the EB lanes just east of Waverly, where a thick layer of soapstock remained firmly on the shoulder. Another example is shown in Figure 25. This shoulder section was on US 63 near Denver, where soapstock had penetrated into the shoulder and could not be seen easily.

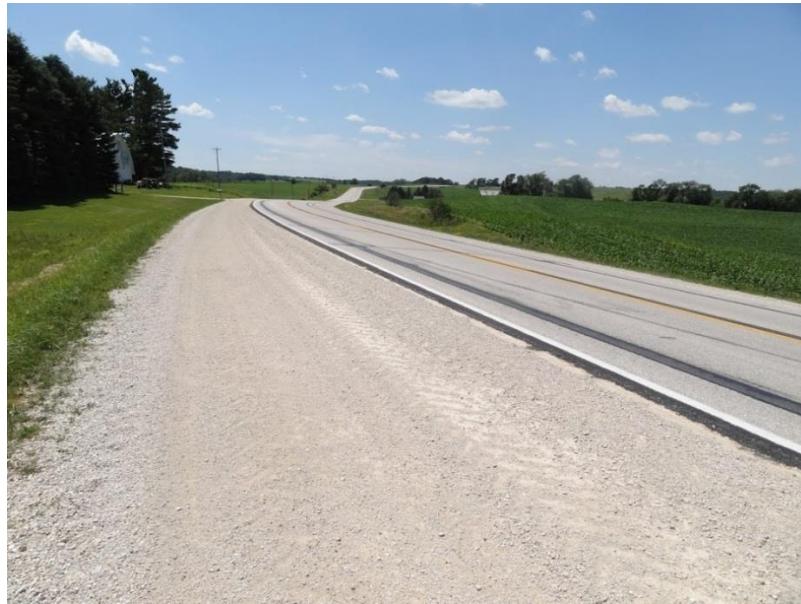
Figure 29. Shoulder of US 18 on eastbound west of Clermont, Iowa

Figure 28 shows one shoulder section of US 18 EB east of West Union. Although the shoulder had been regraded, the hard surface resulting from the soapstock could still be observed. Another example is shown in Figure 29. The shoulder was also along US 18, west of Clermont, where the whole section was regraded with new gravel.
