U.S. Department
of Transportation
**Federal Highway
Administration**

Video Inspection of Highway Edgedrain Systems

April 1998

FHWA-SA-98-044

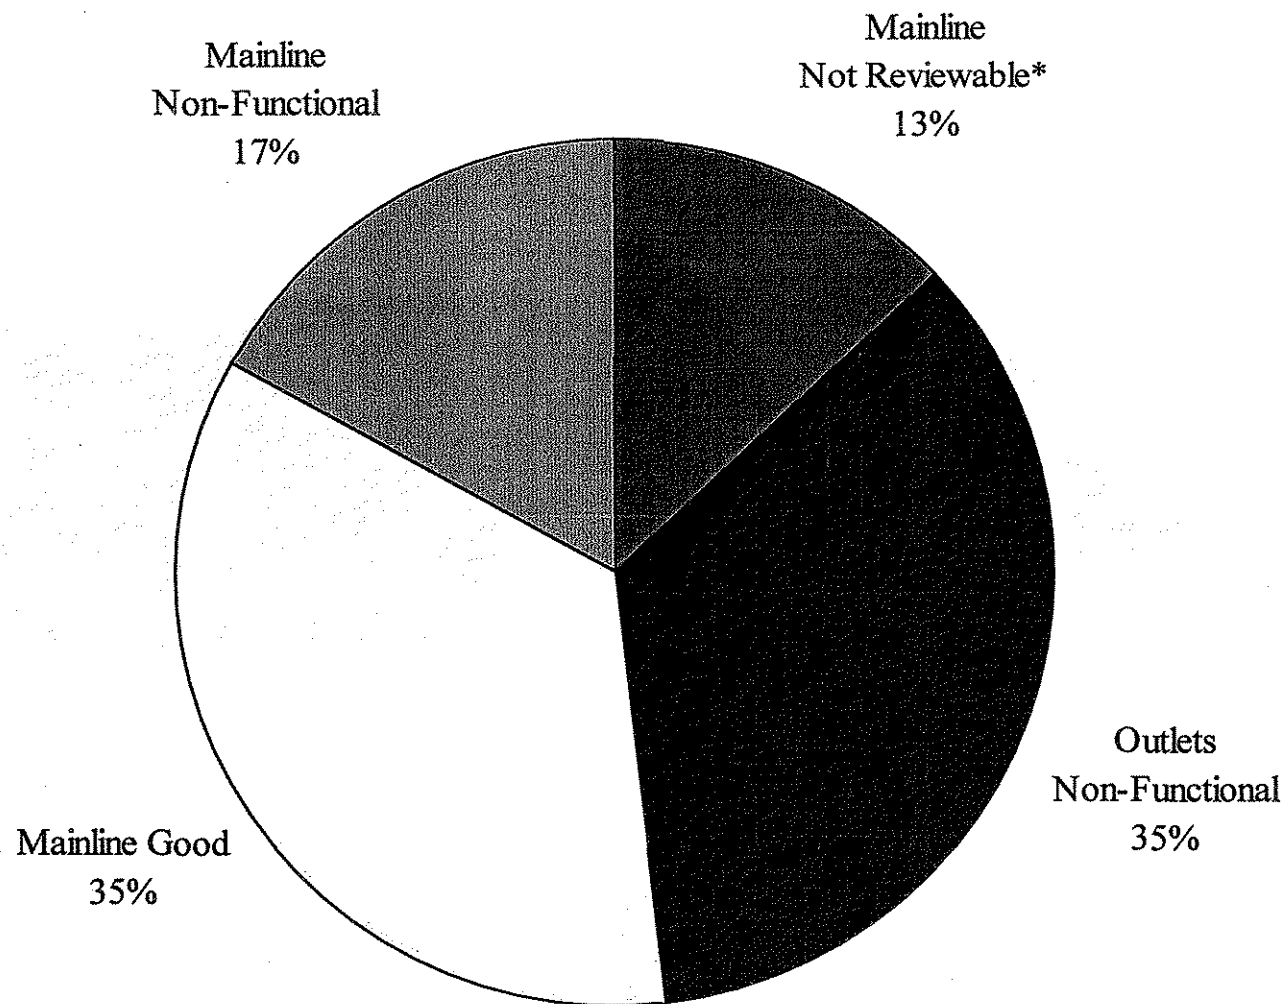
Of the 287 lateral/mainline edgedrain systems attempted, over 100 demonstrations were terminated due to defects with the laterals. Fifty-two (18%) had crushing in the lateral. Another 50 (17%) of the lateral systems were silted-in, limiting the investigations on these systems (Figure 8 and 9). In addition, 36 (13%) were composed of geocomposite sock, panel drain, drop tees, drop inlets, or no mainline systems at all (Figure 10).

* Could not inspect geocomposite socks, panel drains, drop tees, drop inlets or systems where no mainline was installed.

Figure 10. Breakdown of Video Inspections.

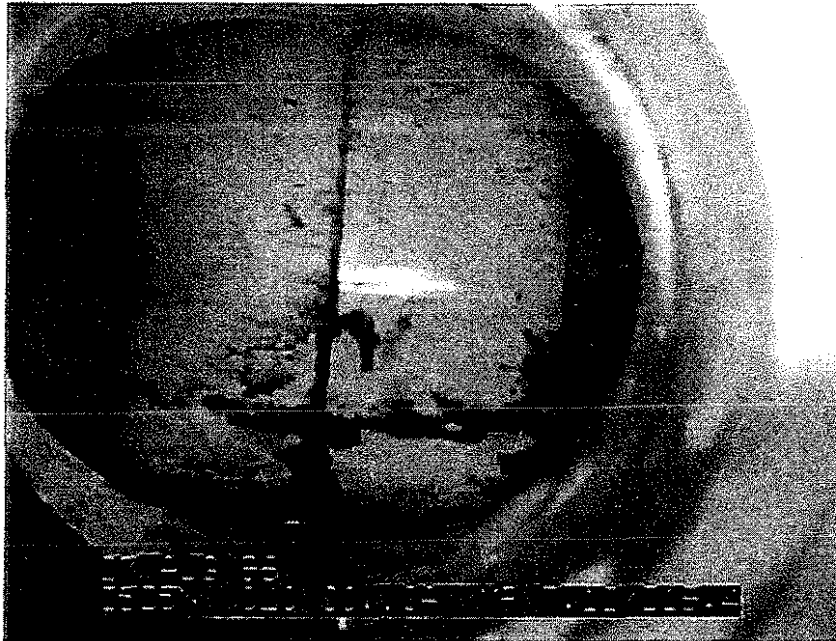
149 (52%) mainline segments were capable of inspection. Figure 11 shows a clear 90° tee junction of the lateral and mainline. Of these 149, 17% (26) were found to be crushed, silted in, or obstructed within the first 30 meters. Sixteen percent (24) of the inspections covered 30-60-meters of the mainline segment, 28% (41) went to the 60-90-meter range (Figure 12), 18% (27) were in the 90-120-meter range and 21% (31) covered 120-150-meters of the mainline (Figure 13). In many instances, a crush in the mainline system could be identified or associated with a known construction crossing prior to the opening of traffic on to a given highway.

Figure 11. Clear 90° Tee Junction of Lateral and Mainline

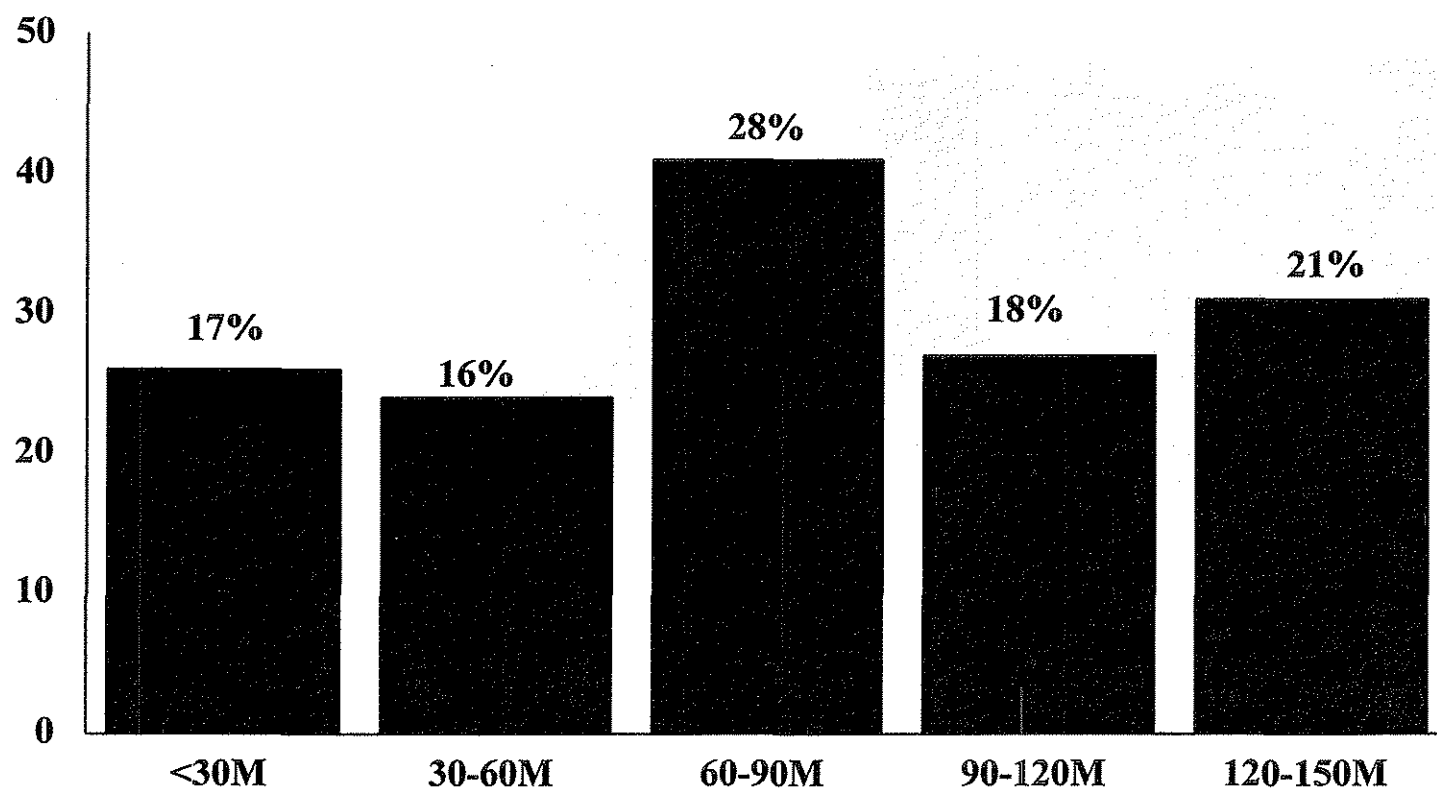
Figure 13. Mainline Demonstrations Resulting in the Following Attained Distances.

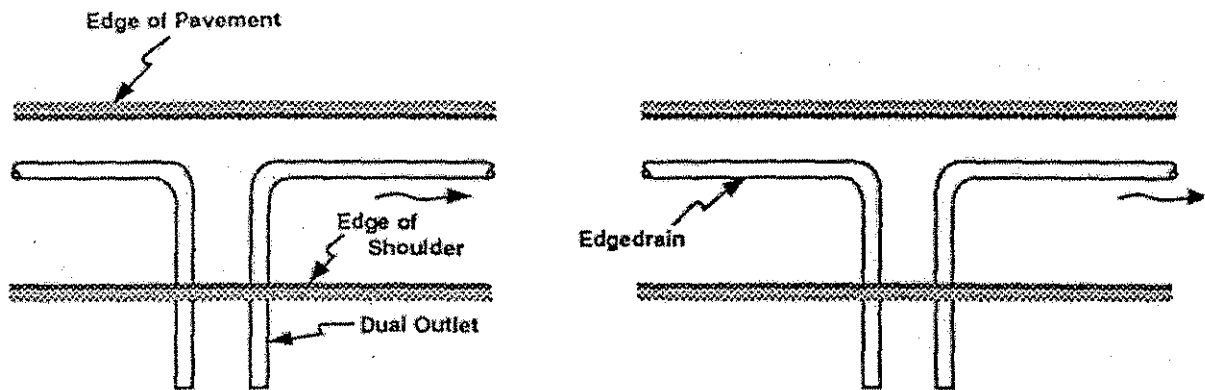
Figure 22. Edgedrain Design for Maintenance.

Edgedrain design is already experiencing changes such as less angular connections (and dual outlets Figures 22 and 23) to facilitate performance and use of inspection and clean-out equipment. From these initial demonstrations one could identify materials which appear to be better suited for use in edgedrain systems. Such a practice for selection of materials can be very misleading. Evaluations incorporating initial materials and construction costs, maintenance and replacement costs were beyond the scope of this project. However, as quality control specifications come into play, such considerations will typically find their own natural balance.
