# LOW PROFILE MARKER FOR WET/NIGHT VISIBILITY

HR - 1005 Final Report

HIGHWAY DIVISION  
April 1977

John H. Moody

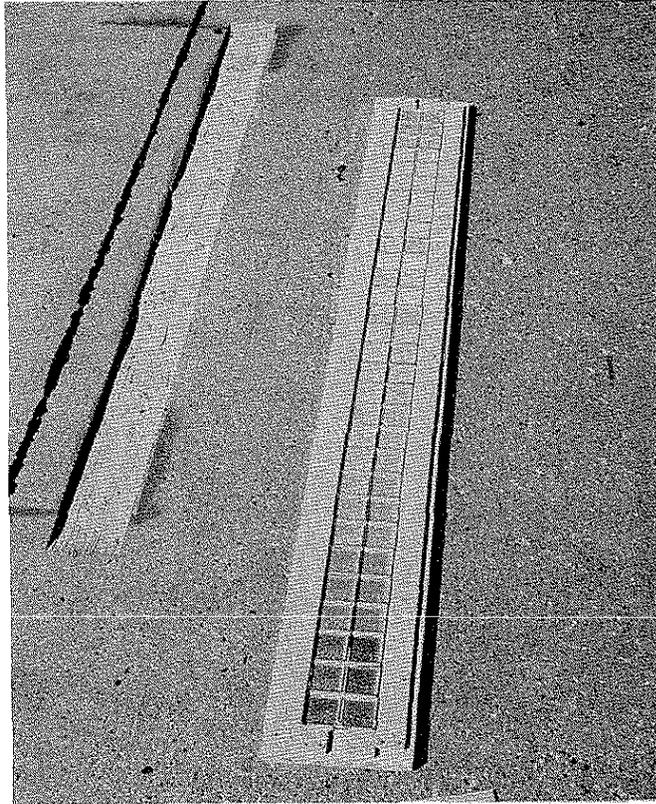
Figure 4. Inverted reflector unit in alignment board

The "low-profile" markers were placed in an inverted position, on a board to which cleats had been attached forming a recessed area 4 inches wide, 60 inches long and 1/4 inch deep. See Figure 4.

Four (4) such boards were on hand to facilitate preparing more than one marker for installation at one time.

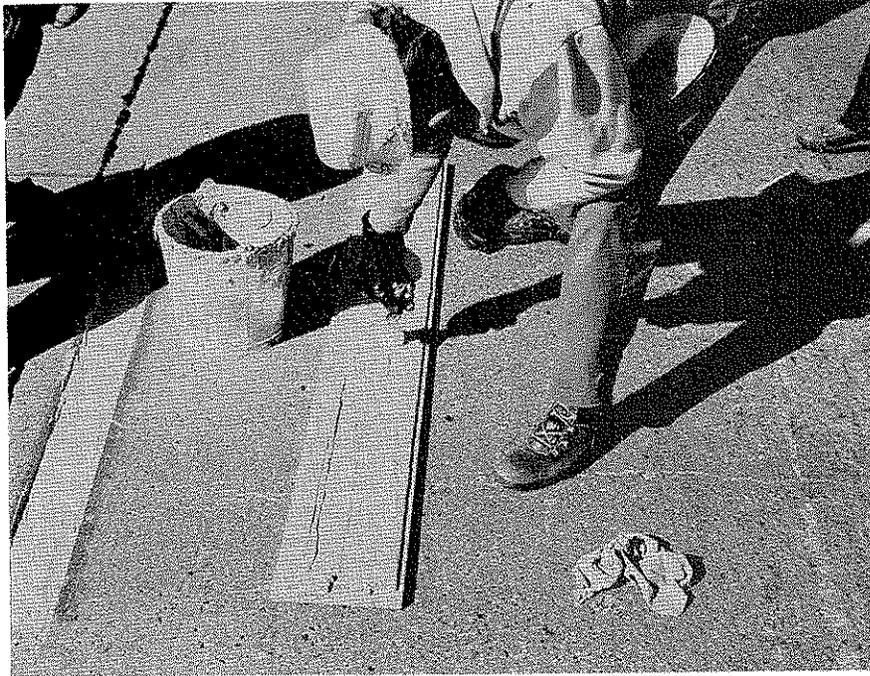
Figure 5. Application of epoxy to reflector unit and to groove in pavement

The back or bottom of the reflector unit was filled with epoxy during which time, epoxy was spread onto the bottom of the 4-1/8 - inch x 60 - inch groove in the pavement. Figure 5 shows this procedure. The board was then overturned depositing the reflector unit, right side

up, into the groove and the reflector elements were pressed into the epoxy.

It has been observed that this method of installation is not acceptable inasmuch as the condition of seven of the eight reflectors referred to above was rated "poor" during the final inspection on September 8, 1976.

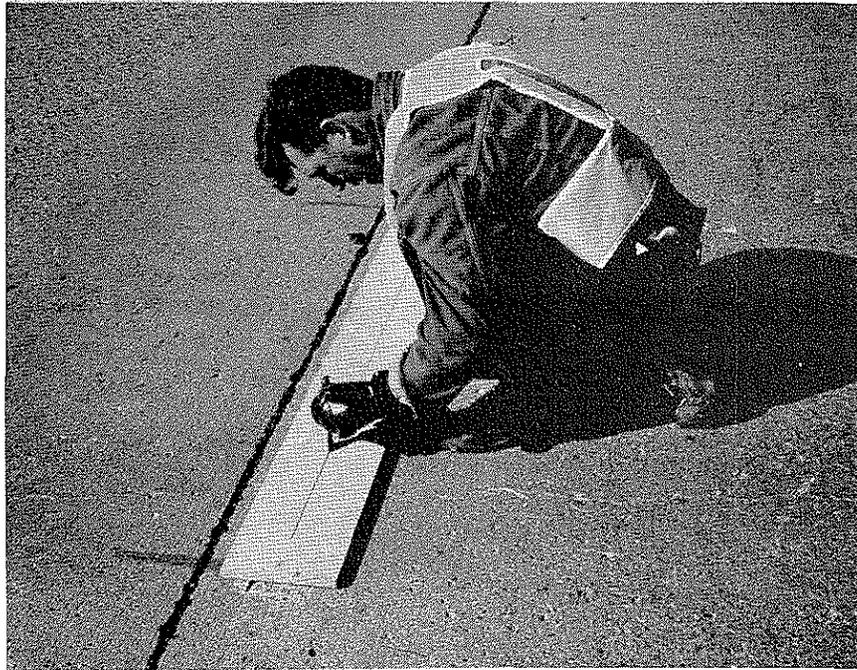
Figure 6. Using a putty knife to eject reflector elements from the alignment board

In order to overcome the problem of not being able to remove the reflector elements from the recess in the alignment board, a saw-cut was made in the board down the center of the recessed area. (See Figure 6). The saw-cut made possible the ejection of the reflector elements with the use of a putty knife while the board was in an inverted position over the groove in the pavement.
