**PRESSURE RELIEF AND
OTHER JOINT REHABILITATION TECHNIQUES**

FINAL REPORT

February, 1987

14. Sponsoring Agency Code	
15. Supplementary Notes FHWA Contracting Officer's Technical Representative: Peter Kopac, HNR-20					
16. Abstract A study of four major concrete pavement joint rehabilitation techniques has been conducted, including: pressure relief joints, full-depth repairs, partial-depth repairs and joint resealing. The products of this research include the following for each technique: a summary of published research, detailed documentation of the design and performance of the 36 projects, conclusions and recommendations of the state highway engineers panel, "Design and Construction Guidelines" and "Guide Specifications." The latter two products are prepared for use by state highway agencies. The results of this study are based upon a review of literature, extensive field surveys and analysis of 36 rehabilitation projects, and the experience of an expert panel of state highway engineers.

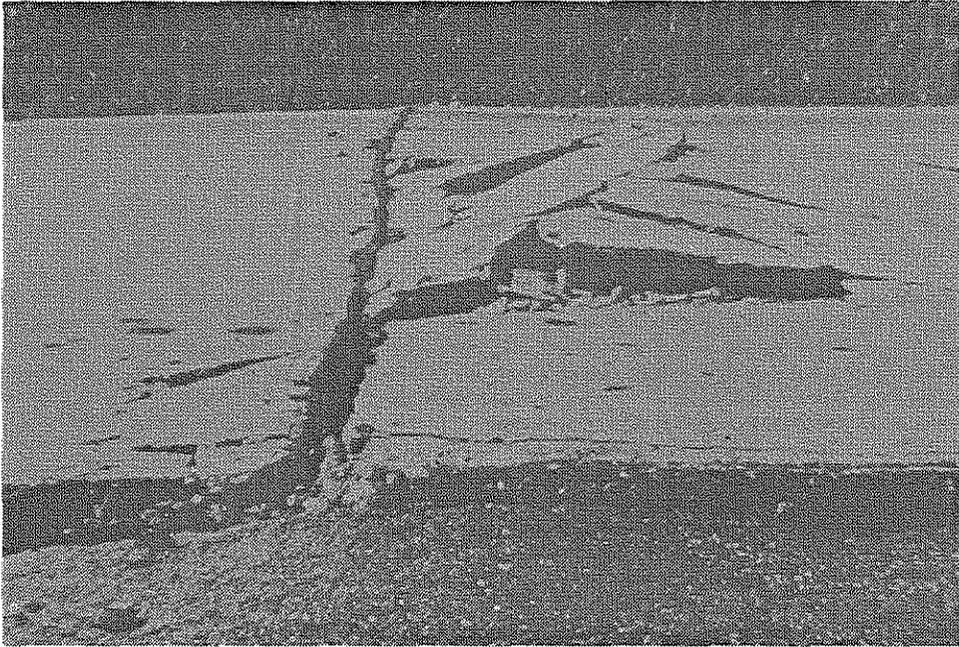
Figure 6. Photo of Blowup (Shattered Pavement).

Blowups are areas of localized upward movement (see Figure 5) or shattering of the pavement (see Figure 6) due to excessive compressive forces in the slab. They often occur in hot weather at a joint or crack which is closed or filled with incompressibles and will not allow expansion of the concrete slab.

Low-severity blowups produce minor buckling or shattering of the slab, but create little discomfort to the occupants of passing vehicles. Medium-severity blowups cause some discomfort, while high-severity blowups cause substantial discomfort, pose a safety hazard, and may require passing vehicles to reduce their speed. (29, 117)

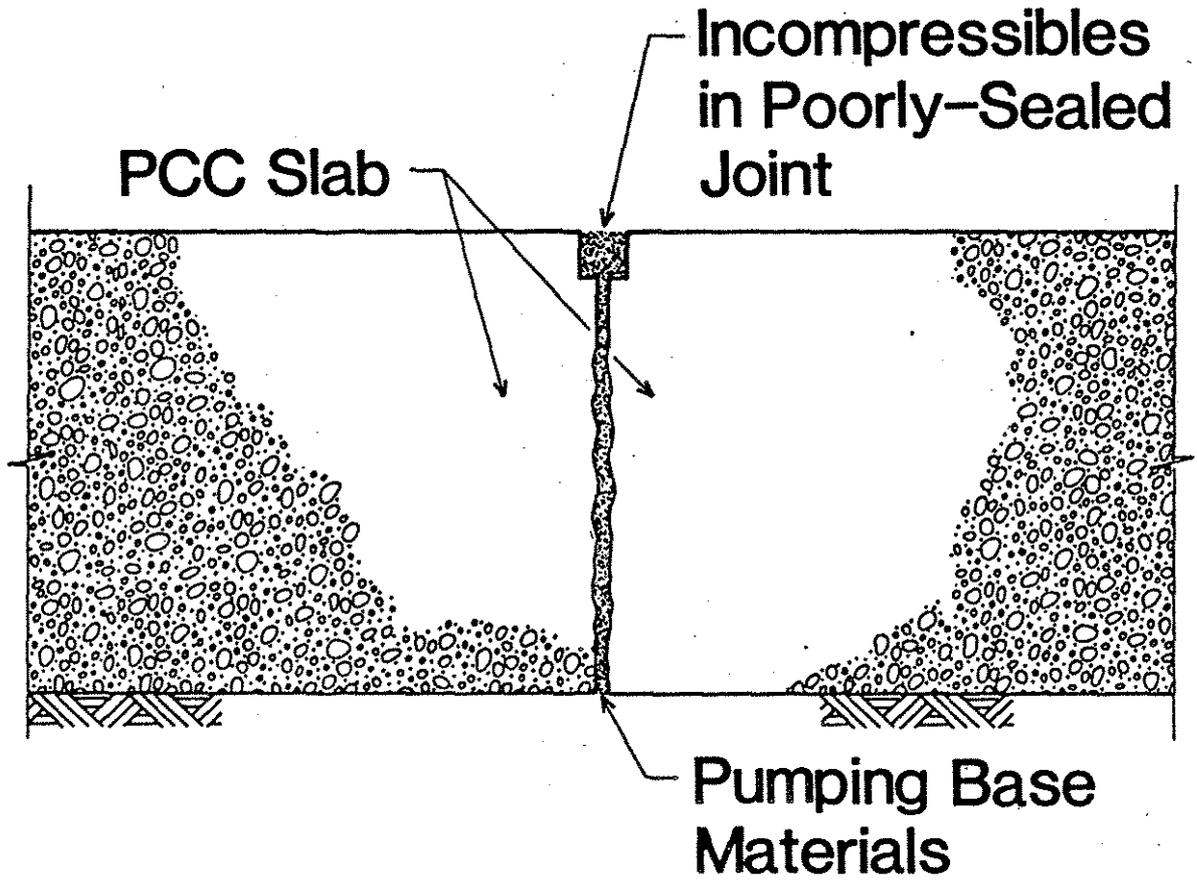
Figure 8. Intrusion of Incompressibles into Joint Area Through Poorly-Sealed Joint and Pumping of Base. (25)

Intrusion can also occur from below the slab when vertical movements at the joints and cracks cause pumping. Water and base material particles are forced upward into the joints and cracks. In time, incompressibles can buildup (see Figure 8) which prevents the joint from functioning properly.

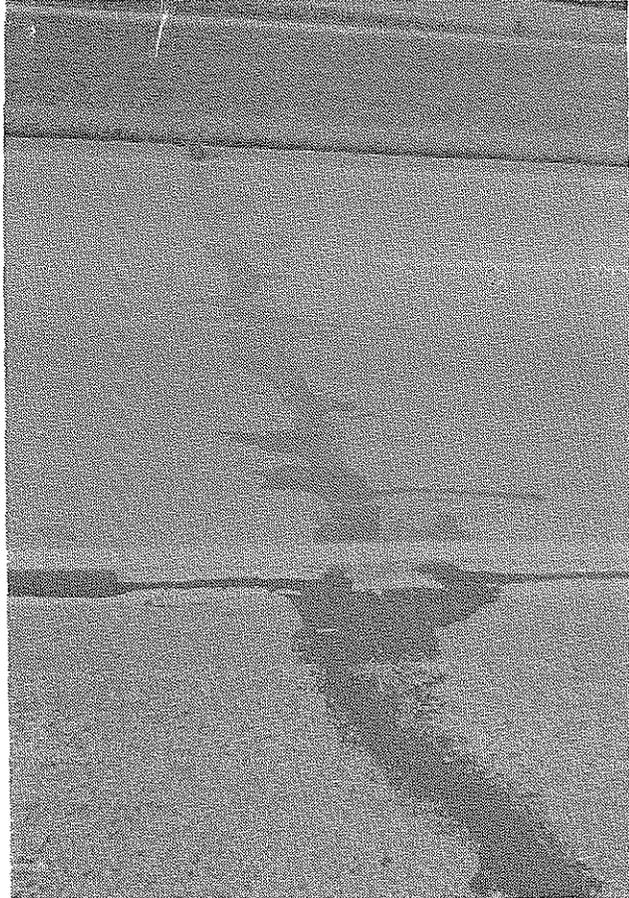
Figure 30. Photo of Sealed Crack Over Pressure Relief Joint on OH070066.

The pressure relief joints have reflected through the overlay, have been sealed and are not spalled (see Figures 30 and 31). The overlay is not "humped" above the relief joints and the flexible repairs have not reflected through the overlay and have not caused "humping."

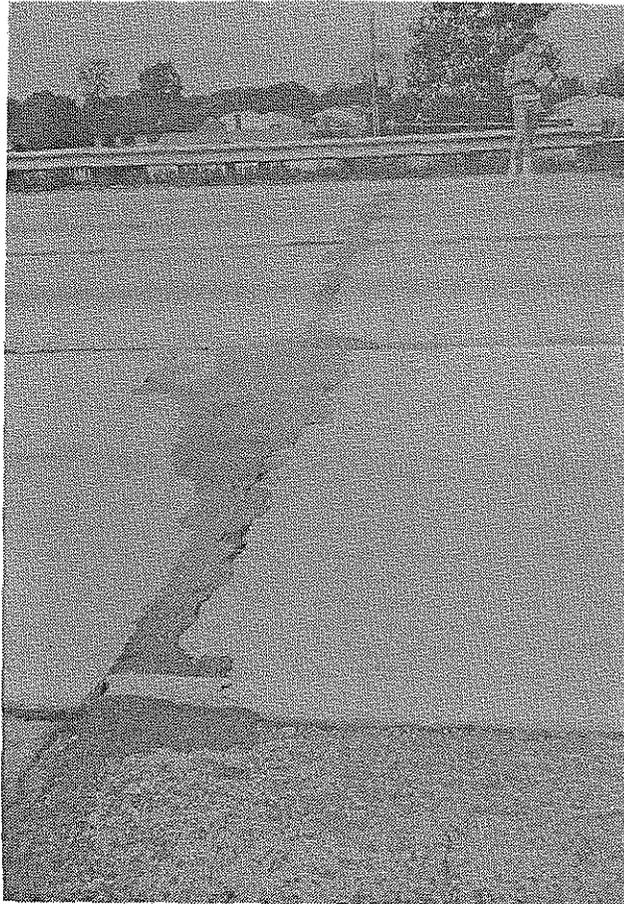
Figure 34. Photo of Pressure Relief Joint on OH270031.

The pressure relief joints are exhibiting medium-severity joint and corner spalling. In addition, transverse cracks adjacent to the pressure relief joints have deteriorated from tight, nonworking cracks (typical of a CRC pavement) to spalled, working cracks (see Figures 34 and 35). Punchouts were more frequently located near the pressure relief joints.

Installation of pressure relief joints on this project was inappropriate because the compressive stresses in areas that had suffered blowups in the past were probably sufficiently relieved by the blowups. Further, the interruption of the continuous reinforcing steel resulted in premature deterioration of adjacent transverse cracks. A better approach might have been to remove pavement sections for the placement of traditional CRC repairs and leave these areas open for 24-72 hours to allow for pressure relief. A properly constructed repair could then have been installed by carrying the steel through the repair to keep the cracks tight. This would have reduced the possibility of loss of support caused by allowing water to enter a wide relief joint.

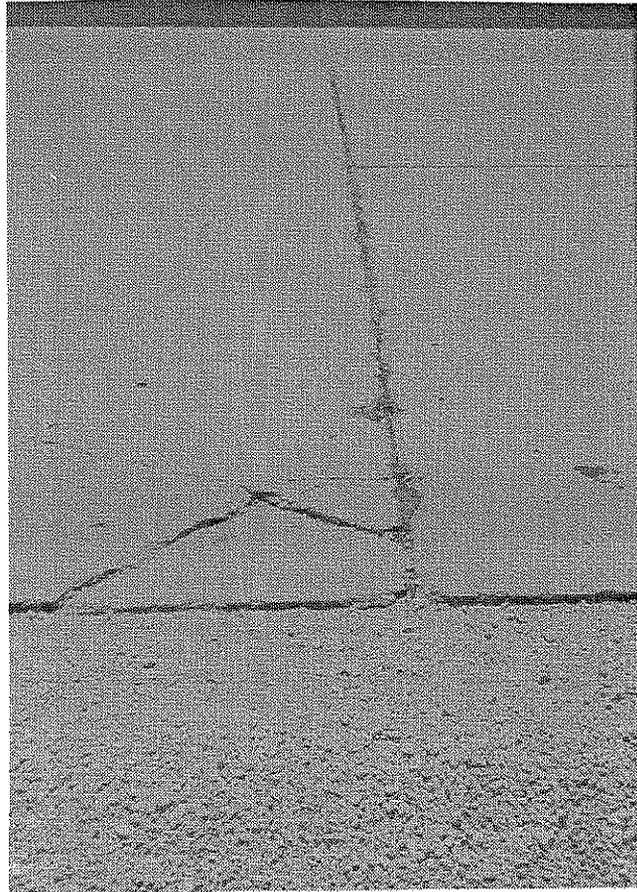
Figure 39. Photo of Typical Pressure Relief Joint
in Sample Unit 2 (Station 8+60) on IA030156.

The pressure relief joints (excluding those located near bridges) have closed to an average width of 0.54 in [14 mm], which is about the same width as the resealed joints. The relief joints have faulted an average of 0.16 in [4.1 mm] after only 0.6 million ESALs, which compares with 0.11 in [2.8 mm] and 2.2 million ESALs for the original contraction joints. Half of the surveyed relief joints had no filler present and incompressibles were observed in all of the surveyed relief joints. Several of the relief joints also exhibited medium-severity transverse joint spalling (see Figures 39 and 40).

The presence of the pressure relief joints contributed to further opening of the transverse contraction joints, enabling water and additional incompressibles to enter the joints. This opening would also reduce the effectiveness of the aggregate interlock load transfer, enabling pumping and increased faulting to develop. The Iowa Department of Transportation has recently changed their pressure relief joint policy and now limits their use, particularly on JPCP.

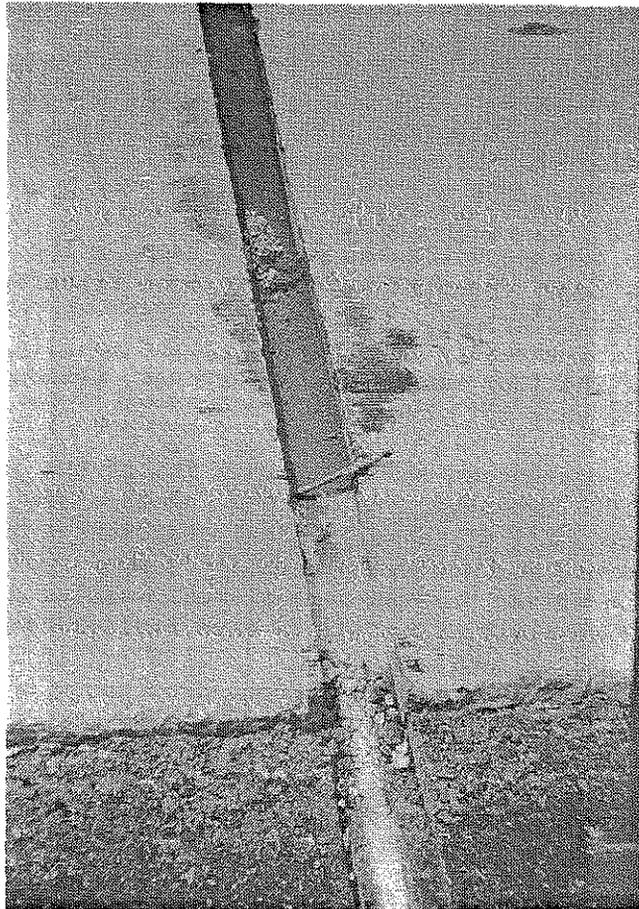
Figure 45. Photo of Typical Pressure Relief Joint in Sample Unit 1
(Station 2+40) of IL080105.

The pressure relief joints that were installed in 1984 had closed to an average width of 3.5 in [89 mm] and had faulted an average of 0.16 in [4.0 mm] in 1985 (twice the faulting of the original contraction joints). The filler was absent from two of the three relief joints surveyed and these joints contained incompressibles (see Figures 45 and 46). The third relief joint was located in the joint resealing project and it showed no

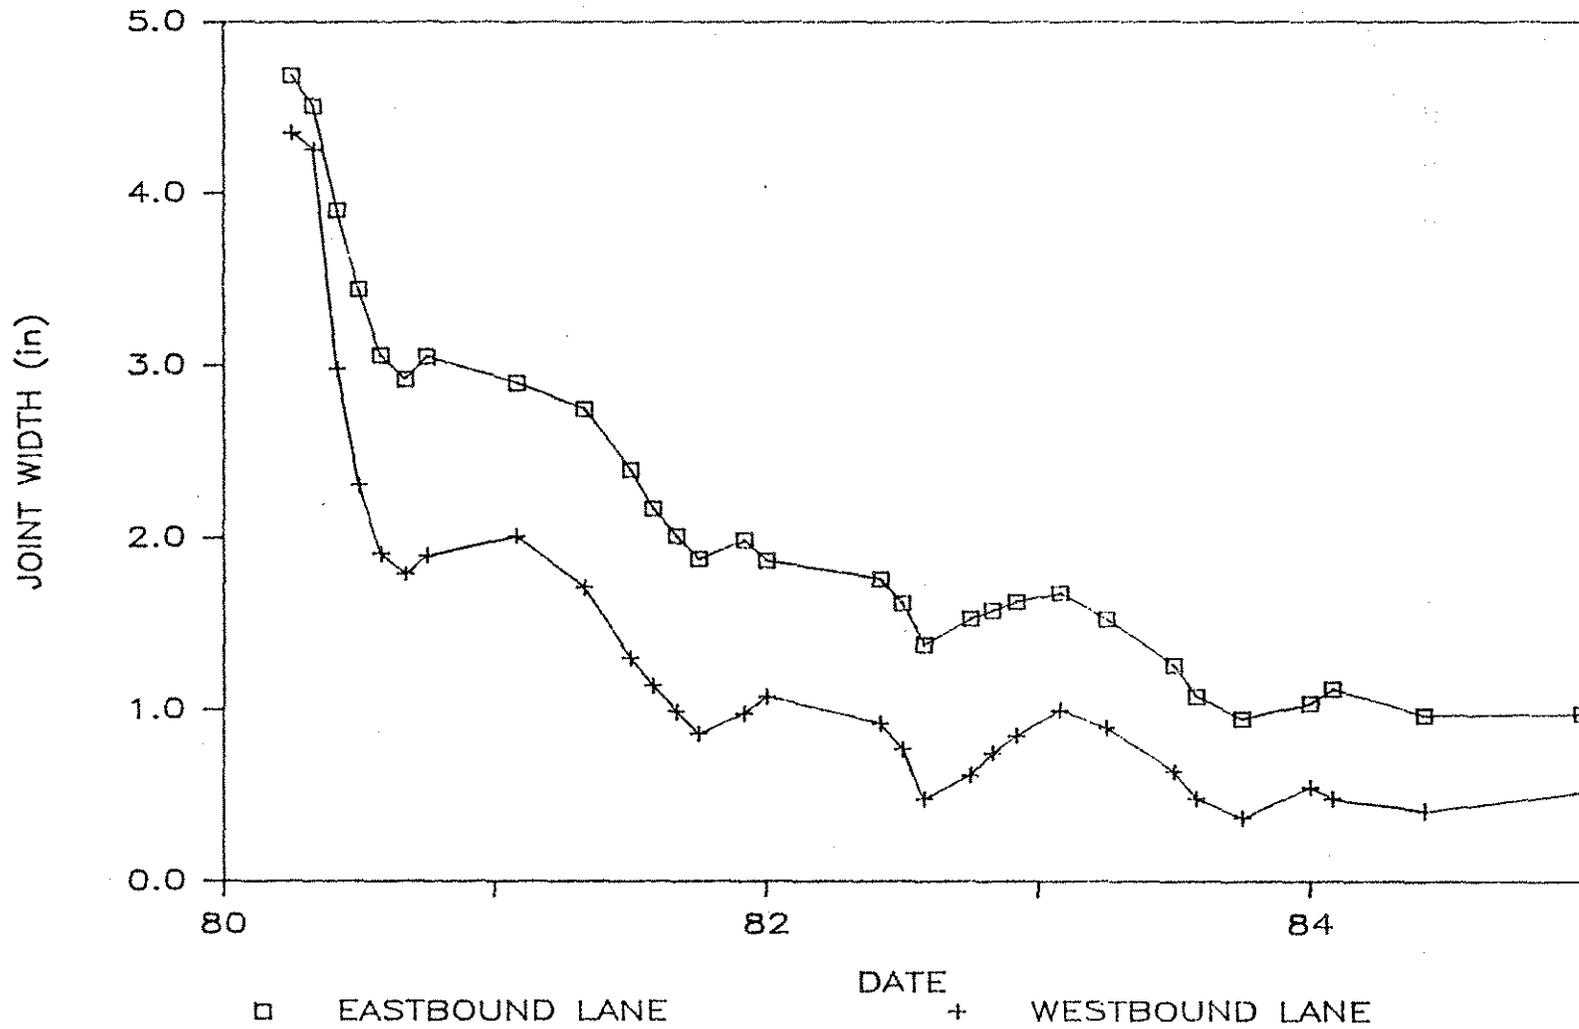
Figure 55. Pressure Relief Joint Closure Over Time on NE080210
[1 in = 25.4 mm].

Less closure and lower rates of closure were found in the relief joints on this project (as determined by the Nebraska Department of Roads) than the preceding one (NE080189). This can probably be attributed to the placement of full-depth repairs before the installation of the relief joints on this project. The full-depth repairs allowed for some of the pressure to be relieved, but the relief joints were still necessary to allow for the expansion of the pavement caused by reactive aggregate problems.

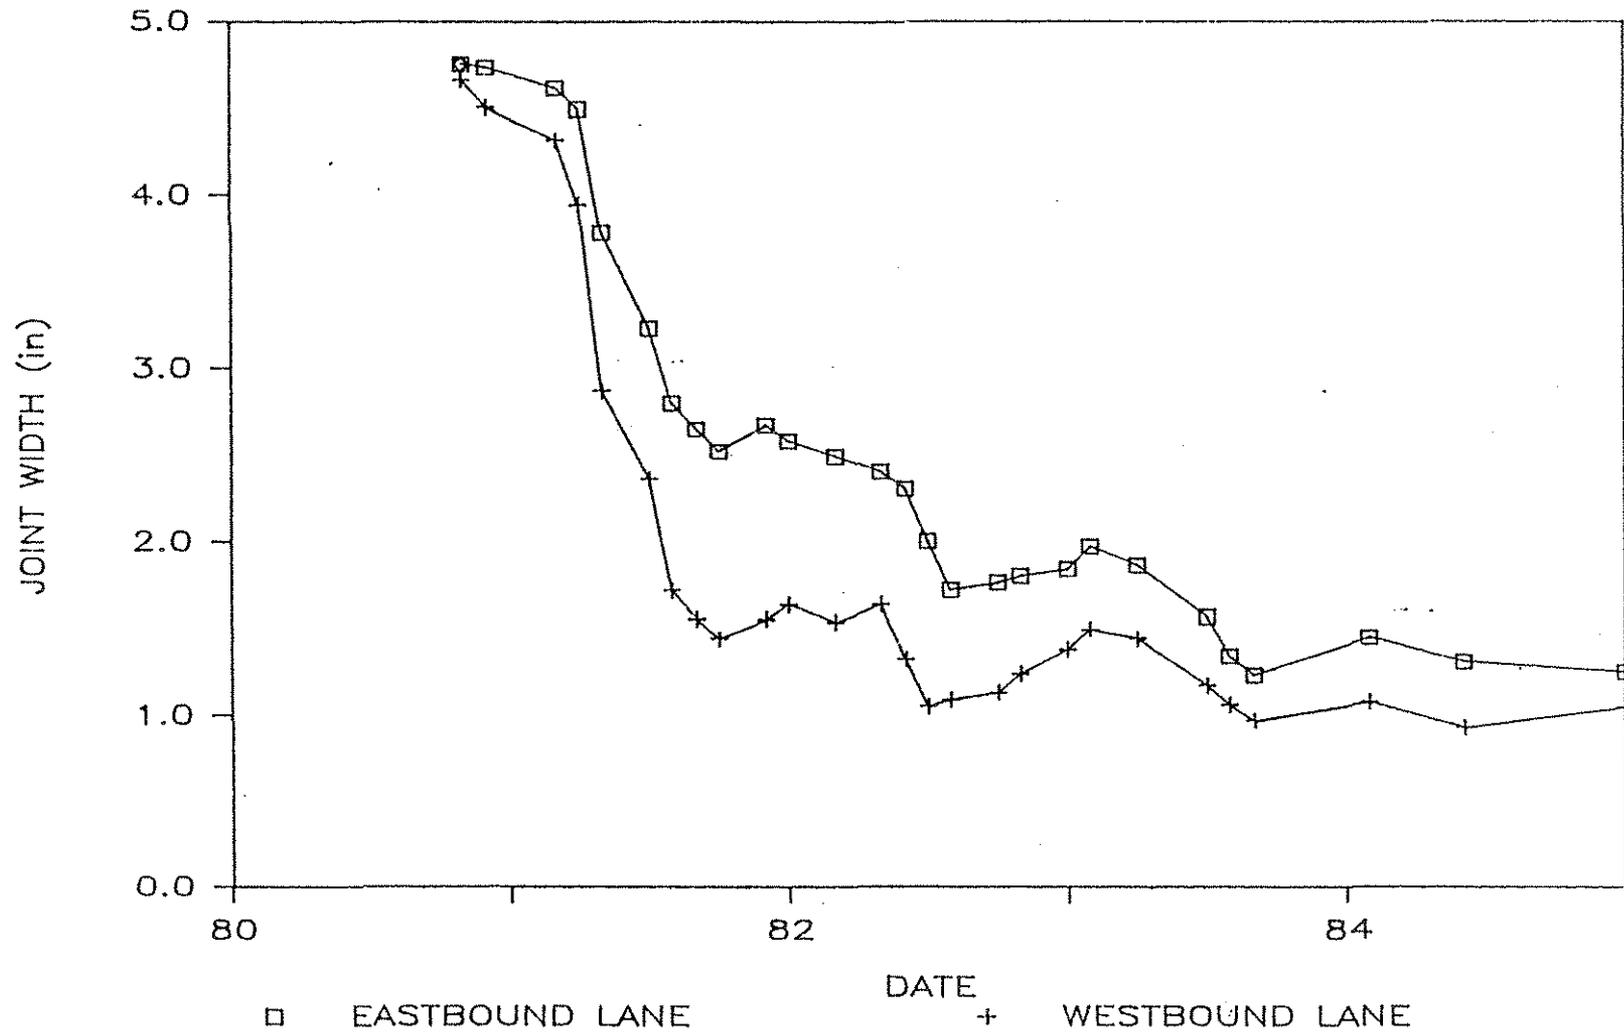
Figure 56. Pressure Relief Joint Closure Over Time on NE080256 [1 in = 25.4 mm].

The pressure relief joints that were installed in 1980 have closed from 4.5 in [114 mm] width to an average width of 0.86 in [22 mm] and have faulted an average of 0.18 in [4.6 mm]. Table 7 presents a summary of the closure of the pressure relief joints for the entire project, as measured by the Nebraska Department of Roads. Figure 56 illustrates the relief joint closure over time. The filler is still intact in most of the relief joints and is keeping incompressibles from infiltrating. Spalling was generally of medium severity.

The performance of the pressure relief joints has been satisfactory for this project and the two preceding it (NEO80189 and NEO80210). It is observed that the rate of closure and the amount of closure is less for this project (NEO80256) where full-depth repairs and pressure relief joints were installed the same year. However, the relief joints were apparently still necessary to allow for the expansion of the pavement caused by reactive aggregate.

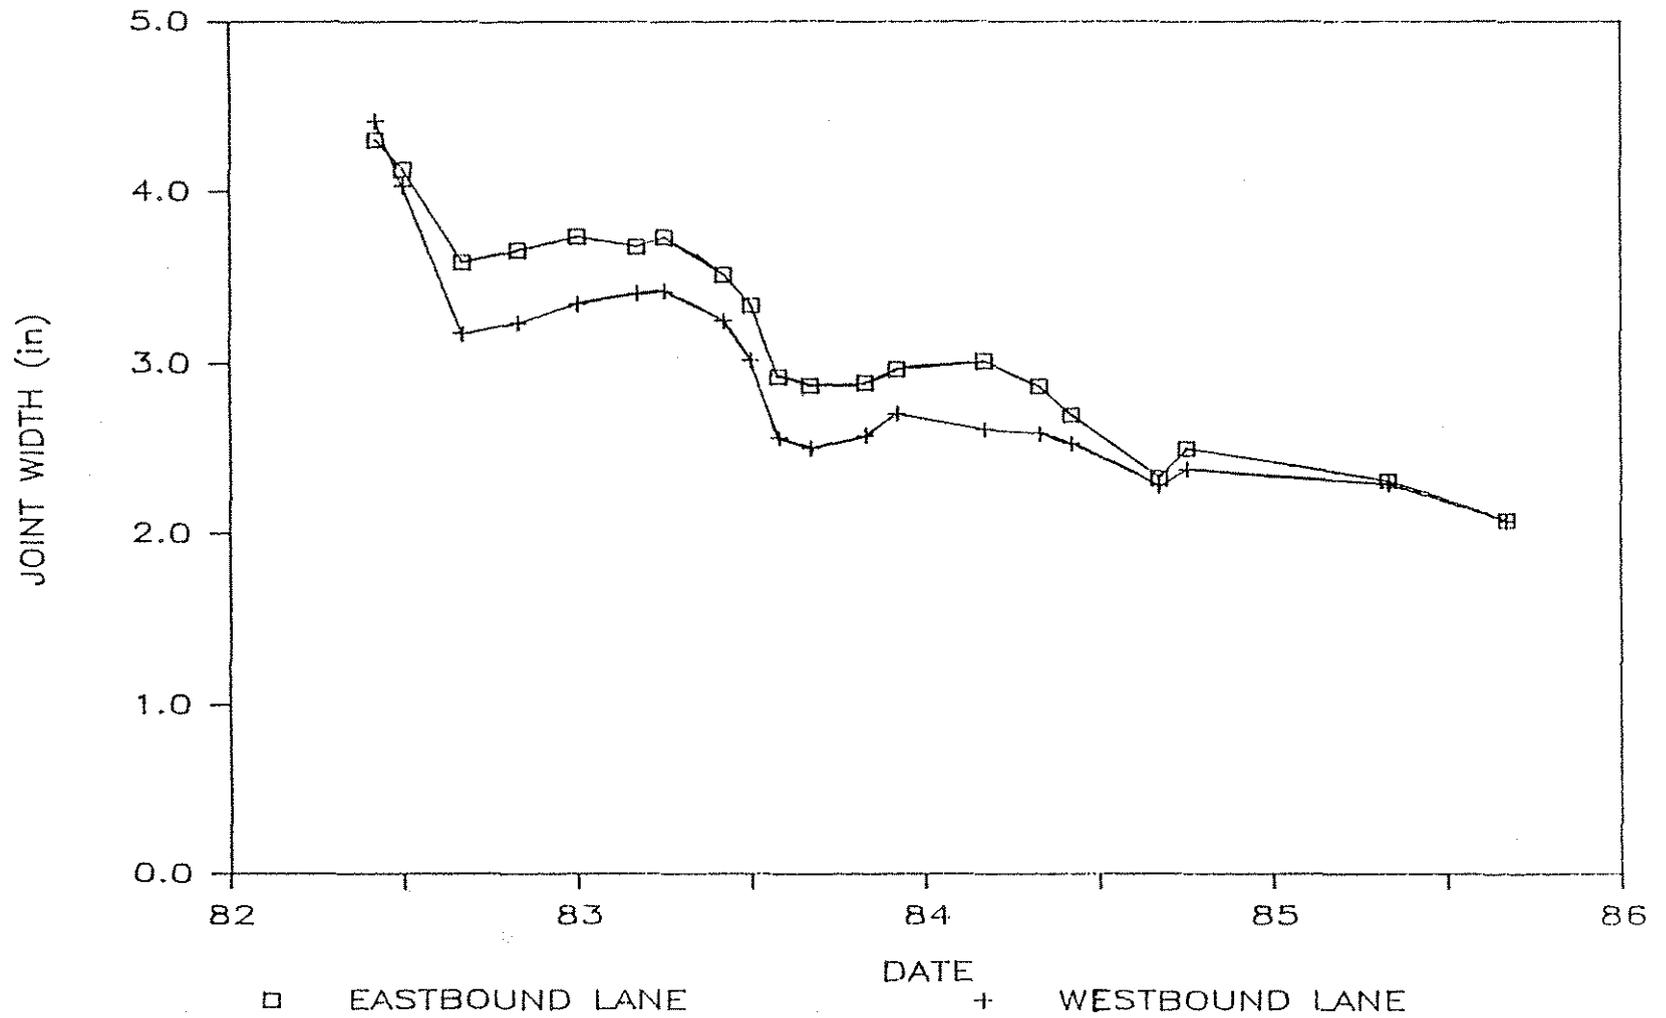
Figure 57. Pressure Relief Joint Closure Over Time on NE080382 [1 in = 25.4 mm].

Although the use of relief joints on this project may be questionable, their presence has apparently not adversely affected the project, because the faulting and opening of adjacent contraction joints is about average and nearby slabs exhibit typical types and amounts of distress. The faulting of the relief joints might have been reduced slightly if a load transfer system (e.g., dowels or a sleeper slab) had been provided.

While the original pavement has several years of serviceable life remaining, the full-depth repairs placed in 1982 should be replaced immediately. The joints will require resealing within the next few years and a longer-life sealant is recommended.

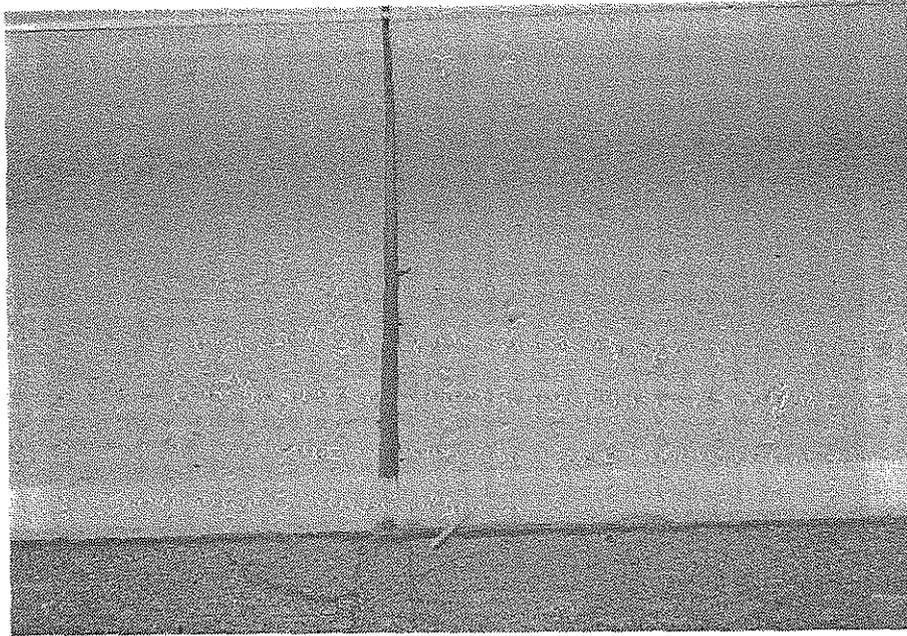
Figure 58. Photo of Pressure Relief Joint in Sample Unit 2 (Station 5+86) of VA064279 (Diamond-Ground Direction).

unacceptable roughness) is approximately 2 to 4 years from the date of survey (1.8 to 3.6 million ESALs in the outer lane). The unground section would benefit from more immediate attention. With proper rehabilitation, this project should provide many additional years of service because it shows little evidence of fatigue or structural failure.

Suggestions for improvements include the incorporation of load transfer devices in future full-depth repairs, installation of subdrains along the entire project, cement grout undersealing at least in the vicinity of the repairs and known voids, and regrinding the pavement when roughness becomes unacceptable. Removal of the relief joints could also be considered.

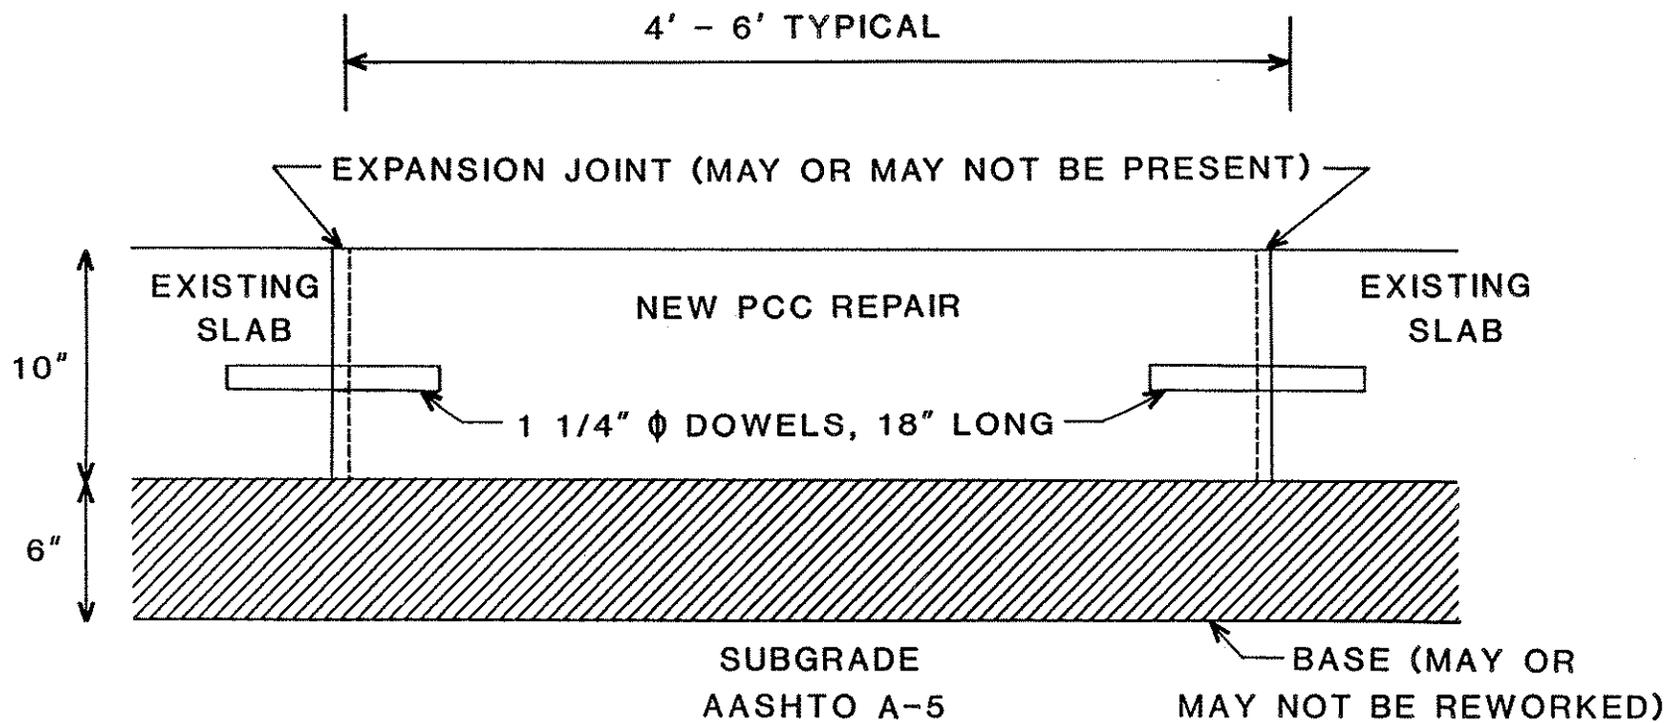
Figure 65. Illustration of Full-Depth Repair Design Used on IL055098
[1 in = 25.4 mm].

Both sets of repairs do not always meet the acceptance criteria for smoothness, which is somewhat surprising for the short period for which they have been down. This large faulting may be due to poor load transfer at the repair joints. The loss of load transfer may be attributed to heavy truck traffic, poor support of the dowels due to a relatively large annular gap around the dowels, and inadequate grouting techniques. No difference in faulting is detected between the 1983 and 1984 repairs.

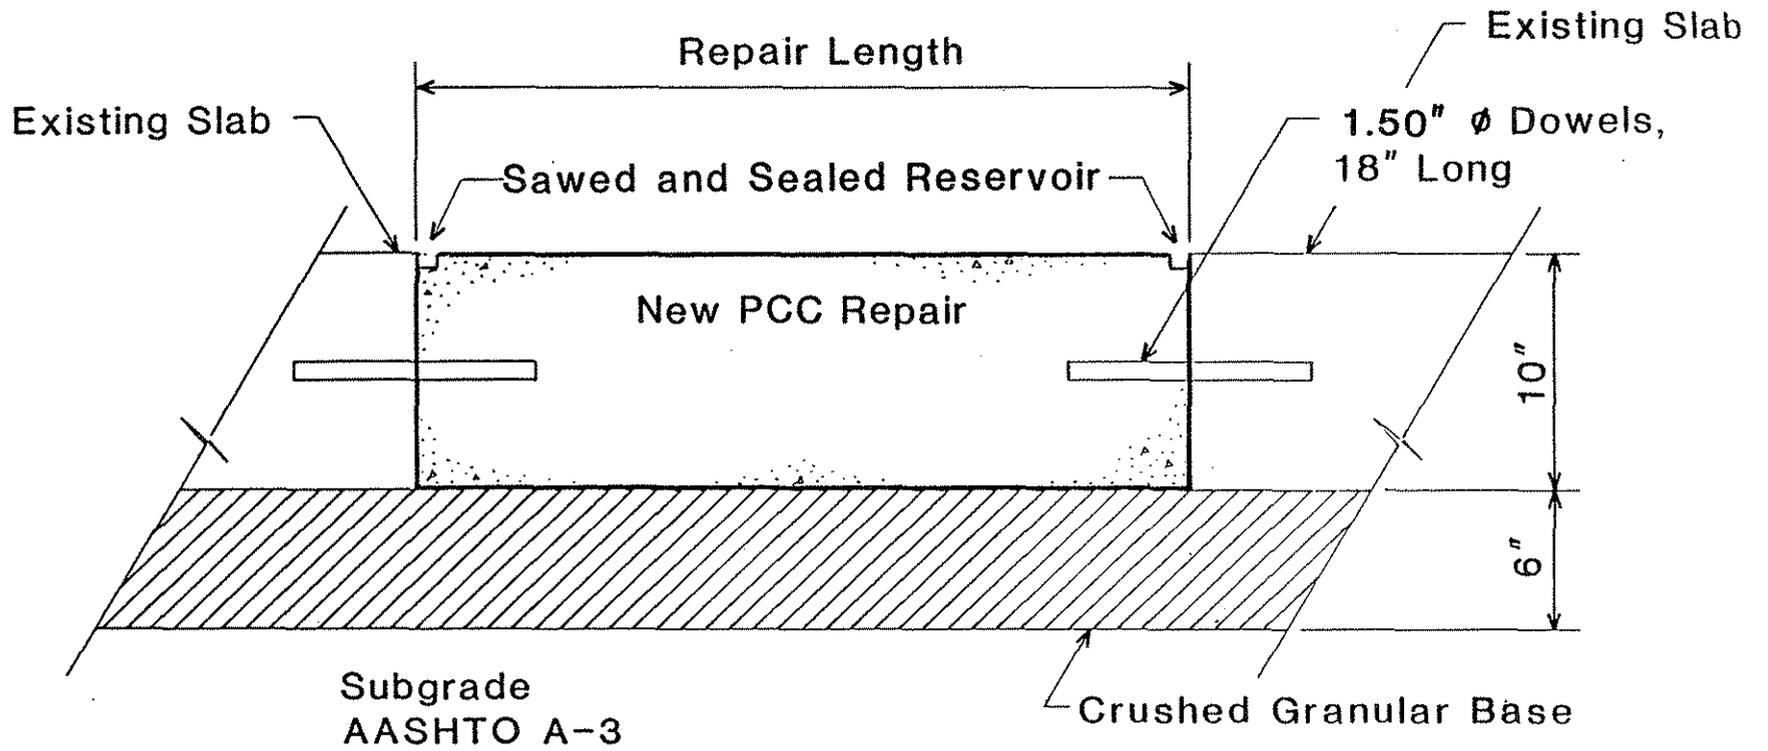
Figure 67. Illustration of Full-Depth Repair Design Used on IL280-74
[1 in = 25.4 mm].

Faulting of the repair joints was not a problem. All of the repair joints were in the smooth ride range of -0.20 in to 0.20 in [-5.1 mm to 5.1 mm], which can be attributed to diamond grinding. Repair joint faults are generally not much greater than faults at the original contraction joints, although one repair leave joint fault measured 0.14 in [3.6 mm]. Repair leave joints were commonly faulted more than repair approach joints, and the repair joints on I-280 were faulted slightly more than those on I-74 (due to there being more traffic on I-280). Although the faults are still very small, there is clearly a tendency towards tilted (approach end low) repairs, which typically accompanies pumping.

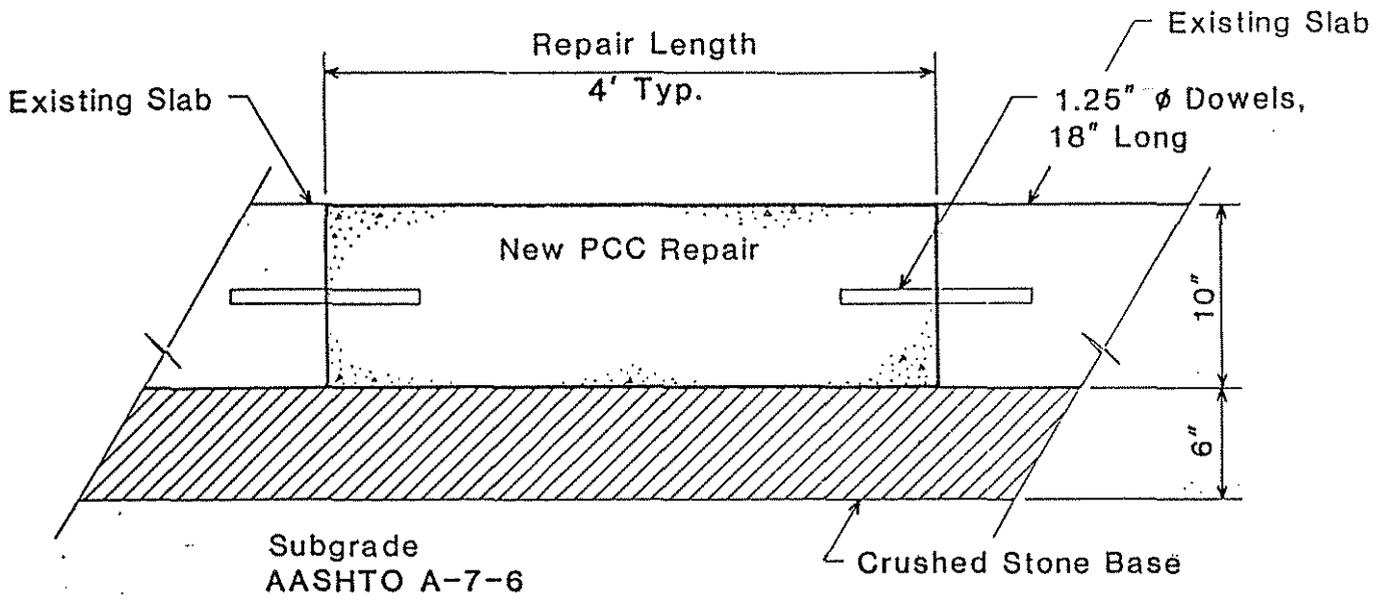
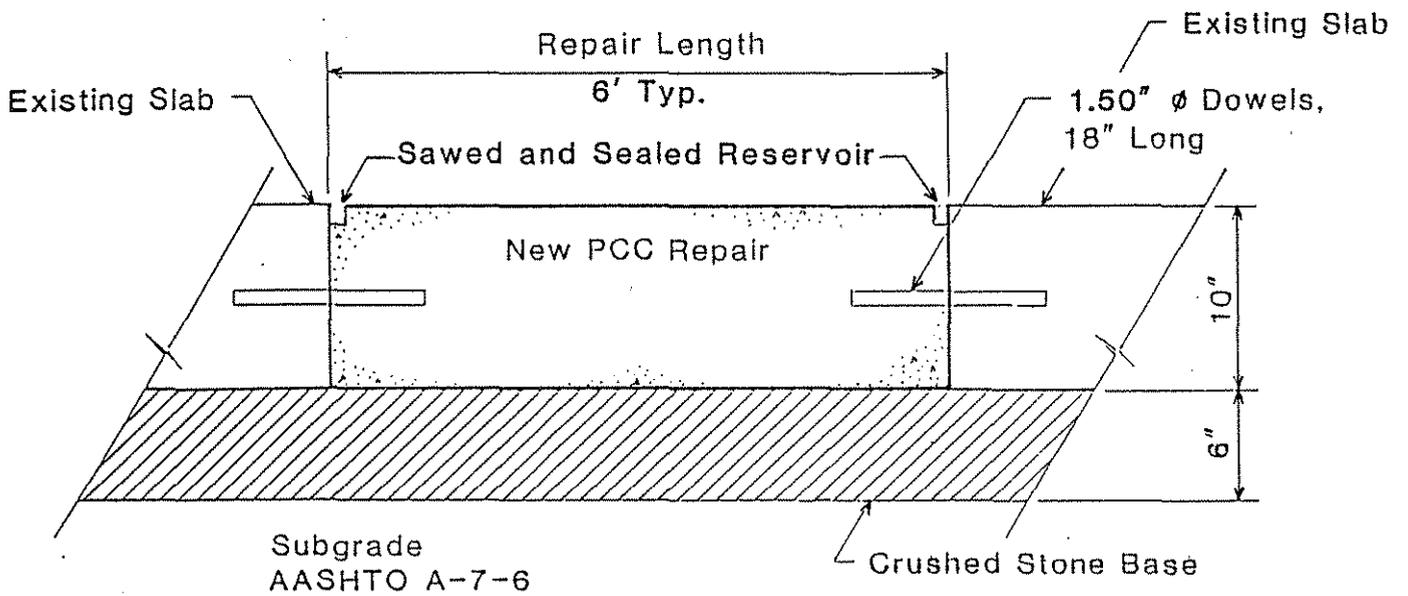
Figure 69. Illustration of Full-Depth Repair Designs Used on IL080105 [1 in = 25.4 mm].

It is observed that faulting of both sets of repairs was generally within the smooth ride range, but one 1985 repair displayed an unusually high leave fault (0.46 in [12 mm]). This is an unexpected fault for such a new repair which not only contains 10 dowel bars, but dowels of 1.5 in [38 mm] diameter.

The faulting of both sets of repair joints did not seem to indicate any consistent pattern in the vertical orientation of the repair. This is probably due to the fact that the 1985 repairs have only been in place for one year and have not started to show "true" faults (from pumping). The faulting that the 1985 repairs are displaying now may have been built in during construction. The faulting of the 1985 repairs is comparable to that of the 1983 repair (which had been diamond ground).

The 1985 repair joints had all been resawed and resealed after their placement. However, the 1983 repair had not been sealed, and both repair joints contained incompressibles and, subsequently, is spalling on the repair side of each joint. In addition, the joints were tight on this repair, as compared to an average width of 0.7 in [18 mm] for both the approach and leave joints of the 1985 repairs.

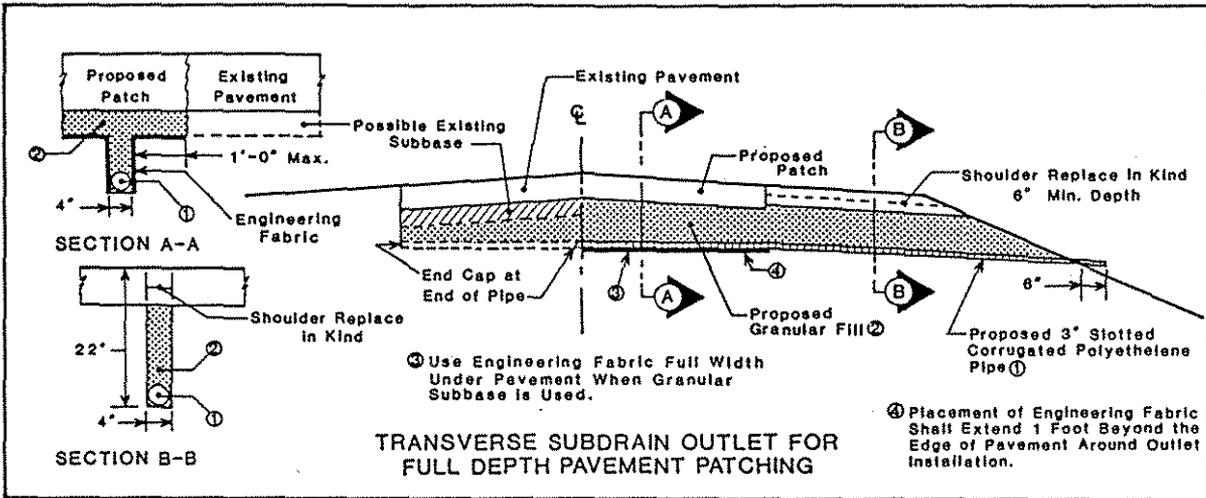
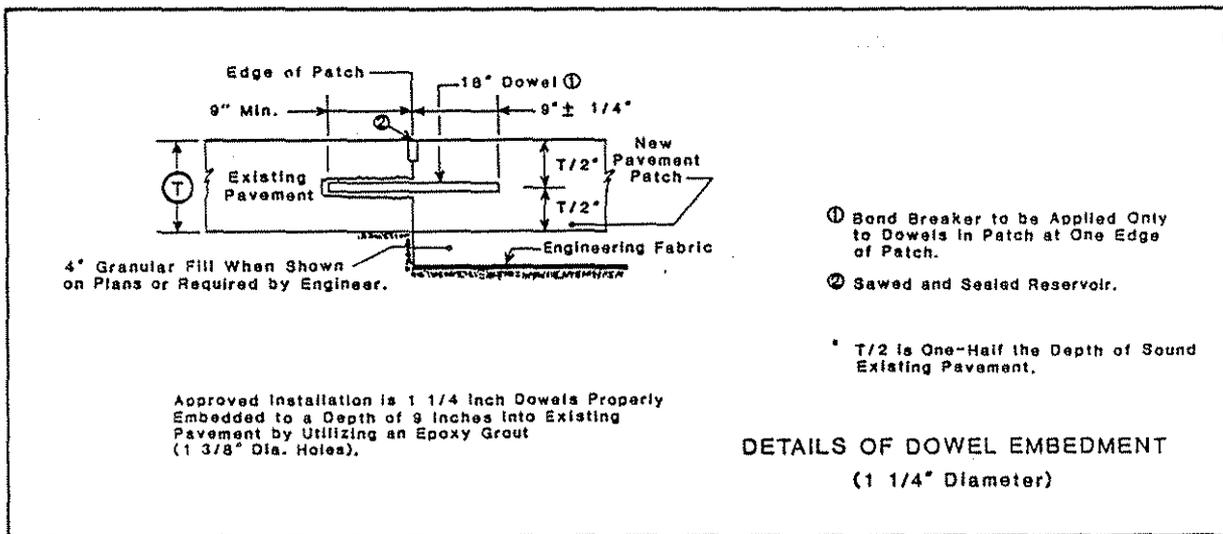
Figure 70. Illustration of Full-Depth Repair Design Used on IA080288 [1 in = 25.4 mm].

Faulting of the repairs is not a problem, as all measurements are well within acceptable limits. However, repair joint faulting is nearly double that of the original contraction joints after grinding. This particular project has historically exhibited a large degree of pumping.

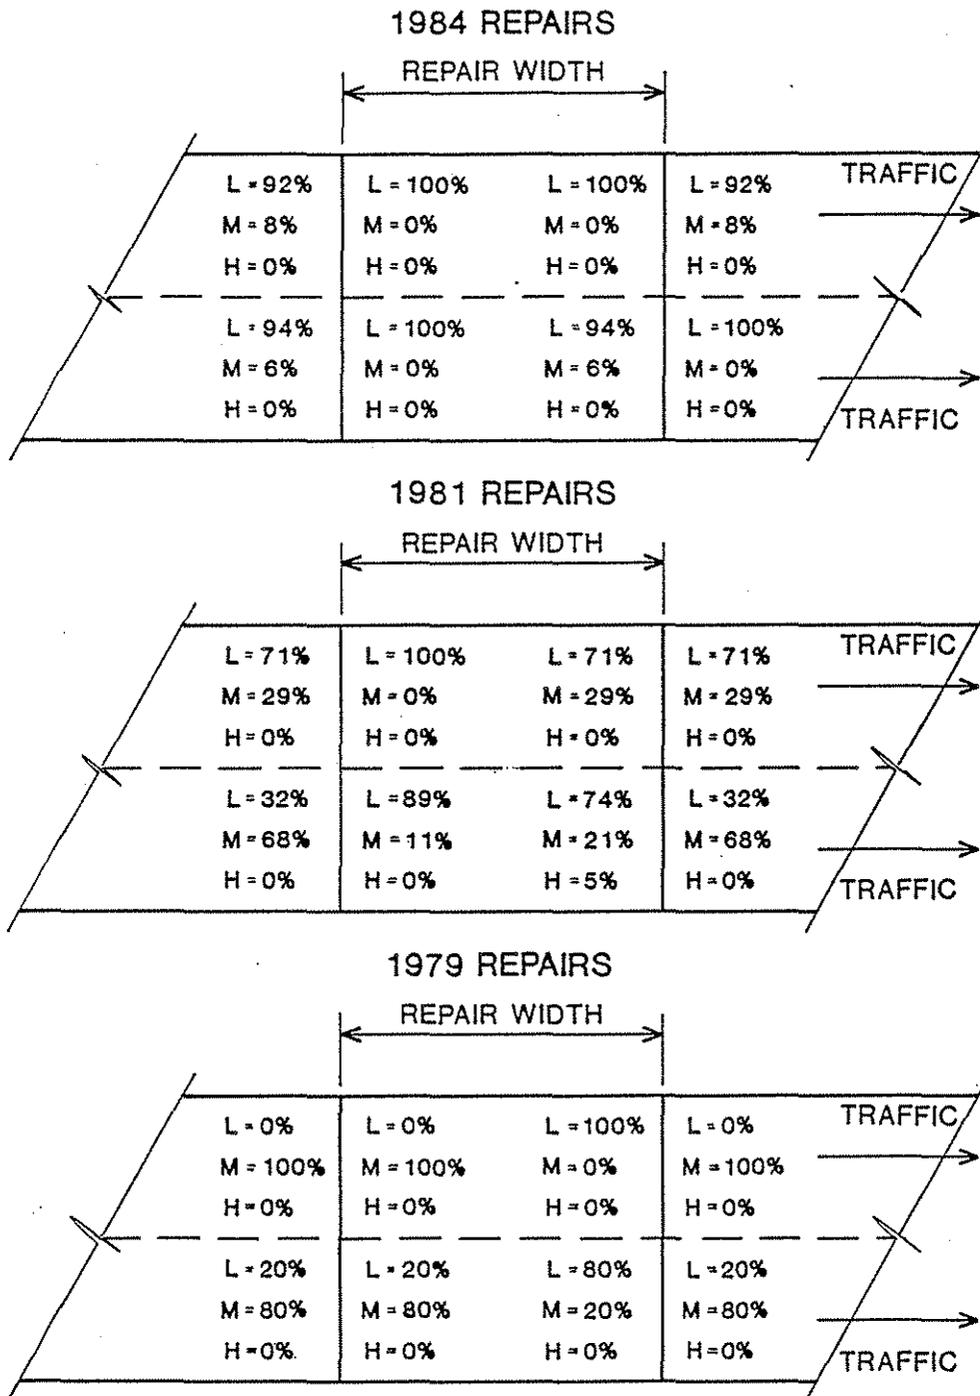
Figure 71. Summary of Spalling at Repair Locations on IA035086.

NOTE: All undamaged joints and all joints with low severity spalling were rated as low severity.

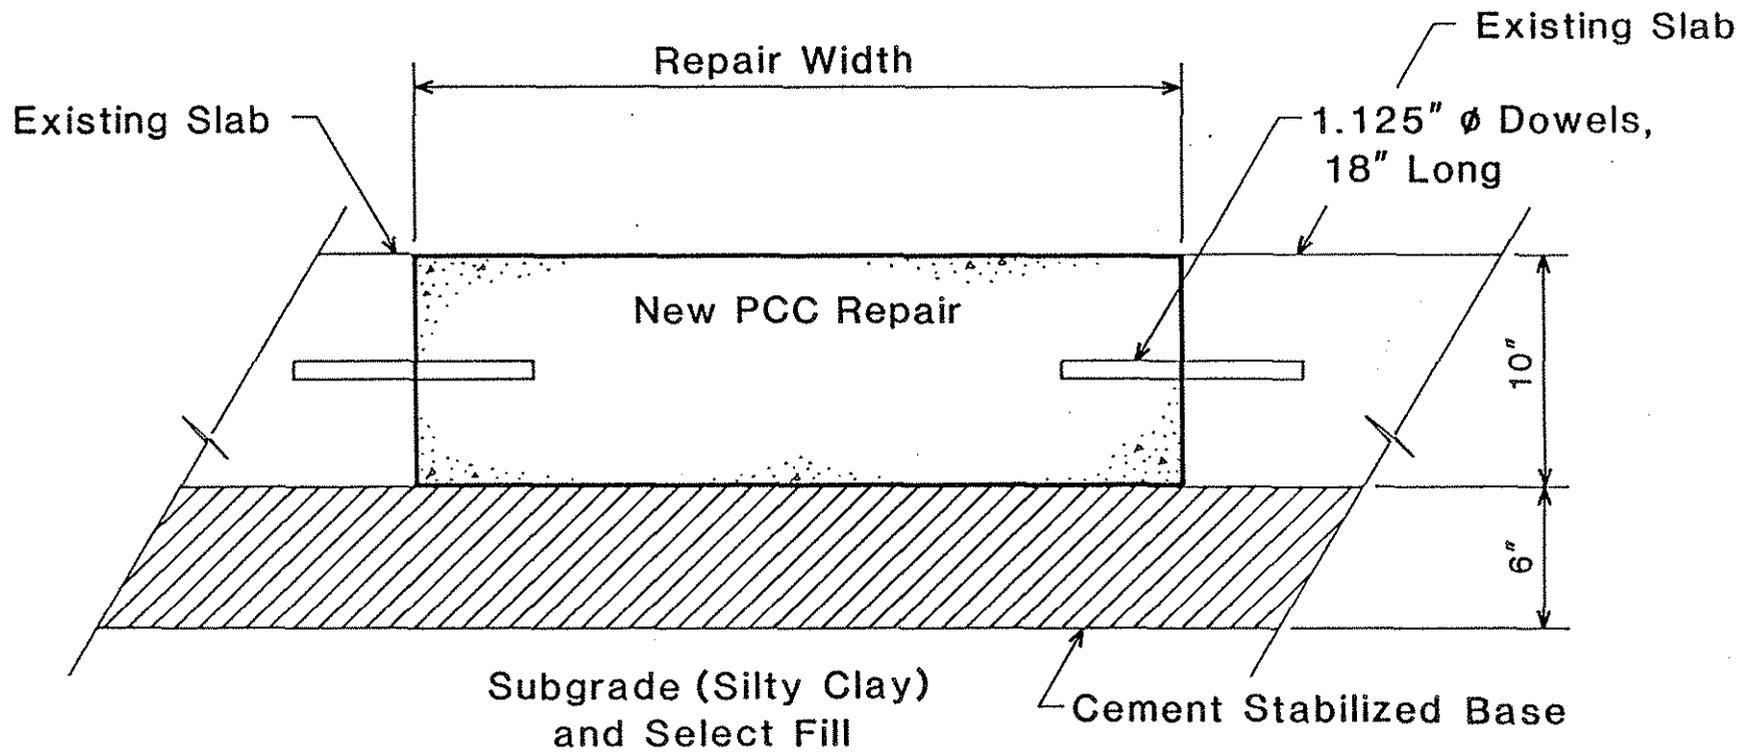
Figure 72. Illustration of Full-Depth Repair Design Used on LA010151
[1 in = 25.4 mm].

Faulting of repair joints where the dowels were epoxyed is similar to that of the regular contraction joints that were ground in 1984. However, the faulting of the one repair without epoxyed dowels was larger than the others. The full-depth repair with the "unconventional" dowel spacing and epoxyed dowels exhibited the same magnitude of faulting as those with the conventional 12 in [305 mm] dowel spacing. It is interesting that the conventionally spaced, epoxyed dowel repairs displayed visible signs of pumping, while the repair with the highest observed faults (conventional unepoxyed) did not.

Most of the full-depth repair joints are performing well. Joint widths ranged from 0.6 in to 1.0 in [15 mm to 25 mm]. The sealant was still intact and no incompressibles were present in the joint. Where spalling was observed it was generally of low severity.

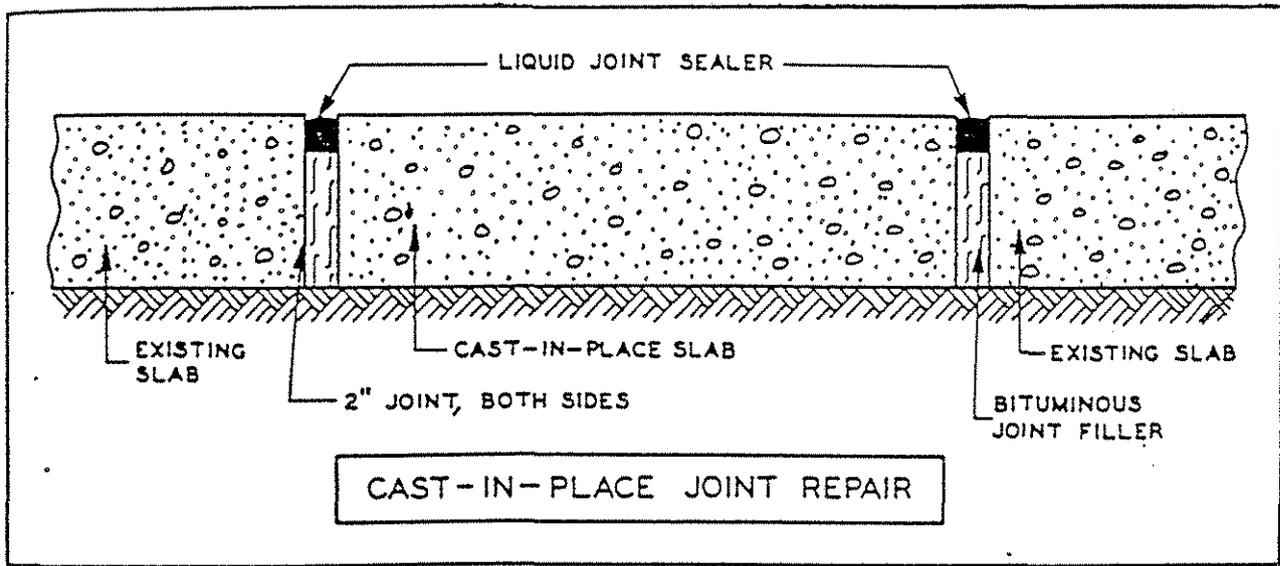
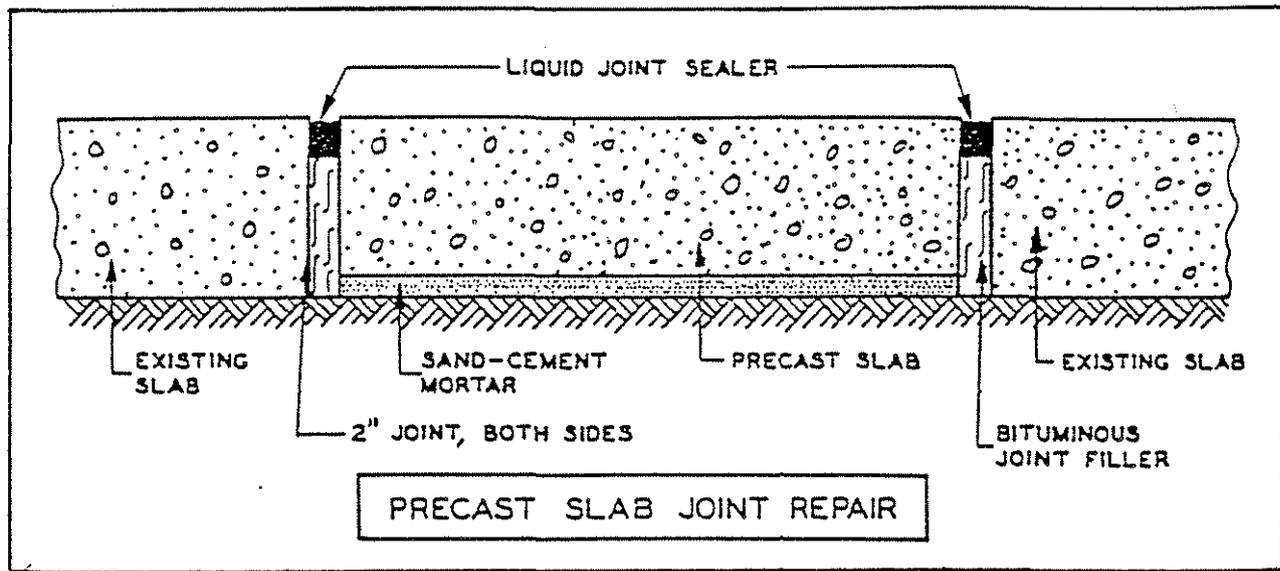
Figure 74. Illustration of Full-Depth Repair Designs Used on MI127 (115) [1 in = 25.4 mm].

Only three full-depth repairs were surveyed: two cast-in-place repairs constructed in 1972 and one constructed in 1979. All of the surveyed repairs (and most of the other repairs observed) are structurally adequate but severely faulted, especially across the leave joint. The average

measured repair faulting in the outer lane was 0.20 in [5.0 mm] for the approach joint and 0.51 in [13 mm] for the leave joint. Medium-severity pumping was also observed at the 1979 repair. No significant difference in repair performance (i.e., faulting, spalling and slab cracking) was detected between the 1972 and 1979 repairs.
