**PRESSURE RELIEF AND
OTHER JOINT REHABILITATION TECHNIQUES**

FINAL REPORT

February, 1987

14. Sponsoring Agency Code	
15. Supplementary Notes FHWA Contracting Officer's Technical Representative: Peter Kopac, HNR-20					
16. Abstract A study of four major concrete pavement joint rehabilitation techniques has been conducted, including: pressure relief joints, full-depth repairs, partial-depth repairs and joint resealing. The products of this research include the following for each technique: a summary of published research, detailed documentation of the design and performance of the 36 projects, conclusions and recommendations of the state highway engineers panel, "Design and Construction Guidelines" and "Guide Specifications." The latter two products are prepared for use by state highway agencies. The results of this study are based upon a review of literature, extensive field surveys and analysis of 36 rehabilitation projects, and the experience of an expert panel of state highway engineers.

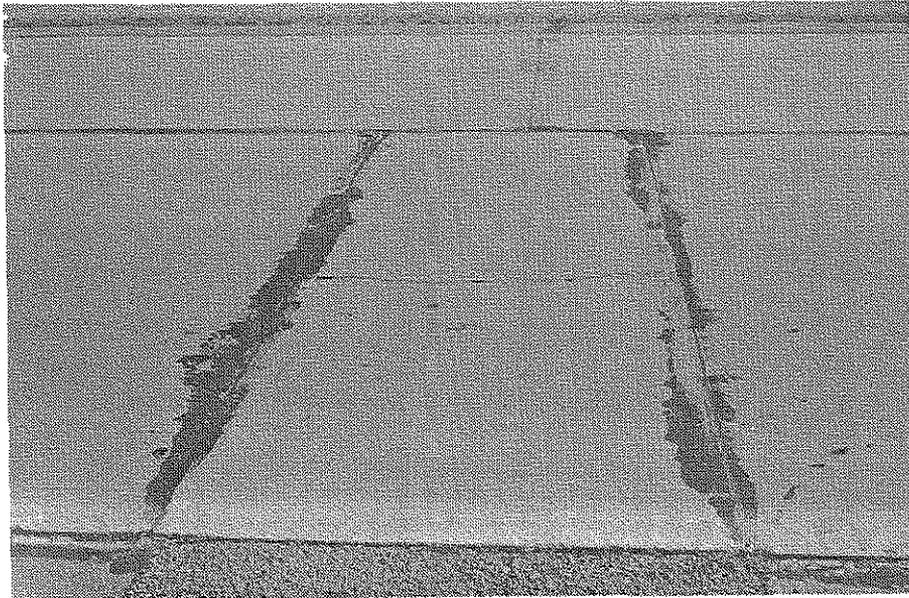
Figure 76. Photo of Typical Full-Depth Repair on NE080189.

Thirty percent of the repairs exhibited low-severity longitudinal slab cracking (see Figure 76). This may be due to either a mechanism similar to the edge punchout in CRCP, or to placement of the repairs in the morning, after which the heat of the afternoon causes the original pavement slabs to expand and crush the new repair. Longer repairs lengths, coupled with late afternoon placement, might eliminate this problem.

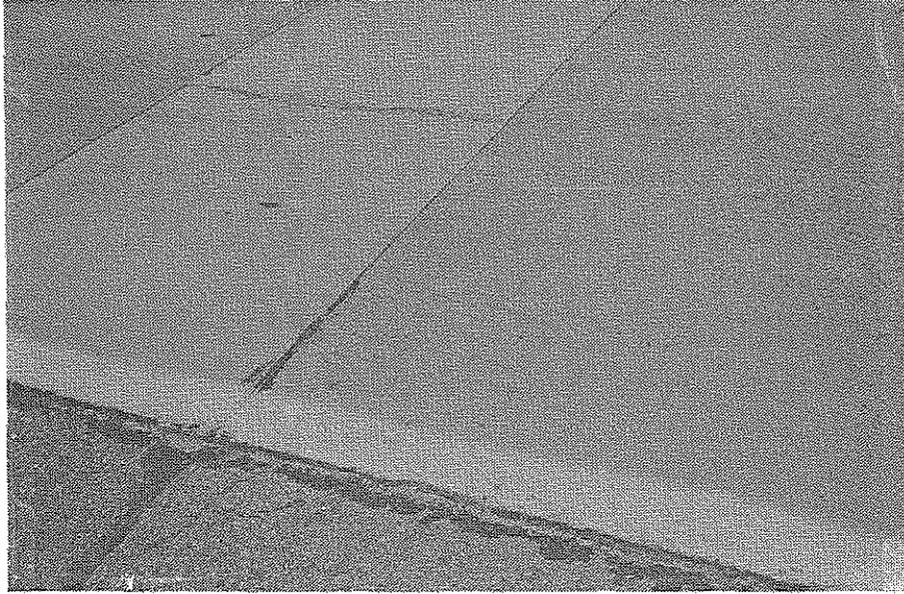
Figure 77. Photo of Full-Depth Repair and Reactive Aggregate Distress on NE080210.

Nearly half of the repairs surveyed exhibited low- and medium-severity longitudinal cracking (see Figure 77). These cracks nearly always occurred at the center of the lane and may be caused either by a mechanism similar to the development of edge punchouts in CRCP, or placement of the repairs in the morning such that the heat of the afternoon caused the original concrete slabs to expand and crush the newly placed repair. Longer repair lengths, coupled with late afternoon placement, may eliminate this problem.

Reactive aggregate distress was observed in the original pavement near the repair joints and was the primary cause for any spalling on the original pavement side of the repairs. It was not found within the repairs themselves.

The use of dowel bars in the design and proper sealing of the transverse repair joints might have improved the performance of the repairs. The use of dowels alone might have held faulting of the repair joints to a level comparable to that of the original contraction joints.

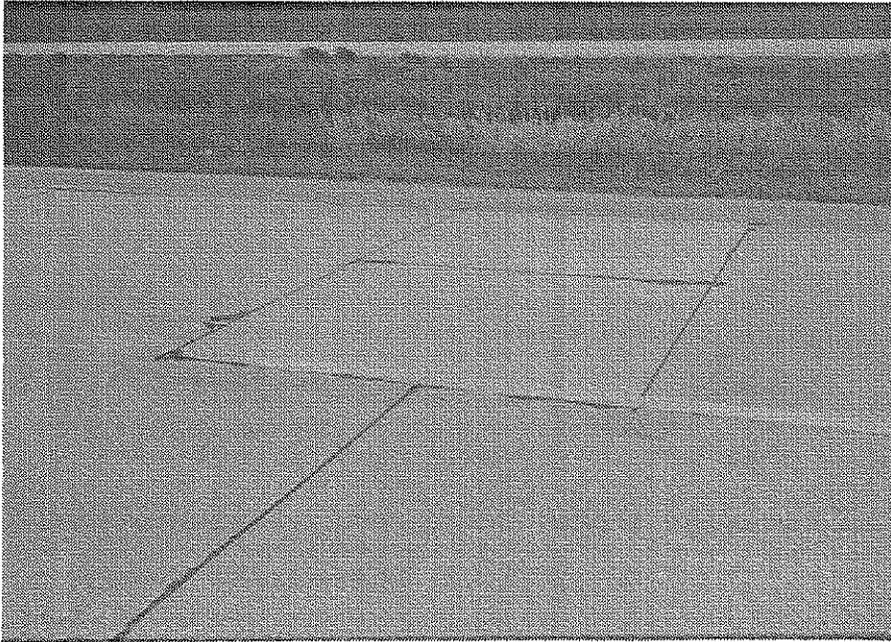
Figure 82. Photo of Full-Depth Repair on NE080404.

The original contraction joints have faulted significantly under heavy traffic and the repair joints are also displaying very high faults (despite having been in service only one year). This large repair joint faulting may be attributed to the lack of dowel bars in the full-depth repair design and the fine-grained subgrade present. Additionally, the repair leave joints consistently display higher faults than the repair approach joints.

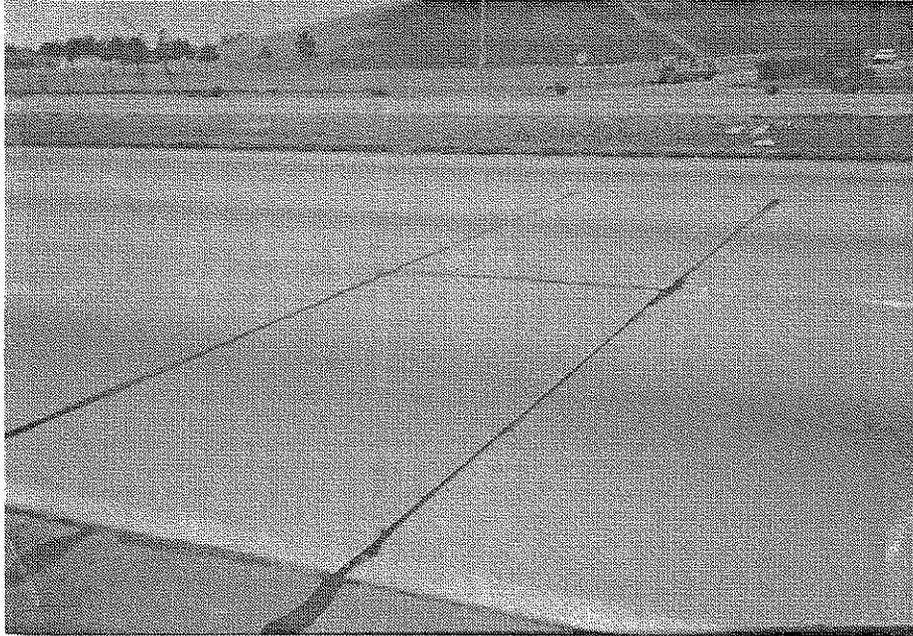
Figure 86. Photo of Typical Full-Depth Repair on VA044000.

The repair joints were well sealed and free of incompressibles, but occasionally had extruded sealant (see Figure 86). There were no spalling or cracking problems associated with the repairs. Repair joint widths ranged from 0.5 in to 0.9 in [13 mm to 23 mm].

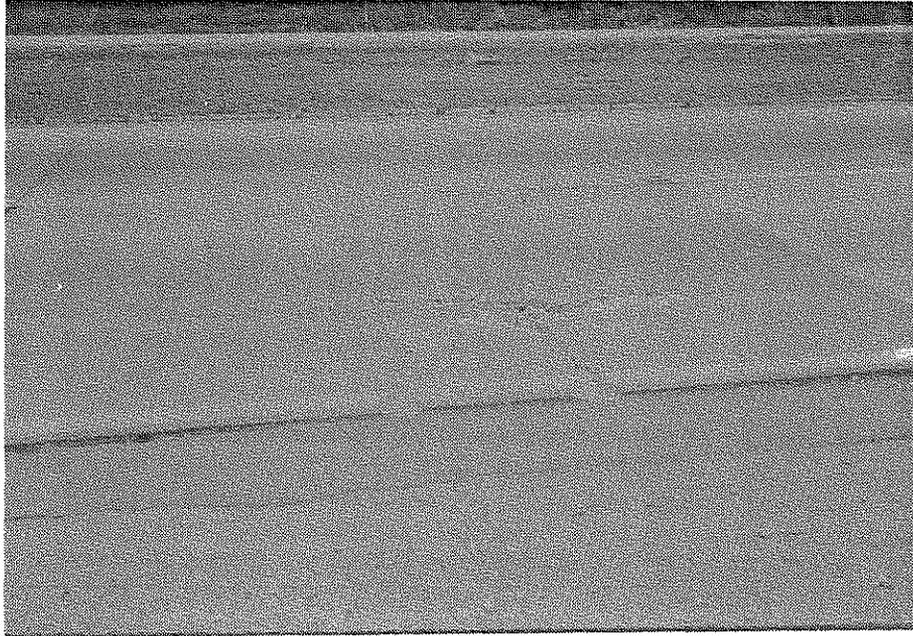
Figure 92. Photo of 1982 Full-Depth Repair with Slab Cracking and Spalling on WV07002.

Most of the transverse contraction joints on both sets of full-depth repairs are performing poorly. While joint widths and spalling are acceptable, joint faulting has been severe, particularly across the repair leave joints. Repair joints have not opened appreciably, although incompressibles were sometimes present and a small amount of low- and medium-severity spalling was observed. Most of the higher-severity spalling occurred in the outer lanes. There was little difference in the amount and severity of spalling between the 1982 and 1983 repairs. Joint widths averaged approximately 0.3 in [7.6 mm].

The faulting of the repairs is due largely to the use of the inverted "T" load transfer design which allows differential vertical movement across the joints and provides the mechanism for the pumping. In addition, the undercut repairs required local excavation of much of the subbase and, as a result, the repairs were often placed directly on the fine-grained subgrade. Water infiltrating the transverse joints had a direct route to the subgrade, which also facilitated pumping and faulting. Properly installed dowels and elimination of the undercut would have resulted in much less pumping, as shown by the original contraction joints and the reconstructed contraction joints within the longer repairs, which exhibited relatively little faulting. The effectiveness of the longitudinal drains would also have been improved by leaving the granular subbase in place.

Longitudinal and transverse cracking was a problem in many repairs. While the occurrence of longitudinal cracking was infrequent and restricted to shorter repairs, it is believed that it could be reduced or eliminated by improving joint sealing and maintenance activities to further restrict the entry of incompressible materials which result in points of high bearing stress. Restrictions on time of placement or ambient temperature might also reduce the risk of overstressing the repair in compression while it is gaining strength.

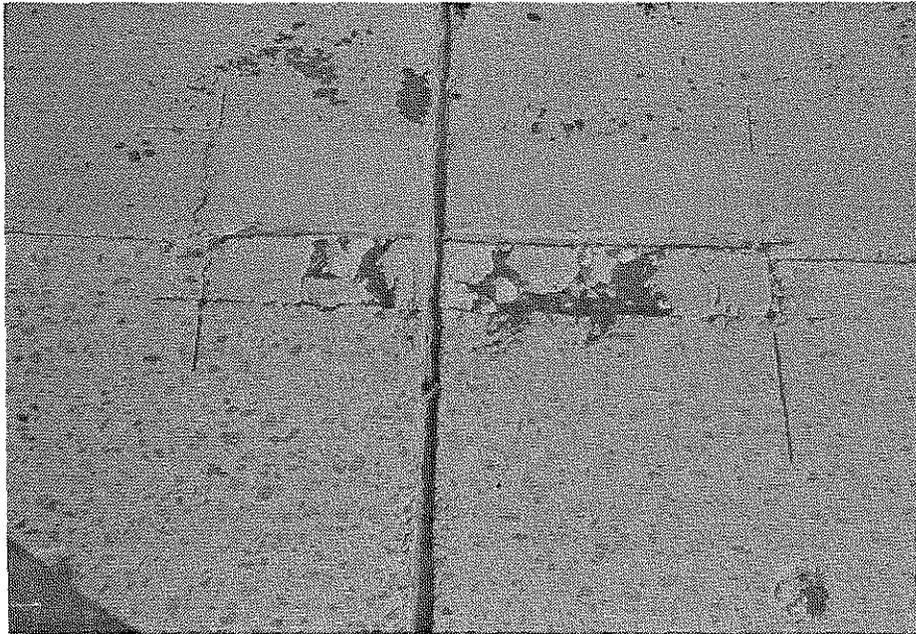
Figure 94. Photo of Partial-Depth Repair on LA010151.

Longitudinal cracks and cracks at the pavement slabs' outer corners were observed at several joints during the 1984 (LDOTD) and the 1985 (ERES) surveys. LDOTD personnel attributed this cracking largely to dowel bar misalignment (24). Longitudinal centerline cracking at any locations other than the transverse joints was not observed during either survey. It may be, that the longitudinal joint spalling which occurred at the transverse joints was not due to poor longitudinal joint construction, but rather to the same mechanisms which caused the longitudinal and corner cracking at the transverse joints (i.e., dowel bar misalignment or compressive stress buildup). If this is true, the corner spalls may have been at the top two or three inches [51 to 76 mm] of cracks through the full slab thickness. This may explain why partial-depth repairs which exhibited material loss were for the most part located in the outer lane, where most of the longitudinal and corner cracking at transverse joints occurred.

The poor performance of the partial-depth repairs in the outer lane after only one year of service suggests that they were inappropriate for this project. Replacement of those partial-depth repairs which have experienced substantial material loss with full-depth repairs should be considered in conjunction with any future rehabilitation work done to repair the transverse joints in the outer lane with longitudinal and corner cracking.

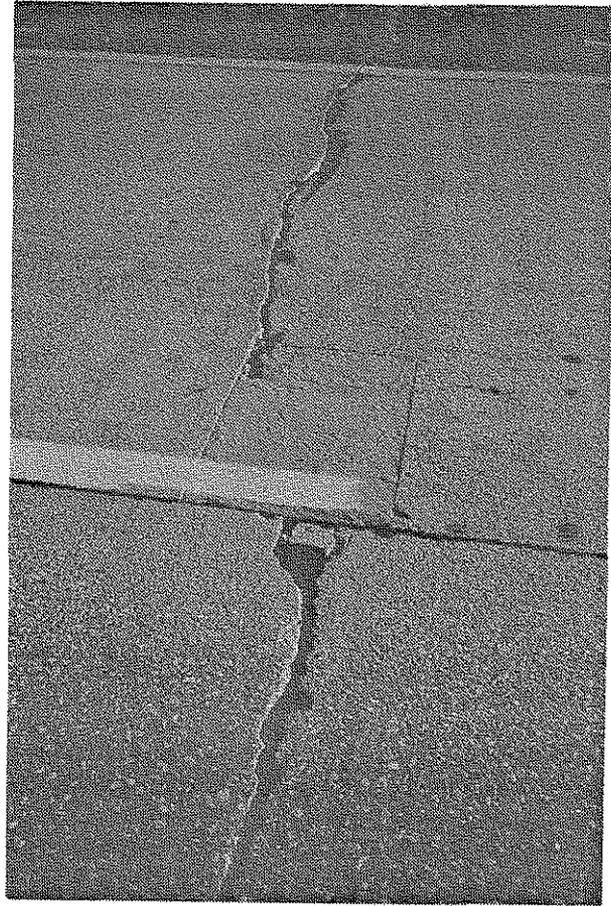
Full-depth repairs would probably have been more appropriate for working cracks on this project (see Figure 95). Replacement of the partial-depth repairs with full-depth repairs could be performed in conjunction with other rehabilitation work which is required on this pavement in the near future.

Figure 95. Photo of Partial-Depth Repair at Major Crack on NE080279.

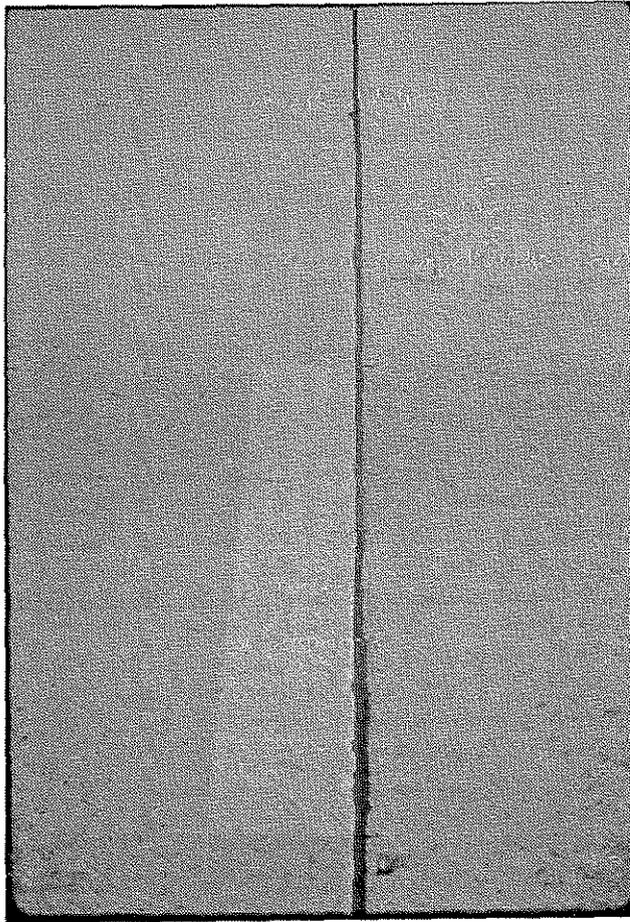
All of the partial-depth repairs are in good condition, with no scaling, debonding, cracking, or material loss (see Figures 98 and 99). The full-depth repairs, however, are experiencing significant cracking, faulting, and pumping. Of the two rehabilitation techniques, partial-depth repair is believed to have been the more successful and more appropriate for this project.

Figure 98. Photo of Partial-Depth Repair on VA095000.

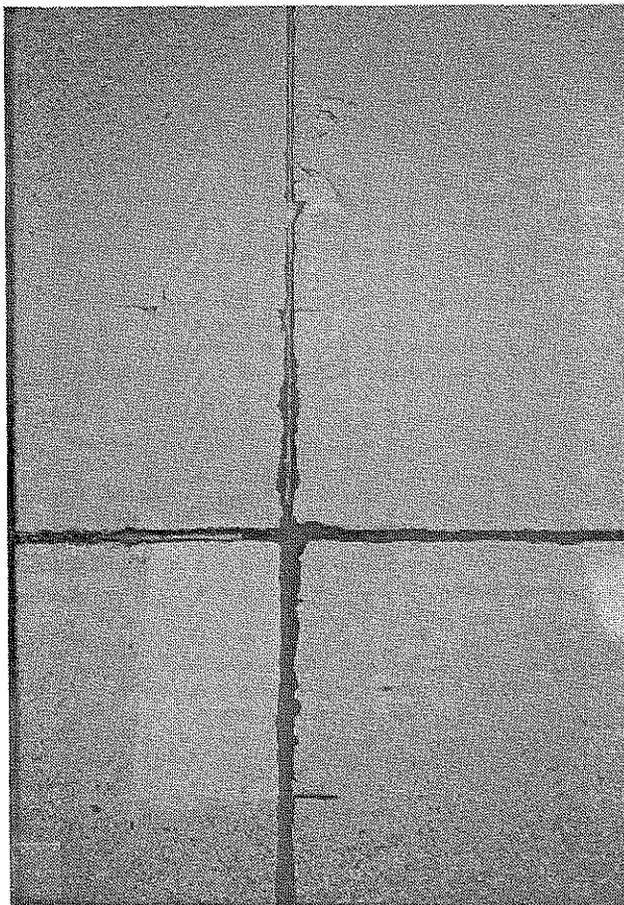
Figure 99. Photo of Partial-Depth Repair on VA095000.
