FIELD INSTRUMENTATION, TESTING, AND LONG-TERM MONITORING OF HIGH-MAST LIGHTING TOWERS IN THE STATE OF IOWA

FINAL REPORT

November 13 2006

Iowa Department of Transportation
Office of Bridges and Structures
800 Lincoln Way
Ames, IA 50010

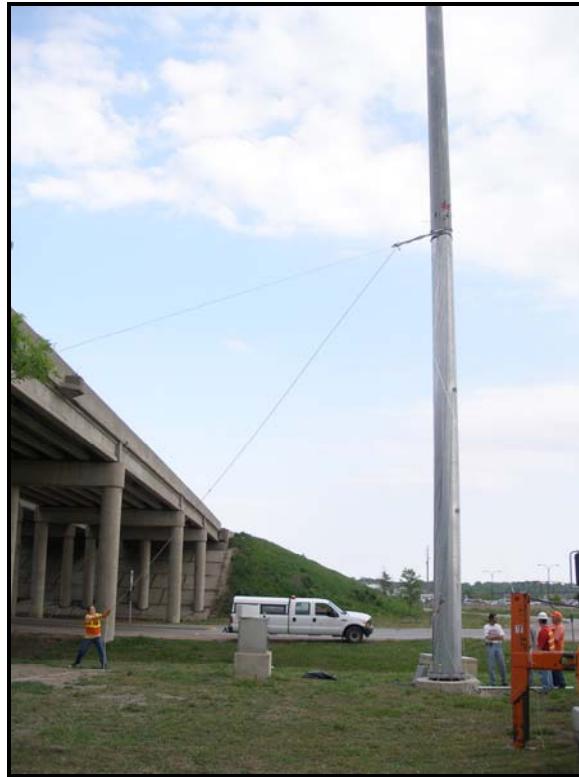
Figure 1.2 – Typical dynamic test of a retrofitted tower along I-29 in Sioux City, Iowa

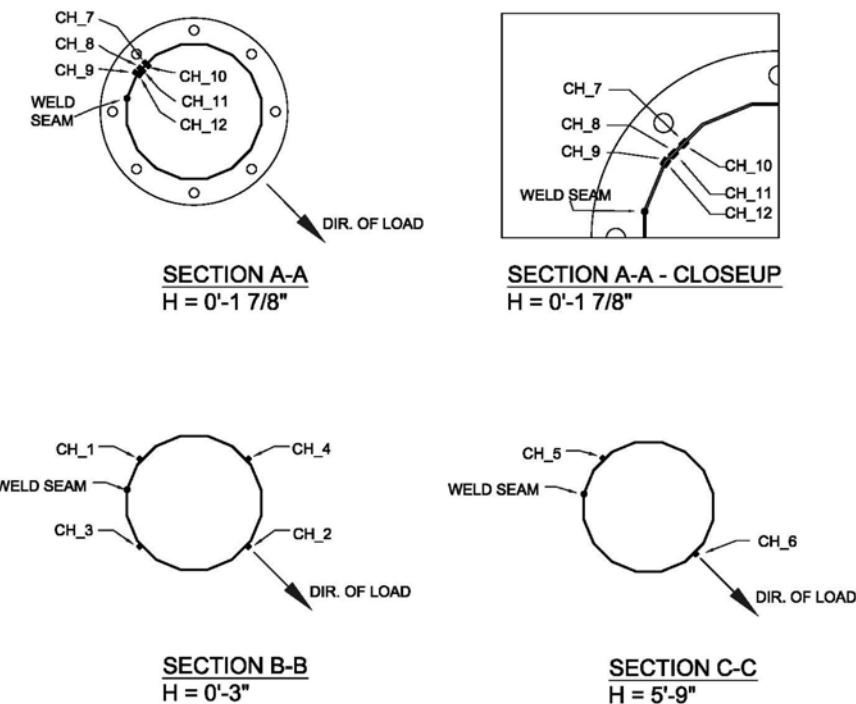
Figure 2.9 – Strain gage details for the As-built tower along I-29 in Sioux City, Iowa
 (H = height above base plate)

Strain gages CH_7, CH_8, and CH_9 are located at the weld toe below CH_1 (see Figure 2.9.) It can be seen that at the weld toe, very high stresses (70 ksi) are induced into the tube wall by tightening down the anchor nut. It is likely that the material locally yielded.

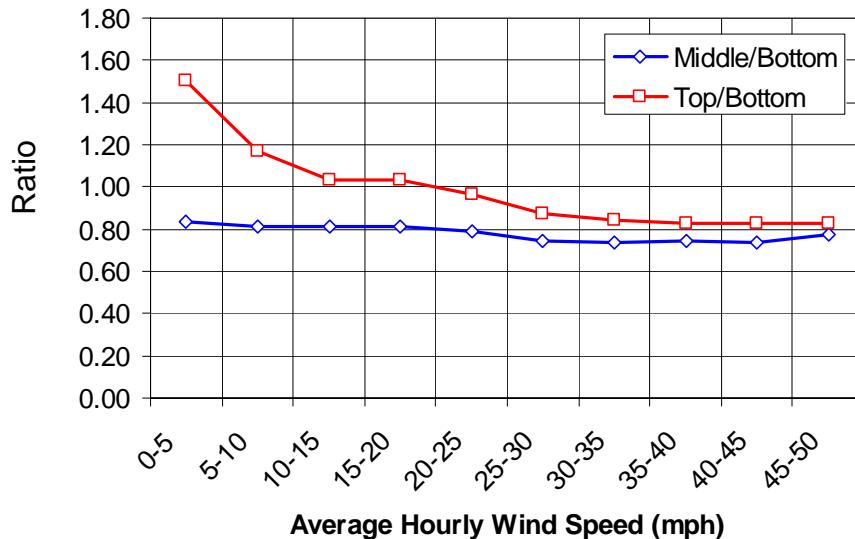
Every hour of data, the average and maximum wind speeds are determined at the base, mid-height, and top anemometers which were installed on the Retrofit tower (see Figure 2.3.) For each hour, the ratio of top and mid height wind speeds (both maximum and average) are calculated. A histogram is then determined separately for the average (Figure 4.8) and maximum (Figure 4.9) quantities for the entire data set based on the wind speed at the base. It can be seen in the plots that for low wind speeds (i.e., less than 10 mph), the wind speeds at the top are higher than the base (approximately 1.5 times

higher) but the wind speeds at mid-height are actually less than the wind speed at the base. This may be due to the local terrain at the tower . The tower is located in a depression, and may be subject to local wind effects.

As the wind speed increases, the top and mid-height wind speeds appear to approach each other, leading to a uniform wind speed distribution from the mid-height and upwards. However, both these wind speeds are less than the average base wind speed; the ratios are approximately 0.8 for both average and maximum wind speed.

Figure 4.8 – Histogram of average hourly wind speed ratios, mid-height/base and top/base for the Retrofit tower

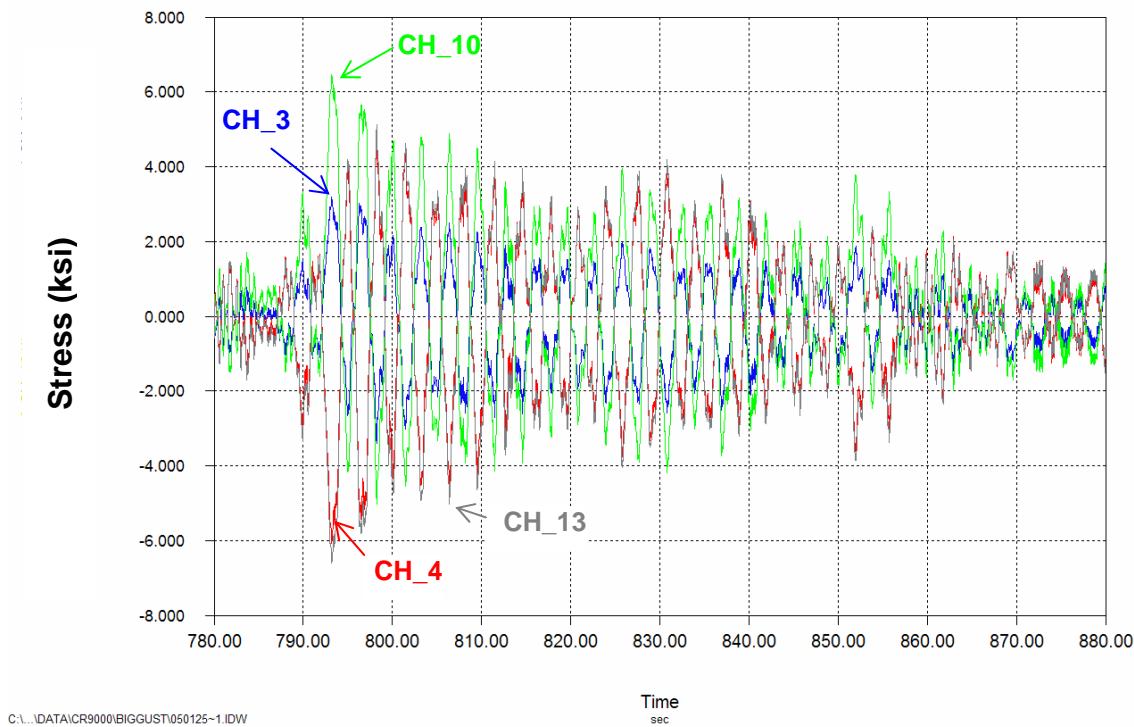
Shown in Figure 4.11 is a stress time history for the rapid gust event discussed above. Strain gages CH_3 and CH_4 are on the west and east sides of the tower, respectively, 3 inches above the base. Strain gages CH_10 and CH_13 are on the west and east sides of the tower, respectively, 5 feet 9 inches above the base. The response at all strain gages was relatively low (less than 2 ksi) until the large gust occurred at time equal to 792 seconds, at which point the stresses in all gages rose dramatically (maximum of 6.2 ksi at CH_10). Primarily the response was in the first vibration mode, as the time between successive peaks was approximately 3.3 seconds. It can also be seen that the vibration of the tower continued for a number of cycles after the original event. These additional stress cycles contribute to the cumulative fatigue damage at the base of the tower.

Figure 4.11 – Stress time-history for four gages on the east and west sides of the tower for a large wind event at the As-built tower on January 22, 2005 and 5:20AM

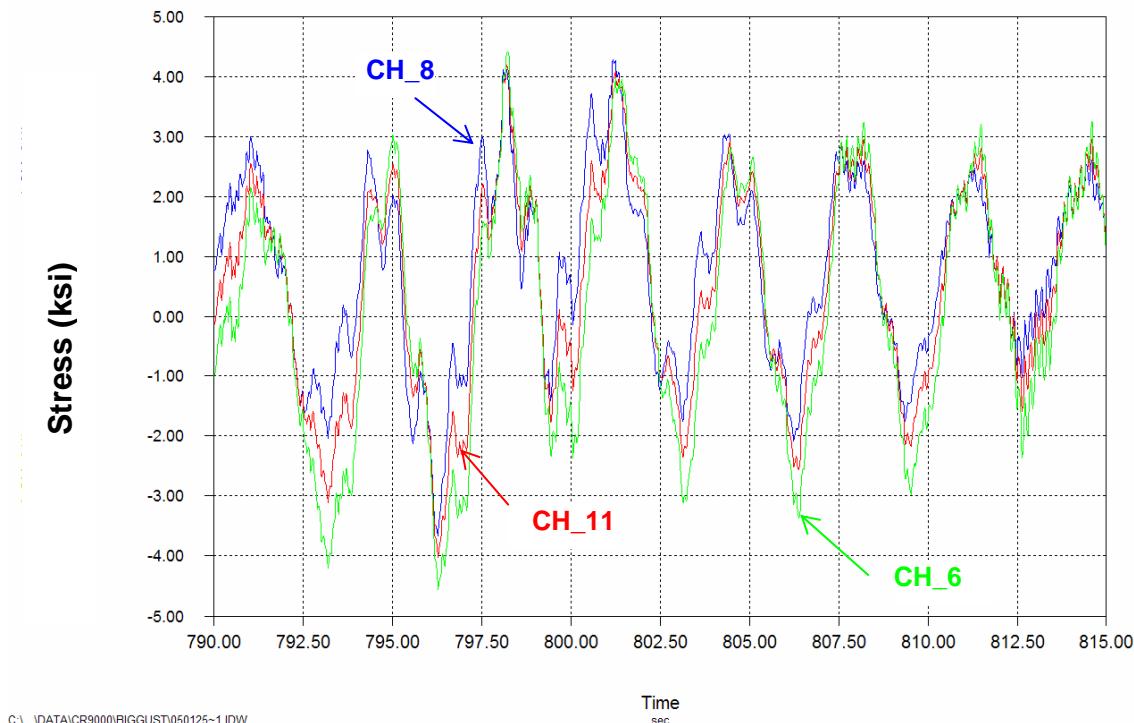
Figure 4.12 shows a stress time-history for three adjacent gages (CH_8, CH_11 and CH_6) for the same high-wind event. Gages CH_6 and CH_8 are centered on two adjacent faces of the tower (away from the bend line). Gage CH_11 is located on the bend line between gages CH_6 and CH_8. All gages are located 3 inches above the base. It can be seen that in general, the magnitude of stress on the bend line appears to be between the stress at the two adjacent faces.

Figure 4.12 – Detailed stress time-history for a large wind event
at the As-built tower on January 22, 2005 and 5:20AM

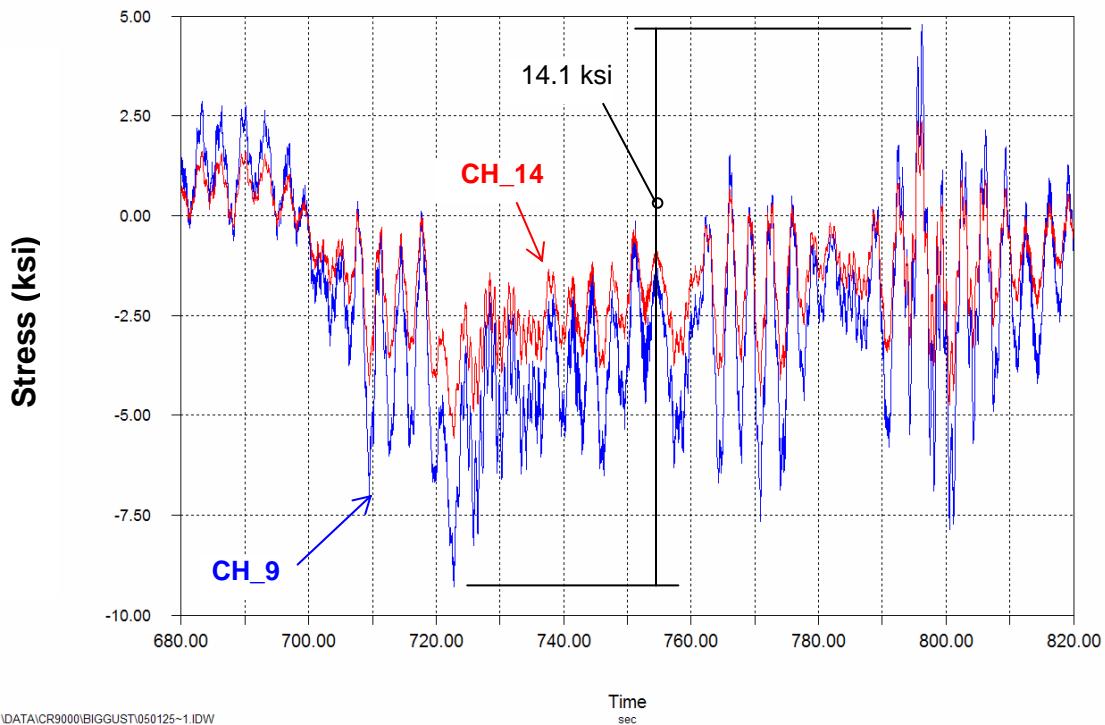
Finally, Figure 4.13 contains a stress time-history for the same wind event, for strain gages CH_9 and CH_14. Gage CH_9 is above the access opening, while CH_14 is several feet above the access opening on the same face of the tower. It can be seen that the stress histories are similar except that the stress at the access opening (CH_9) is higher due to the stress concentration there. Furthermore, the Figure indicates that the stress range at the access opening is very high, equal to 14.1 ksi. This was also evident from the stress-range histogram shown in Figure 4.1. Again, it was found that during the long-term monitoring phase of the project, that the largest stress ranges were caused by natural wind gusting, and the response was primarily in the first mode.

Figure 4.13– Detailed stress time-history for a large wind event
at the As-built tower on January 22, 2005 and 5:20AM
