# Road Safety Audit for the US 61/ Harrison Street and West Locust Street Intersection in Davenport- Scott County, Iowa

**Final Report**  
**October 2008**

**Sponsored by**  
the Iowa Department of Transportation

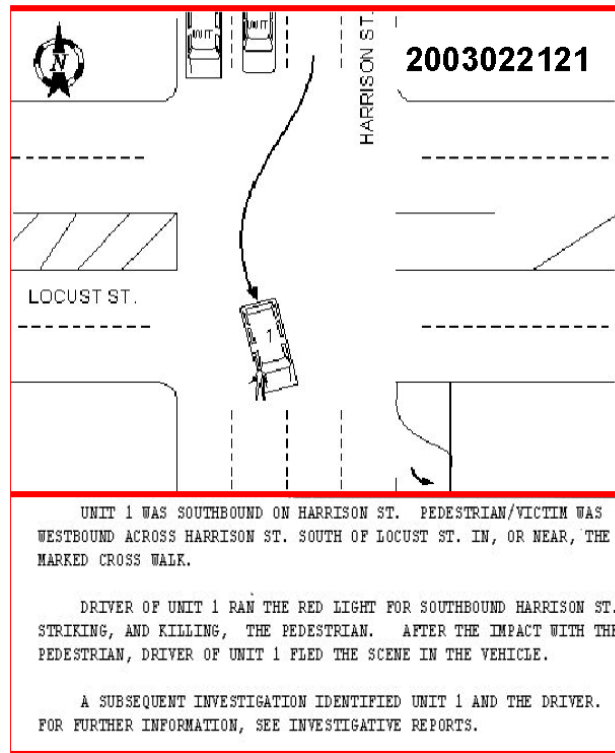
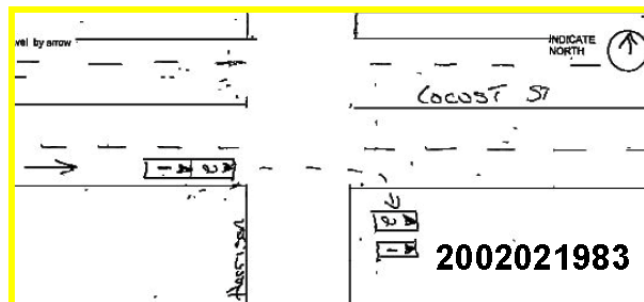
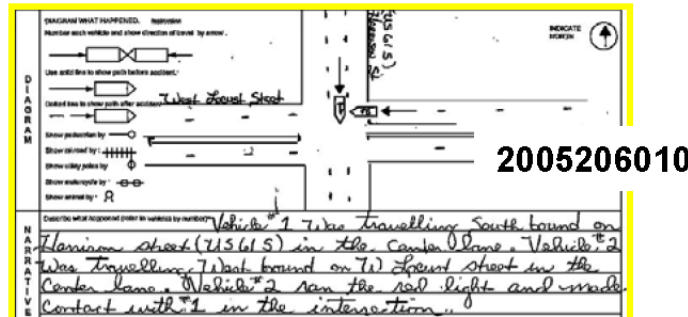
Figure B.3. Crash reports for the intersection

Describe what happened (refer to vehicles by number) UNIT 2 was stopped at the intersection of Locust & Harrison waiting for the light to turn green. UNIT 1 also heading southbound on Harrison St. UNIT 2 was stopped. UNIT 1 attempted to stop but was unable to & struck UNIT 2 in the rear.

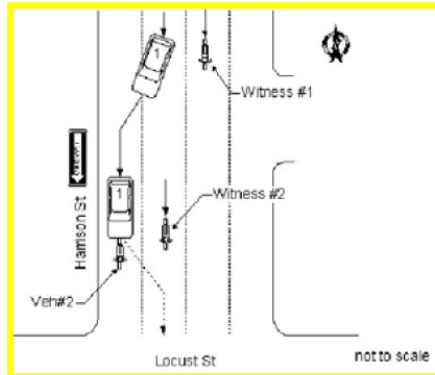
**2005227671**

VEH #1, VEH #2, WIT #1 AND WIT #2 WERE SOUTHBOUND ON HARRISON ST APPROACHING LOCUST ST. VEH #1 APPARENTLY ACCELERATED RAPIDLY, LOST CONTROL, THEN STRUCK THE REAR OF VEH #2.

VEH #2 WAS A MOTORCYCLE OCCUPIED BY ONE SUBJECT WHO WAS THROWN FROM THE MOTORCYCLE, CAUSING NON-LIFE THREATENING INJURIES.

VEH #1 THEN FLED FROM THE SCENE.

THE OWNER OF VEH #1 WAS LATER CONTACTED AND ALLEGED HER CAR WAS STOLEN AT THE TIME OF THE INCIDENT.

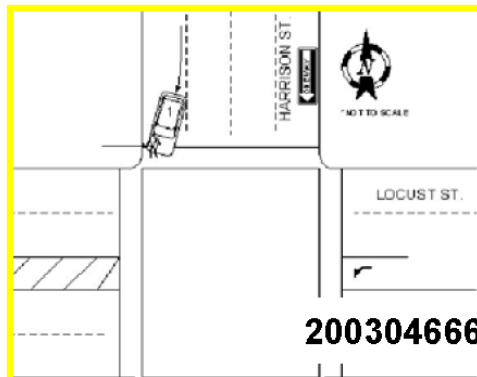
**2003046664**

UNIT 1 WAS SOUTHBOUND ON HARRISON ST. DRIVER OF UNIT 1 HAD STOPPED FOR RED LIGHT AND WAS WAITING TO MAKE A RIGHT/WEST TURN ON TO LOCUST ST.

THE DRIVER OF UNIT 1 WAS UNINJURED, AND UNIT 1 DID NOT RECEIVE ANY VISIBLE DAMAGE. DRIVER OF UNIT 1 WAS CITED FOR FTYROW PEDESTRIAN IN
