PROTECTION OF STRUCTURAL CONCRETE SUBSTRUCTURES

IOWA HIGHWAY RESEARCH BOARD

PROJECT HR-220

CONSTRUCTION REPORT

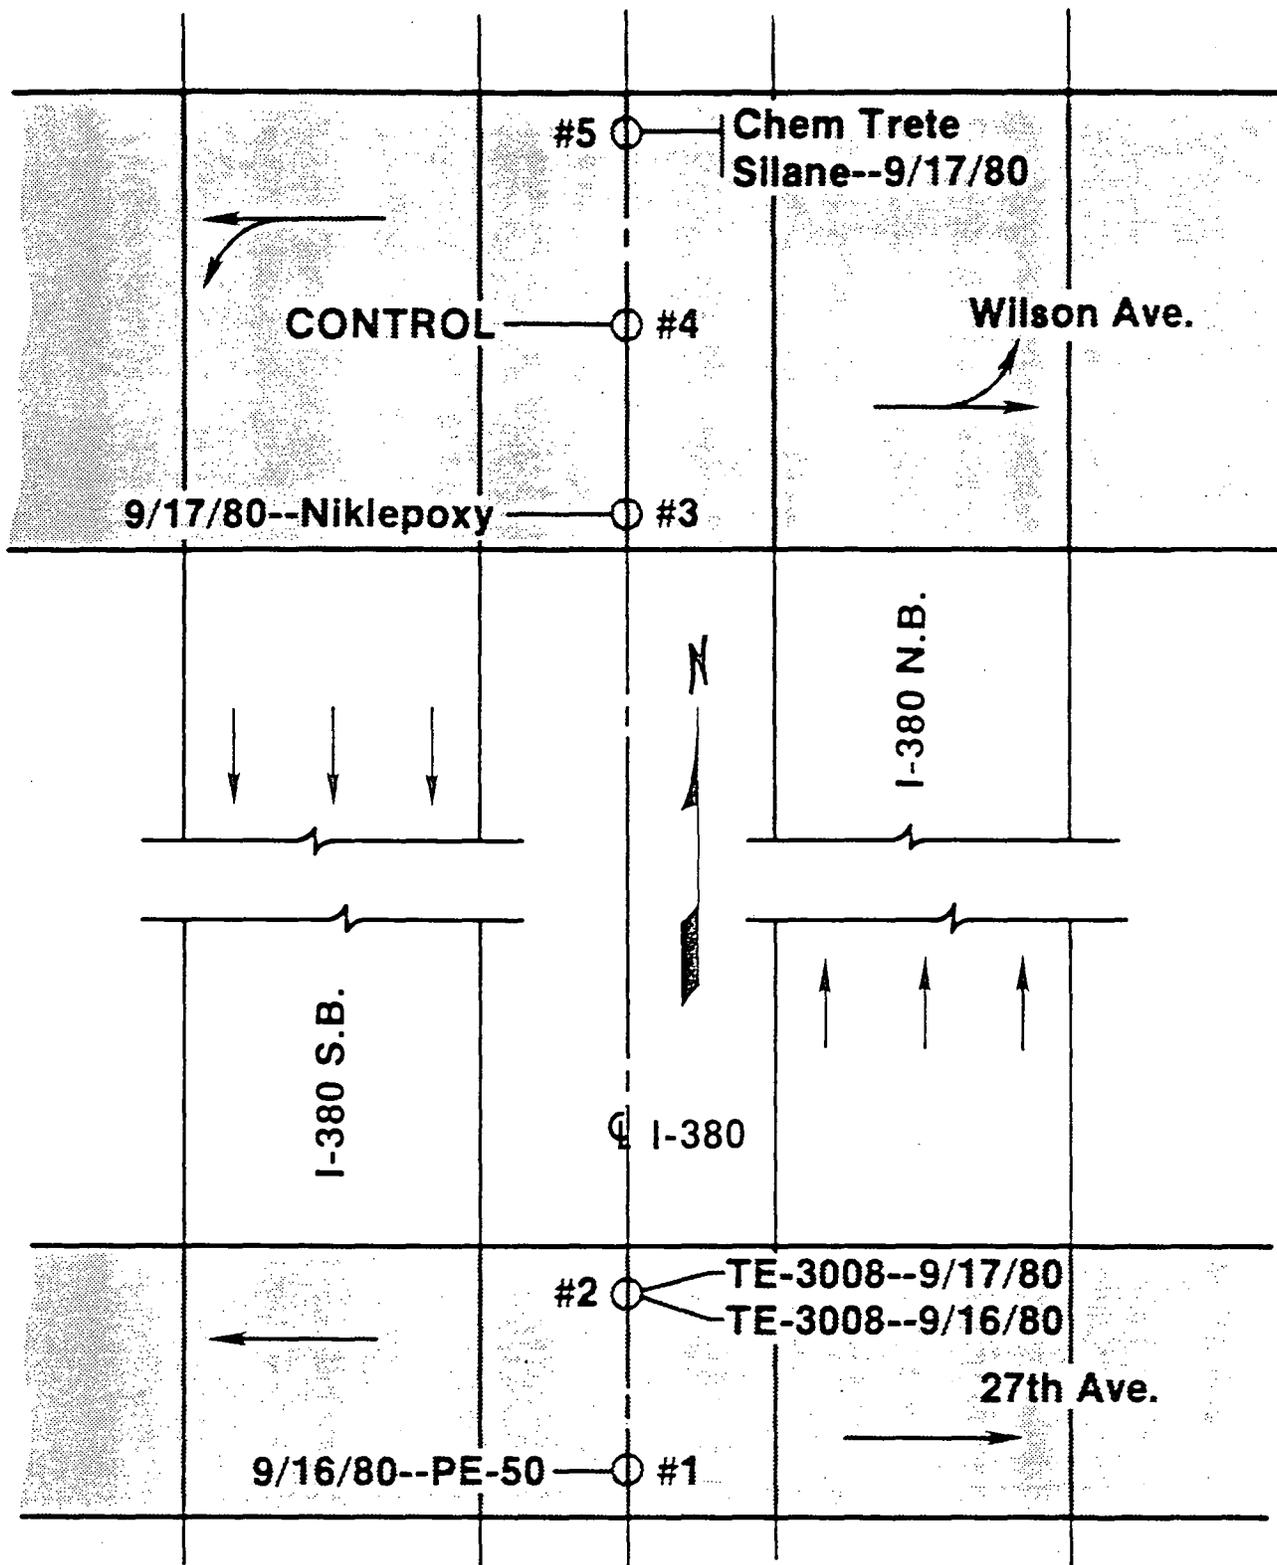
**FIGURE 2 - SITE LOCATION
COLUMN IDENTIFICATION**

Concrete cores were obtained June 17 and 18, 1980 from the candidate pier columns in the I-380 corridor. The location and identification of the columns involved in this project are shown in the sketch "Site Location" (Figure 2, Appendix B). The "Core Sampling Plan" (Figure 3, Appendix B) indicates the locations from which cores were extracted from each pier column and the planned locations for core extractions in subsequent years.

Candidate pier columns were assigned numbers 1 through 5 from south to north ie: Numbers 1 and 2 at 27th Avenue Southwest, Numbers 3, 4 and 5 at Wilson Avenue Southwest (Figure 2, Appendix B).
