NONDESTRUCTIVE EVALUATION AND ASSESSMENT OF CONCRETE BARRIERS FOR DEFECTS AND CORROSION

Final Report

November 15, 2013

WJE No. 2006.5773 (Iowa DOT, Project Number BARR-010)

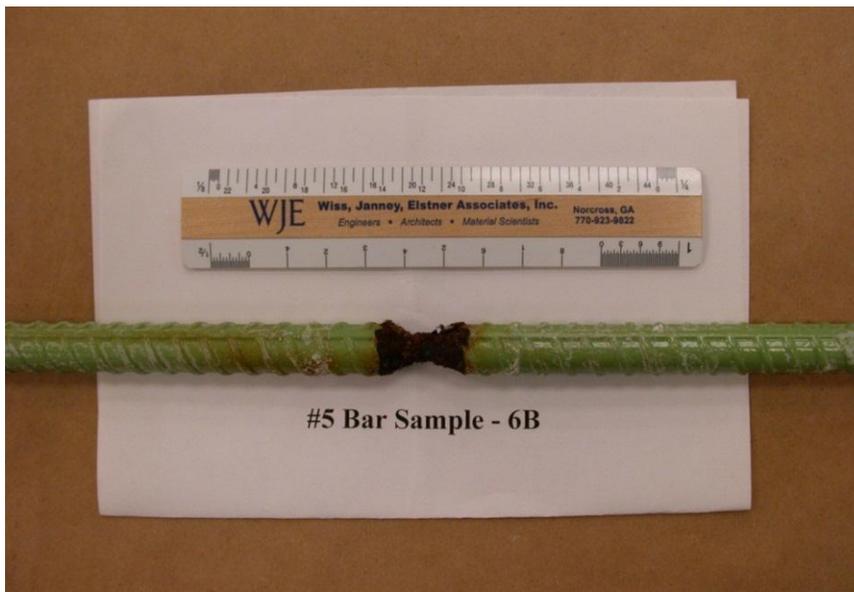
Prior to placement in the slab sample, corrosion was introduced into various reinforcing bars by exposure to wetting and drying cycles with salt solution. Each cycle consisted of wetting the bar in a salt-water solution and then placing the bar in a heat chamber to dry. This process was performed approximately ten times per week for a total of six to eight weeks. An example of a corroded reinforcing bar prior to placement in the slab sample is shown in Figure 13. After the pre-corrosion process was completed, surface chlorides were removed, and the reinforcing bars were cast into the slab sample with the corroded portion of the bar located directly in-line with the construction joint. The placement of the pre-conditioned reinforcing bars is shown schematically in Figure 14.

Figure 13. Pre-corroded reinforcing bar prior to placement in flat slab mock-up.

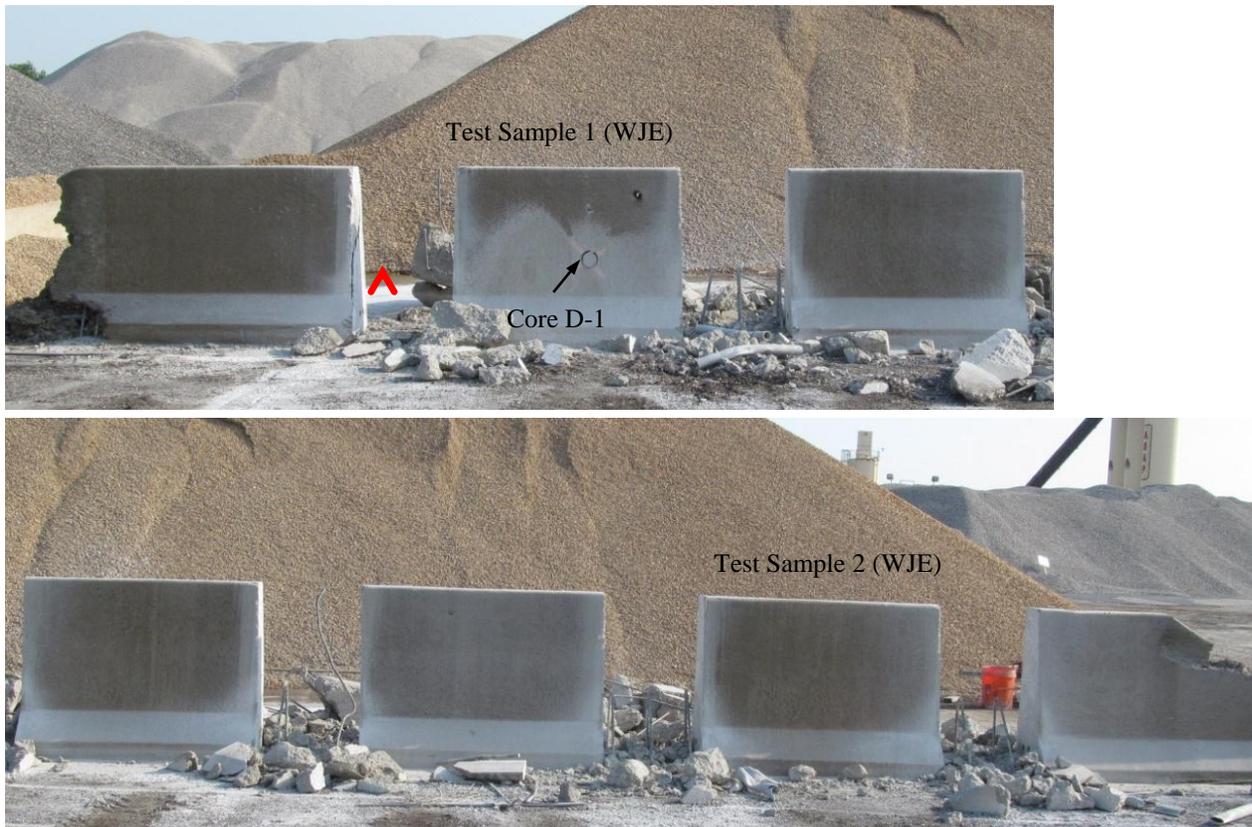
As part of the trial, portions of the parapet were destructively evaluated. Within 24 hours of the barrier wall construction, the wall segment was saw cut into seven segments, each of which measured approximately 5 feet long. The saw cut sections of wall allowed for assessment of the internal conditions within the barrier segment. Additionally, a four inch diameter core was taken from one of the segments.

Figure 25. View of trial parapet segment within storage yard. Portions of barrier wall trial tested by WJE are identified as Test Sample 1 and Test Sample 2.

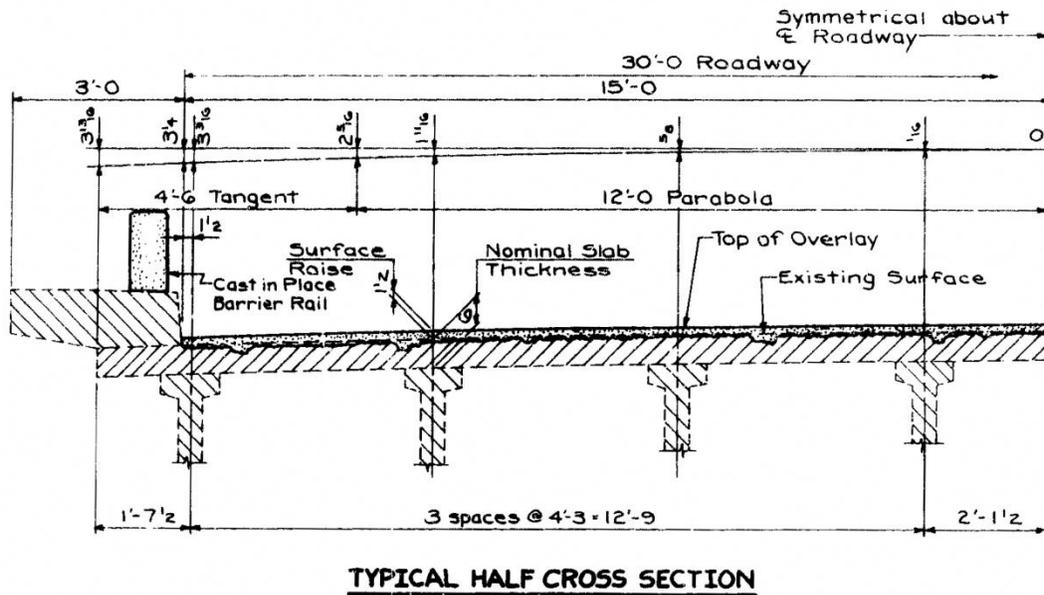
Figure 29. Barrier wall with overlay construction details for US Route 218.

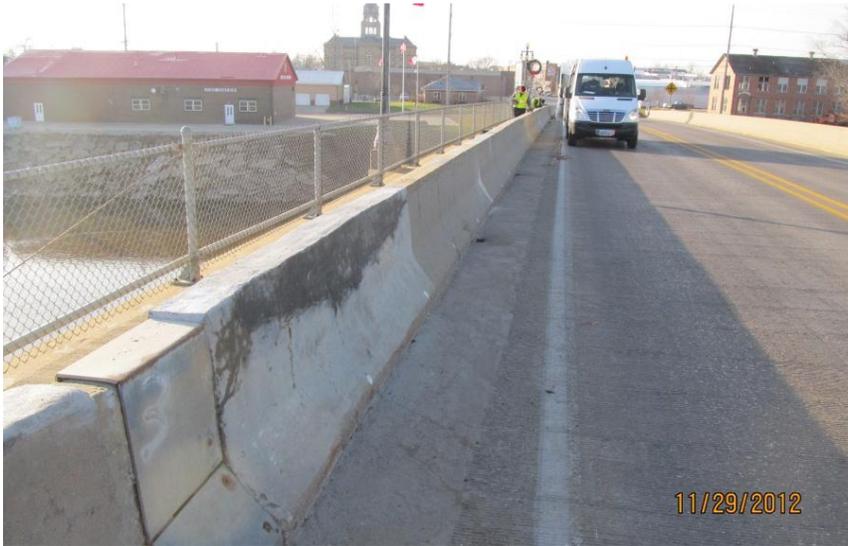
Figure 30. Test barrier for US Route 218.

Lane protection was provided for examination of the southbound (west) barrier wall. The entire barrier length of approximately 130 feet was examined. Figure 30 shows the tested barrier wall. Generally, the barrier was in good condition. Fine vertical cracks were present on the barrier faces with many cracks having efflorescence staining. Cracking was more prevalent along the top and bottom edges of the barrier. Corrosion stains were noted as several local areas along the front face at the bottom edge of the barrier. Hammer tapping did not identify any delaminations or spalling. Examination of the underside of the bridge deck did not show any evidence of water leakage through the construction joint.

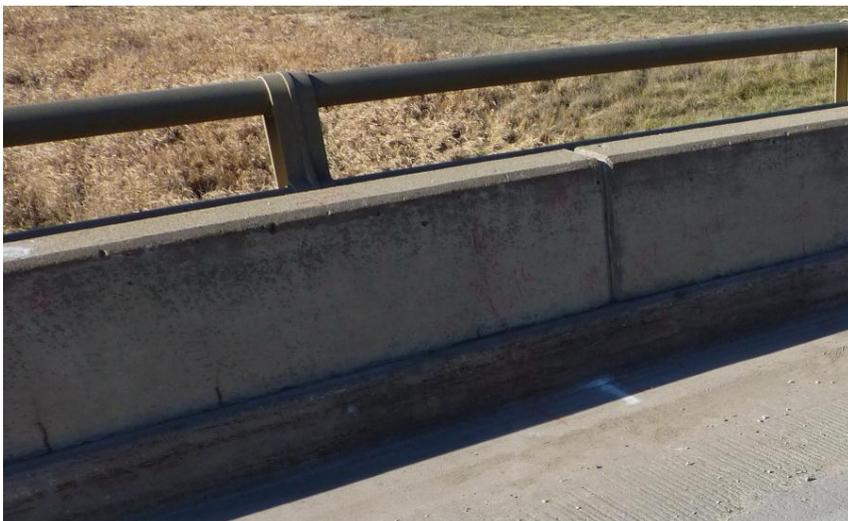
Figure 31. Test barrier for Iowa 150.

Iowa 0601.5S150 in Benton County on IA150 on the north side of Vinton, Iowa is a mainline multi-span, prestressed concrete girder bridge. Lane protection was provided in the northbound lane for inspection of the east barrier wall. The barrier wall separates the roadway from a sidewalk, therefore full access to both the interior and exterior faces of the wall were possible. The barrier is more typical of a Jersey-type barrier as shown in Figure 26. The detailed test area selected was 140 feet to 260 feet from the south end of the bridge as shown in Figure 31. The barrier contained regularly spaced vertical shrinkage-type cracks with some efflorescence or water staining. Some barrier patches were present. Some fine and random horizontal cracking was present with evidence of moisture intrusion. Corrosion stains were not noted on the barrier face. Hammer tapping did not identify any delaminations within the barrier.

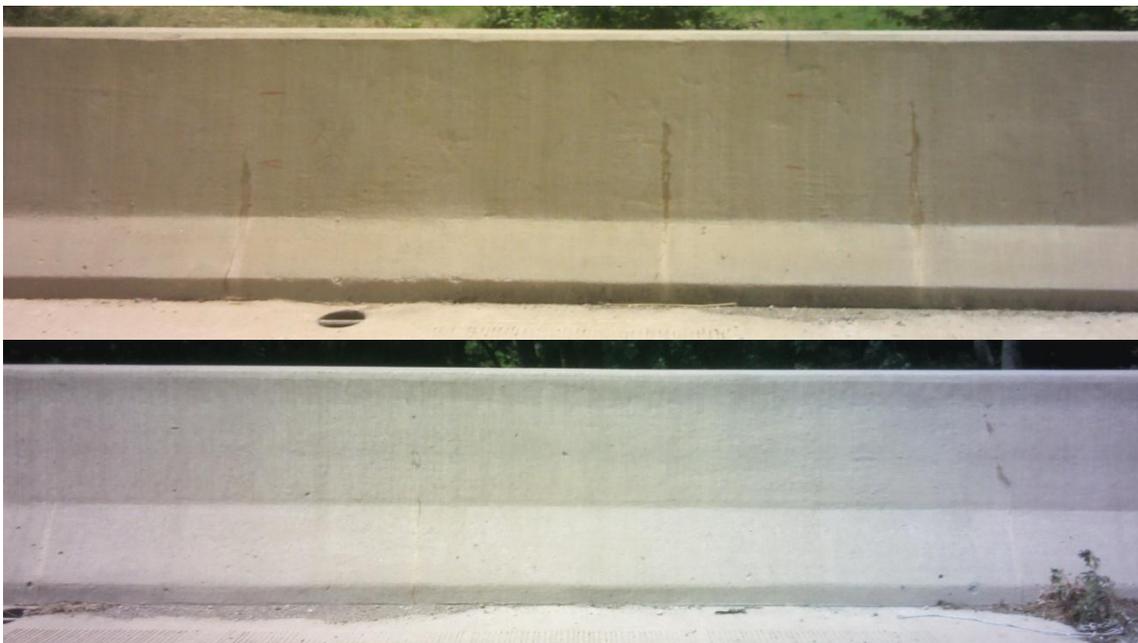
Lane protection was provided for examination and testing of the full lengths (approximately 217 feet) of the east and west barrier walls. Regularly spaced vertical shrinkage cracks were present along the length of the east barrier wall (cast-in-place barrier). Minor staining indicating moisture ingress at the cracks was apparent. Similar vertical cracks were also present at a regular spacing along the length of the west barrier wall (slip formed barrier); however, the cracks were tighter (generally <math><0.005\text{-inch}</math> width) and did not show signs of water ingress. Minor slumping of the top of the barrier resulted in horizontal cracking at some locations along the length.

Figure 35. Representative portions of the east barrier (top) and west barrier (bottom) of Armington Spur over Middle Fork Sugar Creek.

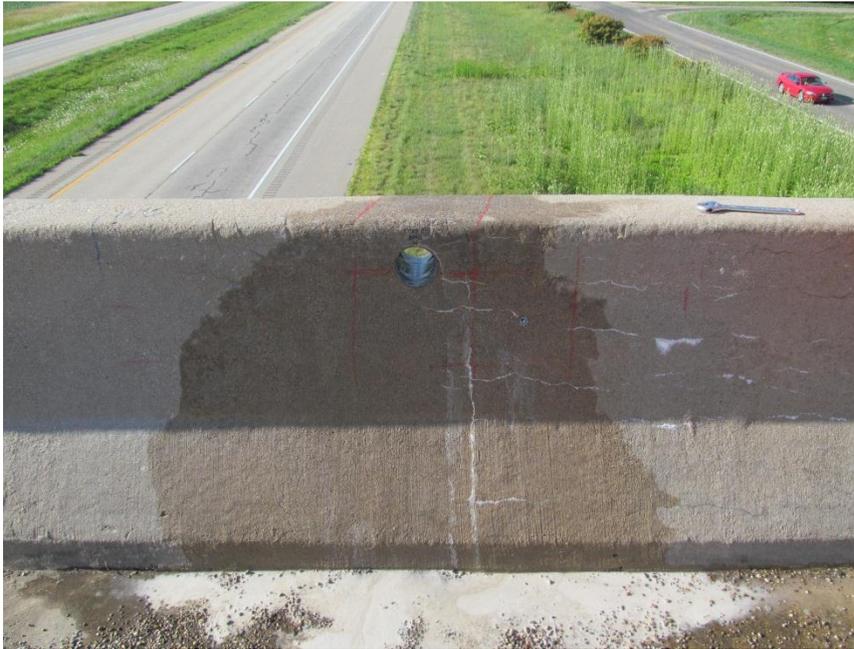
Lane protection was provided for examination and testing of the full lengths (approximately 291 feet) of the north and south barrier walls. The condition of the north barrier wall showed signs of material deterioration and moisture ingress at several locations typically measuring 10-20 feet in length. Pattern cracking with some mineral efflorescence was present on the side faces typically near the top of the barrier (Figure 37). The condition of the south barrier wall was considerably worse than the north barrier. Vertical cracks were typical along the length of the barrier. At several locations along the length, pattern cracking was severe and extended the full height of the wall (Figure 38). At these locations, mineral efflorescence was severe and wide longitudinal cracks were present near the middle of the top surface of the barrier.

Figure 37. Representative section of the north barrier wall of Emden Road over I-155.

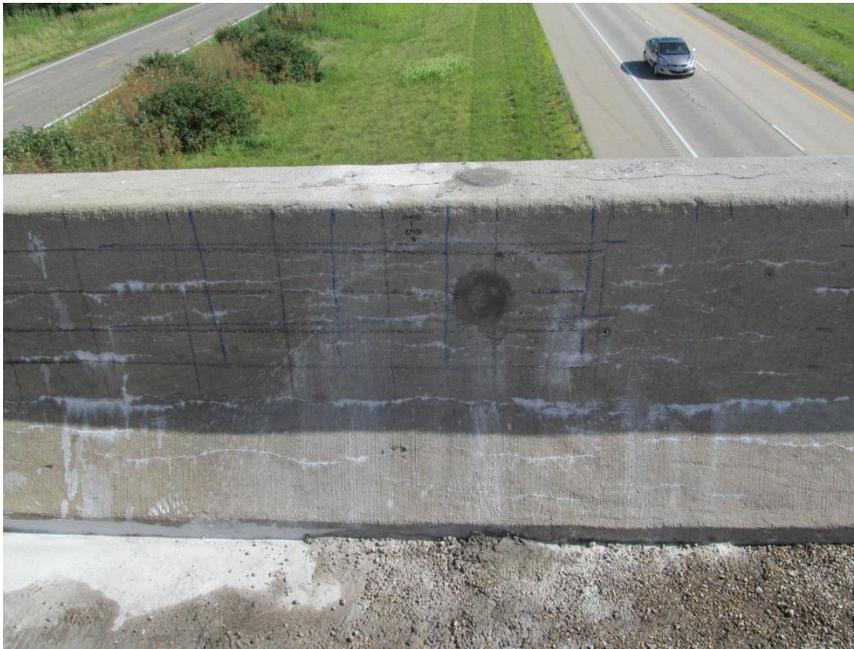
Figure 38. Representative section of the south barrier wall of Emden Road over I-155.

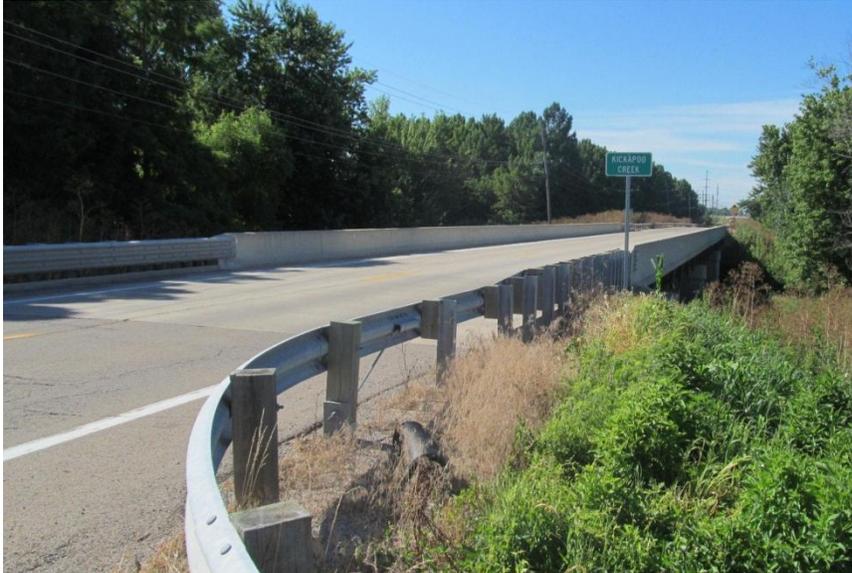
Figure 39. Views of Old 121 over Kickapoo Creek.

Lane protection was provided for examination and testing of the full lengths (approximately 223 feet) of the east and west barrier walls. The condition of the east and west barrier walls was similar. No visible distress was observed on the sides or top faces of the barriers.

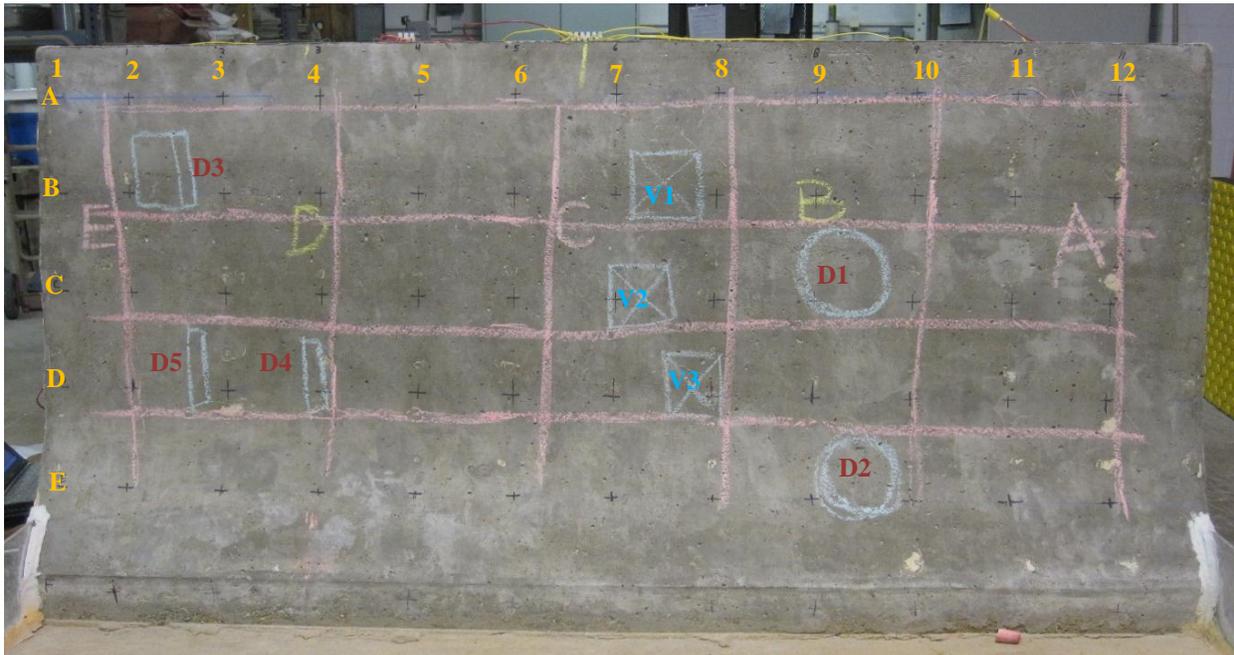
Figure 41. View of interior face of the mock-up barrier wall indicating locations of embedded voids (V1-V3) and honeycomb defects (D1-D5) and IE testing grid labels.

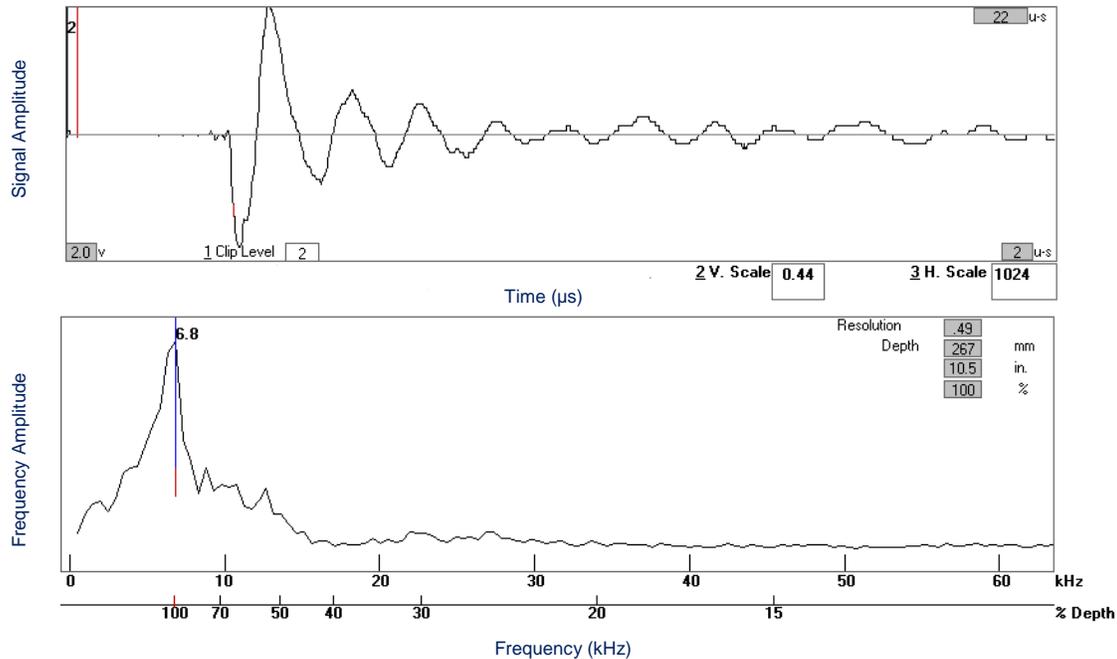
Figure 42. IE test result showing a reflection from the exterior surface of the barrier wall at a depth of 10.5 inches (IE Test Location A-7).

Figure 42 provides the test result at a location on the interior face of the mock-up wall at which no internal flaws were present (IE Test Location A-7). The upper plot in Figure 42 shows the time domain for the longitudinal stress wave received by the displacement transducer. The time domain plot, which displays the signal amplitude on the y-axis and time along the x-axis, represents the sinusoidal waveform received after reflection from any internal interfaces, in this case from the back surface of the mock-up wall. The lower portion of the figure displays the spectral plot, which displays the occurrence of each frequency at which the received waveform occurs. Each dominant frequency peak corresponds to a thickness at which a possible internal interface occurs. At this test location, the only dominant frequency occurs at 6.8 kHz; indicative of the nominal 10.5-inch thick concrete wall using a calibrated ultrasonic velocity of 11,900 feet per second.

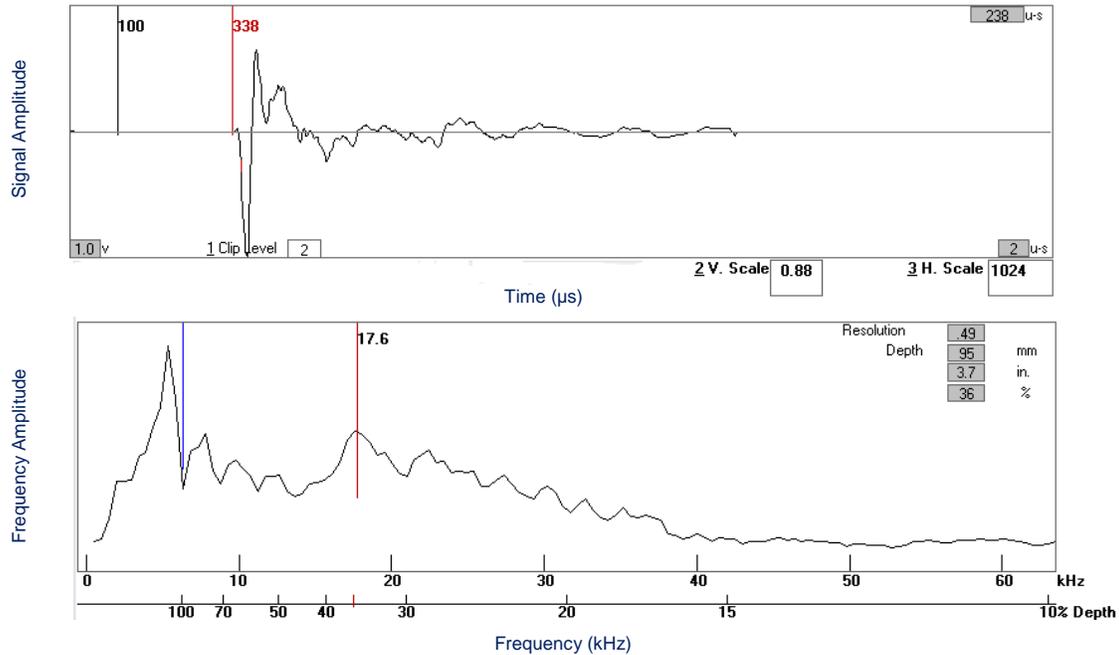
Testing at areas of potentially unsound concrete, internal cracking, or planar delamination results in variations in the time signal and frequency spectrum. Shallow delamination, for instance, typically results in erratic, high amplitude time signals and low frequency peaks in the spectral plot. Deeper internal cracks and planar delamination typically results in irregular time signals, which may identify several dominant frequencies coinciding with the approximate flaw depths. Figure 43 shows an IE test result at void panel location V2. At this test location, the received time-domain waveform consists of higher frequency content and the spectral plot displays high-frequency peaks. Note that a dominant frequency peak occurs at 17.6 kHz, a frequency corresponding to an approximate void depth of 3.7 inches from the exterior surface. Figure 44 shows an IE test result at honeycomb panel location D3. At this test location, the received time-domain waveform consists of higher frequency content and the spectral plot displays high-frequency peaks. Note that several high-frequency peaks occur, including one at 23.4 kHz, a frequency corresponding to an approximate flaw depth of 2.8 inches from the exterior surface.

Figure 43. IE test result at embedded void location V2 (IE Test Location C-7.2).

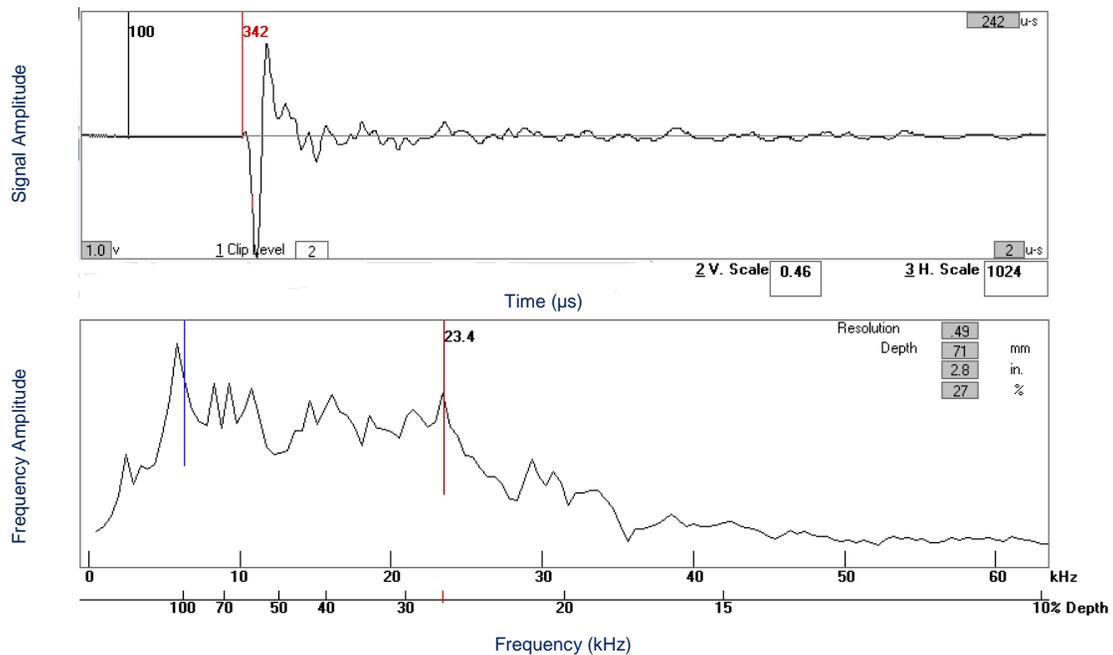
Figure 44. IE test result at embedded flaw location D3 (IE Test Location B-2.5).

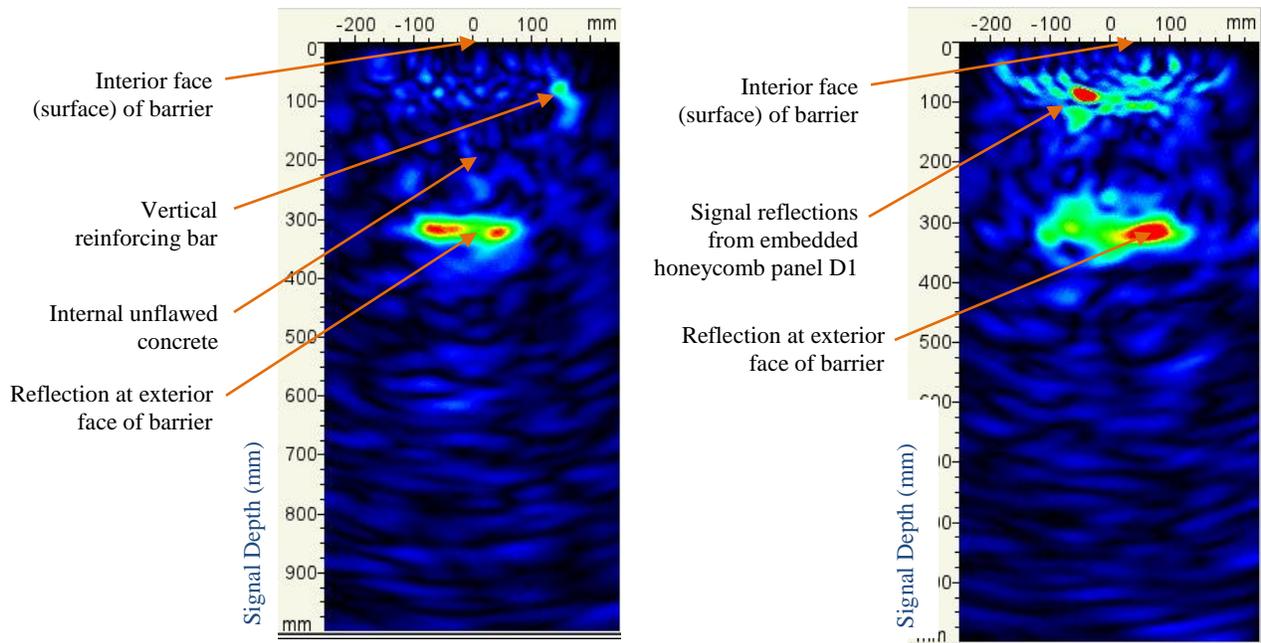
Figure 46. MIRA test results (B-scan) at two test locations on the mockup barrier wall. Left: Test result at unflawed location showing reflection from the exterior face of the wall and vertical reinforcing. Right: Test result at flawed location showing internal reflections resulting from embedded honeycomb panel D1.

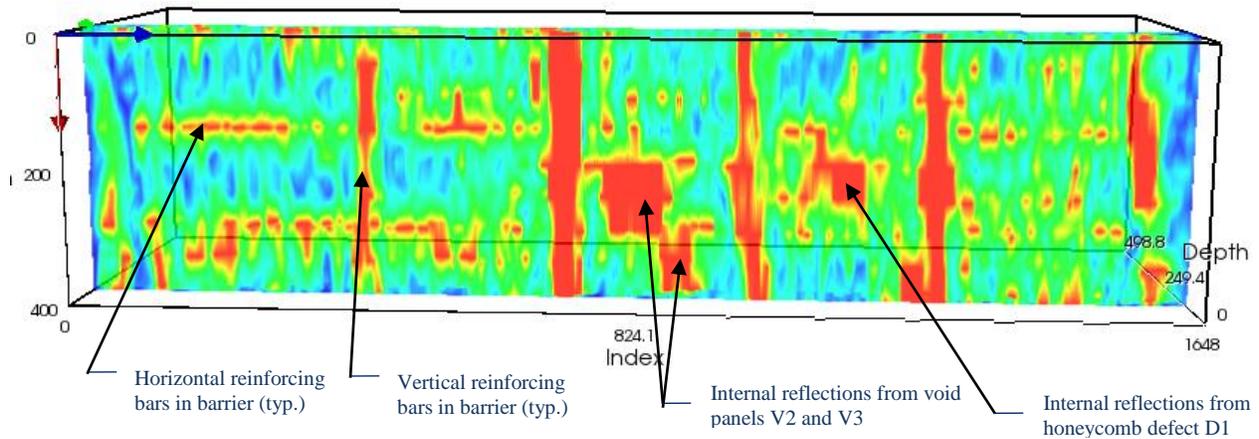
Figure 47. Internal tomographic image (filtered) of a portion of the mockup barrier wall resulting from MIRA testing at testing grid MU5 (indicated in Figure 45). Filtered image includes data from depth of 3 to 8 inches.

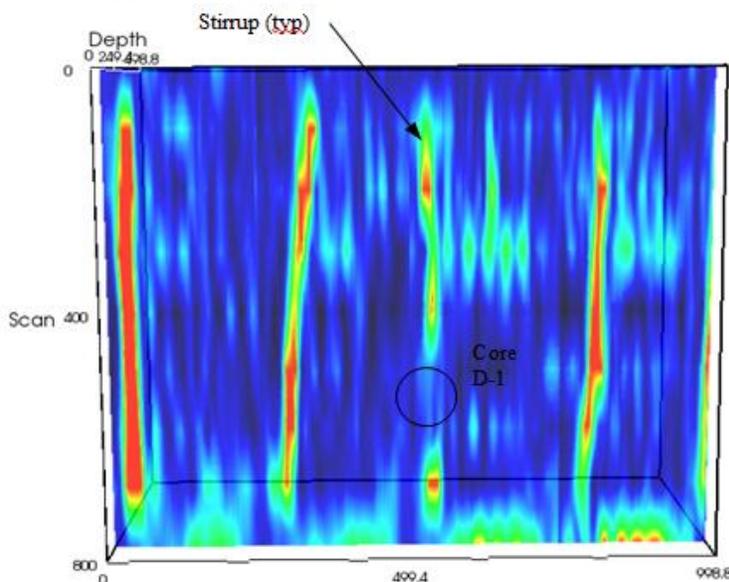
Figure 48. MIRA Result: Elevation view, Killian Test Sample 1, Interior Face. MIRA Analysis Results: No anomalies identified, high resolution through full thickness of barrier.

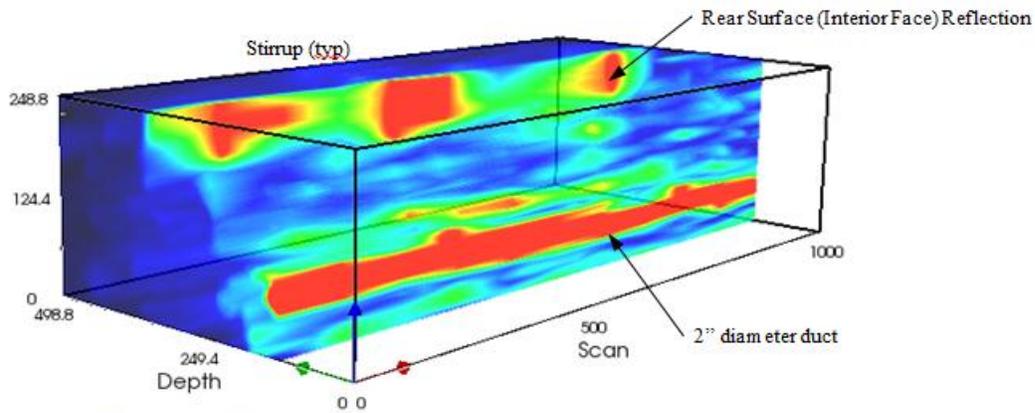
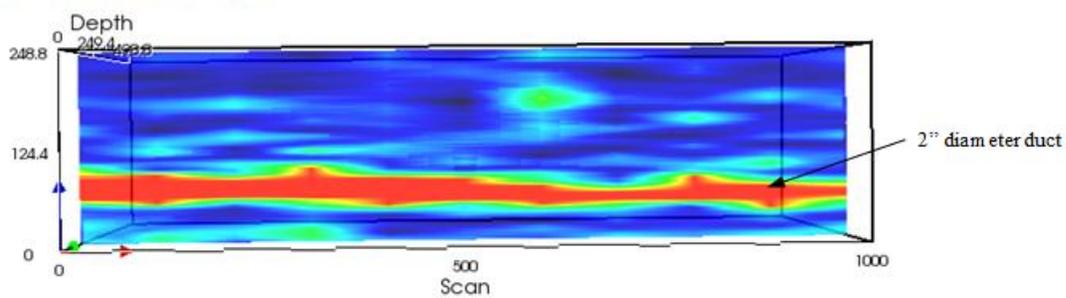
In addition to the laboratory mock-up testing, MIRA testing was performed on the Killian trial barrier segments. Results of the testing indicated that shear wave ultrasonic testing of early-age slip formed barrier walls (48 hour after construction) was feasible and could provide relatively high resolution tomographic imaging for internal flaw detection (Figure 48). Furthermore, MIRA testing performed along the bottom of the Killian barrier wall segments was able to identify the presence of embedded 2-inch diameter conduit (Figure 49 and Figure 50).

Figure 50. MIRA Result: Isometric view, exterior elevation view. Killian Test Sample 2, Exterior face. MIRA Analysis Results: 2" diameter cable duct (nearest tested surface) clearly identified.

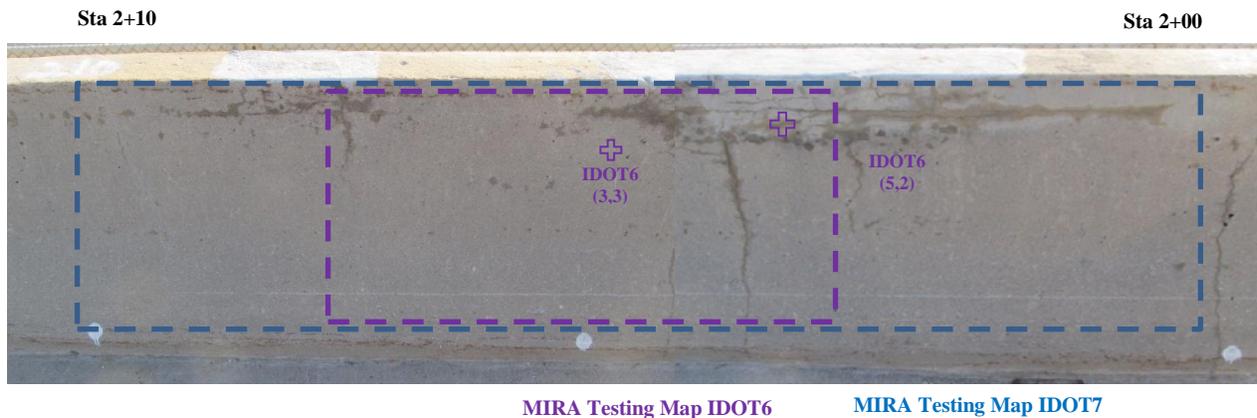
Testing of the selected portions of the northbound barrier wall at Iowa 150 over Cedar River using the MIRA system yielded similar testing results compared with the mock-up barrier wall assessment. Figure 51 through Figure 54 provide examples from several MIRA testing maps collected on the northbound barrier wall using a dominant testing frequency of 75 KHz. Testing at the higher frequency provided better resolution and did not result in near-surface signal reflections during field testing compared with the mock-up barrier wall testing. An elevation view of the interior face (west elevation) of the northbound barrier wall indicating the locations of selected testing maps is provided in Figure 51. Selected individual test results, displayed as B-scan section views of the barrier wall, are shown in Figure 52. The B-scans show high amplitude reflections from embedded reinforcing and the back surface of the barrier wall at an unflawed testing location (Figure 52, left) and internal reflections resulting from freeze-thaw cracking visible at the surface of the barrier (Figure 52, right). A composite tomographic image of the internal reflections resulting from testing of a full testing map is provided in Figure 53 and Figure 54. The unfiltered tomographic image provided in Figure 53 shows the capability of the MIRA testing method to identify embedded reinforcing, the exterior surface of the barrier, and the extent of internal and surface cracking and material degradation. A filter isometric image provided in Figure 54 further highlights the deterioration.

Figure 51. Photograph of interior face of the northbound barrier wall of Iowa 150 over Cedar River showing condition of barrier and indicating locations of MIRA testing grids and individual test points referenced in the following figures.

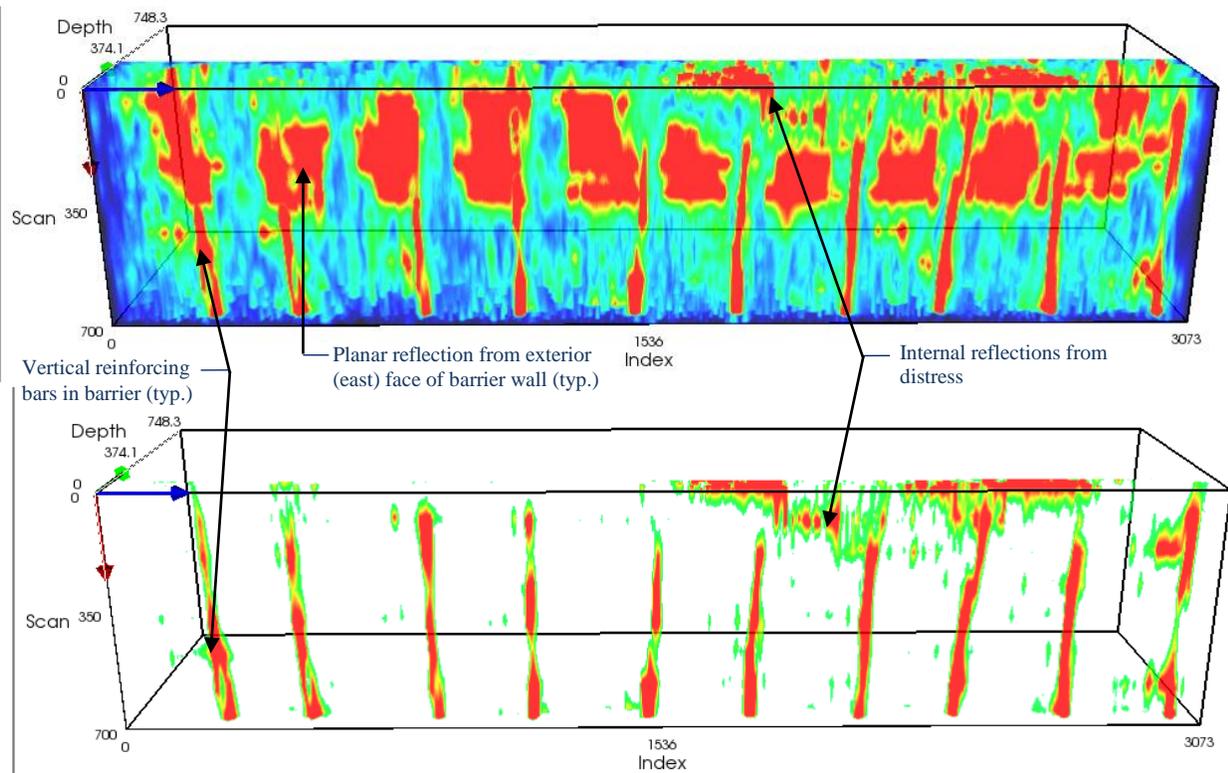
Figure 53. Internal image of the northbound Iowa 150 barrier wall resulting from MIRA testing at Map IaDOT7. Views of interior (west) face of wall showing composite image to depth of approximately 10 inches (top) and filtered image to depth of approximately 6 inches (bottom).

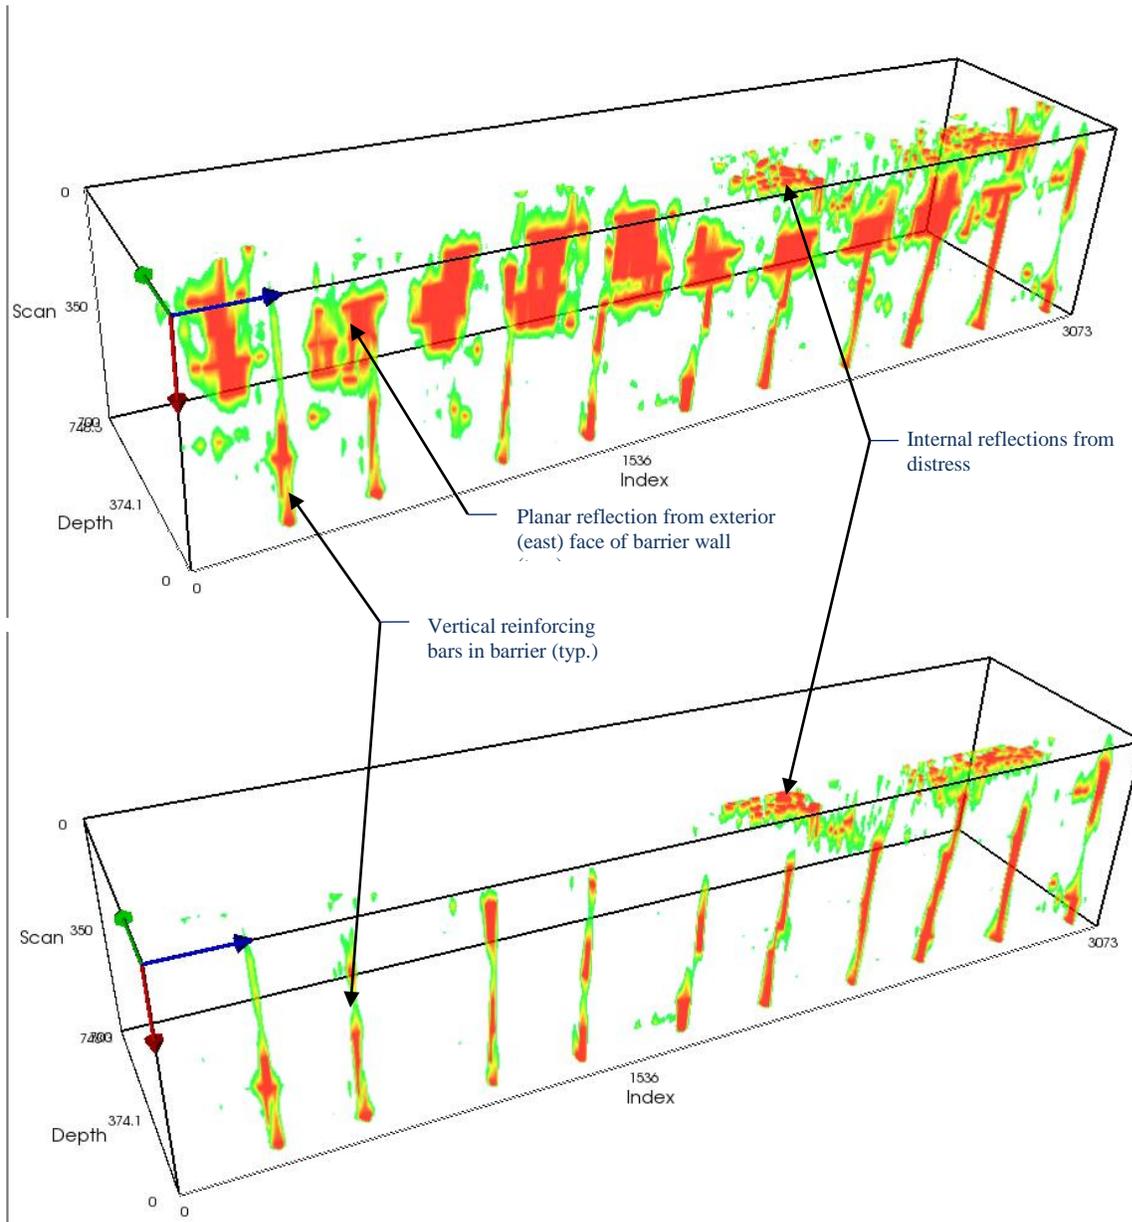
Figure 54. Isometric internal image of the northbound barrier wall of Iowa 150 over Cedar River resulting from MIRA testing at Map IaDOT7. Filtered image to depth of approximately 10 inches (top) and filtered image to depth of approximately 6 inches (bottom).

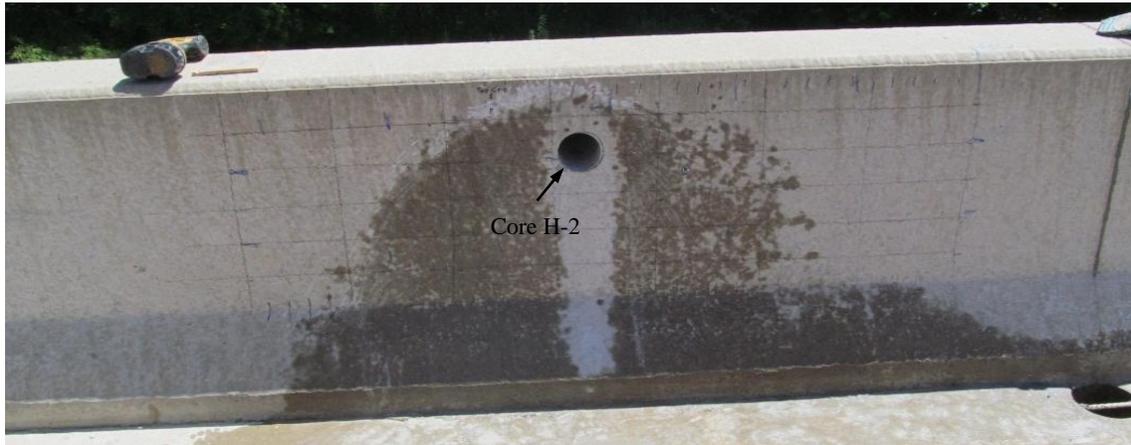
Figure 55 shows MIRA testing grid H-1/H-2 on the interior surface of the east barrier of the Kickapoo Creek Bridge [IDOT Str. No. 054-0505]. Results of the MIRA testing are provided in a selection of views of the tomographic data shown in Figure 56. The interior elevation views provided for Grid H-1 (horizontal test grid) and H-2 (vertical test grid) show that the reinforcing can be clearly identified. Signal reflection from the exterior face of the barrier is visible in the B-scan (horizontal section) from Grid H-1 and the isometric view and D-scan (vertical section) from Grid H-2. Signal resolution was relatively good at this location, indicating unflawed internal conditions. Core H-2, shown in Figure 57, indicated well-consolidated concrete and one isolated void (~1/2 inch diameter) near the exterior face. This void was not identified in the MIRA data and is likely too small to be detected from the interior face.

Figure 55. Photograph of Grid H-1/H-2. Grid Location: Kickapoo Creek, east barrier, 74'-2" - 80'-0" from N end.

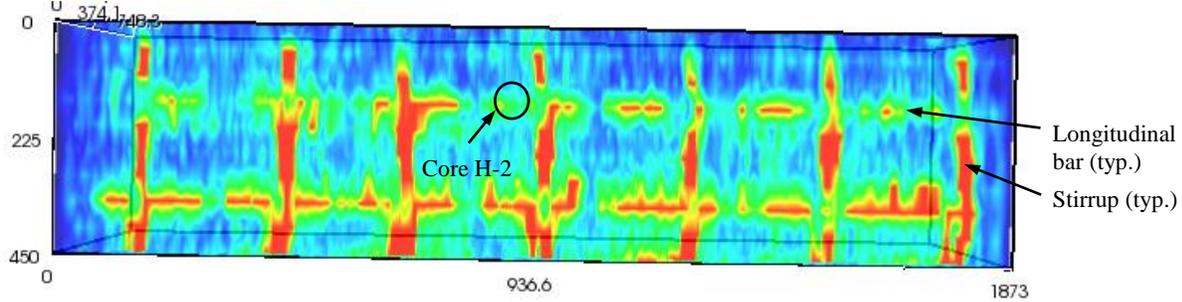
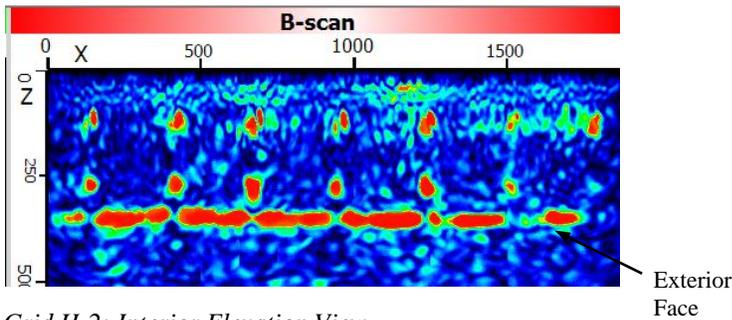
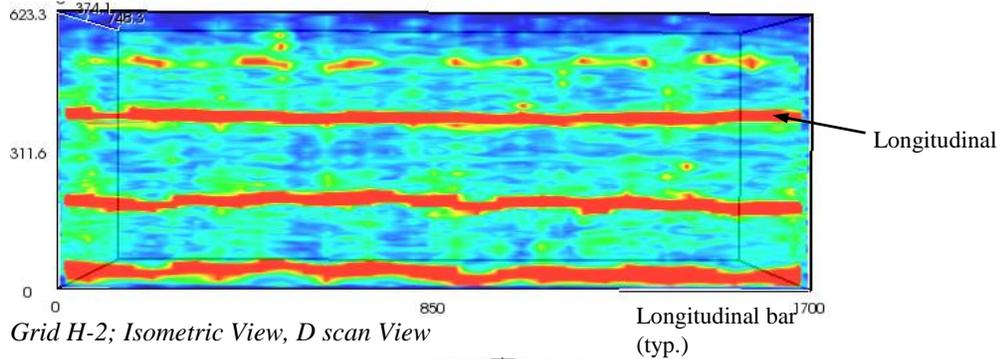
Figure 56. Grid G-2 MIRA Result: Elevation, B-scan, and sliced isometric images. Grid Location: Kickapoo Creek, east barrier, 74'-2" - 80'-0" from N end. MIRA Analysis Results: Interior and exterior reinforcing identifiable, good reflection from back surface, no internal voids observed.

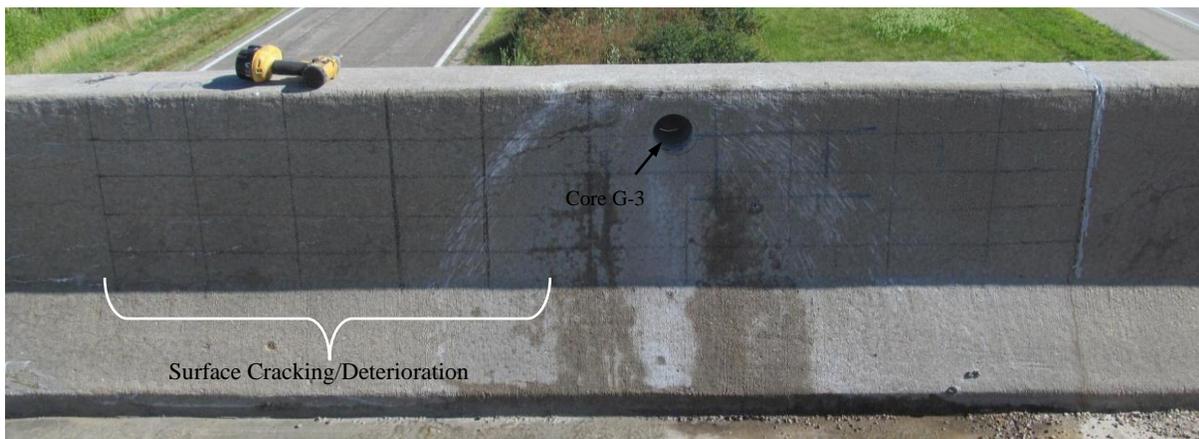
Figure 58 shows MIRA testing grid G-2 collected on the interior surface of the south barrier of the Emden Road Bridge [IDOT Str. No. 054-0078]. Results of the MIRA testing, shown in Figure 59, show the inability of the test method to penetrate beyond areas that are visibly deteriorated on the surface (surface cracking, evidence of freeze-thaw deterioration). Note that MIRA testing did identify additional internal distress extending beyond those areas that were visibly deteriorated on the surface. Embedded reinforcing and the exterior surface of the barrier can be identified at the right side of the testing grid, within tested areas in which no internal or exterior cracking is present. Core G-3, shown in Figure 60, indicated moderate voiding (3/8 to 1/2-inch diameter) behind reinforcing and around aggregate. Given the typical reflections from reinforcing, MIRA was not capable of identifying these voids.

Figure 58. Grid G-2. Grid Location: Emden Road, south barrier, 203'-0" - 210'-6" from W end.

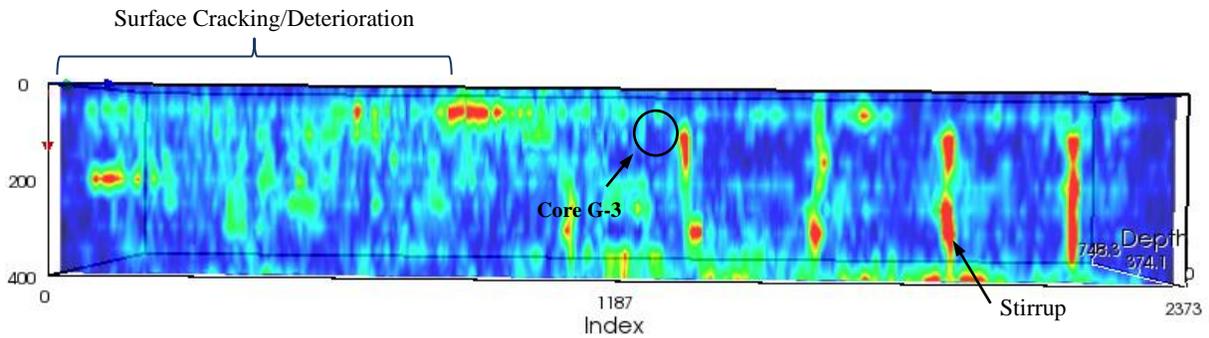
Figure 59. Grid G-2 MIRA Result: Elevation, B-scan, and sliced isometric images. Grid Location: Emden Road, south barrier, 203'-0" - 210'-6" from W end. MIRA Analysis Results: Stirrups and exterior face not identifiable on left side of grid (adjacent to areas that are visibly deteriorated). Extent of deterioration (surface and possible internal cracking) can be seen in MIRA result. MIRA result does not confirm presence of voiding around longitudinal bars.

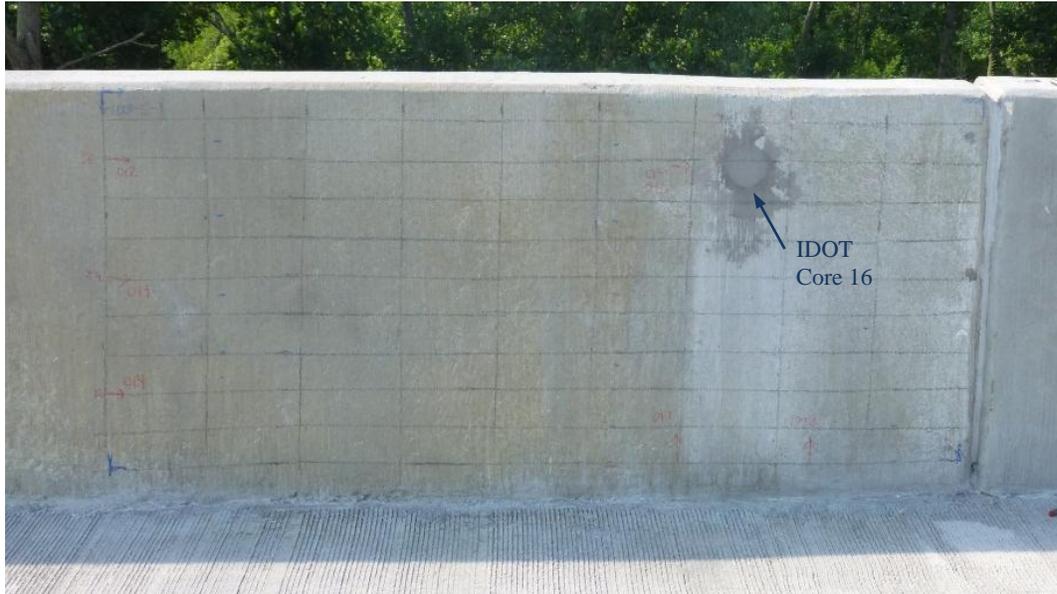
Figure 61 shows MIRA testing grid C-1 on the interior surface of the south barrier of MRB Eastbound. The resultant interior elevation view provided in Figure 62 shows several areas of internal reflections adjacent to the construction joint on the right side of the testing grid. These internal reflections were present near the interior layer of reinforcing stirrups. IDOT Core No 16, inspected by WJE after completion of the field testing, showed interconnected voids near the interior reinforcing typical of consolidation problems during slip forming (Figure 63).

Figure 61. Photograph of Grid C-1. Grid Location: MRB Eastbound, south barrier, Sta. 105+21 - 105+14.

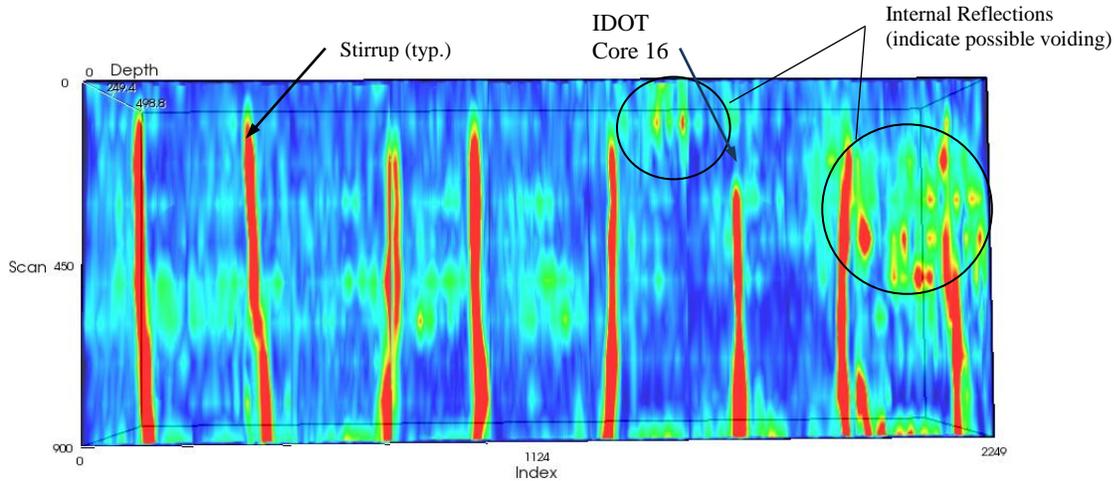
Figure 62. Grid C-1 MIRA Result:Interior elevation image. Grid Location: MRB Eastbound, south barrier, Sta. 105+21 - 105+14. MIRA Analysis Results: Internal reflections near IDOT Core No. 16 and east of joint. Probable internal voiding.
